Glenorchy flooding

Update for GCA, 2nd July 2020

HEAD OF LAKE WAKATIPU HAZARDS STRATEGY

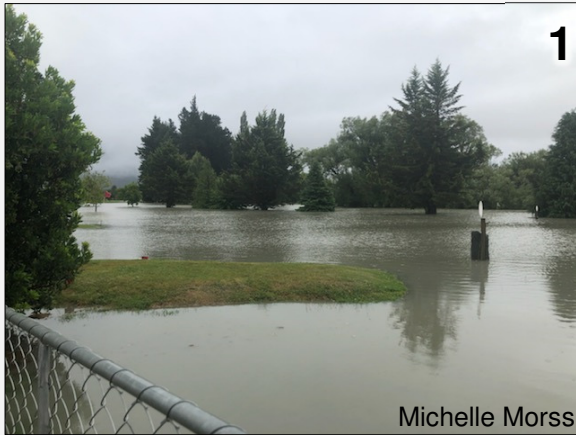
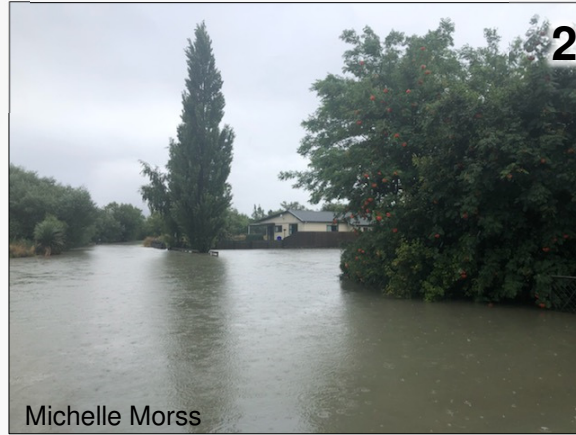
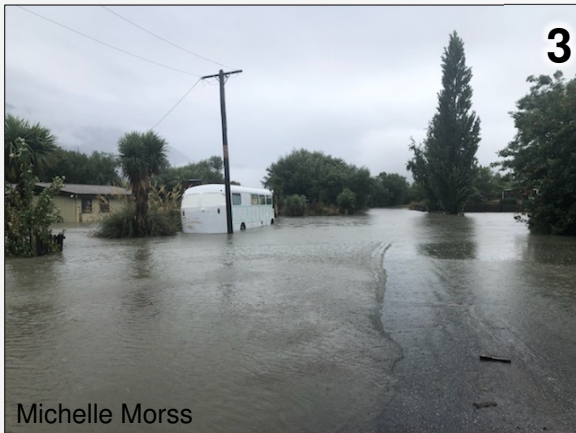
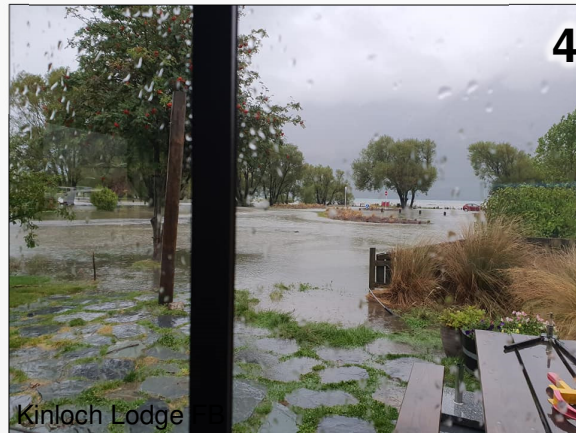
4th February 2020

*Note photos are not necessarily at flood peak

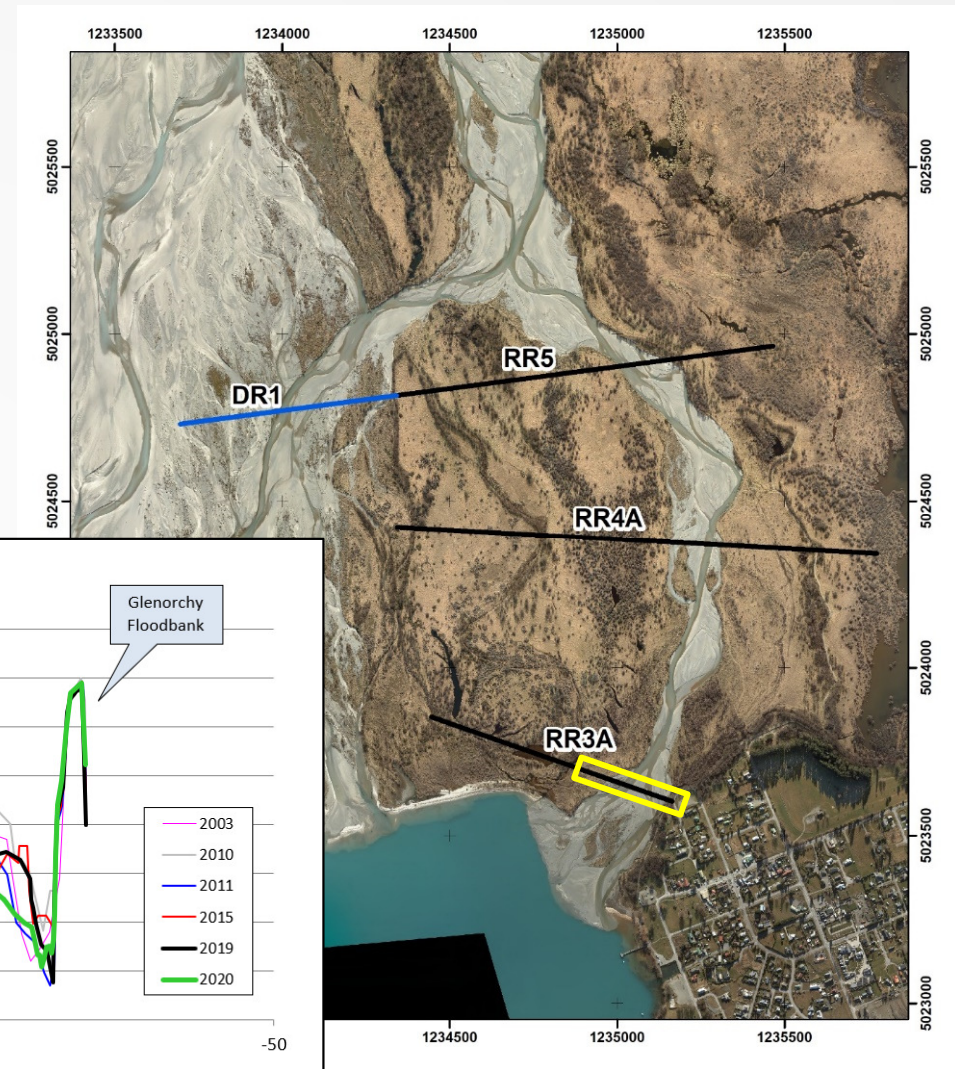
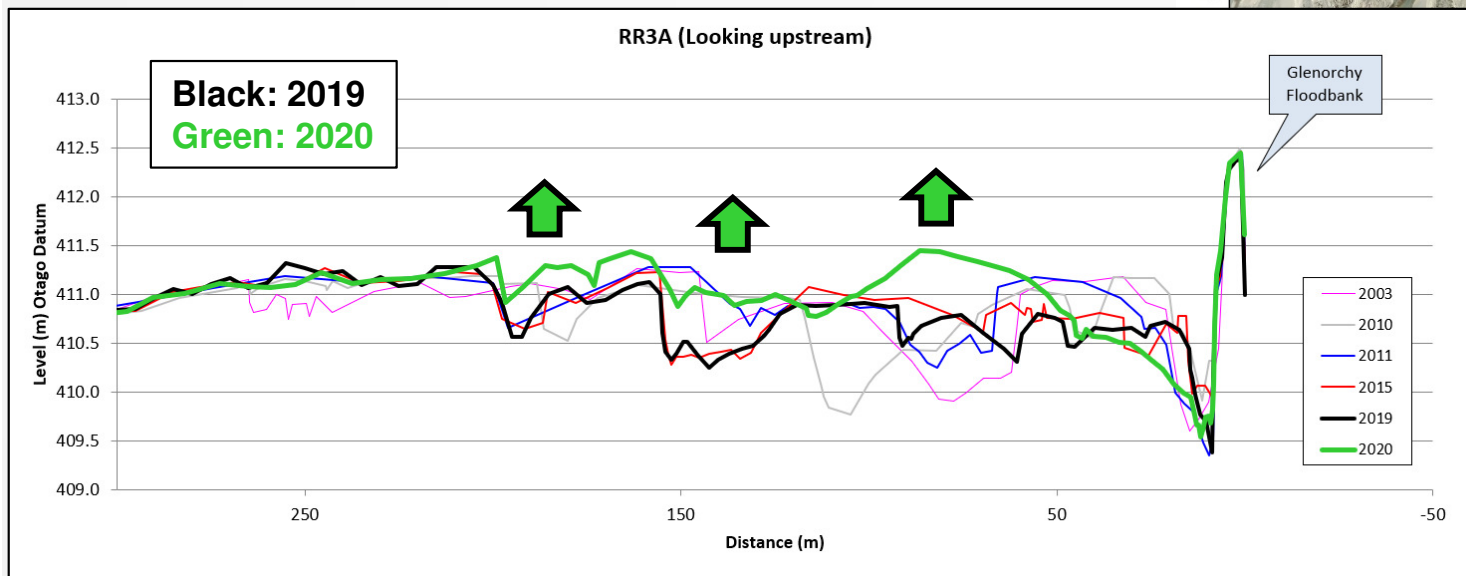
REES RIVER SURVEYS

- **DR1:** 35-40cm degradation
- **RR4A and RR5:** no change (still within 15cm of 2019 bed level)
- **RR3A:** 25-30cm aggradation

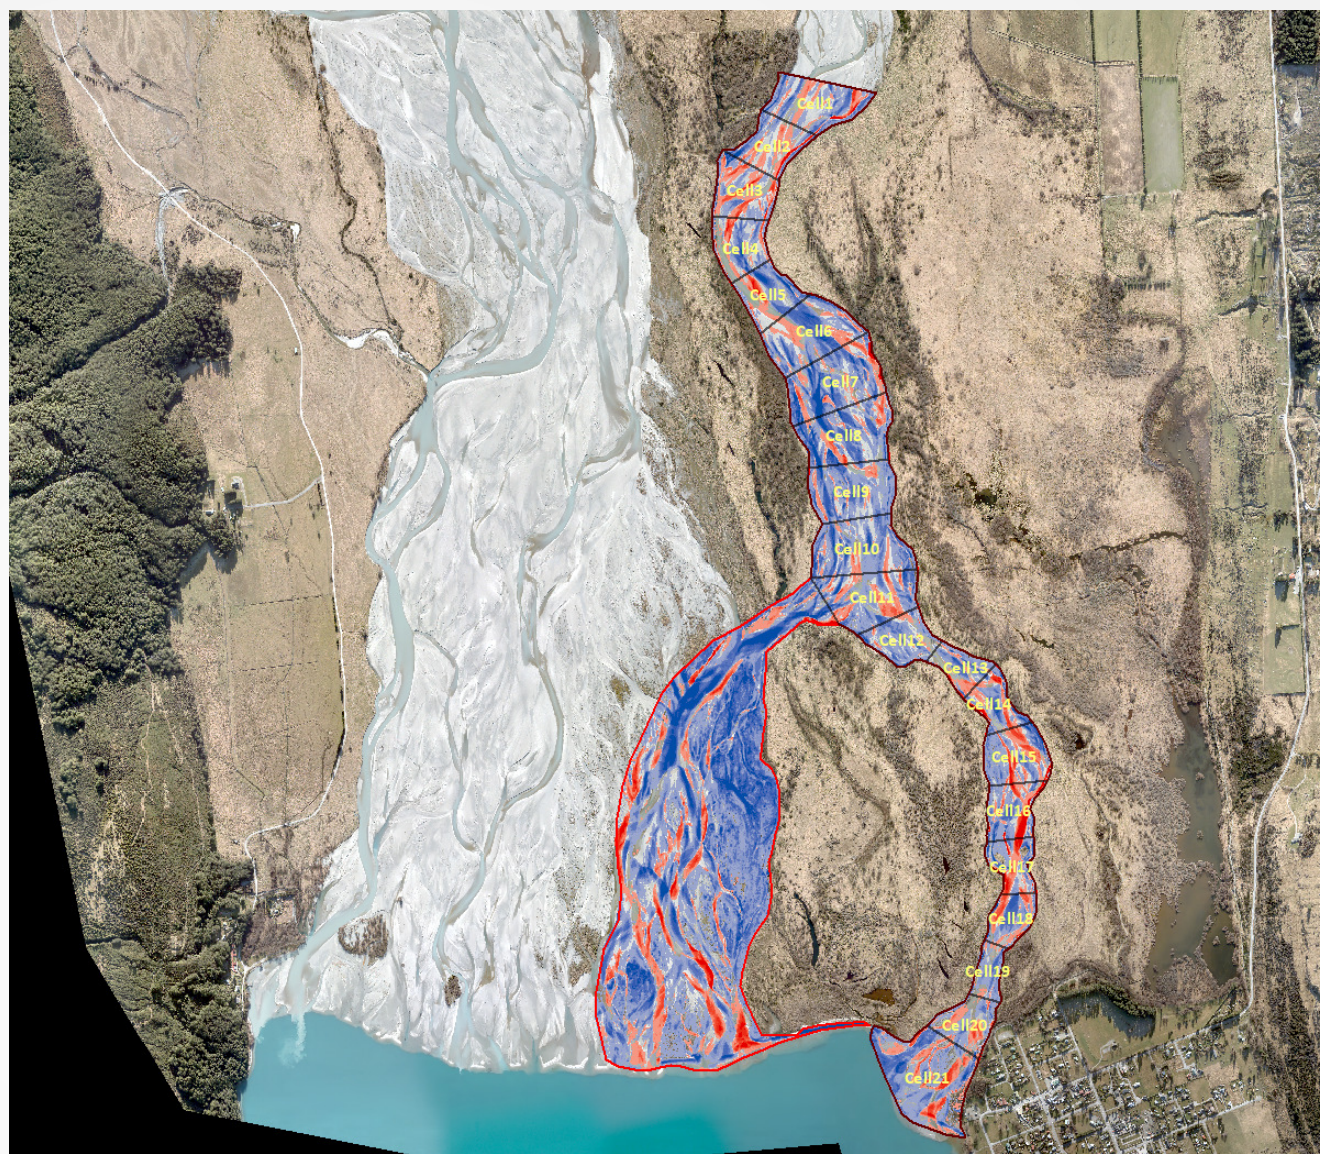
REES RIVER BED LEVEL CHANGE – 2011-2019

Blue = sedimentation
Red = erosion

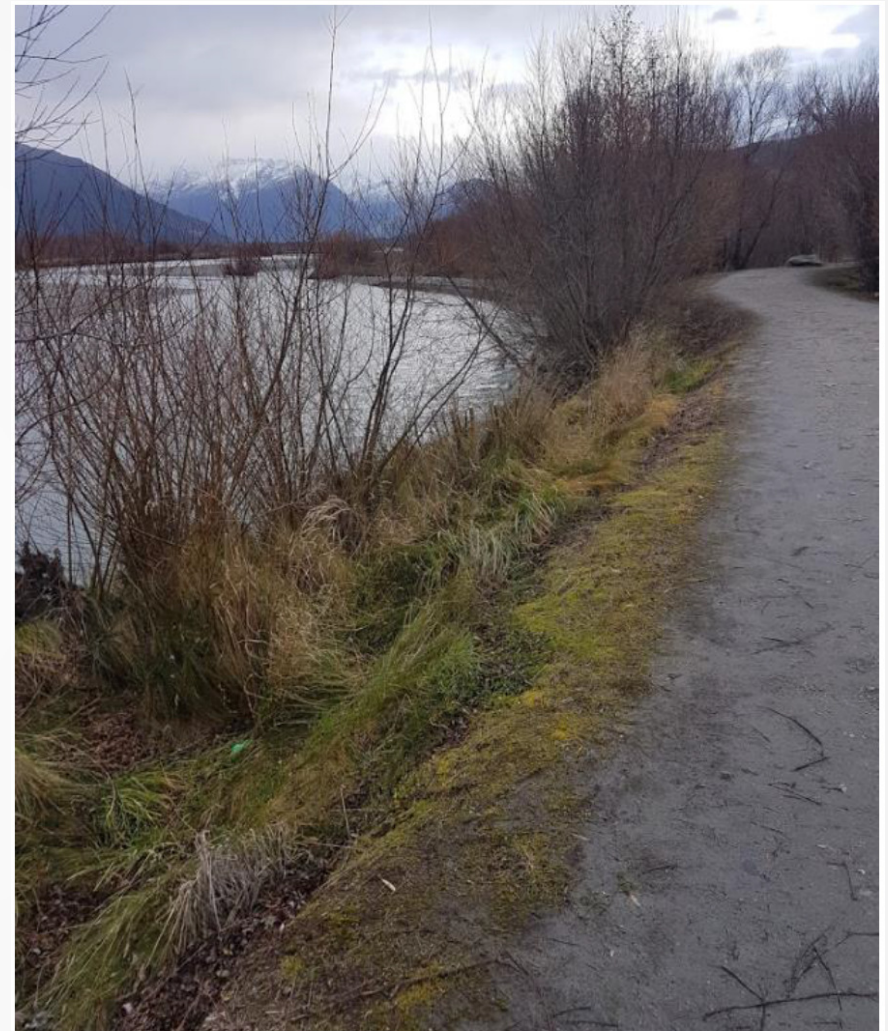
- Review of Rees River erosion and geotechnical issues at floodbank.
- Identified erosion, undermining and scarp formation on river-side of floodbank

Headscarps forming at over steep bank downstream of the Lagoon stream confluence

- Recommendations for bank protection/erosion control
- Evaluate potential for sudden floodbank failure, and possible consequences
- Recommendations for ongoing monitoring of this structure's integrity
