# Macraes MP4 Consenting Project

## Project Element 4.3.2: Open Pit Stability Assessment for Frasers TSF

PSM71-285R Rev 1

01 February 2024

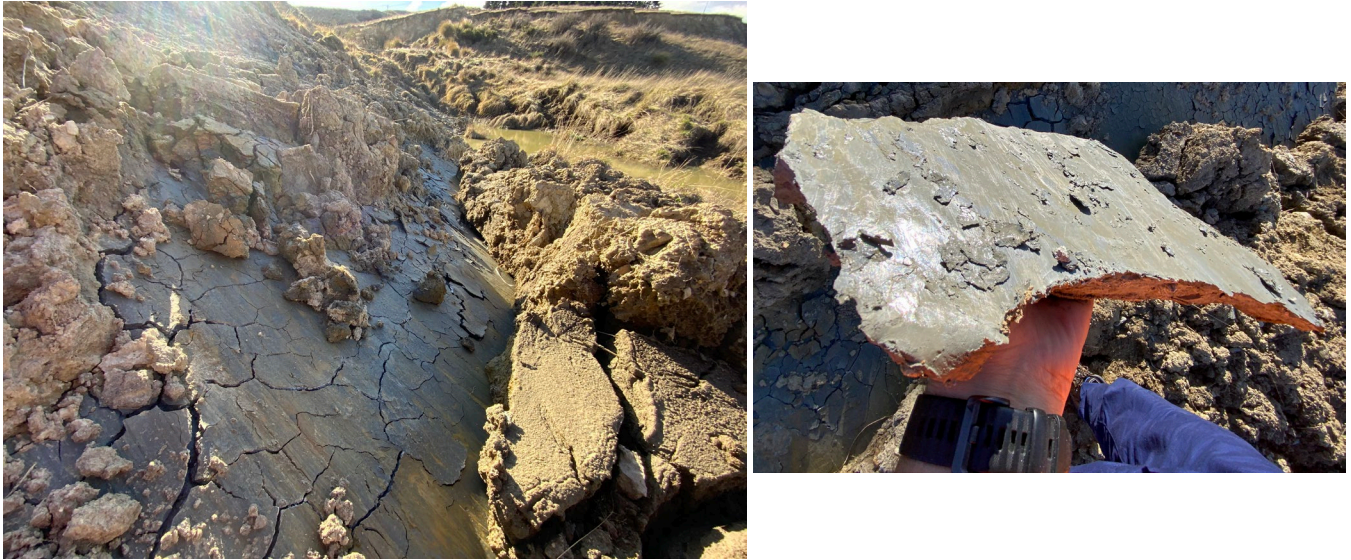
The Footwall Fault (FF) is a north-south trending regional scale fault typically dipping between 10° and 20° that delineates the base of the mineralised zone at Macraes. Geological studies completed in the late 1990s highlight the Deepdell Creek landforms as an ancient landslide with the FF as its basal plane. This provided precedent for slope movement along the FF predating mining activity. A minimum offset of 25 m perpendicular to the structure has been established as a baseline recommendation for slope design by PSM<sup>5</sup> with localised variations adopted relative to the exposure length along strike. The condition of the sliding surface (Photo 1) results in a very low friction angle, creating a highly sensitive structure that responds to small changes in pore pressure and loading.

**Photo 1: Example of the FF surface condition as exposed in the upper Frasers West headscarp. The sliding surface is described as slickensided and undulous, comprising high plasticity moist firm clay. Note: The exposed orientation does not reflect the regional geometry due to interactions with the Macraes Fault Zone.**

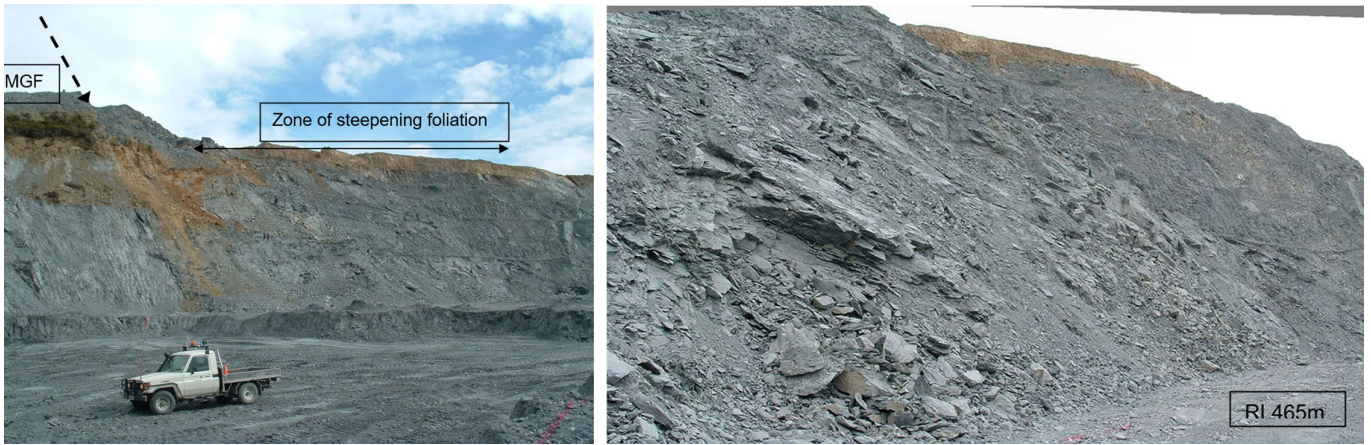
**Photo 2: MGF in west wall of Frasers South. Left: Hanging wall of MGF acting as a failure plane. Right: Close up of steepened foliation.**

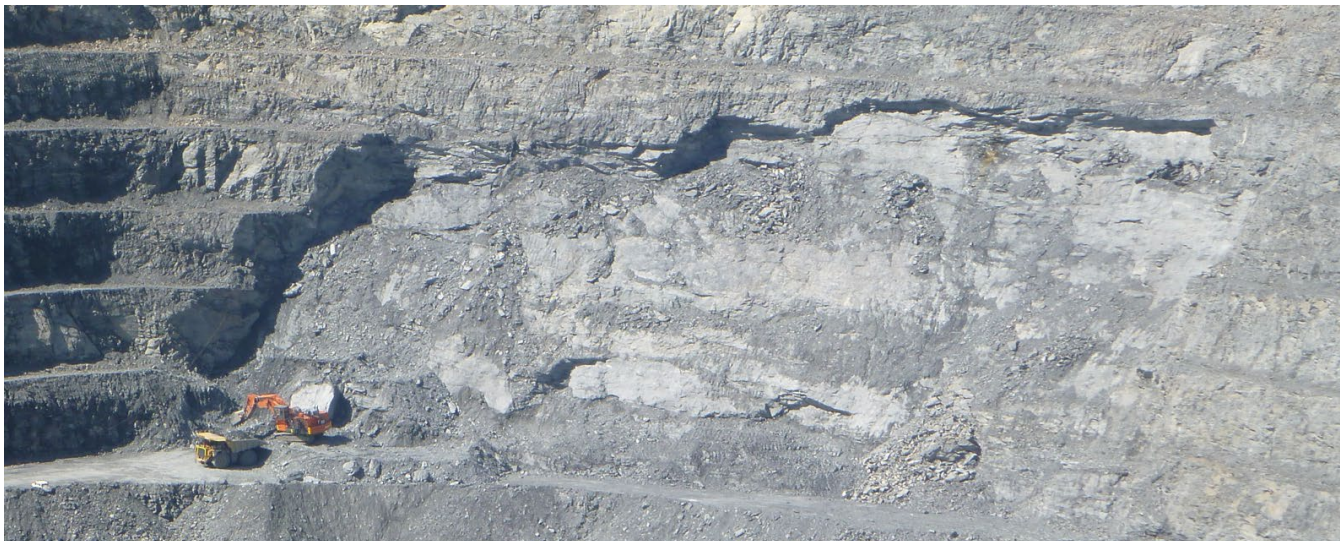
A section of the east wall failed in late 2012 during mining of Frasers Stage 5, Photo 3. The failure extended approximately 170 m laterally and 115 m vertically, from 405 mRL down to 290 mRL<sup>7</sup>. The failure was assessed to be structurally controlled, with sliding occurring along the following structures:

- A continuous rear shear/fault structure oriented sub-parallel to wall, dipping west at approximately 44°:
  - A series of conjugate structures were also observed to be associated with the main shear/fault structure
  - The failure plane appears to have come close to, or daylighted, at the toe of the slide
- Cross-cutting second order joints, observed at the flanks of the failure, Photo 4. These structures acted as side-release planes truncated against the basal surface.

**Photo 3: Frasers east wall failure during mining showing the interim base of failure at 330 mRL.**

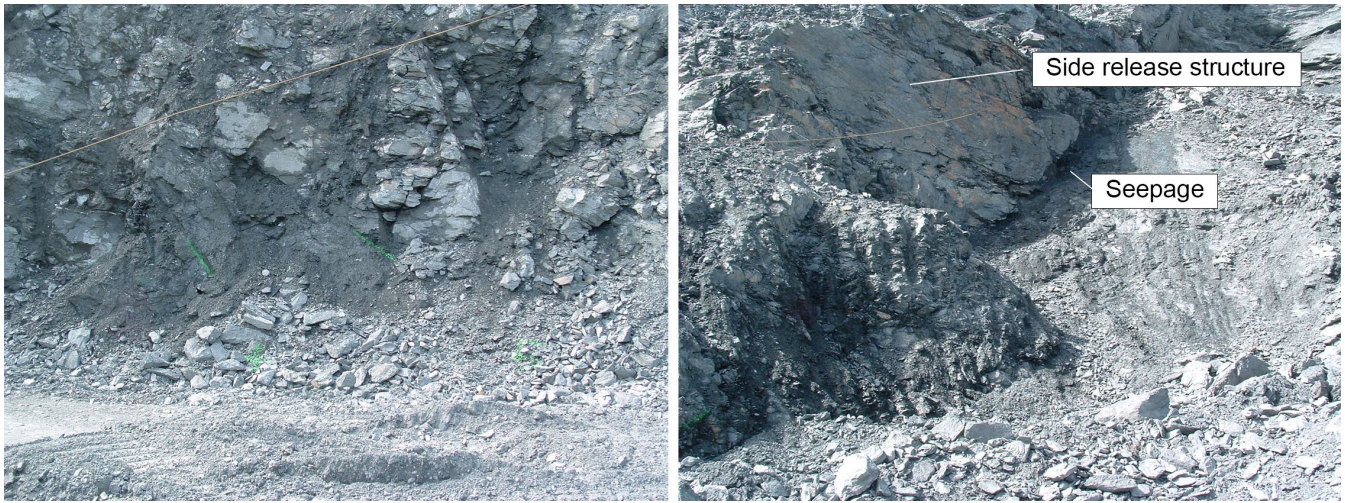
**Photo 4: Structural controls of east wall failure. Left: cross-cutting structures in rock mass near failure. Right: northern flank of failure showing side release structure and seepage.**

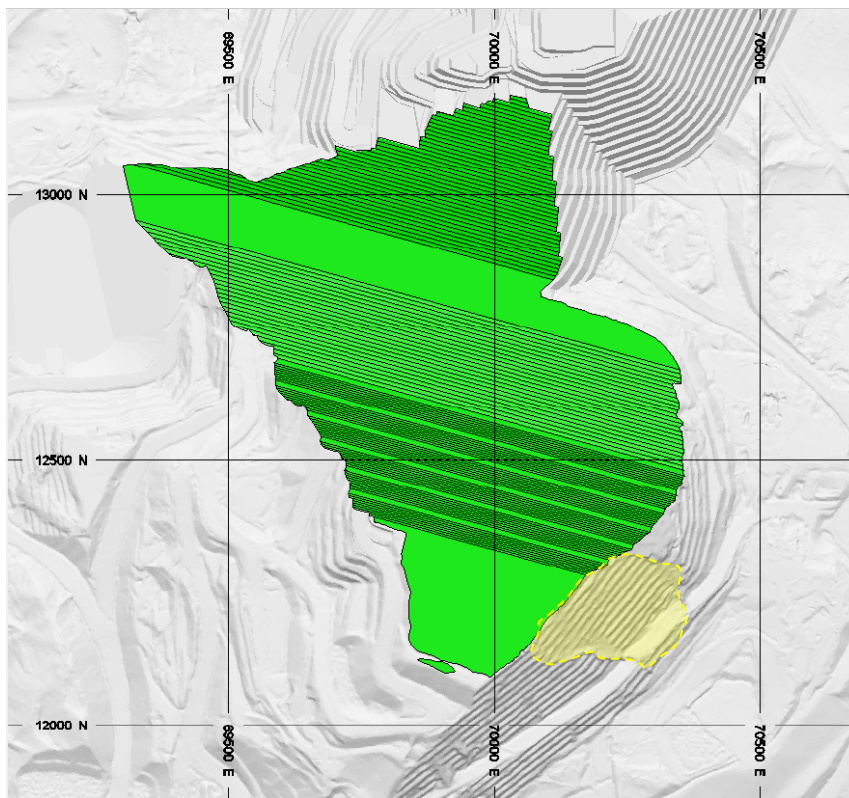
A package of stopes within Frasers Underground (FRUG) known as the “3P’s” are located beneath the east wall of FROP. During December 2022 a localised production blast within these stopes initiated slope movement along a package of geological structures, extending laterally from 2013 failure and truncated by the Hanging Wall Shear at its base. The extent of movement is presented in plan relative to the proposed FTSF embankment geometry, Inset 2. To limit further strain in the rock mass all further development within the 3P’s stopes was halted following the observed movement.

**Inset 2: East wall slope instability extents following 2022/2023 movement. Proposed FTSF embankment geometry overlain for context.**

Buttress support will be provided to this area by the upstream shoulder of the FTSF embankment and deposition of tailings. Construction staging of the FTSF should be assessed during detailed design to manage highwall stability and associated risk of further slope movement. This is an example of potential long-term degradation of the highwalls and helps to define a zone of influence for closure around the pit crest.

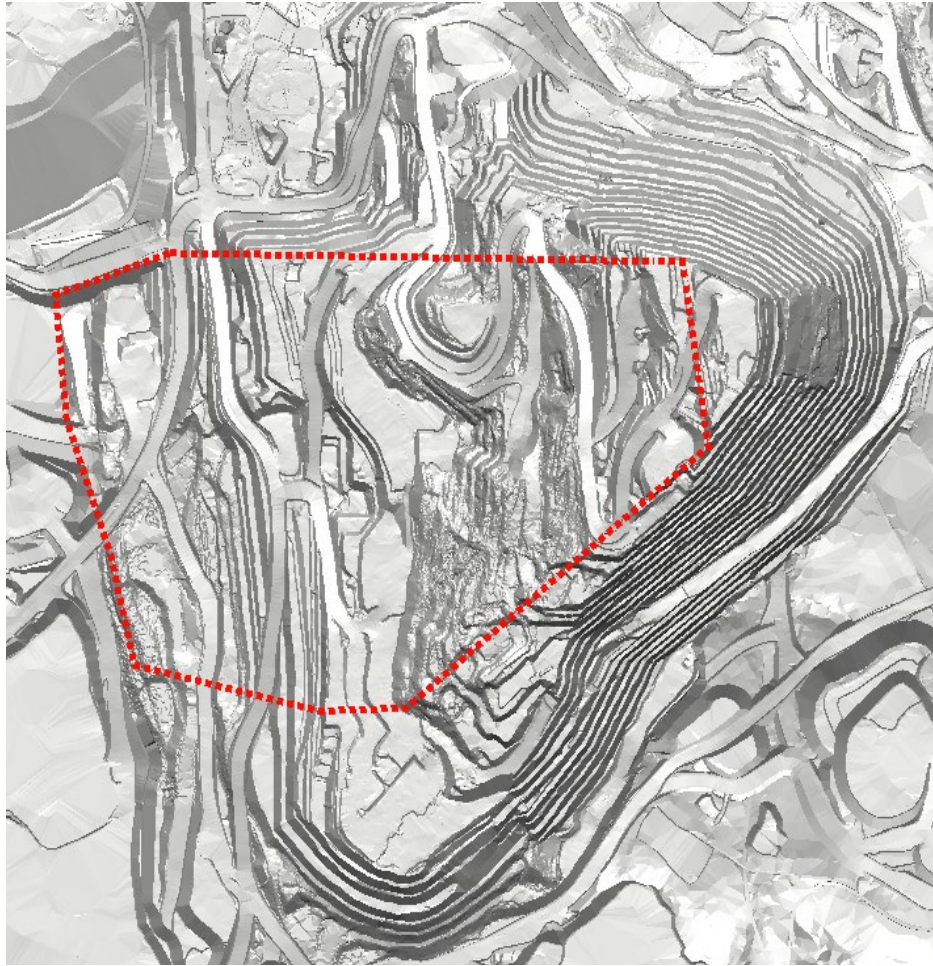
A 20 Mm<sup>3</sup> failure occurred within the west wall on 19 April 2014 following a heavy rainfall event and considered to be a reactivation of the January 2013 failure<sup>8</sup>. The failure extent is shown in Inset 3 and summarised below:

- The northern margin is well-defined at approximately 12500 mN. It is created by a series of discrete joints and cracks induced by previous movement including the 5 January 2013 failure, Photo 5
- The southern margin of the failure is indistinct, blending into the open pit excavation. It approximately coincides with 11800 mN, Photo 5
- The failure stopped against the east wall and pushed up tens of metres of toe heave
- The FF is the basal plane of the failure. The FF has been exposed in part of the failure's headscarp, Photo 6 and Photo 7
- Areas of the failure mass moved up to 200 m into the pit.

**Inset 3:** Approximate extents of the April 2014 20 Mm<sup>3</sup> west wall failure.

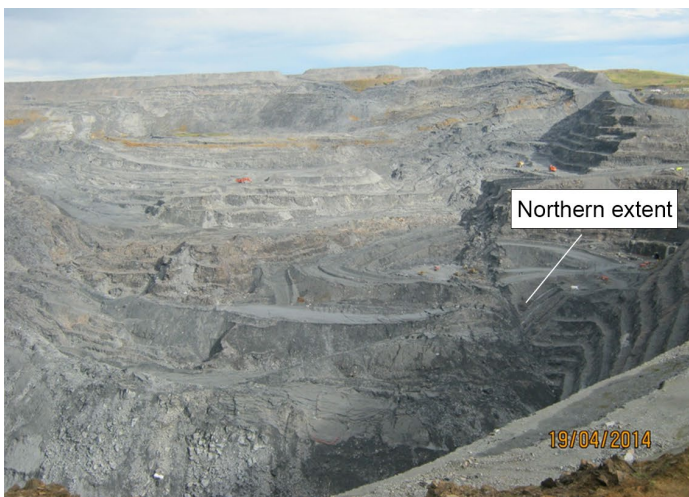
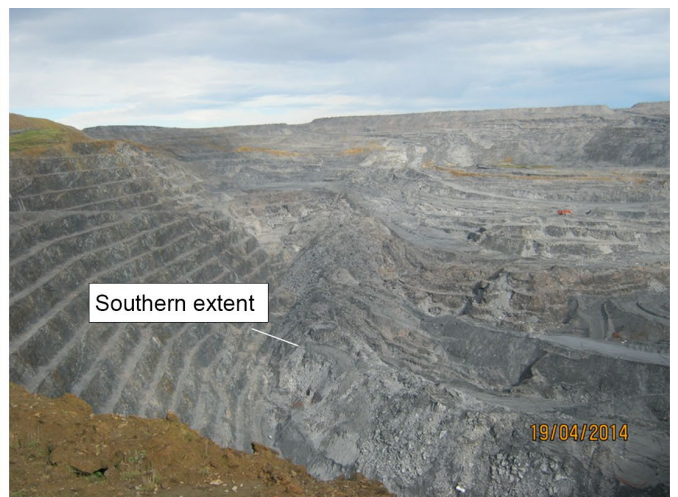
**Photo 5:** Northern and southern extent of failure.

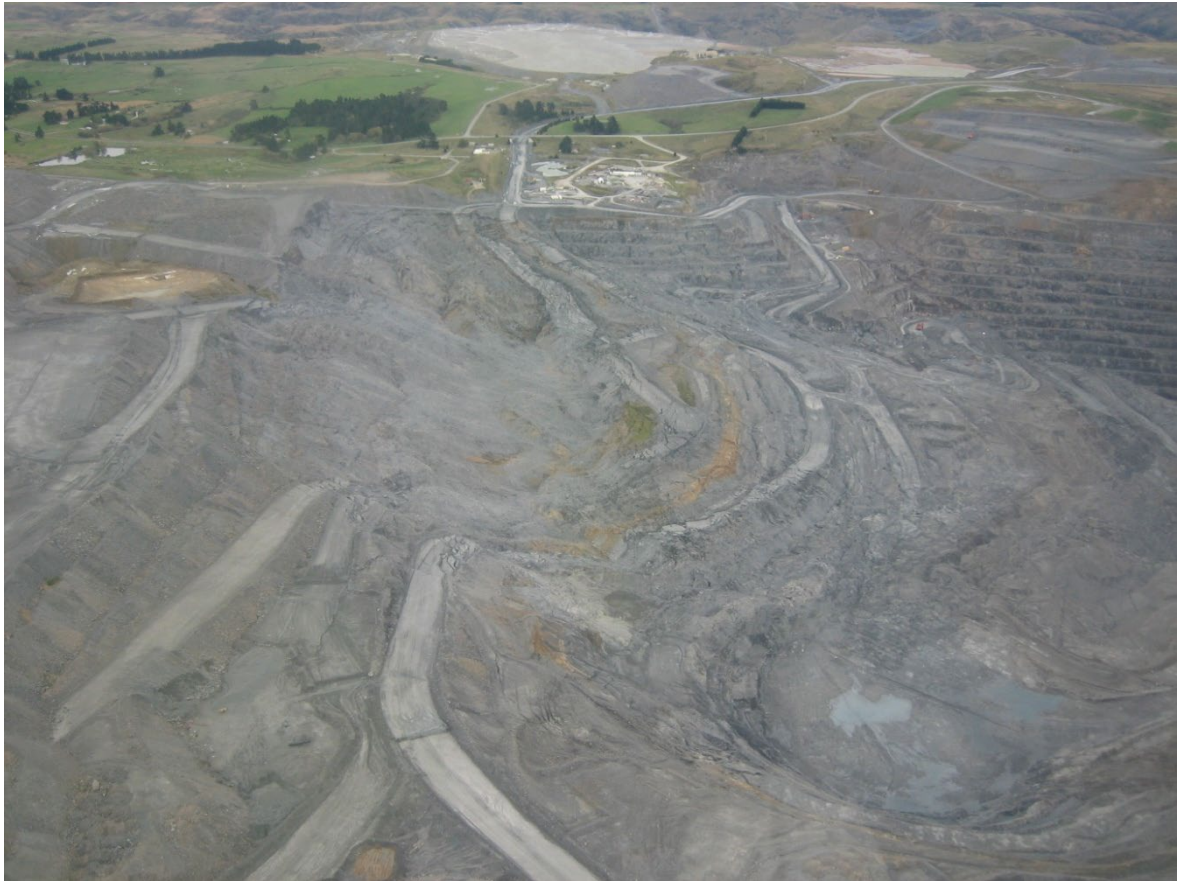
**Photo 6:** Aerial view of the west wall taken from the south looking roughly along strike towards the north. The distance the west wall has moved can be gauged by the offset seen in the haul roads. The smooth plane in mid-photo is the FF.

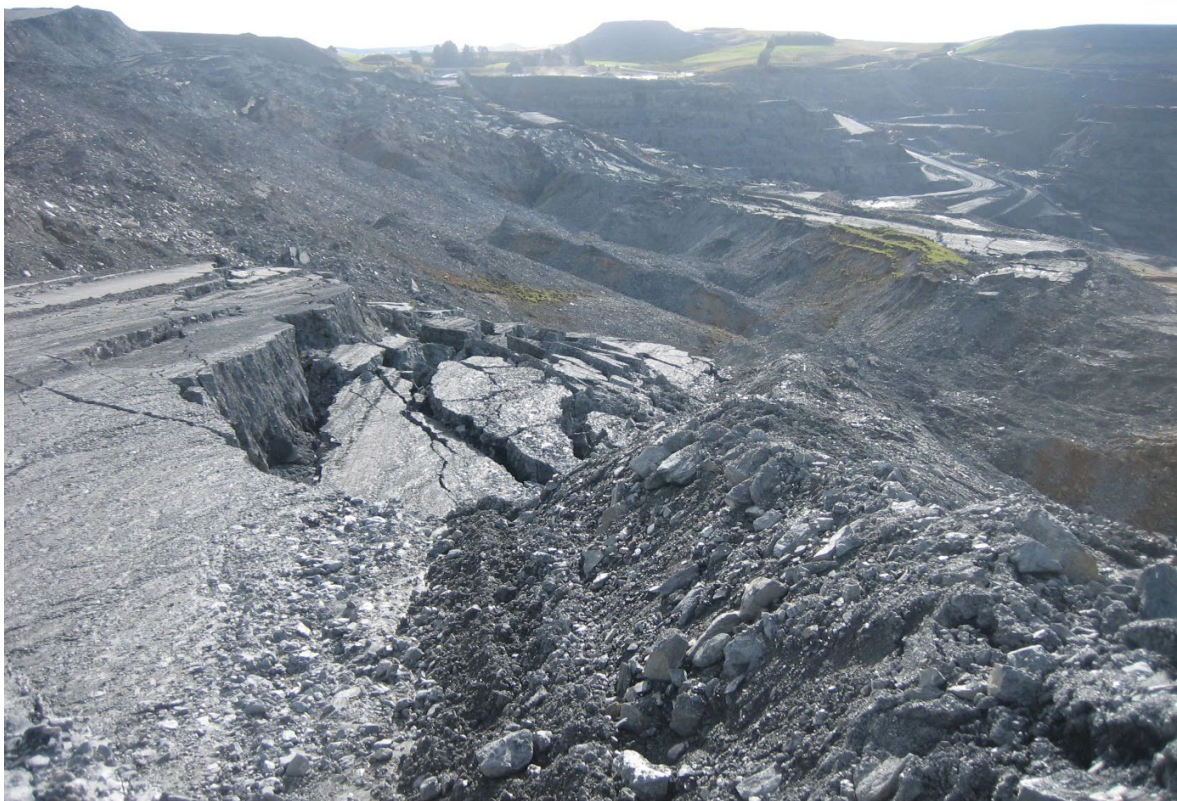
**Photo 7:** Headscarp of FF exposed at the top of failure. Photo taken along strike towards the north.

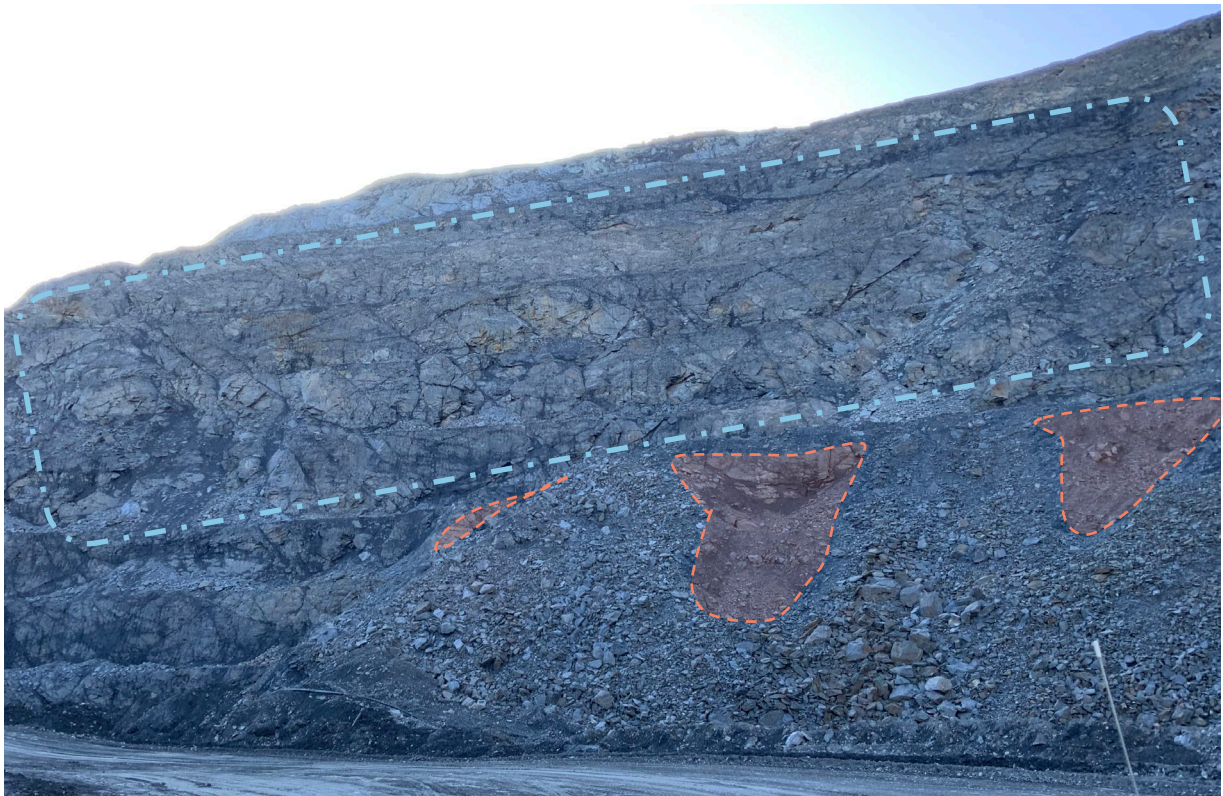
The FRUG mine includes a series of drives and stopes located beneath the Frasers/FRIM highwall. Development of underground workings causes a redistribution of stresses within the rock mass. Yielding can occur where the induced stress exceeds the rock mass strength. Within FROP this is expressed as large-scale fracturing with increased dilation along geological structures. Dilated geological structure is visible throughout the pit wall with localised zones of caving in the pit floor where existing “Panel 1” workings have been mined out, Photo 8.

The FRUG Panel 1 workings with the least rock cover are located beneath the proposed FTSF embankment. Additional surcharge load associated with construction of the FTSF embankment has the potential to cause further subsidence. This is expected to choke rapidly underground and ongoing subsidence is expected to be negligible. During embankment construction the highwall rock mass will be progressively supported with additional buttressing from the placed fill.

**Photo 8: Fraser 6/FRIM north wall - Surface caving expression of near surface stopes highlighted in orange. Dilated structures associated with rock mass relation visible through the zone in blue.**

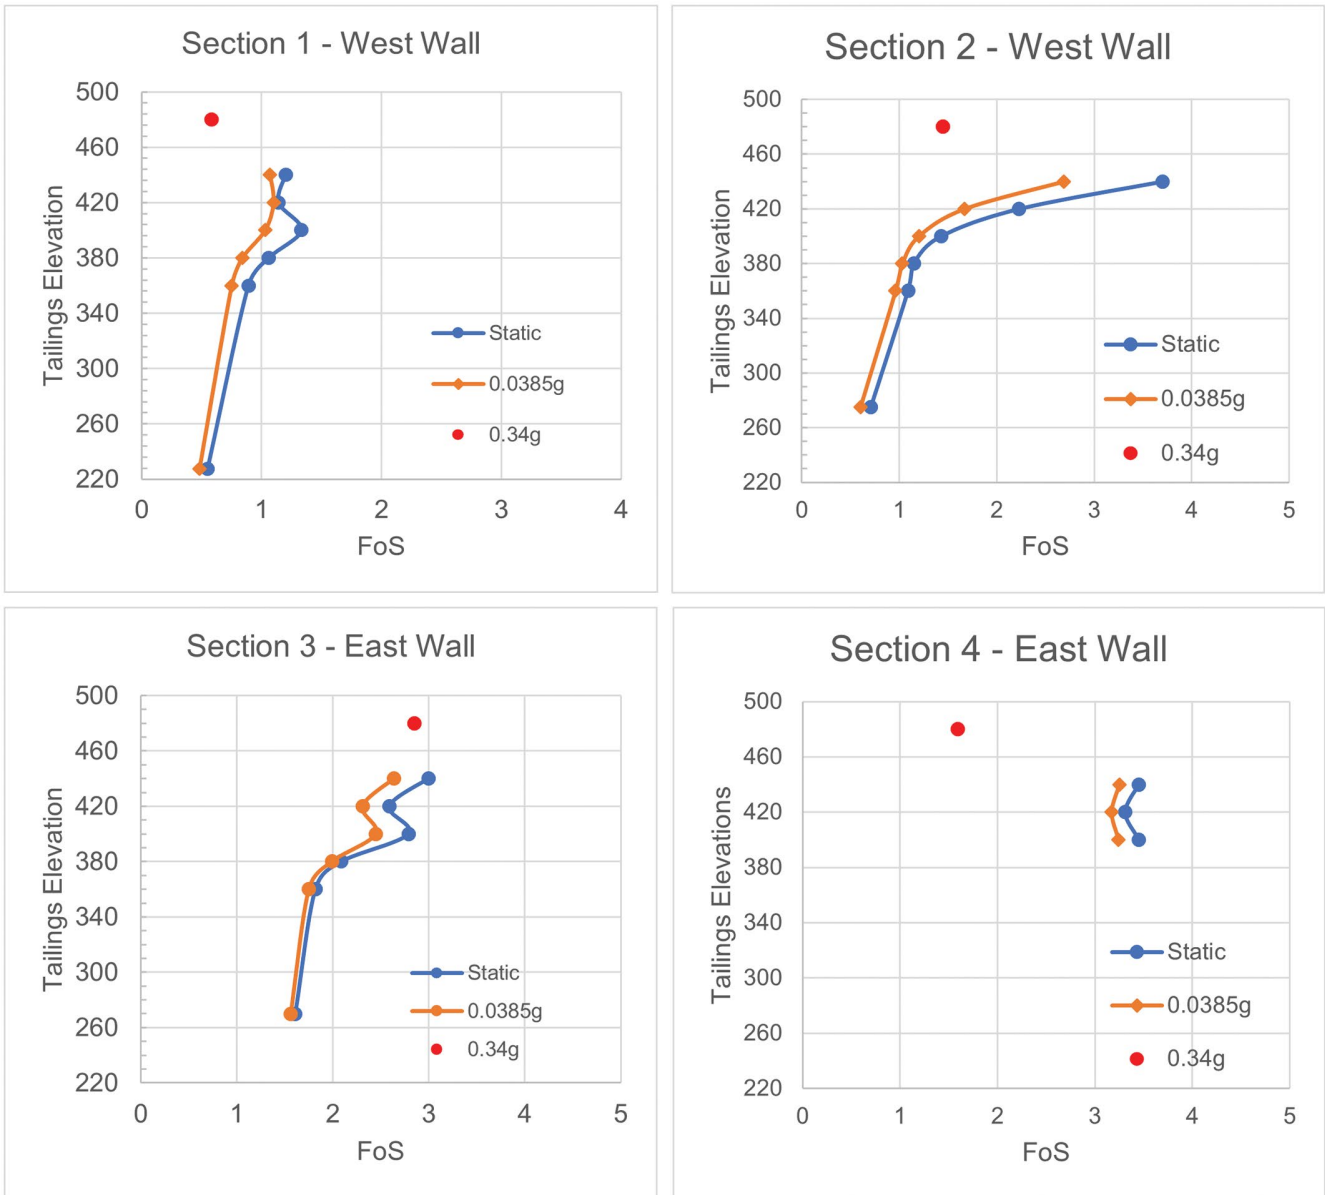
In contrast, the tailings act as a tow buttress. Following the initial FoS decrease, the slope equilibrium is reversed ultimately leading to a more stable slope. The following is noted:

**Inset 9: Stability results illustrating the modelled FoS response to changes in tailings level during backfill.**

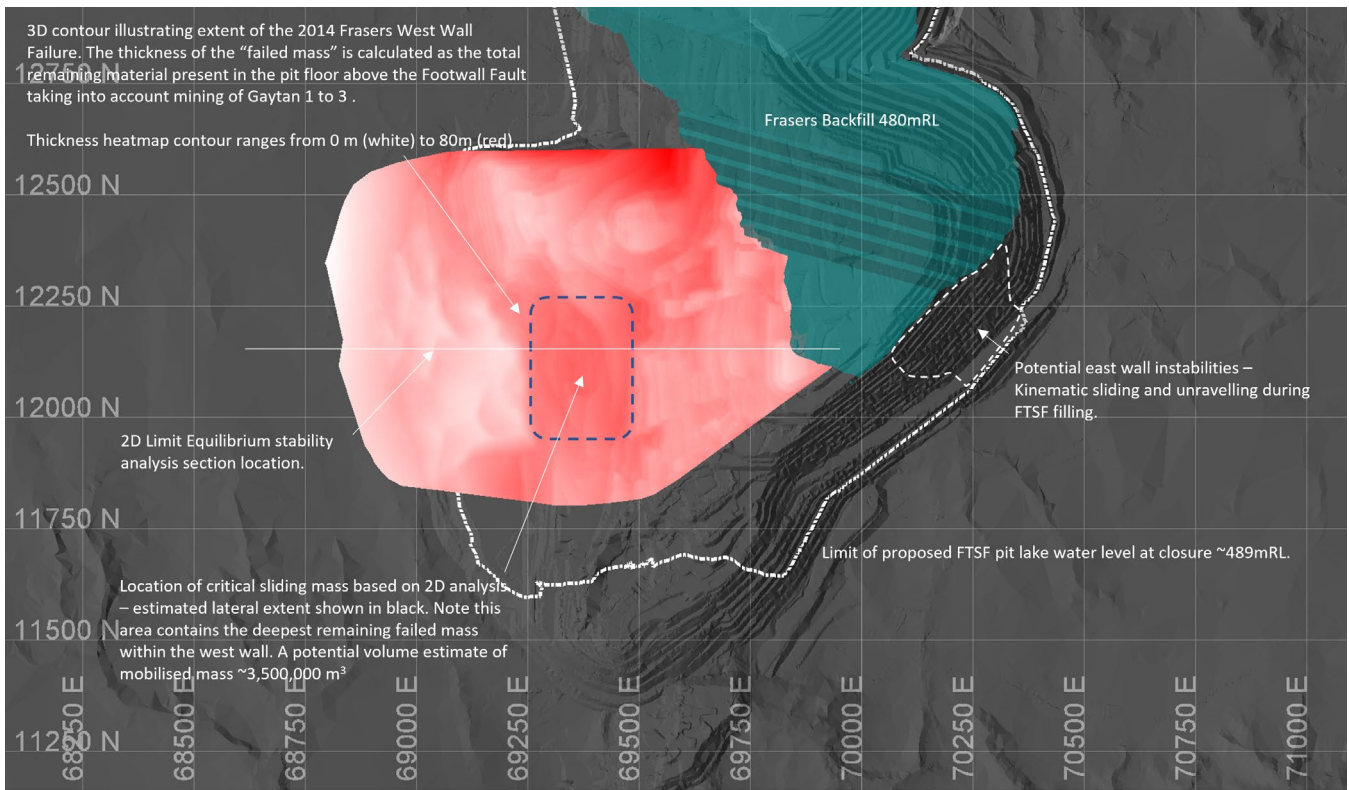
**Inset 11: Summary of potential failure mechanisms with increased susceptibility during FTFS filling.**
