# FISH PASSAGE ASSESSMENT OF THE HAKAPUPU (PLEASANT) RIVER

Prepared by Kāti Huirapa Rūnaka ki Puketeraki

Matt Dale (Waterscape Connections Ltd) and Julia Rata te Raki, 2024

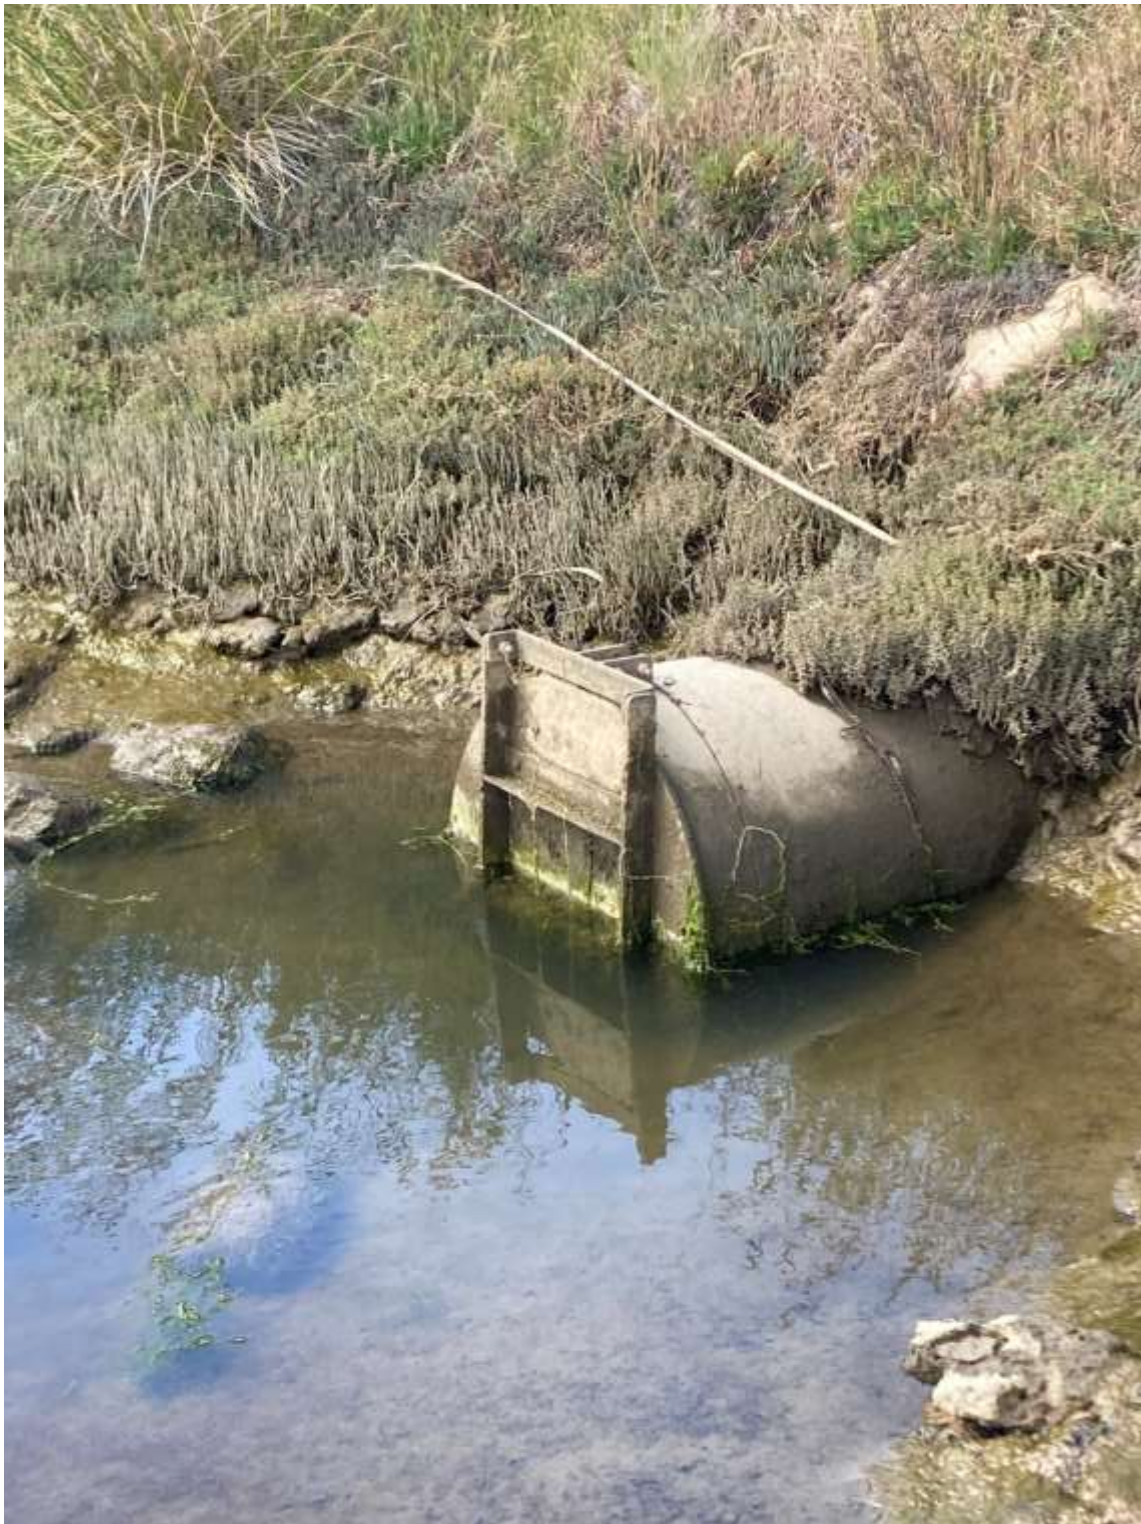
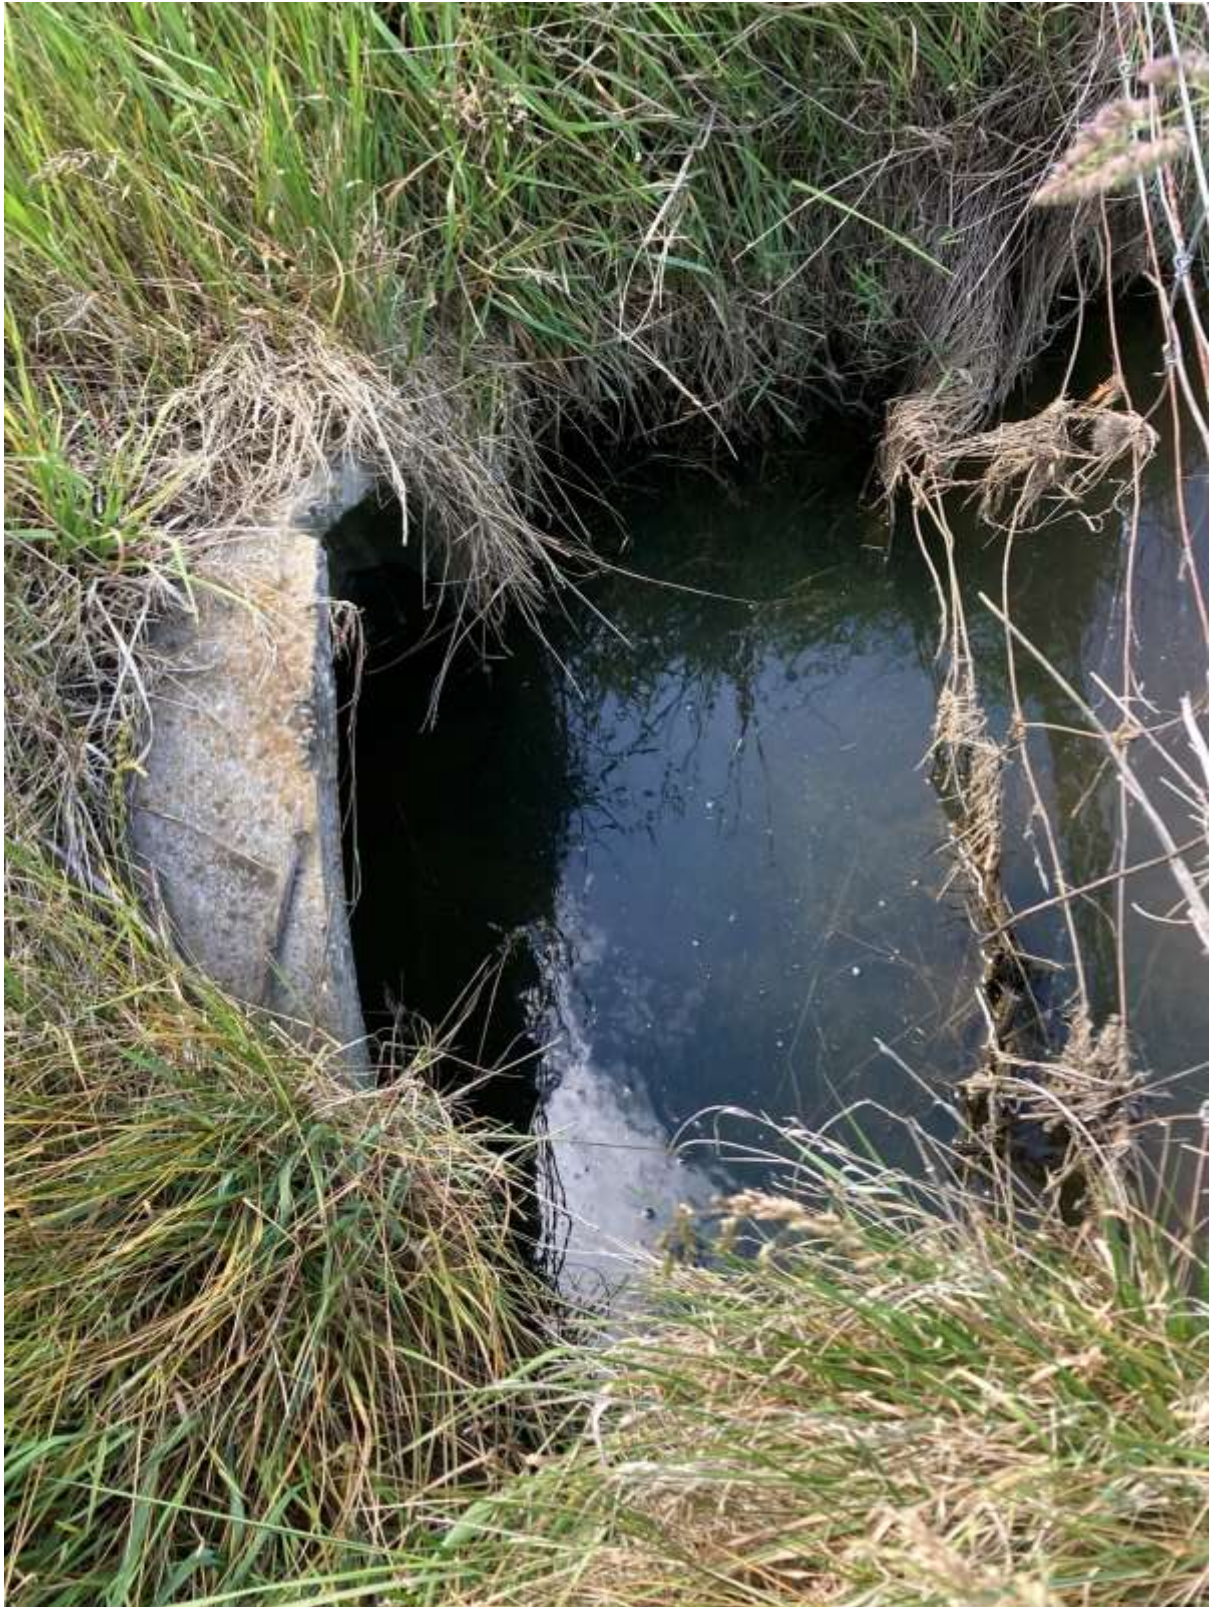
The structure consists of a single 0.75m culvert with a flap gate attached to the downstream end. A small gap was present between the culvert lip and the flap gate which would have allowed passage for small fish at most (if not all) periods of the tide, however there was very little habitat upstream of the culvert meaning that its priority for replacement should be considered low.

Figure 15 Downstream view of the E1 culvert

Figure 16 Upstream view of the E1 culvert

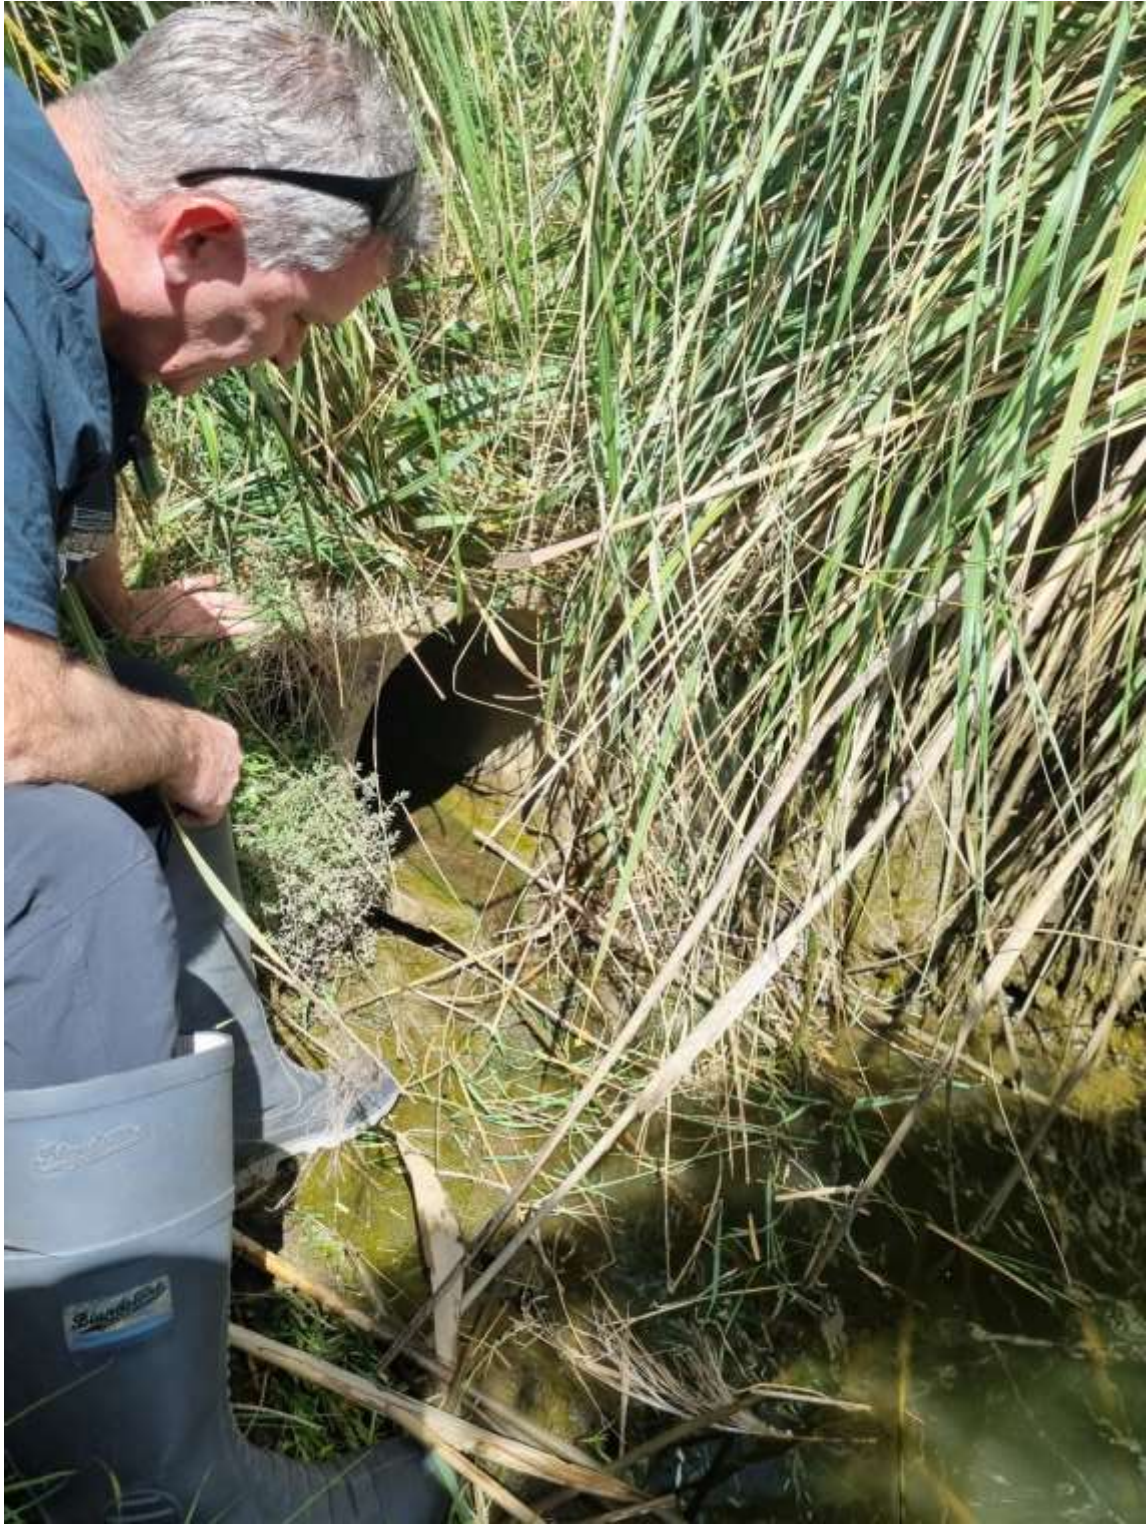
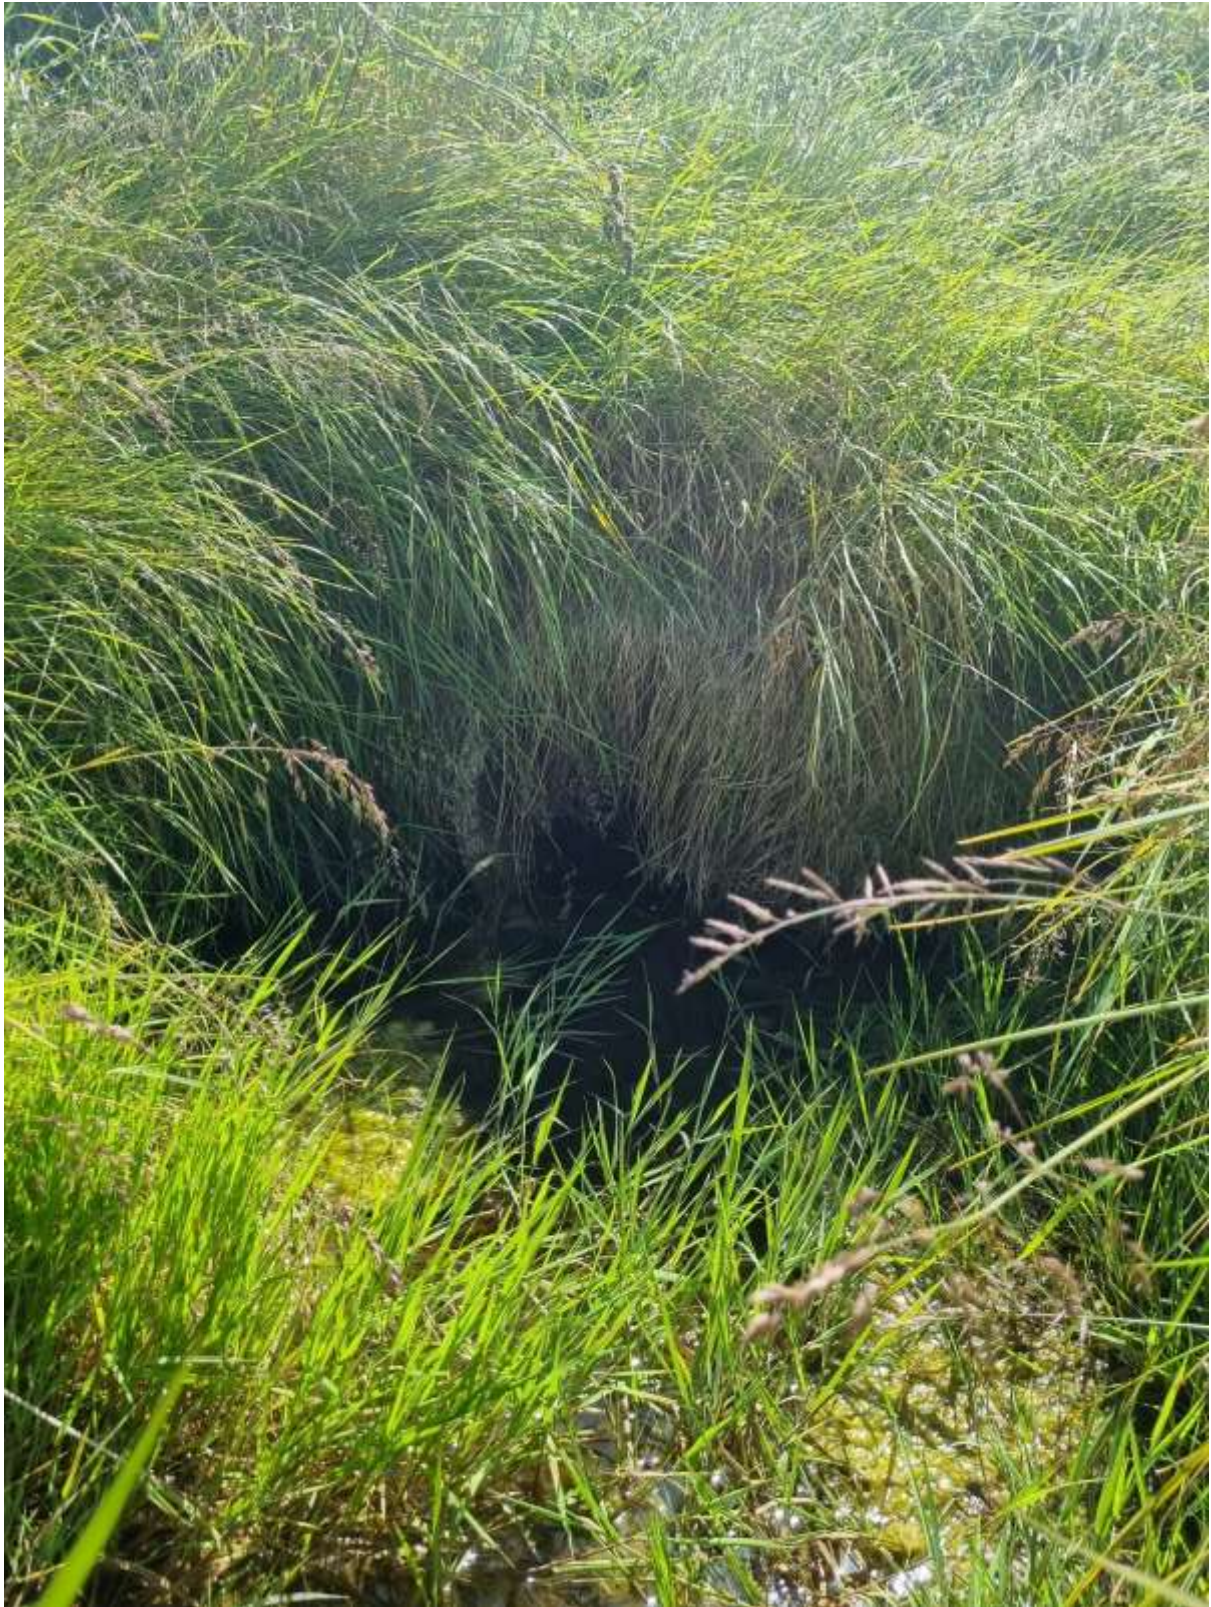
The structure consists of a single 0.45m culvert which has an overhang of 0.05m and a drop height of 0.1m at mid-tide. It is likely that fish passage would be possible during high tide, but the culvert would be considered perched for much of the tidal cycle. There is very little fish habitat upstream of the culvert meaning that its priority for replacement should be considered low.

Figure 18 Downstream view of the E2 culvert

Figure 19 Upstream view of the E2 culvert

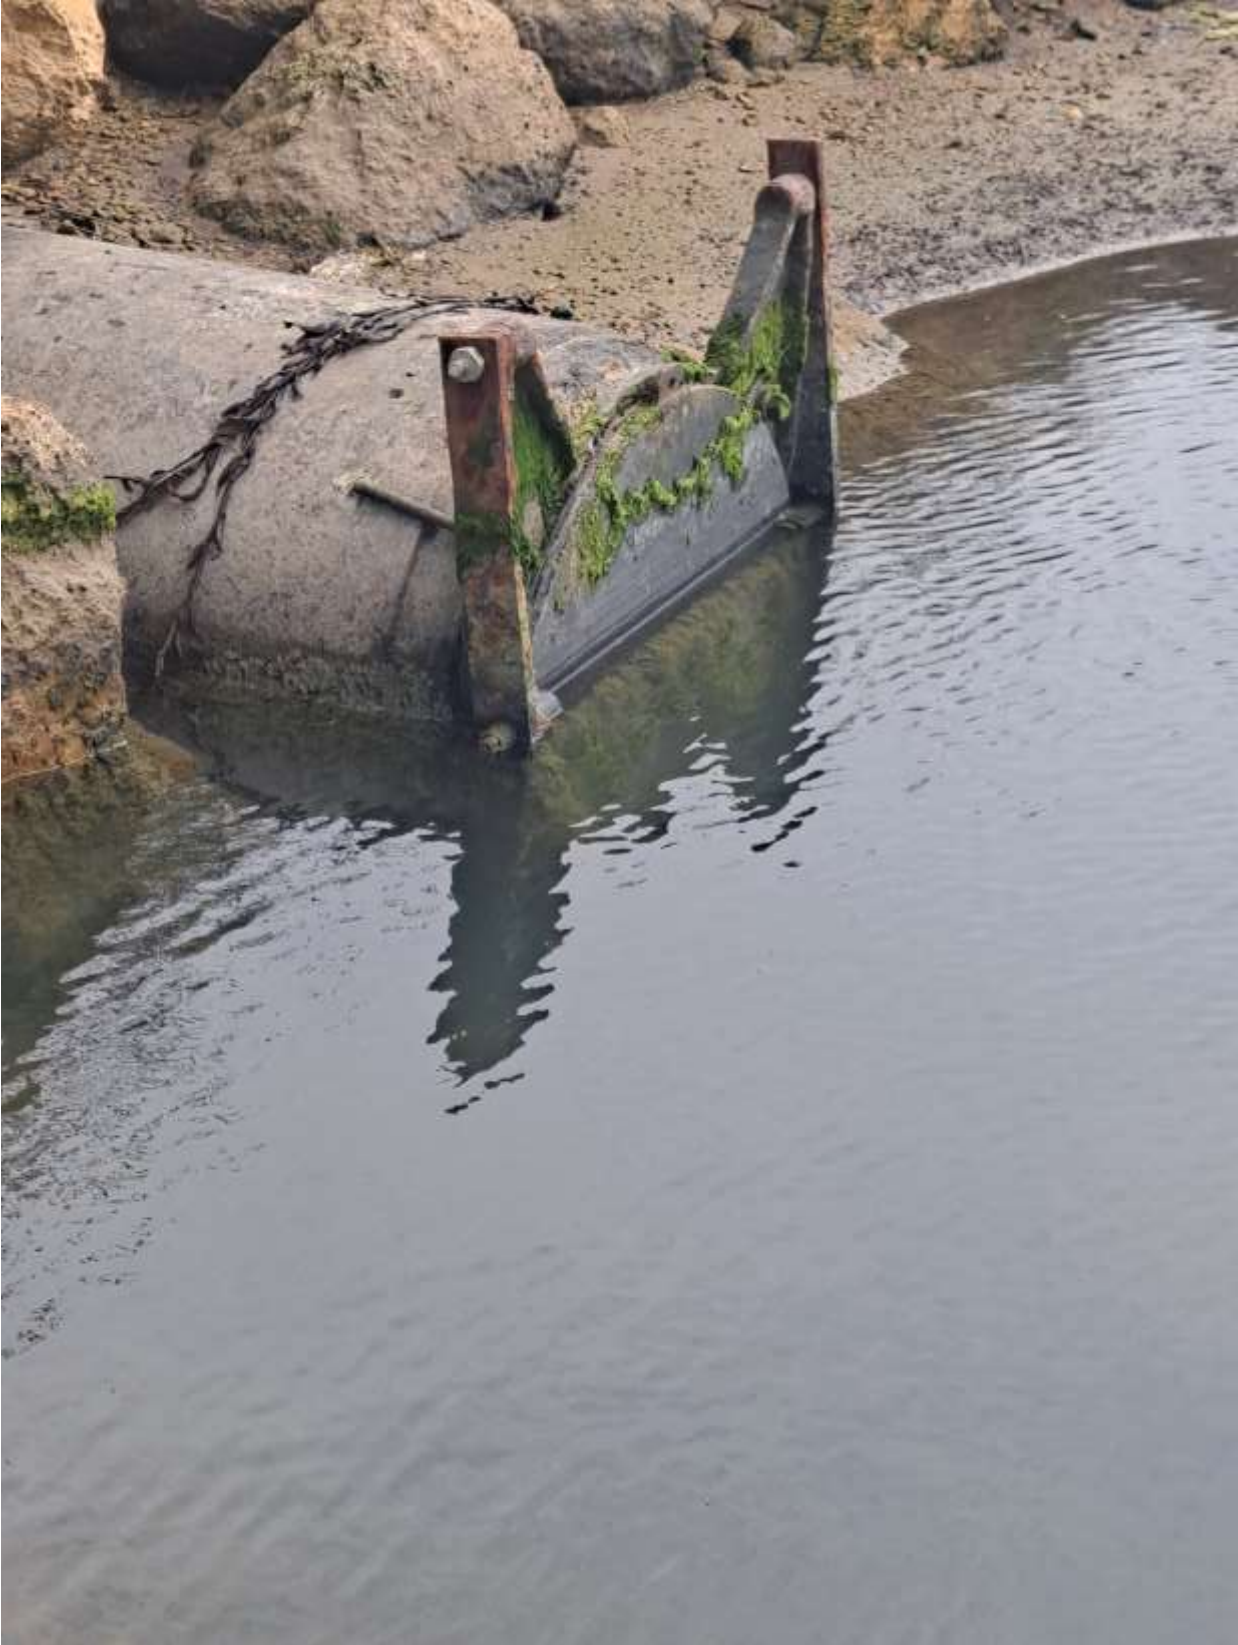
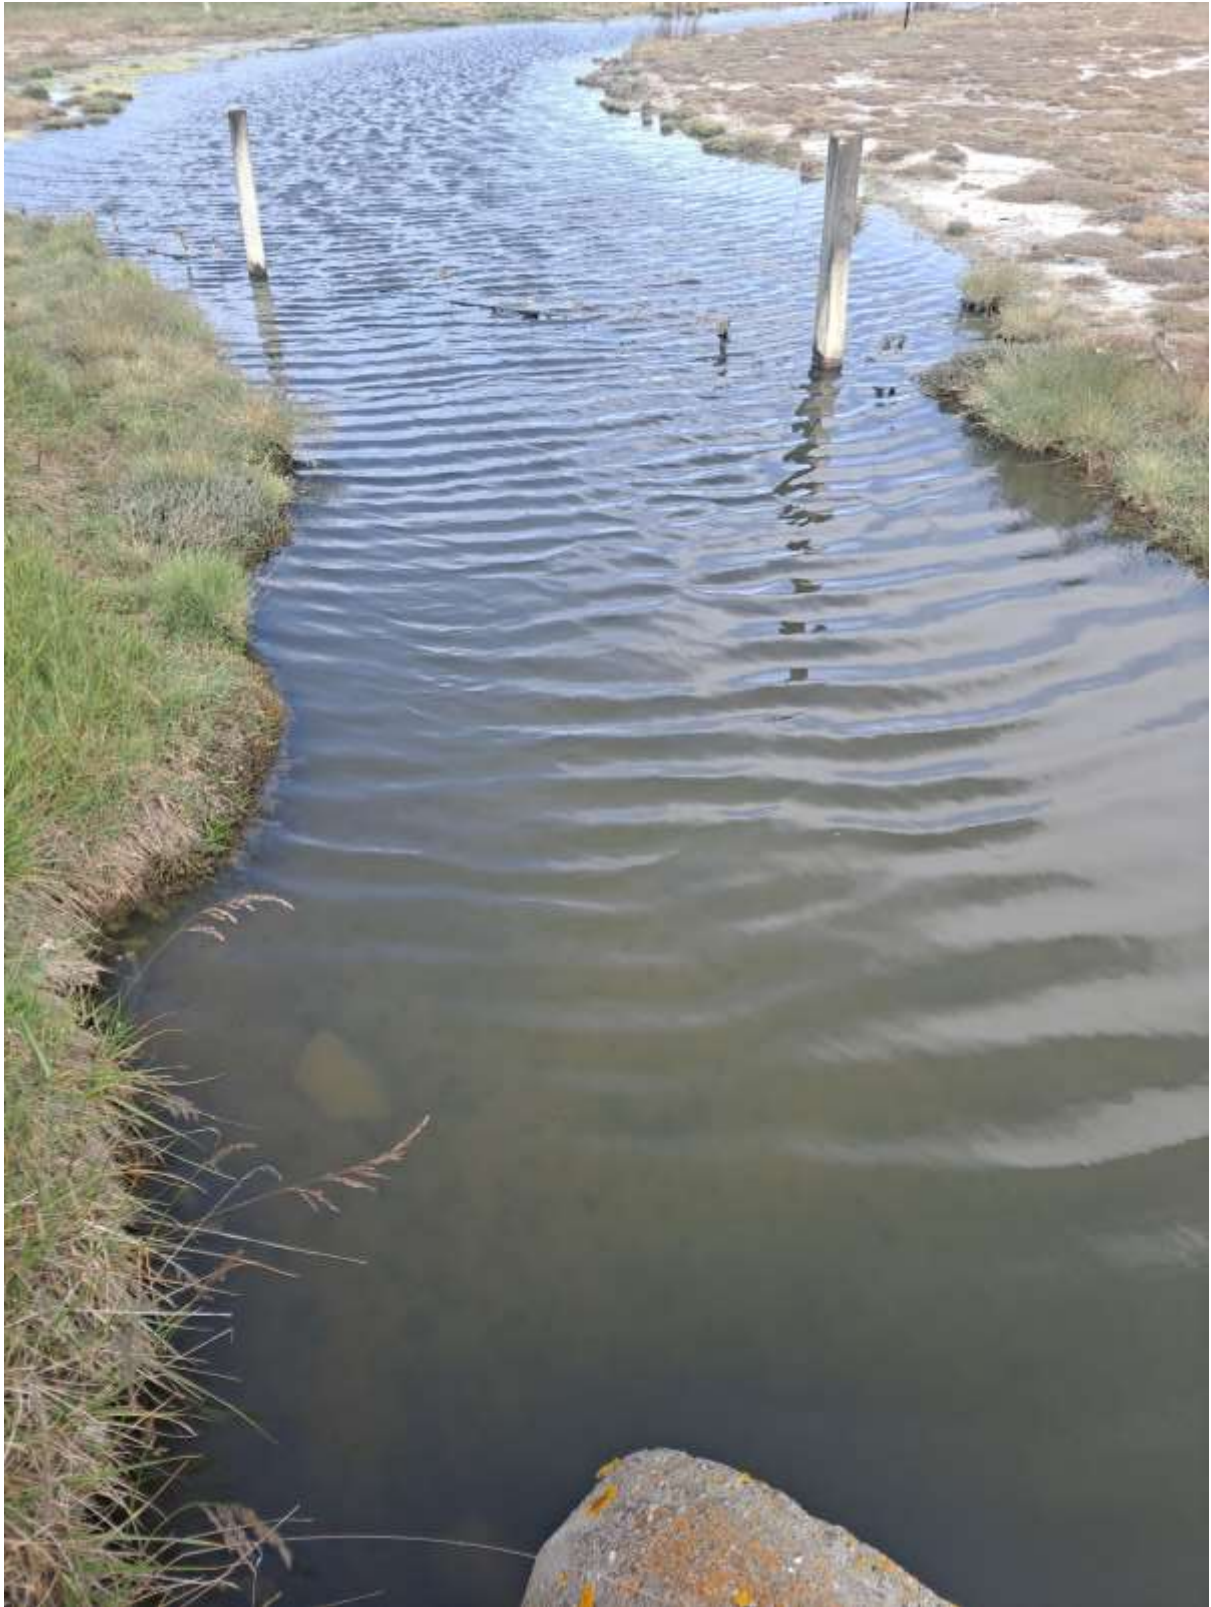
The structure consists of a 1m wide culvert with an attached flap gate with no fish passage remediation. The flap gate creates a strong seal with the culvert preventing fish passage for most, if not all, of the tidal cycle. This structure prevents fish passage to a significant tributary of the Hakapupu estuary. Although riparian habitat is significantly degraded due to stock grazing and channel modification, this tributary would be expected to provide īnaka spawning and adult habitat, should restoration activities be undertaken. The lower reaches of the tributary would also be expected to provide habitat for estuarine species such as mullet, while the upper reaches would be expected to provide habitat for tuna should fish passage be restored.

Figure 21 Downstream view of the E3 flap gate

Figure 22 Upstream view of the E3 culvert

If removal of the flap gate is not possible/desirable, then remediation devices such as a cantilevered or offset “fish friendly” flap gate should be considered.

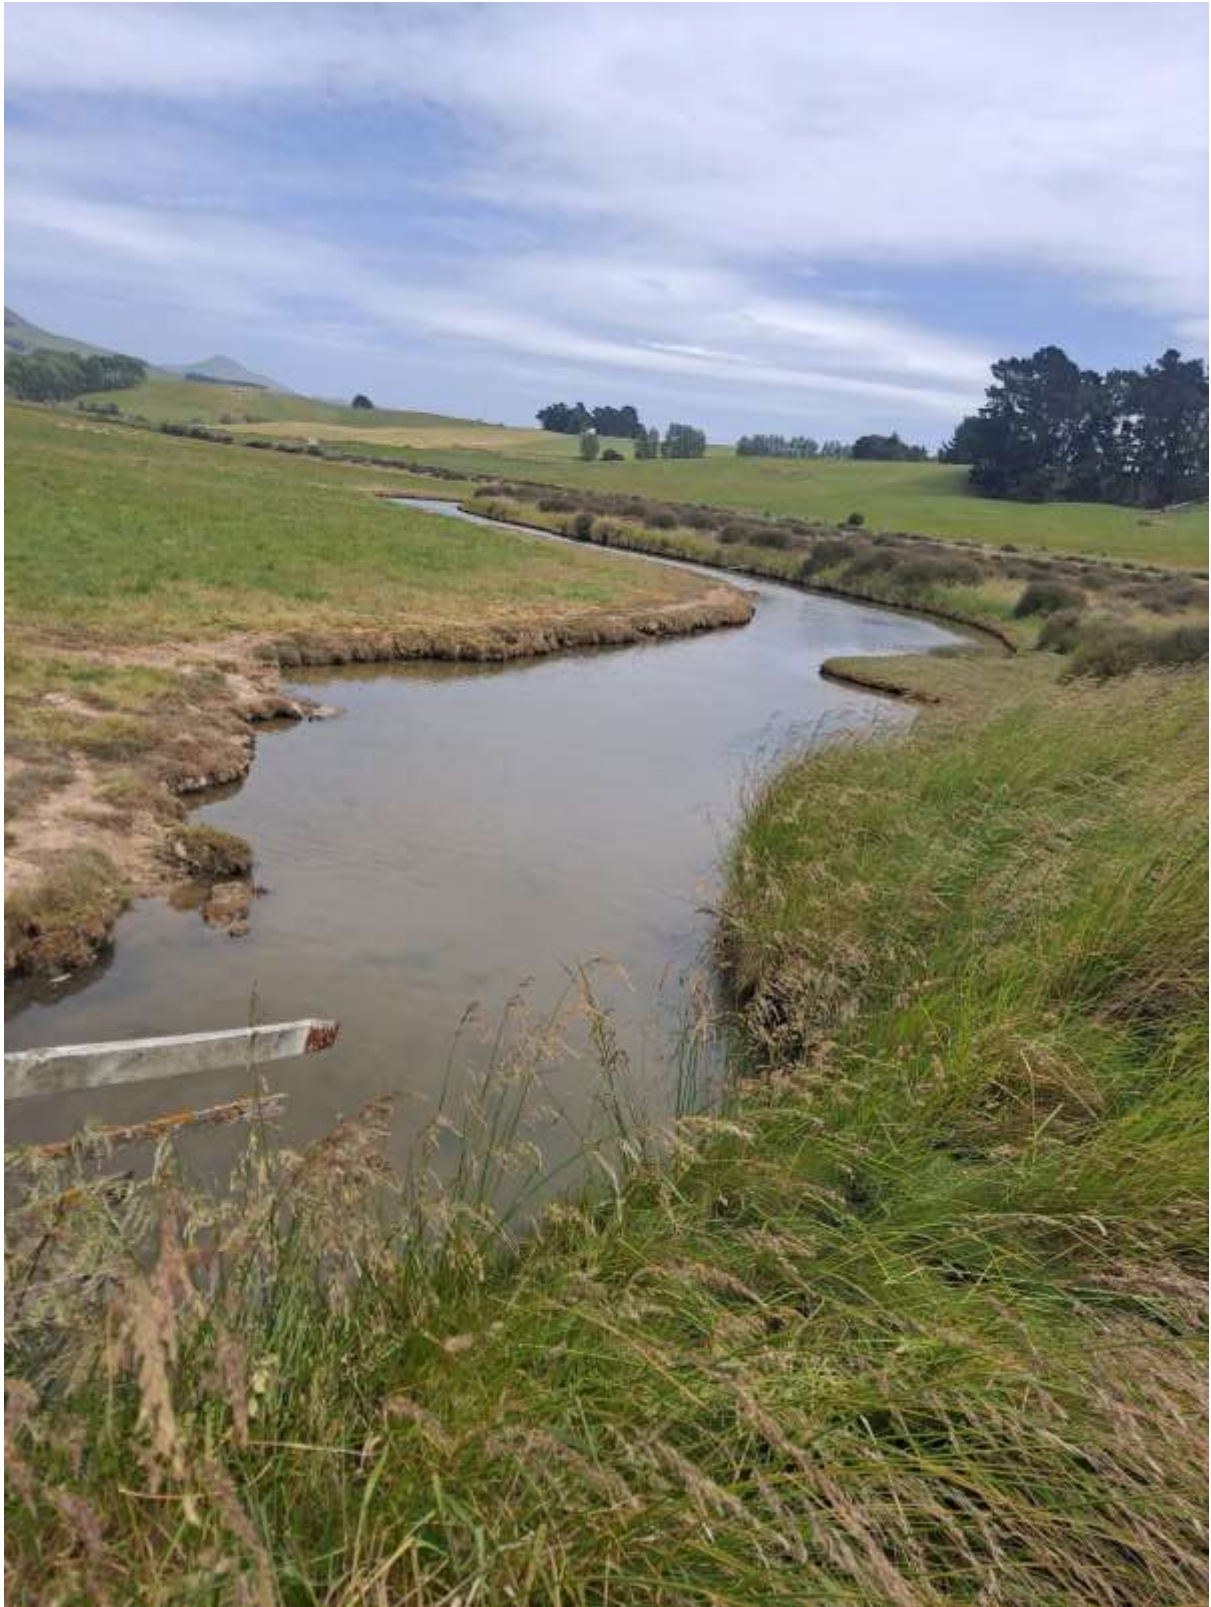
Figure 24 Upstream view from the E4 flap gate

If removal of the flap gate is not possible/desirable, then remediation devices such as a cantilevered or offset “fish friendly” flap gate should be considered.

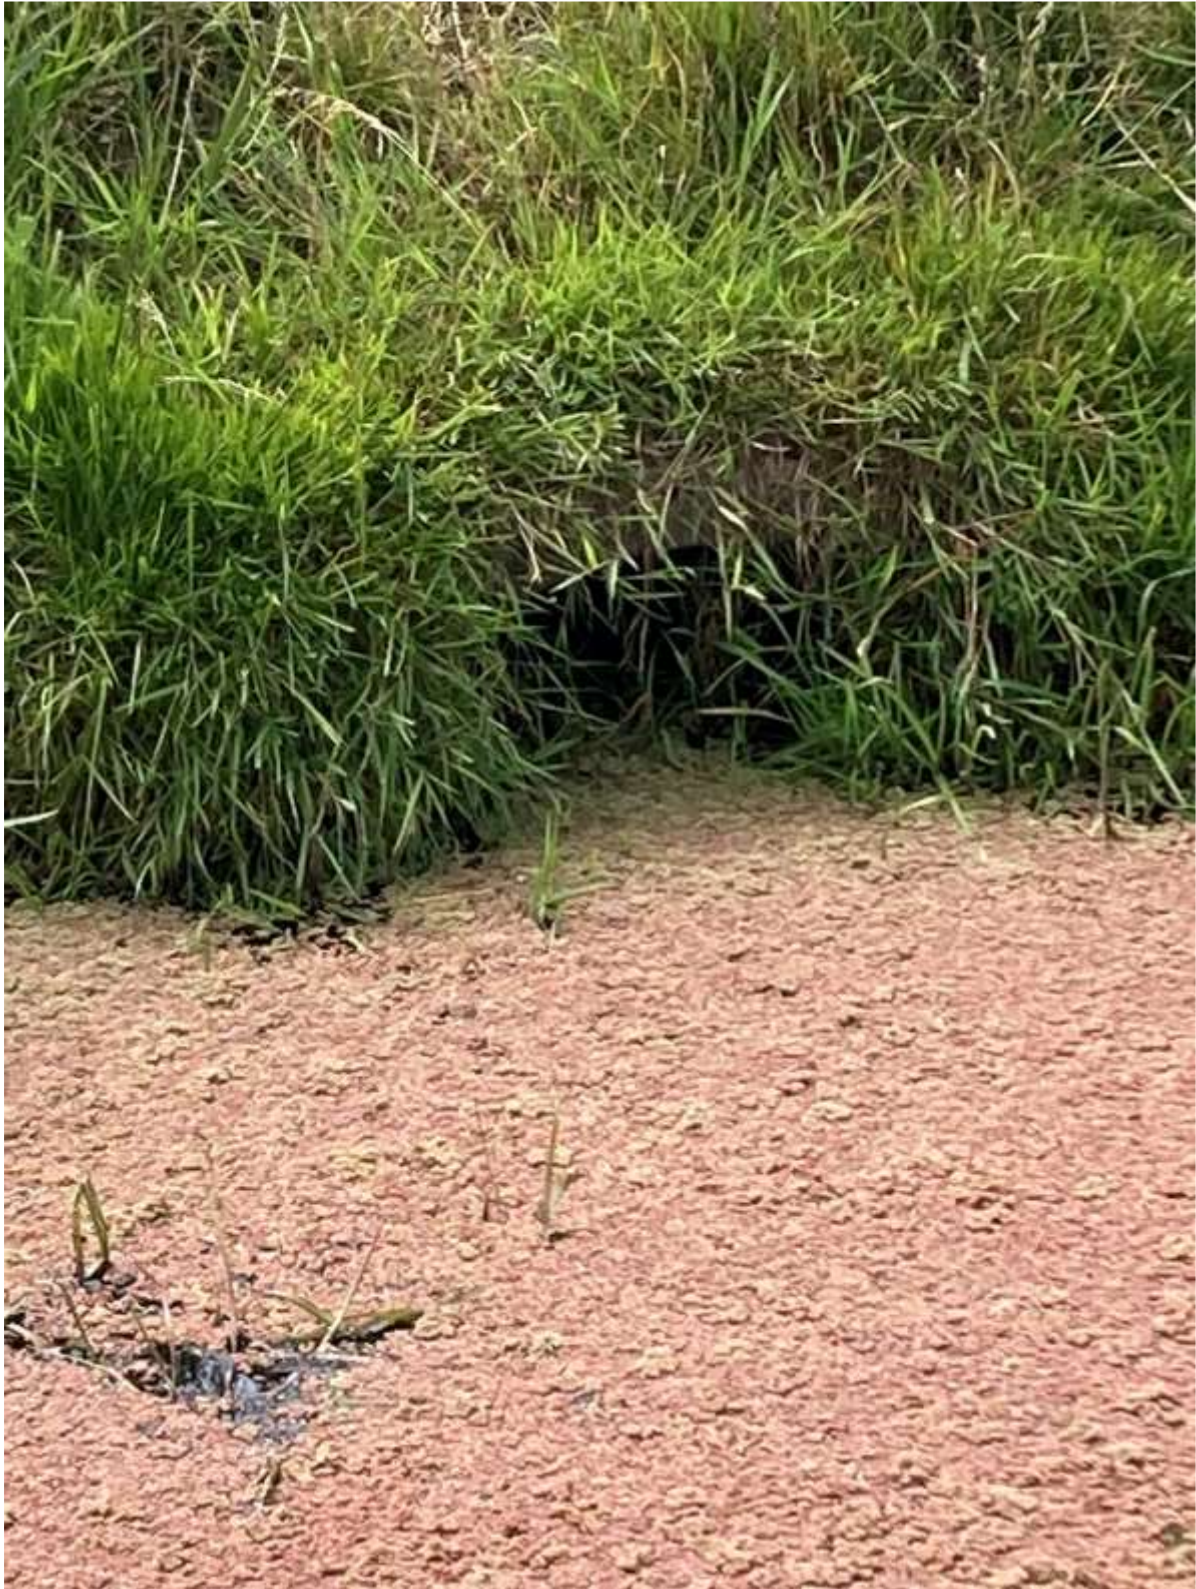
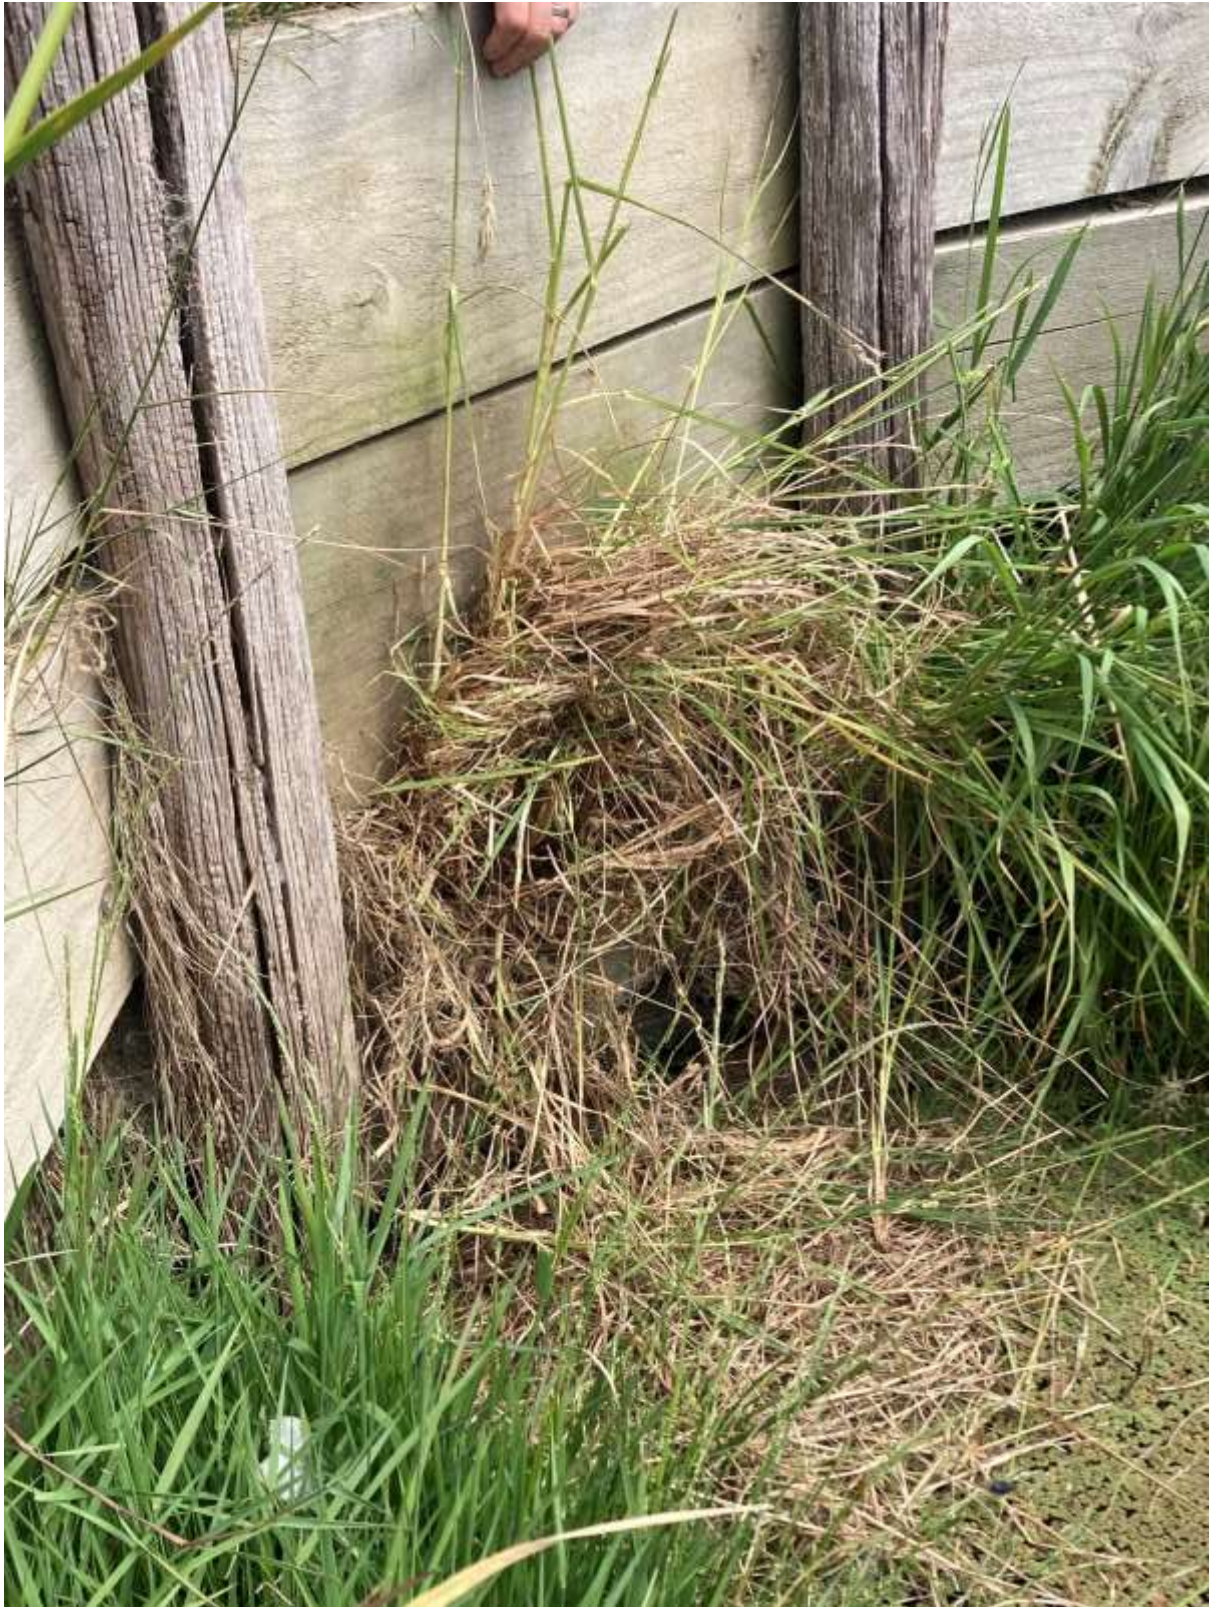
The culvert itself is 0.75m high and half submerged within the wetted channel, providing good fish passage throughout the tidal cycle. No further remediation is required.

Figure 26 Upstream view of E5 culvert

Figure 27 Downstream view of E5 culvert

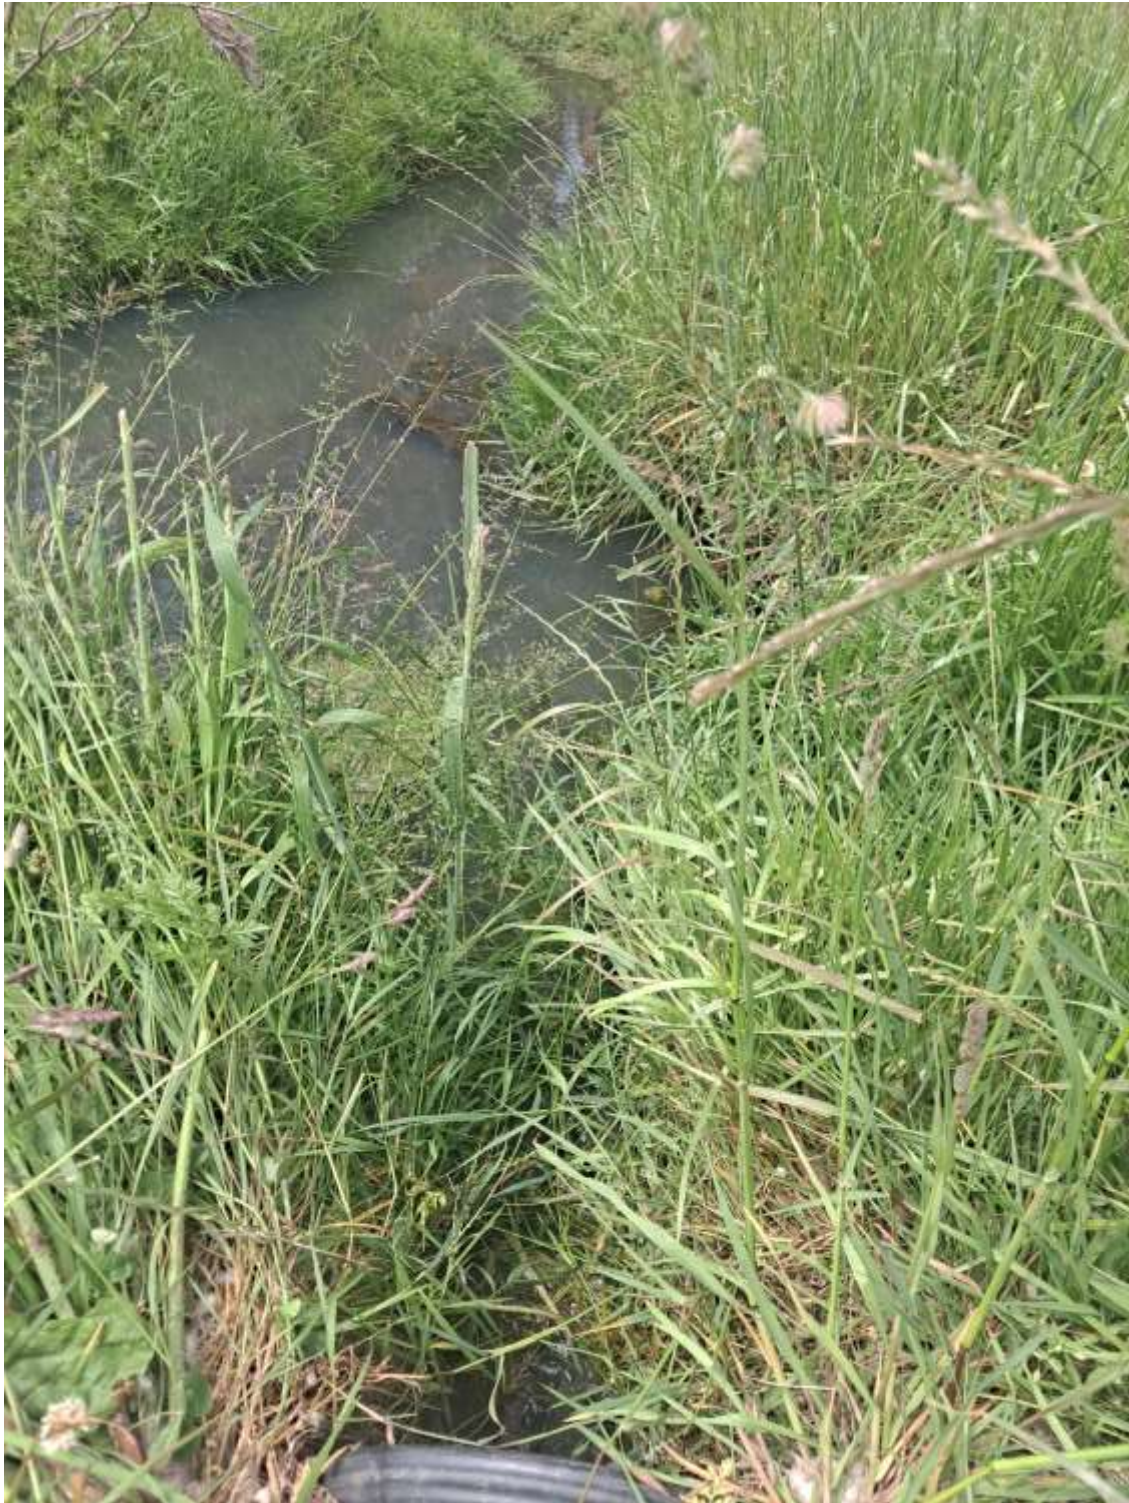
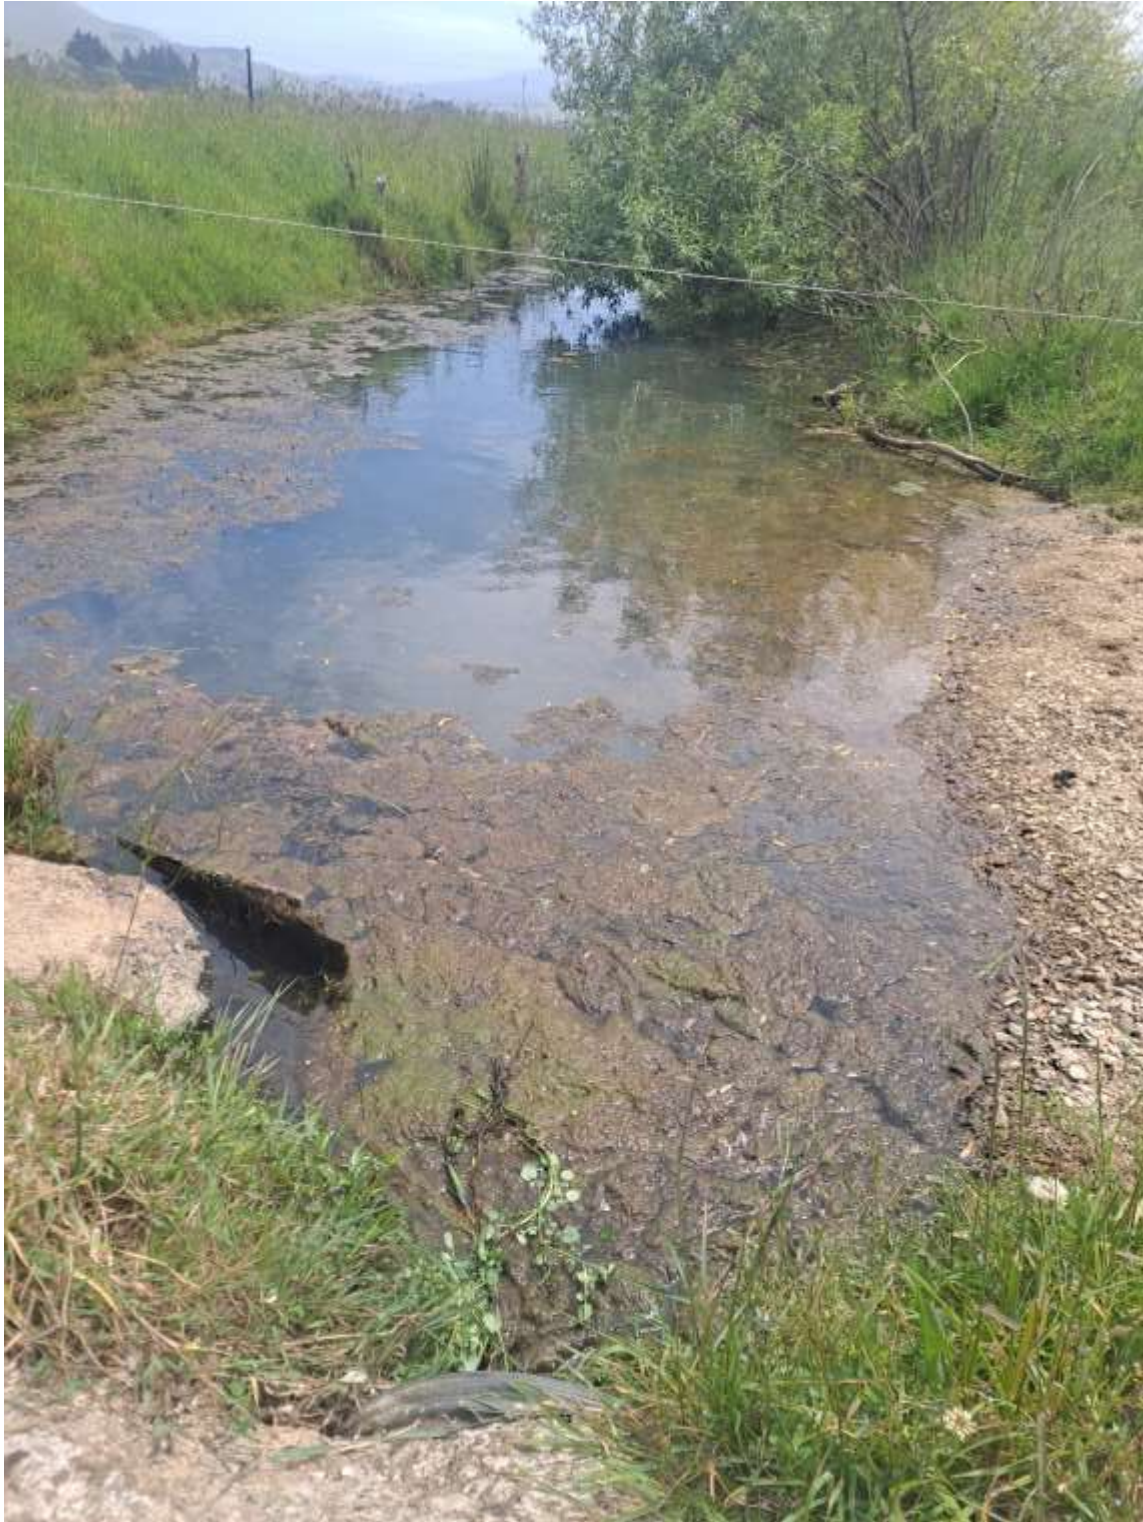
W1 is the most downstream instream structure in Watkin Creek and is located 300m west of SH1 (Figure 28). The culvert is 0.33 m wide and is perched with an estimated drop of 0.2 m and an undercut of 0.05 m, providing a significant barrier to upstream migrating fish. Due to the small size, water velocities through the culvert are particularly high and are likely to pose a significant barrier to upstream migration in addition to the perched culvert. Shoals of *tinaka* were observed immediately downstream of the culvert.

Figure 29 Downstream view from W1 culvert

Figure 30 Upstream view from W1 culvert

considered as a high priority for replacement. Due to the small diameter of the culvert, it is recommended that it be replaced, as any remediation efforts such as fish ladders will not address the high water velocities currently occurring through the culvert. Rock ramps and baffles may be considered as a short-term remediation option, but should not be considered a permanent solution.
