# FISH PASSAGE ASSESSMENT OF THE HAKAPUPU (PLEASANT) RIVER

Prepared by Kāti Huirapa Rūnaka ki Puketeraki

Matt Dale (Waterscape Connections Ltd) and Julia Rata te Raki, 2024

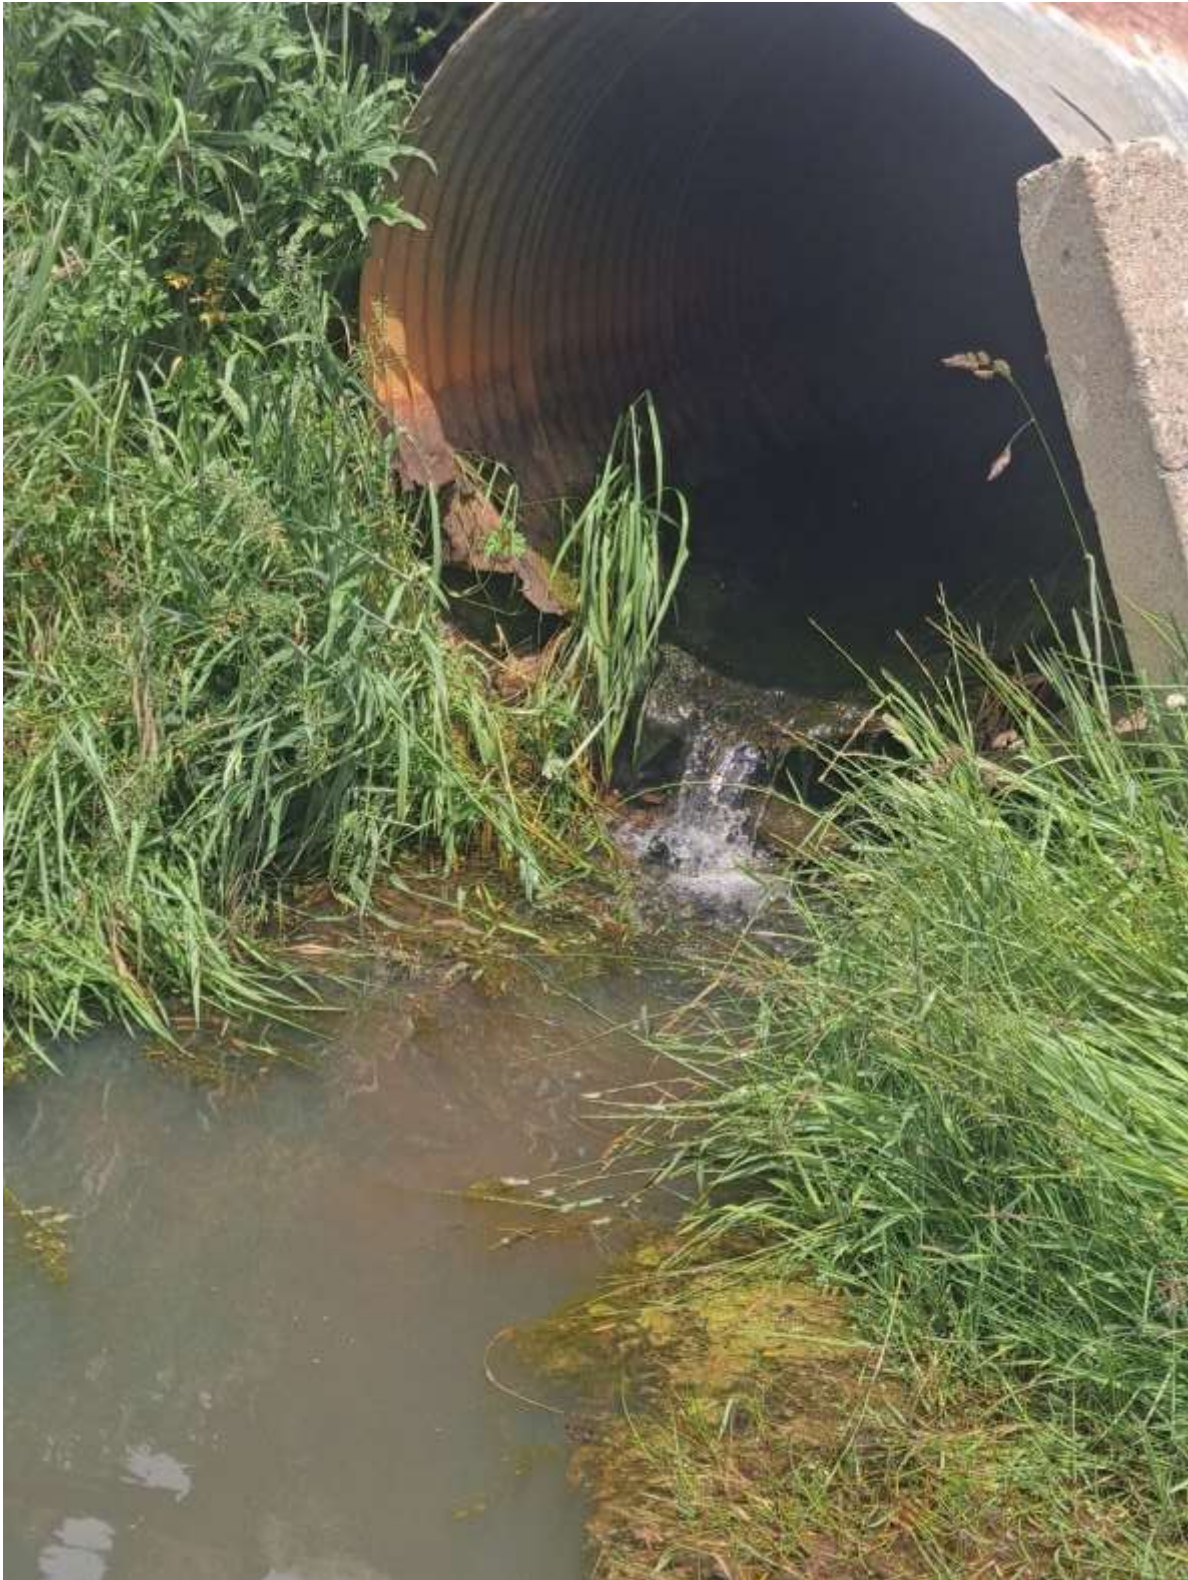
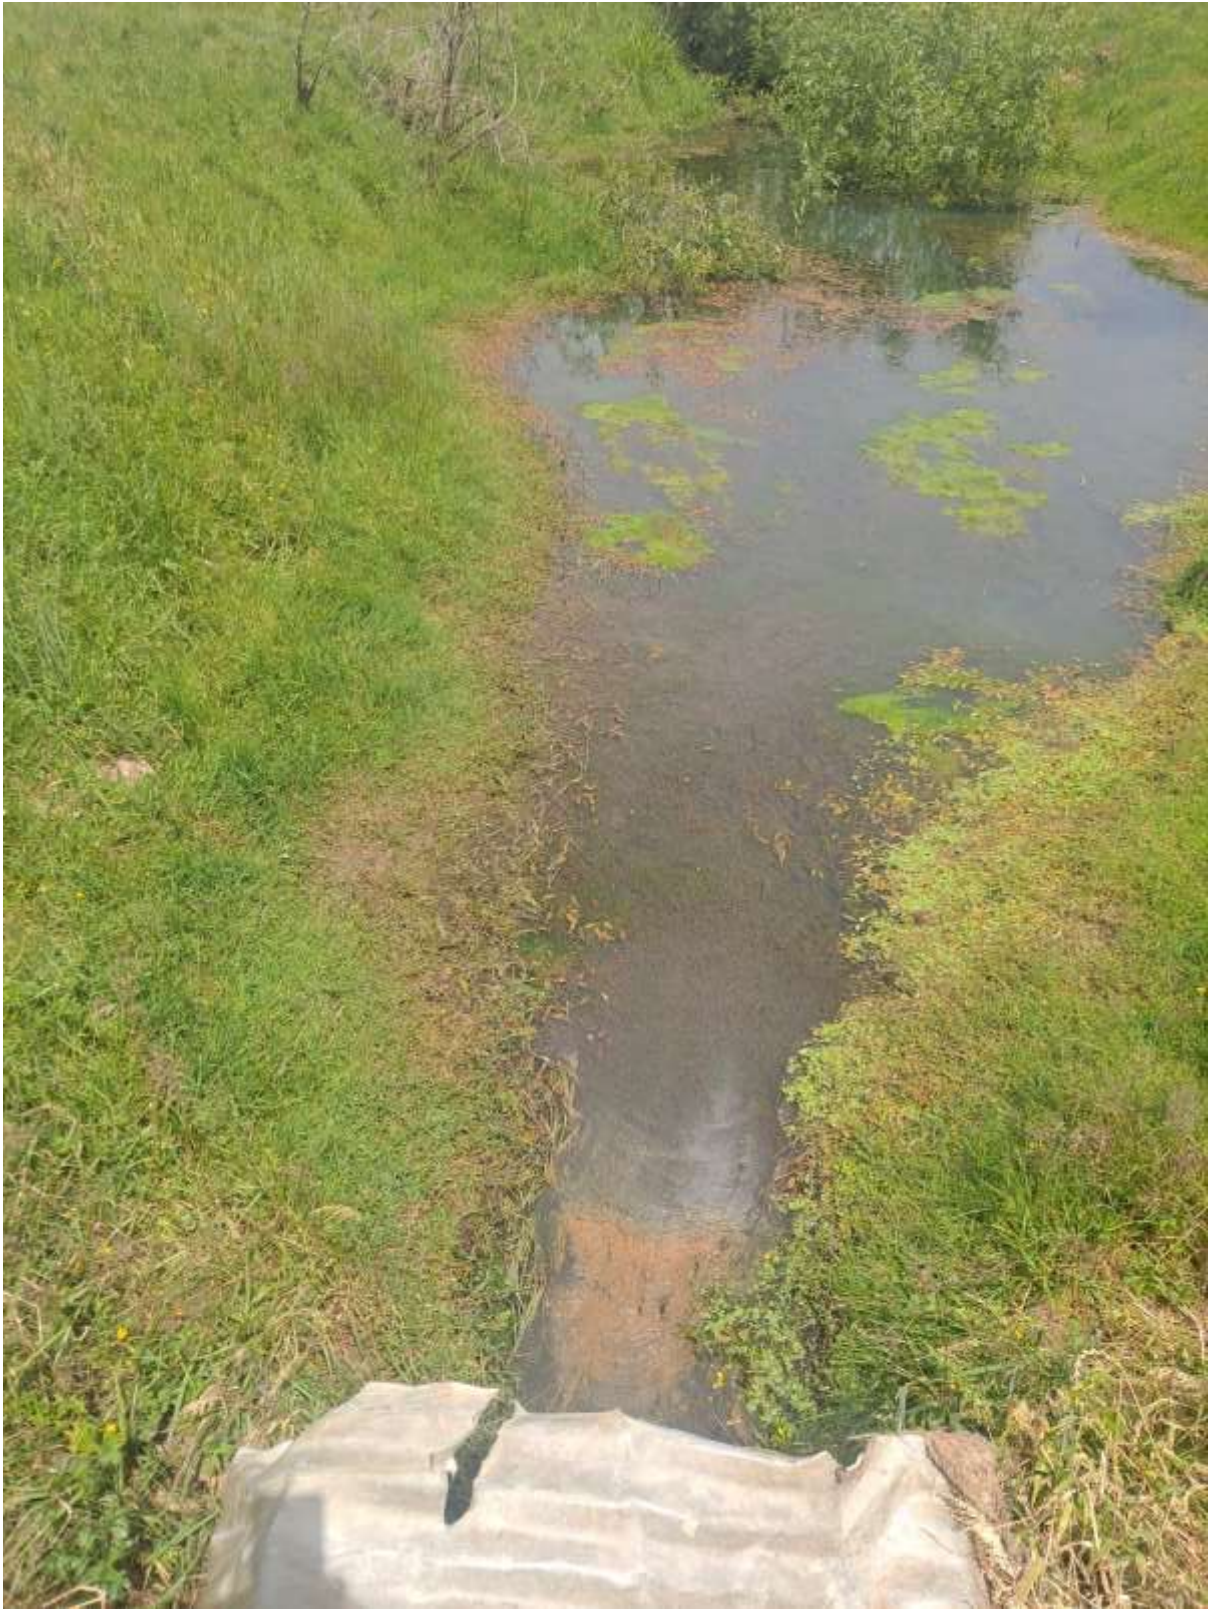
W2 is located 900m west of SH1 and consists of a large (1 m) corrugated iron perched culvert with a 0.2m drop and 0.1m undercut. The culvert is showing signs of rust and degradation, and likely poses a significant barrier to upstream migration. Large shoals of īnaka were observed immediately downstream of the structure.

Figure 32 Downstream view of W2 culvert

Figure 33 Upstream view from W2 culvert

Due to the large amount of upstream habitat, and the presence of significant restoration projects occurring in the upstream catchment, this structure should be considered as a high priority for replacement. Due to the large number of īnaka observed downstream of the site, it is recommended that the structure be replaced by a

similarly sized culvert that is imbedded at an appropriate depth in the stream bed. This is preferable over remediation efforts such as fish ladders, as they will not address the high water velocities currently occurring through the culvert and will be difficult to install and maintain due to the degraded nature of the culvert itself.

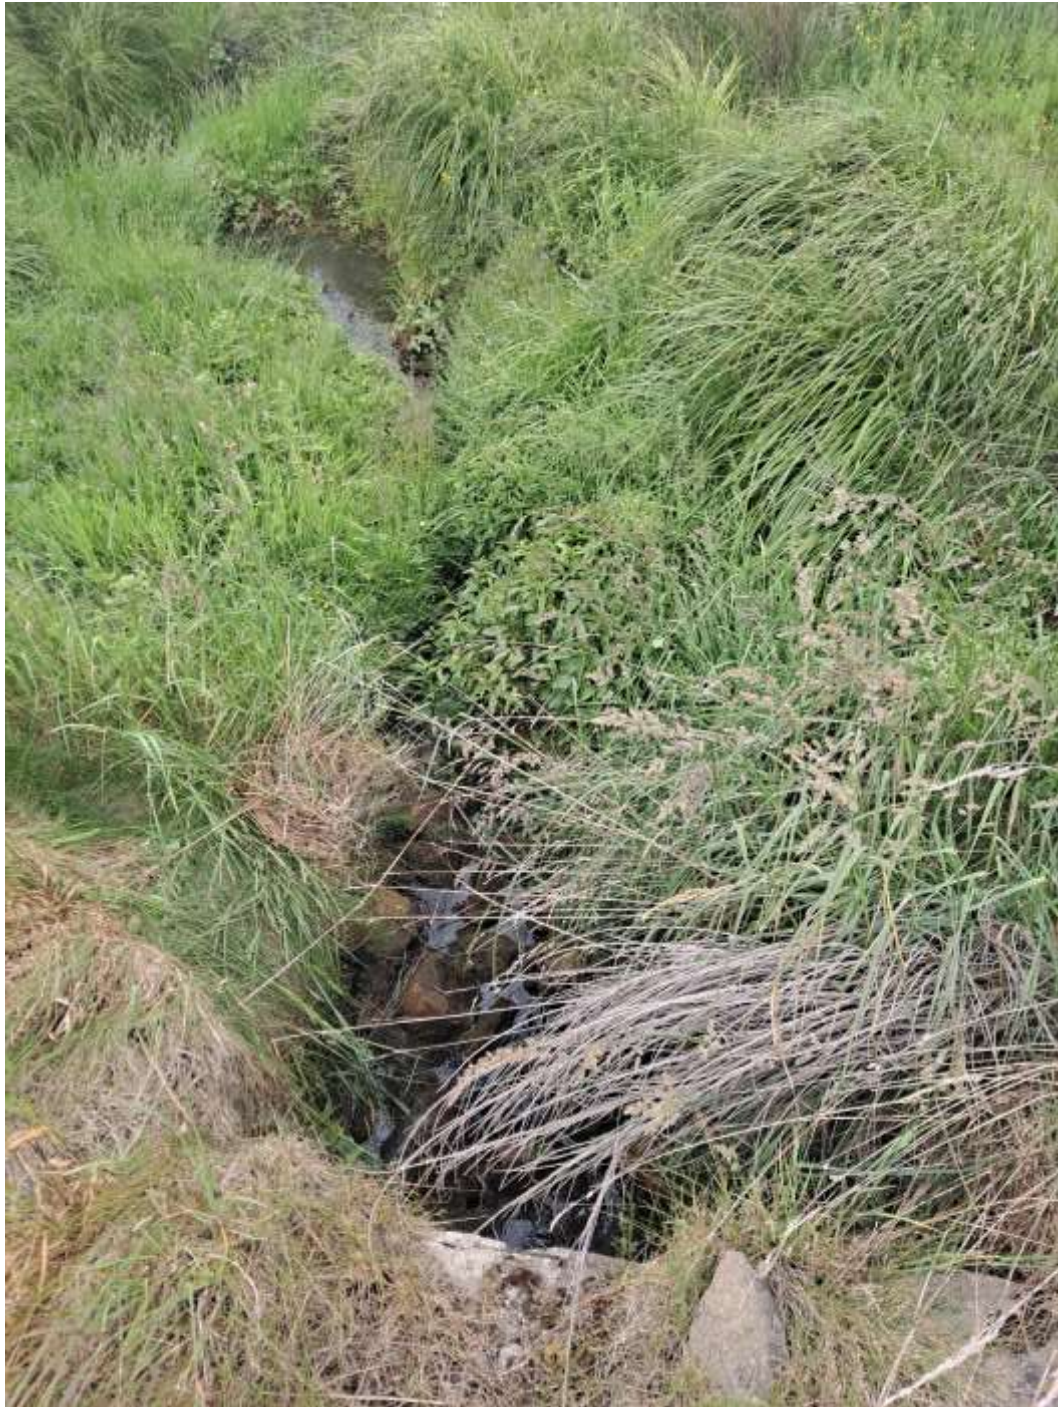
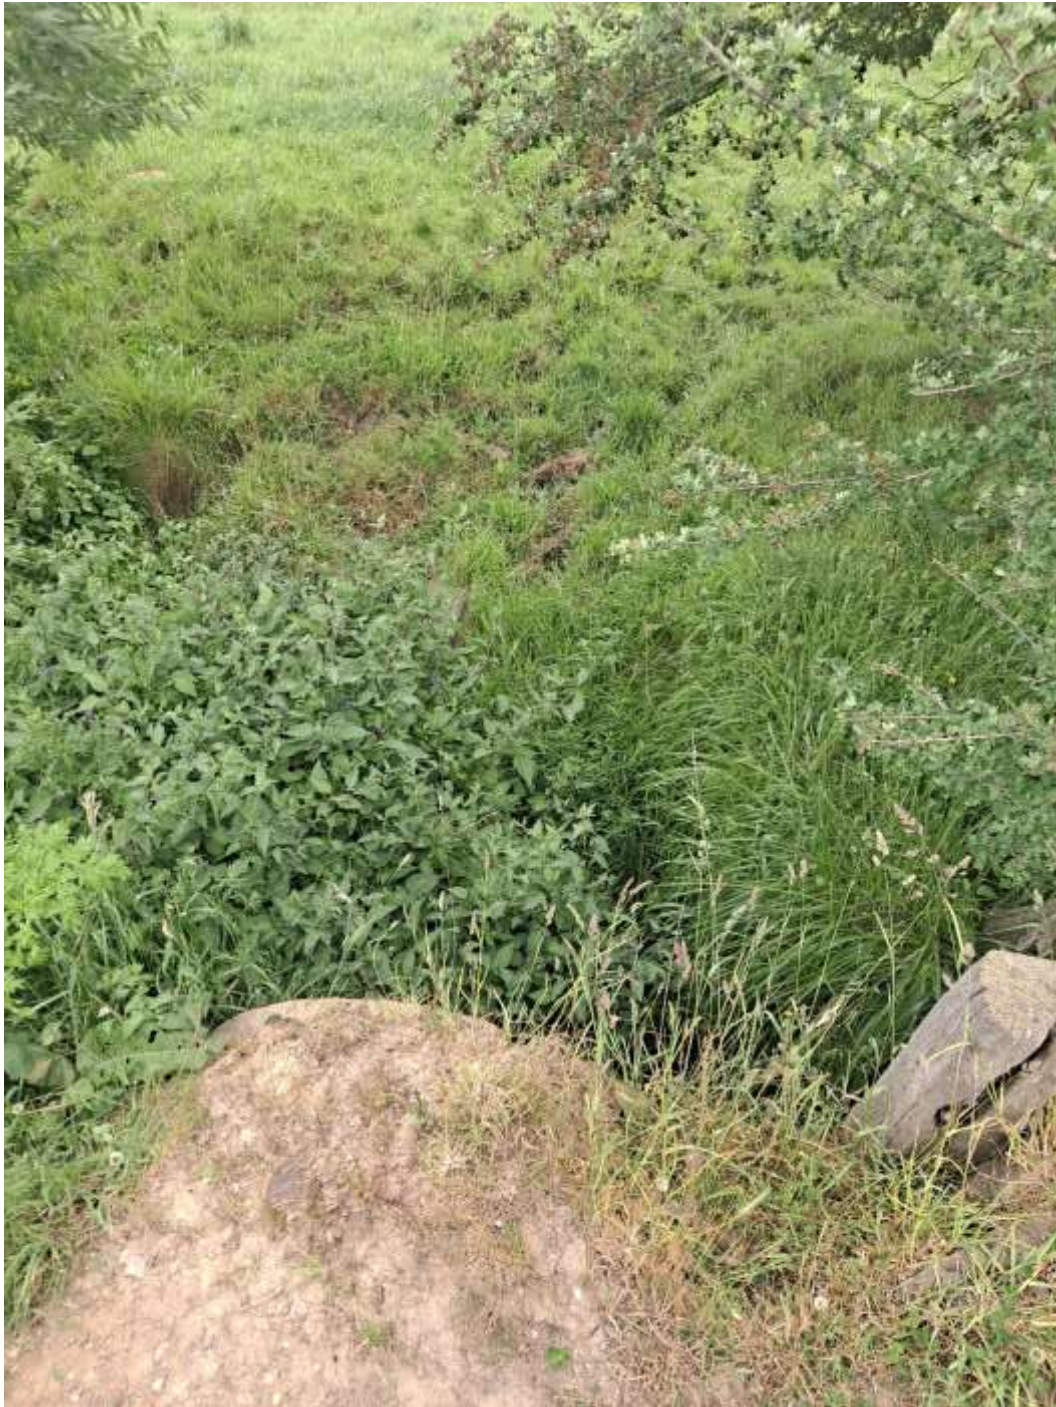
W3 is a large (1.2m) concrete culvert located on Galbraith Rd (Figure 34). The downstream end of the culvert has a small drop (0.1m) into the downstream pool, and although this can likely be navigated by most fish species present in the catchment (with some difficulty for īnaka), fish passage would be improved significantly though low-cost remediation measures such as a rubber matting/spat rope or a floating fish ladder.

Figure 35 Downstream view from W3 culvert

Figure 36 Upstream view from W3 culvert

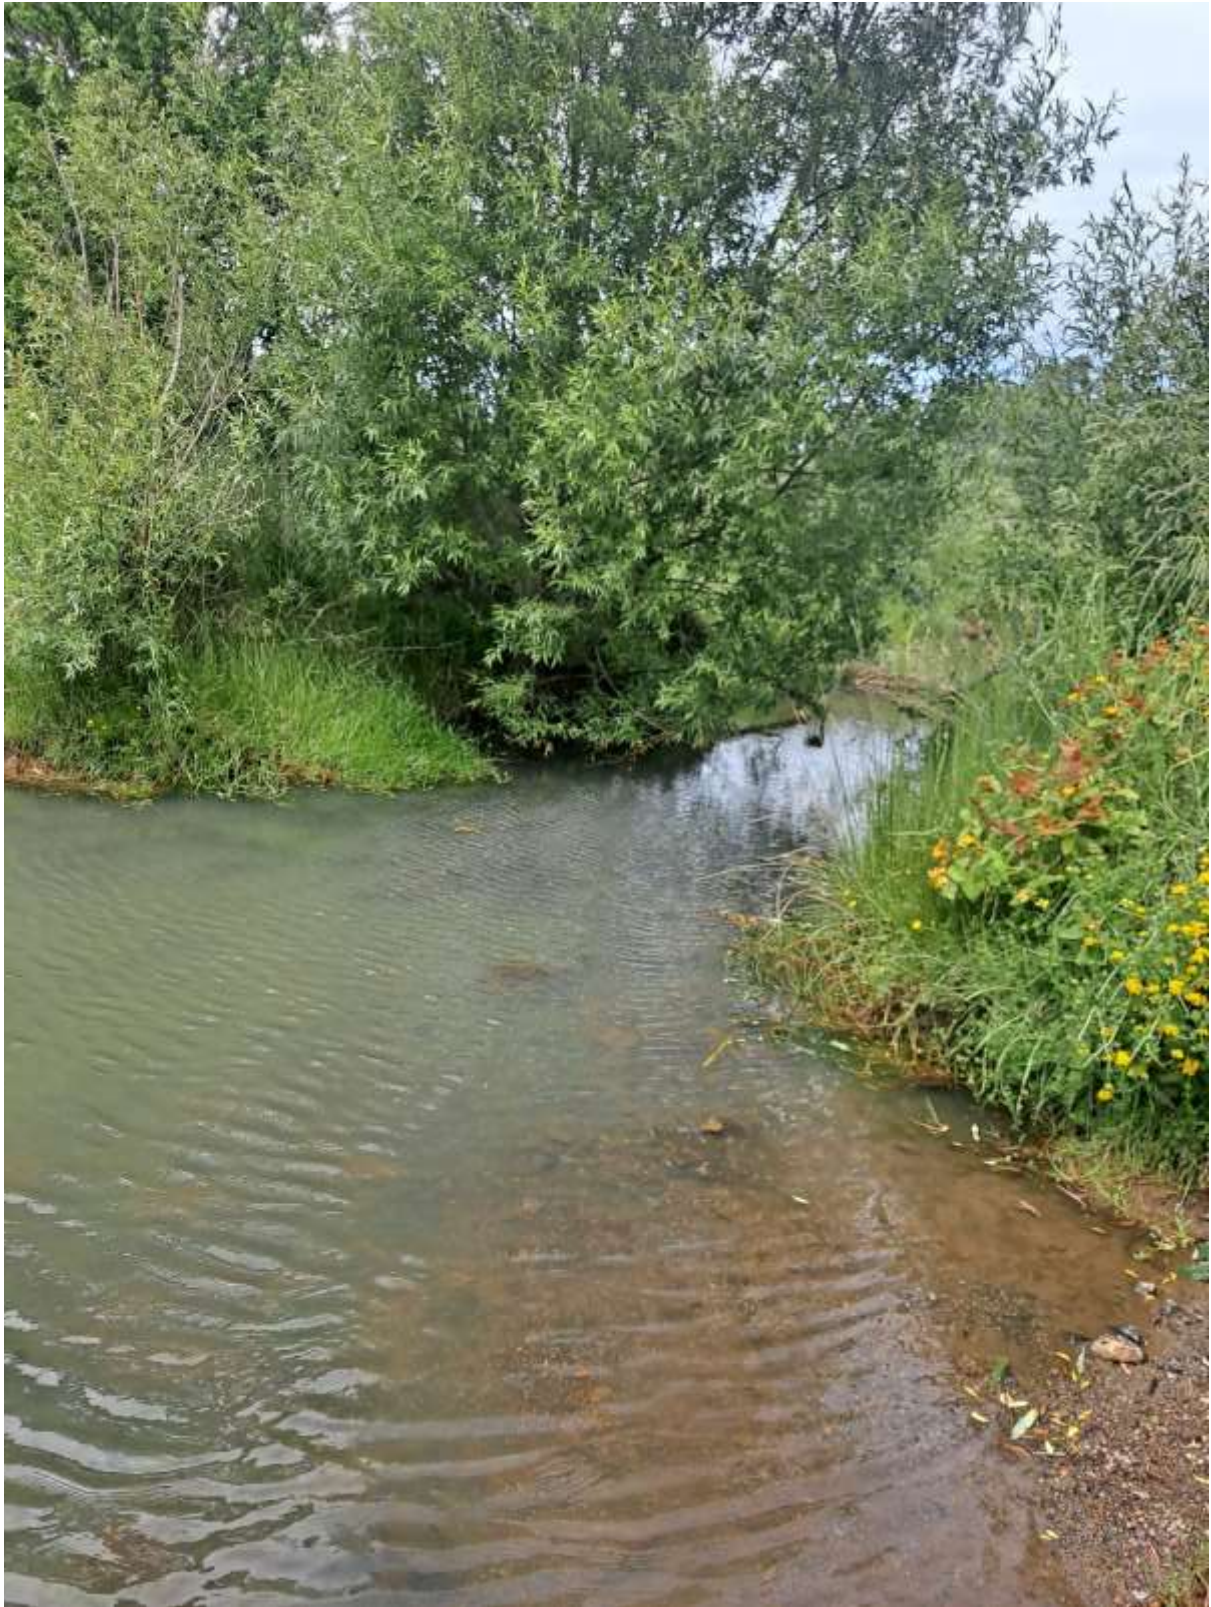
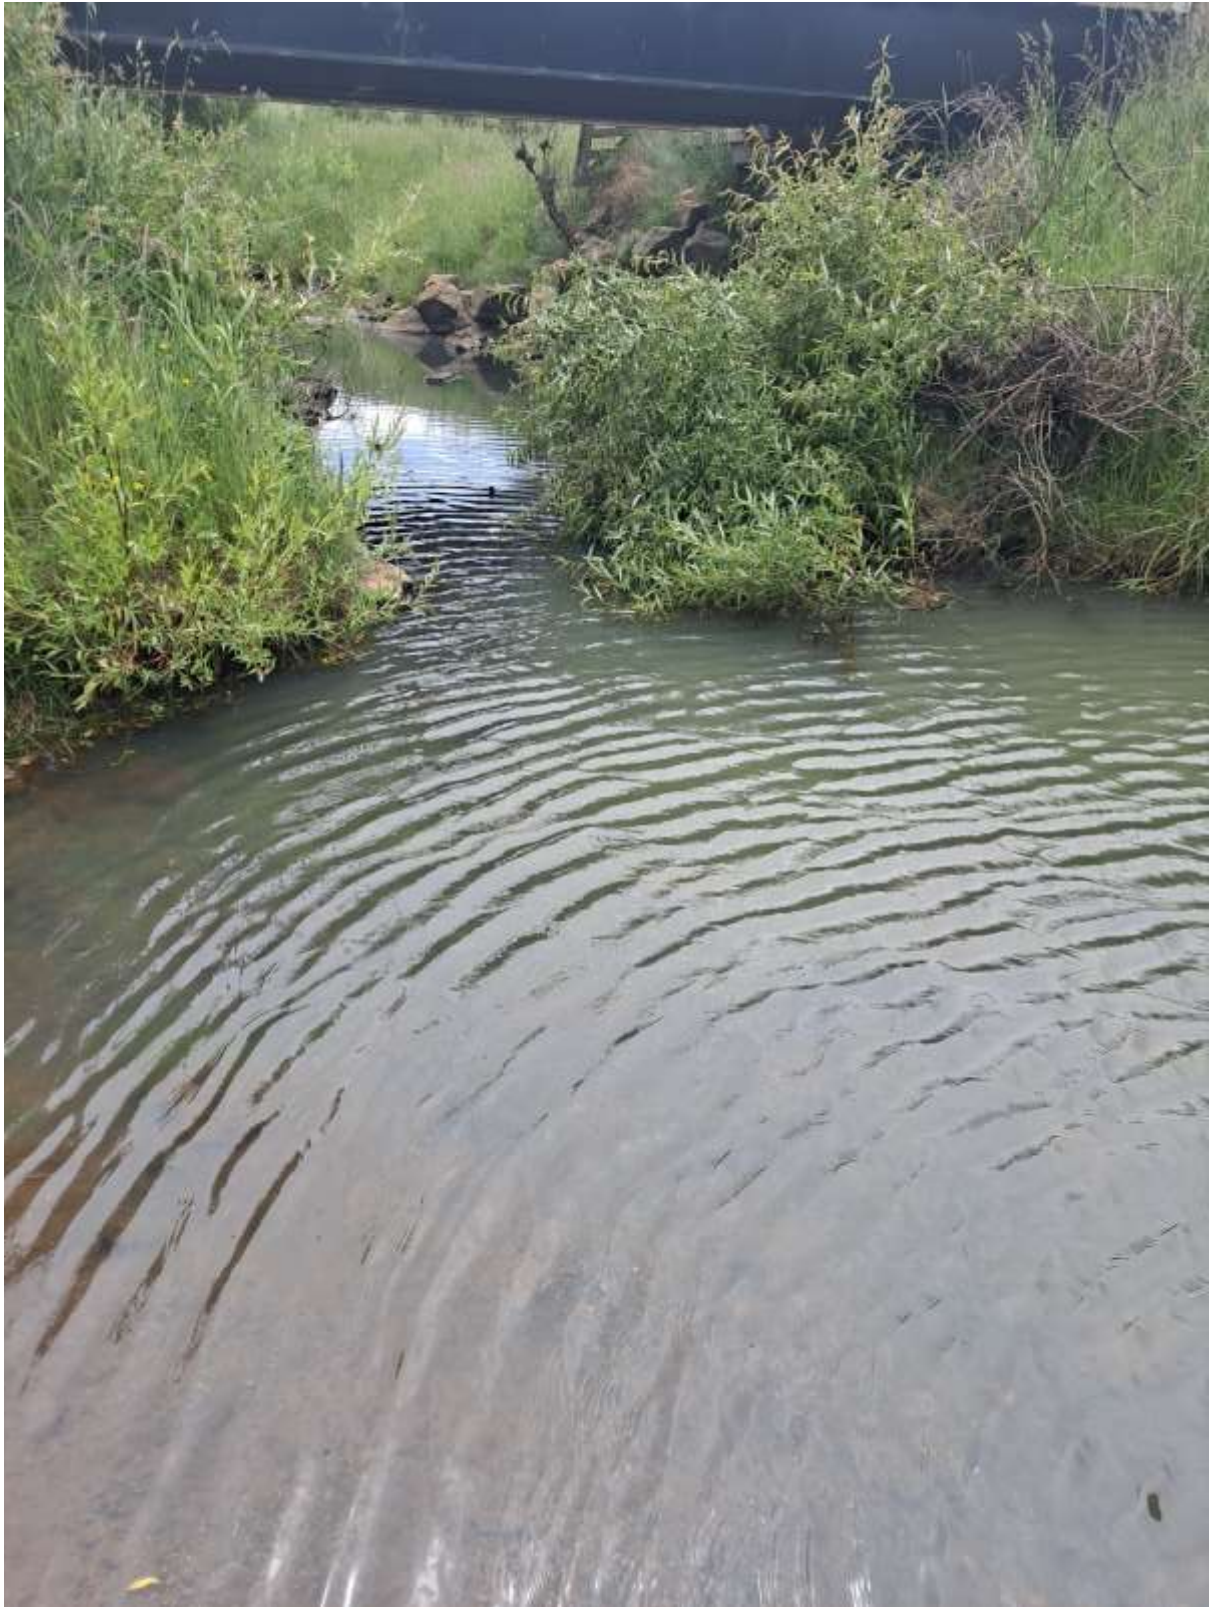
W4 is a ford located immediately downstream of Galbraith Rd in the middle reaches of the Watkin Creek catchment (Figure 37). This ford provides no barrier to fish passage (Figure 38 & Figure 39) and should be considered low priority for mediation.

Figure 38 Downstream view from W4

Figure 39 Upstream view from W4 looking at the Galbraith Rd bridge.

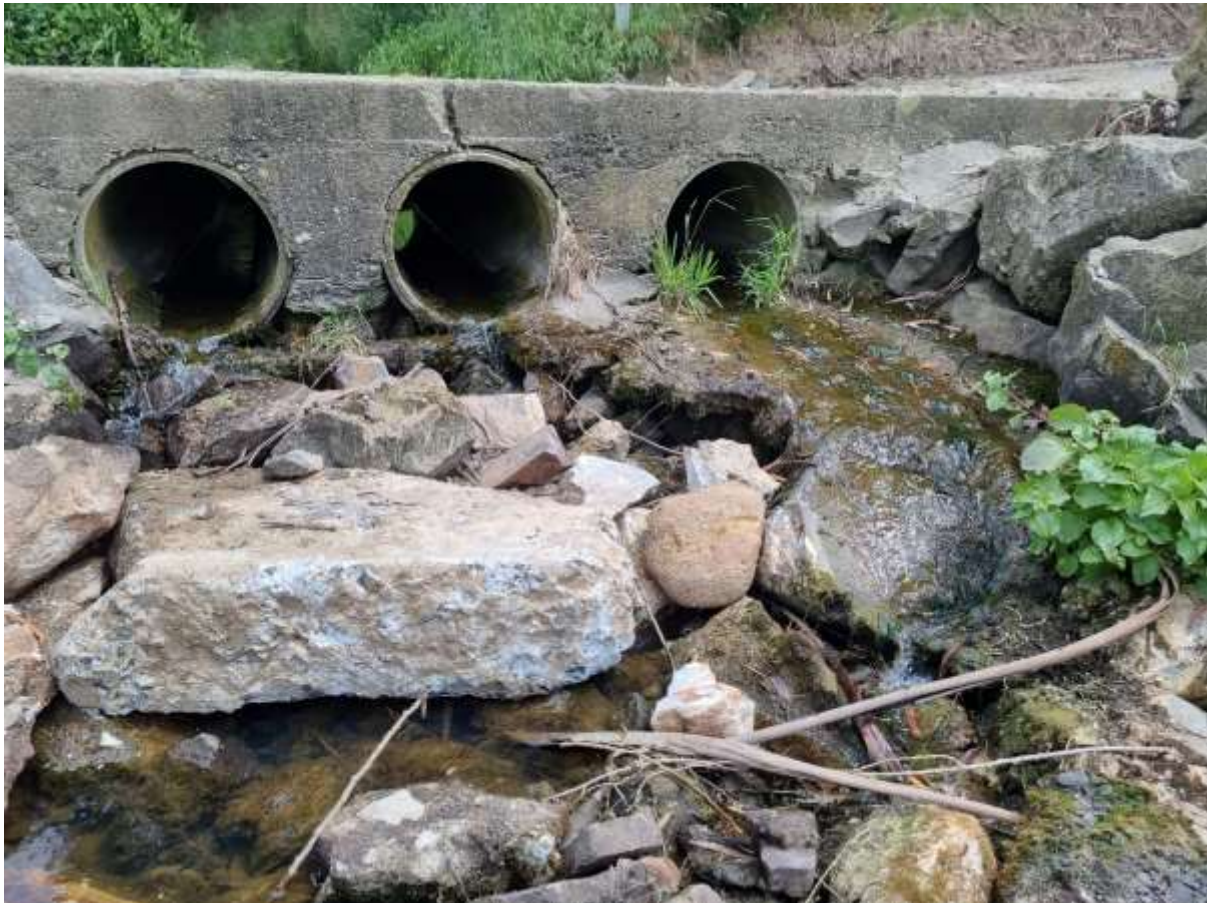
H1 is the most downstream structure on the main stem of the Hakapupu River, and is located on Brooklands Rd, northeast of Goodwood (Figure 40). The structure consists of a concrete ford with three culverts, with all three culvert barrels being perched well above the downstream water level (Figure 41).

Figure 41 Downstream view of the H1 culverted ford

Due to the location of the Brooklands Rd ford and the high risk it poses to fish passage, this site should be considered one of the highest priorities for remediation in the Hakapupu catchment. Ideally, this structure would be completely replaced with a bridge or large box culvert in alignment with the New Zealand Fish Passage Guidelines (Franklin, 2018), and this should be considered the preferred approach for this site. In the event that these works cannot be undertaken quickly due to budgetary constraints, it is suggested that the rip rap is removed and a concrete/rock ramp is installed along with in-culvert baffles. Note that this should only be considered a temporary measure and should not be undertaken as a long-term alternative to replacement.

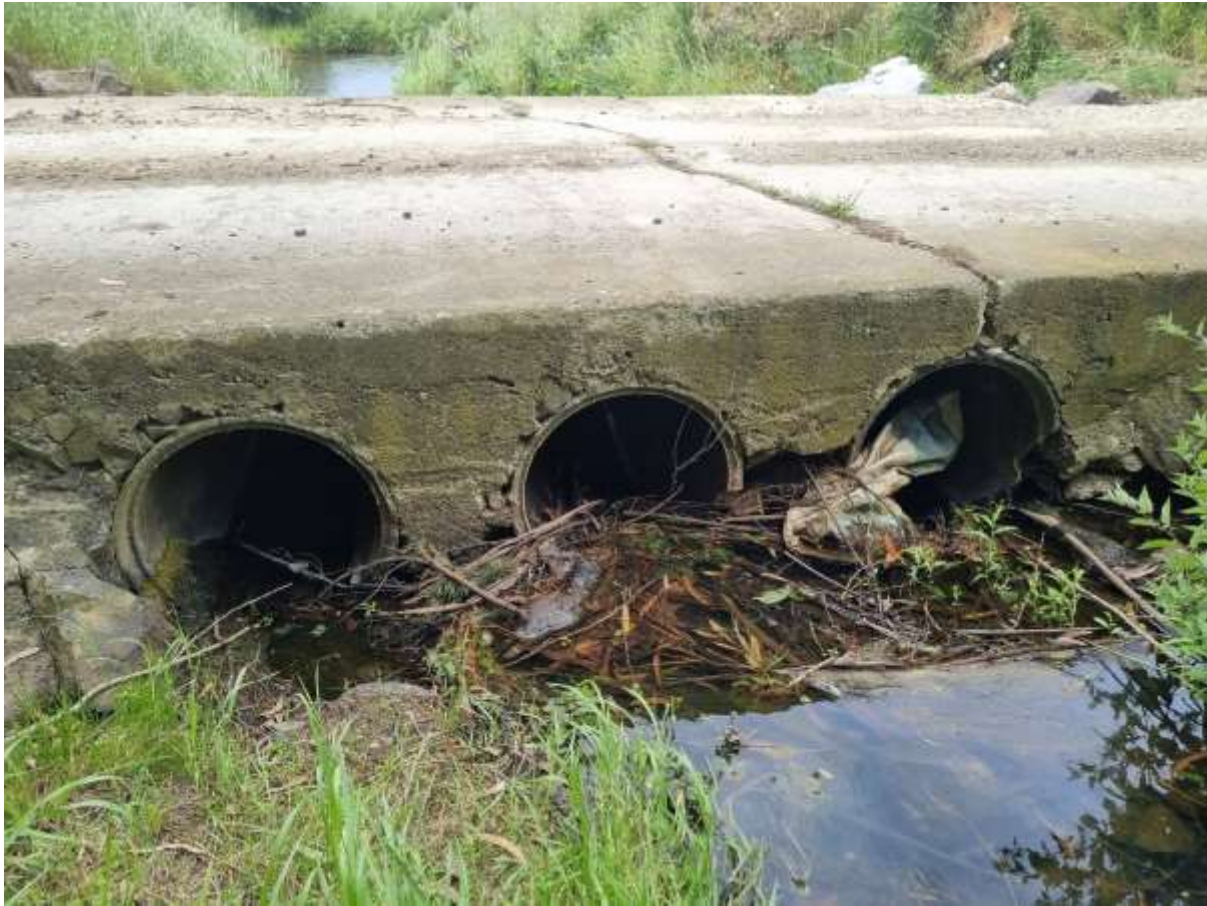
The use of three smaller culverts has led to regular buildup of debris at the upstream end of the structure, which has created a further hindrance to fish passage (Figure 42).

**Figure 42** Upstream view of the H1 culverted ford

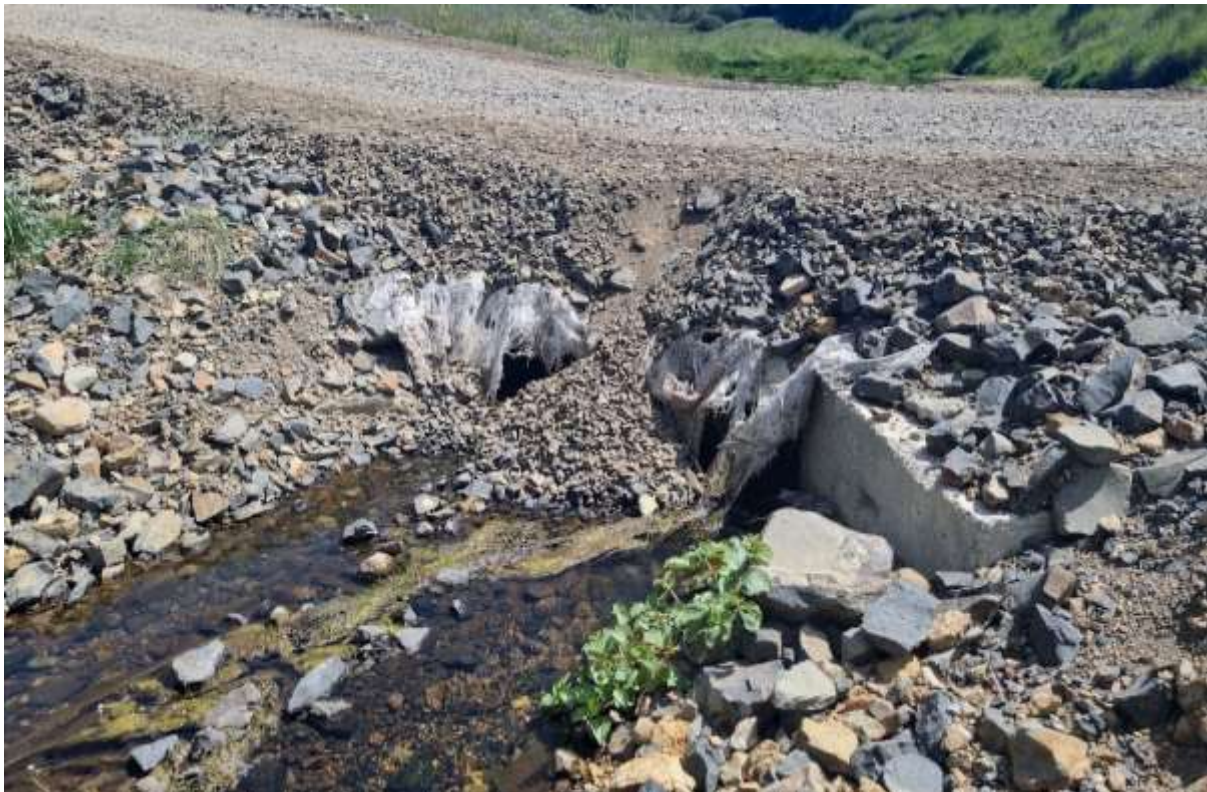
An initial inspection undertaken on December 7<sup>th</sup> showed that the ford had partially collapsed over the downstream end of the culverts, preventing most fish passage (Figure 44). A subsequent visit on December 13<sup>th</sup> showed that this issue has been addressed and that risk to fish passage was low (Figure 45 Figure 46). No further remediation is required at this site, however the structure owners should ensure that further blockages do not occur.

**Figure 44** Partially collapsed ford preventing fish passage at the H2 site on December 7<sup>th</sup>, 2023.

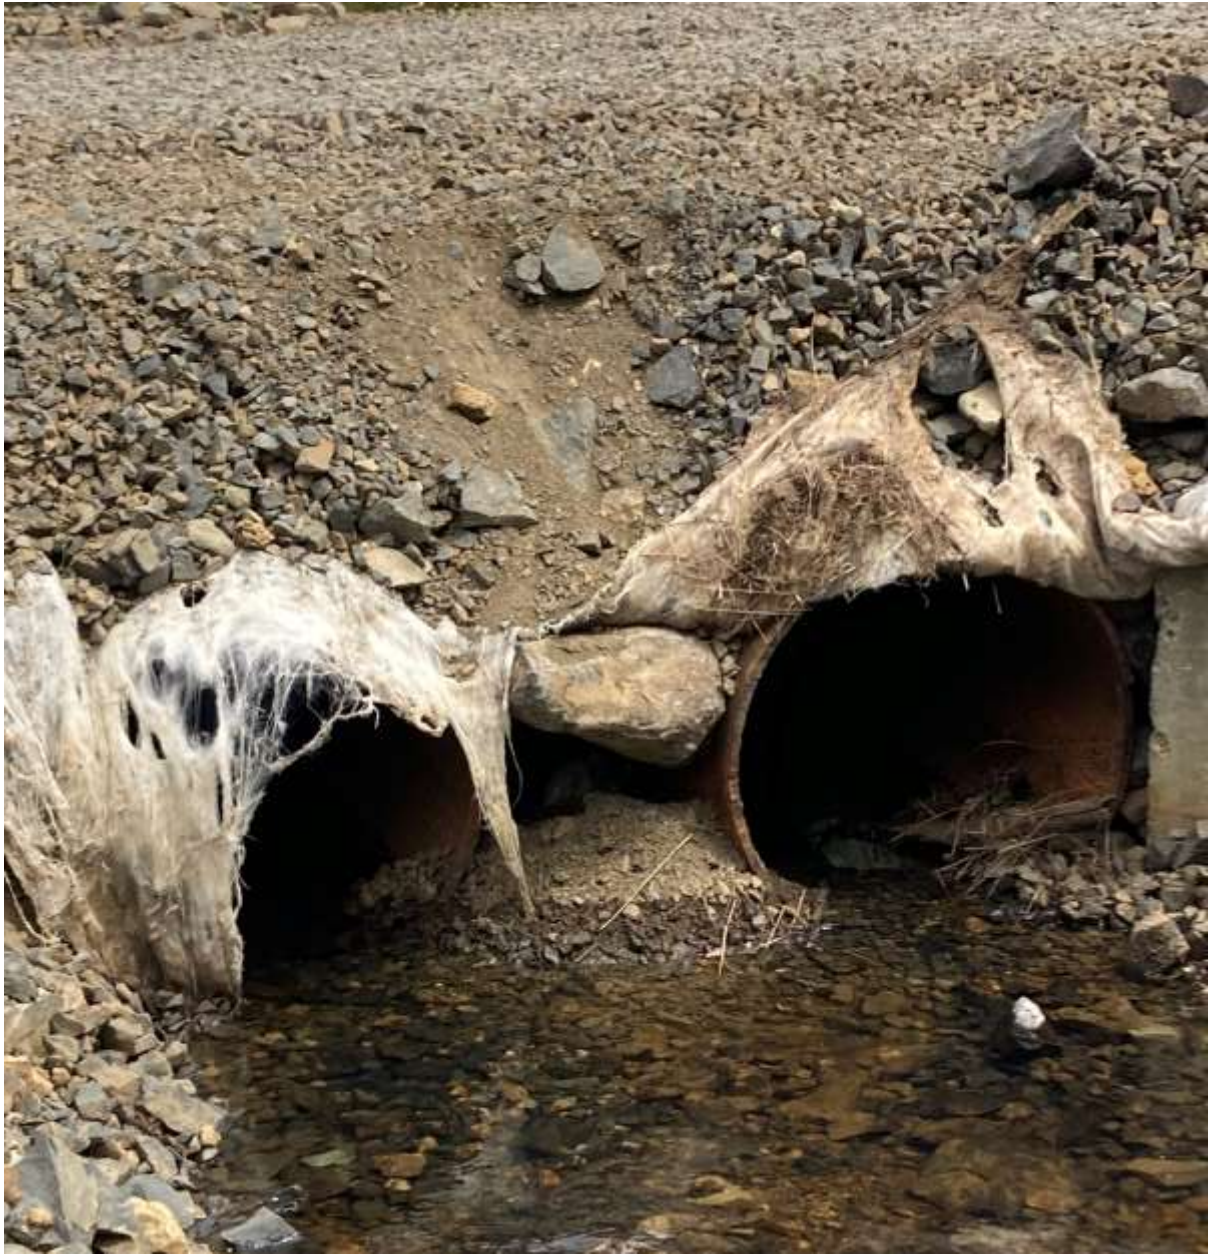
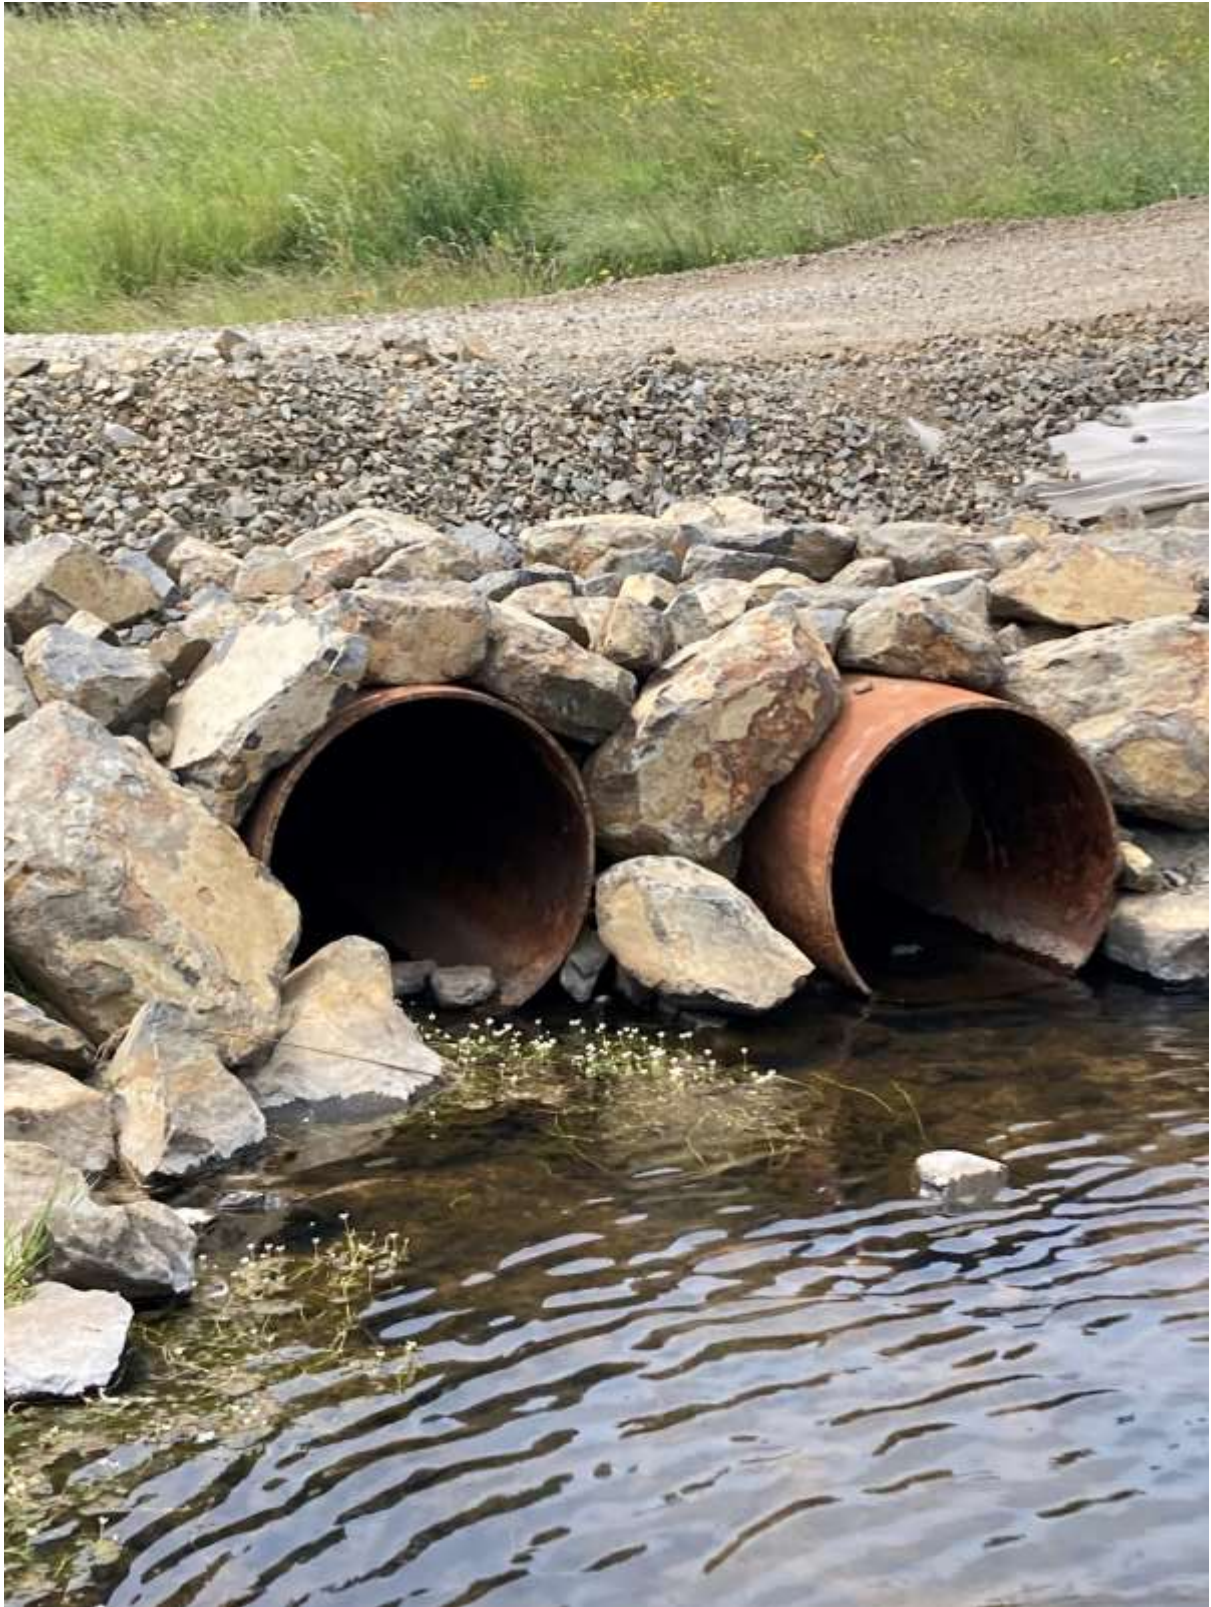
The ford has been constructed by laying steel bridge piles along the stream bed and then covering them with rip rap and road metal. The culvert barrels have been laid at the same gradient as the stream bed with low water velocities and sufficient depth to provide fish passage.

Figure 45 Downstream view of H2 culverts on December 13<sup>th</sup> 2023

Figure 46 Upstream view of H2 culverts on December 13<sup>th</sup> 2023

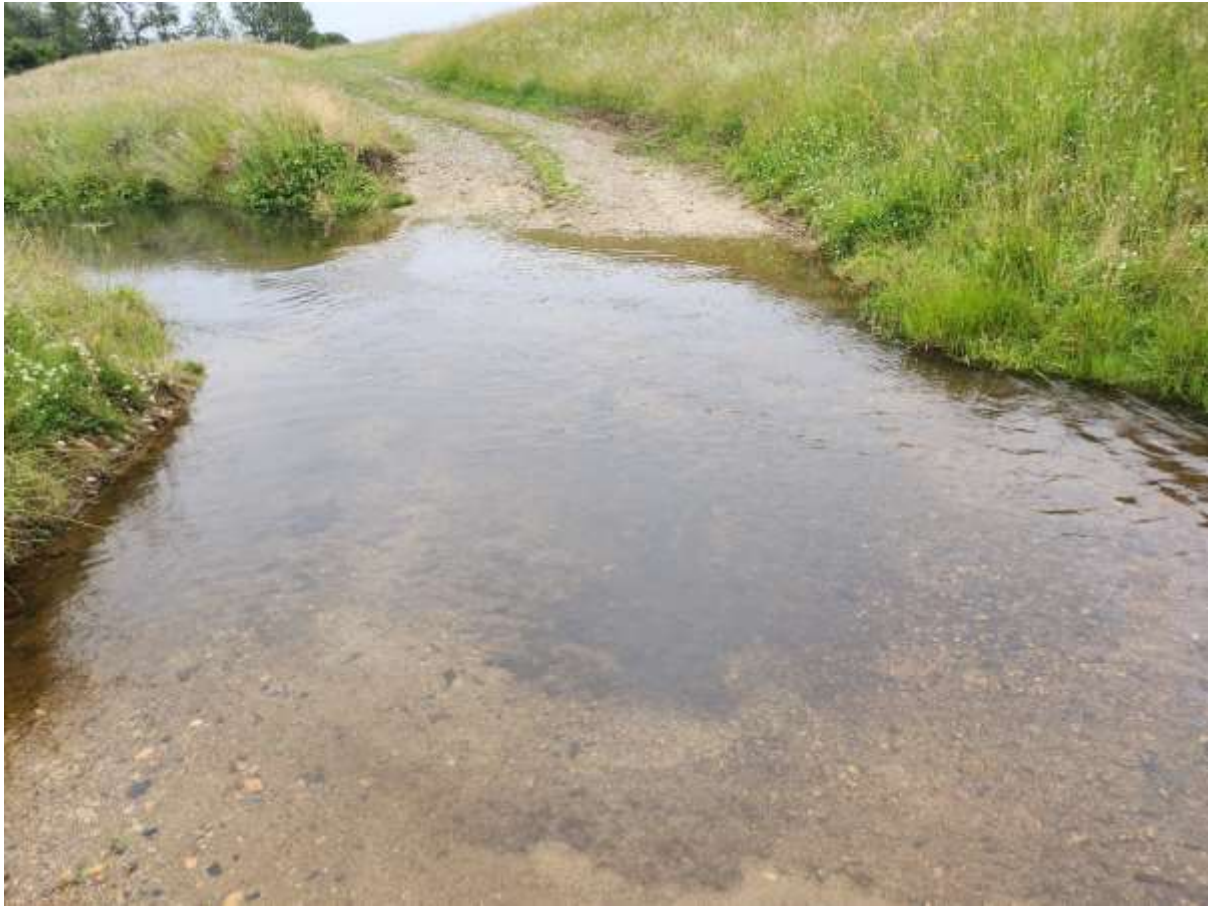
Site H3 is a ford located north of Goodwood on the east side of SH1 (Figure 47). The ford poses no risk to fish passage and does not require any remediation.

Figure 48 The H3 ford

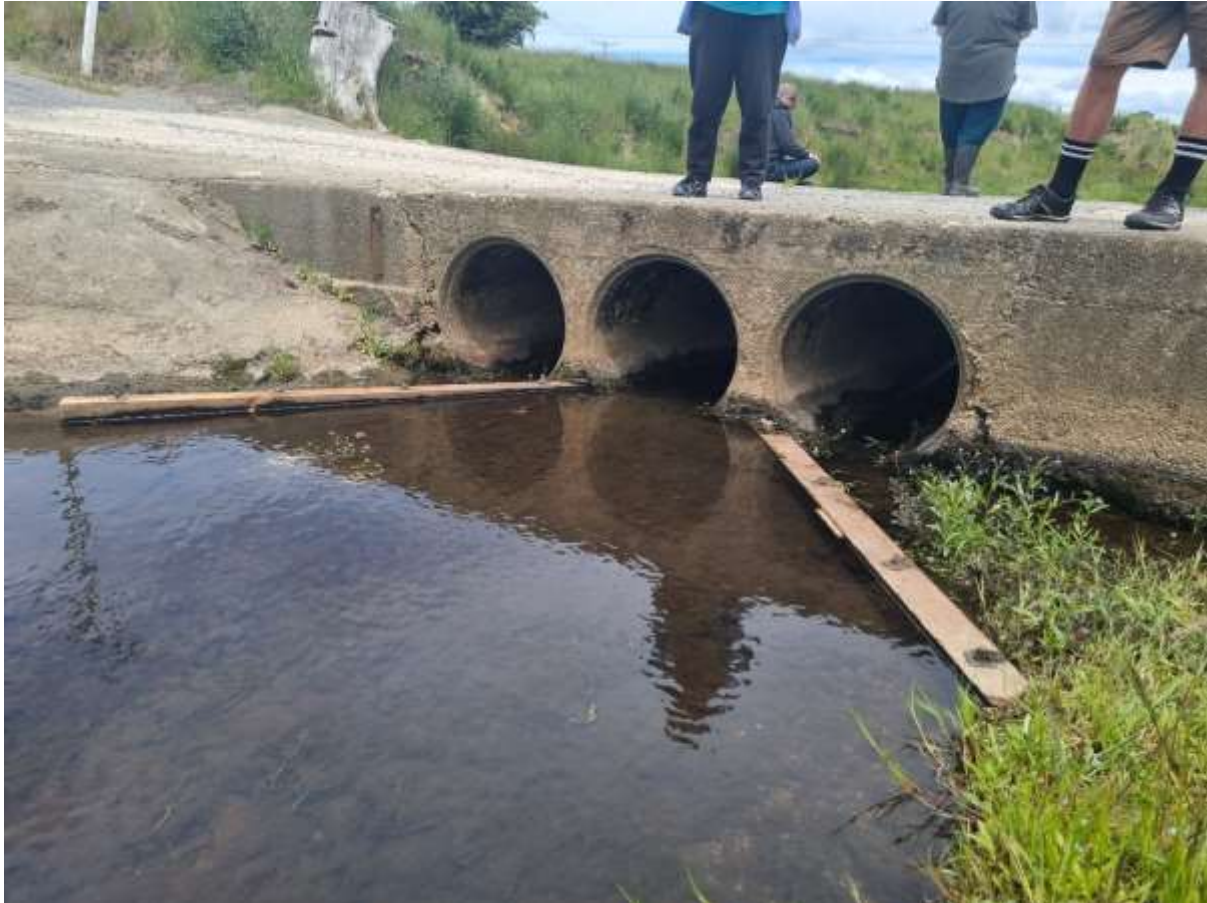
Although the upstream baffles do increase the water depth within the central culvert, it also acts to prevent any fish that pass through the outer culverts from accessing the upstream channel. Several īnaka were observed trapped between the baffle and the bank while the assessment was being undertaken. It is also likely that the increased velocity in the central culvert caused by the baffles is preventing īnaka from navigating the full length of the barrel, and as such is recommended that the baffles be removed.

**Figure 50** Upstream view of the H4 ford at Pattersons Rd showing wooden baffles to channel flows into the central culvert.

Due to the location of the Pattersons Rd ford on the main stem of the Hakaupupu, and the high risk it poses to fish passage, this site should be considered one of the highest priorities for remediation. Ideally, this structure would be completely replaced with a bridge or large box culvert in alignment with the New Zealand Fish Passage Guidelines (Franklin, 2018), and this should be considered the preferred approach for this site.

In the event that these works cannot be undertaken quickly due to budgetary constraints, it is suggested that a concrete/rock ramp be constructed, and internal culvert baffles are installed in all three barrels. Note that this should only be considered a temporary measure and should not be undertaken as a long-term alternative to replacement.

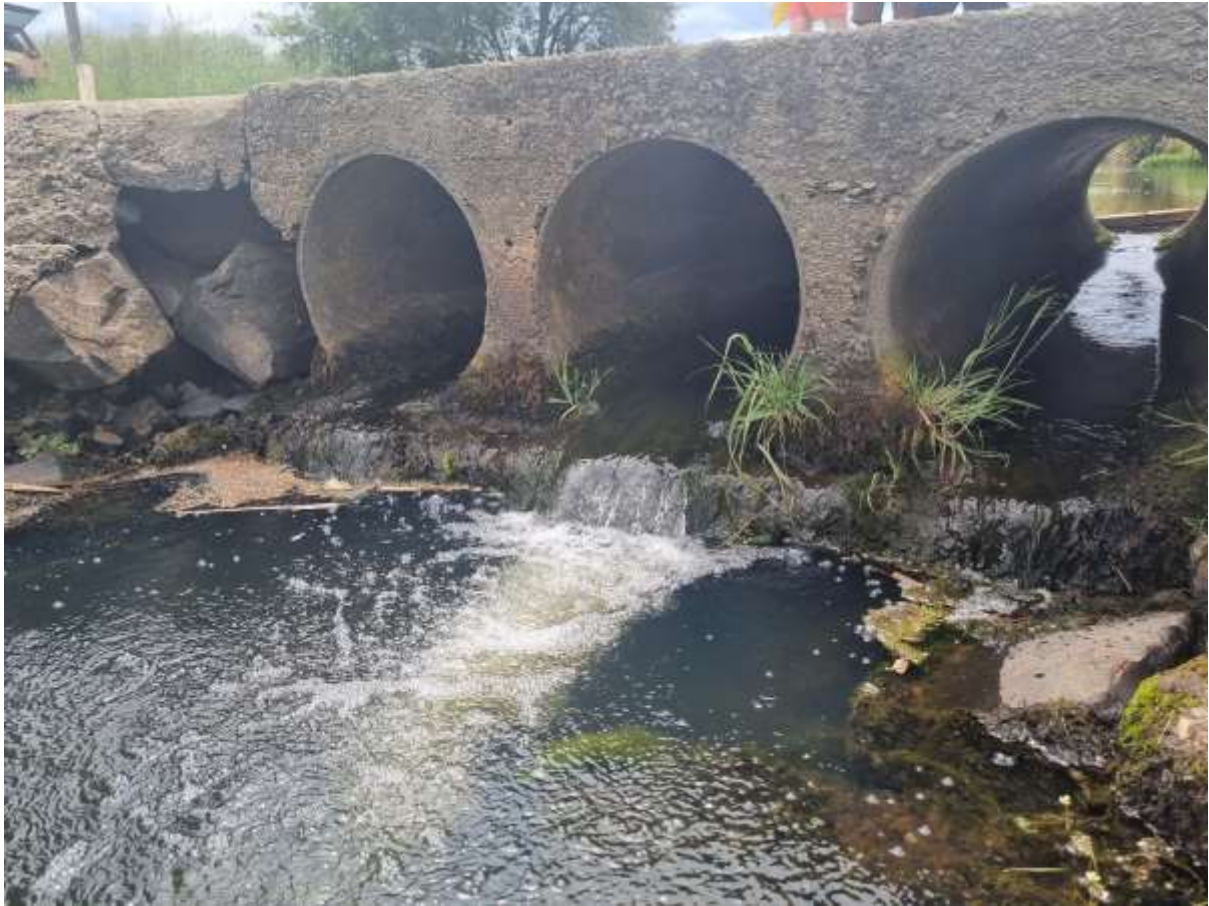
H4 is a three barrelled culverted ford located where Pattersons Rd crosses the Hakapupu River (Figure 49). Each culvert has a width of 0.65m, with the upstream side of the ford having a 2m apron with wooden baffles to guide low flows through the centre culvert to increase water depth for fish passage (Figure 50). The downstream side of the ford has a short apron with a 0.12m drop to the pool below (Figure 51).

Figure 51 Downstream view of the H4 ford at Pattersons Rd
