# FISH PASSAGE ASSESSMENT OF THE HAKAPUPU (PLEASANT) RIVER

Prepared by Kāti Huirapa Rūnaka ki Puketeraki

Matt Dale (Waterscape Connections Ltd) and Julia Rata te Raki, 2024

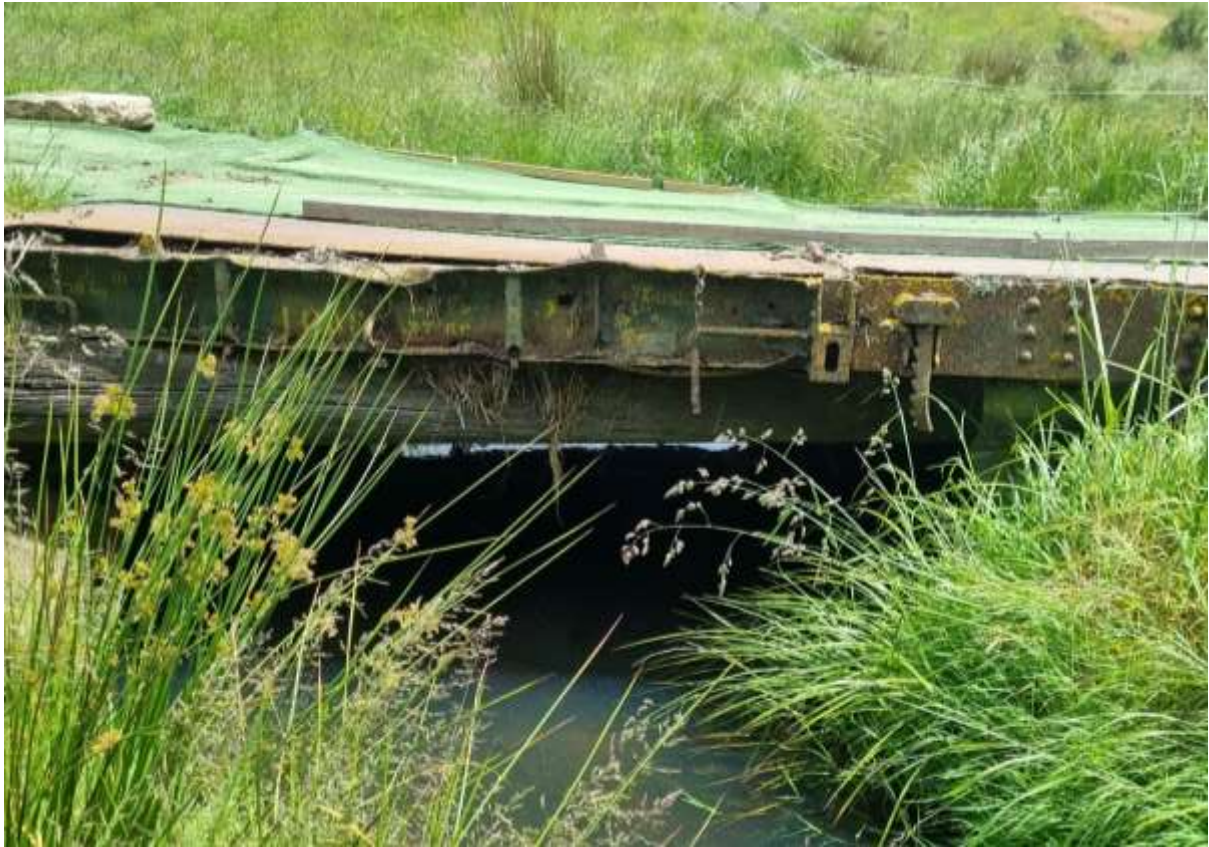
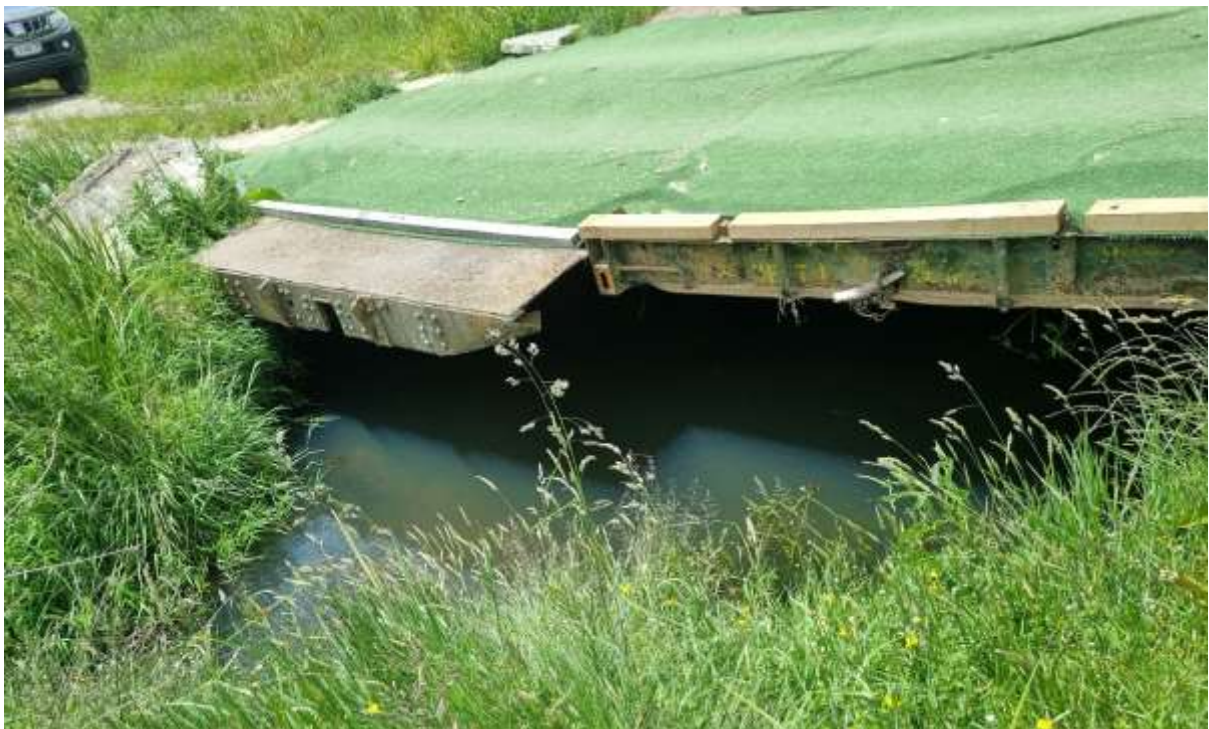
The H5 site is a small bridge located 250m north of Pattersons Rd (Figure 52). The bridge has no effect on fish passage and should be considered a low priority for remediation.

Figure 53 Upstream view of the H5 bridge

Figure 54 Downstream view of the H5 bridge

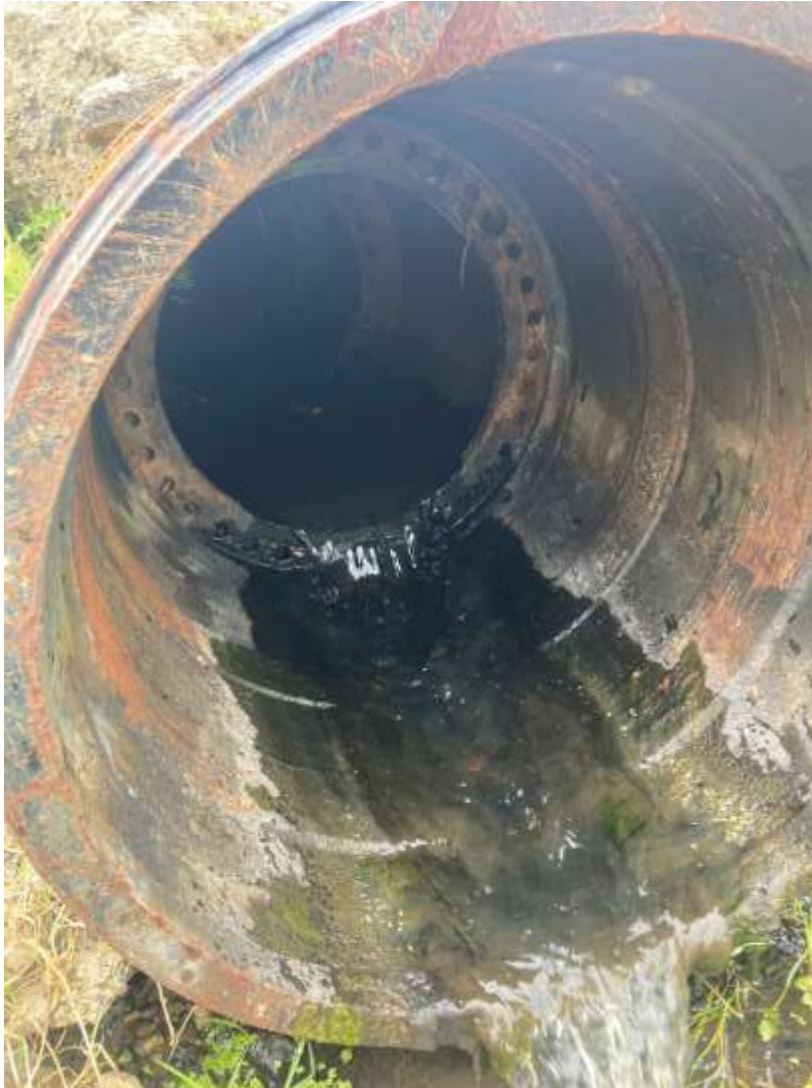
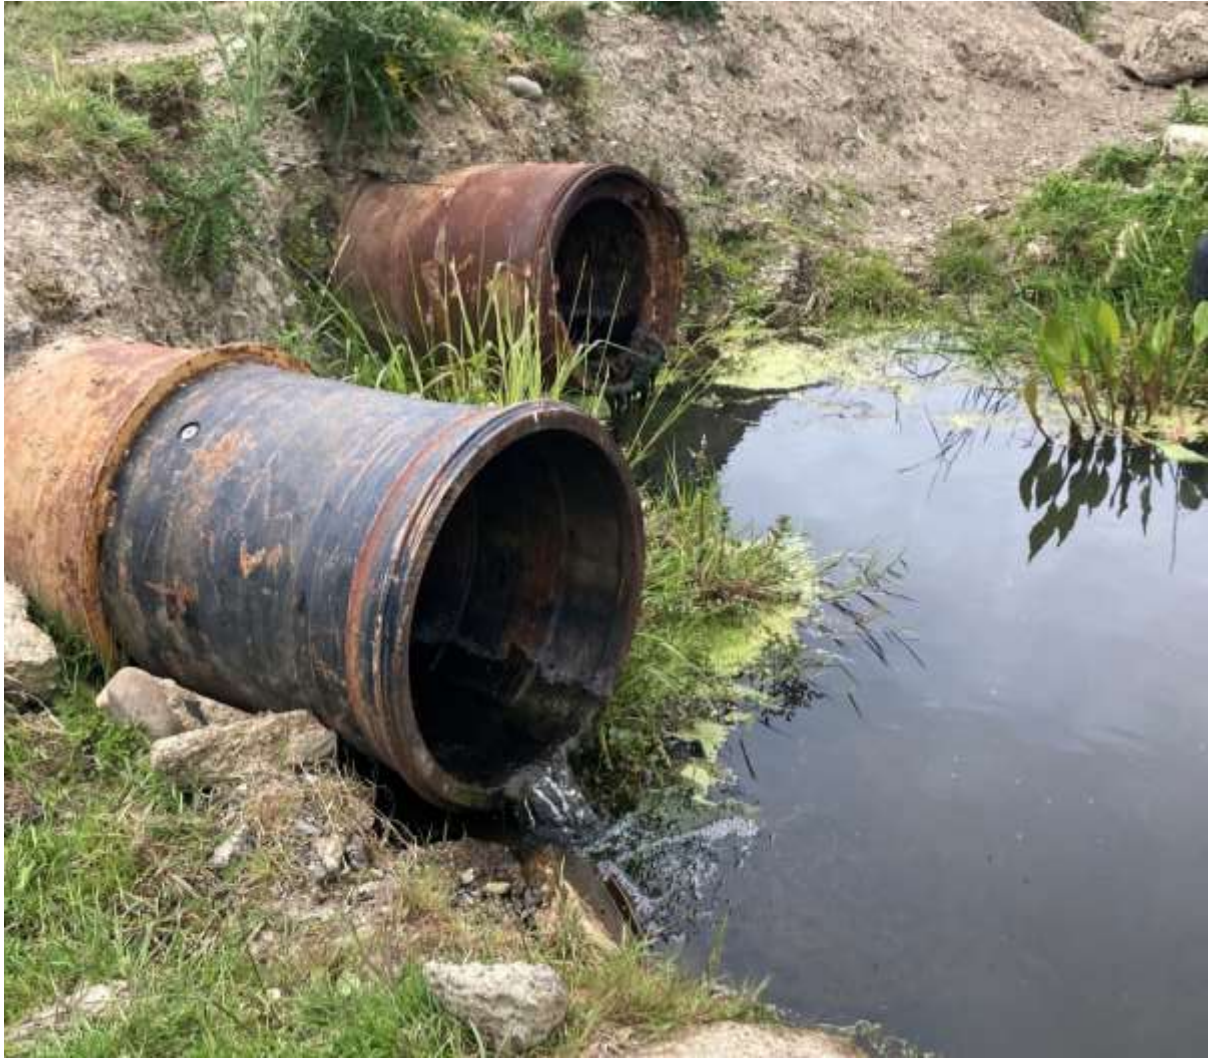
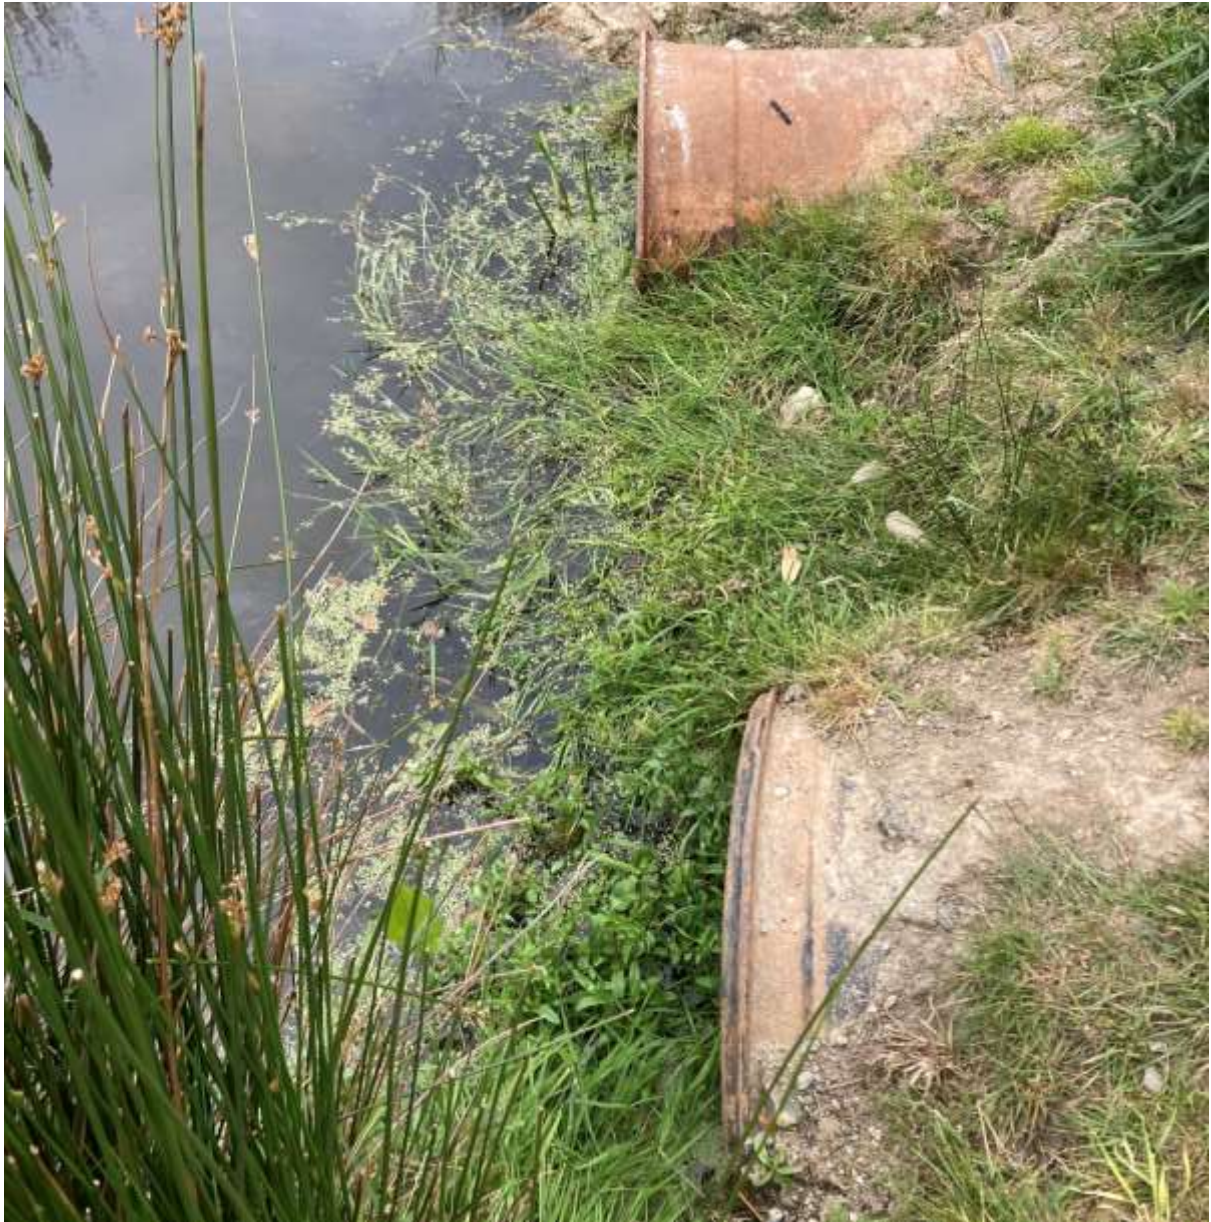
**Figure 56** Internal view of the H6 culvert.

Figure 57 Downstream view of the H6 culverts.

Figure 58 Upstream view of the H6 culverts.

priority for replacement. Because of its location on the main stem of the Hakapupu with a large area of upstream habitat, this site should be prioritised for full replacement rather than remediation. It is suggested that the two culverts be replaced with a single large culvert fully embedded in the stream bed to ensure a natural substrate and water velocities.

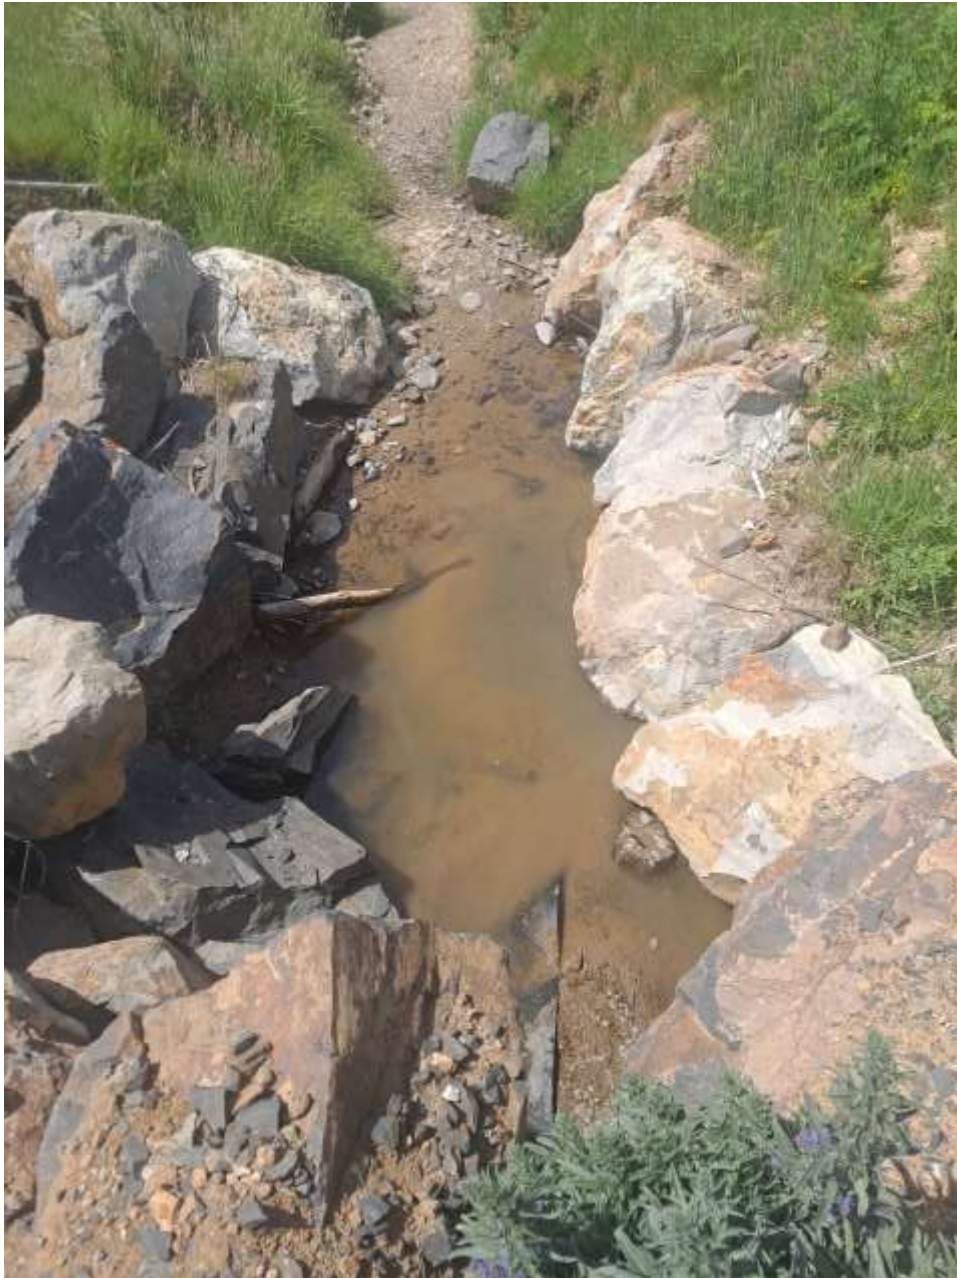
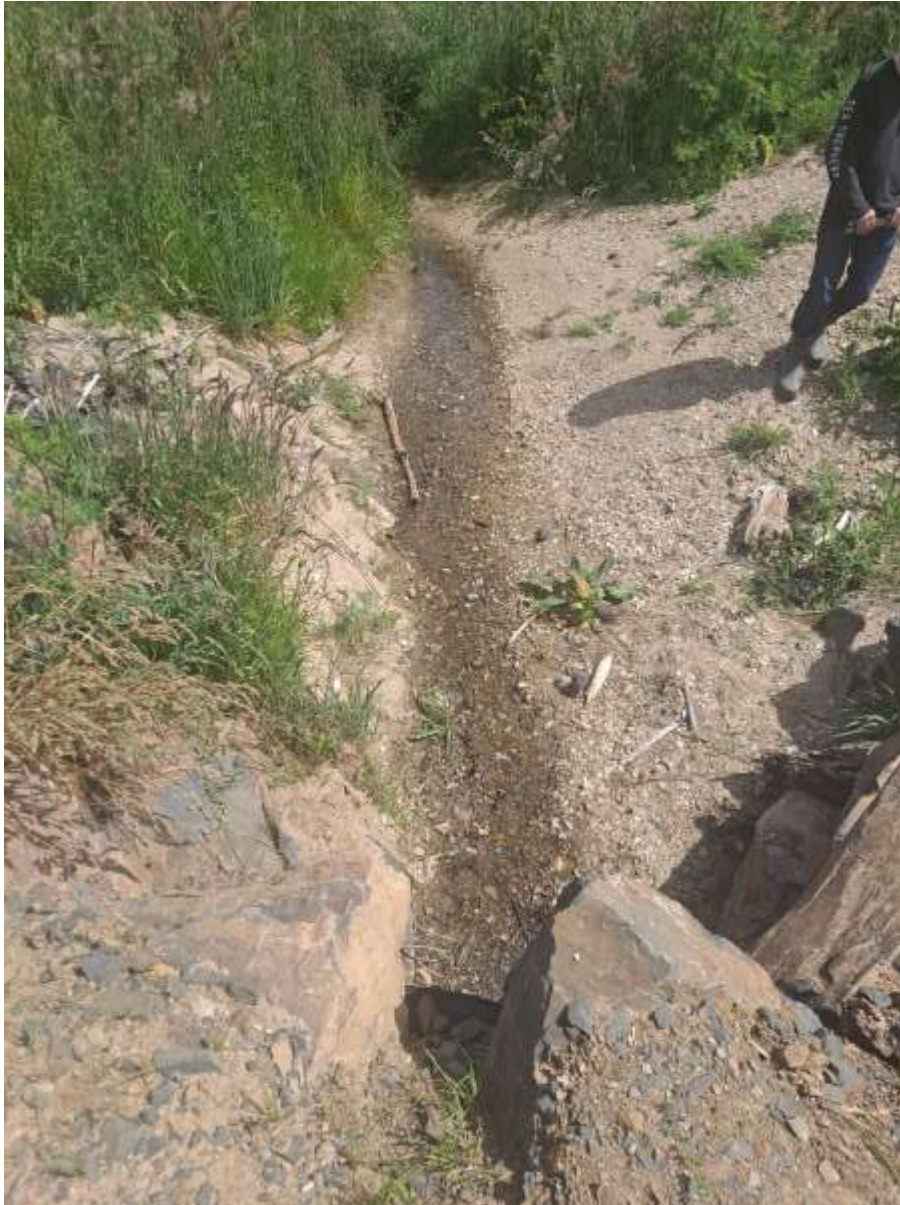
The gradient of the culvert is steeper than the surrounding stream bed and would likely restrict fish passage for species such as īnaka, therefore it is possible that the culvert would not meet the NESFW under conditions of continuous flow. However, the intermittent nature of the stream and a natural lack of fish passage over the summer months reduces the remediation priority for this structure.

Figure 63 Downstream view from the H8 Culvert

Figure 64 Upstream view from the H8 Culvert

It is unclear if there is permanently wetted habitat further upstream of the culvert, therefore as a precautionary measure the landowner should ensure that the culvert is installed in alignment with the NZ Fish Passage Guidelines when it is next repaired following a flood event.

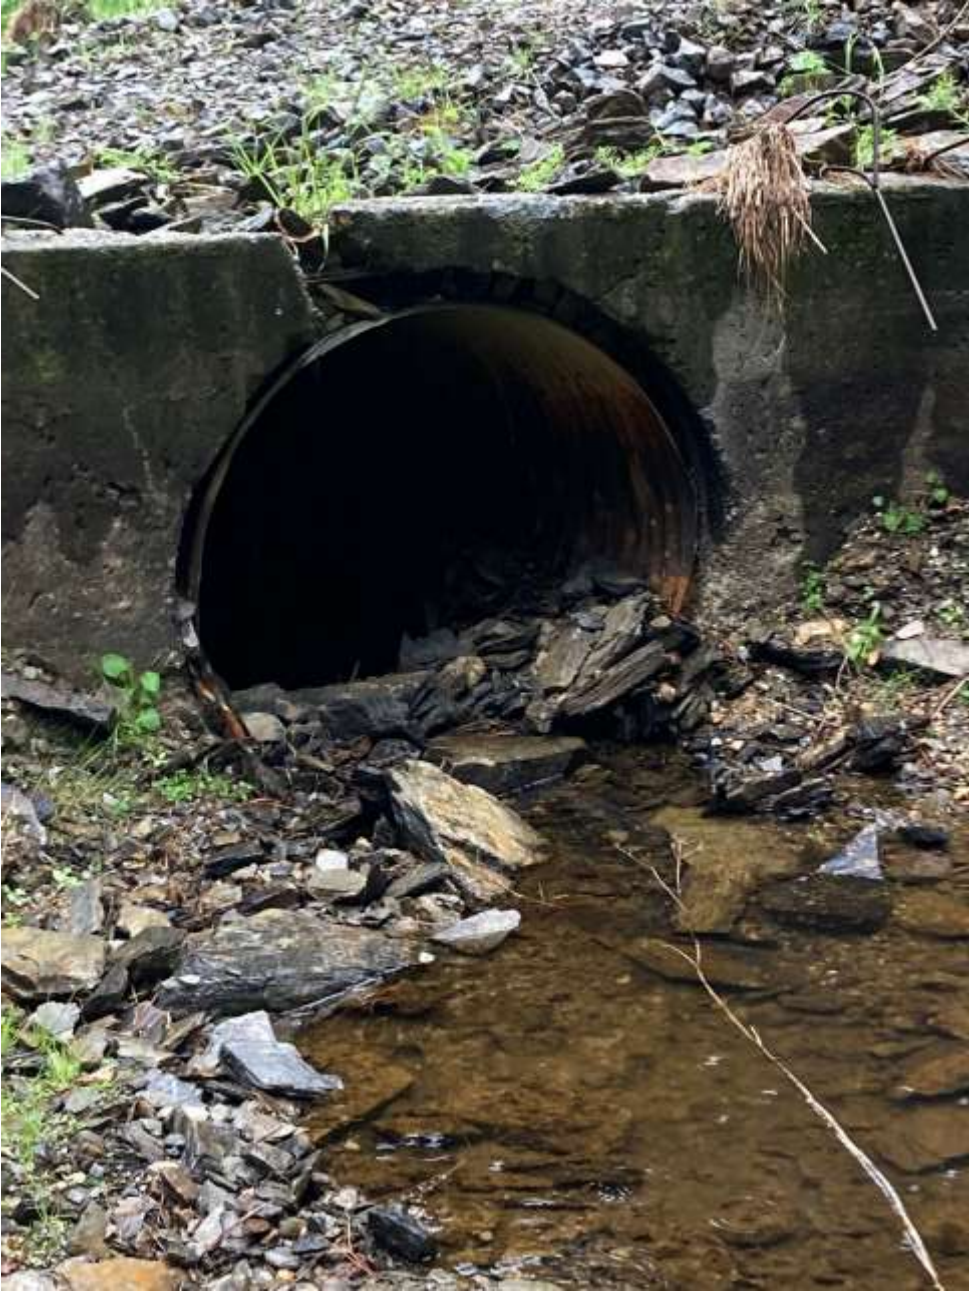
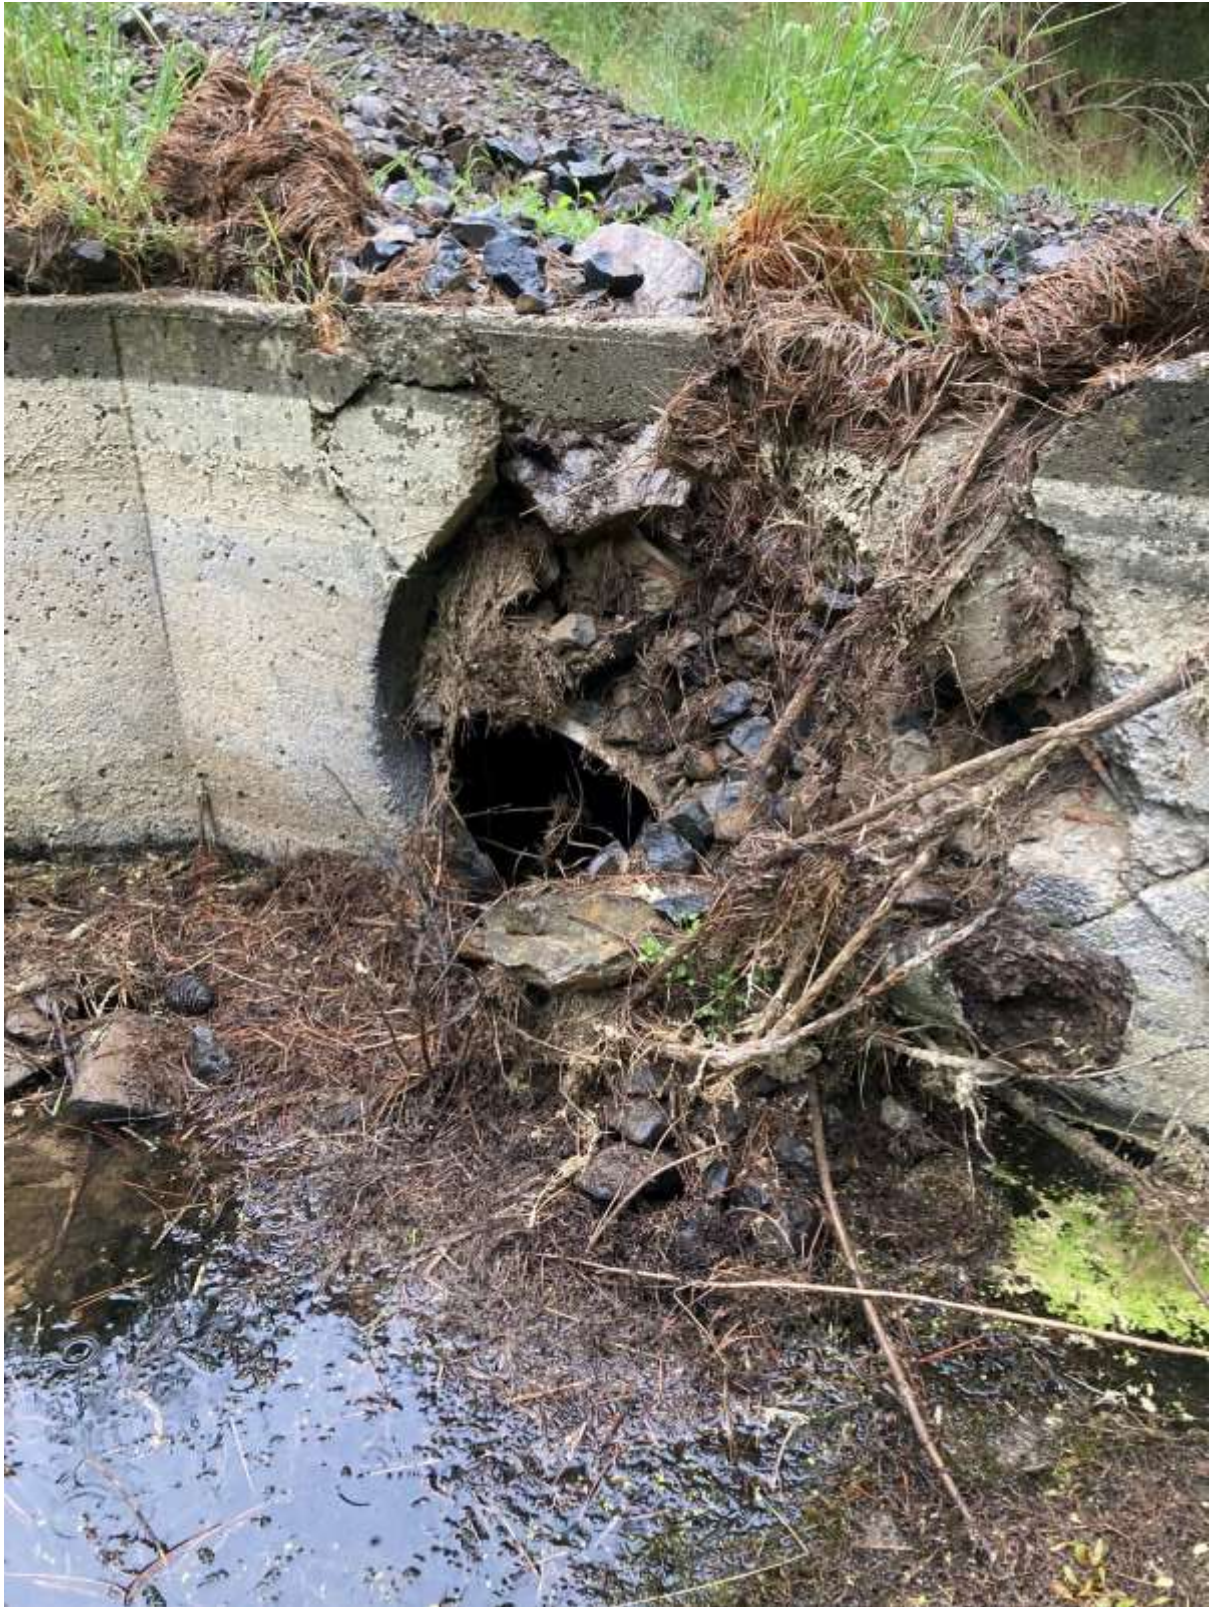
The culvert is 1m wide and located under a forestry access track. It has been damaged and partially collapsed by historic flood events. At the time of assessment surface flows had ceased in several locations either side of the culvert, however the presence of macrophytes, upland bully and stream invertebrates in the remaining pools indicate that they are perennial in nature.

Overall, this structure does not restrict fish passage any more than the surrounding stream bed at low flows. Although its remediation priority is low in its current state, the continued degradation of the culvert due to flood damage will likely result in fish passage issues in the future at which point it will need to be replaced.

Figure 66 Downstream view of the H9 culvert

Figure 67 Upstream view of the H9 culvert

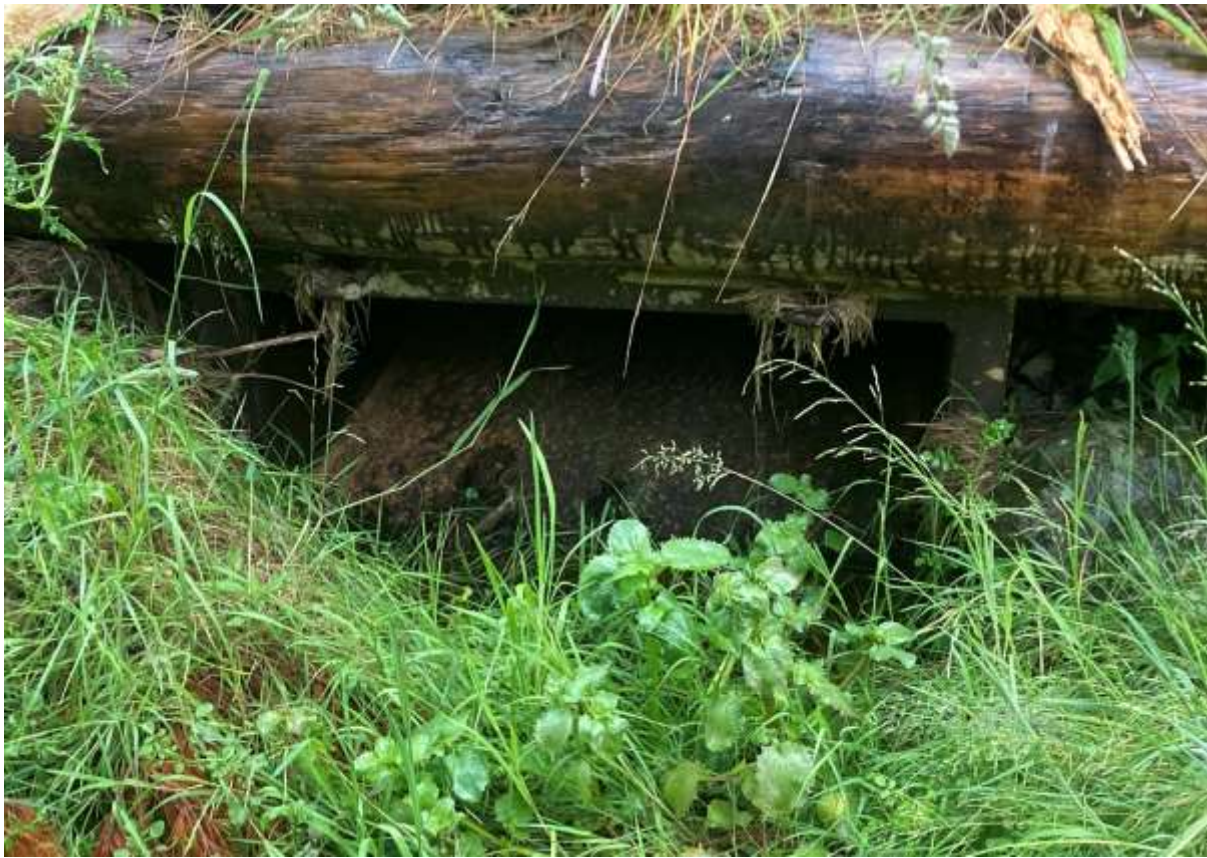
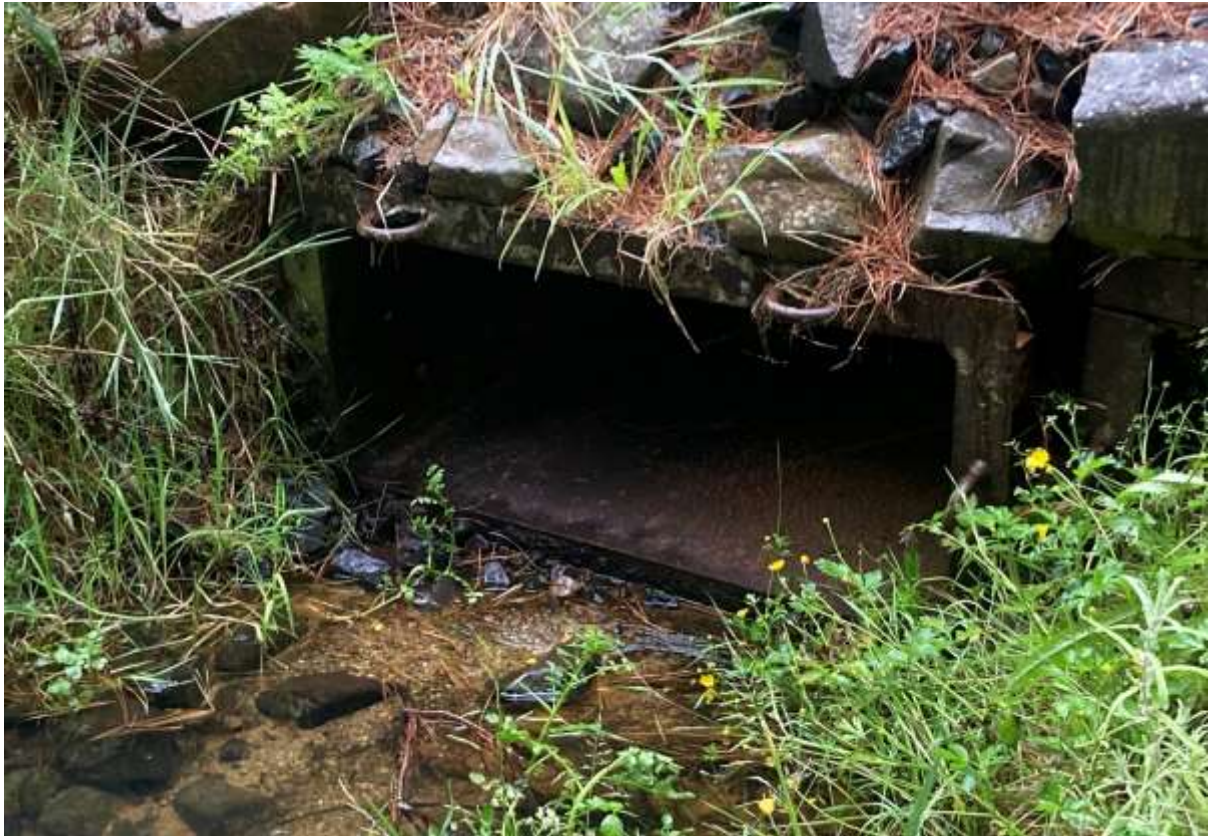
At the time of assessment, there was not continuous surface flow in the reach surrounding the culvert, with the stream consisting of a series of disconnected pools. As such, it is likely that the culvert would create a high risk to fish passage at moderate flows, but not at the low flows observed in mid-December. Although its remediation

priority is low in its current state, the continued degradation of the culvert due to flood damage will likely result in the need to replace the structure in the medium term.

Figure 72 Downstream view of the H11 culvert.

Figure 73 Upstream view of the H11 culvert
