**NORTHERN GULLY SILT POND EMBANKMENT
FINAL CONSTRUCTION REPORT**

NORTHERN GULLY SILT POND EMBANKMENT

CONSTRUCTION REPORT

MACRAES MINING COMPANY LIMITED
NORTHERN GULLY SILT POND EMBANKMENT
FINAL CONSTRUCTION REPORT

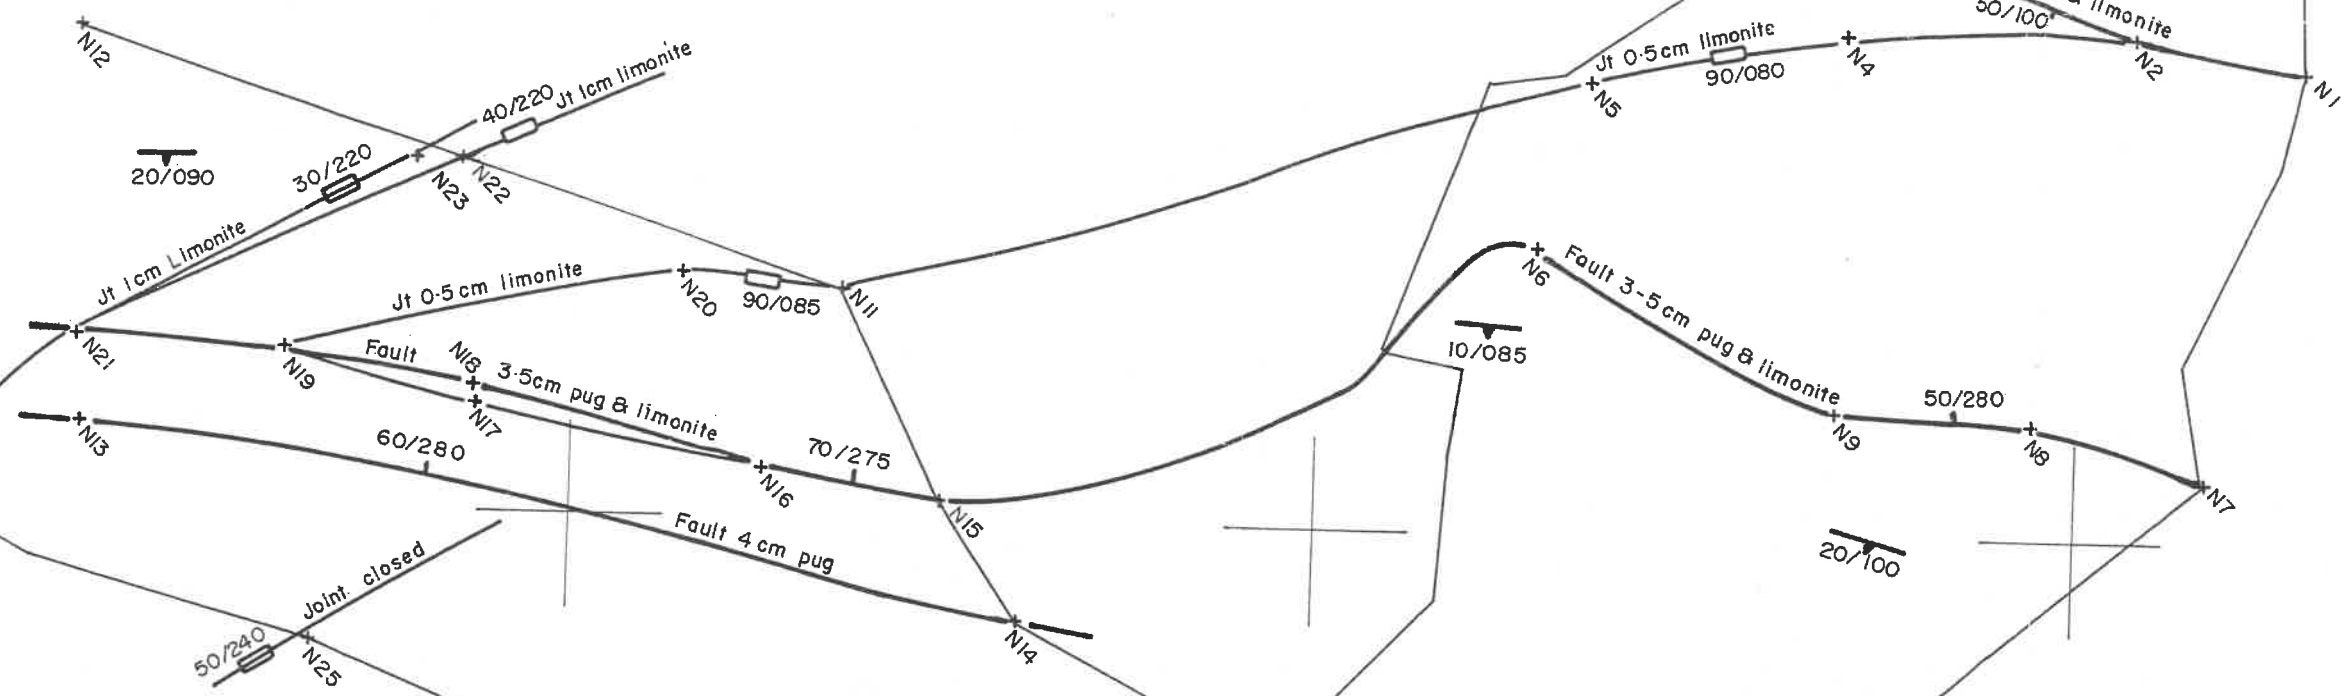
NORTHERN GULLY SILT POND EMBANKMENT
MAIN GEOLOGICAL FEATURES EXPOSED IN THE FOOTPRINT

The geological features of the site are recorded on MCCL Drawing 1 (Appendix A). The main features that affected the construction were the shear zone at 70850E on the left abutment that followed a N-S strike, and numerous steep to

overhanging ledges of schist in or adjacent to the abutments.

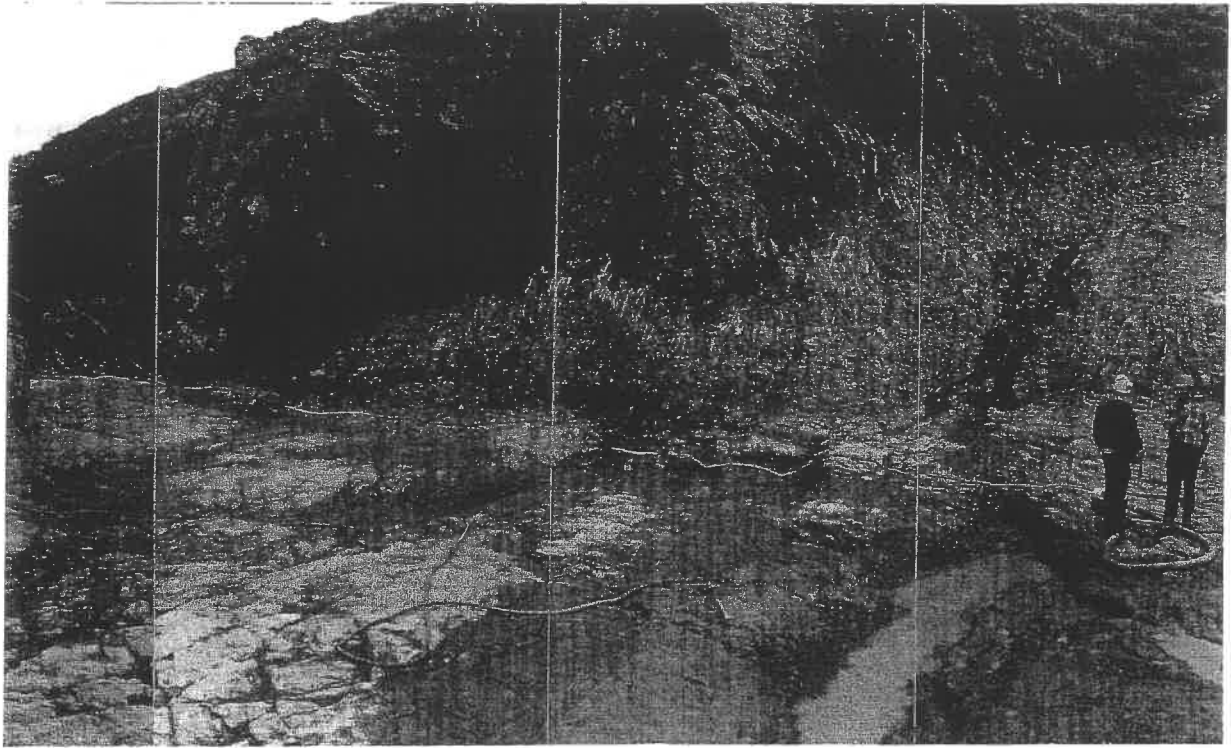
Plate 1

The footprint for the embankment was located within a very tight, steep sided valley. After the initial excavation had been completed it was apparent that quite extensive drilling and blasting, or alternatively concrete infilling, would be necessary if the specified requirements as to abutment slope angle were to be achieved. Refer Plates 1 & 2 (Appendix B). The requirements were:

Embankment Footprint Looking North-west

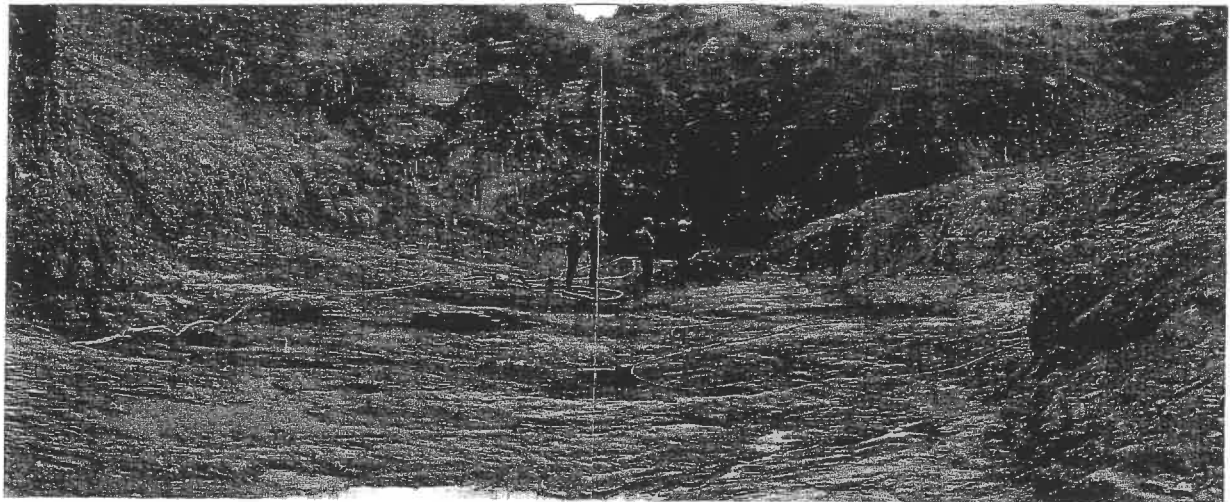
Plate 2

Embankment Footprint Looking South-east

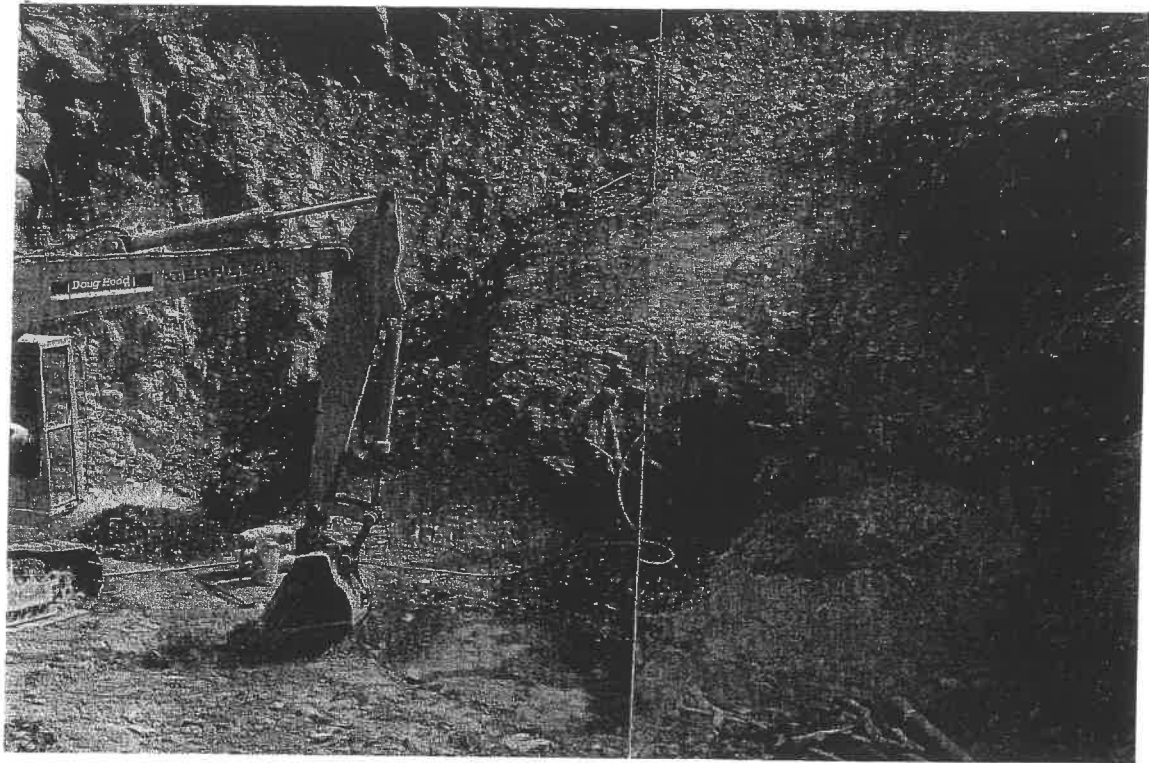
Plate 3

An adjustment to the location of the footprint was made at this time so that the removal of a large tor on the upstream side of the left abutment could be avoided. The fault zone in the base of the embankment which contained fine broken schist and clay gouge was cut back and filled with drainage aggregate wrapped in filter fabric. On the left abutment the fault was cut back and filled with concrete.

Preparation of North Abutment
(Shear zone - Dark brown area beyond bags of cement)

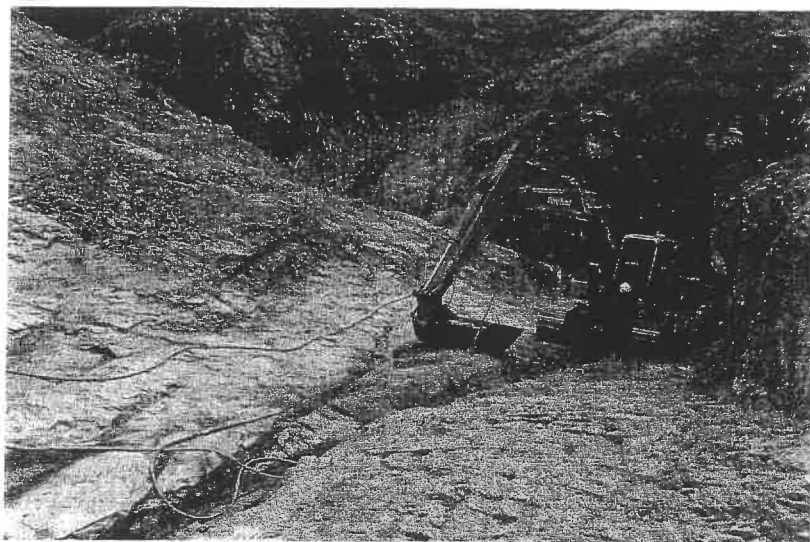
Plate 4

A shallow trench was excavated in the base of the south arm of the gully to accommodate the 300HDPE outlet pipe, refer Plate 4. The pipe was subsequently laid on and encased in concrete through Zone A. In Zone B it was surrounded in drainage aggregate contained within filter fabric so that it could provide drainage to the chimney drain in the south arm (Plate 5). The pipe through Zones A & D was pressure tested to 5 bar for two hours to satisfy the specified requirements before the concrete encasing was placed.

Trench for Outfall Pipe

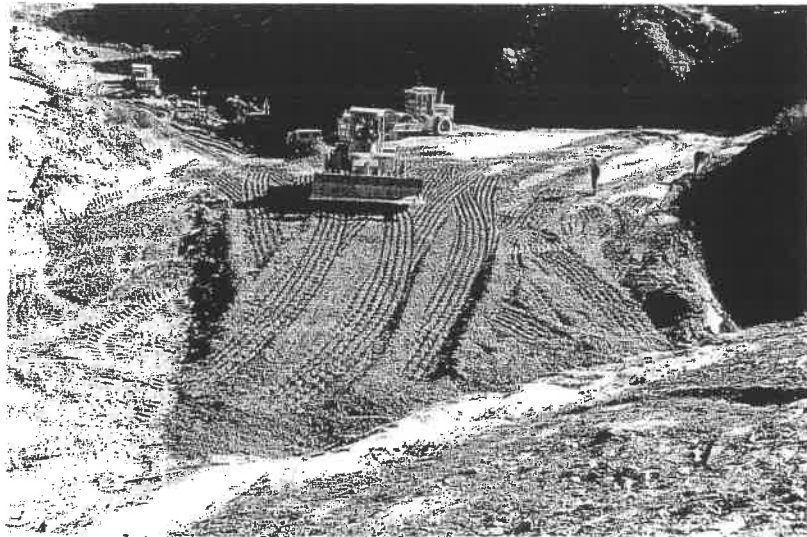
Plate 6

Embankment Construction
(From Right Abutment)

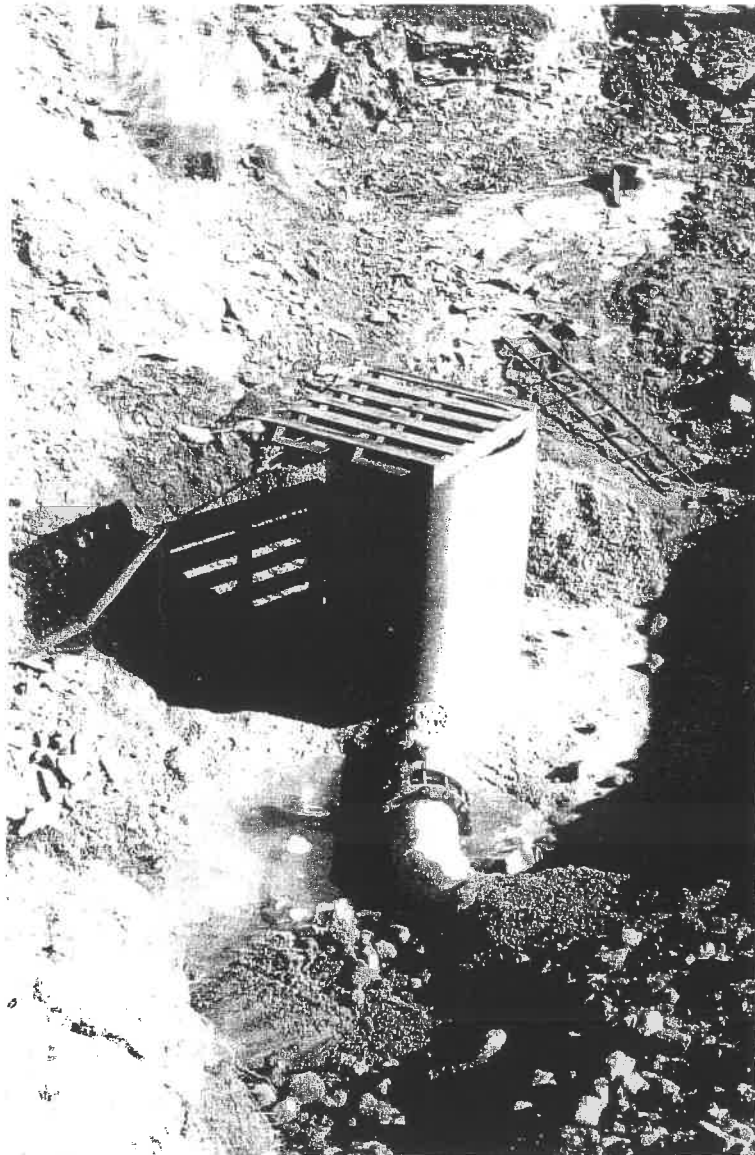
Plate 7

An outlet structure, comprising a precast manhole as an entry to the outlet pipe and a remotely controlled butterfly valve, were constructed at the upstream toe of the embankment (refer Plate 7). The manhole section used was set in concrete placed on a clean rock foundation. The operating shaft for the valve was mounted on steel stakes driven into the upstream shoulder of the embankment. The valve can be operated by turning a wheel fixed to the top end of the shaft. A butterfly valve was also fitted to the downstream end of the outlet pipe. This valve, which is normally set open, can be operated using a lever attached to the top of the spindle.

Outlet Structure in South Arm
(Butterfly valve set with spindle aligned up the shoulder of the Embankment)

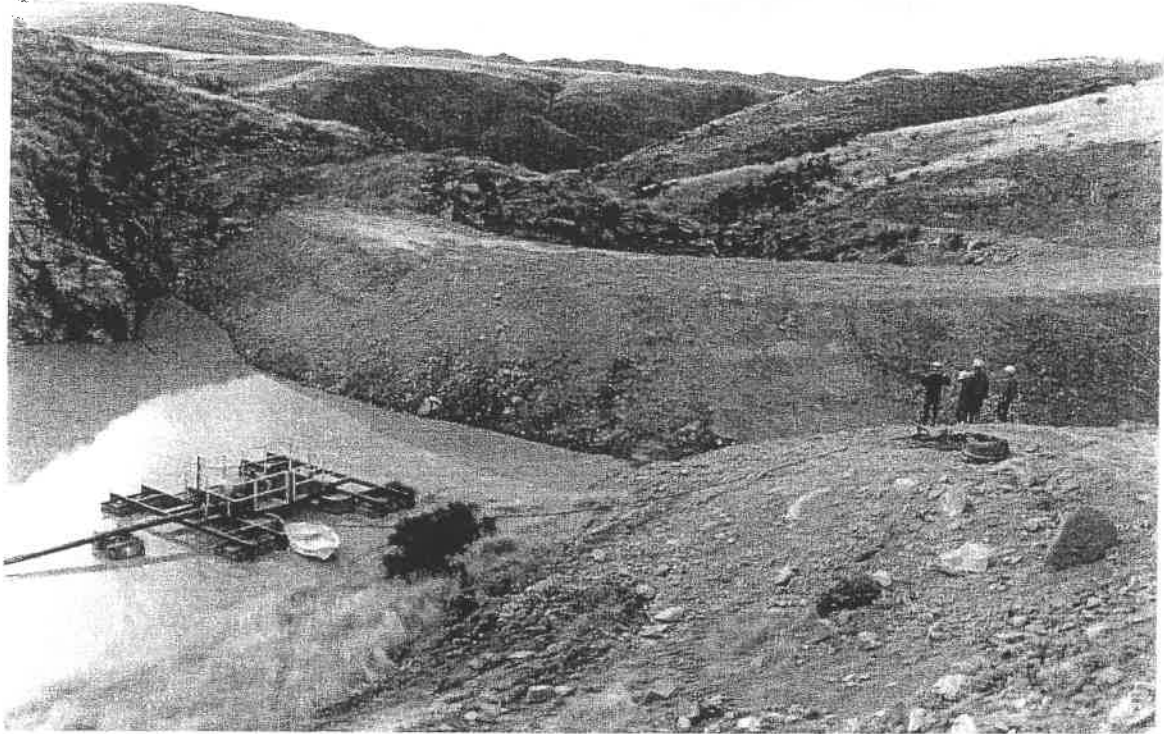
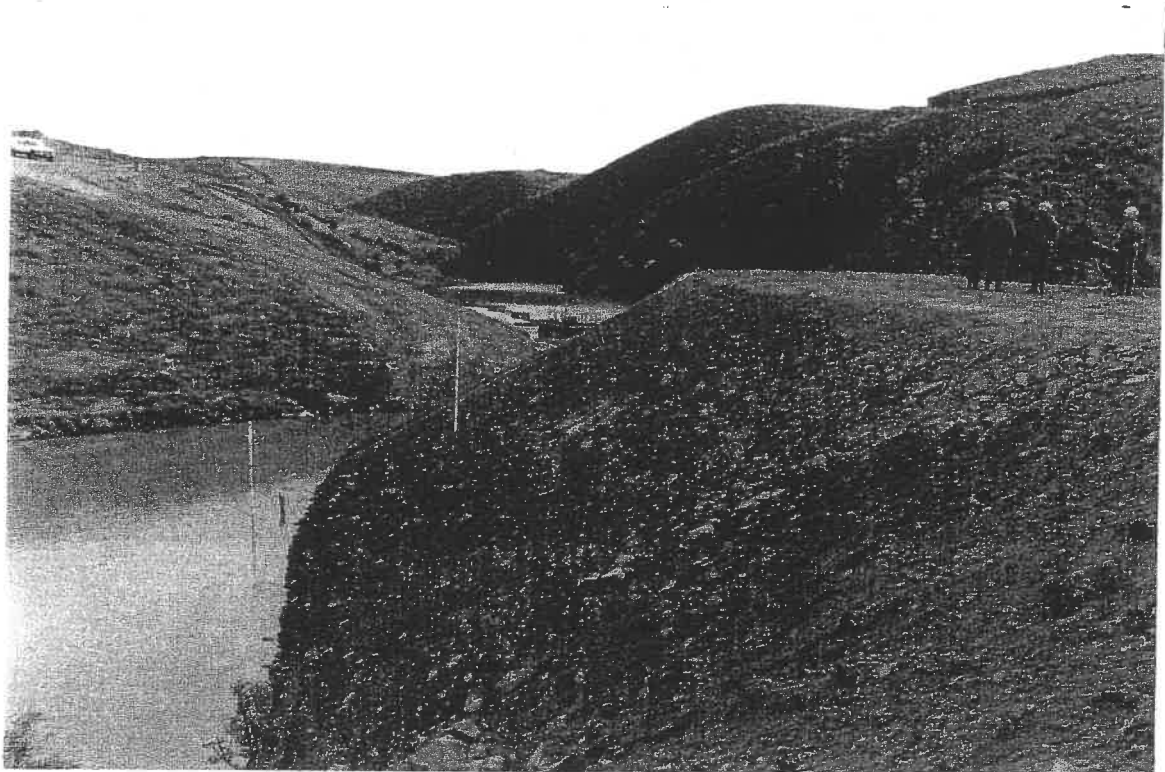
Plate 8
Completed Embankment:

Views of the completed embankment are shown in Plate 8.

Looking North

Looking West

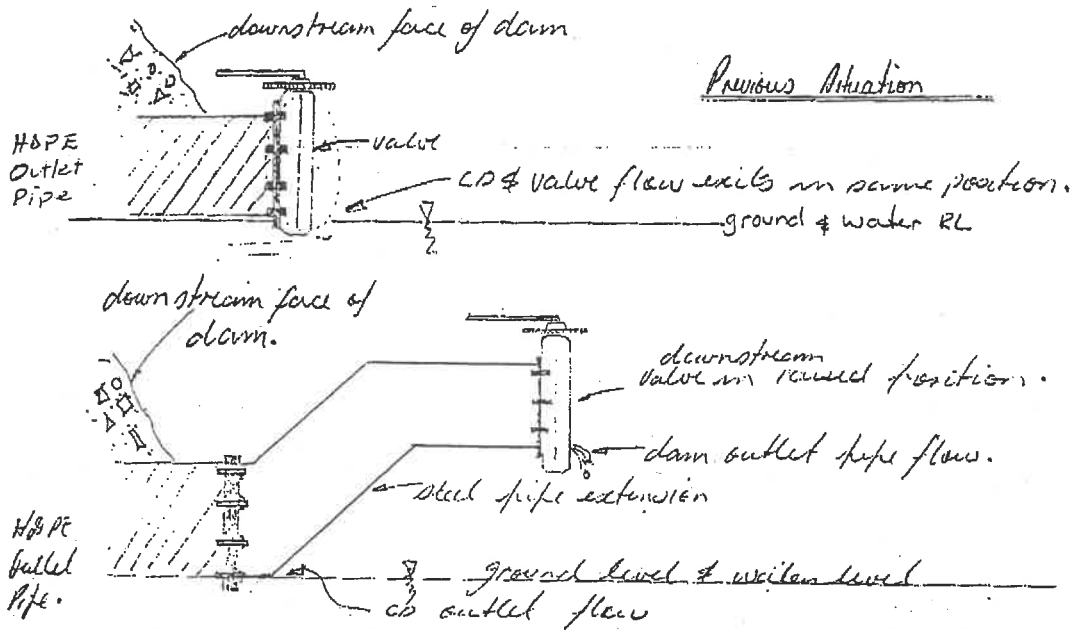
Situation Once Refinement Made

- The downstream valve for the outlet pipe was raised on Friday so that accurate CD and valve leakage readings could be taken. Brian Vickery made the fitting (refer below). A V-notch is also proposed to measure CD flow.
