Attachment 3: Basis for Residual Flows in Cluden and Waiwera Streams

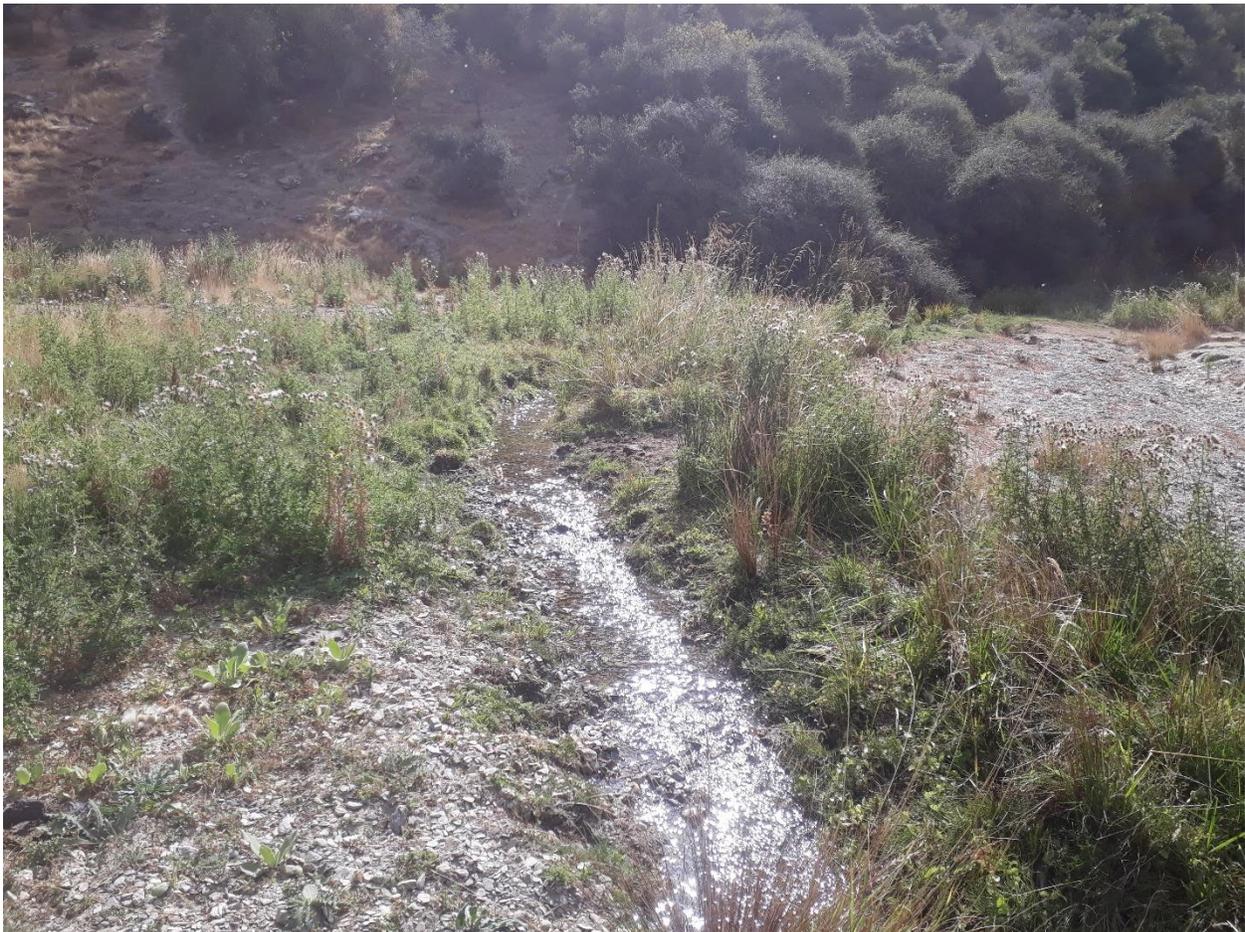
The take from Waiwera Creek is from a steep gorge that is very difficult to access. measuring low flows in this environment is largely impractical without significant expense. Flows have always been observed to increase below the take due to the contribution from tributaries, springs and groundwater.

Figure 1. Waiwera Creek between the take and Ardgour Rd culvert maintaining surface flows below the take.

The applicant proposes a further condition of *“a visible surface flow is also maintained at the Ardgour Road culvert”* to ensure the fish values in the lower Waiwera are maintained.

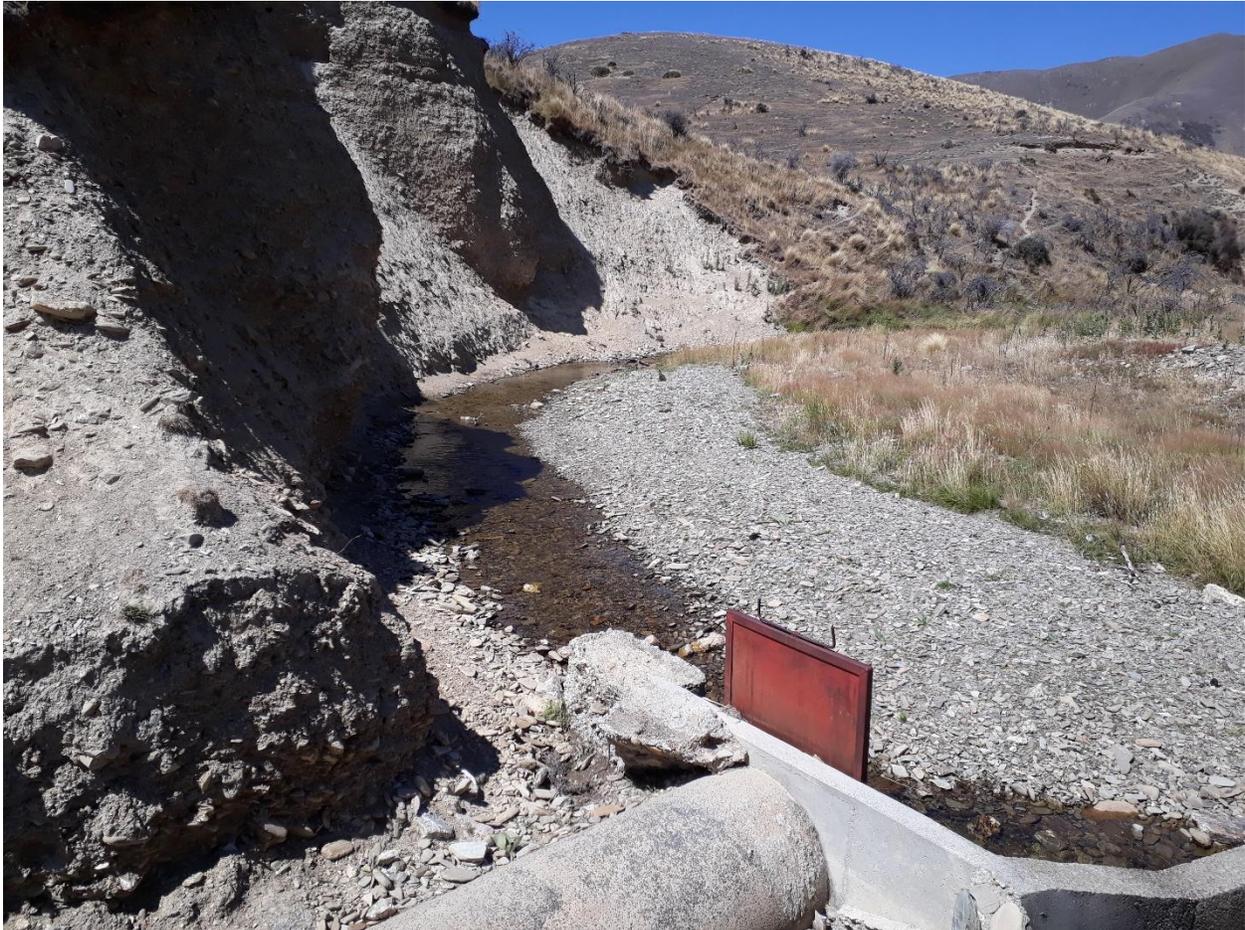
Figure 2. Cluden Stream at the intake.

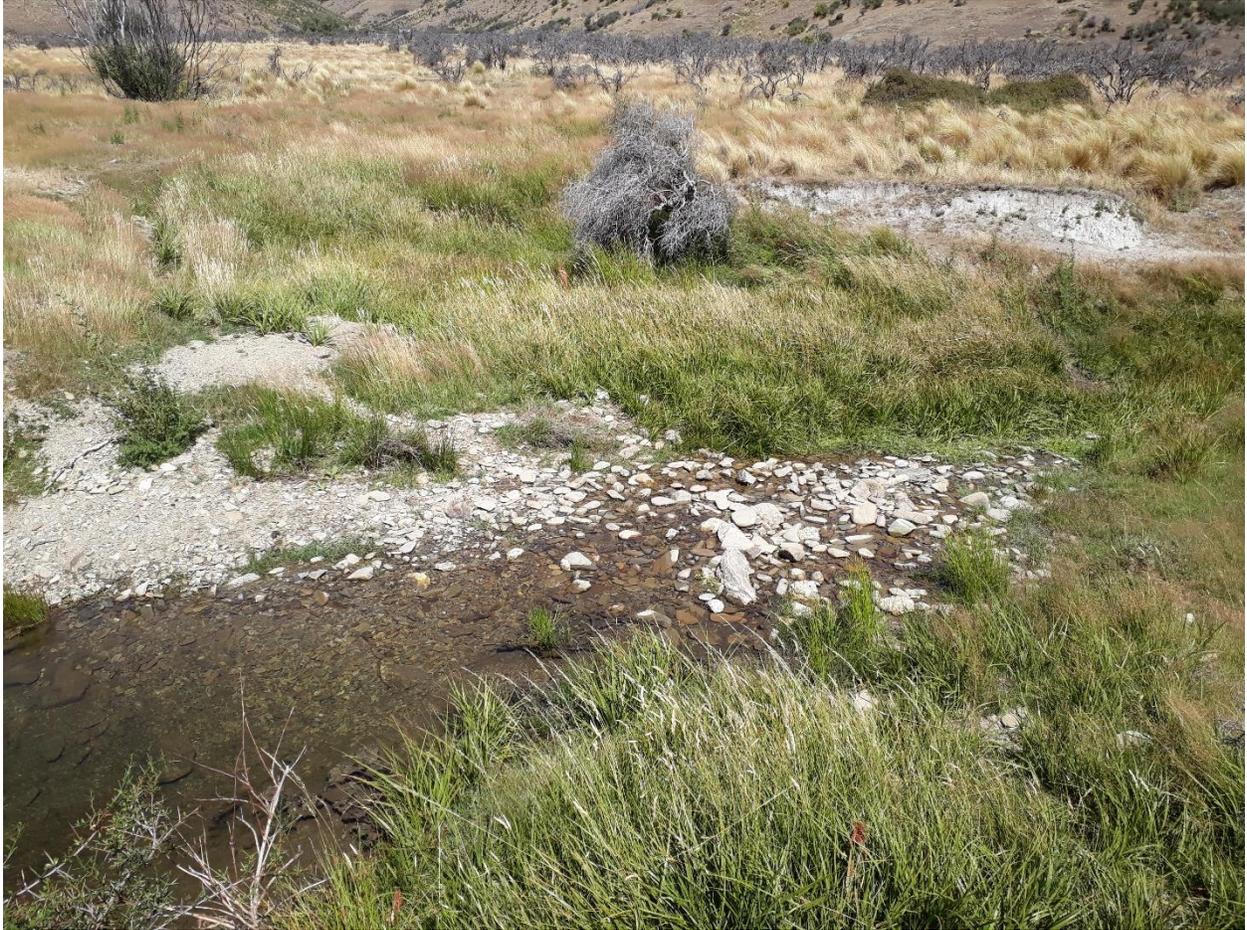
Originally a residual flow of 5 l/s was proposed at the Cluden take to maintain surface connection. A site visit was carried out on the 31st of January 2018, this visit confirmed that a residual flow of 5 l/s at the take location maintains surface flow connection and aquatic habitat downstream with a mixture of riffles, runs and pools. Flows were also observed to increase below the take with contributions from springs seeps and groundwater. Figures 2 – 6 provide photos of Cluden stream from the intake to ~700m downstream.

Figure 3. Cluden Stream immediately below the intake. Flow at ~5 l/s.

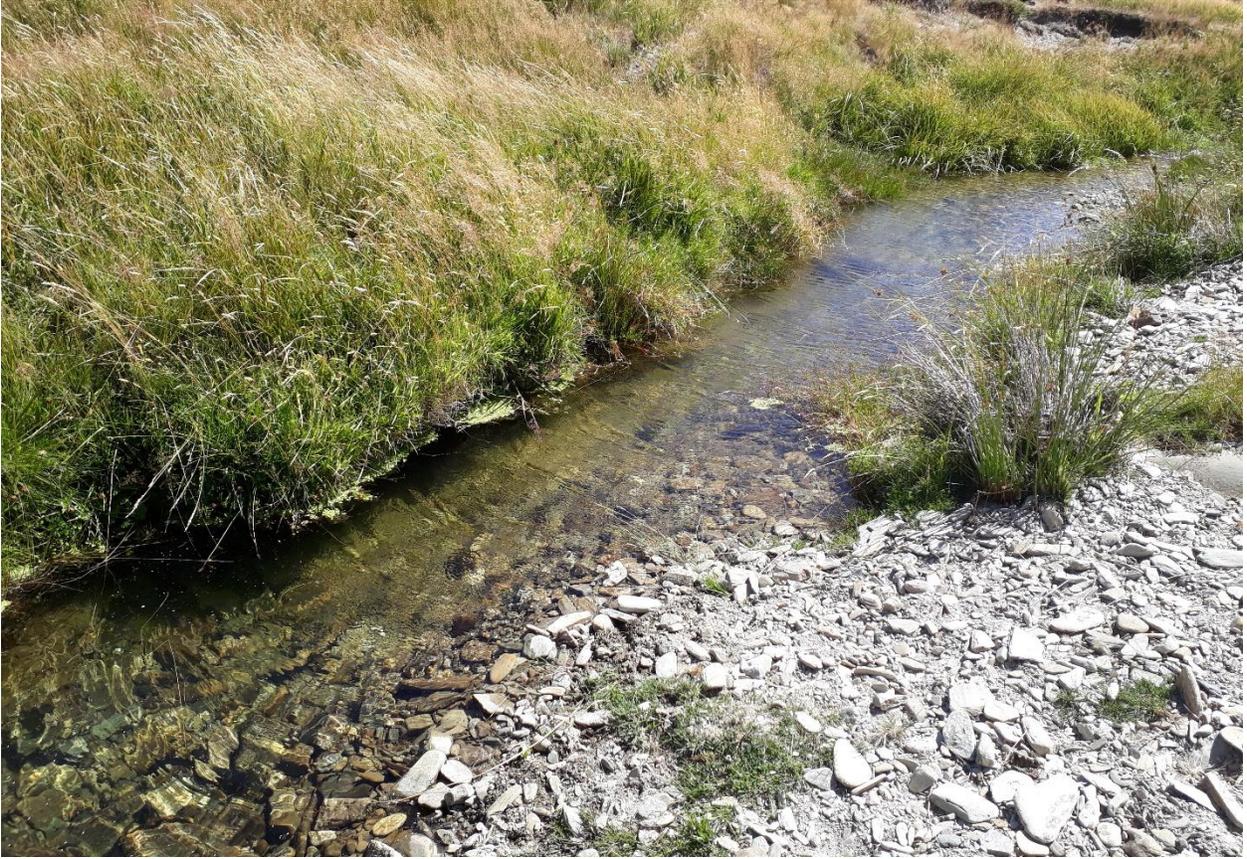
Figure 4. Cluden Stream below intake ~50m.

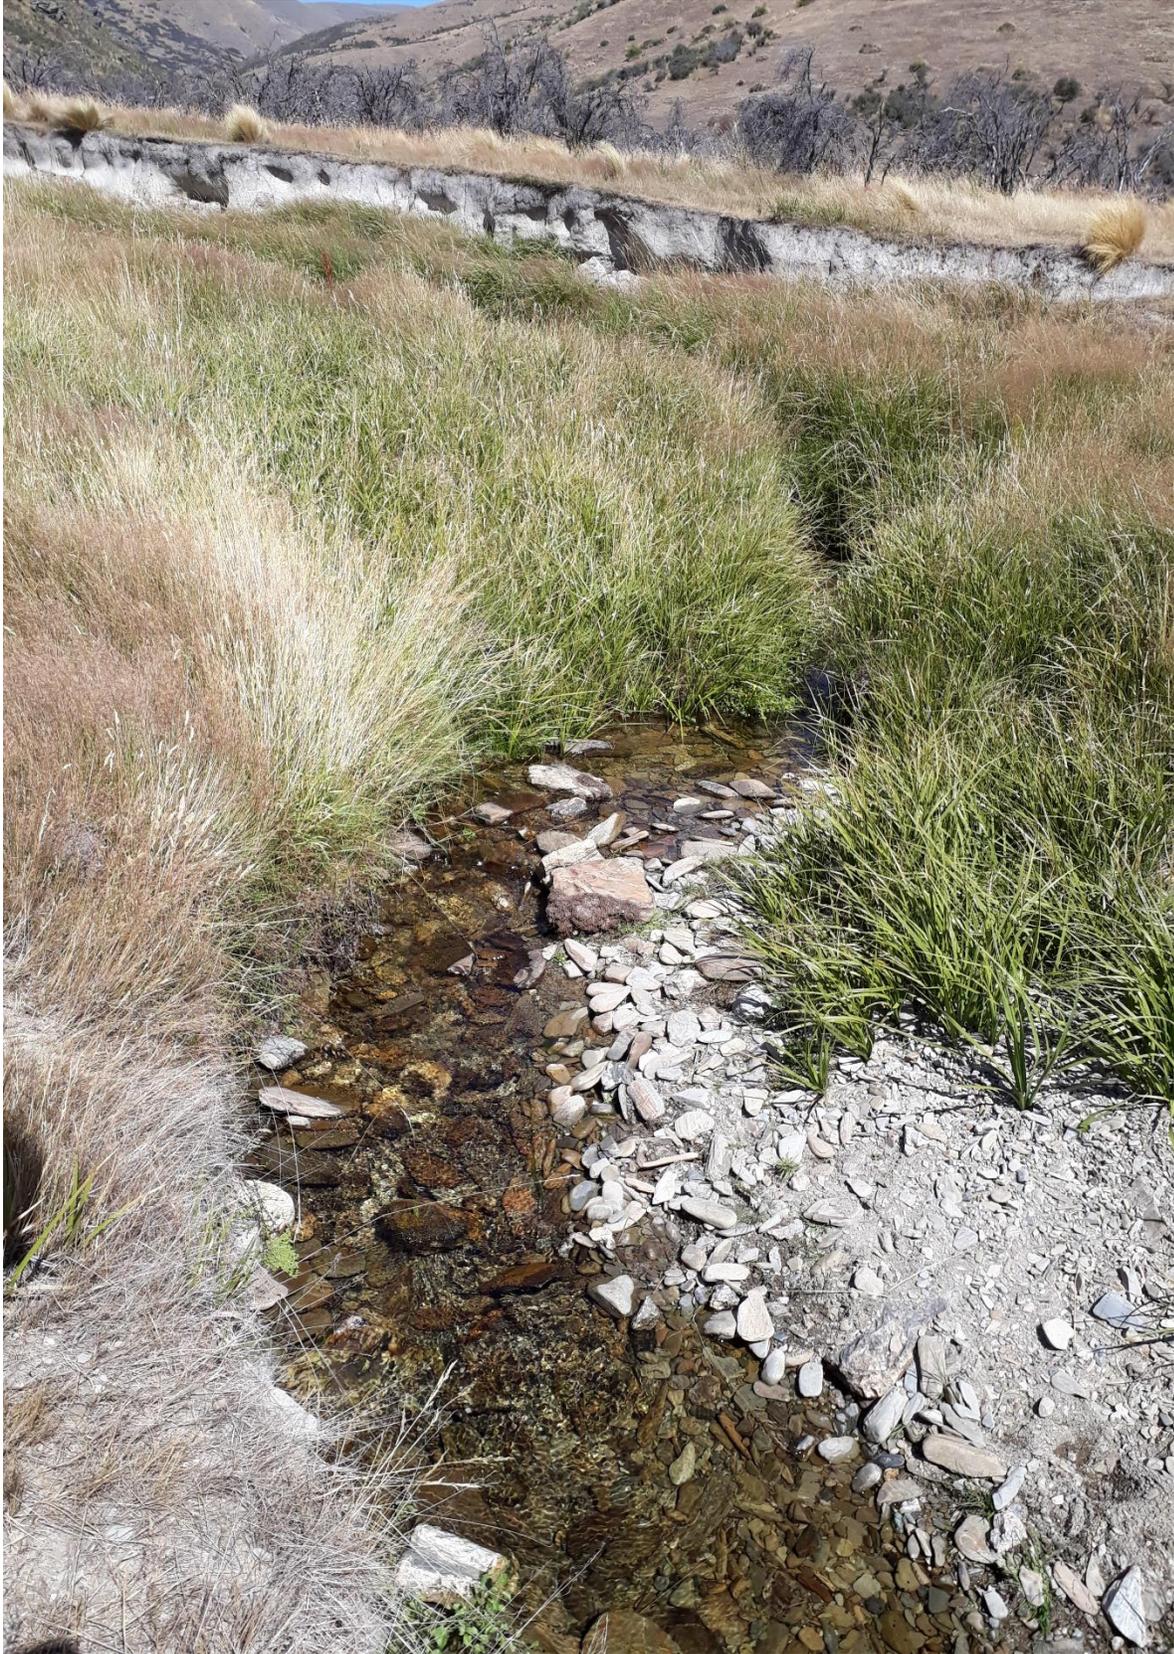
Figure 5. Cluden Stream below intake, ~100m.

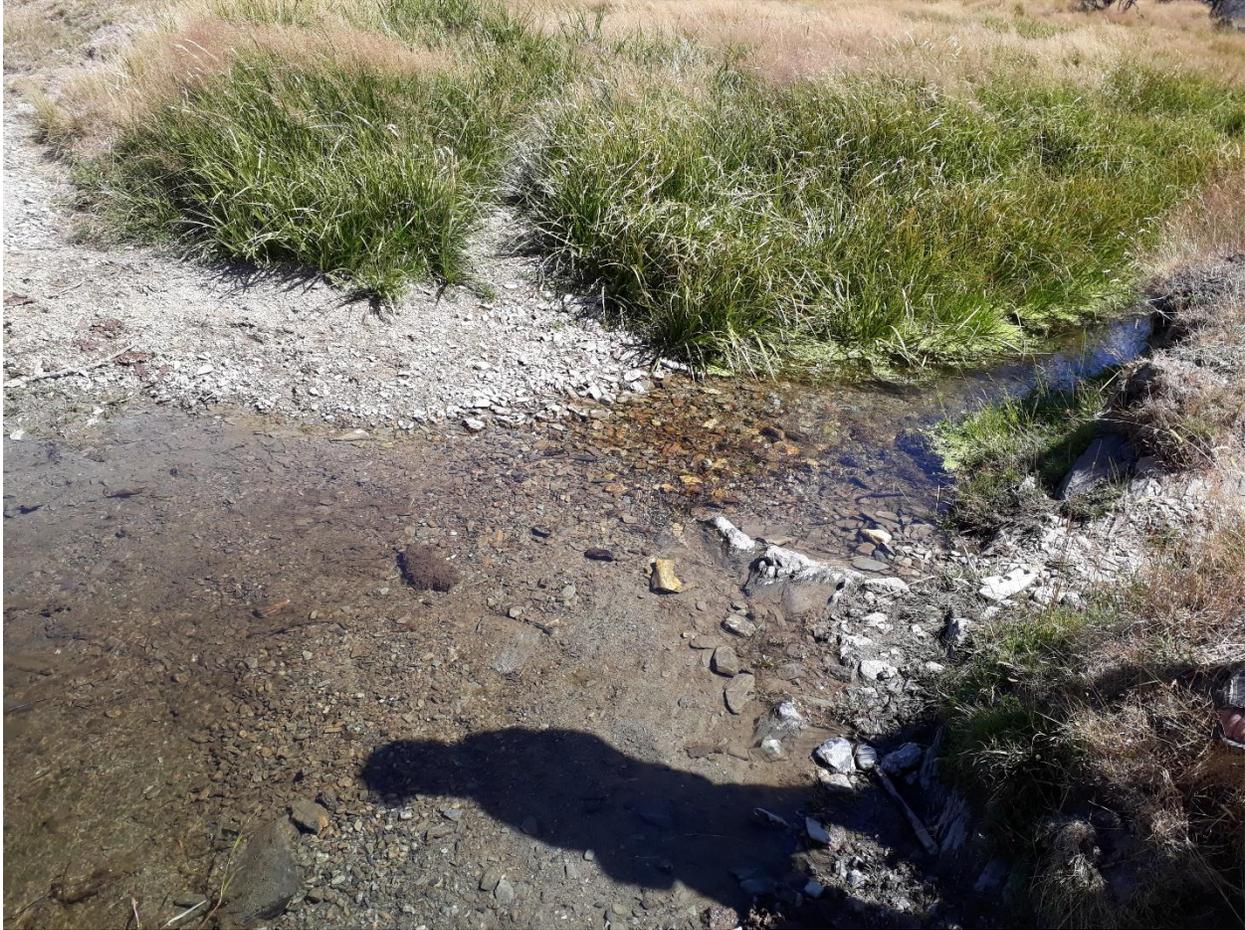
Figure 6. Cluden Stream at Ford ~700m downstream of the take. Flow ~15 l/s.

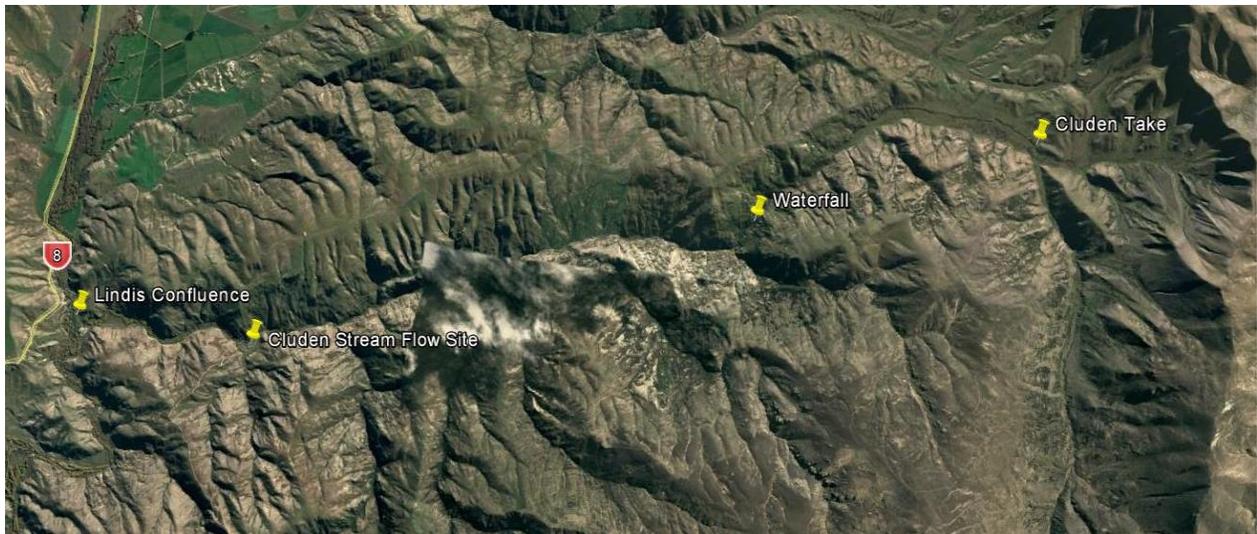
In the reach below the waterfall where it is known that adult trout spawn flows historically are ~85 l/s or more in summer under the existing take regime with no residual flow. By maintaining surface flows below the take in future as depicted in Figure 3 to Figure 6 it is expected that the existing high value juvenile trout rearing reach of Cluden Stream will be maintained.

Figure 7. Location of a known waterfall in the Cluden Stream below the existing water take.

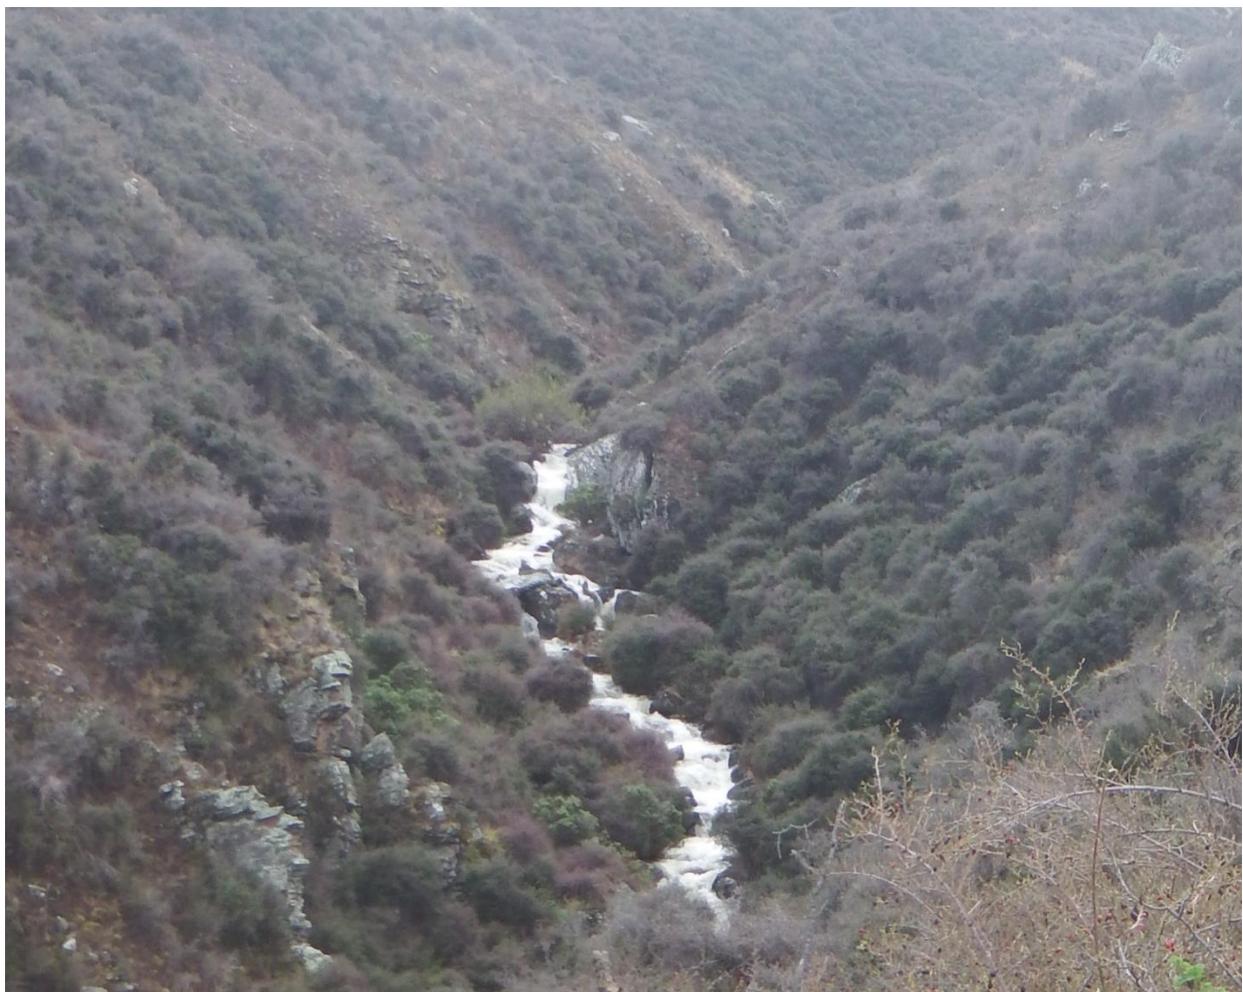
Figure 8. Waterfall in Cluden Stream 11 Km's upstream of the Lindis confluence. Photo taken in Sept 2017.
