Project Number: 6-CO082.00

Mount Cooee Landfill Development Plan and Resource Recovery Centre Geotechnical Interpretive Report

27 April 2023

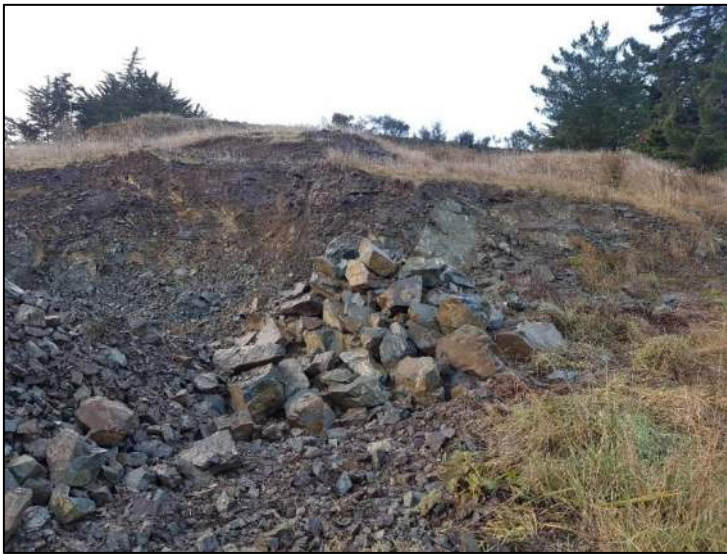
Figure 8: View of cut slope at Site 2

- The rock exposures consisted of interbedded sandstone and siltstone of Caples Terrane.
- The bedrock was found to be highly jointed, with defect spacings ranging between approximately 30 – 100 mm. The bedrock exhibited very close defect spacing (in the order of a few mm's).
- Slightly weathered to fresh rock was observed at sites 1 and 3. Site 3 consisted of a thin (<0.3m) layer of residual soils overlying bedrock, whilst rock was observed at surface at site 2 (refer
- Figure 8 below).

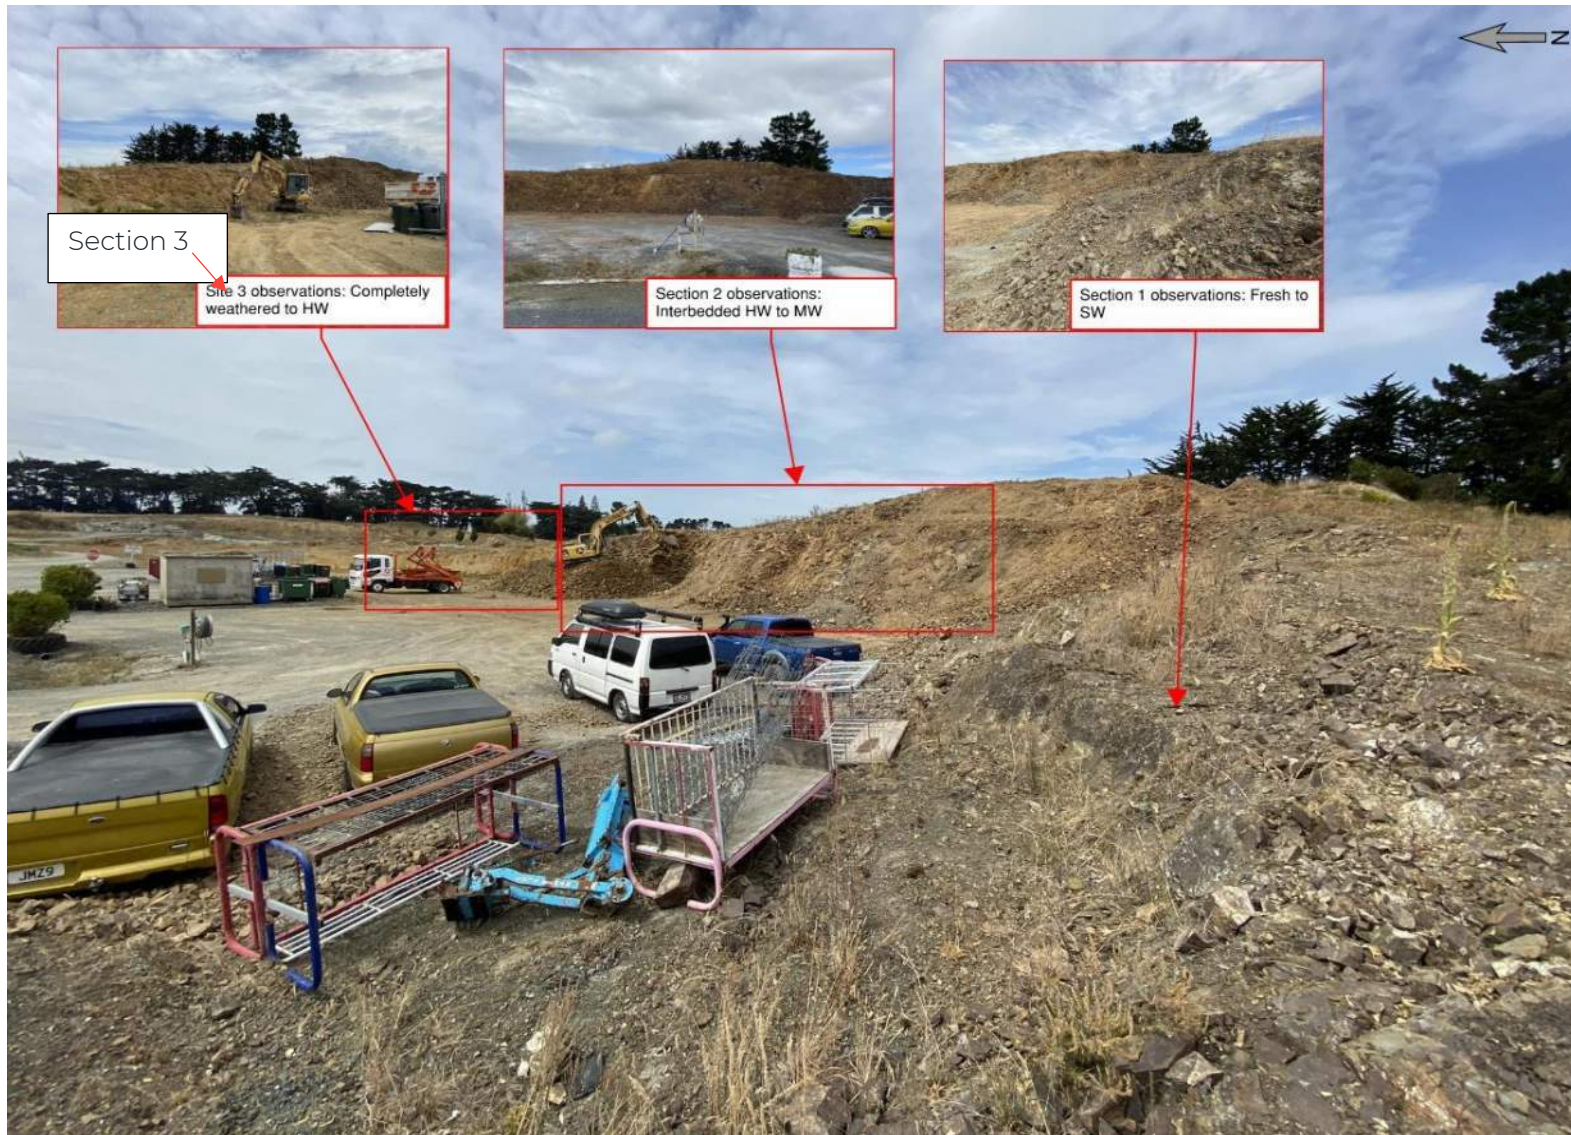
Figure 9: Photograph showing various sections of the cut slope

Based on the visual inspection, the cut slope has been divided to three distinct sections (referred to as Sections 1 to 3 hereafter). A photograph showing the cut slope is presented on Figure 9 below, with further commentary in Appendix D.

- The middle section of the slope is the highest section, with the maximum height of up to 10m based on the site survey. The current slope is typically at a 1(V):1.5 (H) angle.
- At the time of the site visit, this section exhibited marginal surficial stability, with evidence of surficial rock dislodgement along the joints.
- Horizontal jointing of oxidised, highly fractured interbedded sandstone and siltstone was apparent along this section. Measurements were limited on this section due to the marginal stability at the time of the site visit. General observations concluded orientation of bedding to be slightly dipping to the southwest.

Based on the site observations and preliminary mapping, the likelihood of deep-seated instability in the rock slopes across the site is considered to be low. The likely modes of failure are constrained to the surficial rock as blocky or wedge failure, expected along joint or sheared planes. Section 2 of the existing cut slope predominantly displayed this failure mechanism.

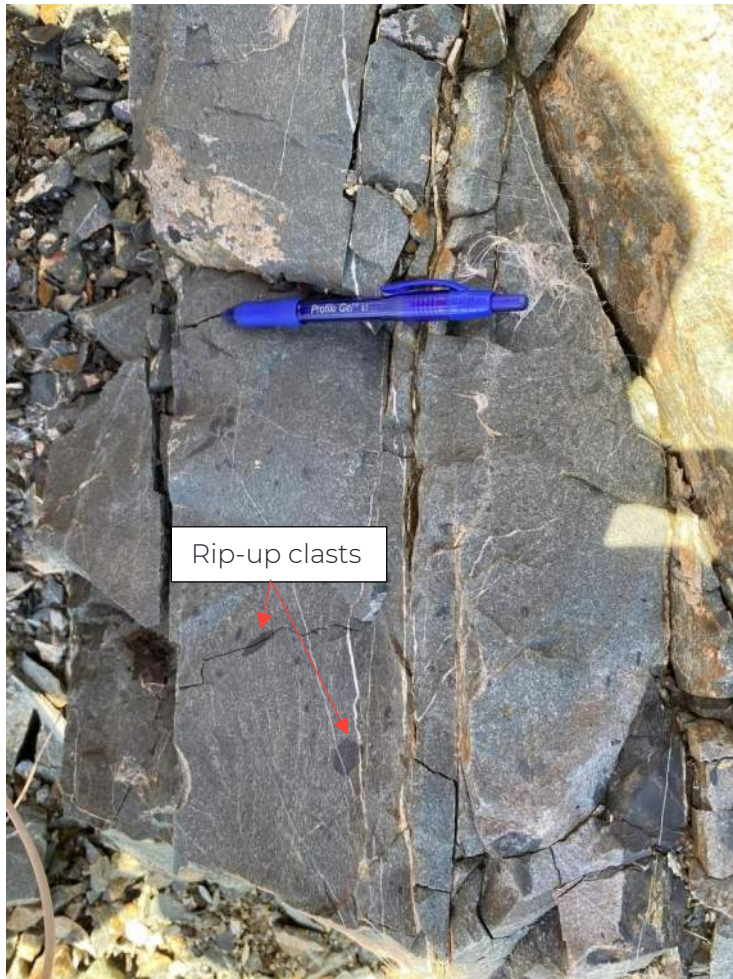
Figure 10: Quartz veining and rip-up clasts in sandstone beds of section 1

- The slope face exhibits various jointing and fracturing throughout, with some veining in the order of a few mm's thick but in groups of up to ~0.5 m in thickness in localised areas (refer

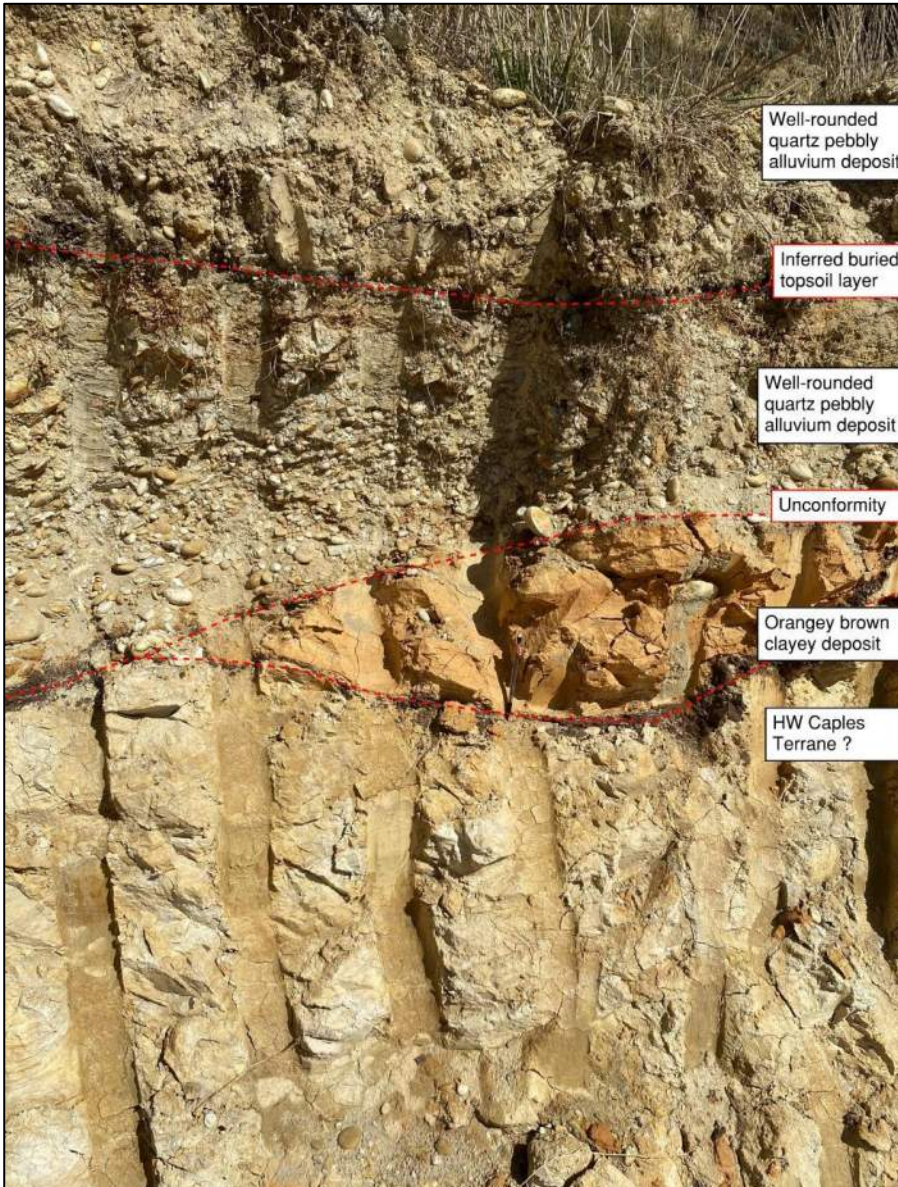
Figure 11: A photograph showing the localised alluvial deposits to the north of the proposed landfill expansion

The proposed landfill expansion site has been excavated in some areas to expose fresh to slightly weathered interbedded rock (refer Appendix D for photographs). An approximately 1 m – 2 m thick layer of well-rounded alluvial deposits was observed at the north-eastern end of the site. These deposits were localised to only this section and are not considered to be continuous across the eastern section of the site.

Depositional bedding features were observed in the alluvium and flow direction was able to be determined by visually analysing the orientation of the quartz gravel in this layer. This paleo-flow direction suggests a south to southwestern trending flow. A photograph showing this section of the landfill is presented on

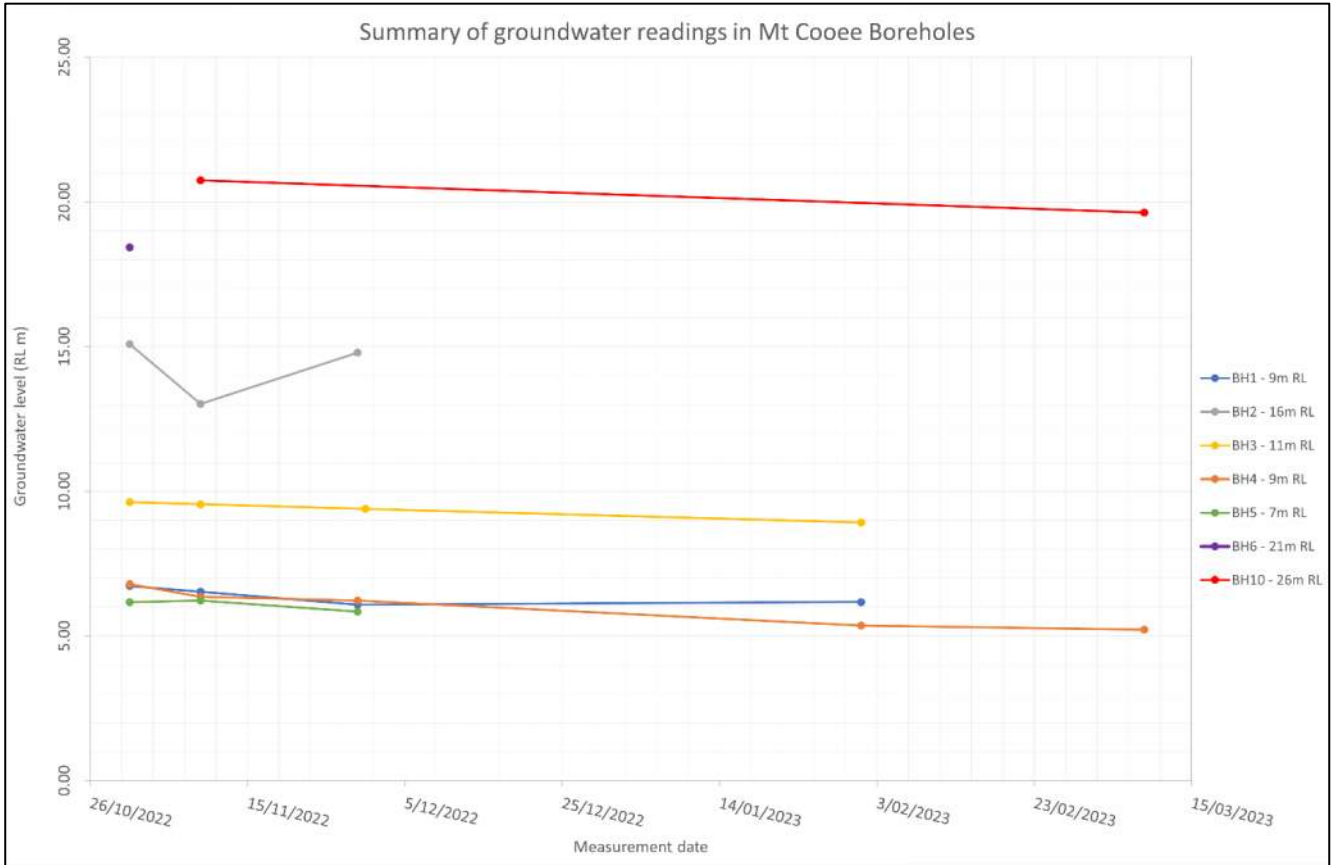
Figure 14: Plot of groundwater levels recorded within standpipe piezometers since October 2022

As indicated on Figure 14 above, the long-term groundwater level is anticipated at depths ranging between 6m to 20m RL (in the order of 1m to 4m below existing ground levels) across the site, with flow towards the Clutha River / Mata-Au in the south. Across the western section of the site, long-term groundwater is anticipated to lie approximately 2m bgl and within the alluvial deposits. The piezometer readings in the boreholes across the eastern section suggest groundwater typically lies within the fractured rock or close to the interface between rock and overlying soils. Except for a groundwater level of 2.3m bgl (~ 18.7m RL) measured in October 2022, the piezometer readings in BH6 at the proposed landfill site have indicated dry conditions.
