# Mount Cooe Landfill, Balclutha

## An Archaeological Assessment

Report Prepared for the Clutha District Council c/- WSP  
Authors: India Gillespie, Victoria Ross, and Claire Thorrold  
Reviewed by: Dr Naomi Woods

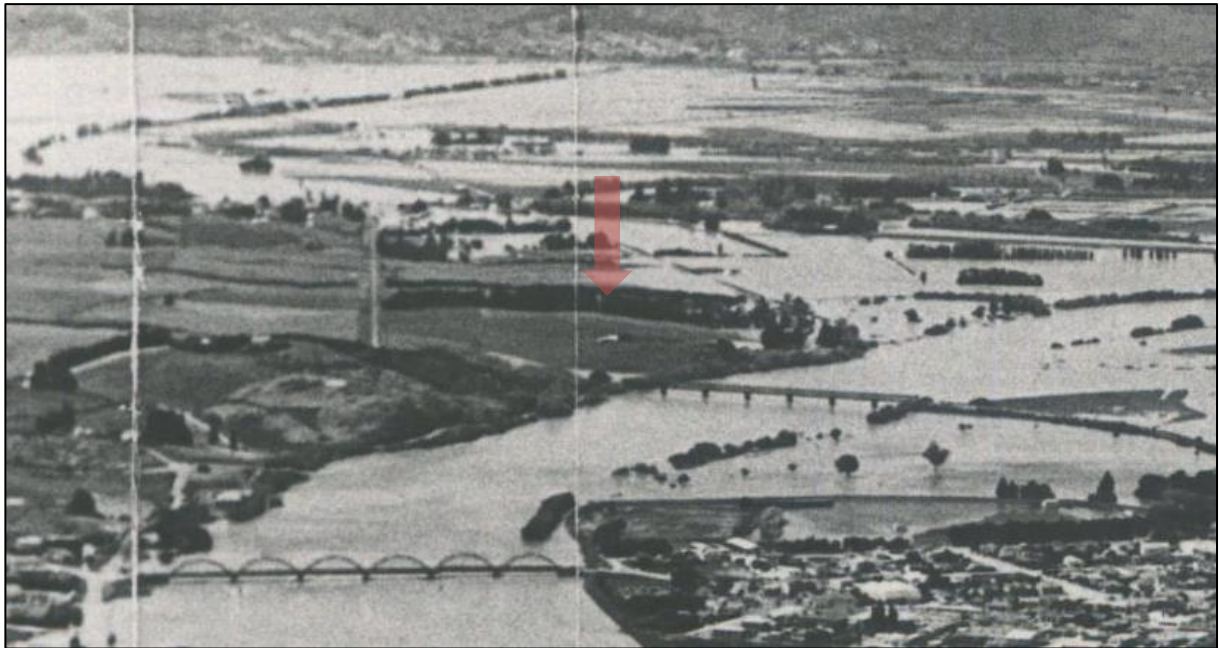
bridge, and partially flooded, dates to 1957, and shows what is likely the cottage depicted in the 1911 plans (see Figure 5-7).

Figure 5-7. Detail of photograph 1957 photograph, with the cottage indicated (O.D.T. Collection, 1957).

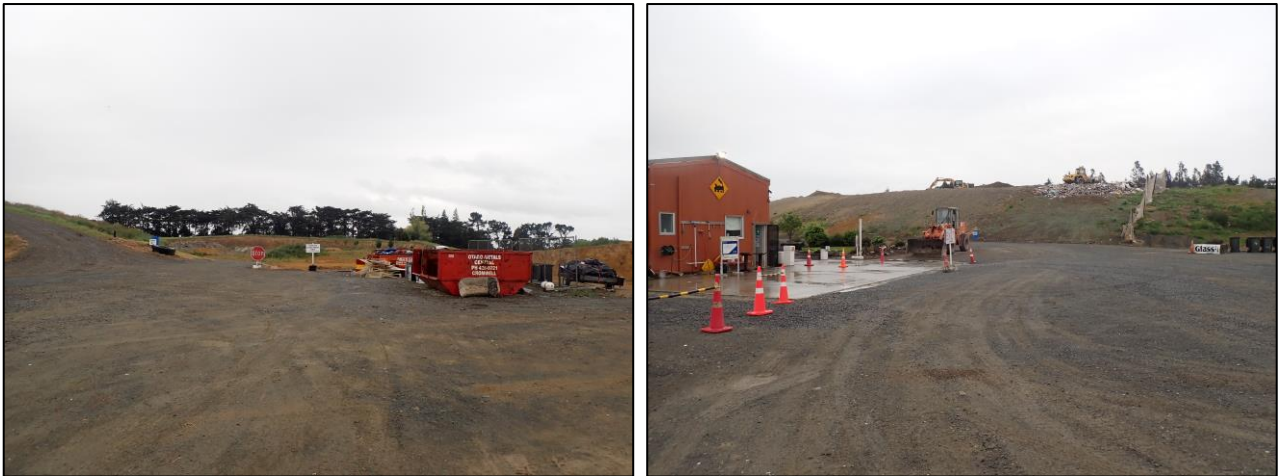
Figure 7-2. Current parking area at the boundary of the two land parcels, looking east then west.

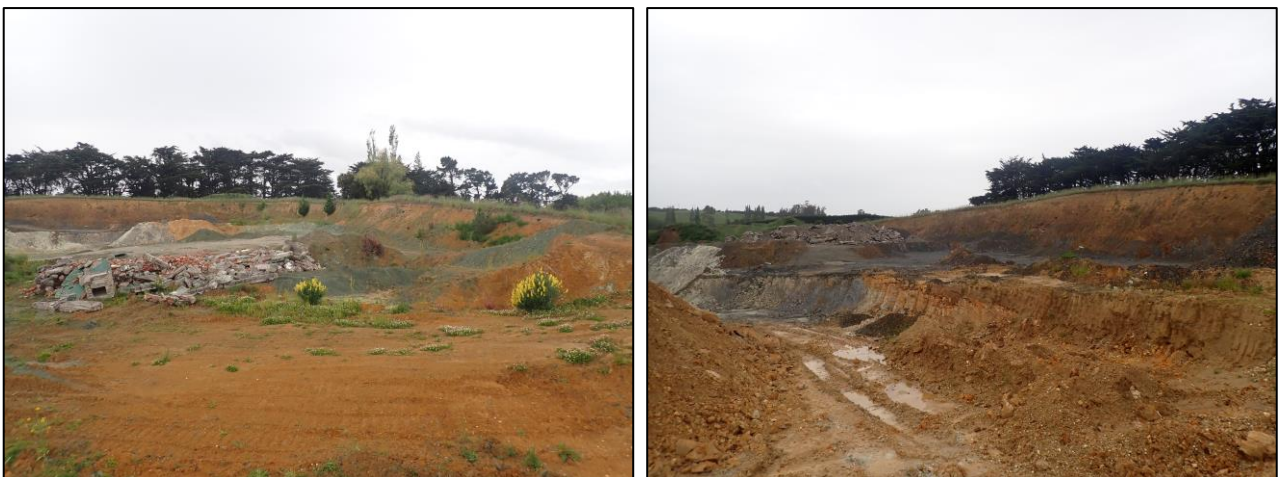
The Mount Cooee Landfill is an active rubbish disposal site, bounded by Kaitangata Highway on the south, and the Main South Line Railway on the north. The south east side of the site is currently utilised for farming, with the current landfill focused in the centre of the site. Access to the site is from the southwest corner, leading to a flat parking area at the boundary of the two large land parcels (Figure 7-2). The site slopes down from the north to the south, with the two active dumping areas cut down into the natural soil profile (Figure 7-3). The site is split into

Figure 7-3. Overlooking eastern dumping area, showing cuts into the natural soil profiles. Looking northeast.

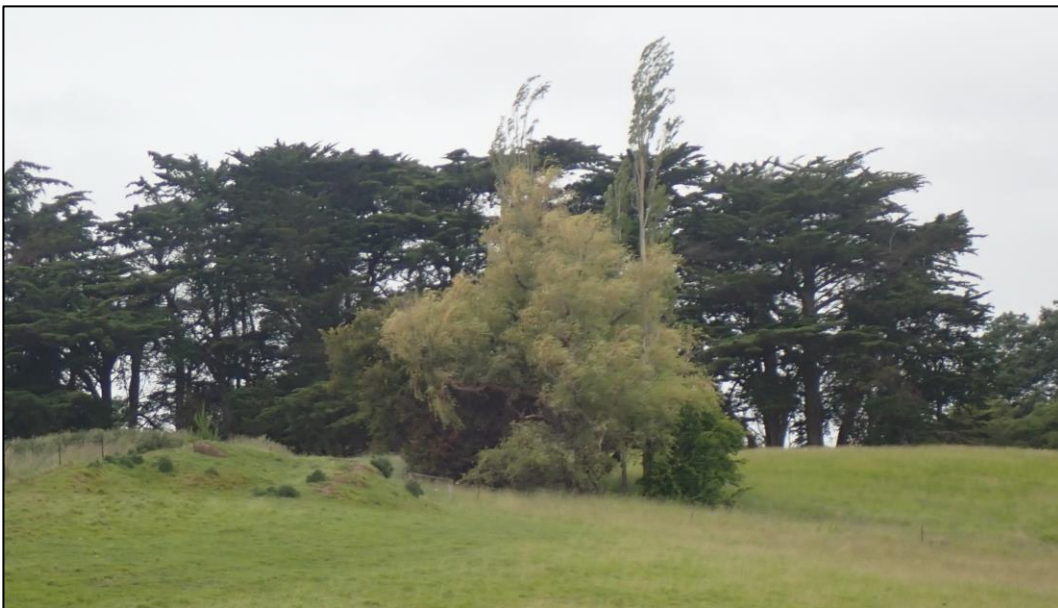
Figure 7-5. Cluster of introduced tree species at the head a small gully, looking southeast. May indicate location of subsurface archaeology.

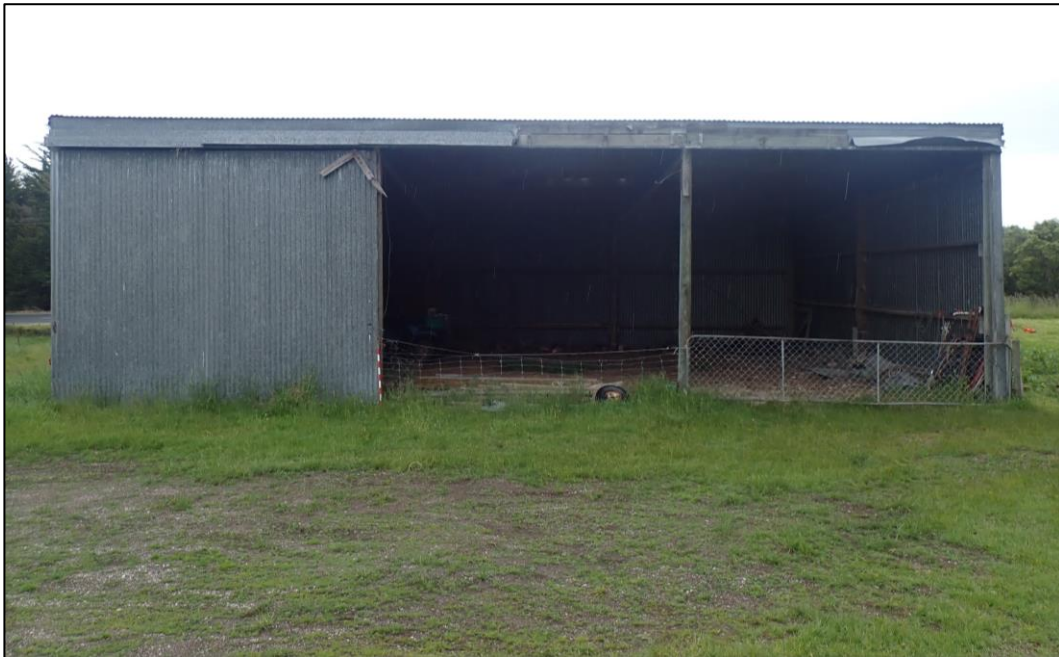
At the south of the project area were two farm buildings, and a number of other agricultural features. A shearing shed sat to the east of a track, while a modern barn sat at the end of the path, on the west side, close to the road (Figure 7-6). This had a levelled area on the north side for access, which aligns with the historic location of a barn. No evidence of archaeology was visible in this levelled area or immediately surrounding the barn building.

**Figure 7-6. Modern barn building at the southwest of site, looking southwest. Note levelled area in front of the barn.**

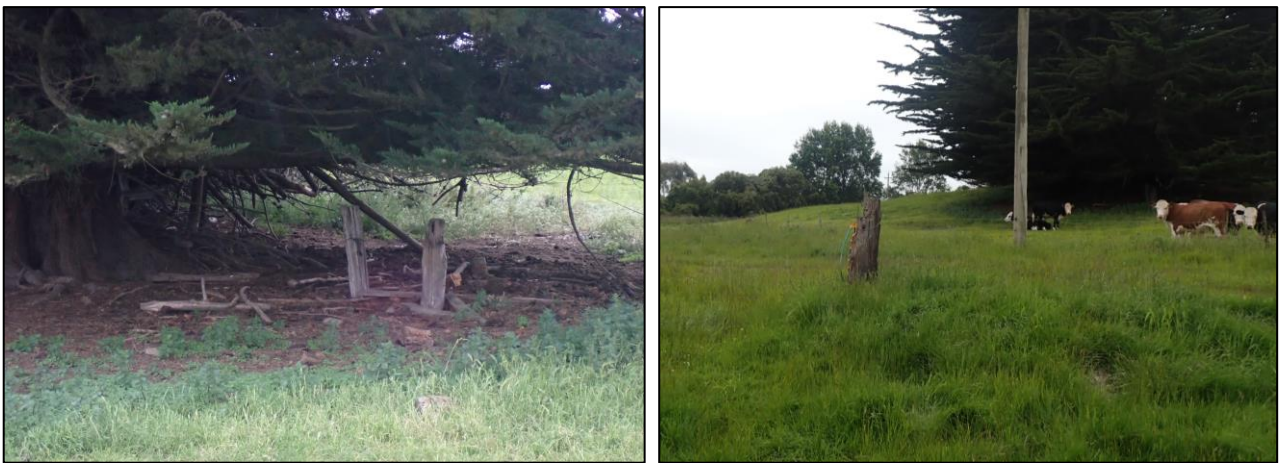
To the north of the barn a series of potentially historic timber posts were visible (Figure 7-7). One was at the edge of the track leading to the buildings, while two were viewed under the *Macrocarpa* tree line. This line of *Macrocarpas* aligns with a fence line visible on the 1911 DP, which indicates there were a set of small yards adjacent. It is likely that all three timber posts relate to this fence line.

**Figure 7-7. Timber posts visible in the south area of site, aligning with a historic fence line. Left: posts under *Macrocarpa* line, looking north. Right: single post adjacent to track, in relation to *Macrocarpas*, looking southwest.**

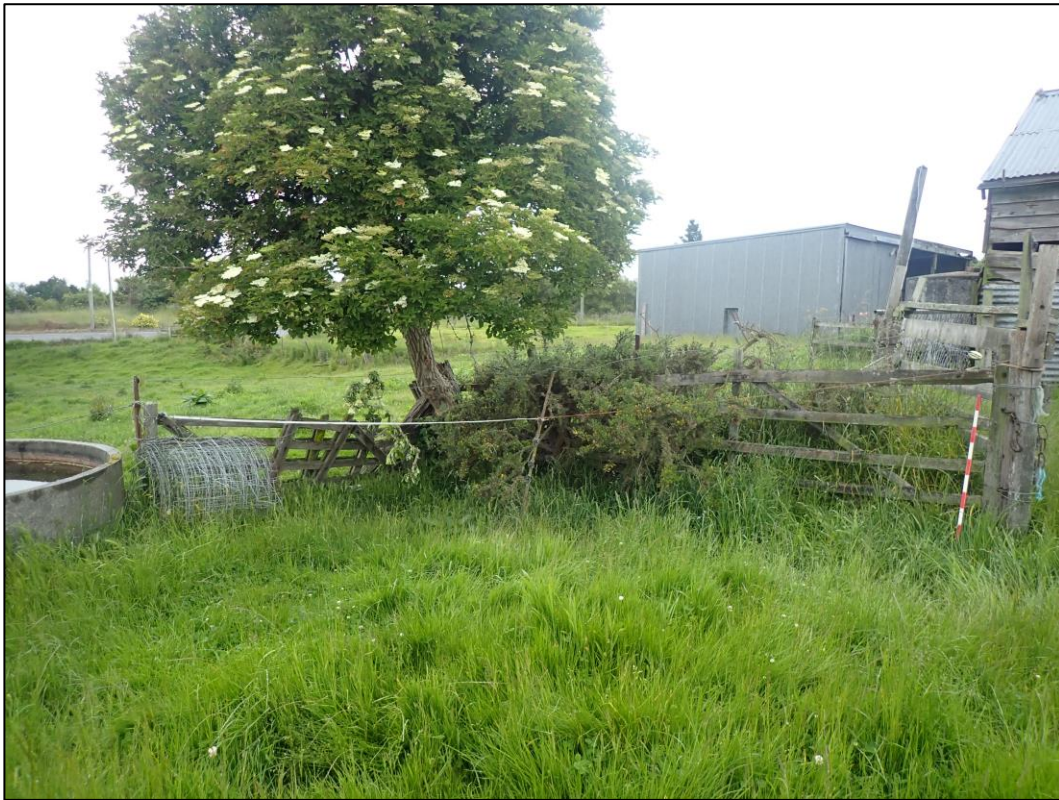
To the east of the track and modern barn was a shearing shed with attached yards, ramp, fence and water trough. The fence is currently a small section to the south of the shed (Figure 7-8), forming a right angle, made of timber with cross bracing and large coach bolts (Figure 7-9). This partially aligns with the historic fence line shown on the 1911 plan, although the east-west section runs perpendicular to the historic line. A modern gate has been added to access the shed, with tall strainer posts bolted to the existing post, and wrapped with wire. At the centre of the right angle is introduced tree surrounded by gorse, and the fence ends at a large concrete circular water trough (Figure 7-9).

**Figure 7-8. Potentially historic fence and tree, south of shed, looking west.**

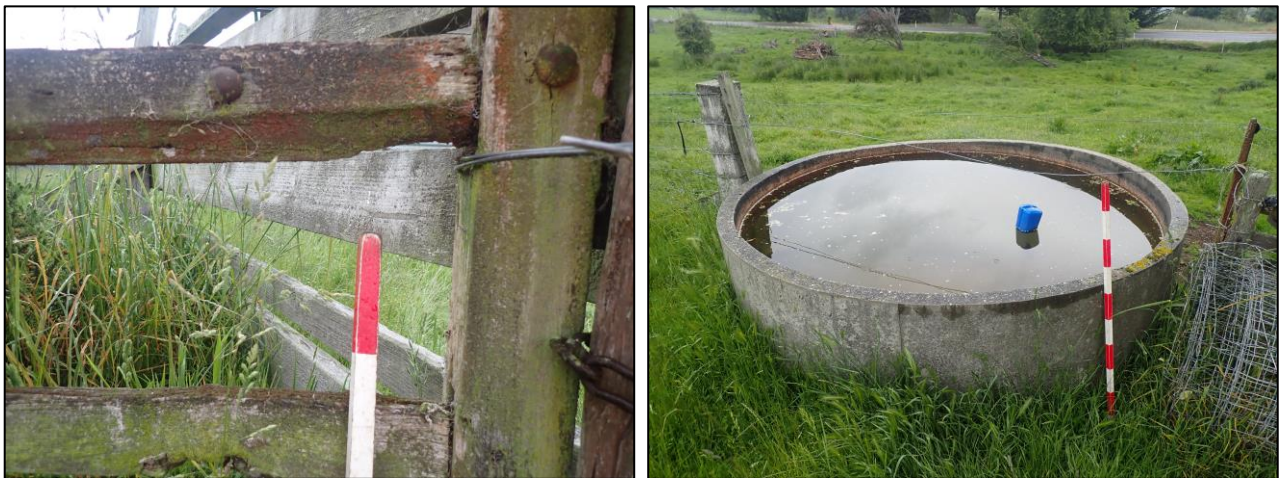
**Figure 7-9. Left: Coach bolts in fence with modern wire wrapping. Right: concrete trough at end of fence.**

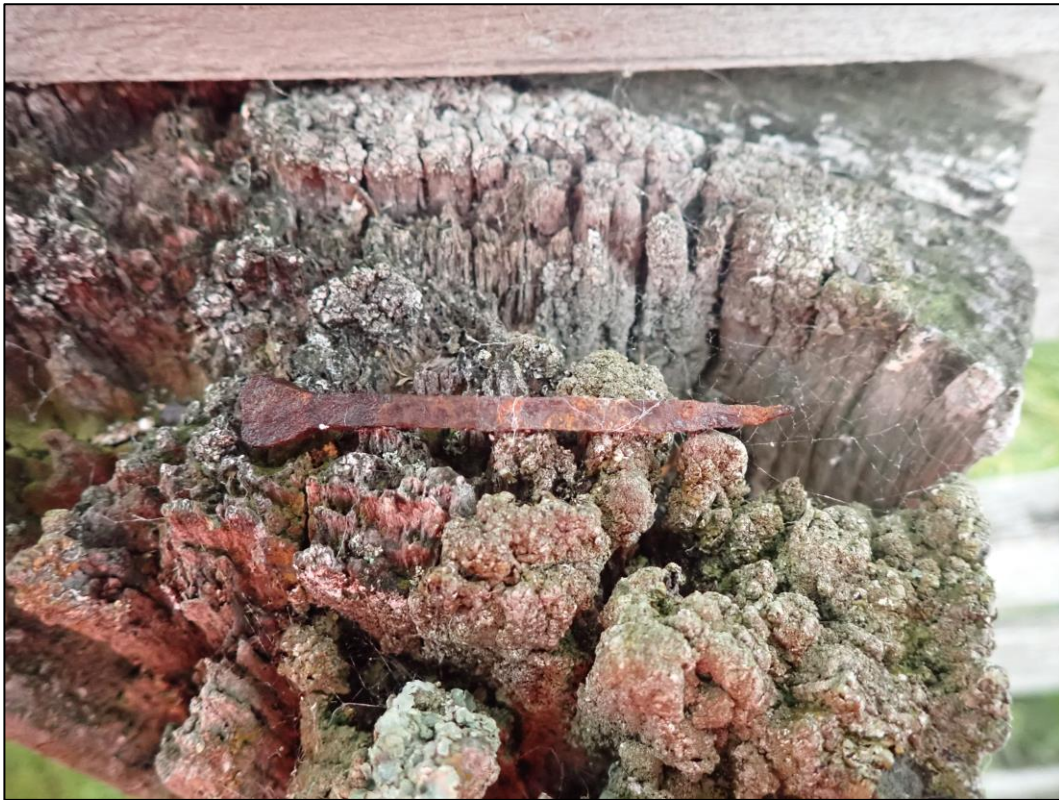
Attached to the shearing shed were a series of small yards and a loading ramp. These were timber with sections of corrugated iron patches. It was clear that there were a range of ages among the fences forming the yards, and the timber run was more modern. Some likely original sections of yard were viewed, identified by the age of wood and fastener used. While some sections had modern screws, bolts and nails, older rose-head nails and wrought nails were viewed in various places (Figure 7-10). At least two posts were reused rail sleepers, complete with iron spikes (Figure 7-11). It is likely these were repurposed from the offcuts or repairs to the adjacent Main South Line.

Figure 7-10. Wrought nail found on fence post, matching others still in situ.

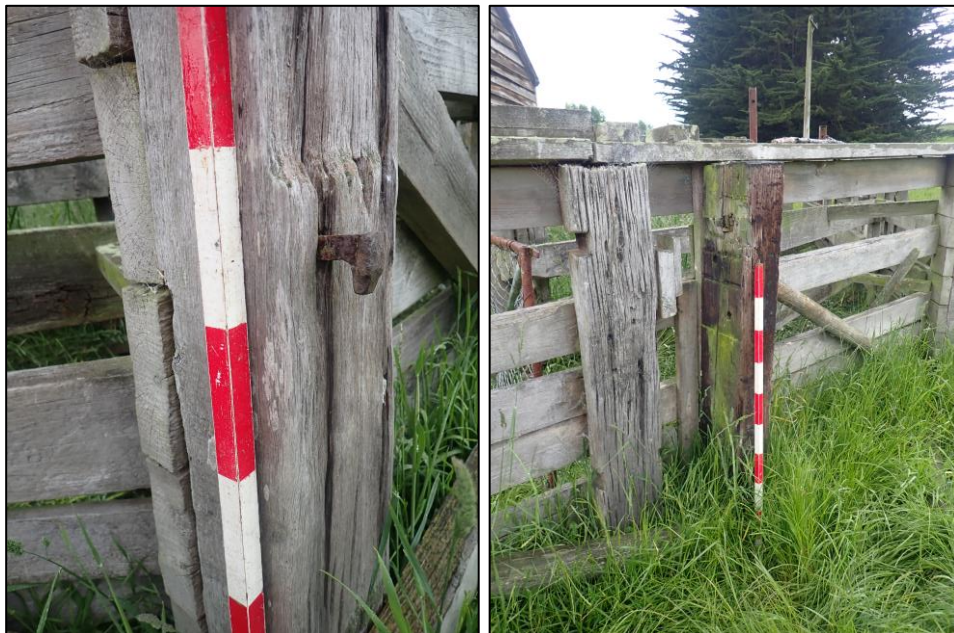
Figure 7-11. Repurposed railway sleepers with iron spikes, utilised in the construction of the yards.

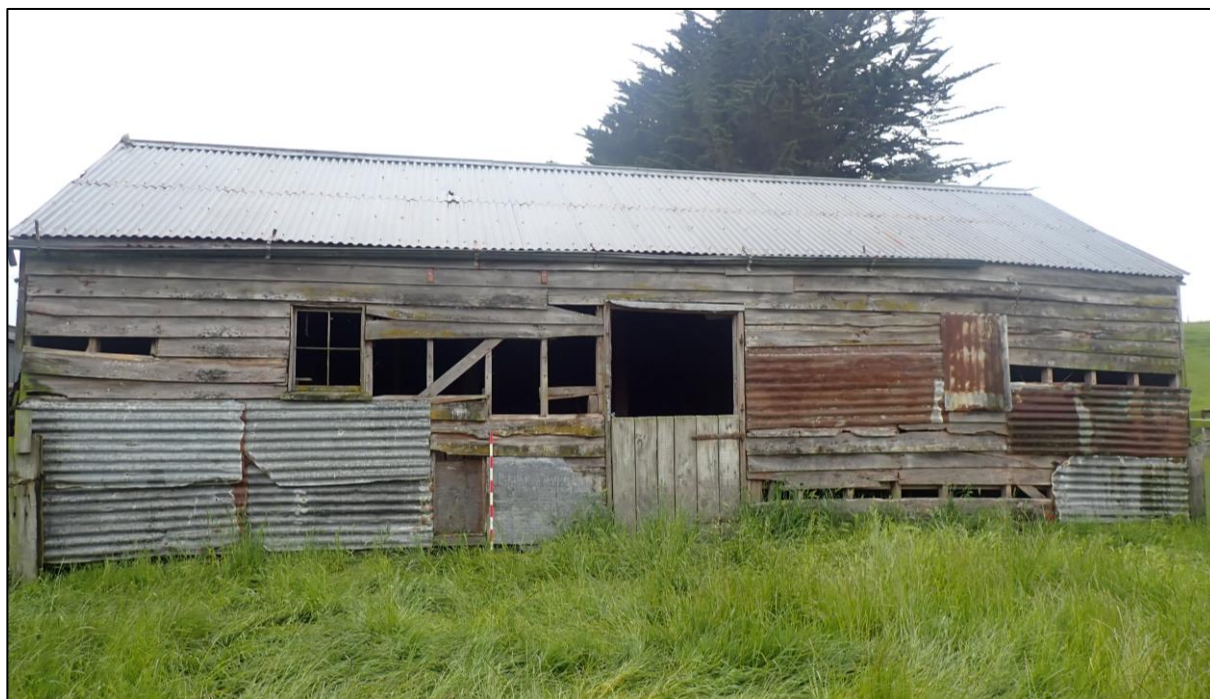
The stable is a small building towards the southern extent of the site (Figure 7-12). This is a timber framed building, currently used as a shearing shed, though clearly originally a stable as marked on the 1911 plans (see Table 7-1 for a summary of the building construction). The building was clad originally in lapped weatherboards, apparently unpainted, which has been repaired throughout the years with various sheets of iron and corrugated iron (Figure 7-13). The roof is corrugated iron which has been replaced sometime in the last 20 years. The north, west and south elevations are plain, with no windows or doors. A large door and two small windows are present on the east elevation (Figure 7-12). The windows are simple four light fixed sashes, two over two. The window on the north

**Figure 7-12. East elevation of the stable, now shearing shed.**

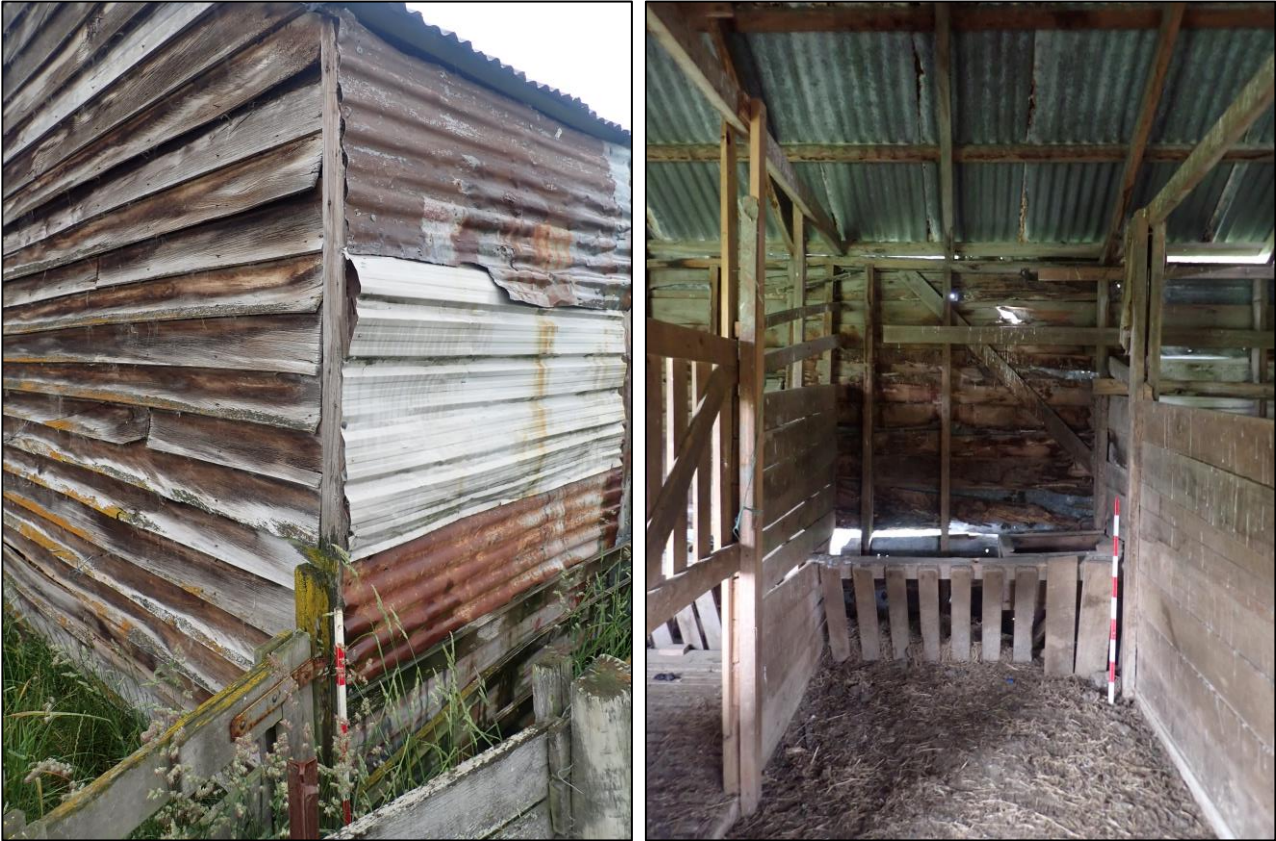
The stable is a single room, with four stalls created with half-height partitions, along with an open space at the south and east sides. The stalls had been adapted, with low gates added to the front to house sheep (Figure 7-13). At least two of the stalls still had feed troughs built into the back wall. The timbers used for the stall partitions and feed troughs were mostly pit sawn, with rose-head nails (Figure 7-14, Figure 7-15). There were some repairs evident across many of the stalls. The bracing at the front of the stalls had been largely replaced with modern timbers showing circular saw marks. The floor was a laid brick floor, in stretcher bond, with no mortar (Figure 7-16). It appears this was laid directly on the packed earth. In the south end of the stable, a timber floor had been added over the brick as a working floor, with a sorting table added against the south wall. The roof was a simple truss, with rafters checked into the top plate and ceiling joists checked into central support columns. Many alterations have been made to the stables throughout its life, including its adaptation to a shearing shed, but the majority of the original fabric appears to be intact.

Figure 7-13. Left: north corner of stable, showing meeting of two phases of cladding. Right: stall within stable, showing the original partitions and modern additions.

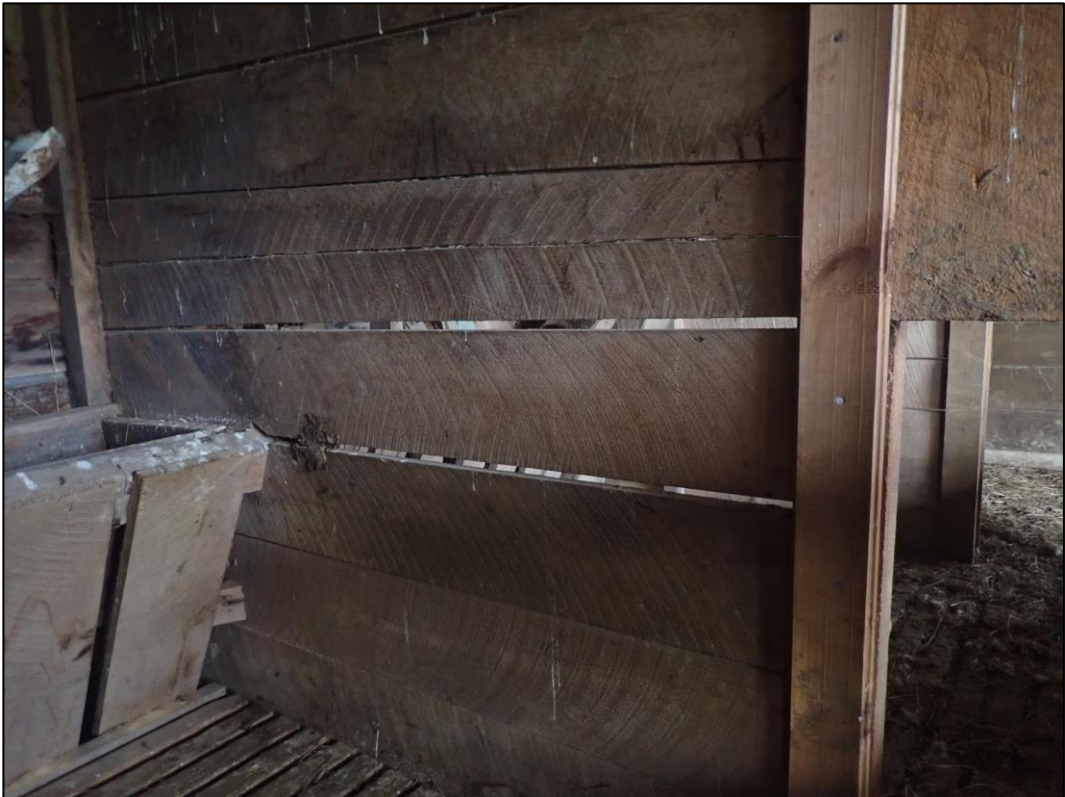
Figure 7-14. Pit sawn timbers used for the partitions between stalls.

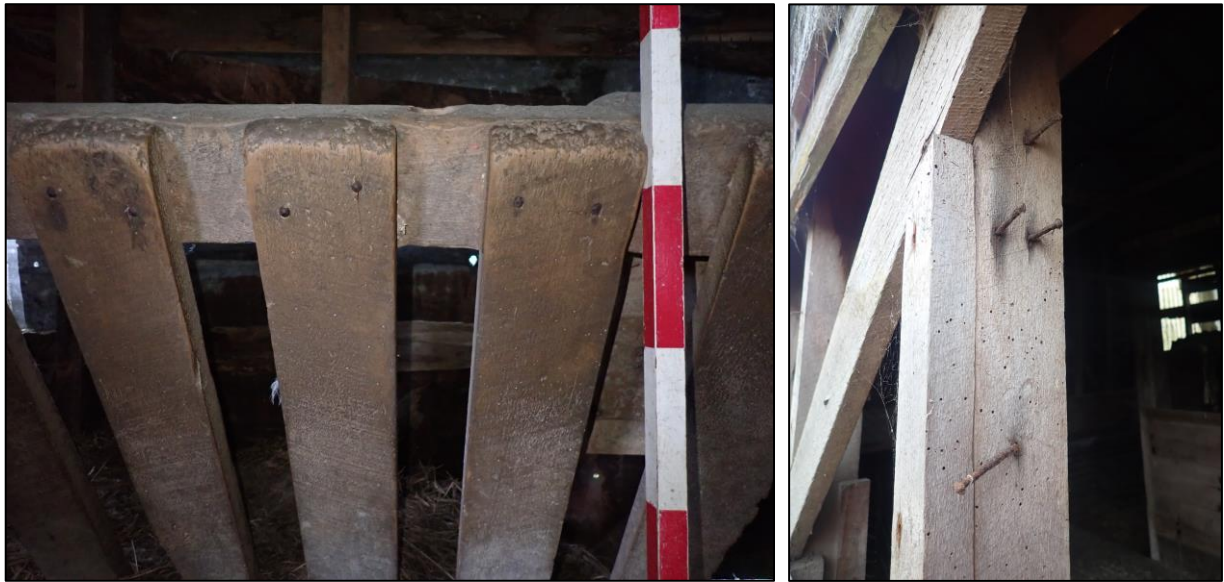
Figure 7-15. Left: Pit sawn timbers and rose-head nails on feed troughs. Right: rose-head nails used in wall framing.

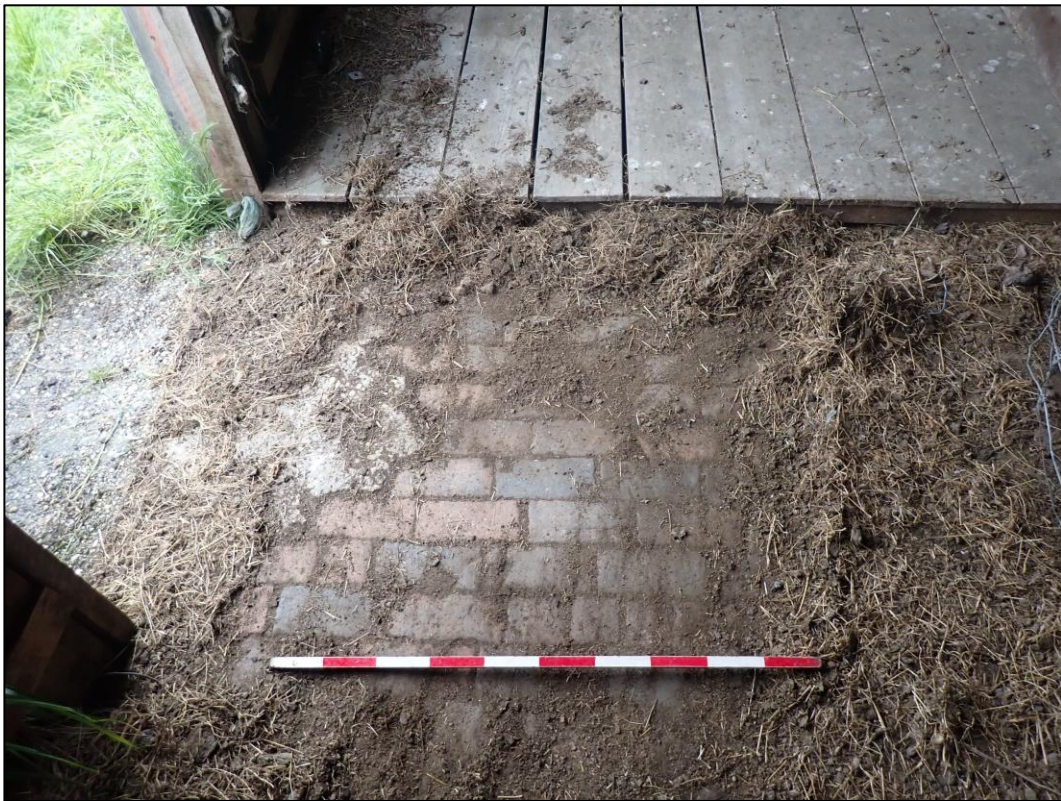
Figure 7-16. Brick floor with modern timber added over.
