MEMORANDUM

Job 10639

To: Sarah Davidson
From: Terry Hughes, Brittany Paton, Brian Ellwood
Date: 15 March 2021
Subject: RFI Queenstown Lakes District Council – Kingston Township
Wastewater Discharge Application RM20.164.01

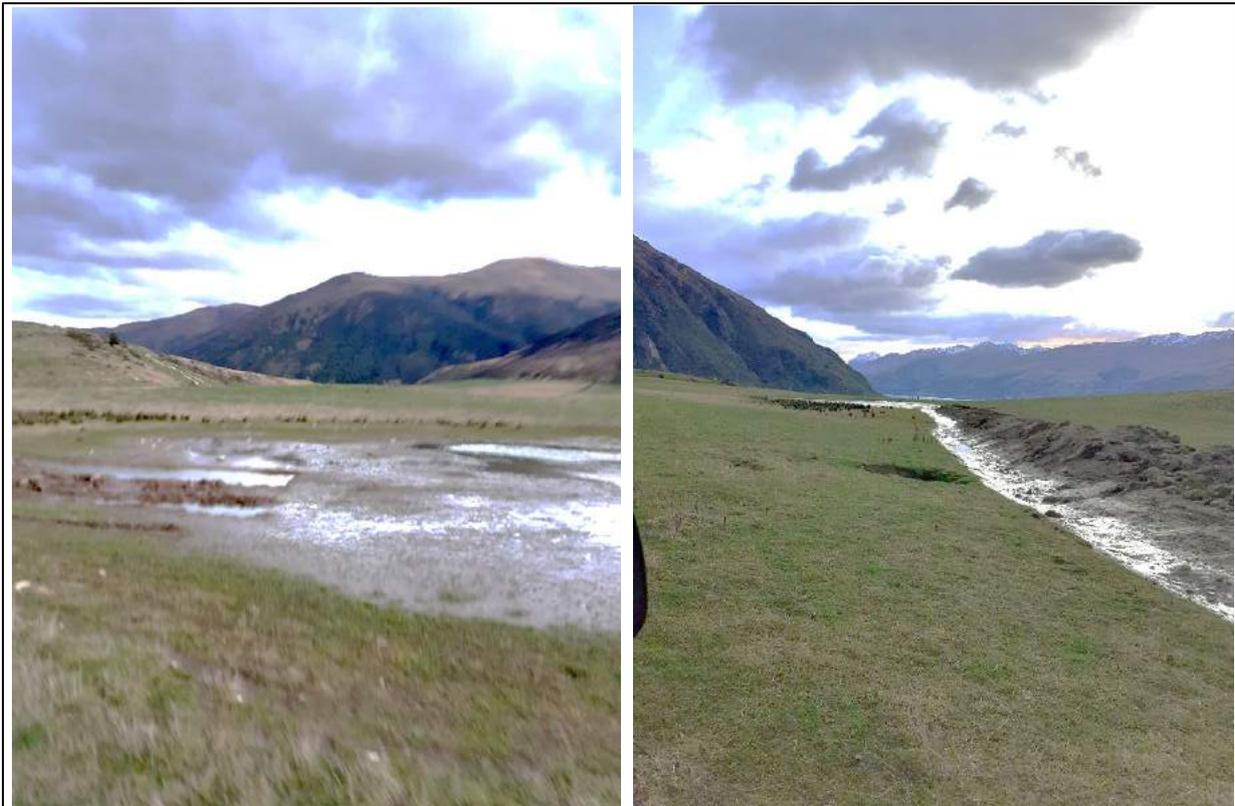
Figure 1: Drainage of Nearby Surface Water Pond (near LTA 1)

The pond near LTA 1 has recently been drained by the landowner in this southerly direction. Figure 1 from June 2020 show the drainage of this pond in the southerly direction (Figure 1). Ryder Environmental did not assess this pond due to its drainage path.

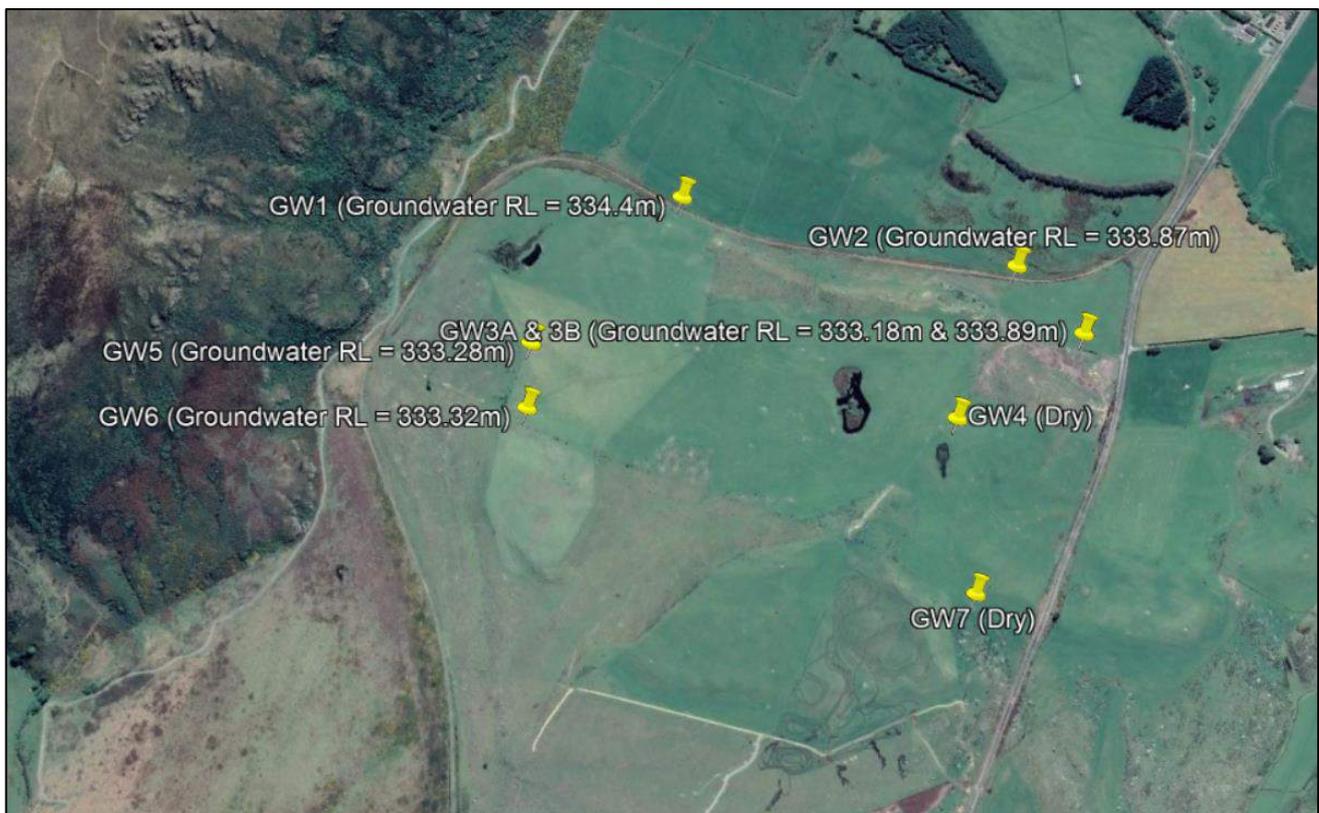
Figure 2: Kingston LTA Monitoring Bore Locations

Subsequent discussions were held between Hilary Lough (PDP) and Terry Hughes (LEI) to confirm the bore locations. These discussions were conducted on the phone and via email and locations were confirmed with some acknowledgement that the locations could shift slightly due to site conditions and landowner considerations. The final locations for the 7 monitoring bores are presented in Figure 2. Washington's Drilling were employed to drill the holes and install the piezometers and screens. Screening depths were decided onsite in response to geological conditions encountered and in agreement between driller, LEI, PDP reviewer and the client (QLDC) project manager. Borelogs are contained within Attachment 1, and a summary of geology and construction details are presented in Tables' 1 and 2. Borehole descriptions are presented in drilling order.

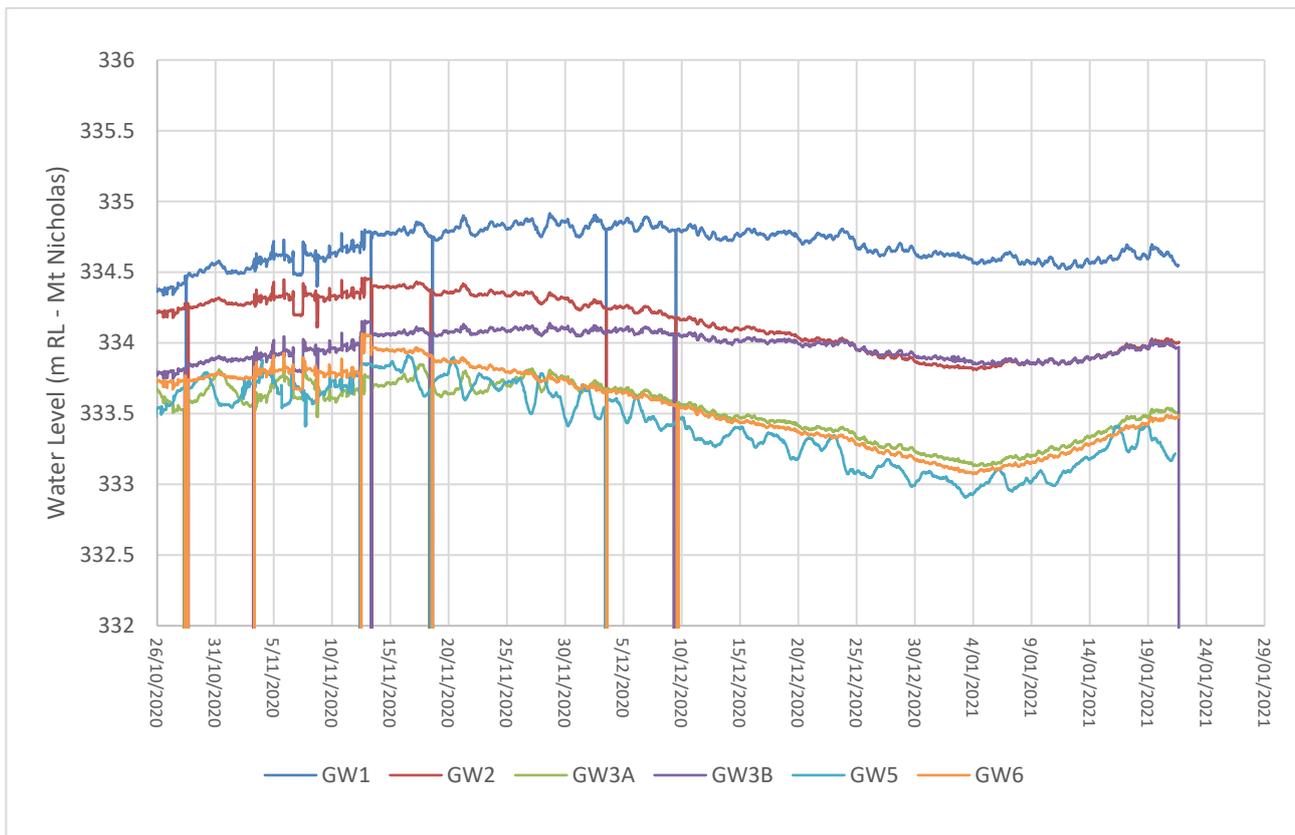
Figure 3: Kingston LTA Monitoring Bore Hydrographs

Water level data loggers were placed within the monitoring bores' GW1, GW2, GW3a, GW3b, GW5 and GW6. GW4 and GW7 were dry and therefore not considered for water level monitoring. Atmospheric pressure readings were also taken to compensate for total pressure readings. Approximately 3 months of recorded data has been processed and is presented in a hydrograph in Figure 3 below. A desktop assessment of water levels outside of the study area (both north and south) was also undertaken, albeit with sparse data.

The water level study indicates that water level arrangement beneath the proposed LTA's is complicated. Plan and sections showing borehole locations and interpretative sections are presented in Figures 5, 6a and 6b. Conclusions that can be drawn from these water levels include:

- GW1 was uncharacteristically higher than all other water levels, indicating a localised groundwater perching that could be sourced from the nearby boggy area. It is understood from the Ryder Ecological Report (Attachment 2) that GW1 exists near to a stretch of stream that is dry and displays water loss. This perching of groundwater above a highly compact dense layering of silt was also observed in GW2 and GW3a when being drilled.

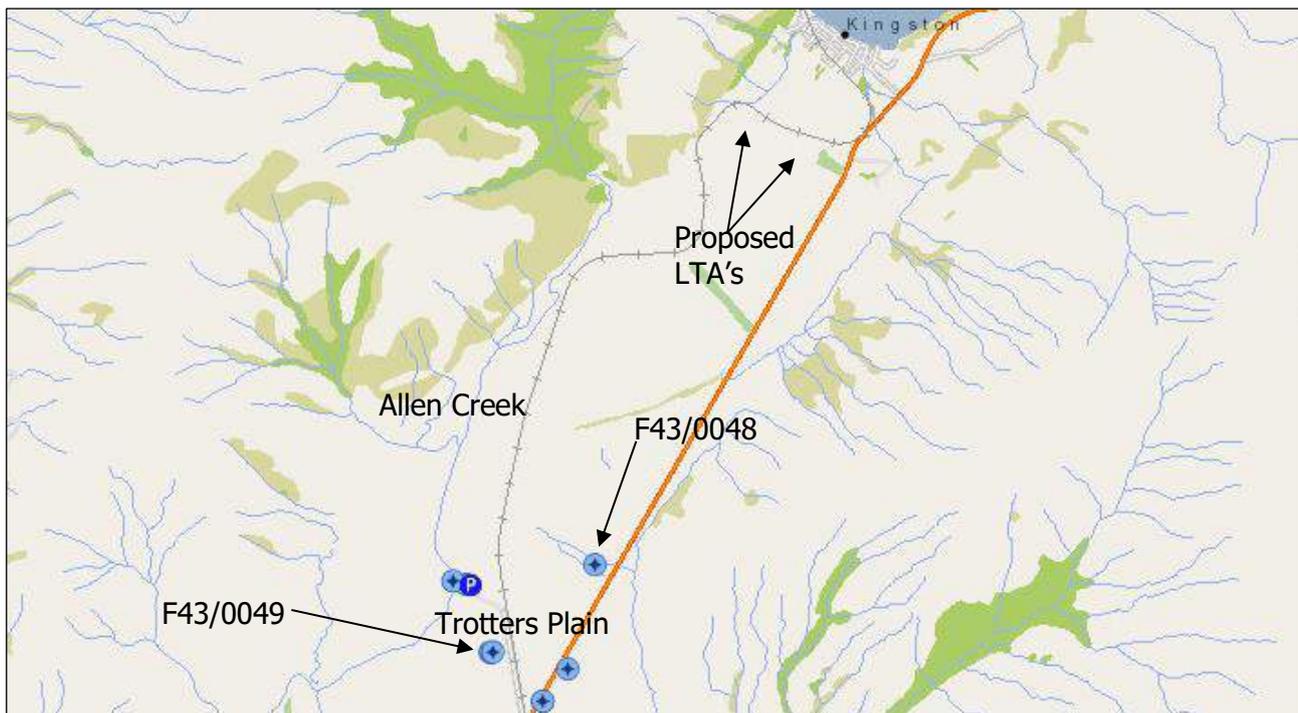
Figure 4: Matura Catchment Bore Locations

- Further to the south in the Mataura catchment and towards Trotters Flat (Figure 4), some bores are present with details recorded on the Environment Southland GIS (Beacon). Of particular note is Bore F43/0049 that is calculated to have a water level (RL) of 334 m indicating that water levels do not necessarily drop off significantly to the south, however, this could also be indicative of local highs due to localised terrace highs. In comparison, Allen Creek sits within a localised

depression some 20 to 30 m lower than the outwash terraces and will likely draw groundwater from the terrace with a commensurate groundwater gradient. Bore F43/0048 sits within a gully structure dissecting the outwash surface approximately 5 km south of the site. Water level RL calculated for F43/0044 is significantly lower than F43/0049, but is likely controlled by topography and the drainage gully structure that the bore sits within, indicating that groundwater has a significant localised behaviour, adhering to topography.

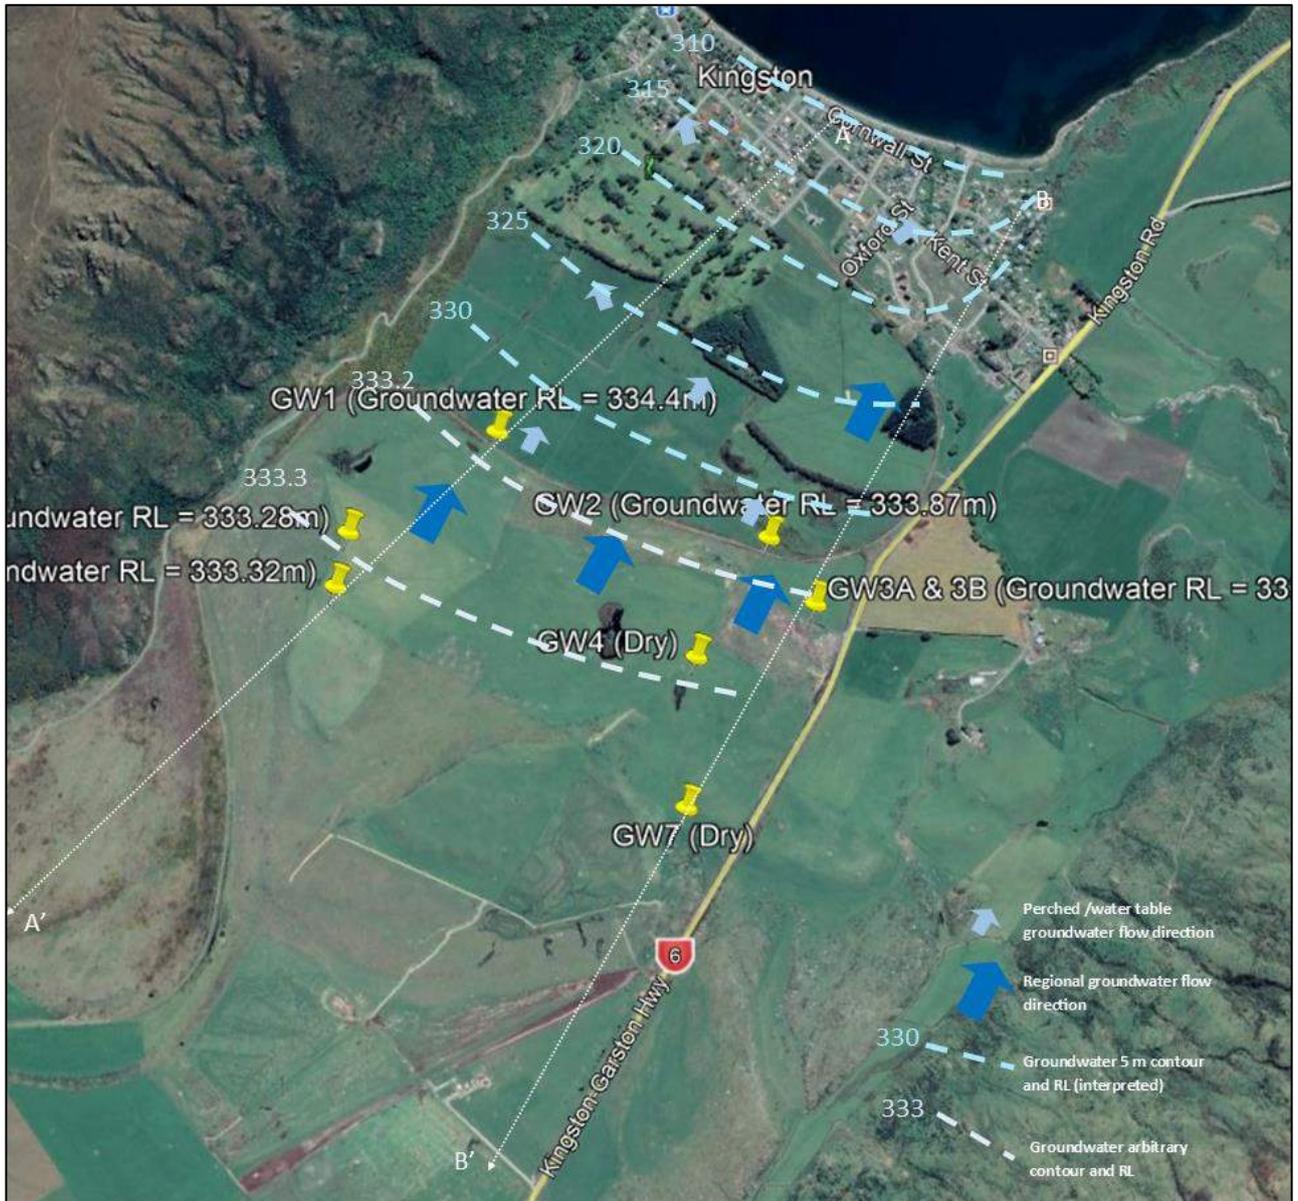
Figure 5: Interpretative Conceptual Hydrogeological Flow Model

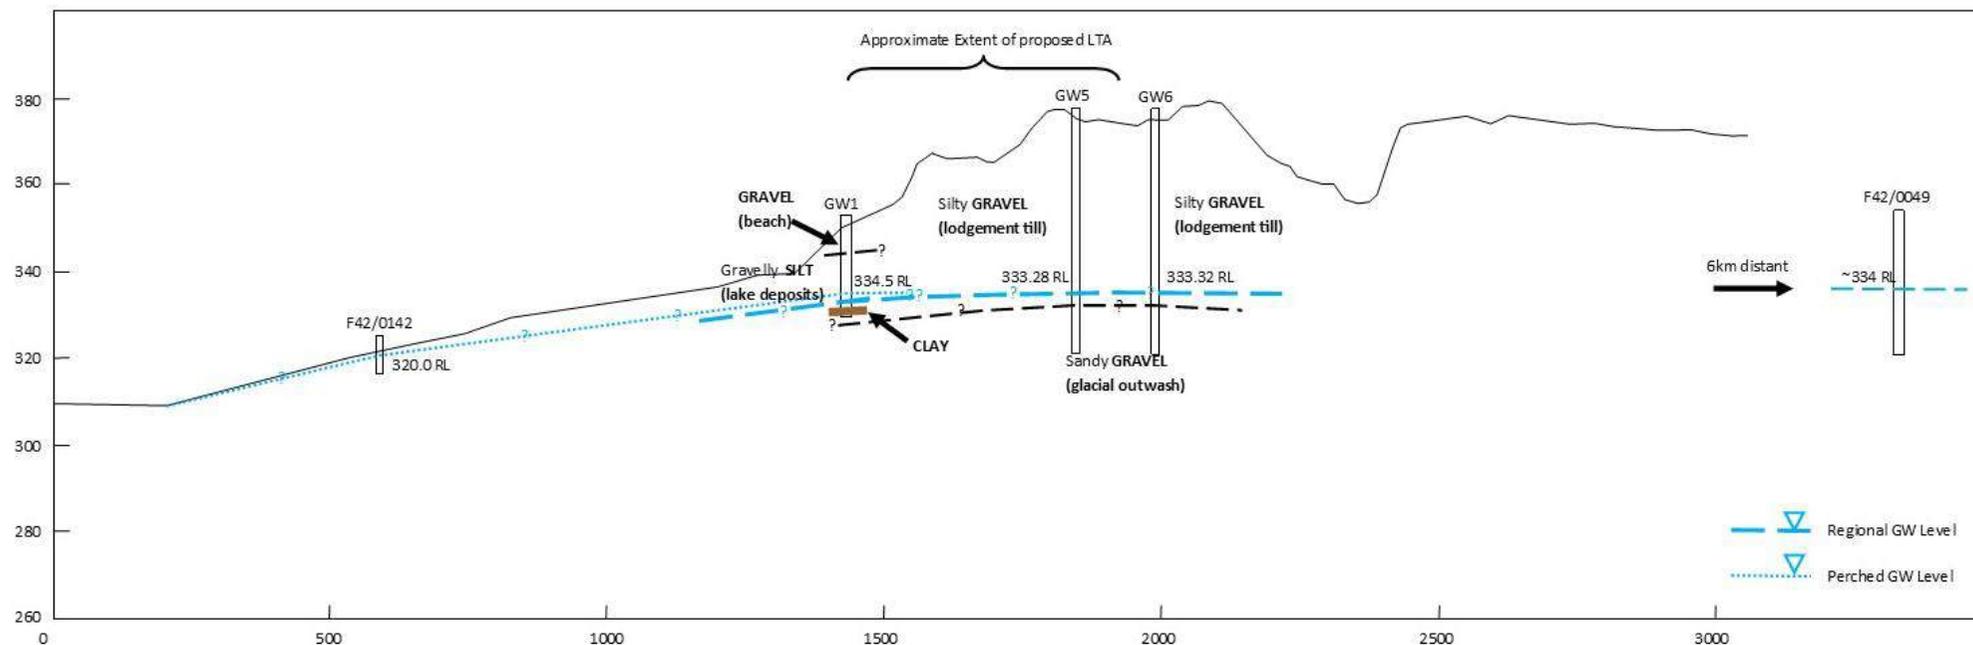
Figure 6a: Interpretative Conceptual Hydrogeological Sections A-A'(refer to Figure 5 for locations). Vertical exaggeration = 10:1 (approximate). Scale in metres.

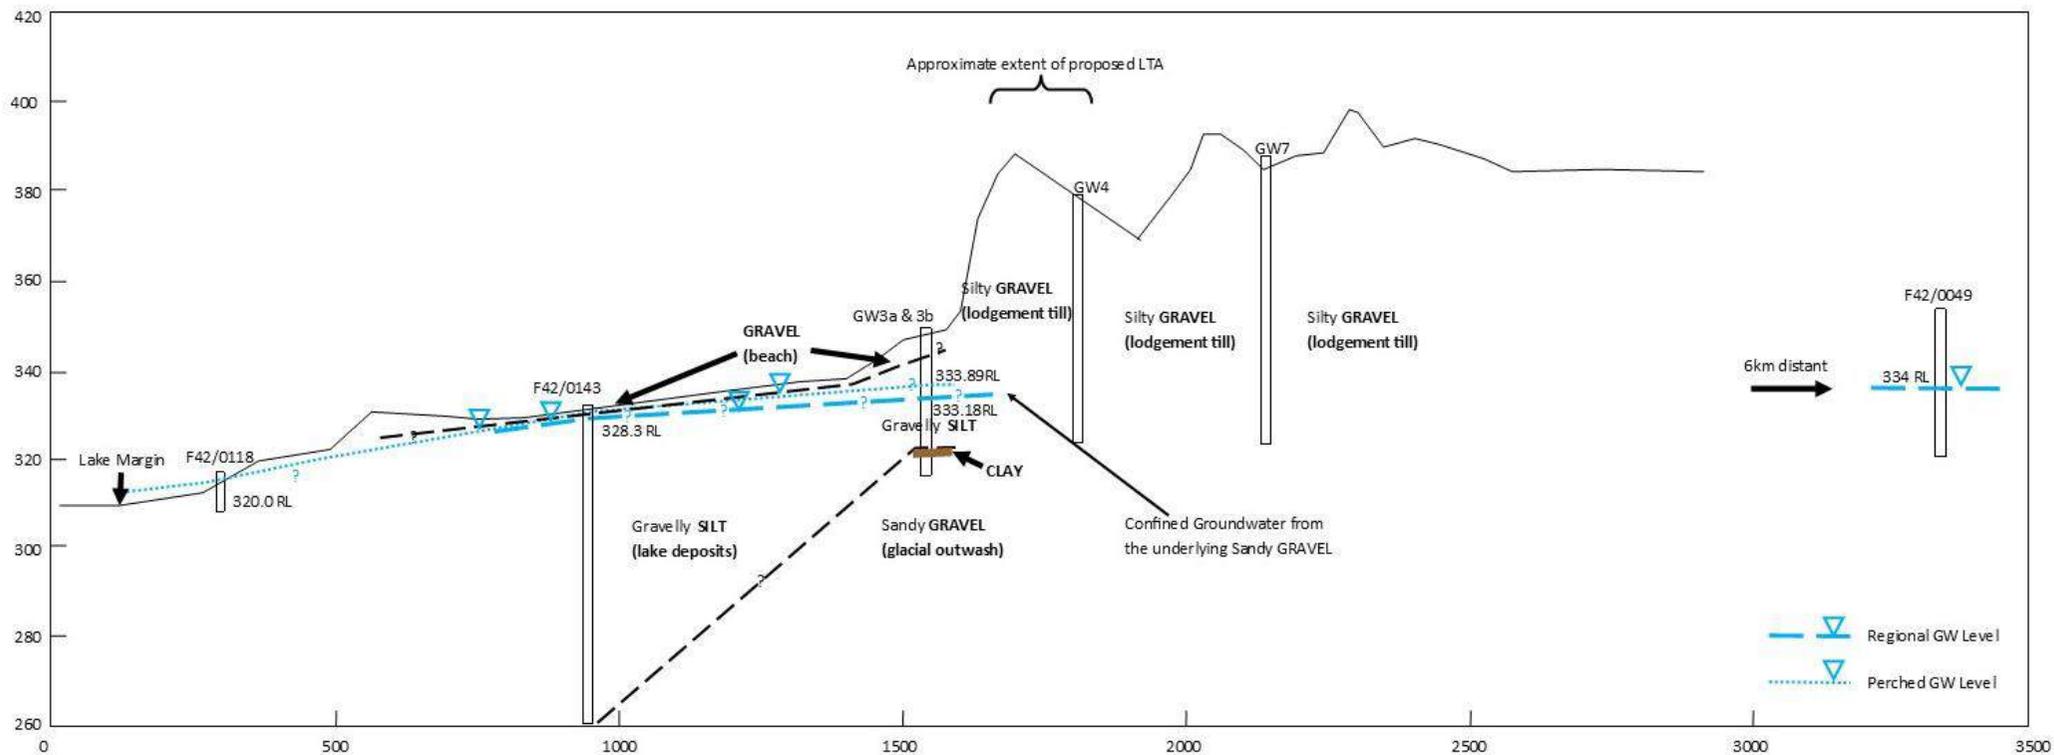
Figure 6b: Interpretative Conceptual Hydrogeological Sections B-B'(refer to Figure 5 for locations). Vertical exaggeration = 10:1 (approximate). Scale in metres.

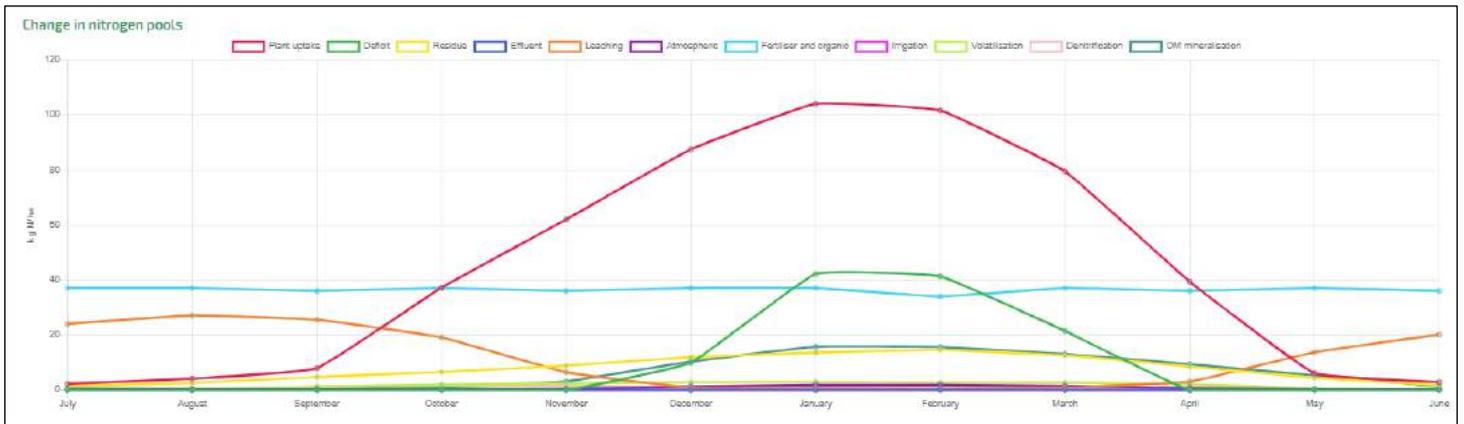
Figure 7: Full capacity 900 cubic metres over 365 days

In Figure 7, the pasture uptake per month is reported and it shows that lucerne growth is low over winter and is greatest in late summer. This matches the typical lucerne growth profile shown below in Figure 8, which shows typical lucerne monthly dry matter production in comparison to pasture. It shows that there is very low growth in June, July and August, with peak dry matter production in January and February.

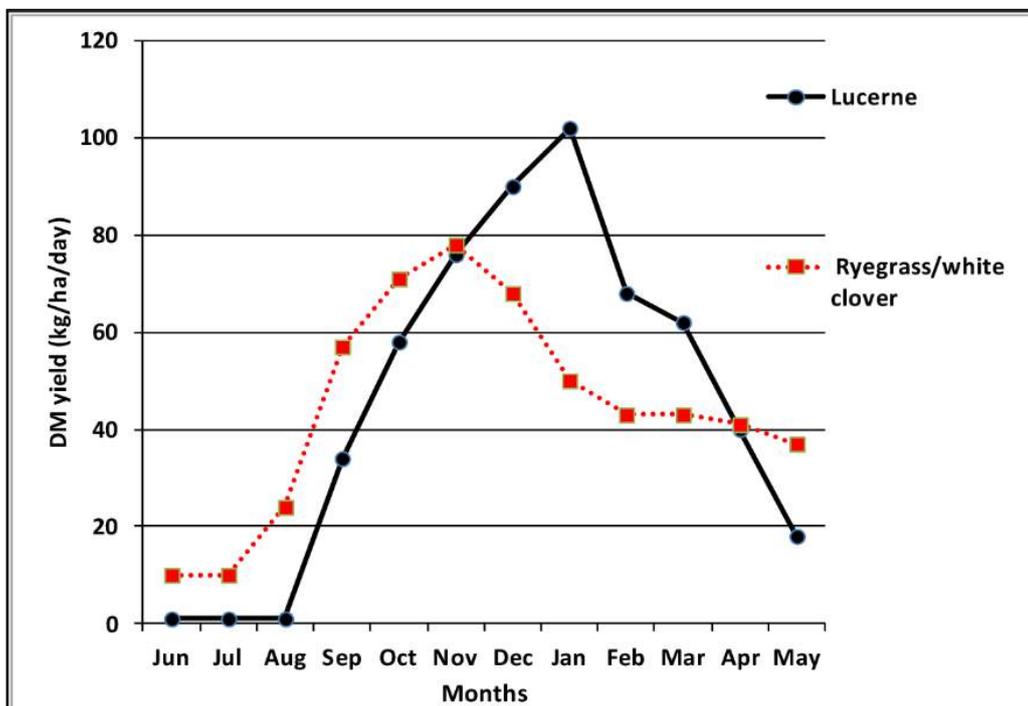
Fig. 2.4 The general production and productivity trends of lucerne and RG-WC pastures in response to the

Figure 8: Typical Lucerne Growth Pattern

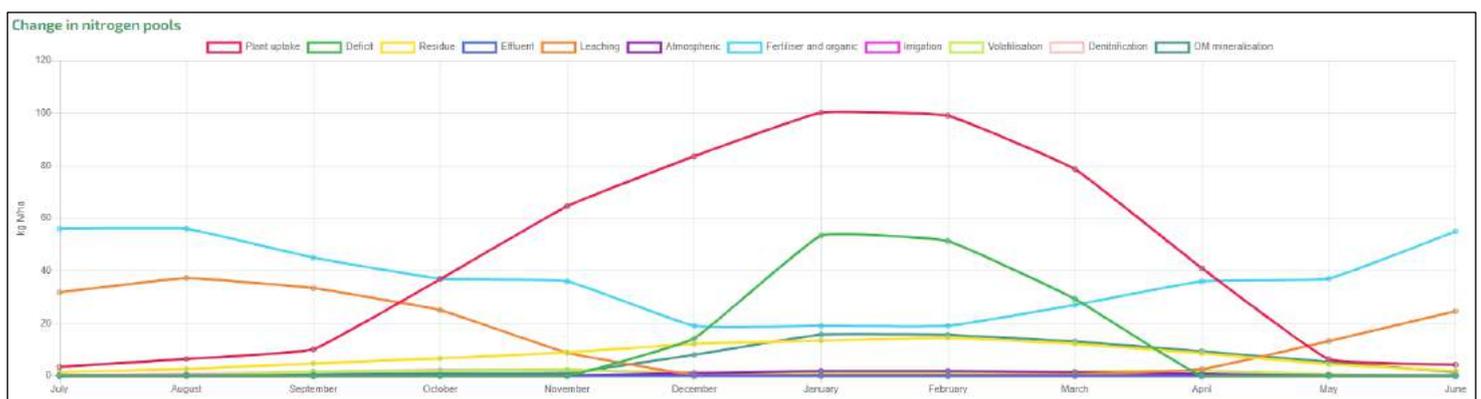
Figure 9: Seasonal Variation of N loading – High Winter

Figure 9 below shows the monthly plant uptake and N losses within the system.

The N loss from this scenario was 178 kg/ha/yr from the 15 ha. This scenario applied 166 kg N/ha over the winter and overall the system is losing an additional 36 kg N/ha (i.e. 178 vs 142) over the winter. See Table 4 below for comparative scenarios and mass balance impact of greater winter leaching. However, given this scenario, the impact on the environment is still considered less than minor.

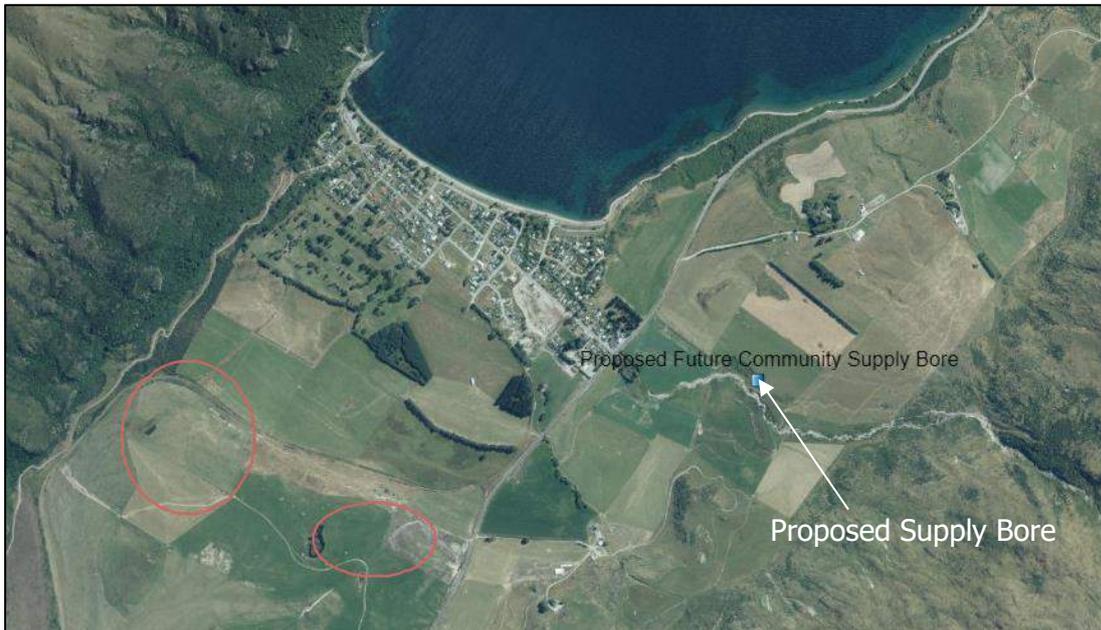
Figure 10: Location of Proposed Bore

The bore associated with the proposed reticulated community supply (Kingston HIF) was installed in June 2020. The location of the bore is in the same location as was proposed in the AEE (See image below). The bore number is F42/0147 and location coordinates are NZTM: 1265516E, 4970488N. This bore is not located in aquifers downgradient of the LTA, as shown in Figure 10.

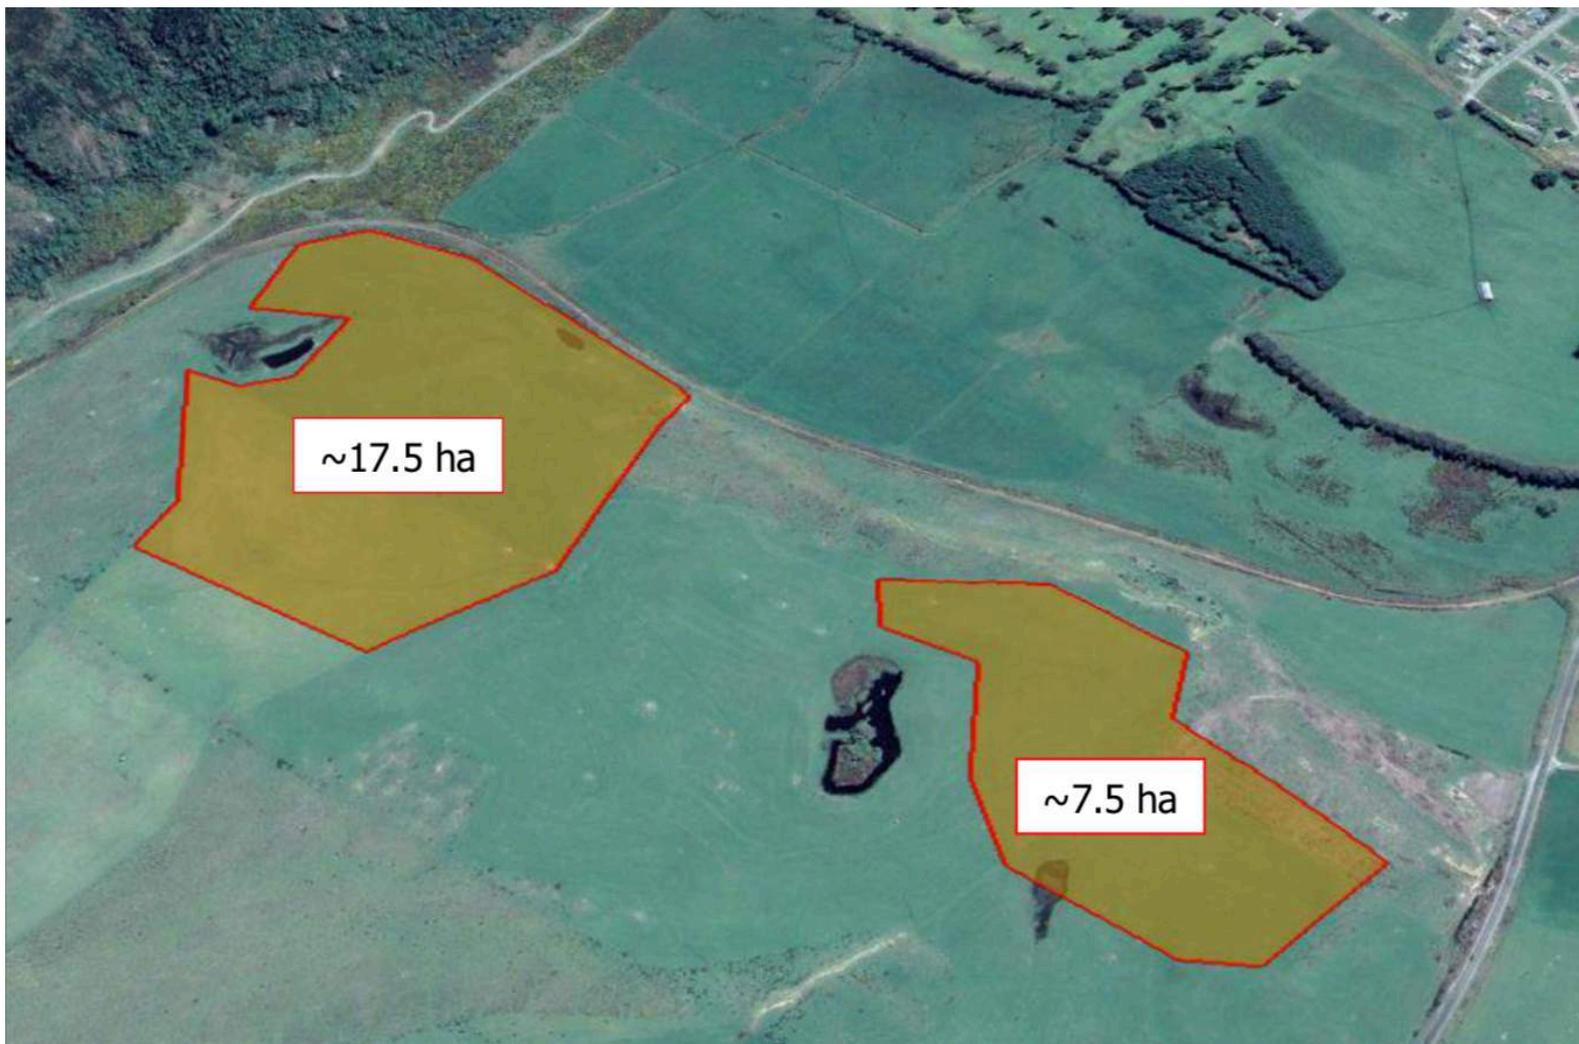
Figure 1. Kingston Township Community Wastewater proposed land treatment command area (from LEI 2020).

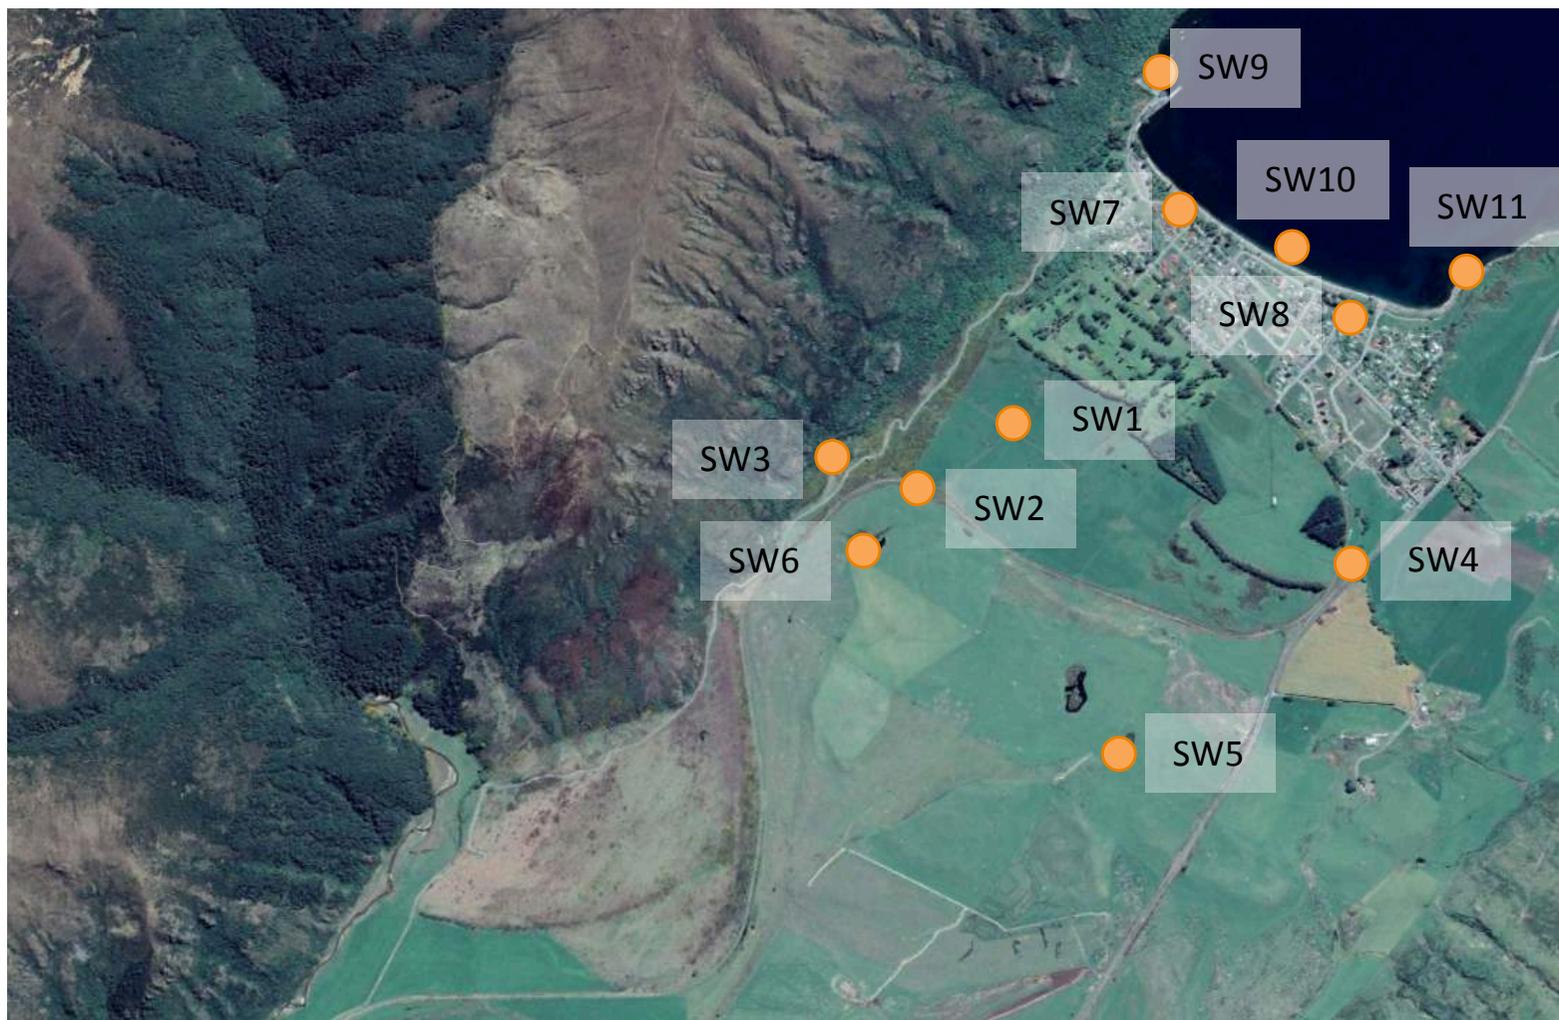
Figure 2. Kingston Township Community Wastewater proposed land treatment command area surface water quality sampling sites, October 2020.

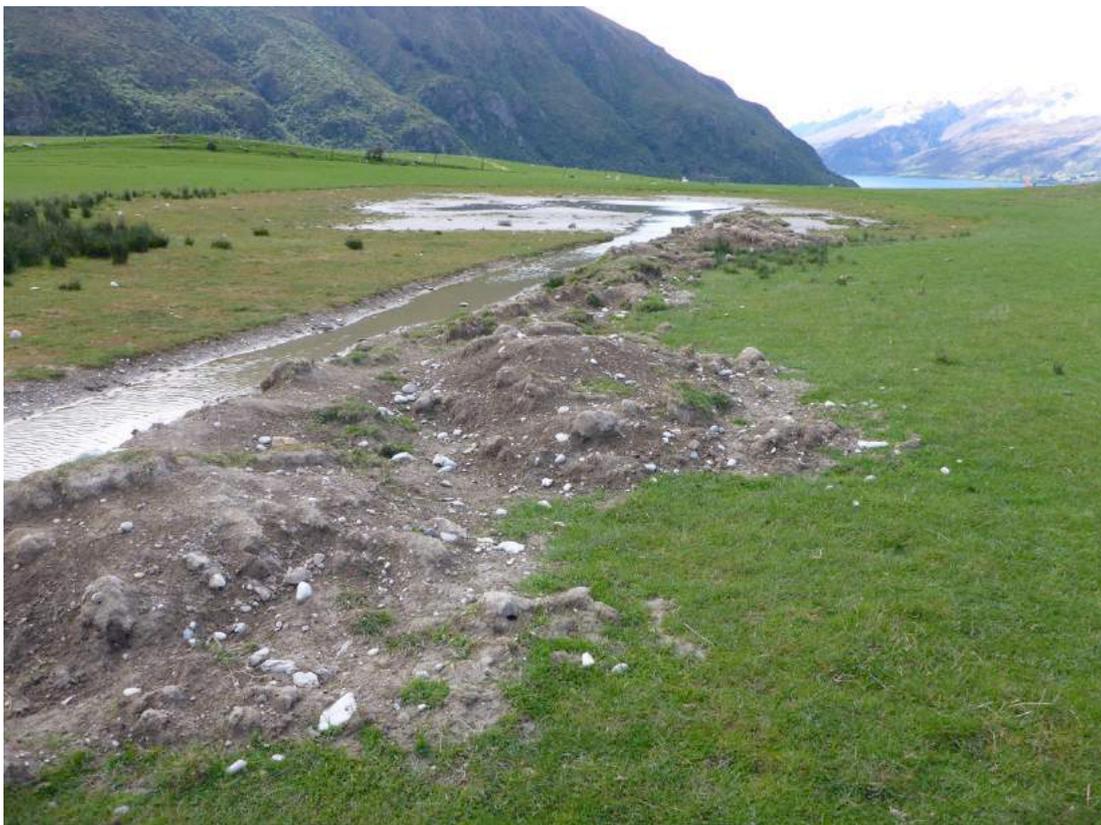
Figure 3. Pond 1 (SW5).

Two ponds (SW5 and SW6) are located within or adjacent to the proposed land treatment area (Figures 1 and 2). Pond 1 (SW5) had been drained prior to the October 2020 survey and therefore did not provide any existing aquatic habitat (Figure 3). Pond 1 was therefore not sampled (Table 1) and is not discussed any further in this assessment.

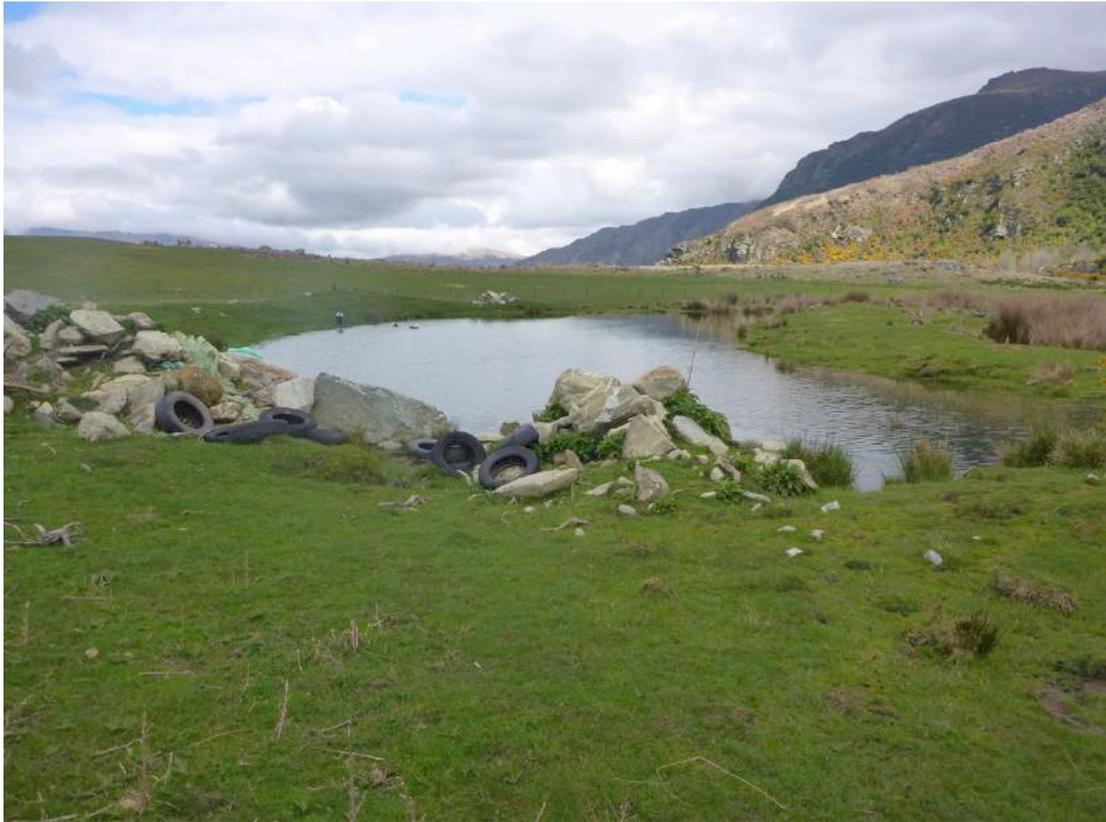
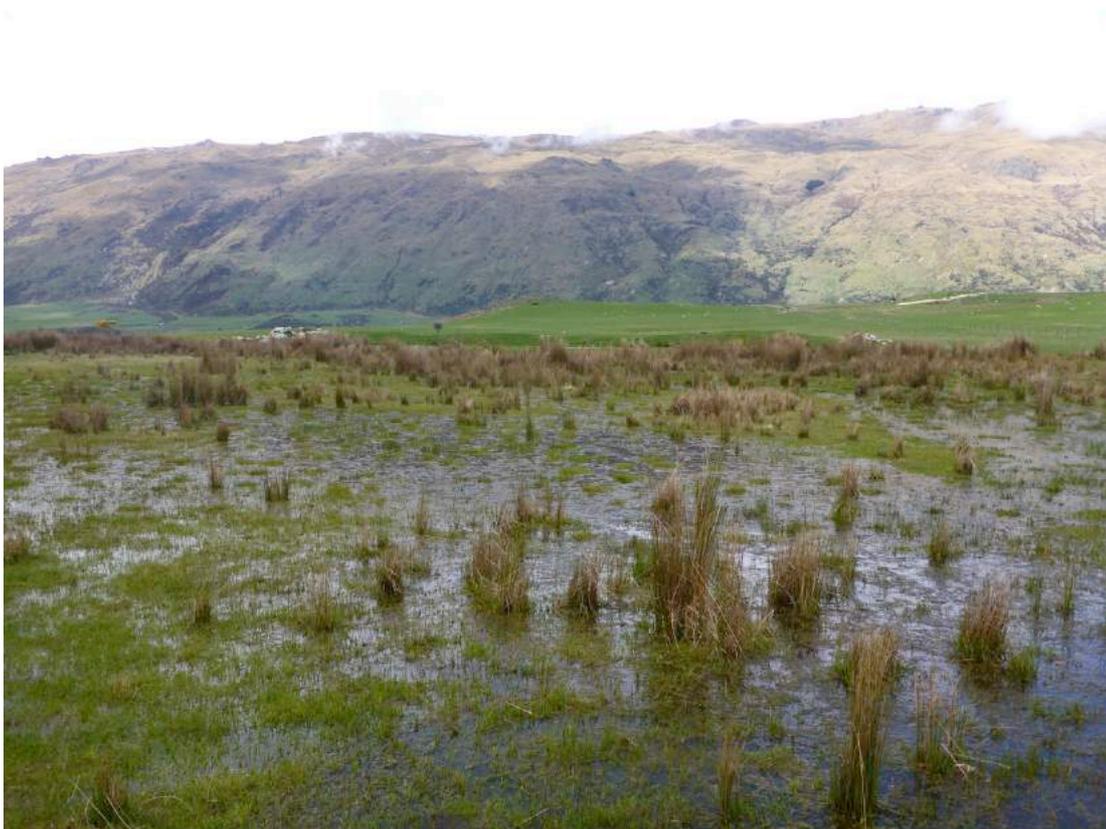
Figure 4. Pond 2 (SW6). Top: Pond 2. Bottom: Wet area of pasture connected to the pond.

Pond 2 (SW6) is surrounded on three sides by the proposed land treatment area (Figures 1 and 4). The pond has a surface area of approximately 0.09 ha and is artificial, having been created by excavation of a naturally wet area, some of which remains (Figure 4, bottom). It is also isolated, having no direct connection to any other surface water bodies. Pond 2 is surrounded by grazed pasture and there is no restriction to stock access. Water quality was measured, and a benthic macroinvertebrate sample taken (by sweeping a kicknet along the pond margins). Three Gee-minnow traps and one fyke net were set overnight in the pond (Table 1).

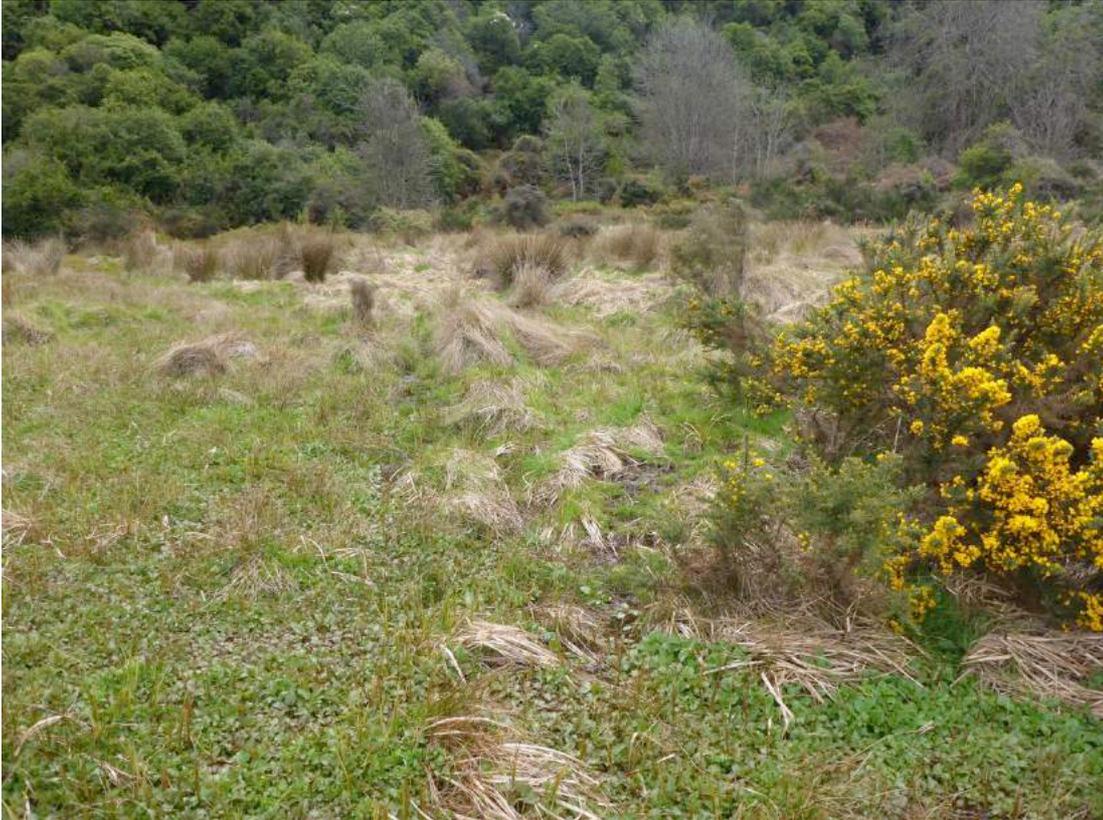
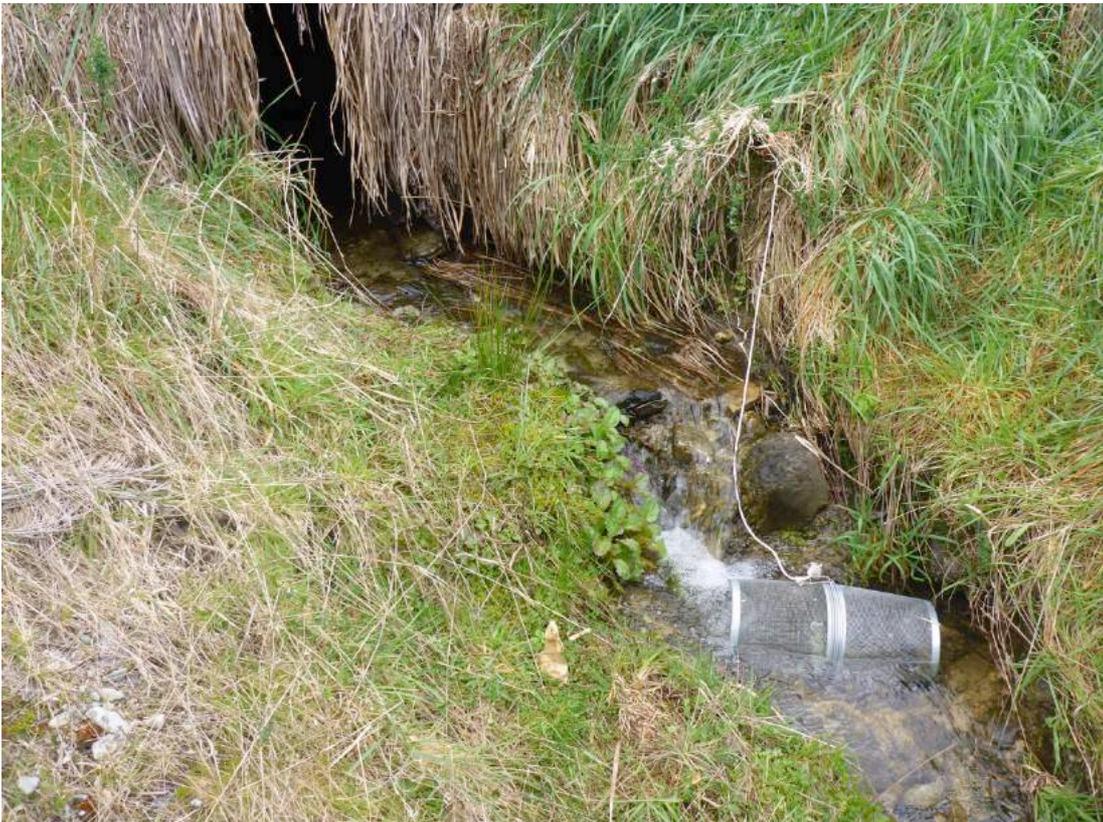
Figure 5. Unnamed tributary - upstream (SW3). Top: Wide undefined channel upstream of cycleway culvert. Bottom: Confined channel downstream of cycleway culvert, with Geeminnow trap.

The unnamed tributary – upstream site (SW3) was located upstream of any potential influence of the proposed land treatment area. The tributary channel here was initially poorly defined, flowing off the steep hillside through a wide, heavily vegetated (dominated by monkey musk) area with a soft fine sediment substrate (Figure 5, top). Immediately upstream of the cycleway culvert the tributary channel then became more defined and downstream of the culvert continued to flow through a narrow, incised channel with a firm, gravel and cobble substrate (Figure 5, bottom). Flow at this point was gauged to be 3 L/s. Approximately 3 m downstream of the cycleway culvert the tributary entered a second culvert, flowing in a defined channel for a short distance after it exited the culvert before widening again into an undefined wet area. The channel in this section of the tributary downstream to the unnamed tributary – downstream site 1 (SW2) was fenced from stock grazing and overhung with tall broom and other exotic shrubs. Due to the dense vegetation cover it was not possible to follow the channel the entire 150 m to downstream site 1 (SW2), however from what was observed there was a surface flow connection throughout.
