MEMORANDUM

Job 10639

To: Sarah Davidson
From: Terry Hughes, Brittany Paton, Brian Ellwood
Date: 15 March 2021
Subject: RFI Queenstown Lakes District Council – Kingston Township
Wastewater Discharge Application RM20.164.01

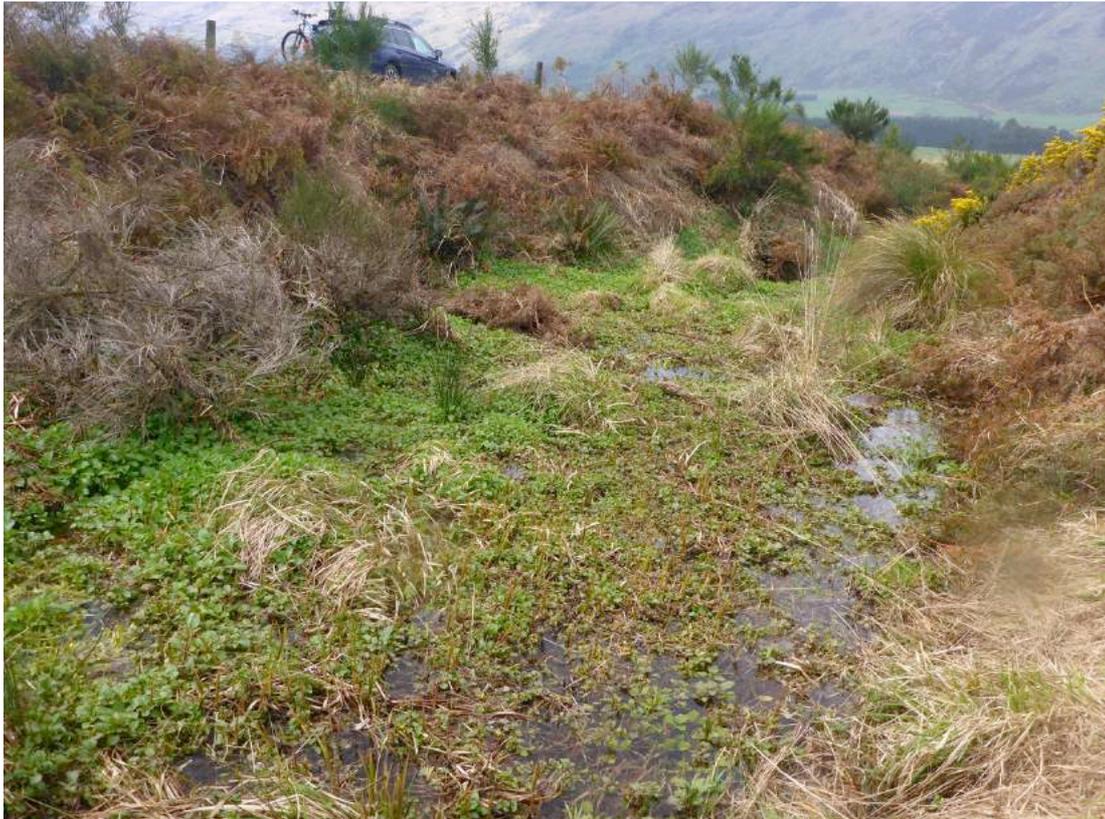
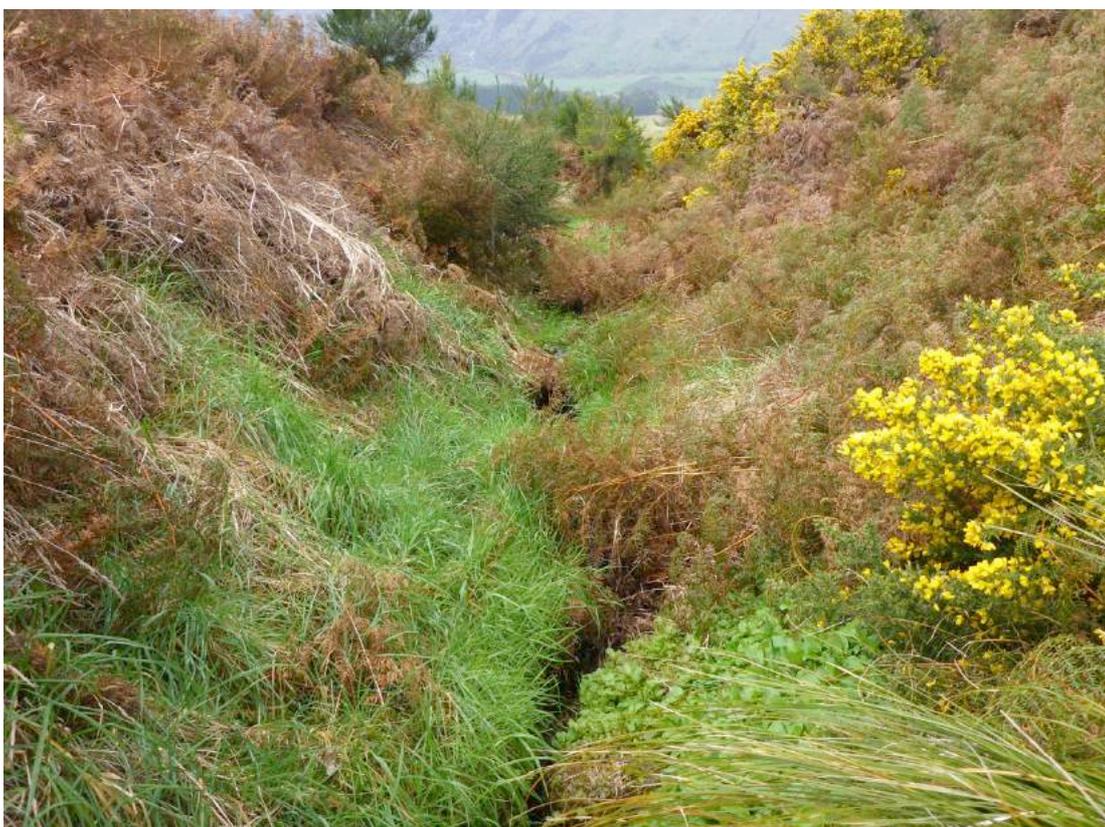
Figure 6. Unnamed tributary – downstream 1 (SW2). Top: Wide undefined channel. Bottom: Confined channel.

Unnamed tributary – downstream site 1 (SW2) was similar to that of the upstream site. Within this site the channel varied from being an undefined wide, heavily vegetated (again dominated by monkey musk) area with a soft fine sediment substrate (Figure 6, top), to being narrow and incised with gravel and cobble dominated substrate (Figure 6, bottom). Immediately downstream of the site there was an approximately 10 m long section with no visible surface flow at the time of sampling. It appeared though that during higher flows this section of channel would have surface flow.

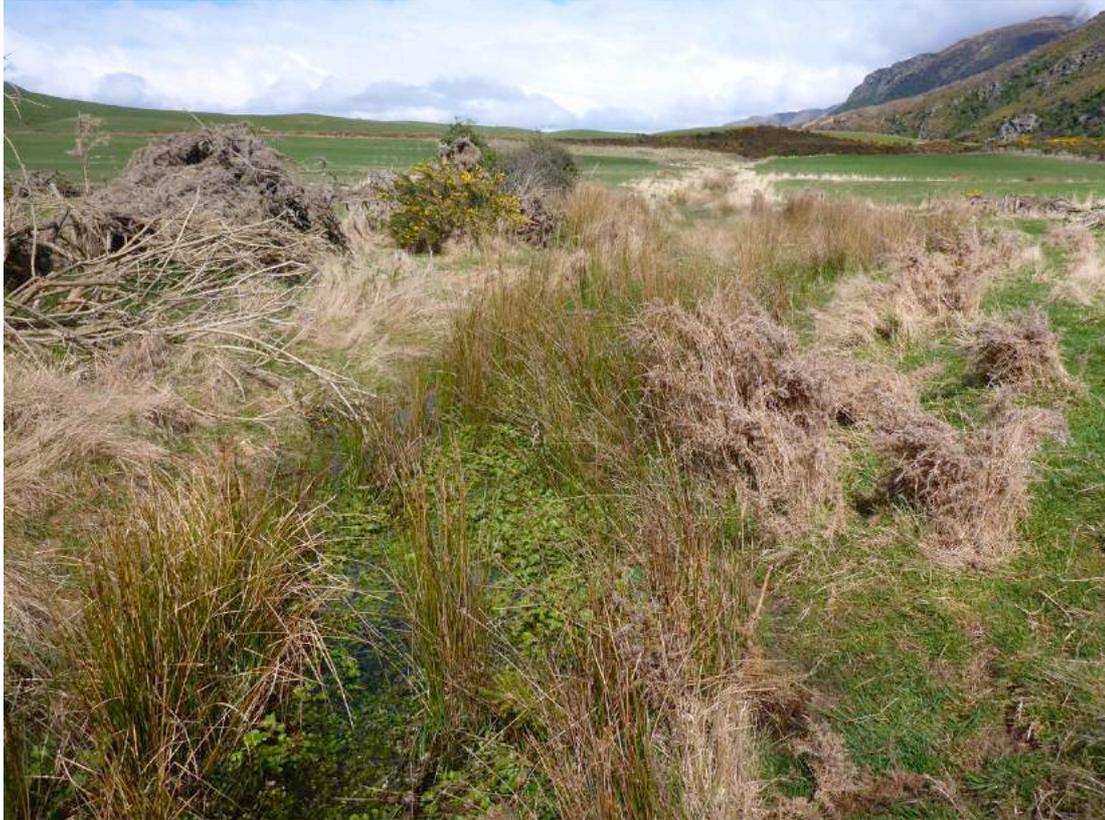
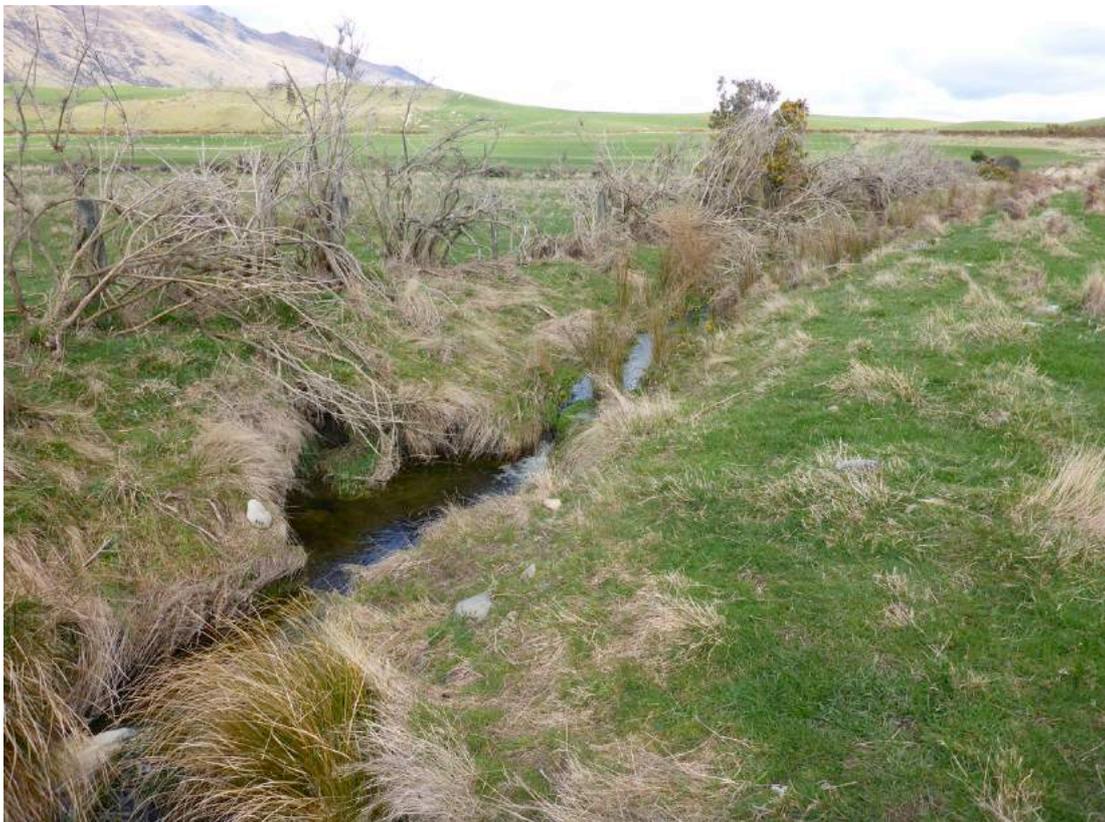
Figure 7. Unnamed tributary – downstream 2 (SW1). Top: Wide undefined channel. Bottom: Confined channel.

Unnamed tributary – downstream site 2 (SW1) was located approximately 300 m downstream of downstream site 1 (Figure 2). Here the channel varied again from being wide and heavily vegetated (Figure 7, top) to narrow and incised (Figure 7, bottom). The channel was uniformly straight and it appeared that it had been excavated in the past. It was open to stock access and the banks were dominated by grazed pasture grasses.

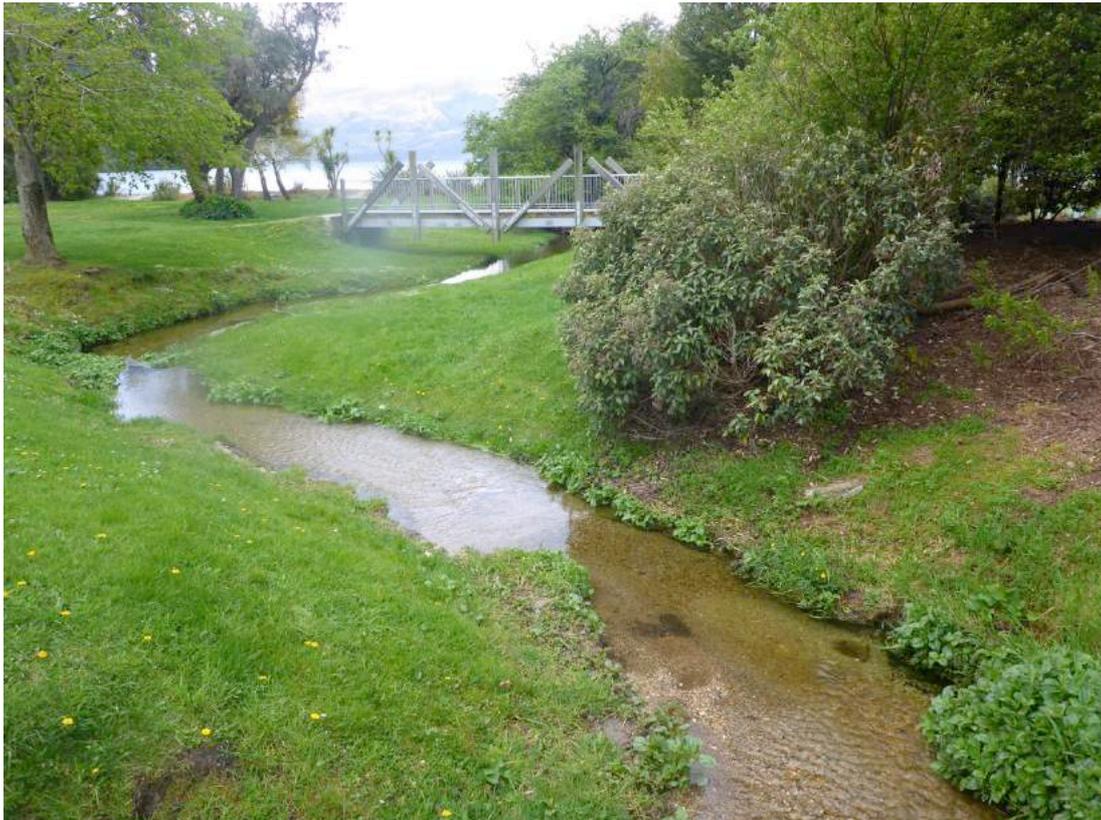
Figure 8. Unnamed tributary – at Lake (SW7).

The fourth site (SW7) on the unnamed tributary was located approximately 50 m upstream of Lake Wakatipu and approximately 1 km downstream of the proposed land treatment area (Figure 2). The habitat at this site differed from that at the other unnamed tributary sites upstream, in that the channel was uniformly open with minimal vegetation and had a mobile, gravel dominated substrate (Figure 8). The site was located within a recreational reserve, and there was mown grass and occasional shrubs and trees on the banks.

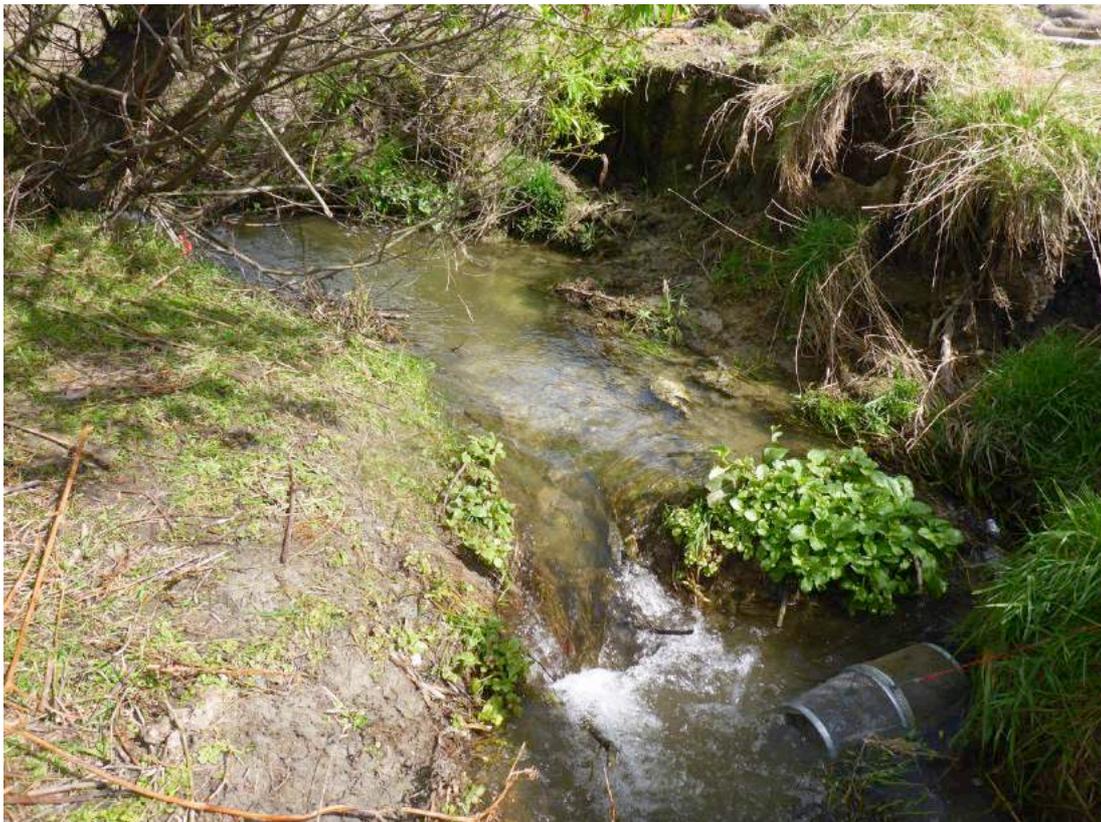
Figure 9. Kingston Creek – upstream SH6 (SW4).

The Kingston Creek – upstream SH6 site (SW4) was located within a grazed paddock, immediately upstream of the SH6 road culvert (Figure 2). The channel was open to stock and some slumping of the creek banks was visible (Figure 9). Willow trees were present on the banks in places. The substrate included soft, fine sediments amongst gravel and cobbles, and patches of vegetation were also present (dominated by monkey musk) (Figure 9).

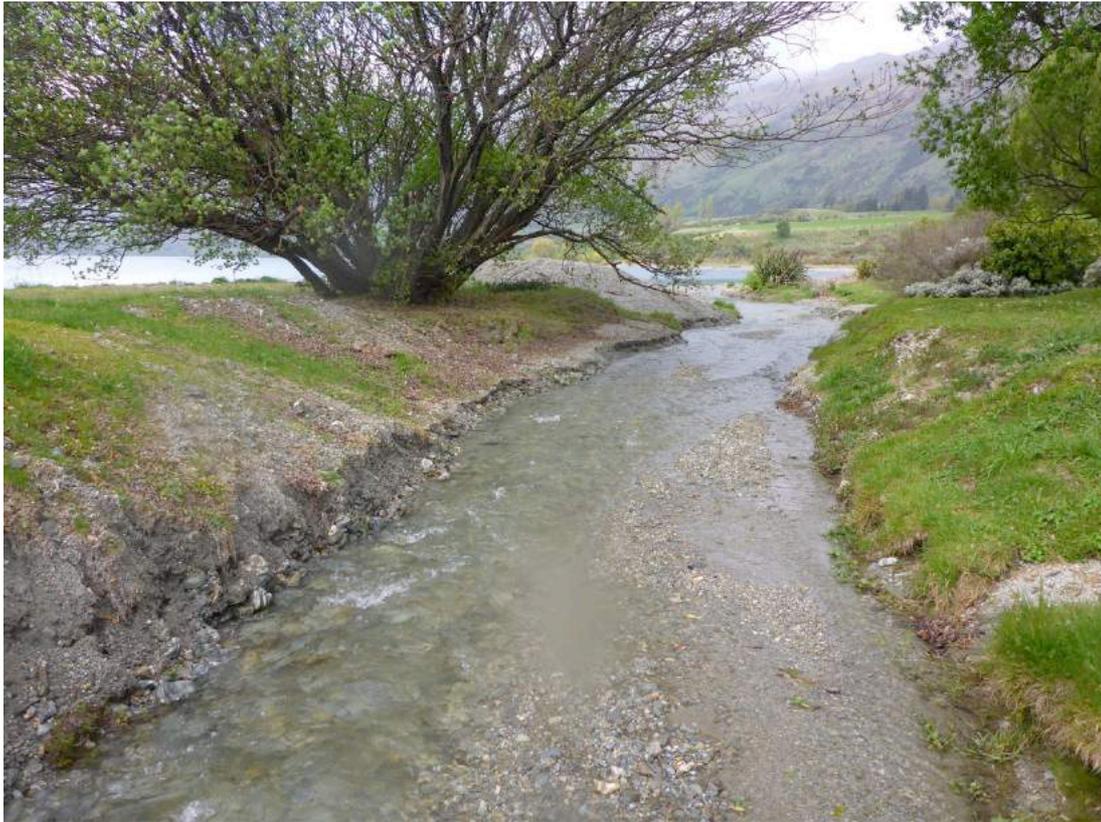
Figure 10. Kingston Creek – at Lake (SW8).

The Kingston Creek – at Lake site (SH8) was located approximately 50 m upstream of Lake Wakatipu (Figure 2). The habitat at this site differed from that at the site upstream, in that the channel was wide and open with minimal vegetation and had a mobile, gravel and cobble dominated substrate (Figure 10). The site was located within a recreational reserve, and there was mown grass and occasional shrubs and trees on the banks.

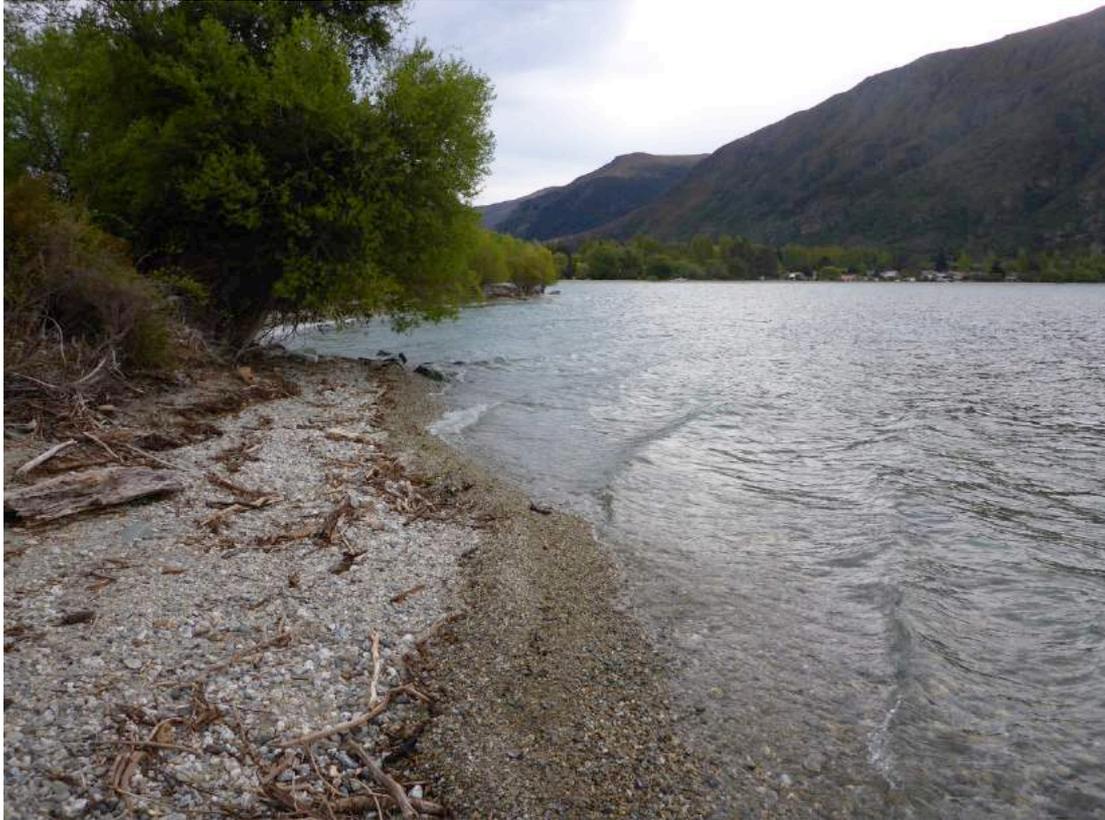
Figure 11. Lake Wakatipu – West (SW11).

Aquatic habitat at all three Lake Wakatipu sites was similar, with a gravel and cobble dominated substrate and occasional large boulders (Figures 11 and 12). A small unnamed tributary entered the lake near the Lake Wakatipu – West site (SW11) and there was some woody debris and leaf matter on the lake bed at this site in association with this.

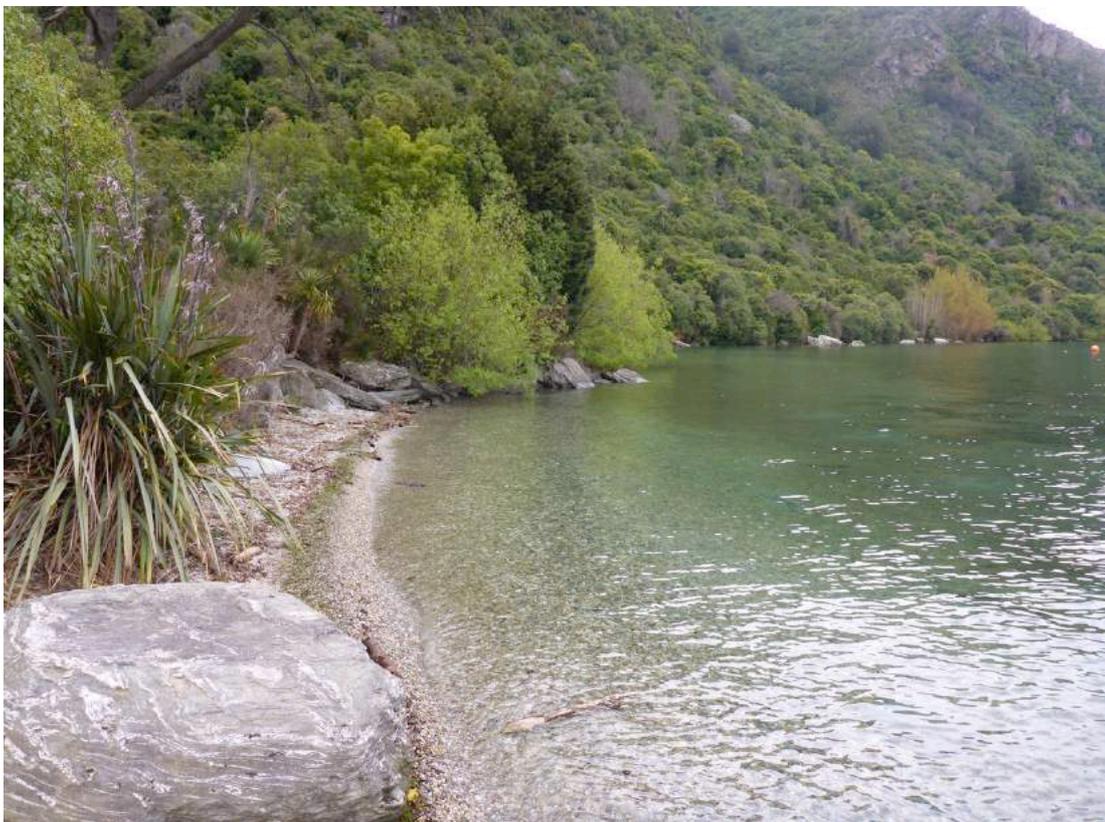
Figure 12. Lake Wakatipu – East (SW9).

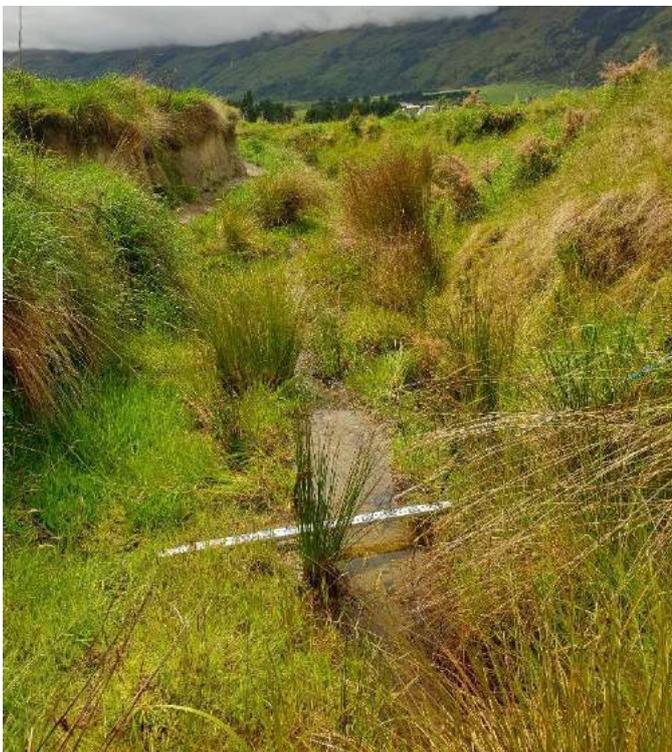
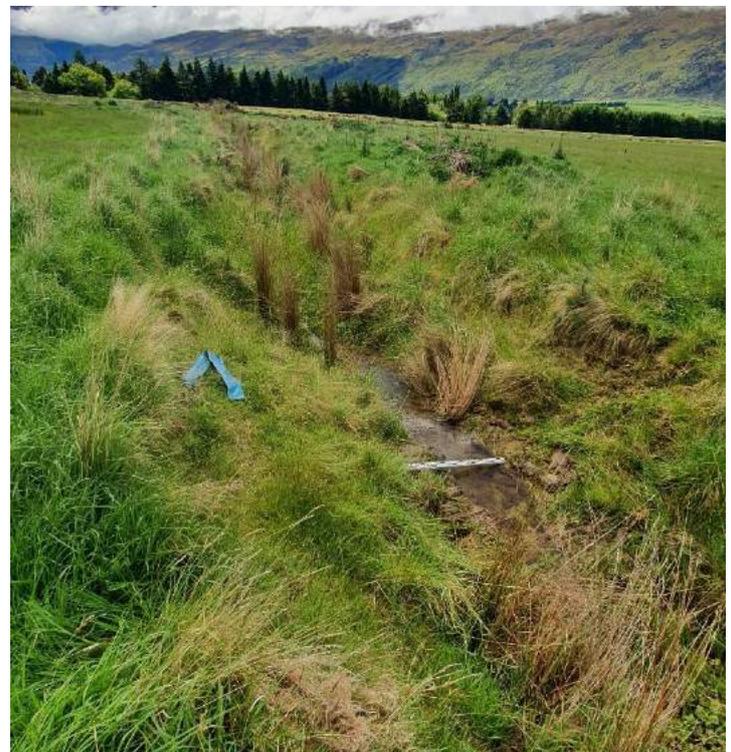
Figures 2 and 3 : From left downstream views of gaugings locations UT 1 and UT 2.

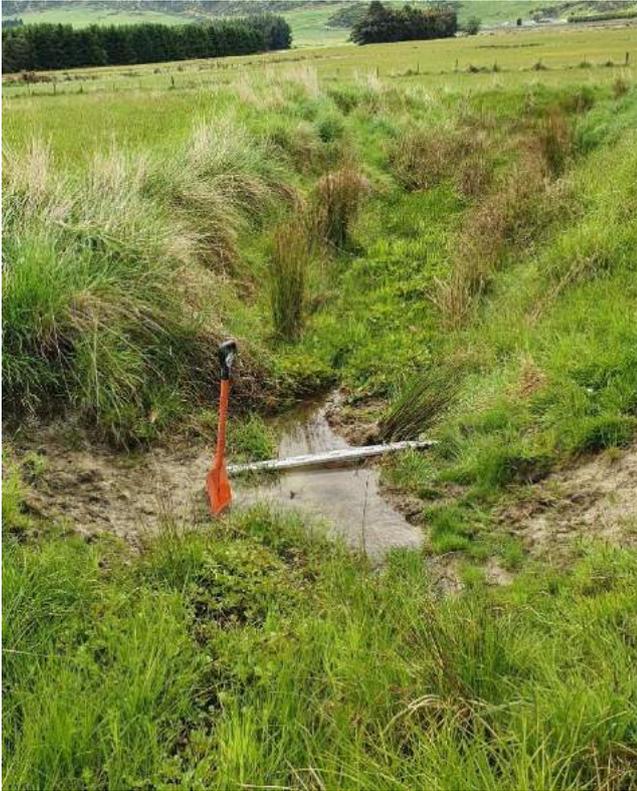
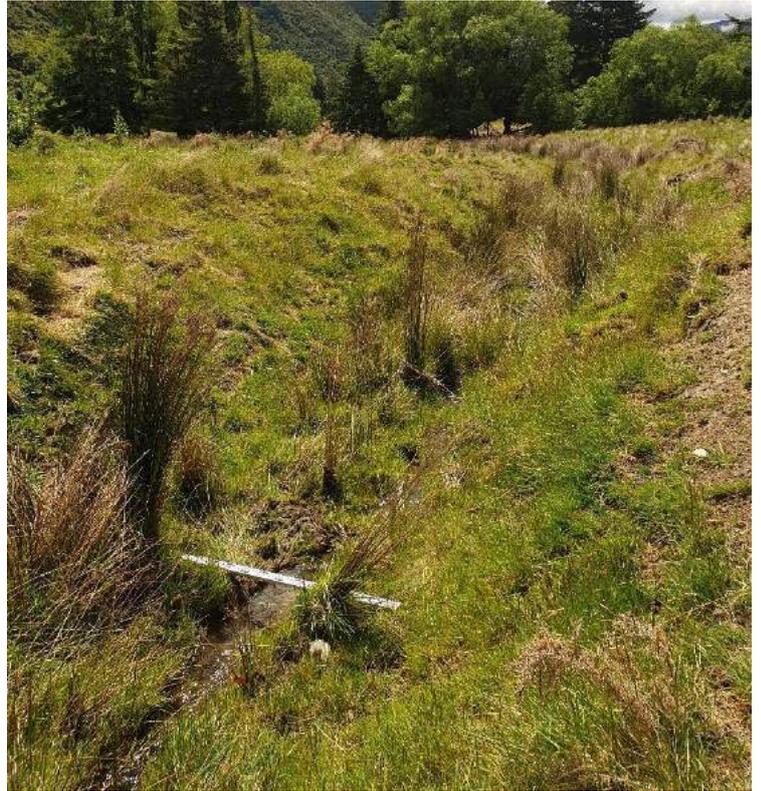
Figure 4 and 5 : From left downstream view of shifted gauging location for UT 3 (figure 4) and downstream view of gauging location for UT 4.

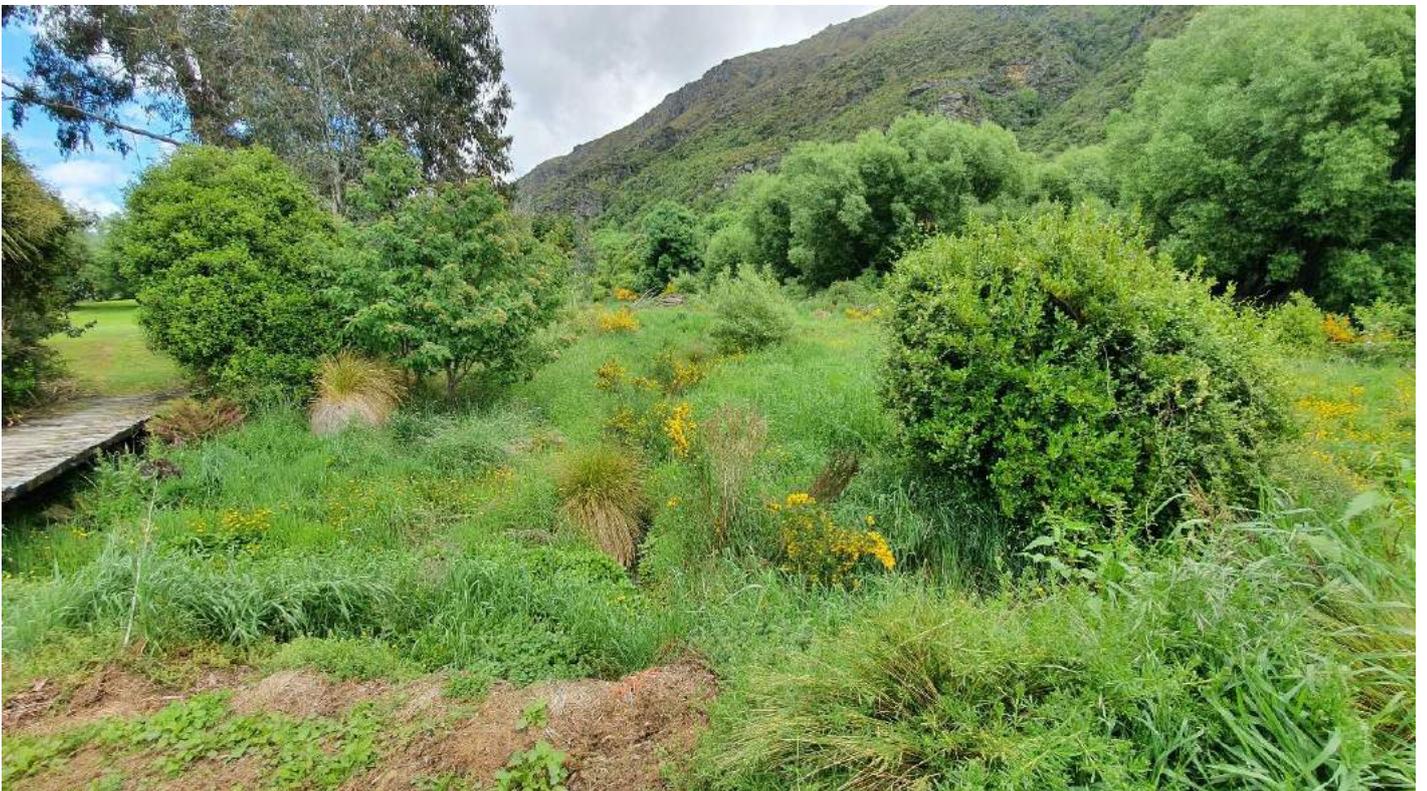
Figure 6 : Gauging section for UT 6 is in lower left corner of shot. Intersection of tribute channel and UT channel (under bridge) can be seen in centre of shot.

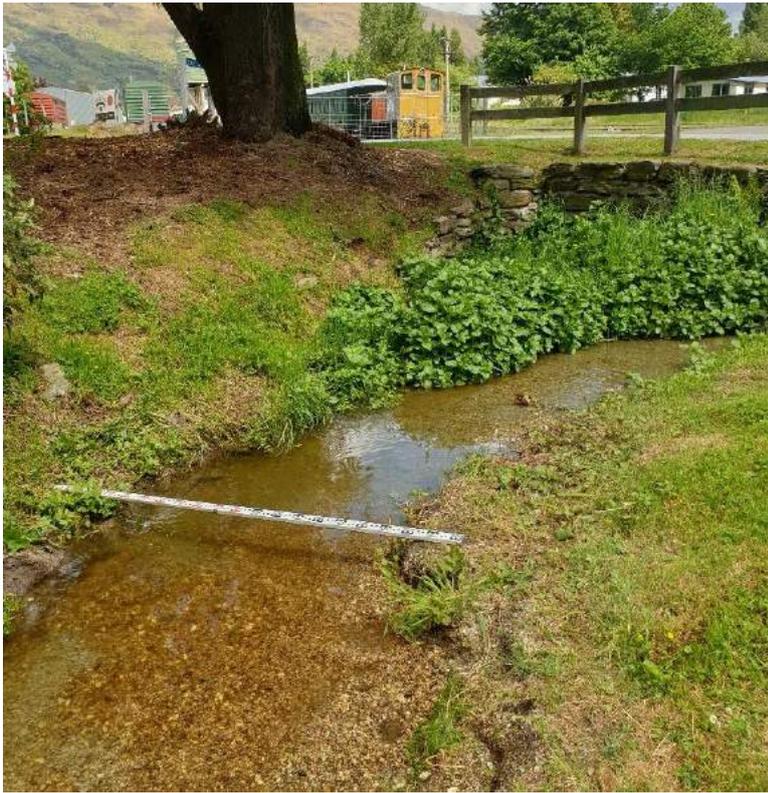
Figure 7: Gauging location for UT 8.

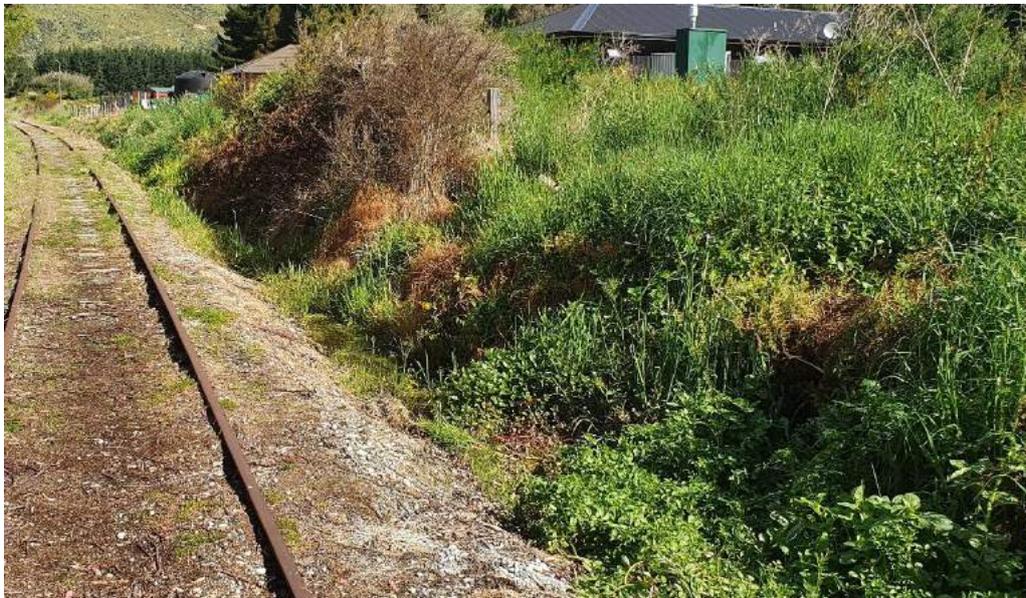
Figure 8: RD channel at RD 1.

Two locations (railway drain sites) could not be measured due to the nature of the weedy channel and no significant flow. An estimated flow was recorded by the NIWA technicians. A pipe draining water into the RD channel was observed roughly 5 metres below the RD 1 location. This pipe was draining at roughly 0.5 to 1.0 L/s.

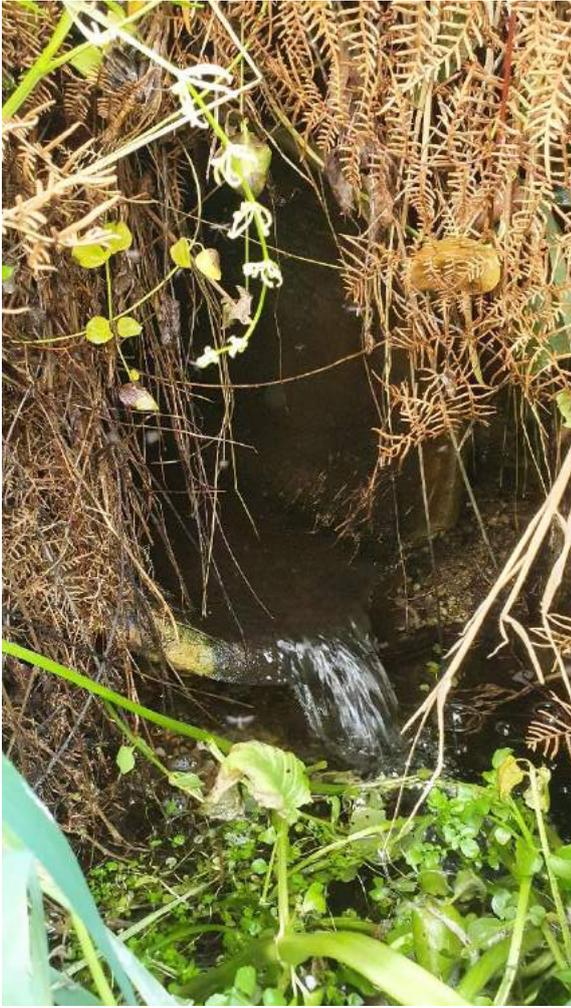
Figure 9: Pipe 5m below RD 1

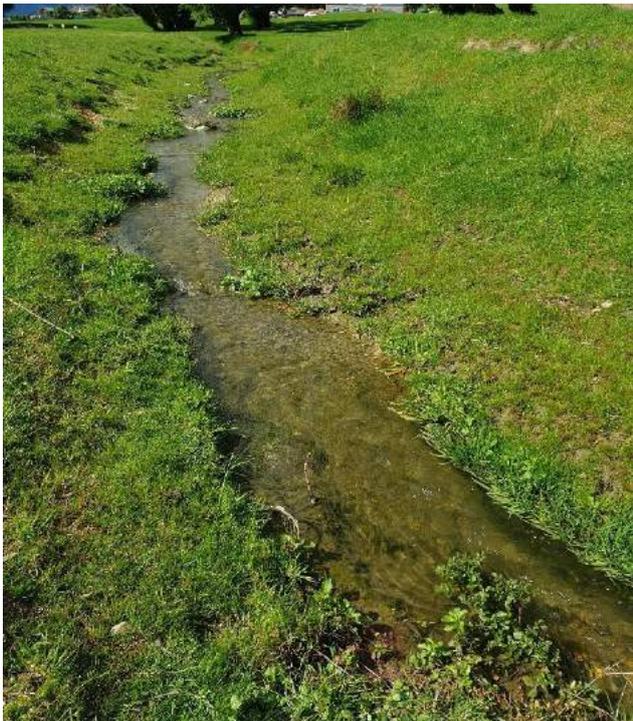
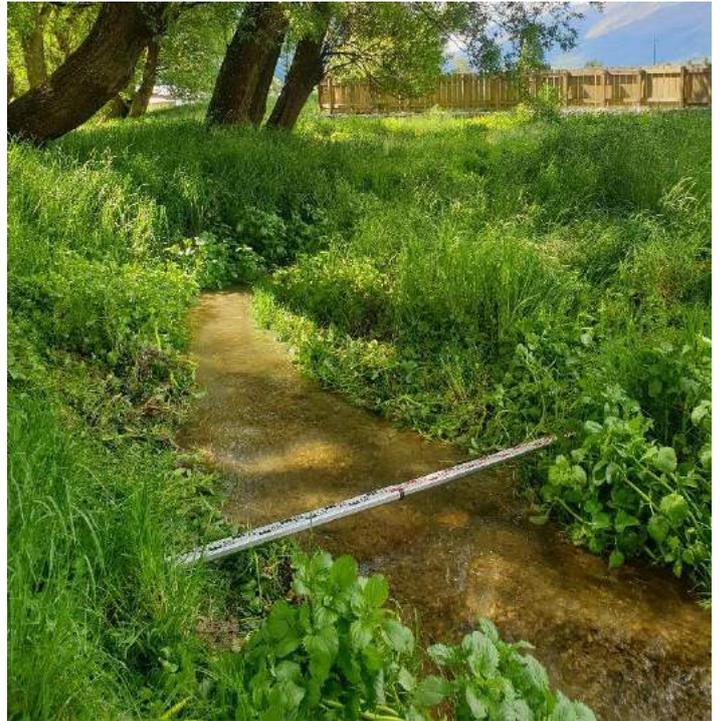
Figure 10 & 11: From left downstream views of gauging sections for KC 1 and KC 2.

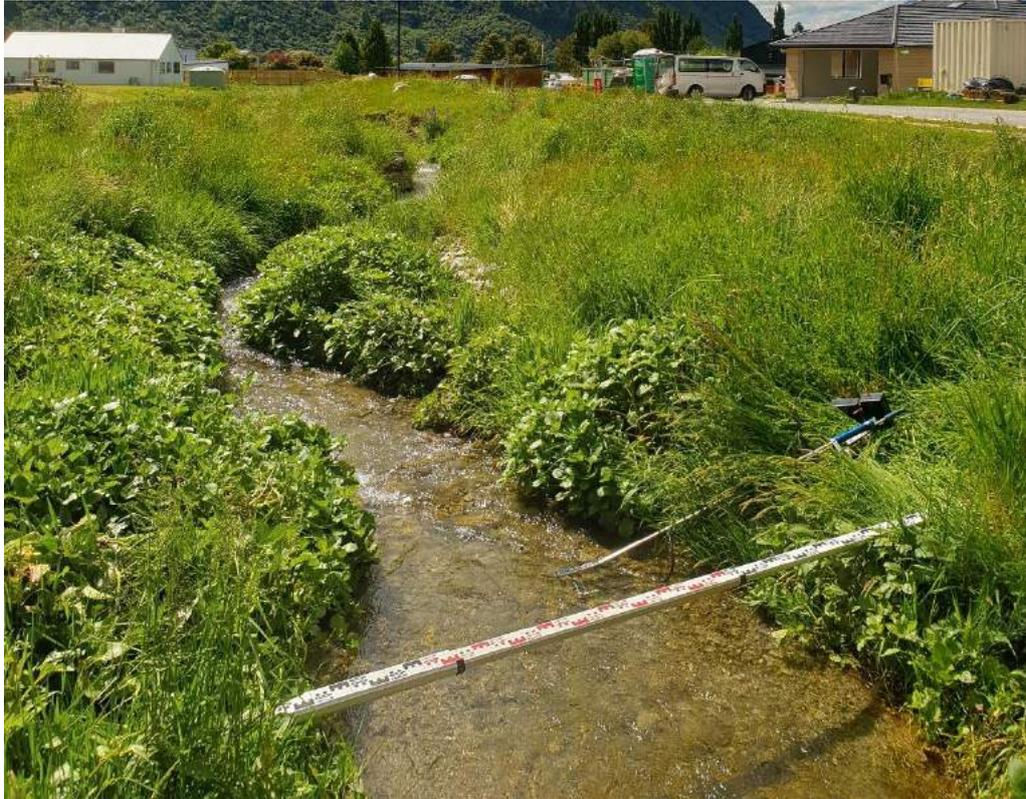
Figure 12: Downstream view of gauging section for KC 3.

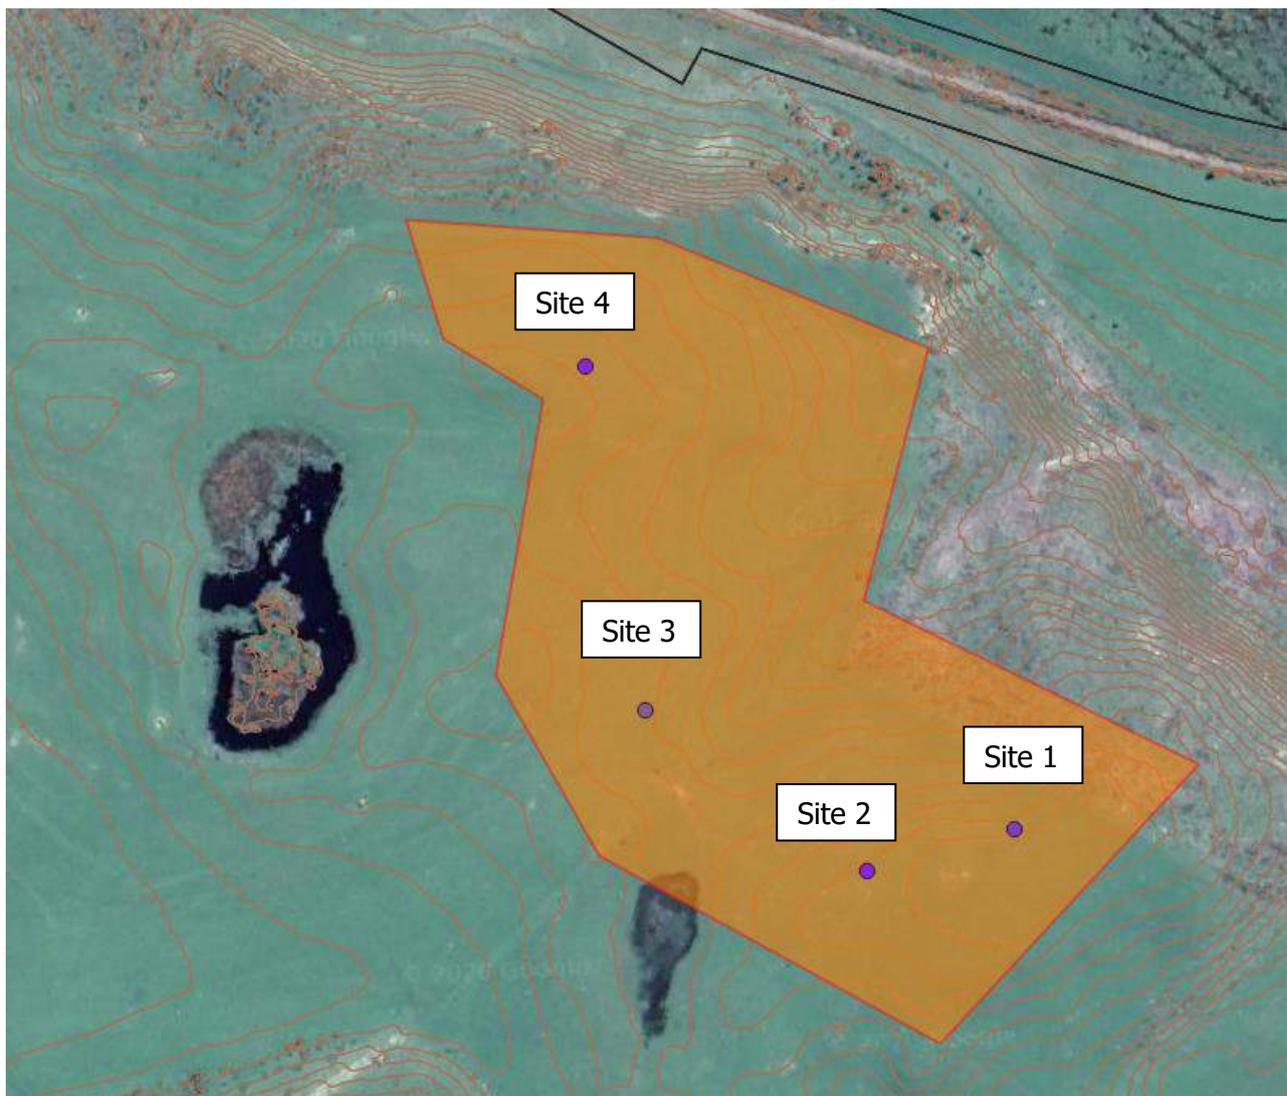
Figure 1: Location of Test Pits on Additional LTA Area.

Soil cores were taken from the topsoil at a depth of 0 – 100mm and from the subsoil at a depth of 150mm to 200mm at a similar depth to the hydraulic conductivity tests.

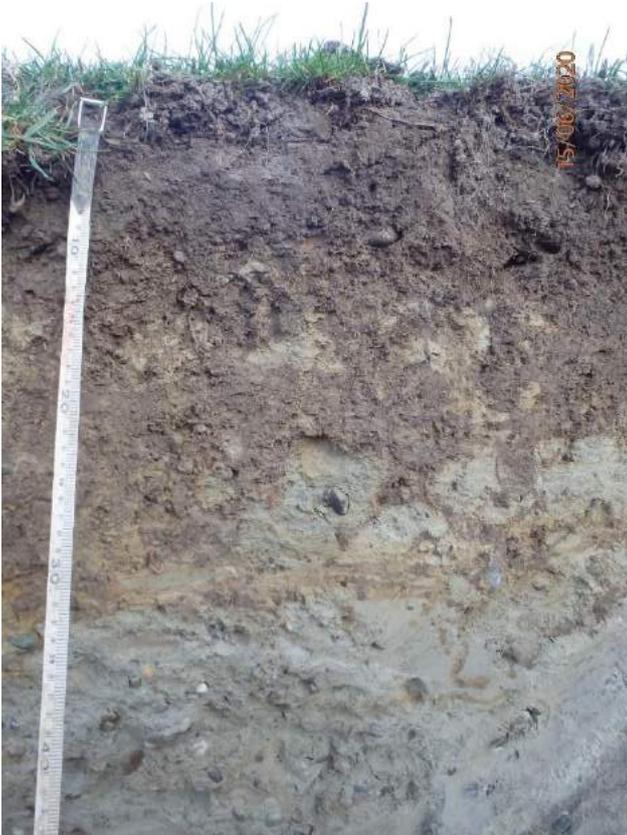
Site 1

SOIL PROFILE IMAGES

Depth B.G.L	Soil Symbol	Soil Description	Notes
0-30cm		Brown topsoil silty loam with some sands, damp, granular, crumb, no mottles, presence of fine roots Indistinct boundary	
30cm - 85cm		Orange brown silt with minor sands, compact, presence of small gravels, damp Indistinct boundary	Perched lines where water sits
85cm – 1.5m		Grey silt clay with minor fine sand, compact, dry, gravel (assorted sizes), no roots	Flat orange streaks through subsoil at 85cm -95cm depth
