Habitat Mapping of the Tokomairiro River Estuary

Otago Regional Council State of the Environment Report

Ryder Consulting

November 2009

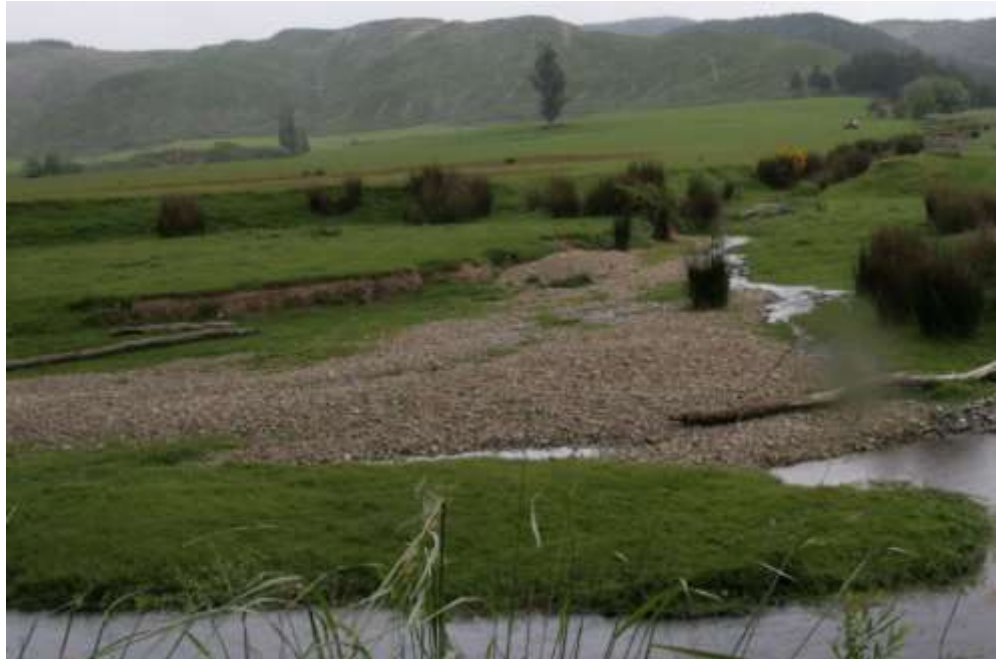
Figure 2a. *Erosion in a tributary along the true right bank of the Tokomairiro River Estuary.*

Erosion does not appear to be a major issue at the Tokomairiro River Estuary. There is evidence of relatively recent scouring of gravel in a tributary along the true right bank of the river (Figure 2) but this is not considered serious. The sand banks nearer the mouth may be more prone to erosion (Figure 2b). Flooding certainly occurs, as evidenced by debris left in fences some 1-2m above river level (Figure 3), with very large areas of low lying land likely to be inundated.

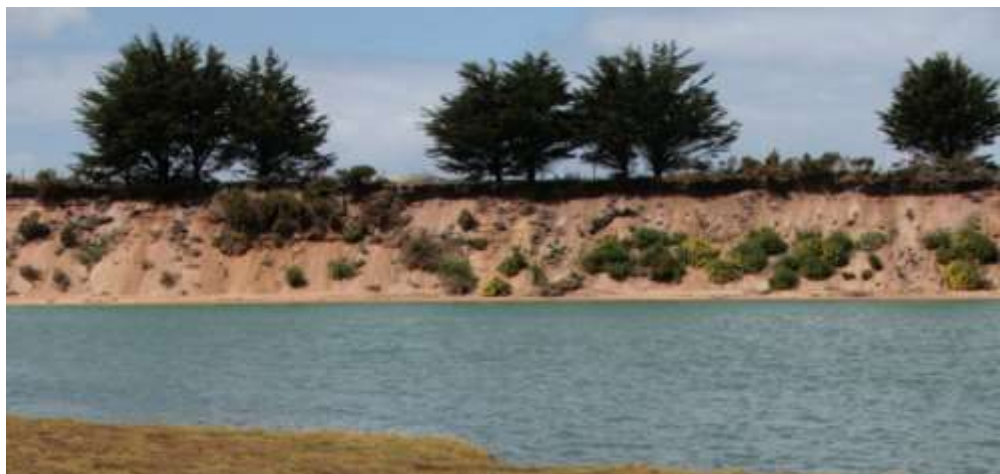
Figure 2b. *Erosion of sand banks along the true left bank of the Tokomairiro River Estuary near the mouth.*

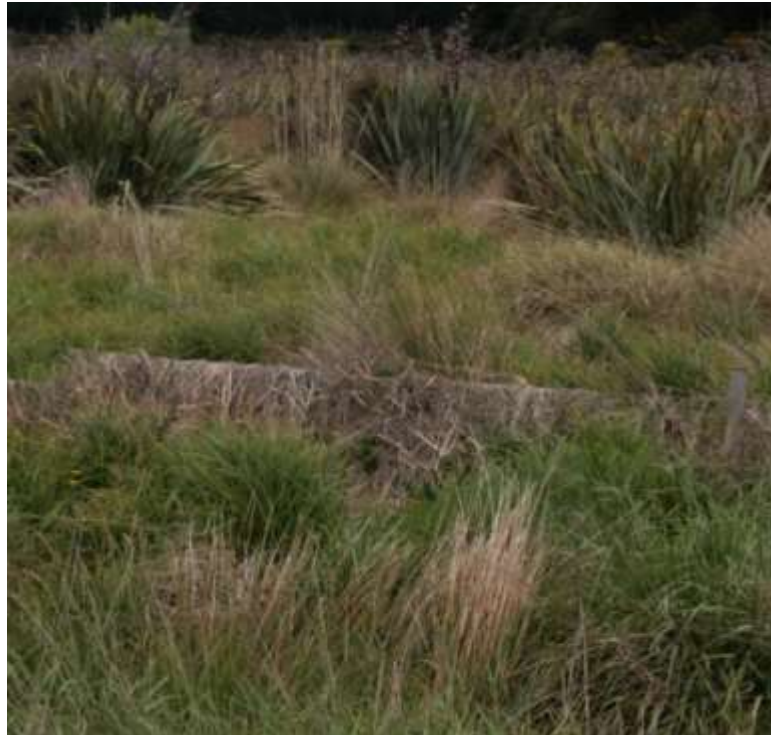
Figure 3. *Flood debris in a fenceline along the true right bank of the Tokomairiro River Estuary.*

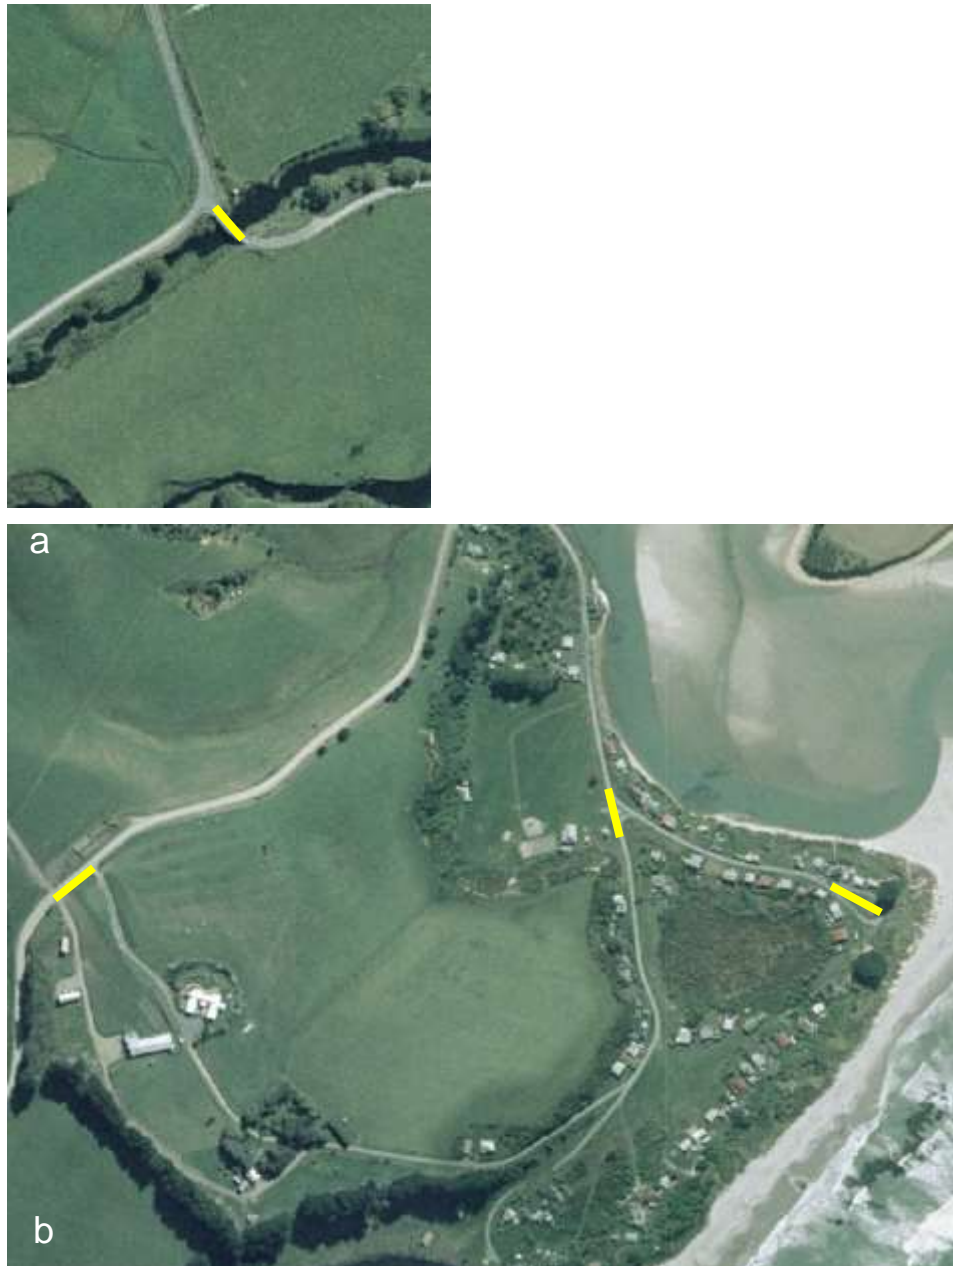
Figure 4. Tokomairiro River Estuary with ground truthing sites marked as yellow bars.

The Tokomairiro River Estuary was visited for the purpose of broad scale mapping on the 9th of November 2009 and again on 13th November 2009. Four prominent landmarks were located using aerial photographs (Figures 4a and 4b) and GPS readings taken at points either end of each landmark. The distance between points on each landmark was measured using a 100m tape, then compared with maps generated using aerial photographs and tfw files supplied by the ORC. Aerial photographs were ortho-rectified using MAPublisher® 6.2. All distances measured on photographs corresponded with ground truth measurements to within 2m.

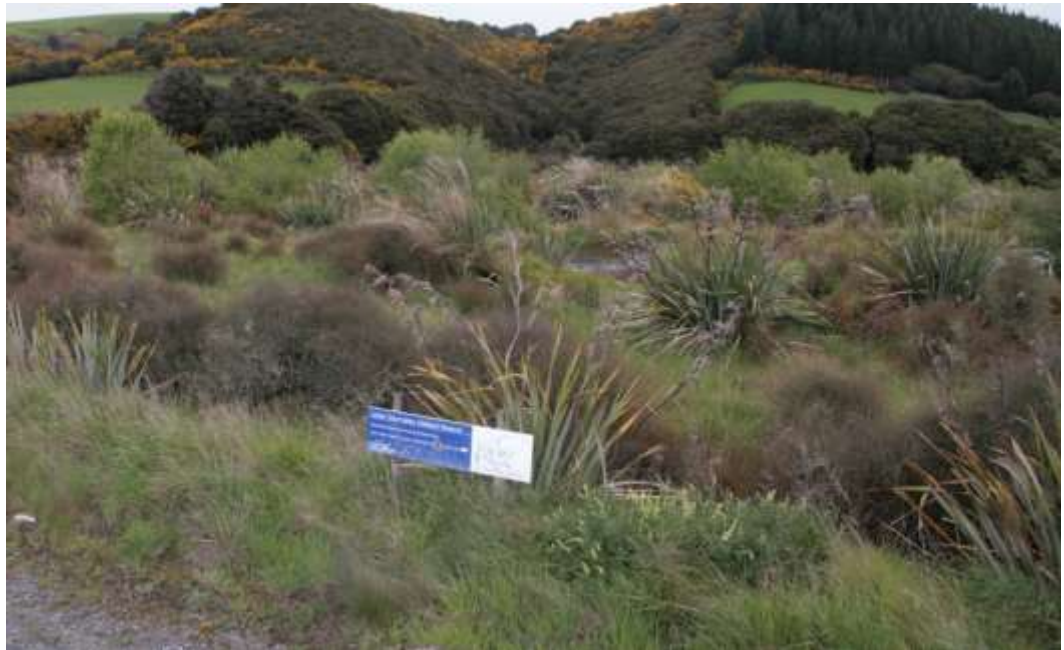
Figure 6. Lower Tokomairiro Wetland Reserve, true right bank, Tokomairiro River Estuary.

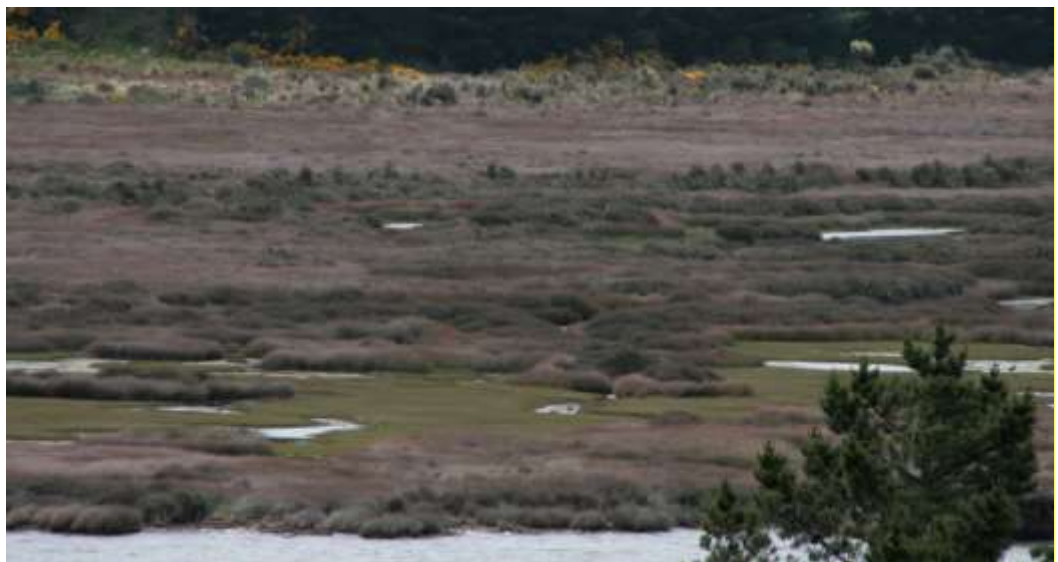
Figure 7. Extensive areas of rushland and herbfield on the true left bank, lower Tokomairiro River Estuary.

However, most of these tracts on both the true left bank and true right banks can be described as flood plain and, although currently used for grazing, may become inundated at times of high flood. A small portion of this floodplain has been set aside as a wetland reserve (Figure 6) and a large proportion of previously drained land appears to have been allowed to revert to its natural state (Figure 7).

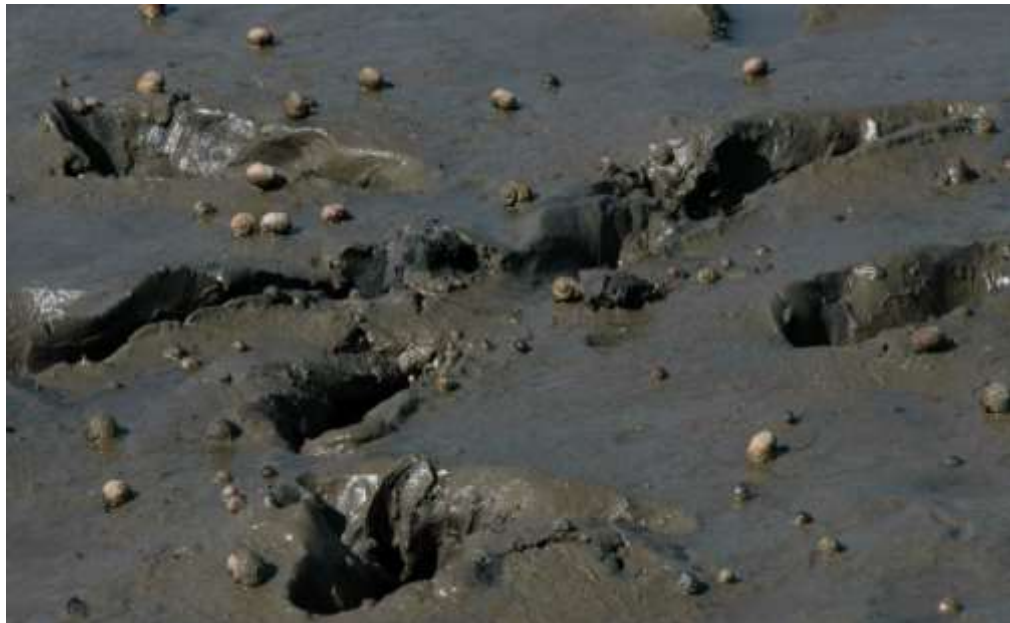
Figure 8. Soft muddy sand with a sprinkling of *Amphibola crenata* at Site 1, Tokomairiro River Estuary.

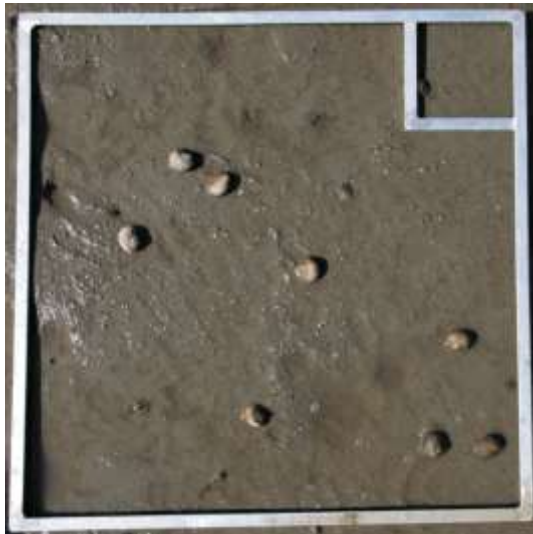
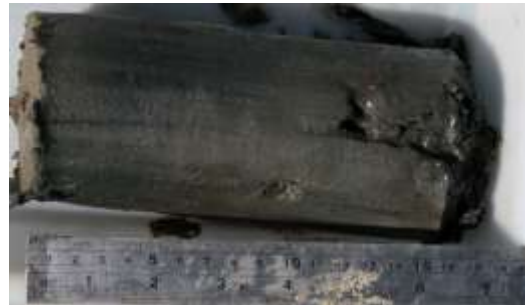
Quadrat 1

Tokomairiro River Estuary Site 1 (Upstream)

Photographs of sediment cores are presented in Appendix 1. The upstream site (Site 1) comprised predominantly soft sand and mud with a fine gravel component and abundant decaying fibrous organic material. A redox discontinuity layer (RDL) appeared in many of the cores (Table 4) and varied in nature from a deep but relatively diffuse layer to a very intensely discoloured upper layer. A very mild smell of hydrogen sulphide associated with each core was detectable at Site 1 but not at Site 2.

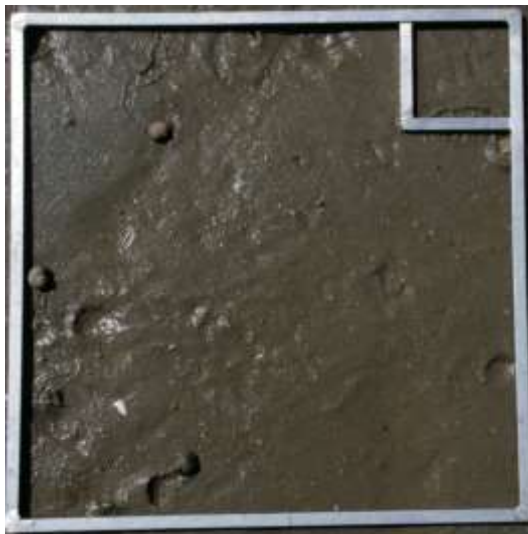
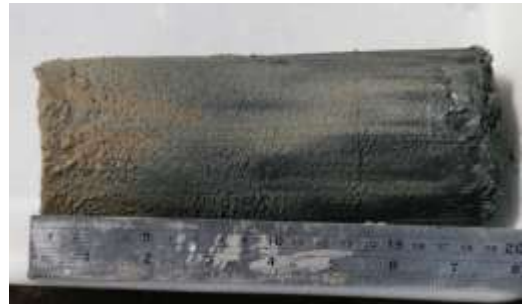
Quadrat 1

**Tokomairiro River Estuary
Site 2 (Downstream)**

Site 2 (downstream) had a substrate surface characterised by fairly uniform fine sand and the very occasional broken shell fragment and very small pebble. There was
