Habitat Mapping of the Taieri River Estuary

Otago Regional Council State of the Environment Report

Ryder Consulting

April 2008

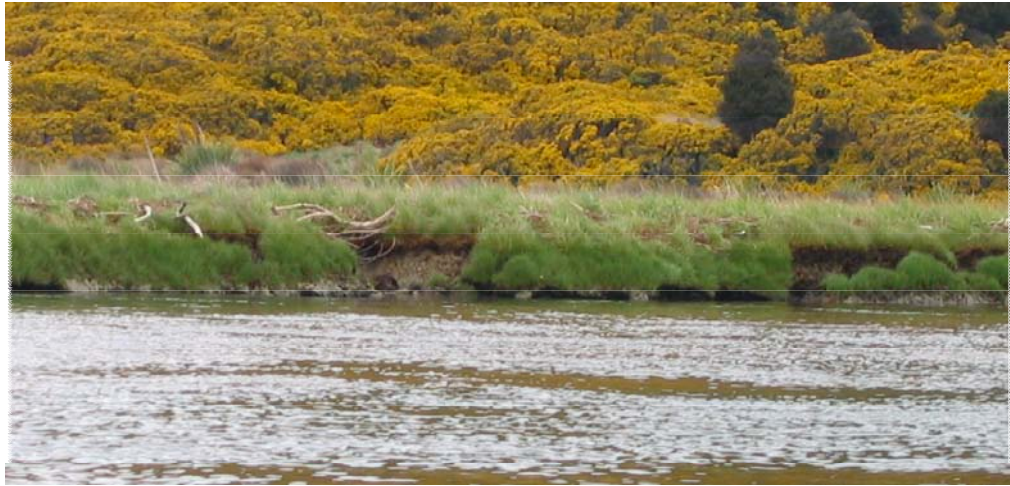
Within the estuary there were a few places at the upstream end of the gorge that showed signs of relatively recent, and reasonably heavy, erosion (Figure 2). This may be due to the very high flows experienced on 1 August 2007 as the erosion is generally confined to the main channel. Although scoring just a C3 in the level of concern matrix above

(Table 2) due to the relatively small area affected, we believe this issue is of some concern.

Figure 2. *Evidence of relatively recent erosion along the main channel, Taieri River Estuary.*

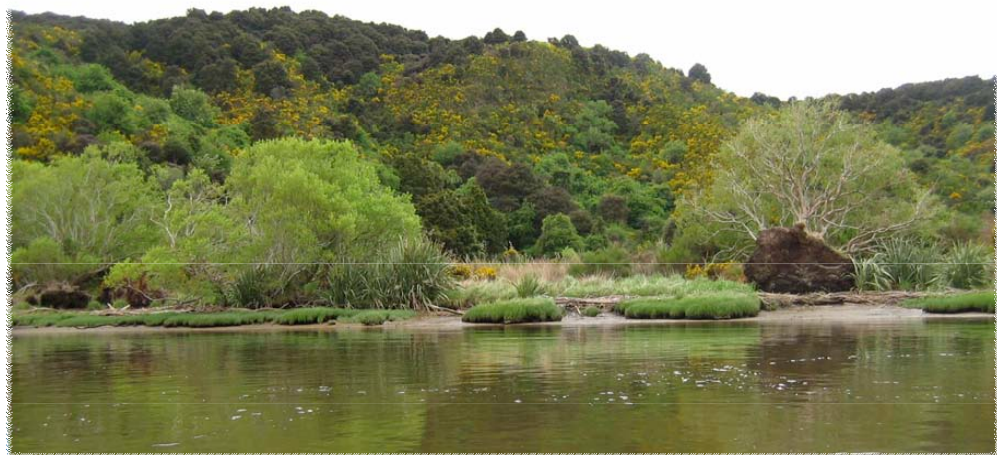
Although likely not attributable to erosion, we did observe wind damage that will have occurred during the high winds of late October 2007 (Figure 3).

Figure 3. *Wind damage, Taieri River Estuary.*

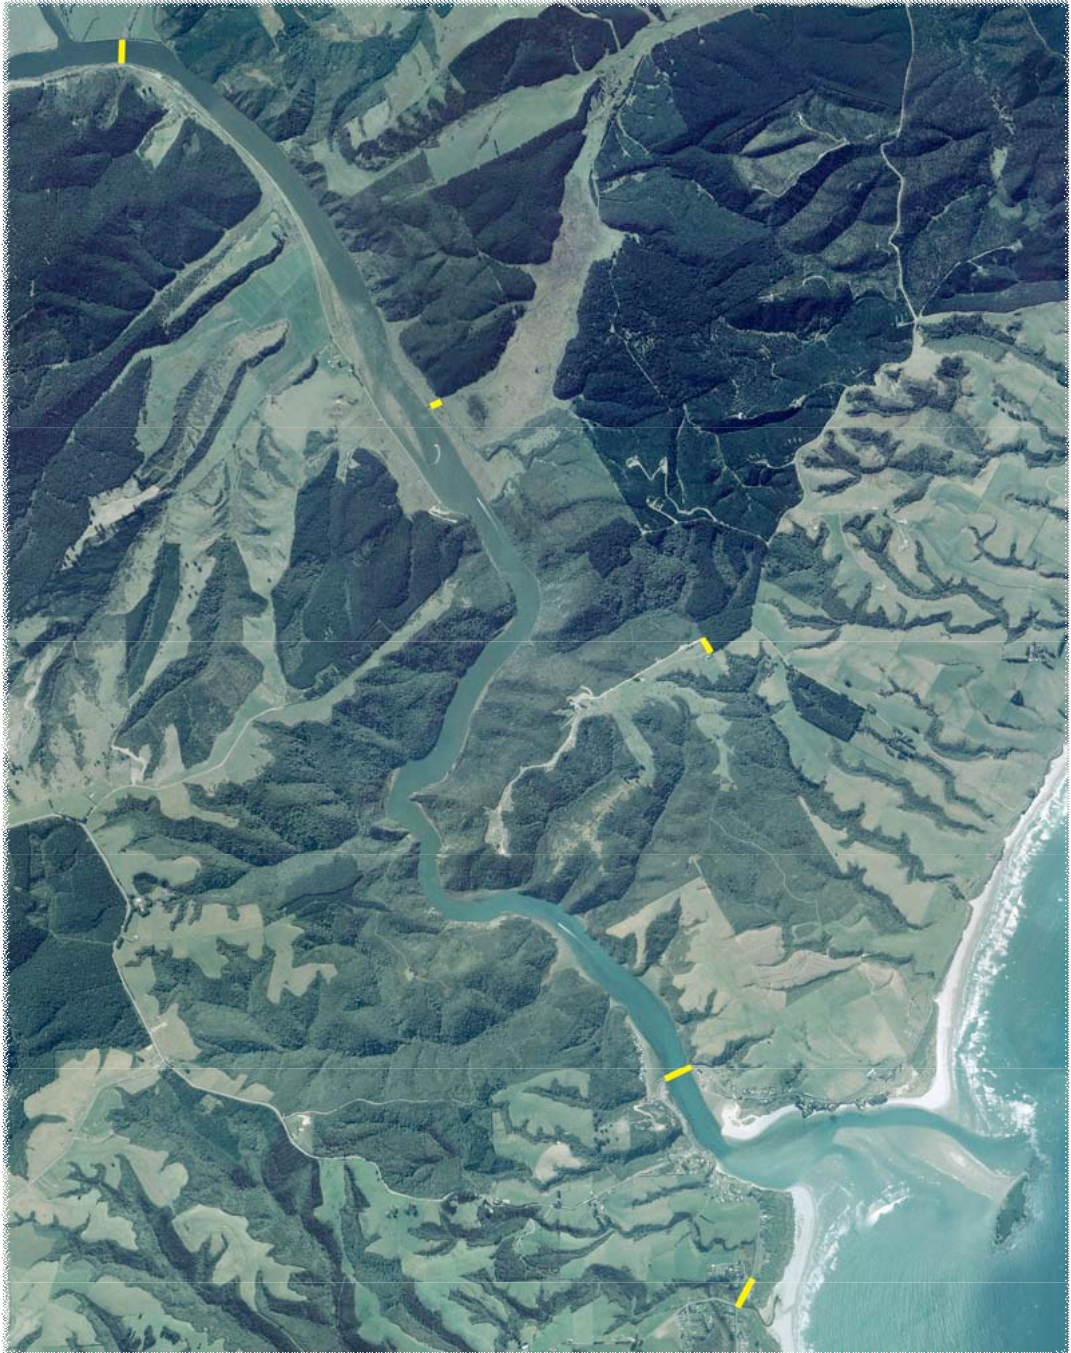
The Taieri River Estuary was visited for the purpose of broad scale mapping on 31 October 2007. Five prominent landmarks were located using aerial photographs (Figure 4) and GPS readings taken at points either end of each landmark. The distance between points on each landmark was measured using a 100m tape, then compared with maps generated using aerial photographs and tfw files supplied by the ORC. Aerial photographs were ortho-rectified using MAPublisher® 6.2. All distances measured on photographs corresponded with ground truth measurements to within 2m.

Figure 4. Taieri River estuary with ground truthing sites shown as yellow bars.

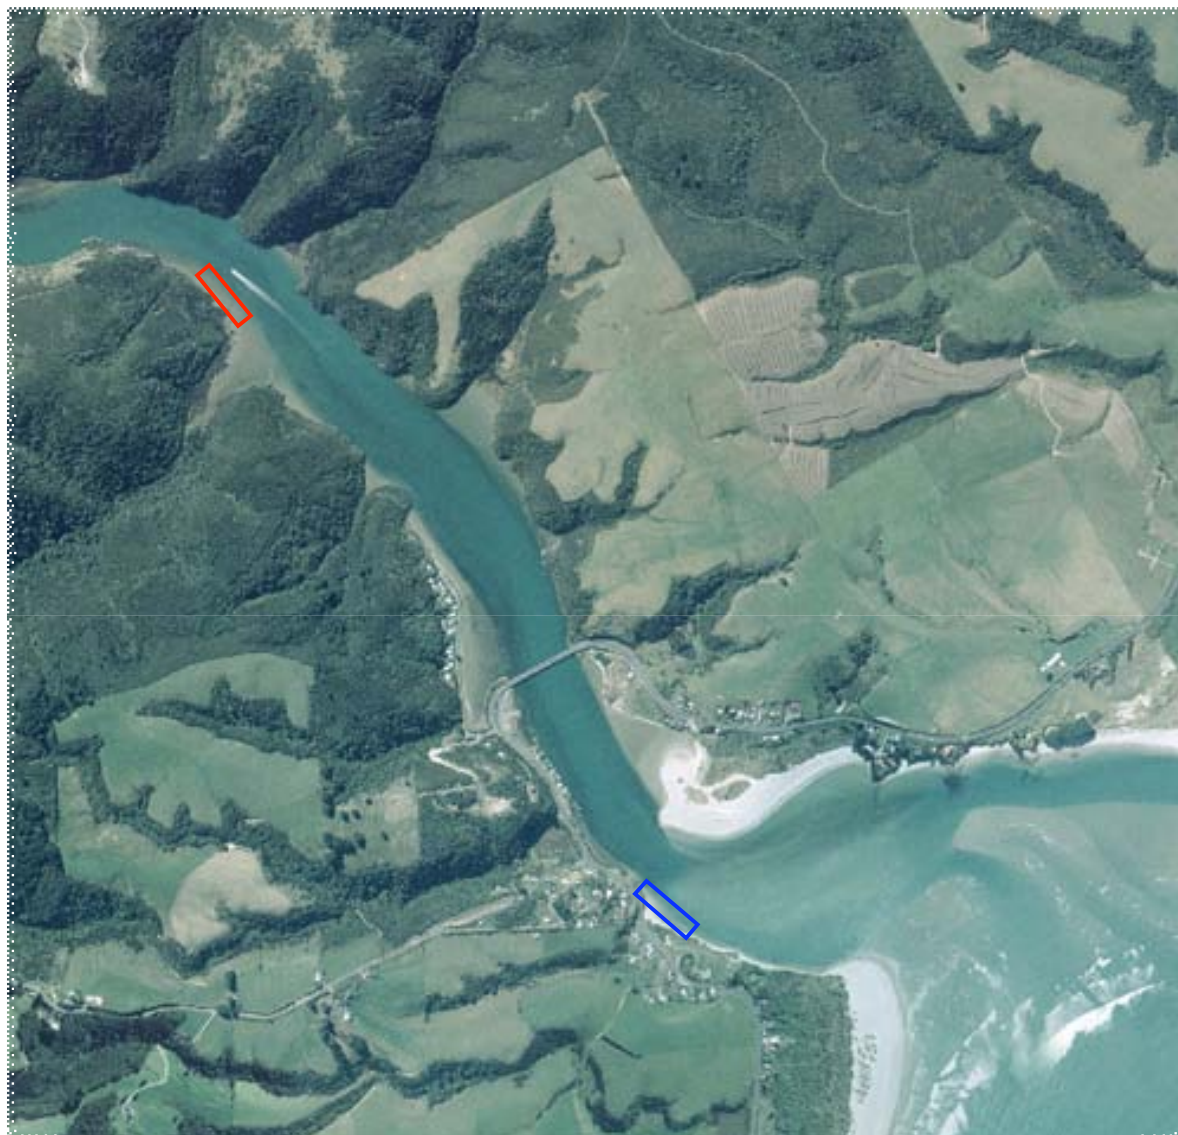
The Taieri River Estuary was visited on 31 October and 1 November, 2007. Two sites (Figure 6), selected during the broad scale mapping, were sampled according to the methodology described above. Both sites were located on low tidal sand flats, representative of much of the greater estuarine area.

Figure 6. Taieri River Estuary with locations of Downstream (blue) and Upstream (red) fine scale mapping sites shown.
