Preliminary Site Investigation

**1484 Teviot Road
Millers Flat**

**for
Hawkeswood Civil Limited**

June 2022

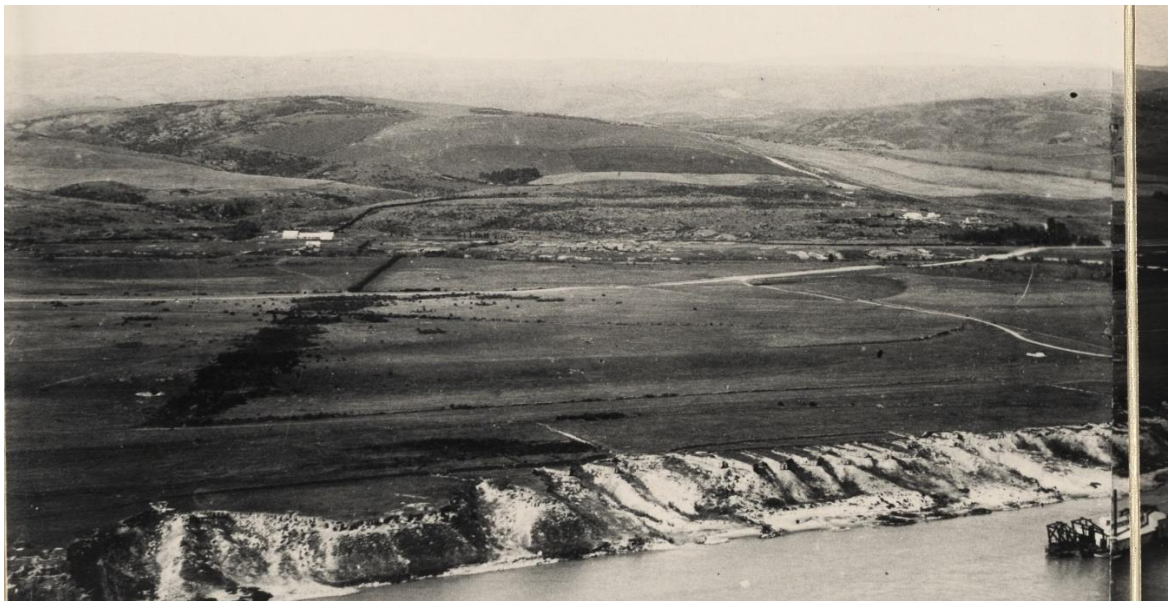
Figure 3: The property located in the centre of the image, and its surrounds in 1903 (Source Hocken Collections, Uare Taoka o Hākena, University of Otago; Title: CLUTHA RIVER - Goldmining Dredging c1903 (left) from near Ettrick to (right) Miller's Flat [Part 3 of 4 part panorama]).

The earliest image of the property, in Figure 3, shows the site in 1903. At this date the site is in pasture. This image is one of a four-part panorama with the adjacent photo (not shown) showing gold dredging of the gravel deposits adjacent to the Clutha River occurring to the northwest of the property.

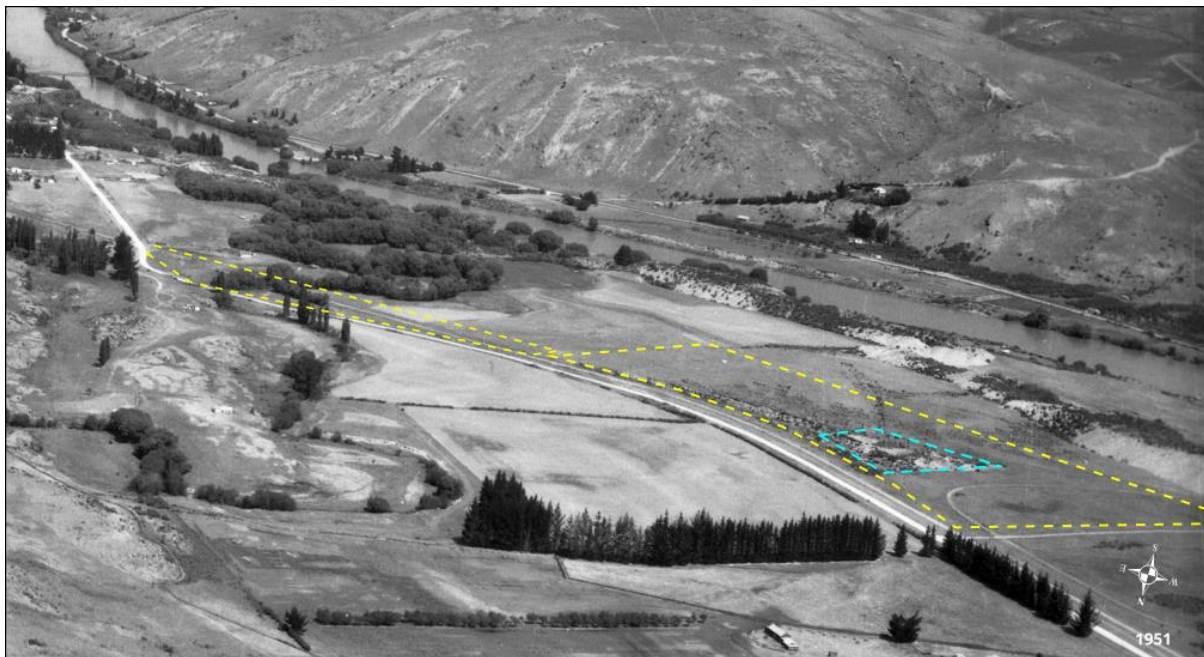
Figure 4: The property in 1951, with the approximate property boundary outlined in yellow and the HAIL site outlined in turquoise (V.C. Browne and Son NZ Aerial Photograph Collection).

Gravel was quarried from within the site during construction of the railway with the gravel quarry forming a long trench adjacent to the north-eastern site boundary. This long, curved trench has the appearance of an access road that terminated in a quarried area extending roughly three quarters of the way across the site. The quarry and trench are visible in the image in Figure 4 showing the site in 1951. In this image the majority of the site remains bare of distinctive features and the disused quarry appears undisturbed from the earlier image in 1944 (not shown) with no evidence of landfilling or vehicle access being evident. The railway is present along the road boundary of the property.

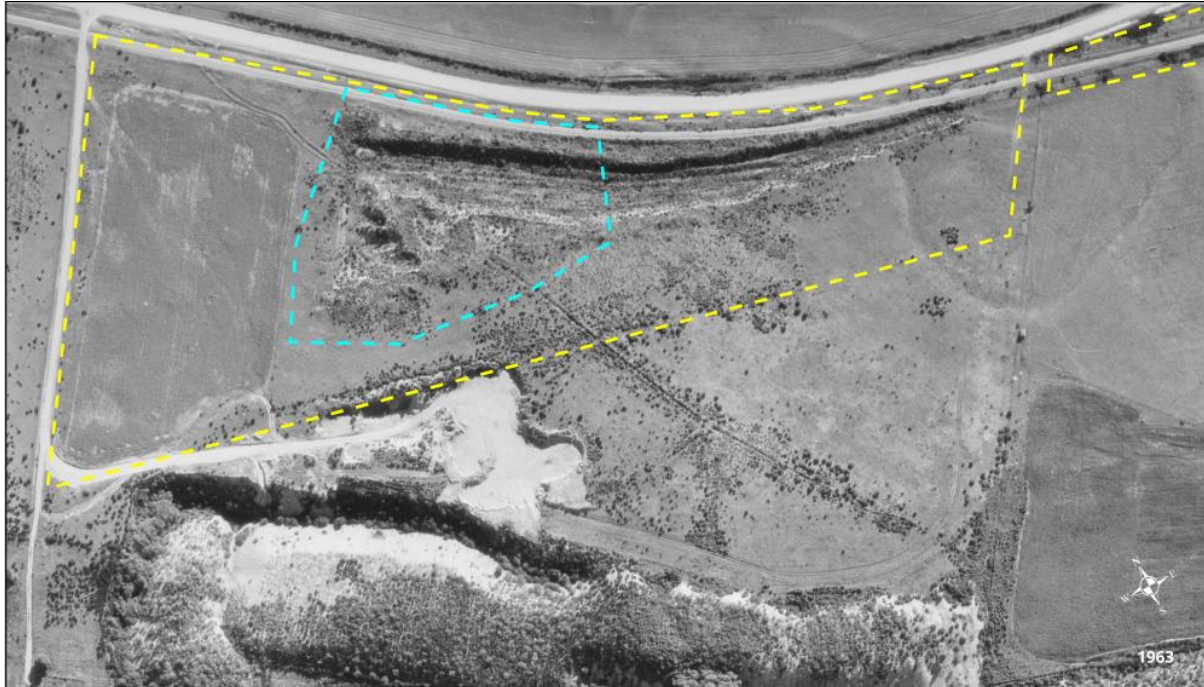
Figure 5: The site in 1963, with the HAIL site boundary outlined in turquoise and the property outlined in yellow (Sourced from <http://retrolens.nz> and licensed by LINZ CC-BY 3.0).

The image from 1963 (Figure 5) shows the site and the HAIL site in considerable detail. There is no evidence of significant landfilling at this date. A substantial gravel pit has been excavated adjacent to (outside of) the site southwestern boundary.

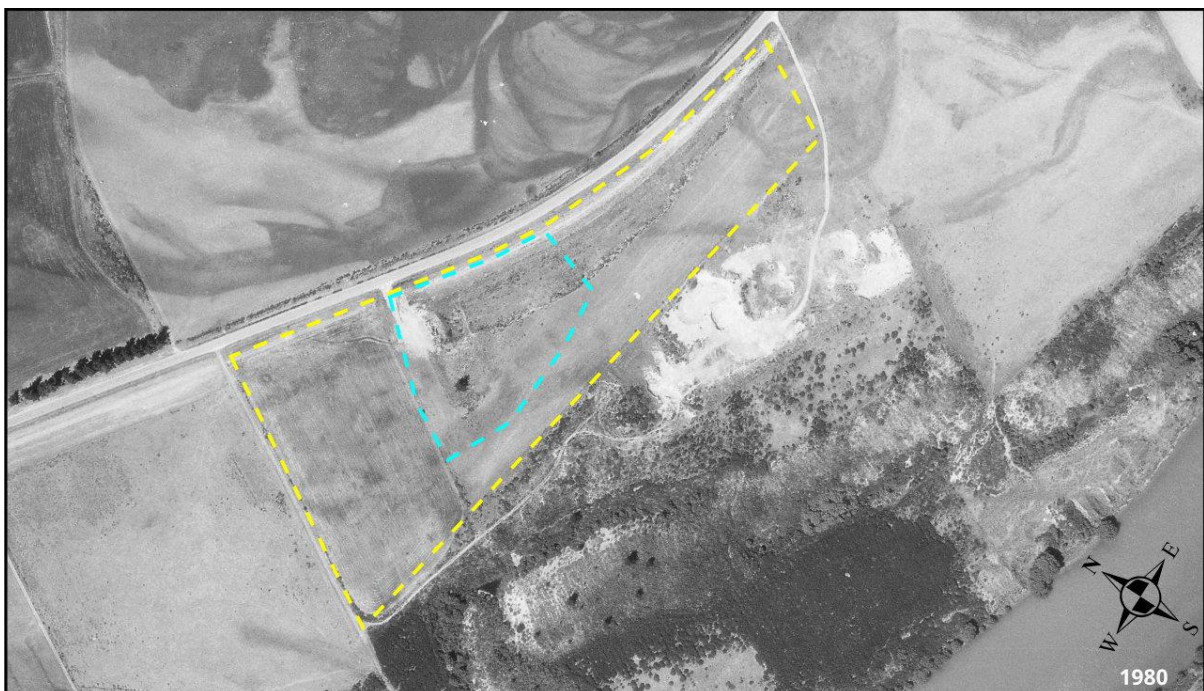
Figure 6: The site in 1980, with the HAIL site boundary outlined in turquoise. The landfilling activity is clearly present at this date with a short access track from Teviot Road. The western part of the gravel quarry appears to have been filled (Sourced from <http://retrolens.nz> and licensed by LINZ CC-BY 3.0).

The next image of the site from 1980 in Figure 6 shows active landfilling occurring at the head of the former quarry closer to Teviot Road with the western part of the quarry already filled and covered over. The landfill area is served by a short access track. The railway formation remains present but appears less well defined. A further image from 1983 (not shown) show no change within the site from the 1980 image.

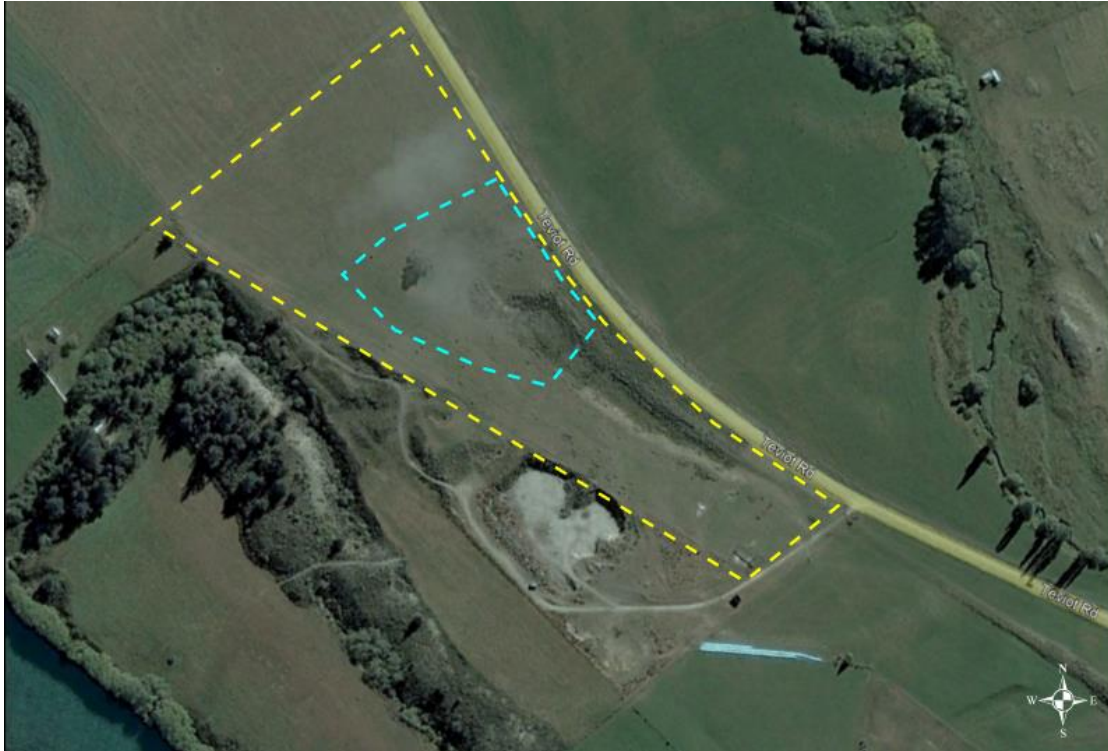
Figure 7: The site in 2005, outlined in yellow and the landfill site outlined in turquoise. The landfilling activity evident in the image from 1980 is no longer occurring and the landfill access road has been removed. The parts of the former gravel quarry not used for landfilling remain otherwise unchanged (Image @ 2022 Maxar Technologies, Google Earth).

There is an interval of 22 years between the 1983 image and the first Google Earth Image of the site from 2005 shown in Figure 7. By this date the landfill area is no longer in use and appears to have been covered over and the railway formation is no longer visible. The entire head of the quarry has been filled and all that remains of the old quarry appears as a long narrow pit adjacent to the road boundary of the site. This remnant part of the quarry otherwise appears largely unchanged from the earliest image. By 2011 (Figure 8) the pit appears to have been "recontoured". The reshaping

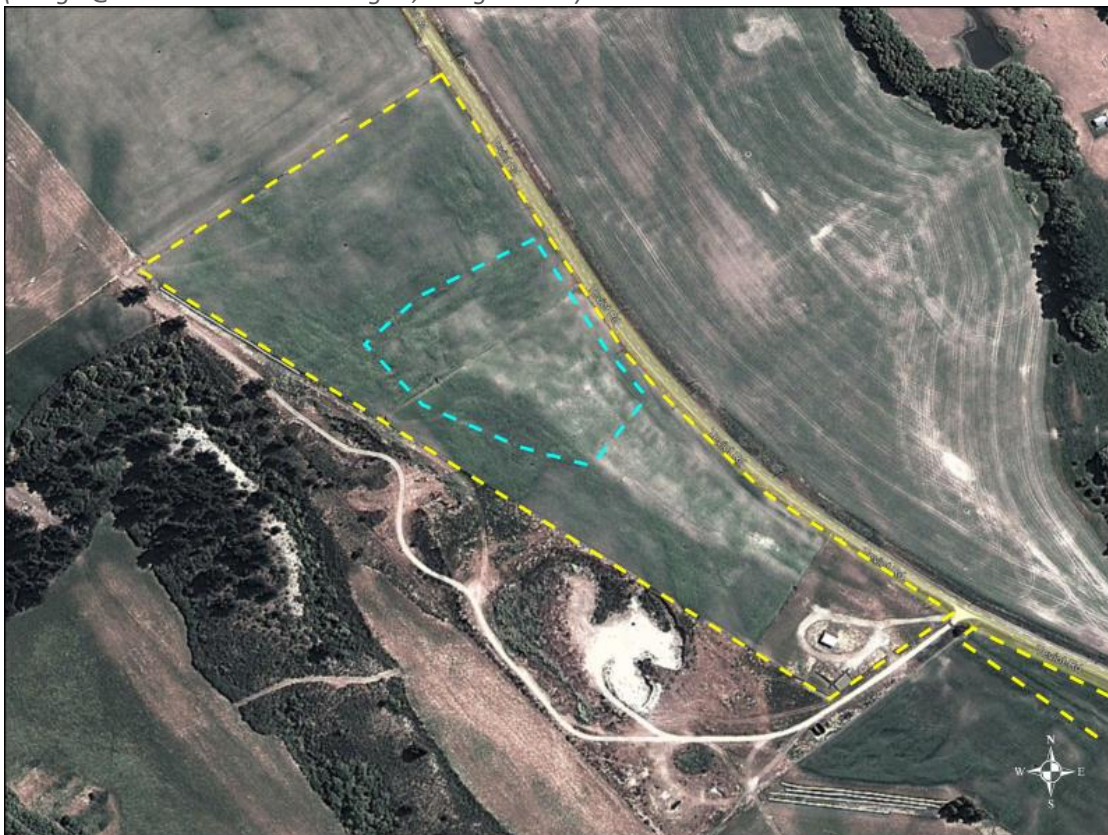
Figure 8: The site in 2011 showing the area formerly occupied by the quarry has been recontoured to remove the abrupt edges to the pit and to raise the lower parts such that the feature now forms a gentle swale in the paddock (Image @ 2022 Maxar Technologies, Google Earth).

appears to have involved trimming and shaping the upper edges of the pit with the material derived from that being placed in the bottom of the pit as the contour of the pit reduced to a broad swale enabling the land to be integrated into the irrigated cropping regime presently occurring on the site. At present the site appears unchanged from the 2011 image.

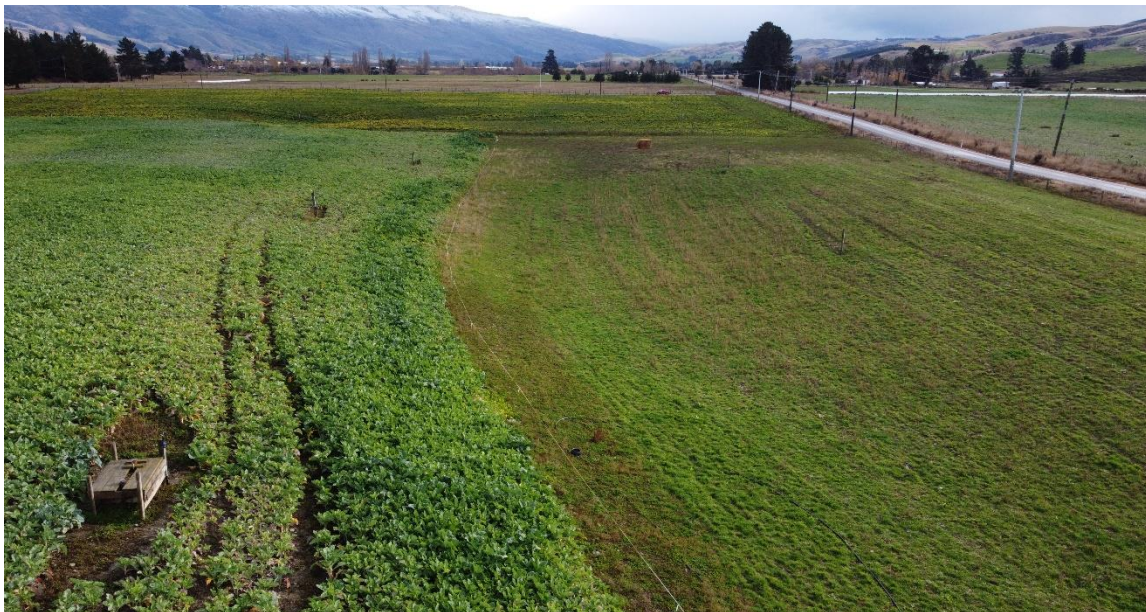
The HAIL site is shown in Figure 10. The landfill occupies the lower lying parts of the land in the central and more distant parts of the land shown in this image. The landfill monitoring bore G43/0112 is visible in the foreground at lower left in the image. A farm fence crosses the HAIL site and irrigation sprinklers on pipe upstands are spread across the site in lines parallel with the Teviot Road boundary.

Figure 10: The site looking north with landfill area occupying the area from the depression at upper left of image to Teviot Road at right. The ground water monitoring bore is within the wooden structure at lower left (20 May 2022).

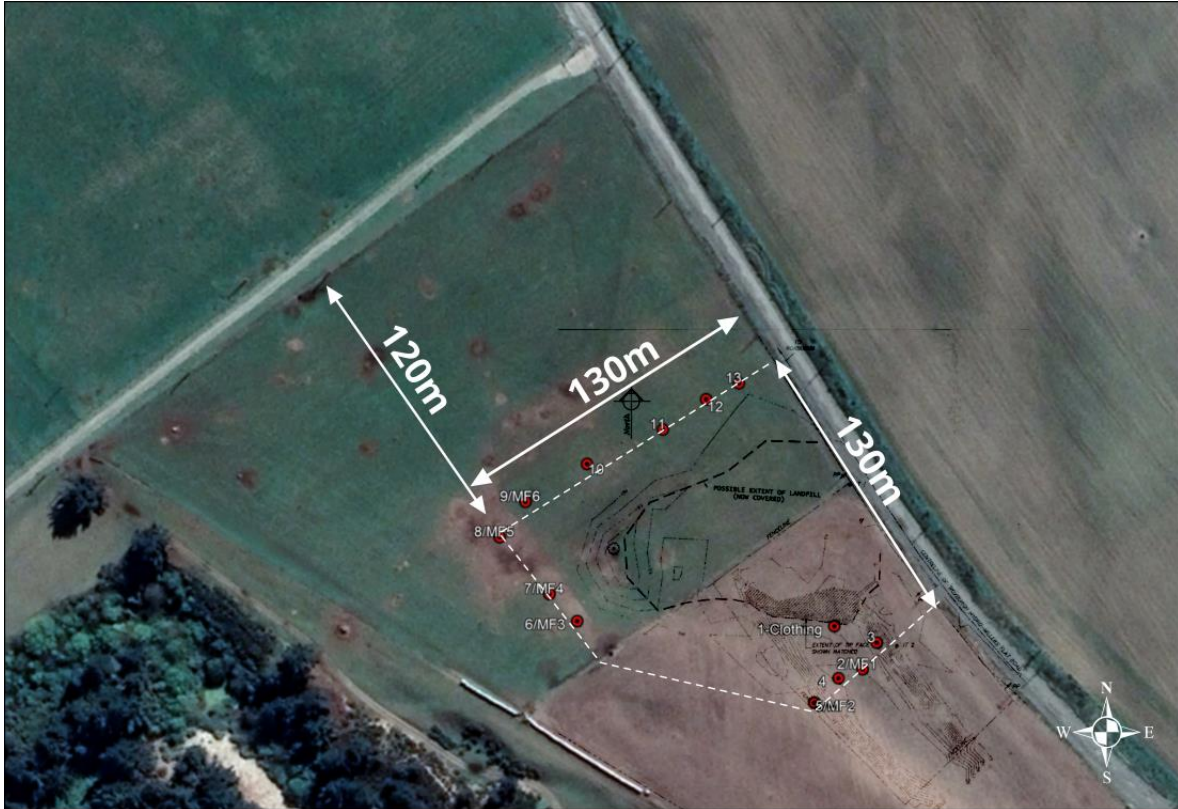
The approximate landfill extent was established by measuring distances on Google Earth from fence lines and roads that were present when the landfill was in operation and that remain on site now. The perimeter has been based on establishing a minimum of 10 m separation between the landfill as indicated by the maximum extent of the gravel quarry in the 1963 aerial view in Figure 5 and recent Google Earth imagery with the fill area as shown in the closure plan overlaid as a guide (Figure 12). The boundaries forming the approximated perimeter were located in the field using a hand-held GPS unit with an accuracy to 2-5 m. Thirteen holes were augered to a depth of 2.5 metres along the identified perimeter as shown in Figure 11, to confirm that undisturbed ground was present at each location and that no visible or olfactory evidence of landfilling was observed. The site plan contained within the Landfill Closure plan showing the full extent of the landfill is overlain on this image so that the relationship with the sampling points to the surveyed location of the landfill can be seen. The location of the auger holes were recorded with a handheld Garmin InReach GPS with an accuracy of 2-5 m.

Figure 11: Location and dimensions of the HAIL site as measured on 2020 Google Earth imagery and with landfill extent as documented in the CODC Landfill Closure Plan overlaid with auger holes as recorded with handheld GPS (Image © 2022 CNES/Airbus, Google Earth).

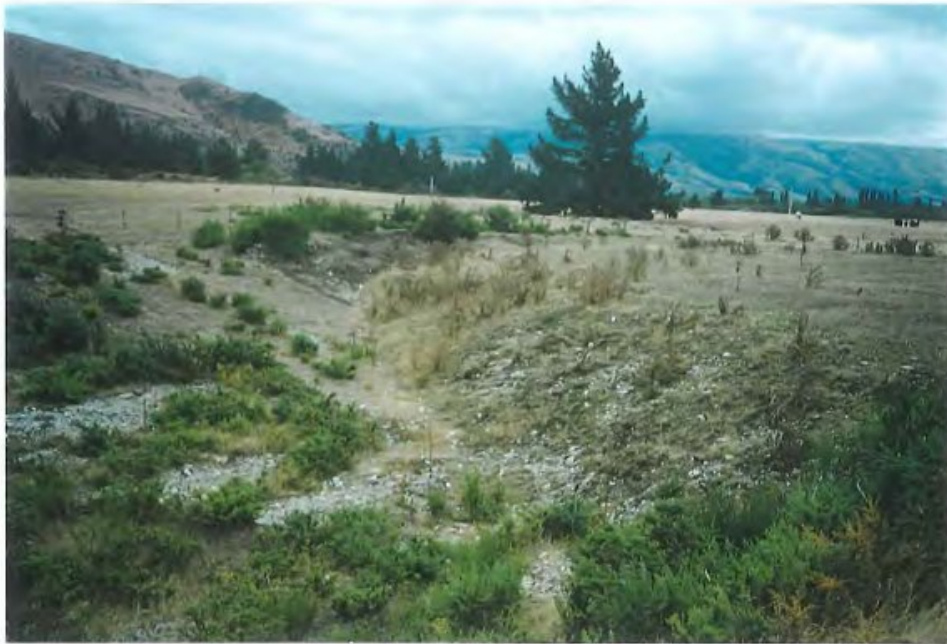
Millers Flat Closed Landfill – After Covering

This landfill was closed and covered in June 1997. It now has pasture established on it.
