Tima Burn Aquatic Ecology Assessment

Report prepared for: Hawkeswood
Mining

Date: September 2023

Report Number:34-2023

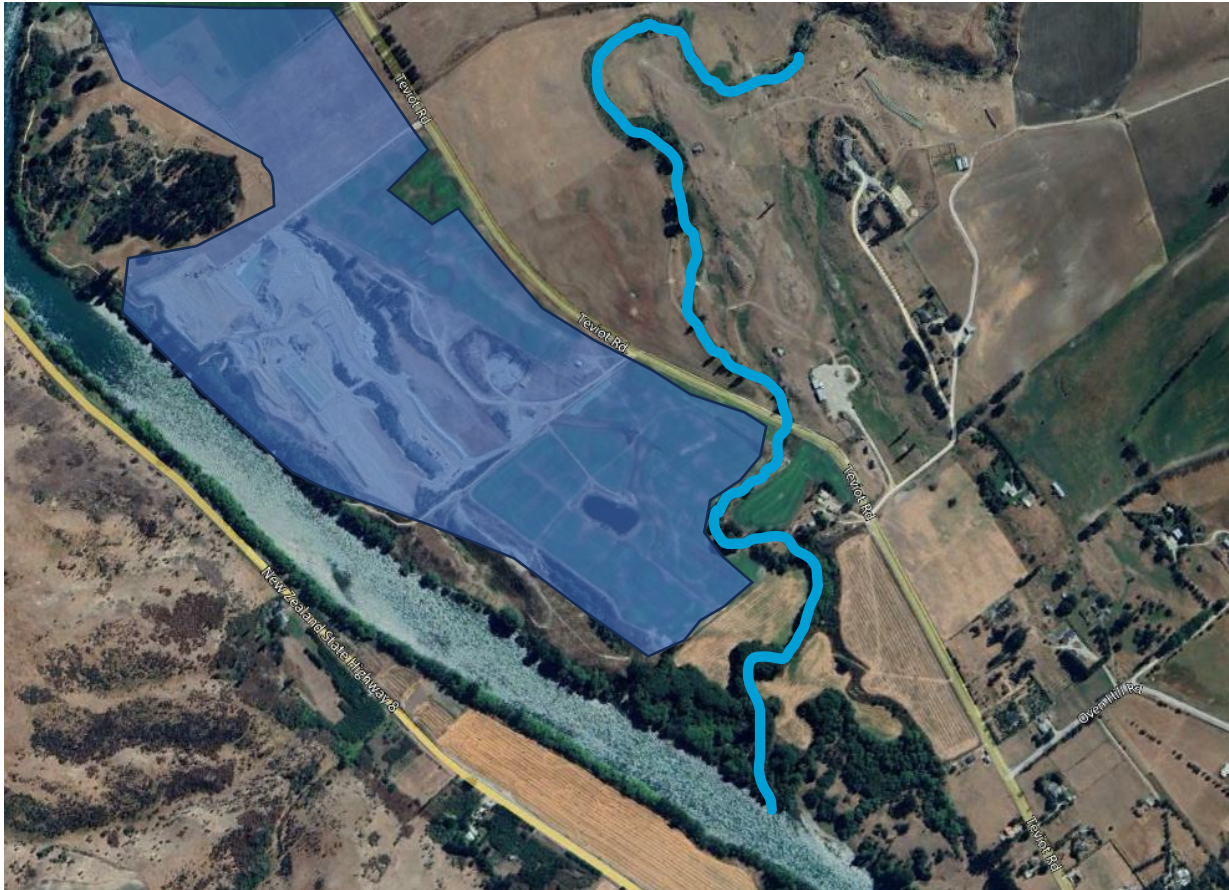
Figure 2: Mine site area and the location of the Tima Burn.

Hawkeswood Mining Limited are seeking resource consent to undertake alluvial gold mining along the Clutha River/Mata Au river terrace on the true left of the river just upstream of Millers Flat township (Figure 1). The mine area is placed between the Clutha River/Mata Au and Teviot Road. The Tima Burn, a small Clutha River/Mata Au tributary flows just to the southeast of the mine boundary (Figure 2).

The proposed mine area does not encroach on the stream bed (Figure 2) so the only potential effect of the mine works is the loss of surface flow via draw down of the groundwater when water is being pumped out of the mine pit. This potential effect is most likely to occur along the stream reach below Teviot Road downstream towards Site 3 where the mine is the closest to the stream.

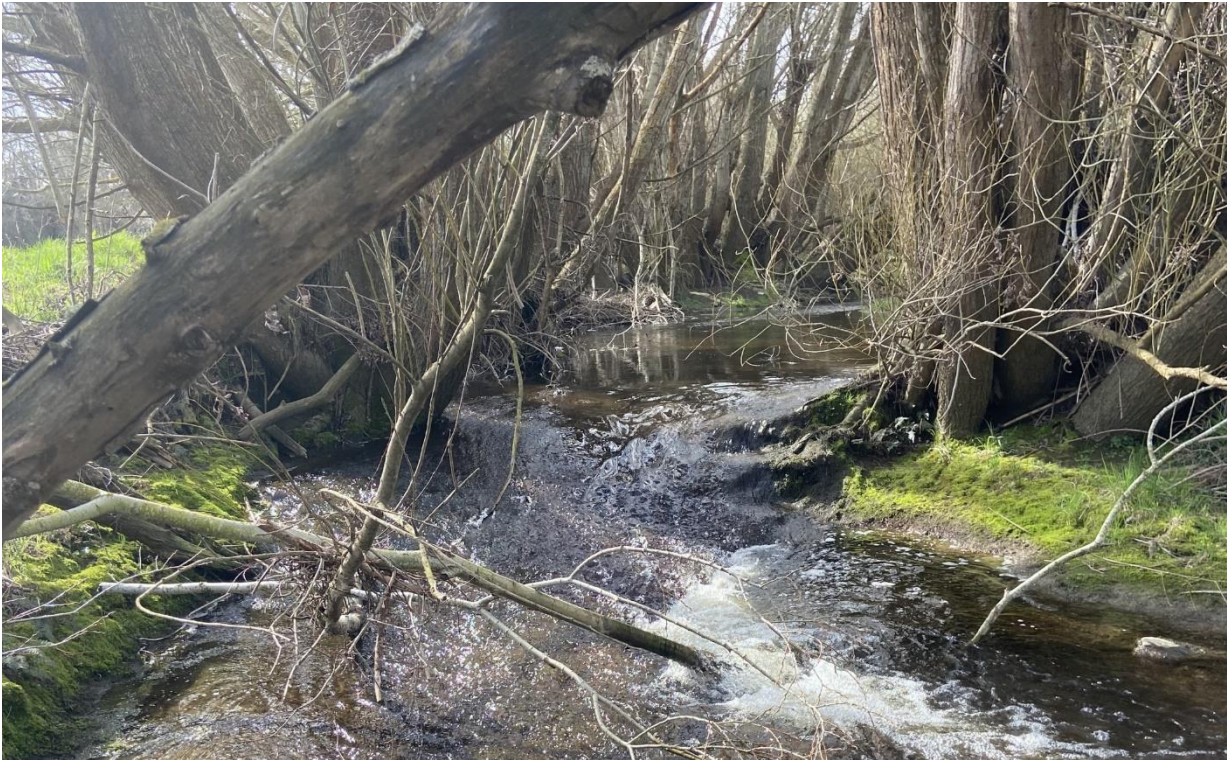
Site 3 was set along a crack willow lined section of the stream channel (Figure 4). The area was stock fenced, but cattle had been grazing within the fenced area. The willows form a continuous line along the stream and in some areas the willow root mat was extending well into the stream channel with some riffle areas being 90% or more covered in willow roots. The margins of pool habitat were also lined with willow roots. The substrate in the pools ranges from mud to cobble and there were areas of woody debris and leaf material to provide fish cover. This reach would be fully shaded when the willow trees are in leaf. The stream in this reach showed evidence of a declining flow with areas of exposed bed with no vegetation along the stream edge.

Figure 4: Site 3 with willow trees extending into the channel and bare banks on the stream edge indicating a declining flow.

The stream at this site had bare stream banks showing the water level was dropping, and this was not observed at the two upstream sites. This may be indicating that flow is declining in this reach when the upstream reaches have stable flow and water levels. The growth of crack willow roots over the riffle habitat is also a feature associated with low or no flow (Allibone pers. obs.) as the willow roots expand out across the stream bed during the low flow periods presumably when the water velocity is insufficient to keep the root mats from extending across the stream.

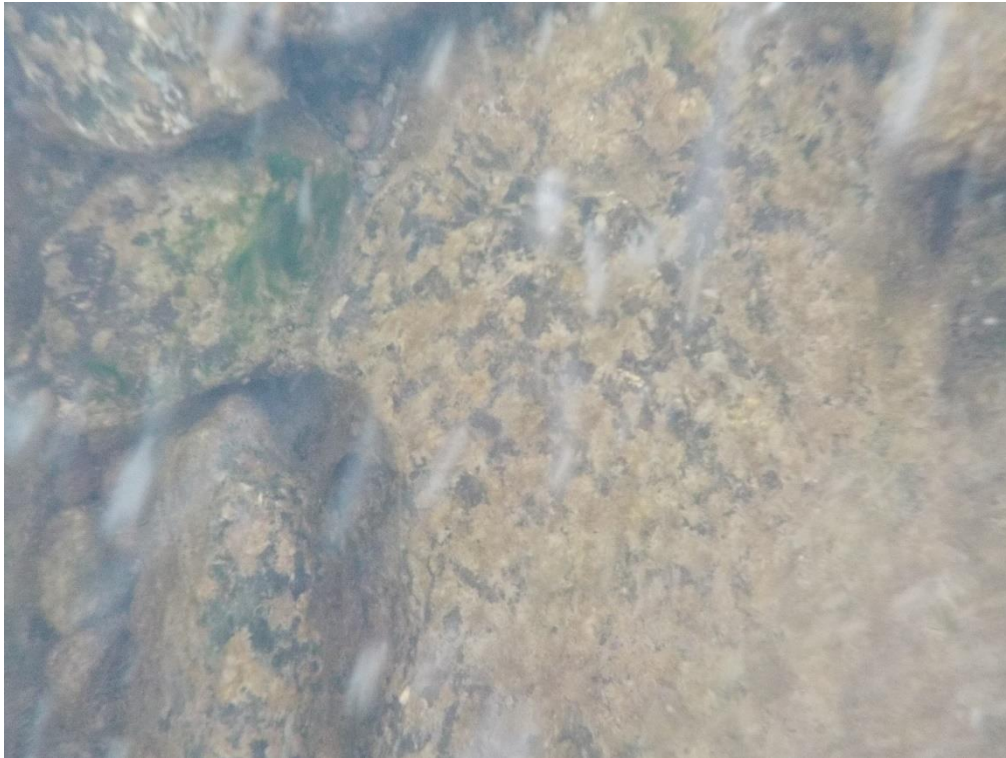
Site 1 was characterised by a high percentage of the stream bed being covered by periphyton with coverage estimated to being between 80.5 and 90 % of the stream bed. Periphyton communities differed in riffle and run/pool habitat. In the riffle areas periphyton was predominantly thin (0.5 mm thick) and medium (0.5 mm - 3 mm thick) thick light brown films (Figure 5). There were small pockets of green filamentous algae in the riffle, but these appeared to be restricted to pockets of low water velocity. Small didymo patches were also present in the riffle. The run/pool periphyton community was dominated by brown filamentous algae with smaller areas of green filamentous algae. The filaments were up to 5 cm long.

Figure 5: Riffle periphyton community at Site 1.

The high periphyton cover at Site 1 also indicates that flushing flow over the winter have not occurred and may indicate some nutrient enrichment is occurring. The lack of periphyton at Site 2 does indicate the periphyton issue is not widespread. At Site 3 the lack of periphyton is in part due to the willow root mats and possibly due of the shading effects of the willow trees.

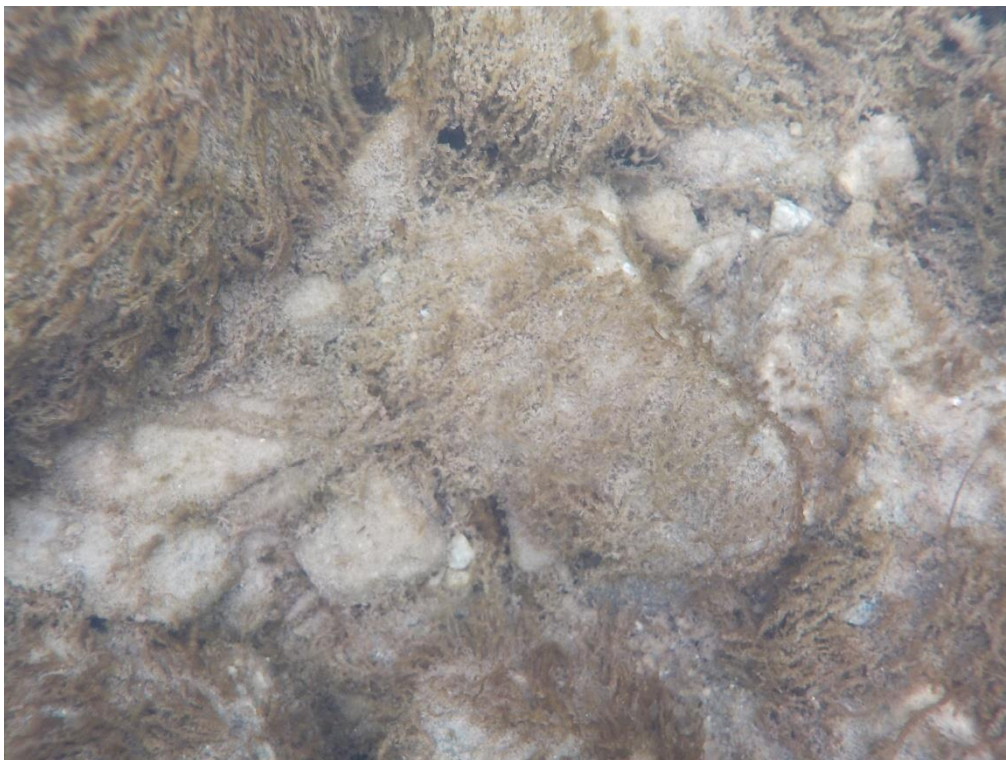
Figure 6: Run periphyton community at Site 1.

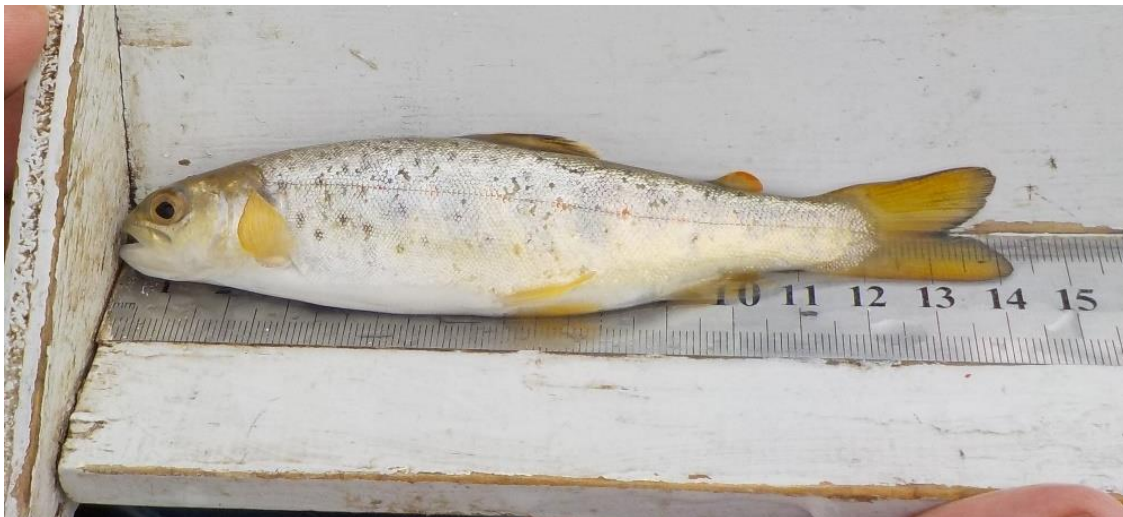
Figure 7: A brown trout caught at Site 2

Downstream of the waterfalls pool and riffle habitat was fished and one longfin eel (350 mm), two brown trout and one inanga were collected. Another eel evaded capture. The two trout were juvenile individuals, 117 mm and 132 mm long (Figure 7). The inanga was an adult individual, 94 mm long (Figure 8). It is likely that the waterfalls were of sufficient height to prevent the inanga moving further upstream, but the waterfalls would not stop brown trout upstream movement.

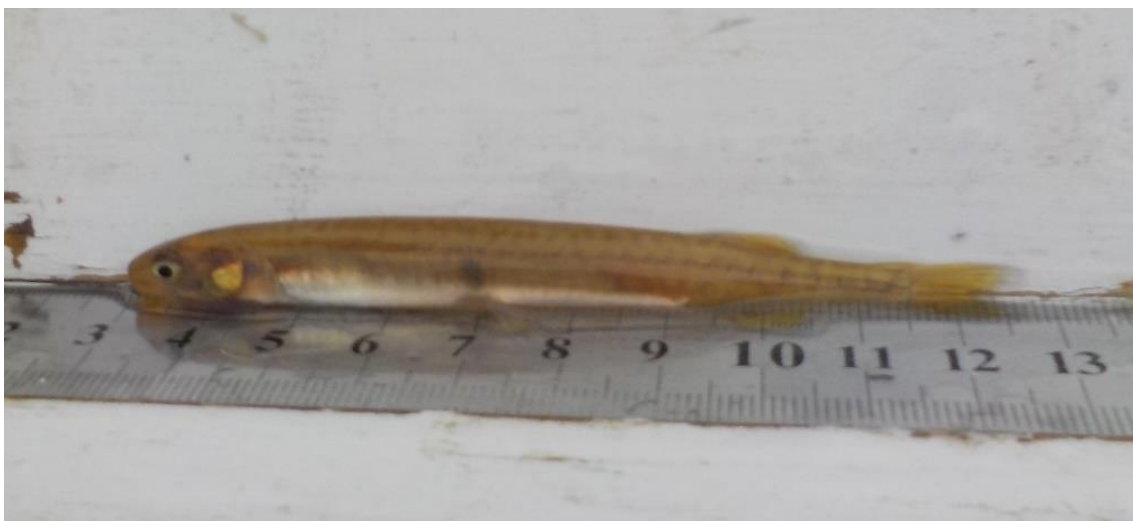
Figure 8: The inanga caught at Site 2.

The adult inanga was an unexpected find as in October inanga are generally migrating into freshwater in the whitebait run. This adult individual could to be either an individual that migrated into freshwater in spring 2022 and remained over winter in the Tima Burn rather than spawning in the Clutha River /Mata Au estuary, or it is an individual that migrated into freshwater outside the usual whitebait season. Very low numbers of inanga whitebait do migrate back into freshwater outside the spring whitebait season (Allibone pers. obs., McDowall pers. com.) and this individual could be a late summer/autumn migrant.

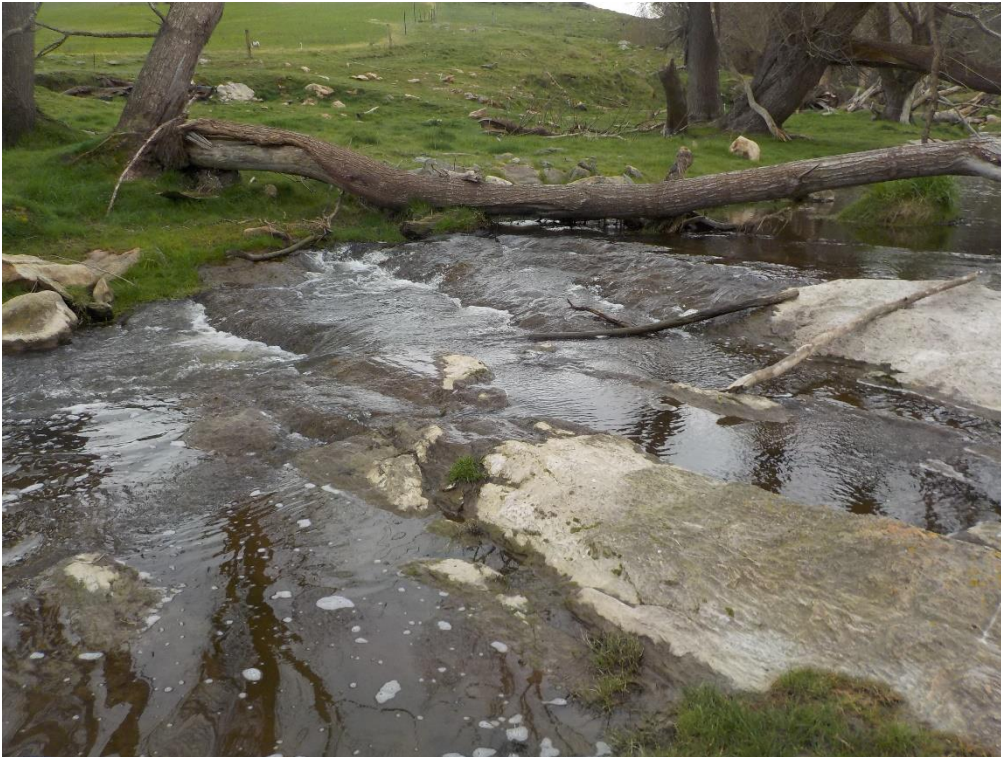
Upstream of Site 1

Figure A1: Bedrock riffle habitat upstream of Site 1, note open grazed riparian zone.

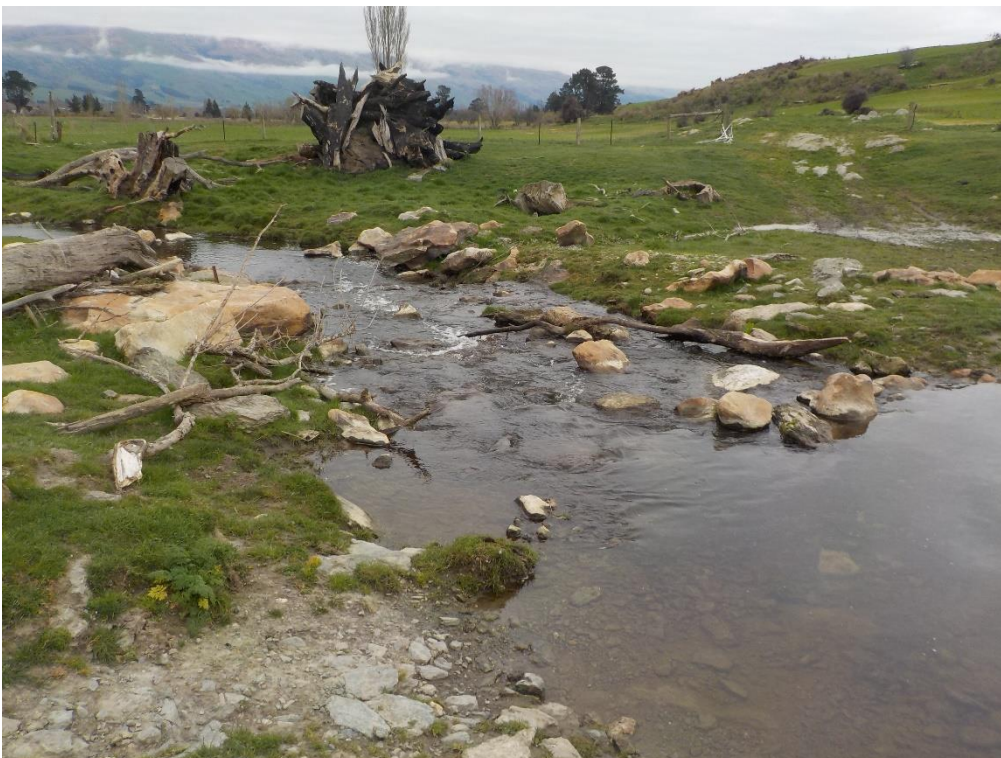
Site 1 was immediately downstream of areas of bedrock stream bed and the major riffle in this reach was a constructed riffle that provided erosion protection for an upstream vehicle ford. This was the areas with largest stream bed substrate – cobbles and small boulders and appeared to provide the best fish cover in the 100 m around the site. The riffle habitat did have good interstitial spaces for fish and macroinvertebrates but the stream substrate in the upstream pool and run area was comprised of small cobble, gravel and fine gravel and sand and had no interstitial space. The combination of abundant periphyton growths and accumulations of fine sediment indicated that there had been no winter floods to flush the periphyton and fine sediment. Small backwater areas with fine sediment were scattered along the reach.

Figure A2: The boulder cobble riffle with run and pool habitat down and upstream respectively.

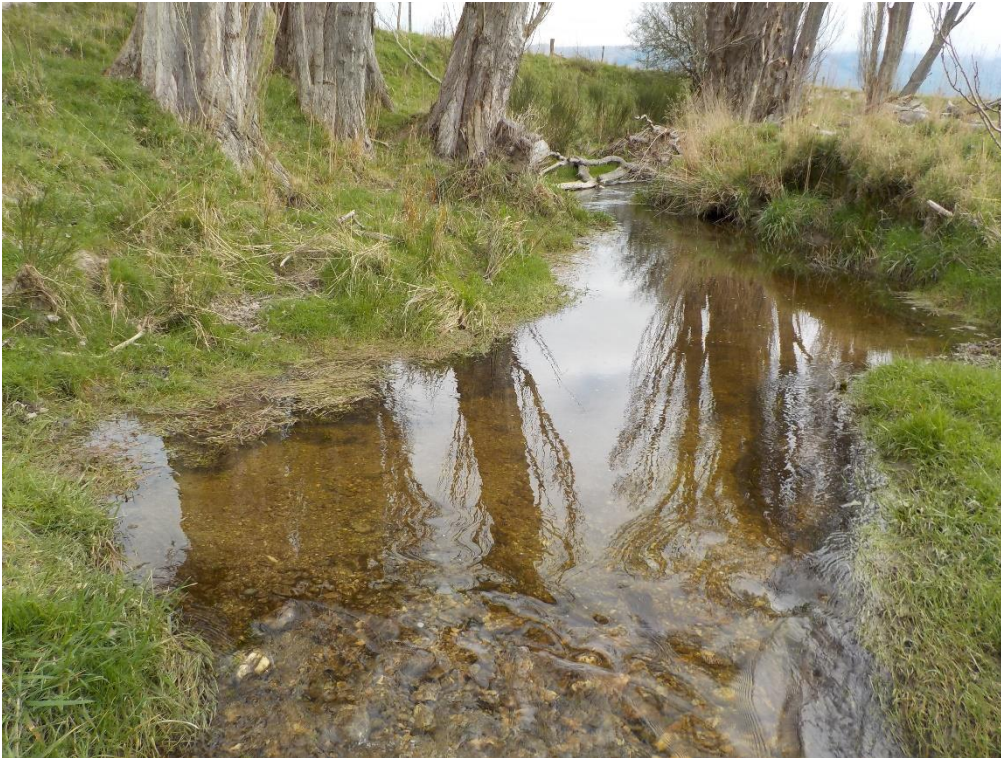
Site 2 was split into two distinct sections separated by two small bedrock waterfalls. Upstream of the waterfalls the stream had cobble dominated riffles and pool run habitat with finer stream bed material. The substrates were generally poorly consolidated and moved easily when walked on. There was some overhanging vegetation, instream vegetation and undercut banks in the pools. Downstream of the waterfalls there was a bedrock scour pool that transitioned into a cobble riffle and then a larger pool with a fine sediment substrate and some woody debris that provided fish cover.

Figure A3: Pool habitat upstream of the bedrock waterfalls.

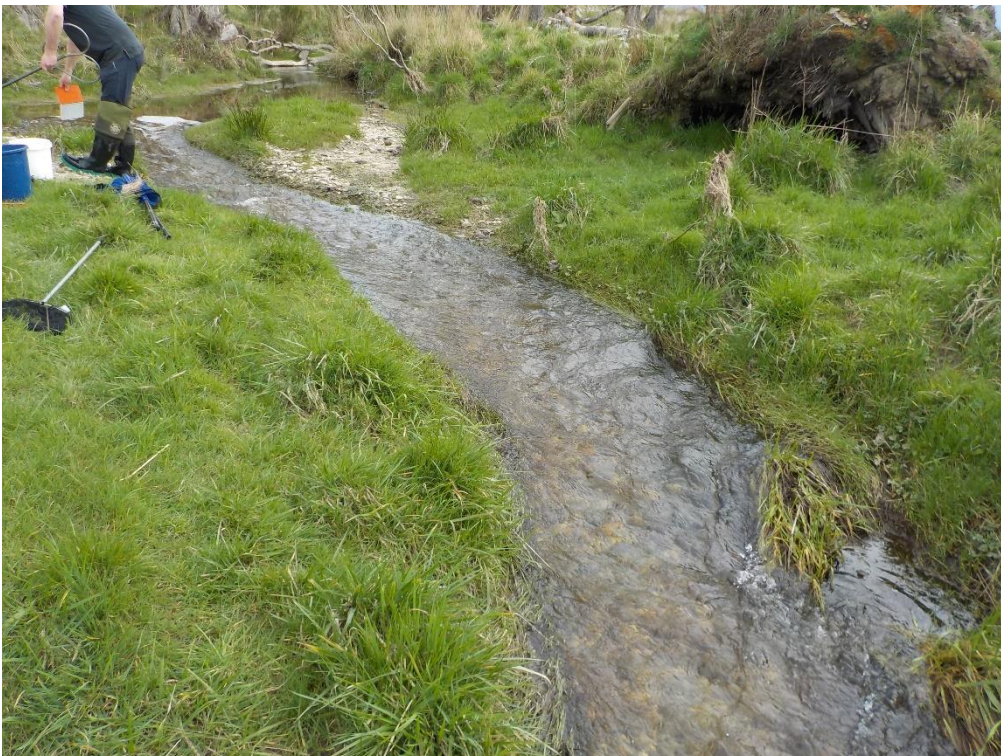
Figure A4: Riffle habitat upstream of the bedrock waterfalls.

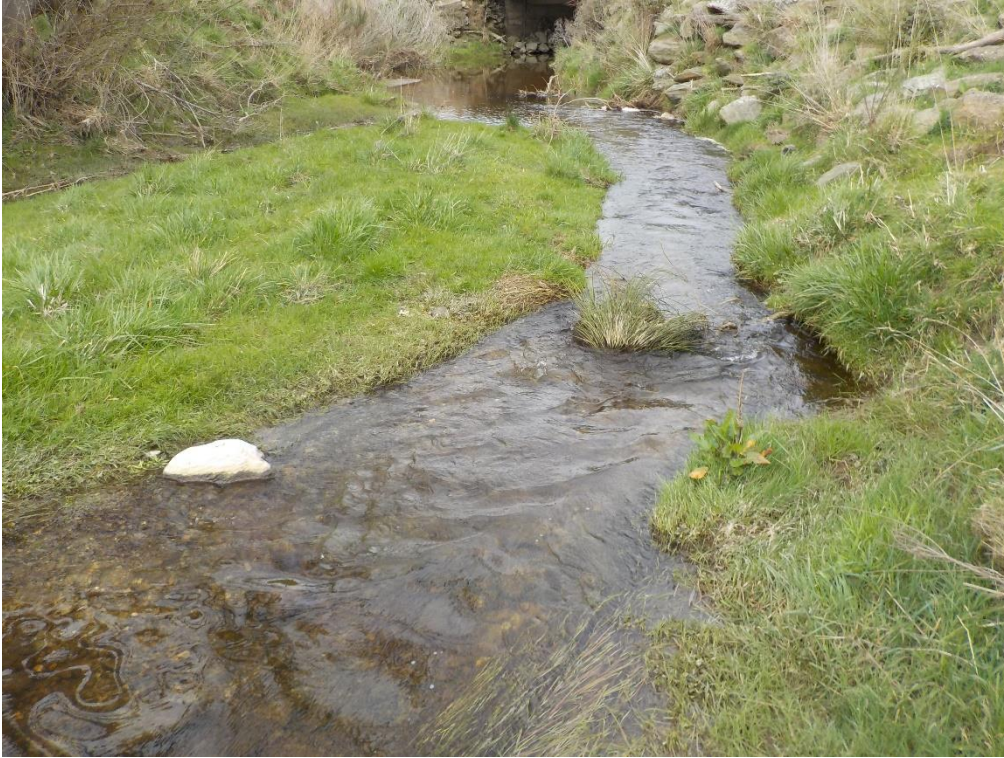
Figure A5: Pool and riffle habitat downstream of the bedrock waterfall, inanga and brown trout were caught at the pool riffle interface.

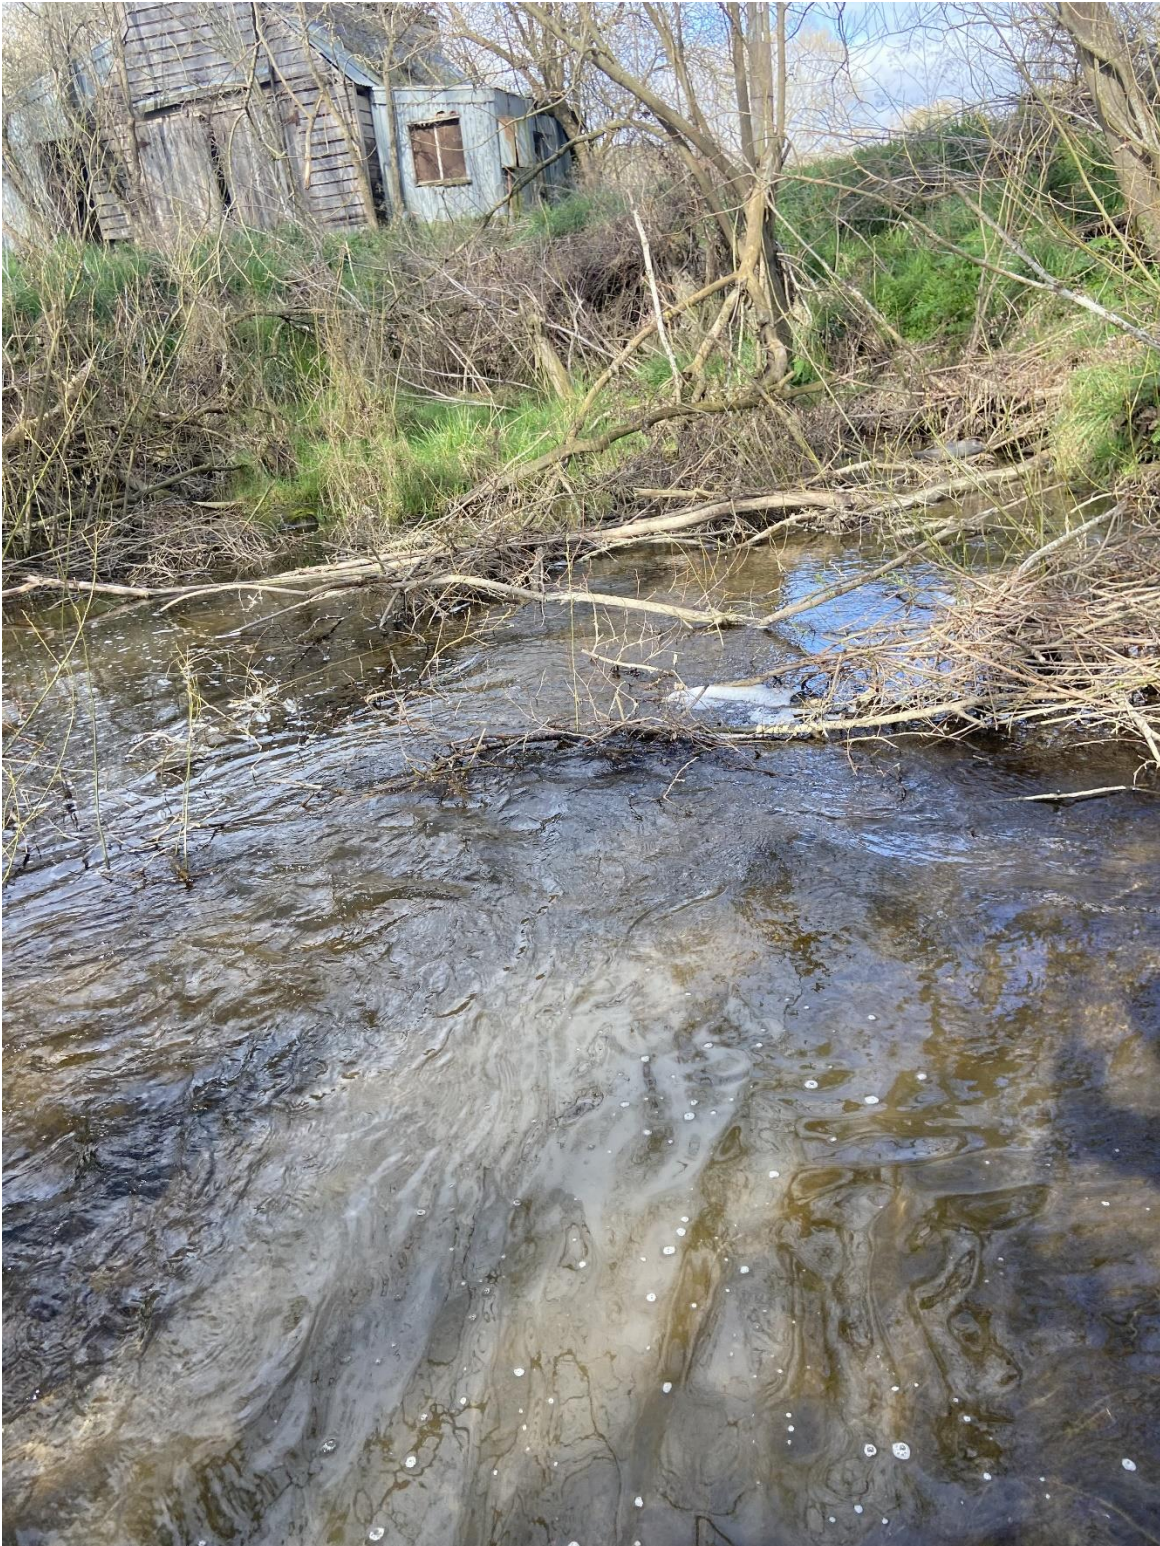
Site 3

Figure A6: Pool habitat with crack willow logjam.

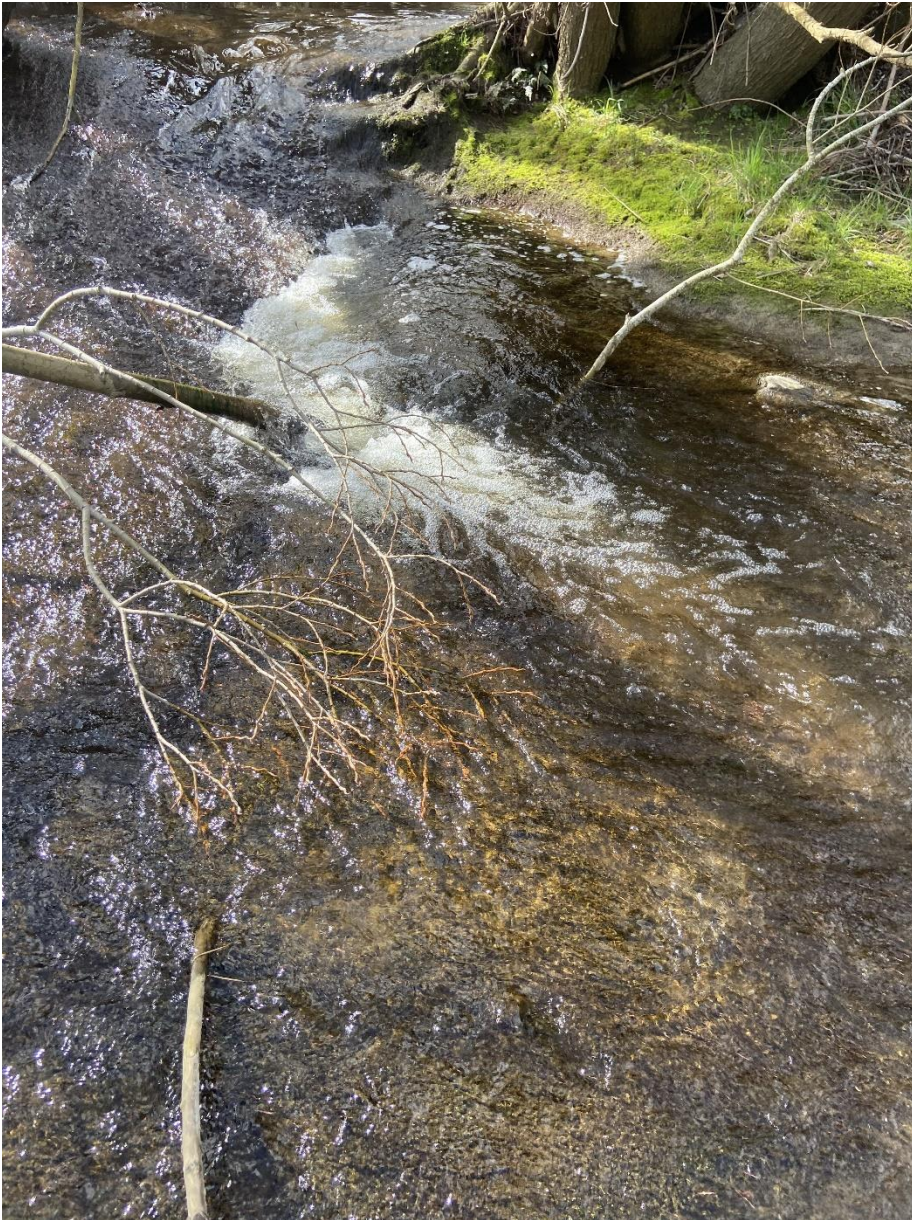
Willow roots extended well out into the stream, especially in the riffles in parts of this reach and this limited the habitat available for periphyton. The available cobble and gravel in riffle had no visible periphyton although the cobbles were slippery under foot indicating thin films were present. Pool habitat had no periphyton.

Figure A6: Riffle habitat overgrown by willow root mat.
