Seismic hazard in the Queenstown Lakes district

August 2015

Report writer: Ben Mackey, Natural Hazard Analyst
Reviewed by: Michael Goldsmith, Manager, Natural Hazards

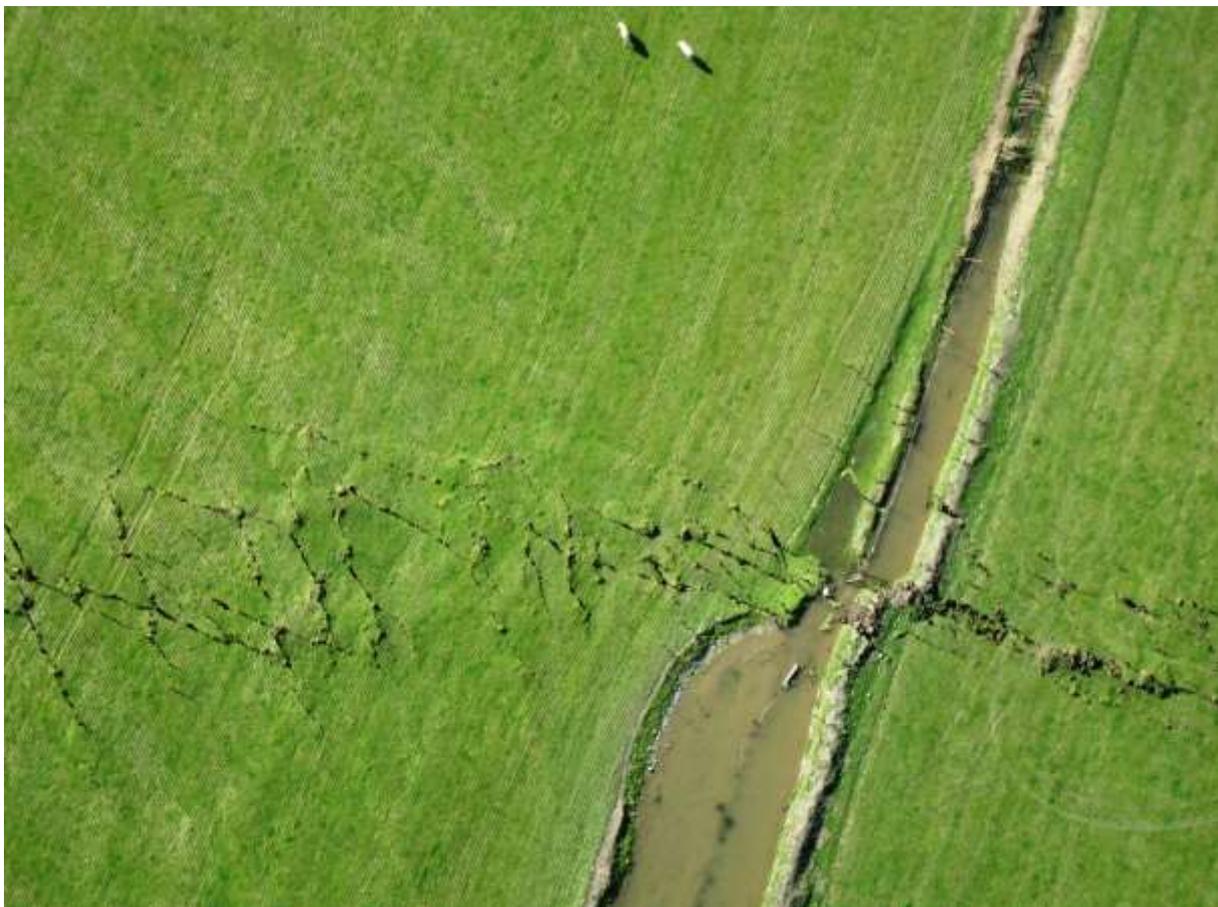
Figure 1. The surface trace of the Greendale Fault rupture cut across paddocks in the Canterbury Plains in September 2010 (photo courtesy M. Quigley). The ground moved up to 5.3 m laterally, but was expressed at the surface as a zone of distributed deformation up to 300 m wide, as seen in the network of shear structures (Quigley *et al.*, 2012).

A fault rupture at the ground surface is one of the most dramatic signs of an earthquake (Figure 1). The ground can be displaced laterally on a strike slip fault, or vertically on a thrust or normal fault (Figure 2).

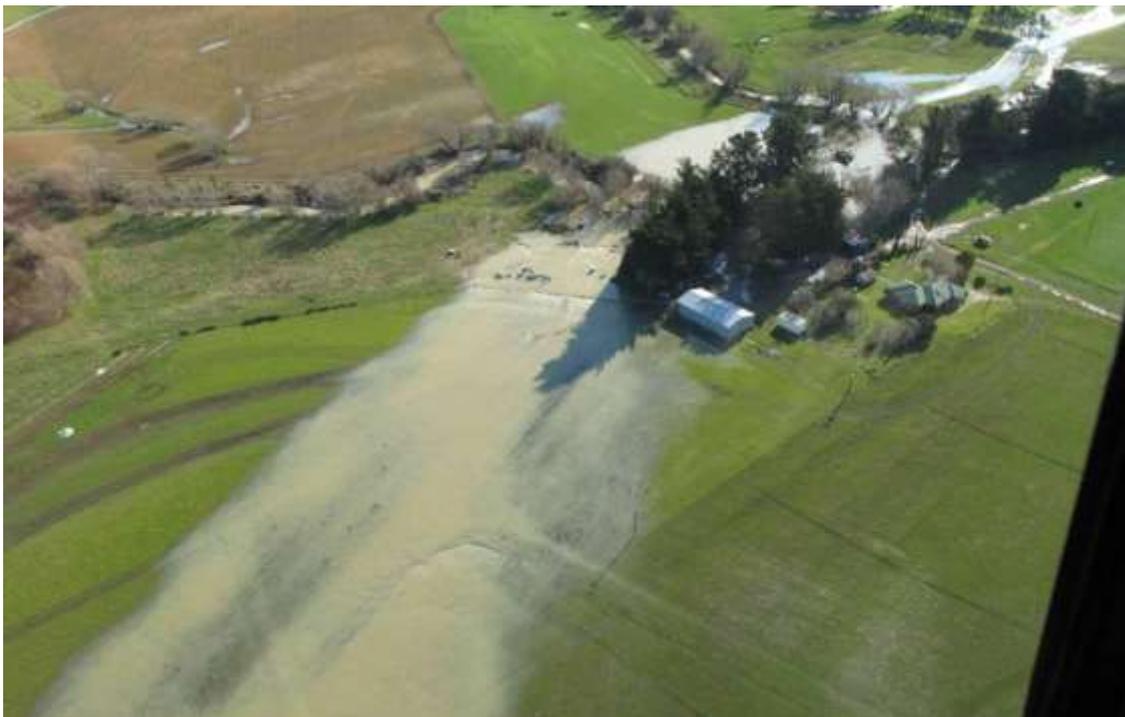
Figure 4. Avulsion of the Hororata River following fault movement during the September 2010 Darfield earthquake (photo courtesy D. Barrell, GNS Science)

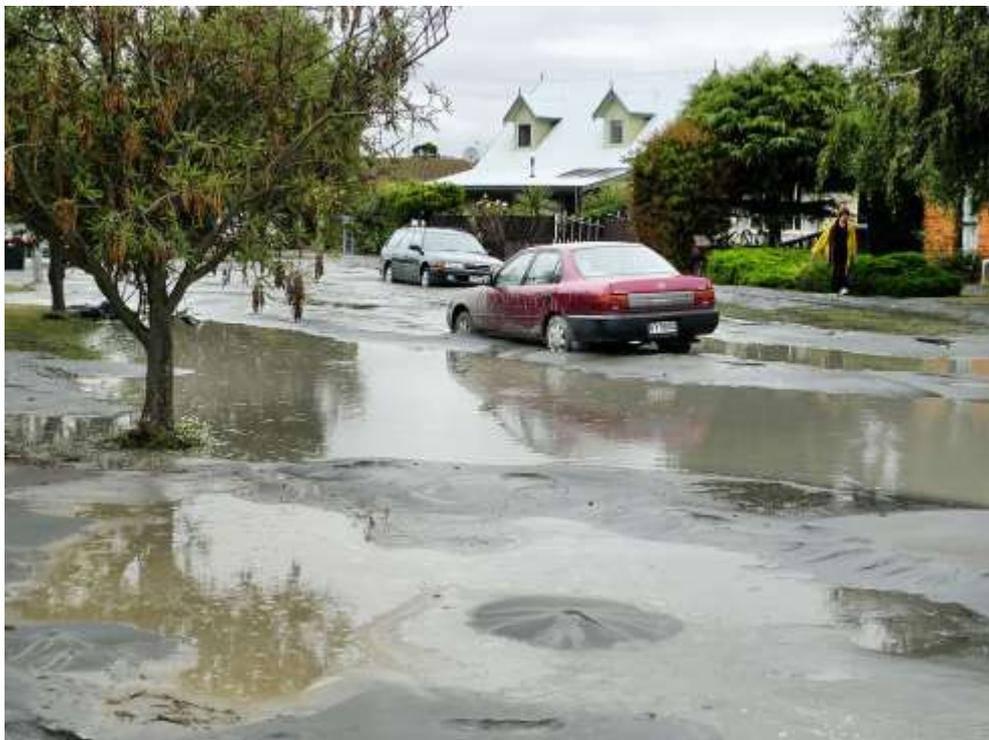
Figure 6. Liquefaction in Avonside following the February 21 Christchurch 2011 earthquake (photo by Martin Luff, Wikipedia Commons).

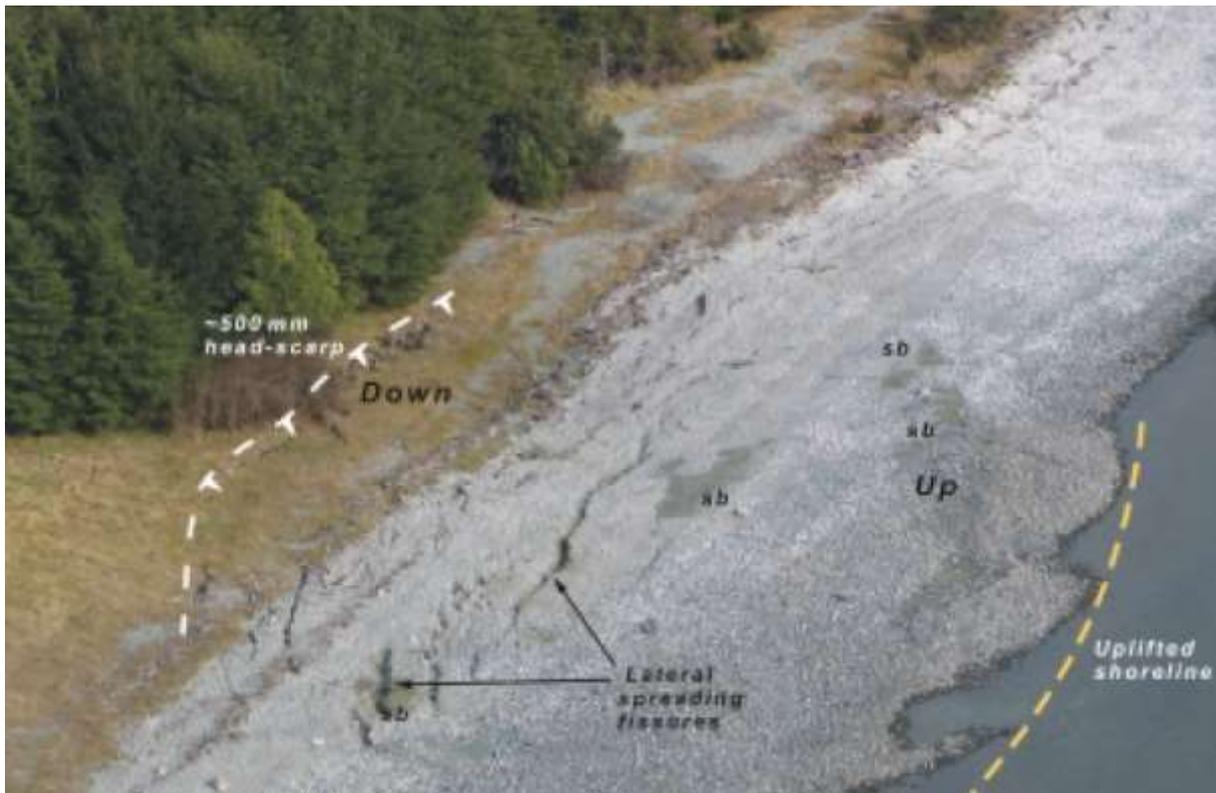
Figure 7. Lake-edge failure along Lake Te Anau during the 2003 Fiordland earthquake (Hancox *et al.*, 2003). This failure incorporated liquefaction and lateral spreading of the lake-beach area.

Lake-edge collapse was observed on the margins of Lake Te Anau during the 2003 M_w 7.0 Fiordland earthquake (Figure 7). These failures occurred in undeveloped shorelines, but people with assets on lakeshores in Queenstown or Wanaka should be prepared for this process occurring during an earthquake.

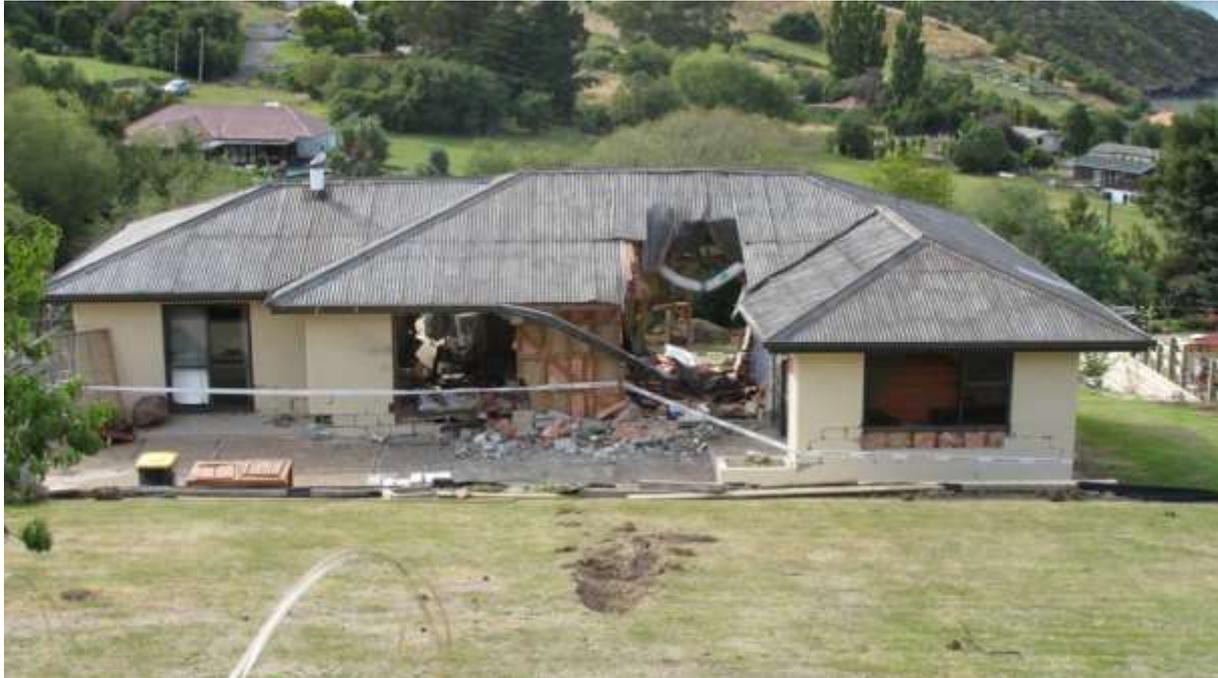
Figure 8. Rockfall damage to dwelling at Rapaki, Christchurch, during Feb. 22nd 2011 earthquake. The gouge in the foreground is an impact divot from a boulder, which then impacted the house (photo courtesy D. Barrell, GNS Science).

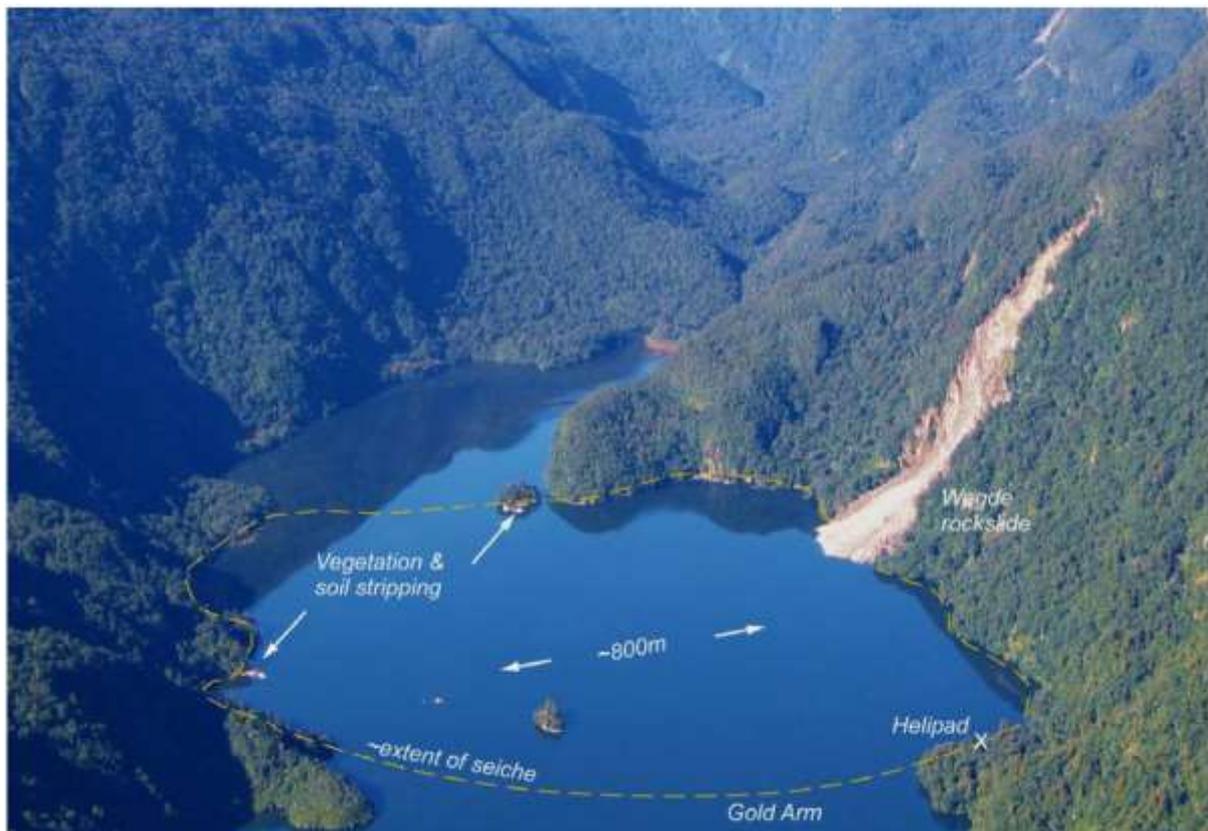
Figure 9. The 2003 Fiordland earthquake caused a 200,000 m³ rockslide into Charles Sound. The landslide caused a small tsunami, which ran 4-5 m up the other side of the sound, approximately 800 m away (Hancox *et al.*, 2003).

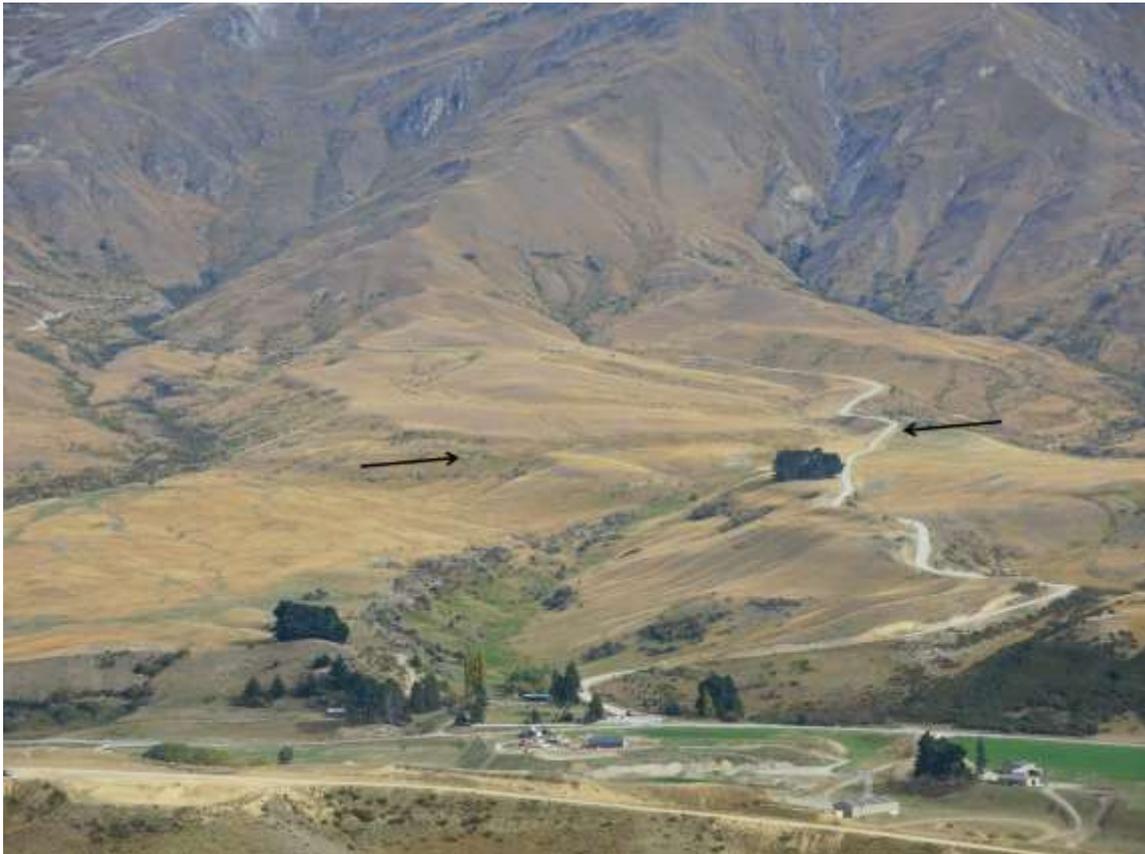
Figure 22. View towards the west across the Cardrona Valley. The Cardrona skifield access road runs lower right to upper left across the ridge. A visible, active trace of the NW Cardrona Fault is highlighted between the two arrows (photo April 2015).

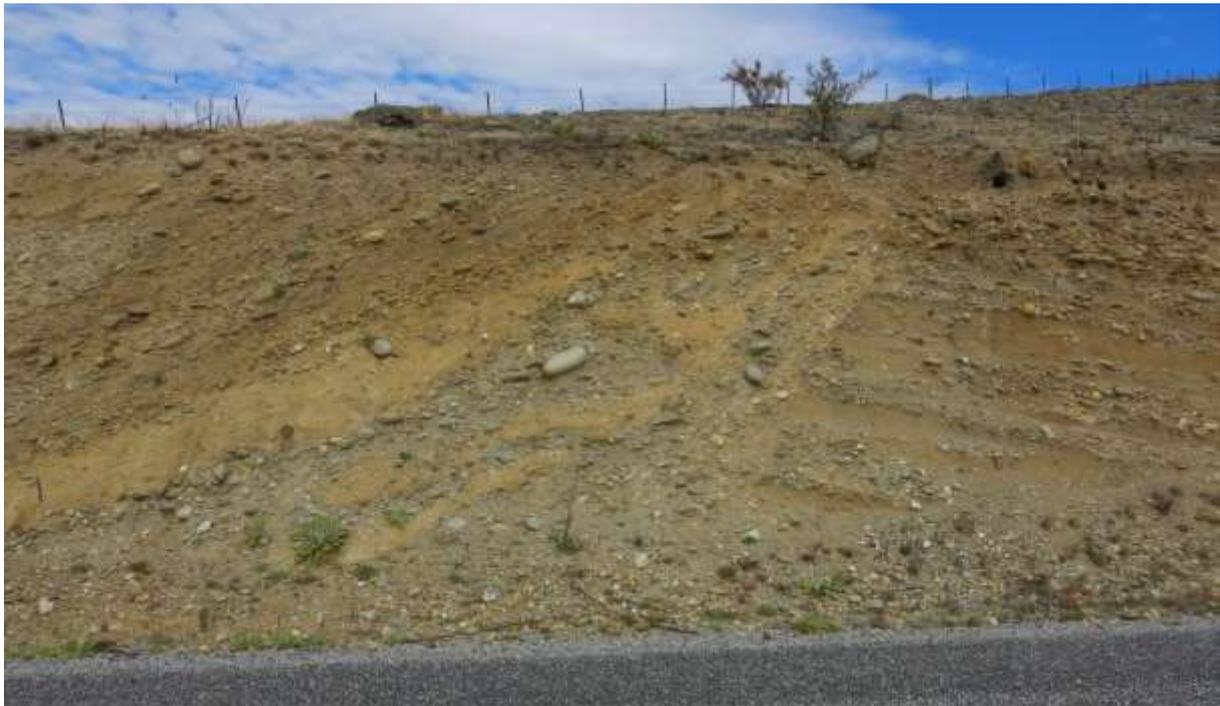
Figure 23. Road cut along Mt Pisa Road showing faulted alluvium and glacial till units along the Pisa Fault Zone. The gravels, assessed as outwash deposits, are associated with the Lindis glacial advance (~430,000 years old).

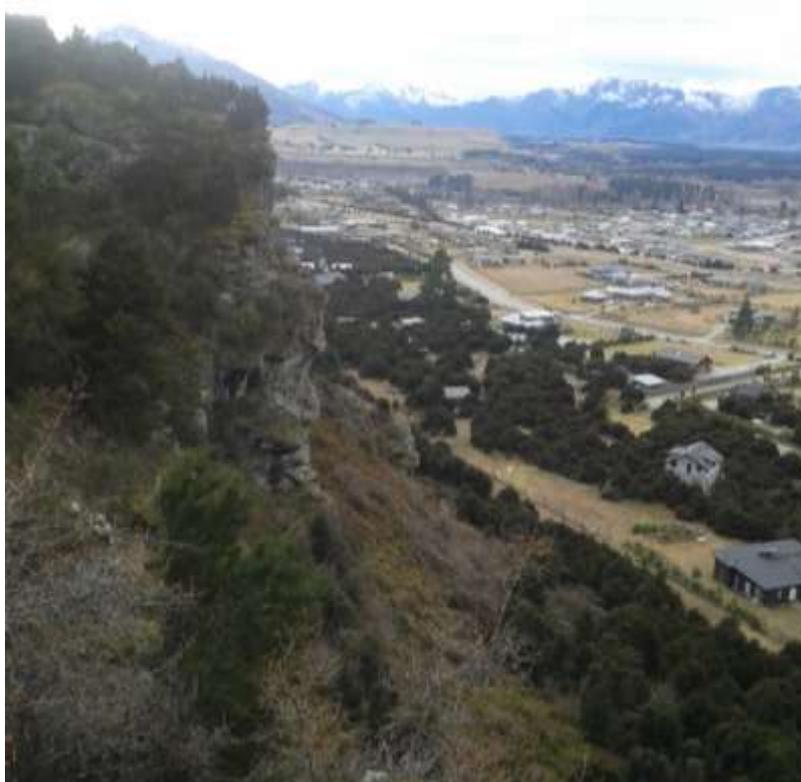
Figure 26. View of the east side of Mt Iron. Steep to subvertical schist cliffs on the eastern and southern sides of the hill provide source areas for rockfall boulders to roll downslope (July 2015).

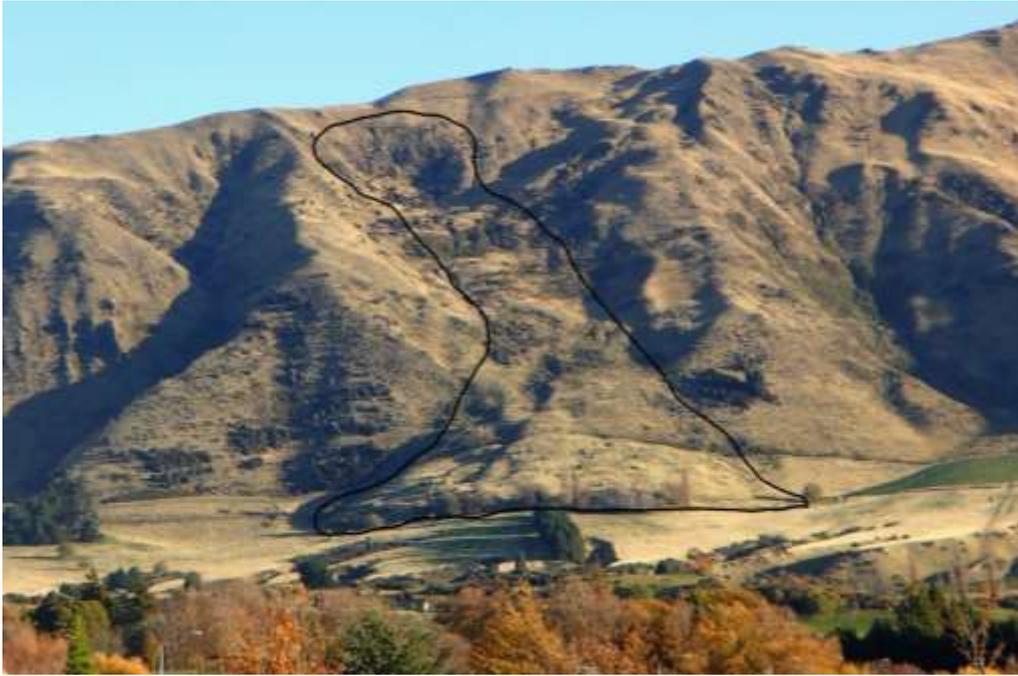
Figure 27. Rock avalanche deposit south of Wanaka township (photo courtesy of G. Halliday). Approximate extent of rock avalanche outlined in black.

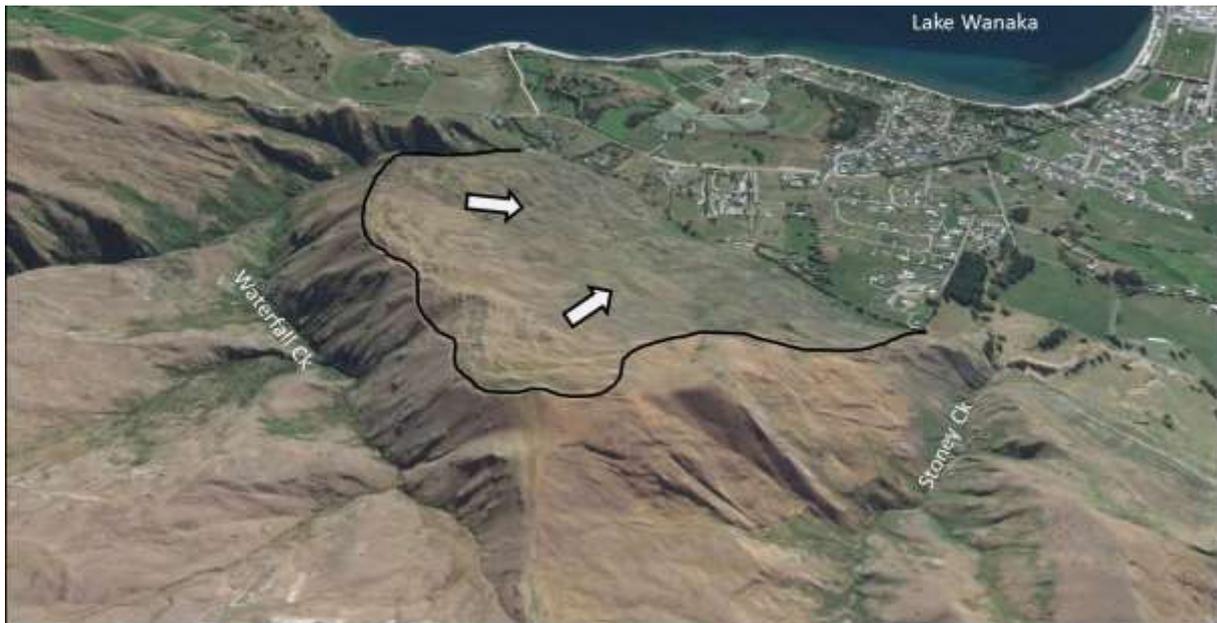
Figure 28. Oblique view towards the north, with downtown Wanaka visible in top right of image. A large deep-seated schist landslide south of Wanaka is outlined in black. Ridgeline relaxation can be seen at the top of the landslide.

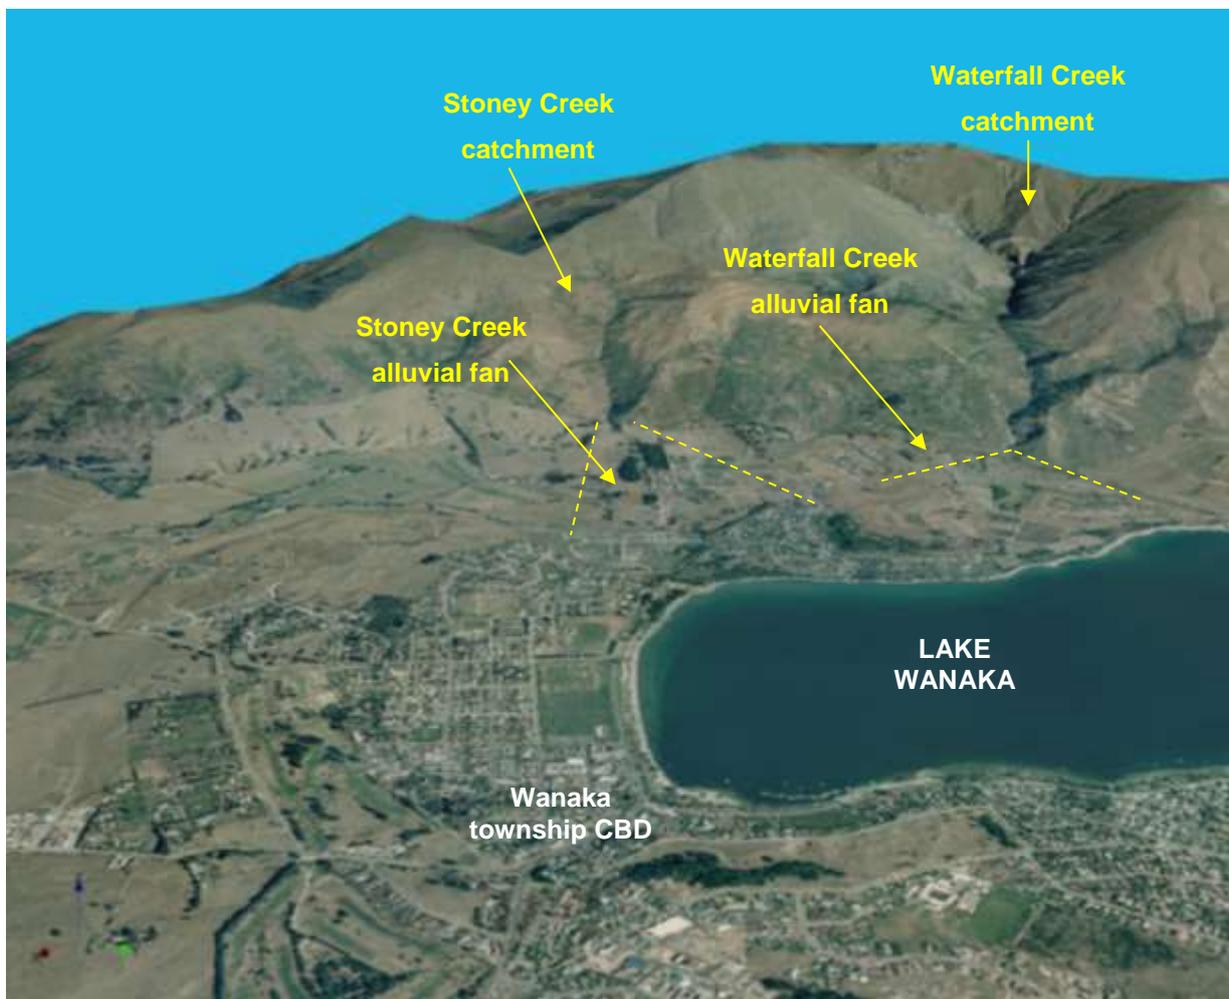
Figure 29. Oblique view towards south of Stoney Creek and Waterfall Creek catchments, and their associated alluvial fans in southern Wanaka (modified from Woods, 2011)

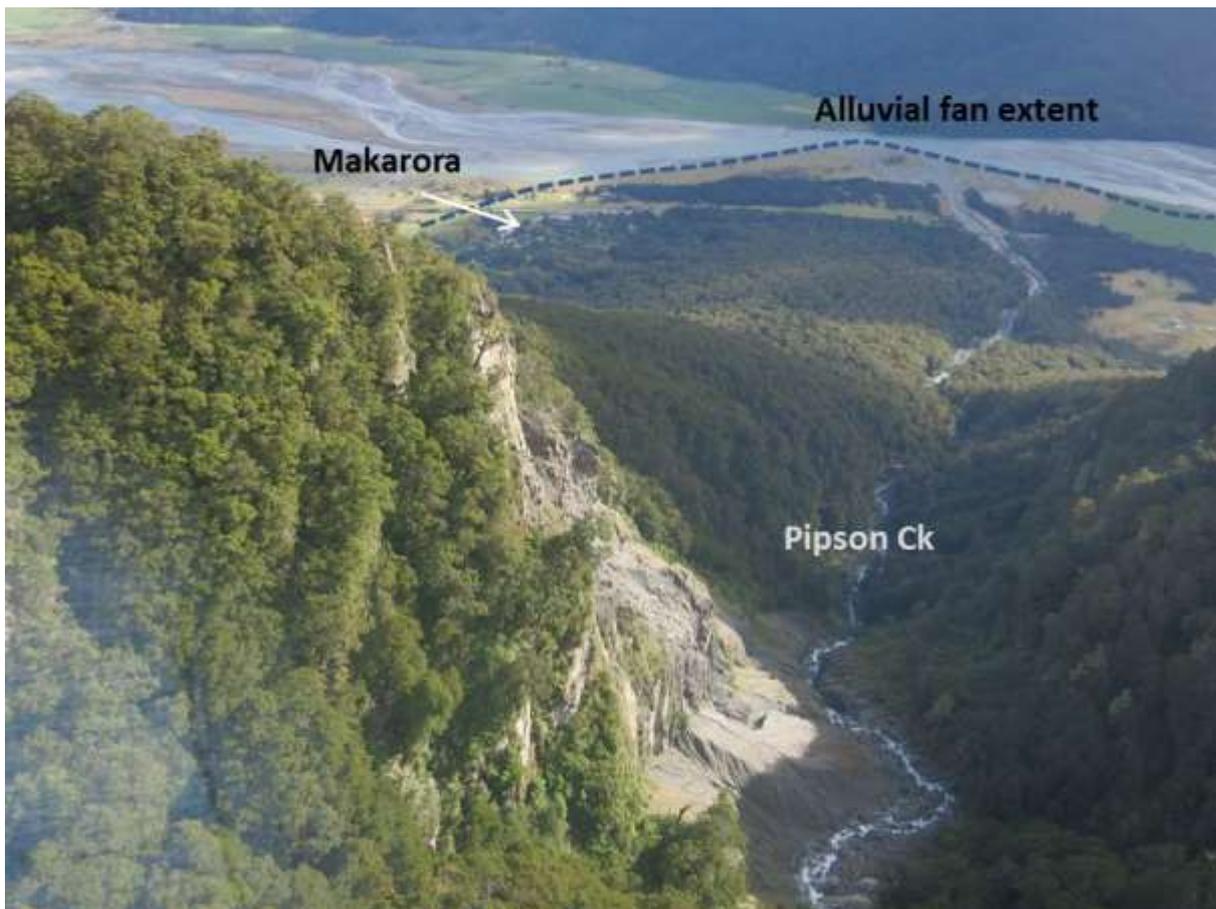
Figure 30. View down Pipson Creek, near Makarora (May 2015). The eroding cliffs in the foreground (and other cliffs upstream) contribute rock and sediment to the channel, which can mobilise into debris flows during high rainfall. Earthquake shaking is liable to cause extensive rockfall and landsliding into the creek.

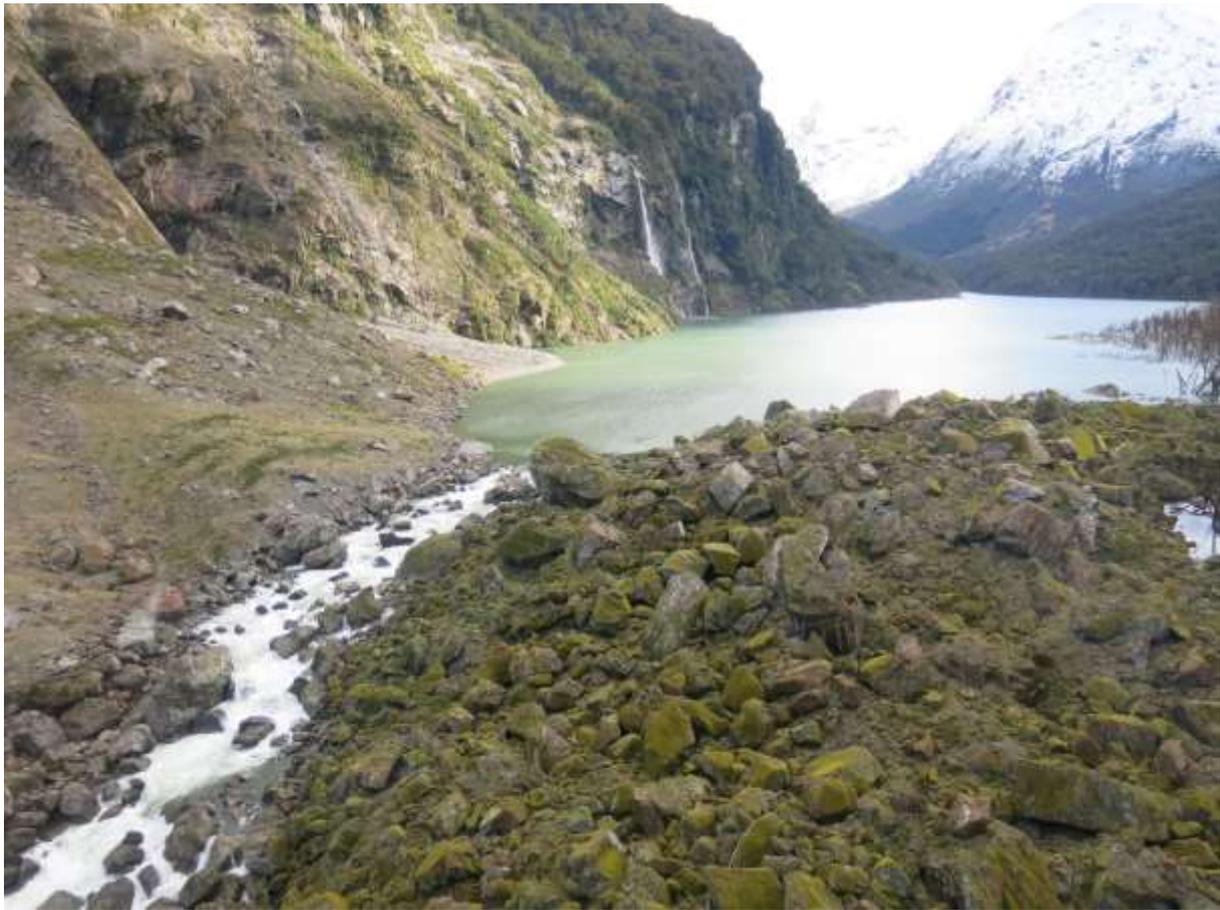
Figure 31. View of the Young River landslide dam. A landslide in August 2007 dammed the Young River to a height of 70m, and formed a ~1.5 km long lake (May 2015).

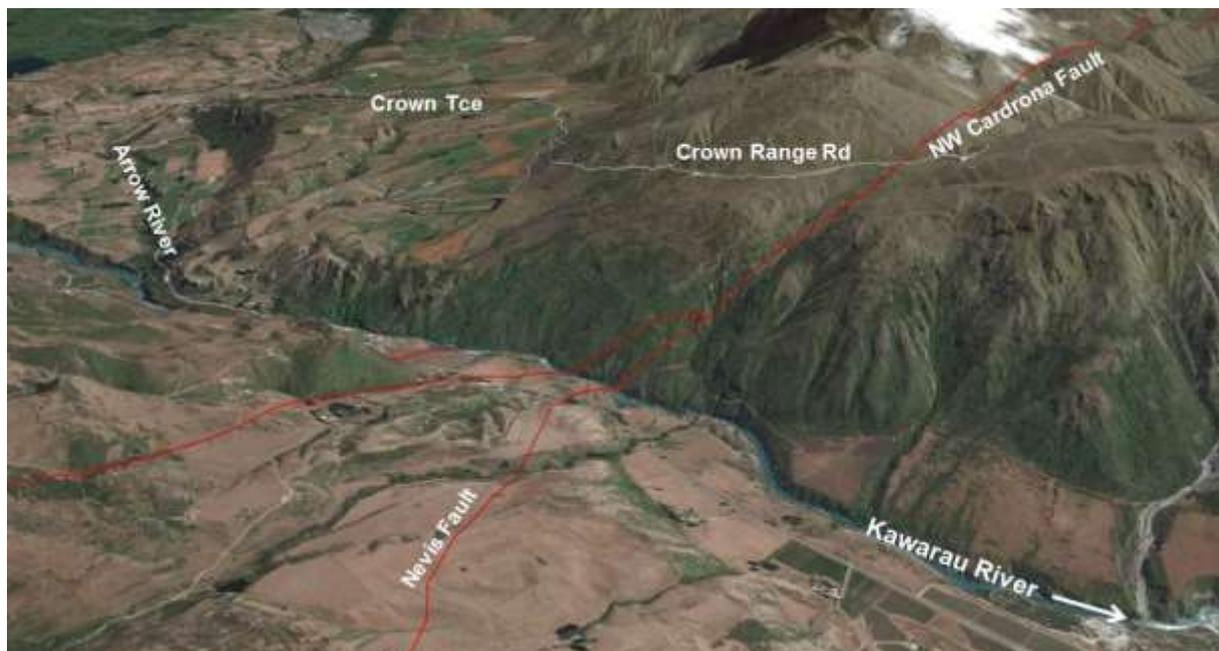
Figure 37. Oblique view of the upper Kawarau Gorge towards the northwest. The Nevis-Cardrona Fault (red) runs across the gorge and continues along the Cardrona Valley. The trench in Figure 38 is across the upstream-most strand (Kawarau Trace). The fault runs through a large landslide complex on the north side of the valley. The Crown Range Road can be seen climbing up from the Crown Terrace and crossing the fault near the summit (Google Earth).

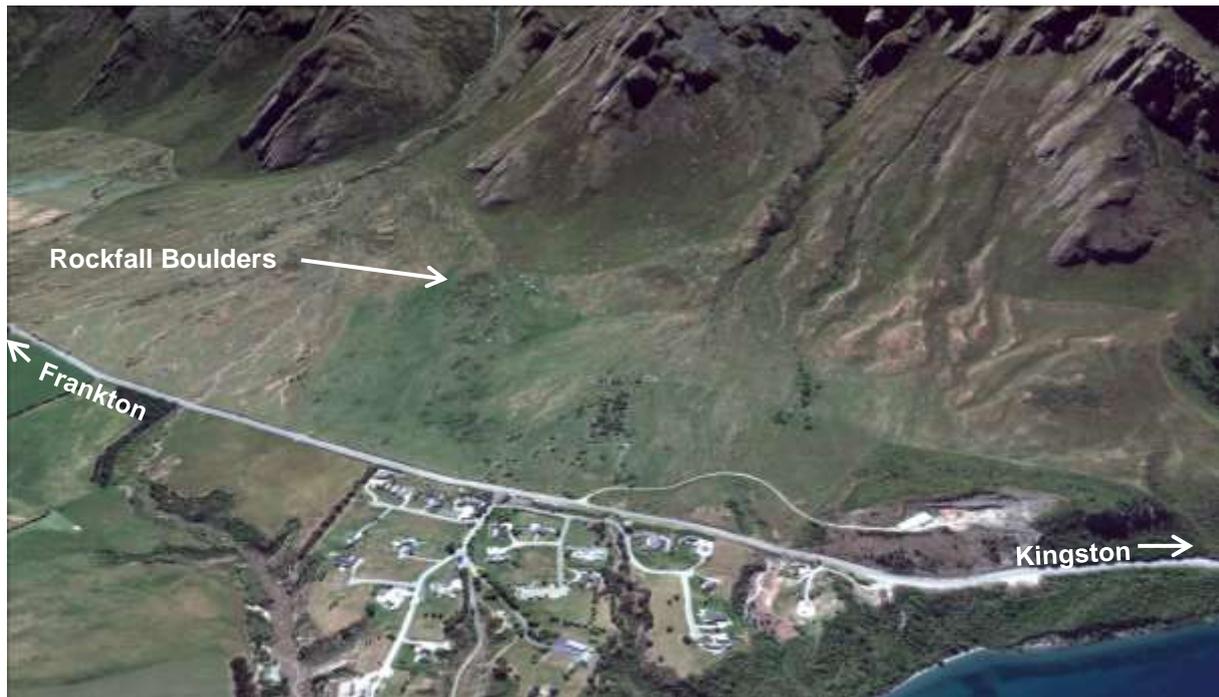
Figure 42. Oblique view towards the foothills of the southern Remarkables Range. SH6 runs across the lower view, with Lake Wakatipu on the lower right. Large boulders, probably from a rockfall, can be seen on the slopes below the rocky cliffs in the middle of the view (white dots). Active alluvial fans drain the catchments (Google Earth).

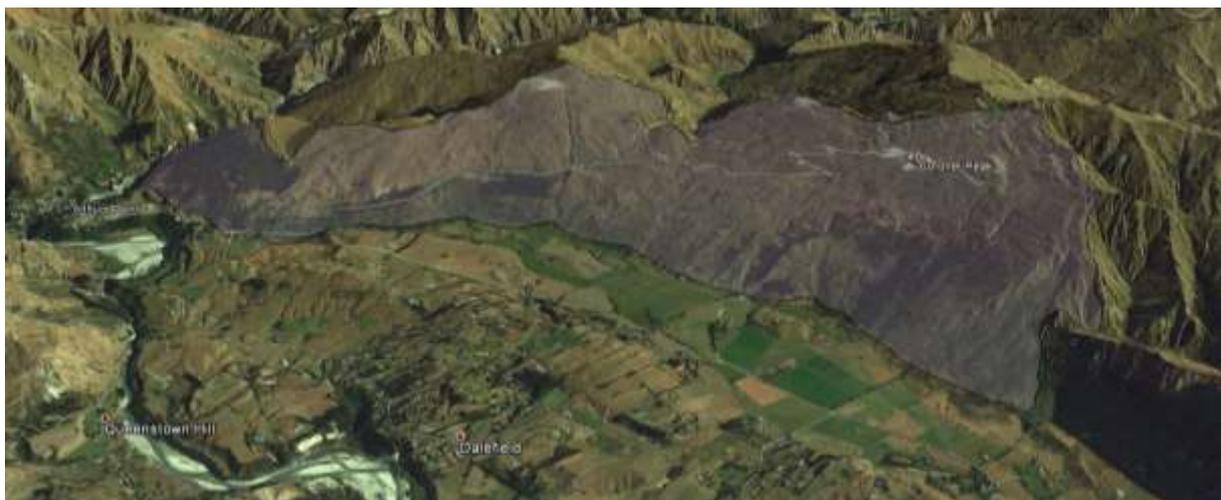
Figure 43. Oblique view showing outline of the Coronet Peak landslide, a large deep-seated schist landslide. The Shotover River runs along the left side of the image (Google Earth).

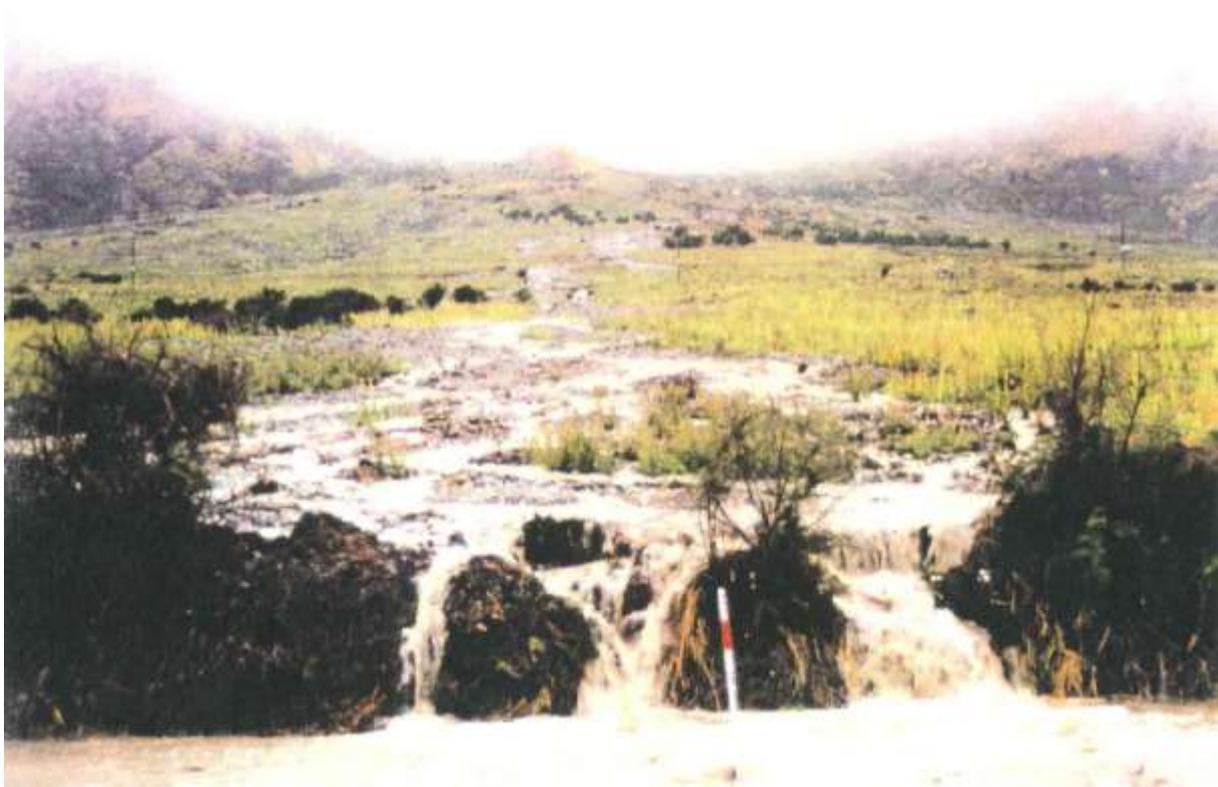
Figure 44. Active alluvial fan and debris deposition in February 1994 as seen from SH6 looking towards the Remarkables. Gravel was deposited across SH6. These fans have the potential to become more active if the headwaters are inundated with sediment following an earthquake (photo from Cunningham (1994)).

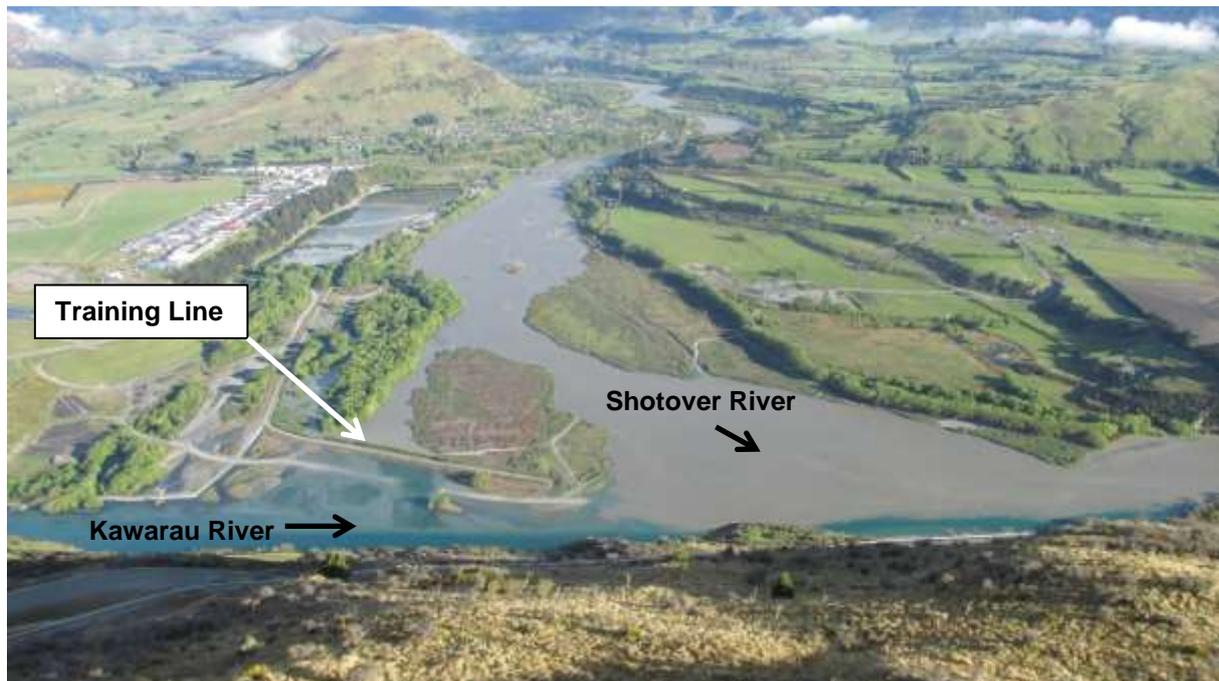
Figure 45. View of the Shotover River confluence with the Kawarau River. The Shotover River (in flood) meets the Kawarau River 4 km downstream of Lake Wakatipu. The training line on the left of the photo is intended to focus the Shotover flow to the right (2013).

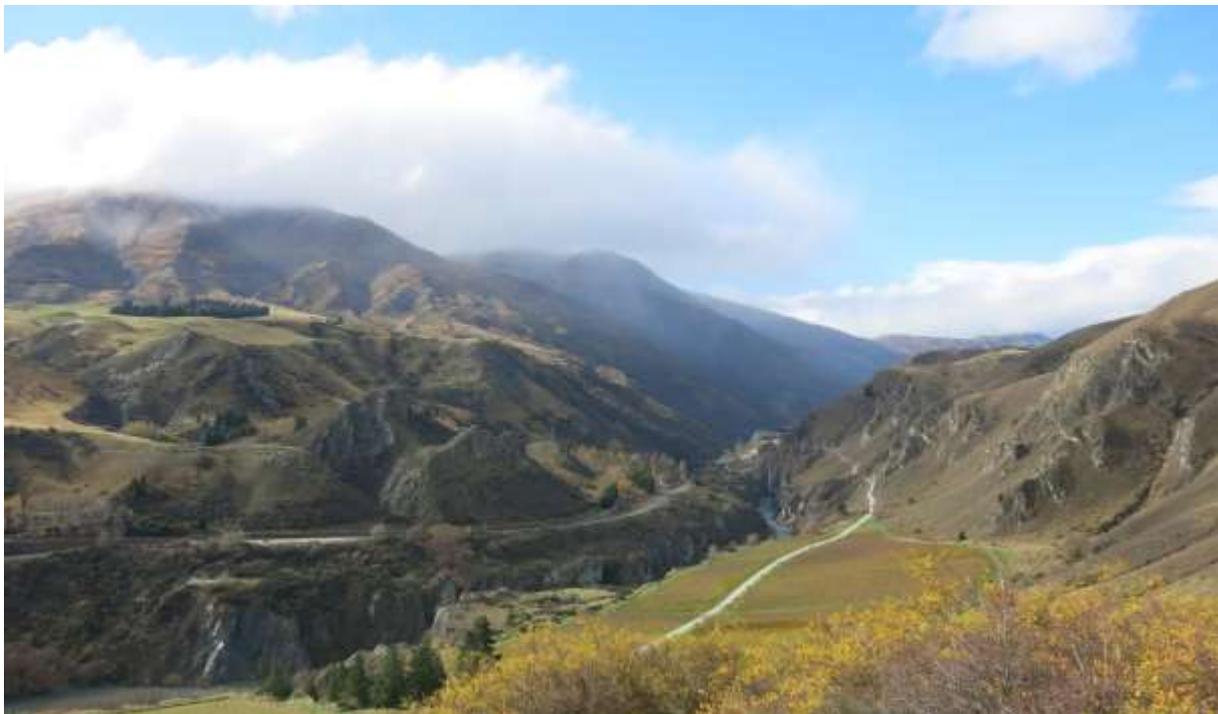
Figure 46. View down the Kawarau Gorge from Chard Farm Winery. The deep, narrow gorge along this section of the river, which drains the Wakatipu Basin, has the potential to be blocked by a large landslide from the side slopes (May 2015).
