Flood and erosion hazard in the Arrow River at Arrowtown

April 2015

Technical summary

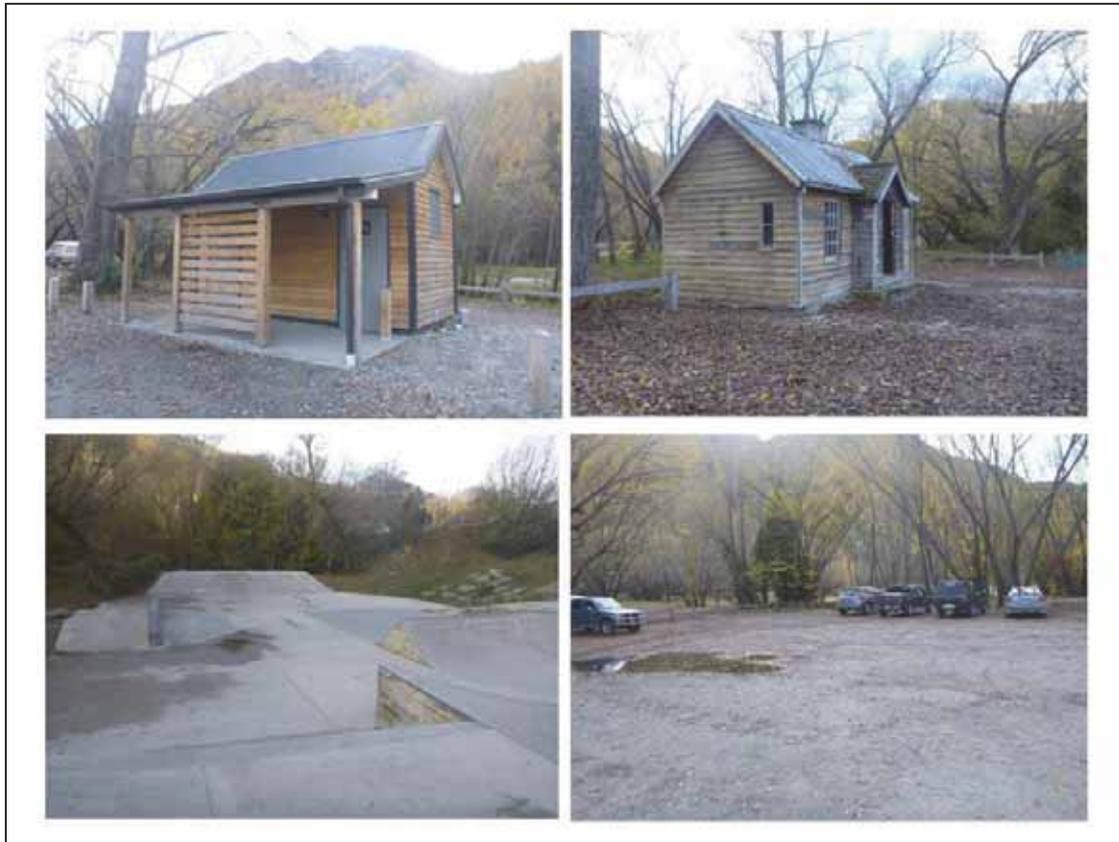
Figure 2. Assets and structures vulnerable to flood hazard. Top left: public toilet; top right: historic hut; bottom left: skatepark, Bottom right: public parking area (May 2012)

While the Arrowtown urban area is predominantly raised up above the Arrow River floodplain, there are still structures that can be inundated and damaged by flood water (Figure 2), including the local skate park, walkways, car-parks and the pipeline for the arrow irrigation scheme. Flood-protection work has been undertaken in the past on this section of the Arrow River, including reshaping of the channel to avoid erosion of the river banks and the management of willow trees along the bank (Strong, 2005). This work helps protect the car park and the recreational areas on the true right of the floodplain (Strong, 2005).

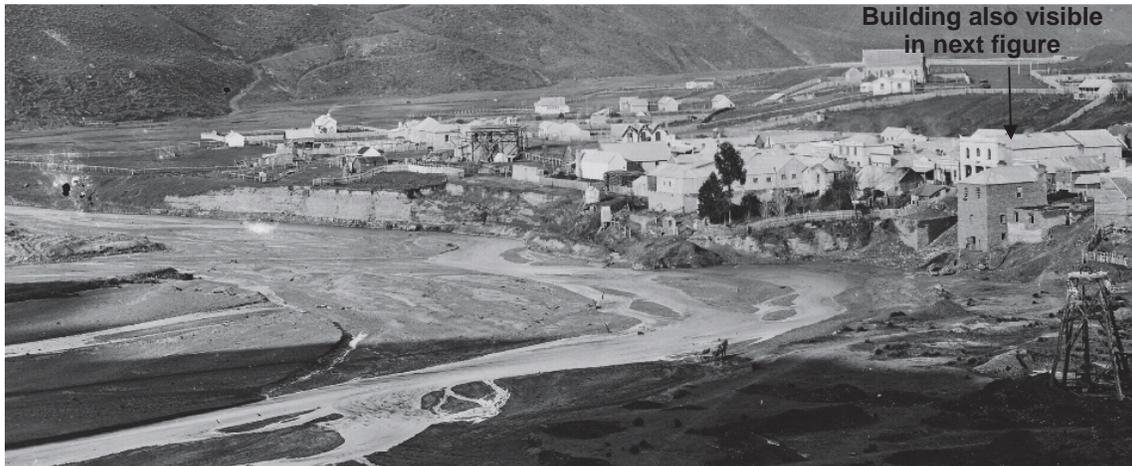
Figure 6. Arrow River and Arrowtown, sometime between 1867 and 1875. A multi-storeyed building shown in the centre of this image is also visible in Figure 7. (Source: Burton Brothers (photographers))

braided form. Figure 6 shows Arrowtown sometime between 1867 and 1875,² while Figure 7 shows this same area sometime in the early 1900s.

The two older photographs highlight the large amount of freshly deposited sediment located at this site, compared to the current setting. This sediment may be associated with the mining activities occurring on the Arrow River and its tributaries at this time. Active erosion of the raised terrace upon which Arrowtown lies is visible in the oldest photo (Figure 6). Other changes are also evident in the two photos, including changes in vegetation cover and the steepness of the terrace riser (bank between the raised terrace and the river bed).

In the past, the Arrow River has occupied the true-right side of the floodplain, and actively eroded the terrace riser (Figure 6, Figure 7), suggesting that the natural tendency of the river is to flow in this location. Bush Creek may also contribute to erosion of the terrace during a flood event due to its close proximity to the terrace riser.

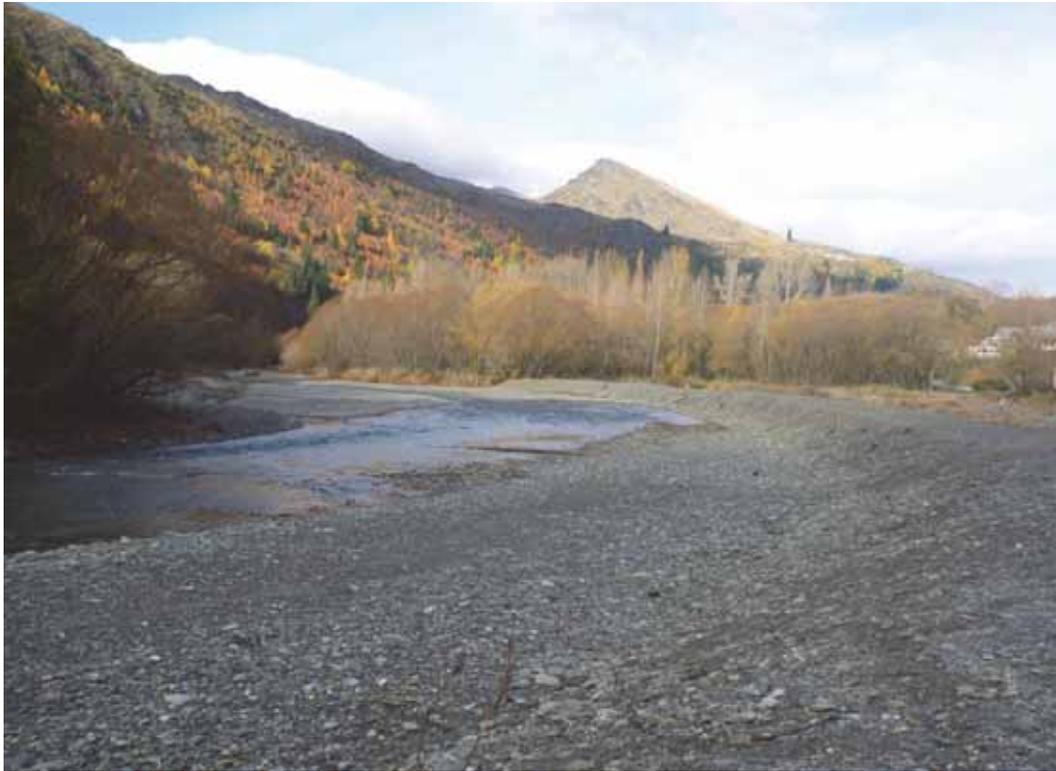
Figure 9. View downstream showing raised bund (right) and main channel (May 2012)

As it exits the gorge, the river is currently confined to the true left of the floodplain by a raised bund of loosely sorted river gravel (Figure 9, Figure 12). The ORC obtained resource consent (2004.A16) in 2005 to construct and maintain this bund, due to concerns raised by the local community. The consent for the bund expires in May 2015. The bund is intended to contain small- to medium-sized floods on the true-left (northern) side of the floodplain and prevent ongoing erosion or the deposition of fresh sediment at the base of the true-right terrace during such events. Before the construction of the bund, moderate-sized flood events could push the main channel towards the true-right side of the floodplain. An example is shown in Figure 8, where the main low-flow channel at cross-section 3 migrated 50m towards the right bank and filled in the previous channel between March 1995 and December 1996. This change is likely associated with the flood of December 1995 and helps to illustrate the dynamic nature of this part of the Arrow River floodplain.

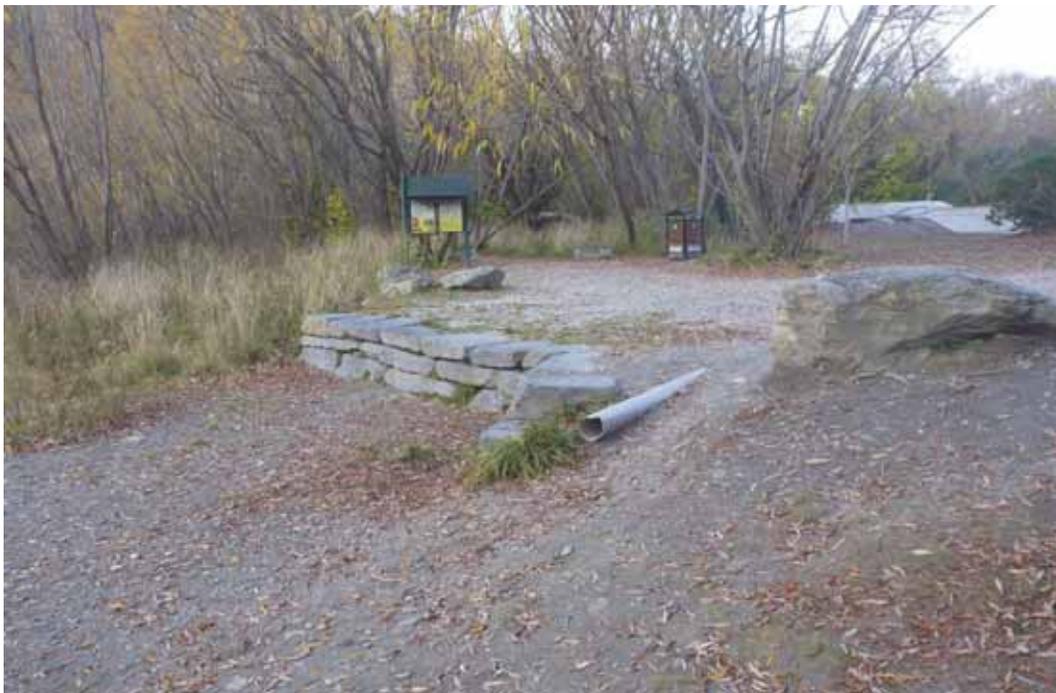
Figure 10. View of the true-right side of the Arrow River floodplain, in the vicinity of the skate park (May 2012)

The Arrow River continues to form a relatively wide (compared to the rest of the catchment) shingle bed as it exits the gorge upstream of Arrowtown. This shingle bed continues downstream for another 300m (Figure 9) before once again becoming more confined in the vicinity of Nairn Street (Figure 12). The true-right side of the floodplain is now well vegetated in parts and has a more stable appearance because of the smaller number of flood events that affect this area (due to the existence of the bund) and the work that has been undertaken to improve the recreational and visual amenity of this area (Figure 10).

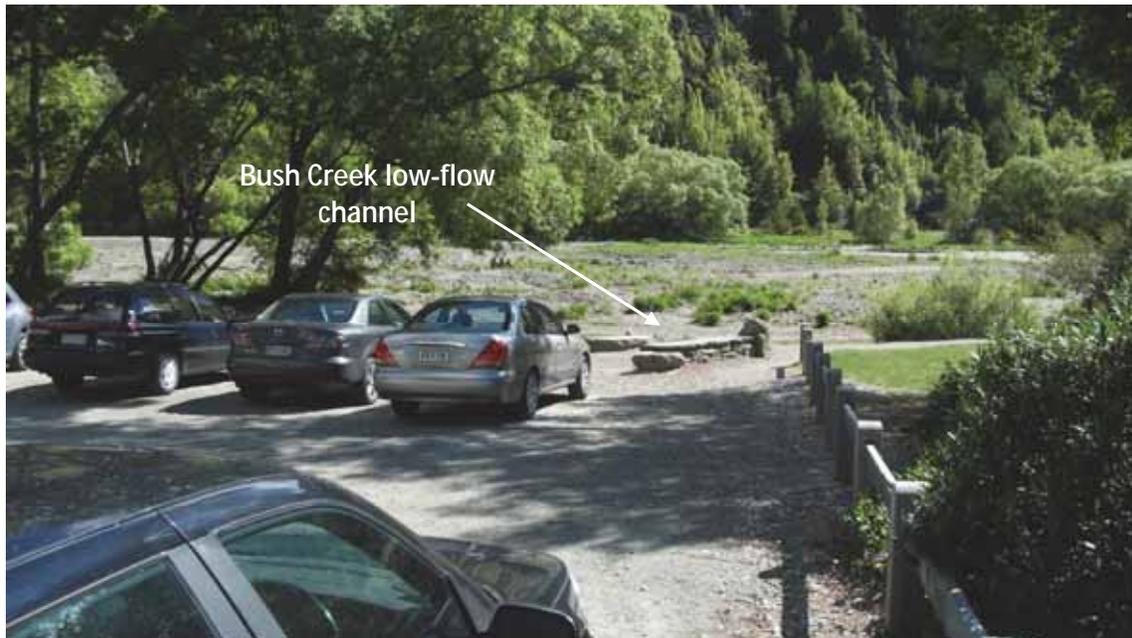
Figure 15. Top: cross-section 3, looking downstream, showing the modelled 1:100-year flood level. Bottom: view from true right to true left at cross-section 3, showing the Bush Creek low-flow channel and the carpark (November 2011)

The water levels associated with the modelled flood event described above⁷ are shown for each cross-section in Figure 13 to Figure 17 below. Once floodwater occupies the wider flood channel, it can move unpredictably across the flatter terrain, although the depth of water will be deeper in the main channels of the Arrow River and Bush Creek, and any older

stream channels/depressions. As shown in the figures below, the depth of water across the floodplain during the modelled flood event ranges from shallow (e.g. 0.2m in the vicinity of the skate park at cross-section 2/3) to more than 1m deep (e.g. in the vicinity of the Bush Creek low-flow channel at cross-sections 3/1 and 3). Figure 18 shows that if floodwaters have minimal velocity, wading (for an adult) becomes unsafe at a depth of about 0.8m, and vehicles can become unstable at 0.3m. As velocity increases, the effects of flooding start to become significant for vehicles, people and structures at an even shallower depth.⁸

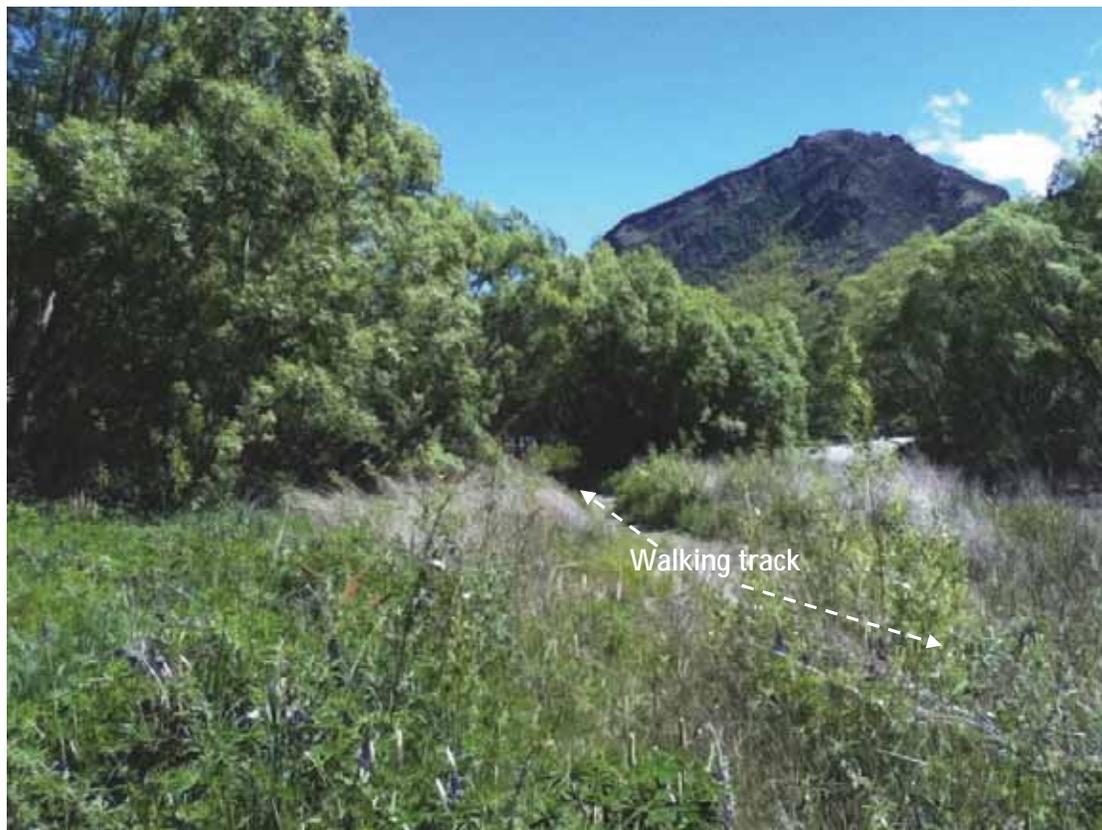
Figure 17. Top: cross-section 2/2, looking downstream, showing the modelled 1:100-year flood level. Bottom: view upstream from cross-section 2/2, showing the walking track (November 2011)

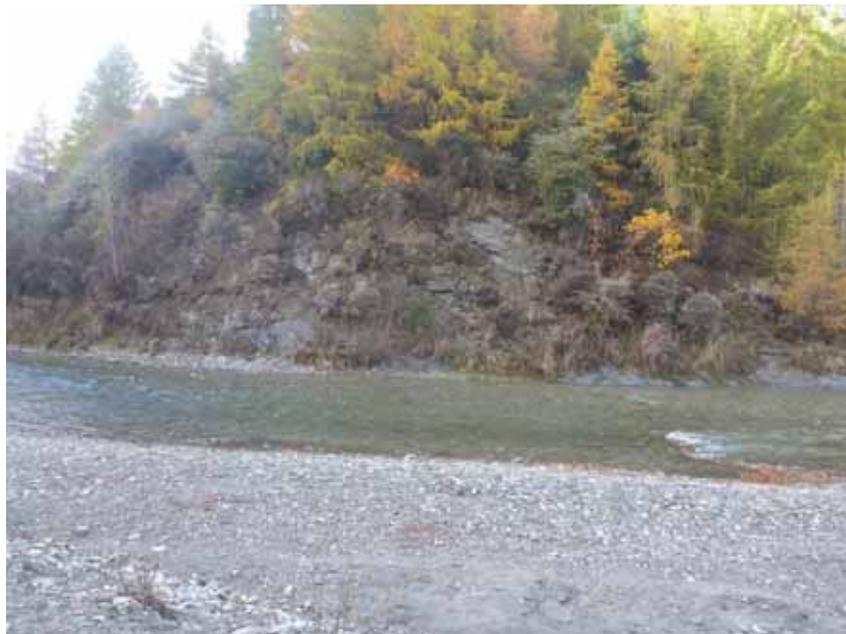
Figure 21. Bedrock banks on the true-left bank, cross-section 4, May 2012

MBL at cross-section 4 lowered by about 0.2m between 2006 and 2011, continuing the trend that has been observed since 1987. The bund moved to the right by about 2.6m and has lowered to about 0.25m over the same period. There has been minimal bank erosion at this location due to the river being confined between steep bedrock banks as it exits the gorge onto the wider floodplain.

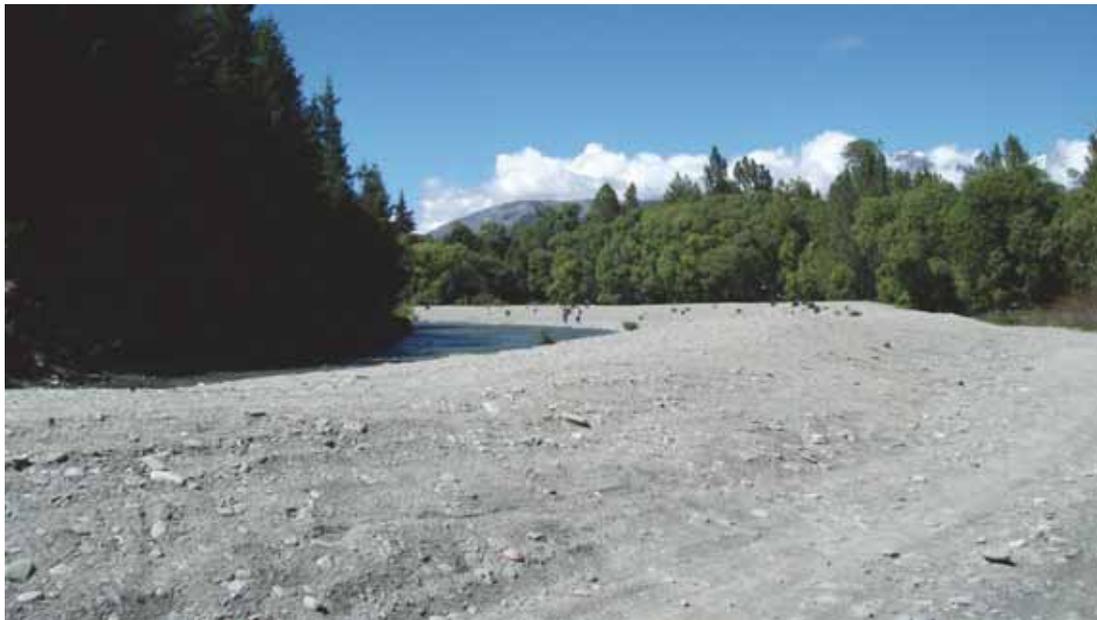
Figure 23. Looking downstream from cross-section 4, November 2011

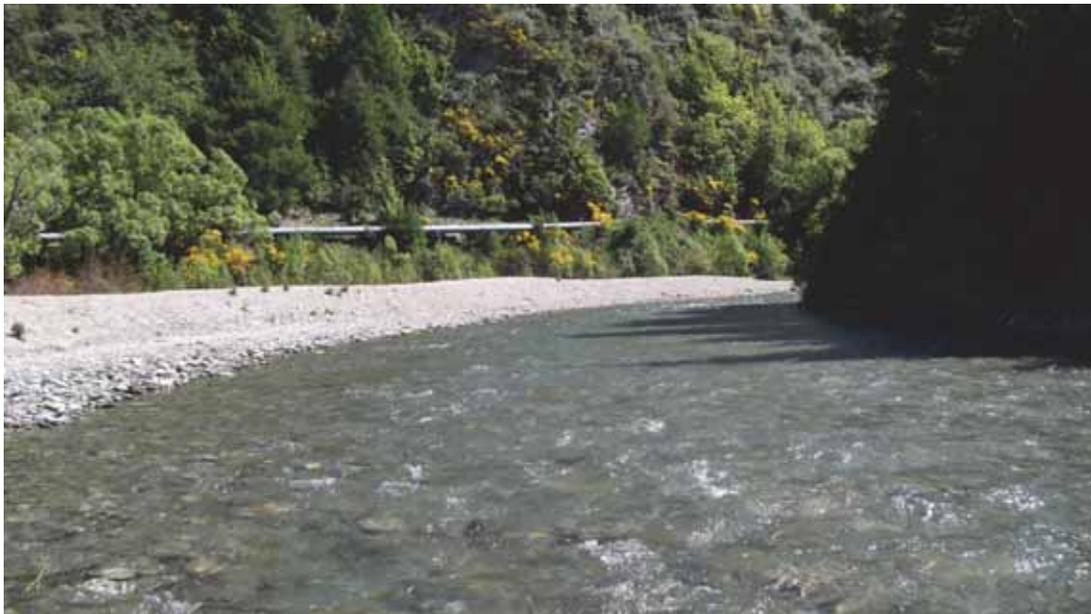
Figure 25. Cross-section 3/1 looking upstream, November 2011

The artificial bund was created in 2005 forcing the Arrow River to the true left of the floodplain. The channel has widened towards the right bank between 2006 and 2011 due to the bund being reshaped. There was an overall trend of bed-level degradation in the Arrow River between 2001 and 2011, and there was limited bank erosion of the true-left and true-right banks.

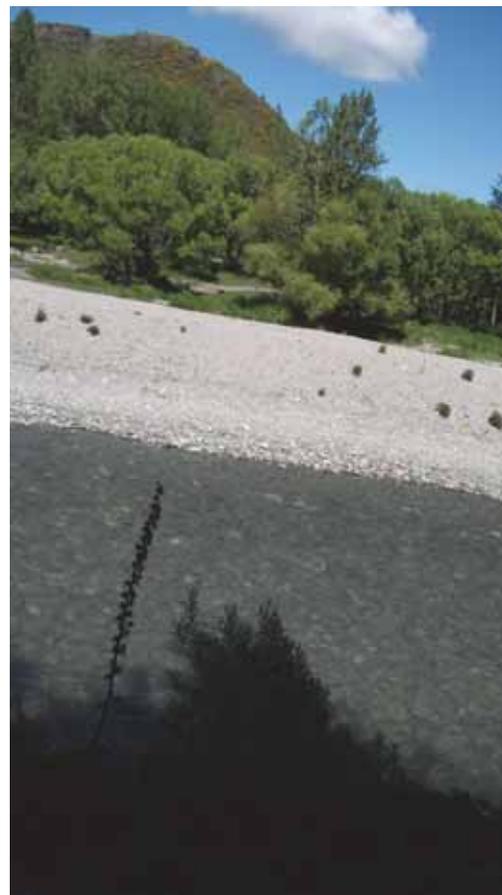
Figure 27. Cross-section 3/1, looking from the true-left to true-right bank, November 2011

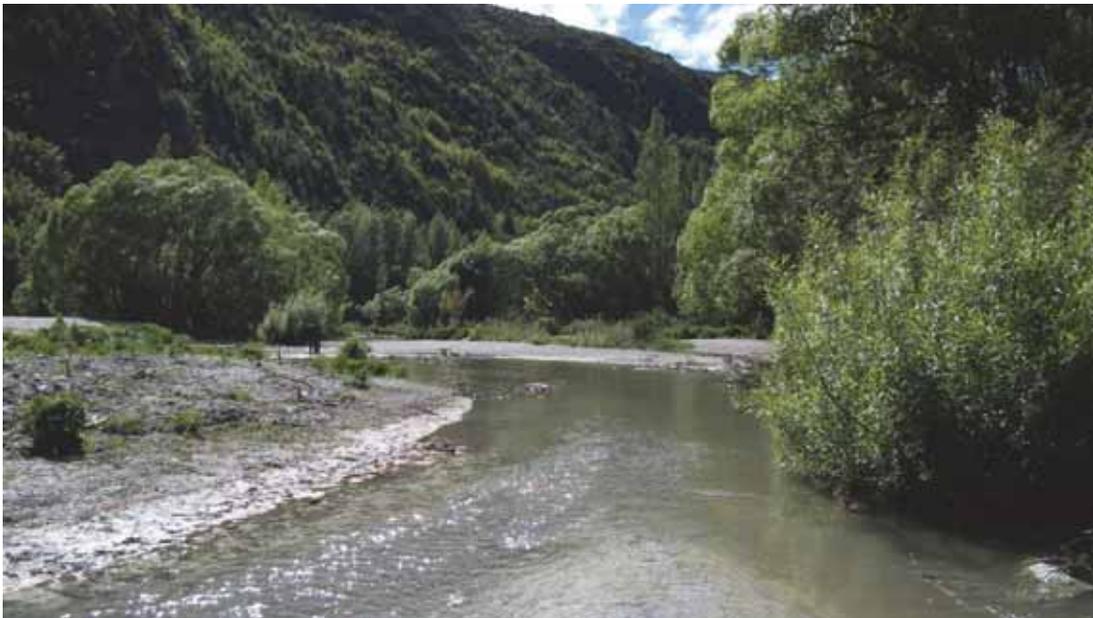
Figure 29. The Bush Creek low flow channel part of cross-section 3, looking downstream, November 2011

There has been degradation of the Arrow River channel between 2001 and 2011 at cross-section 3. A decrease in MBL of 1m occurred between 2001 and 2011, indicating long-term degradational processes. The bund was increased in height by about 0.25m between 2001 and 2011, and limited bank erosion was observed during this time.

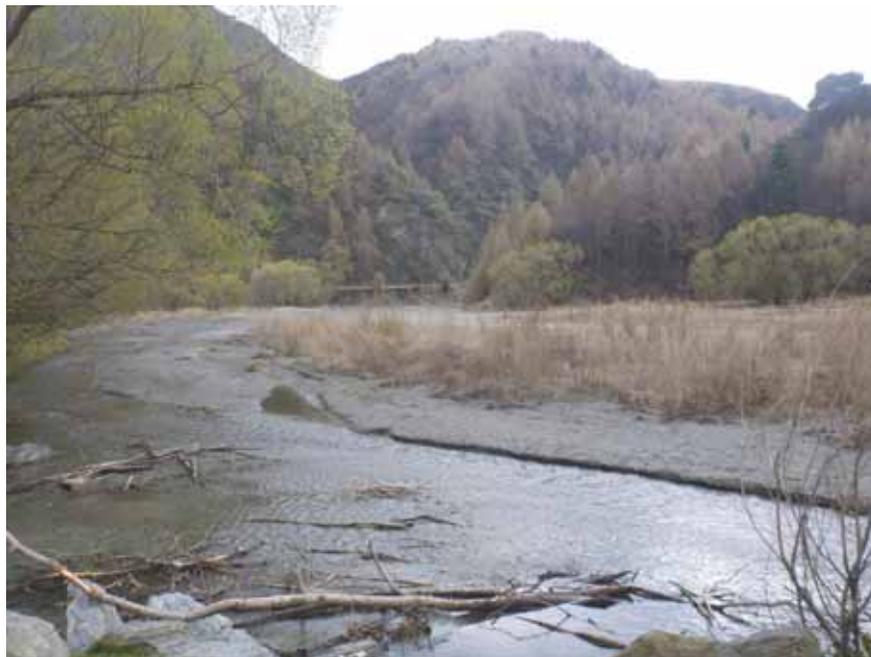
Figure 31. The Bush Creek low-flow channel part of cross-section 3, looking upstream, September 2014

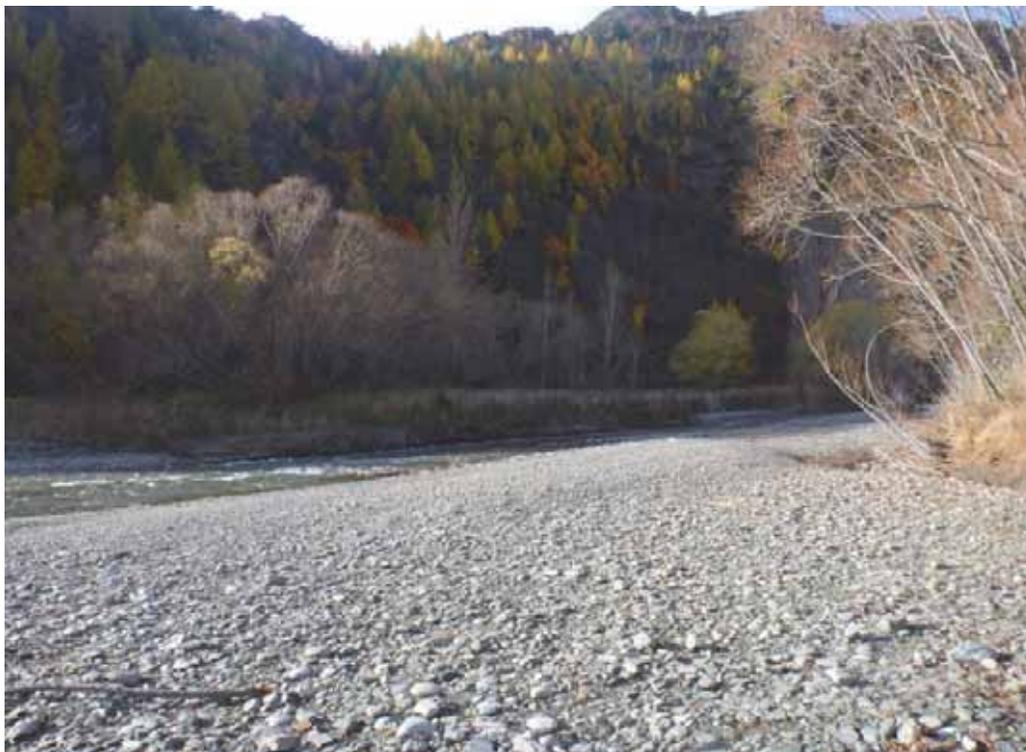
Figure 36. Looking downstream from below cross-section 2/2, May 2012

As at cross-section 2/3 upstream, the Arrow River and Bush Creek channels degraded between 2001 and 2011 at section 2/2, continuing a trend that has been observed since 1987 and indicating that long-term degradation is taking place at this location. There has been little lateral movement in the Arrow River thalweg between 2006 and 2011. However,

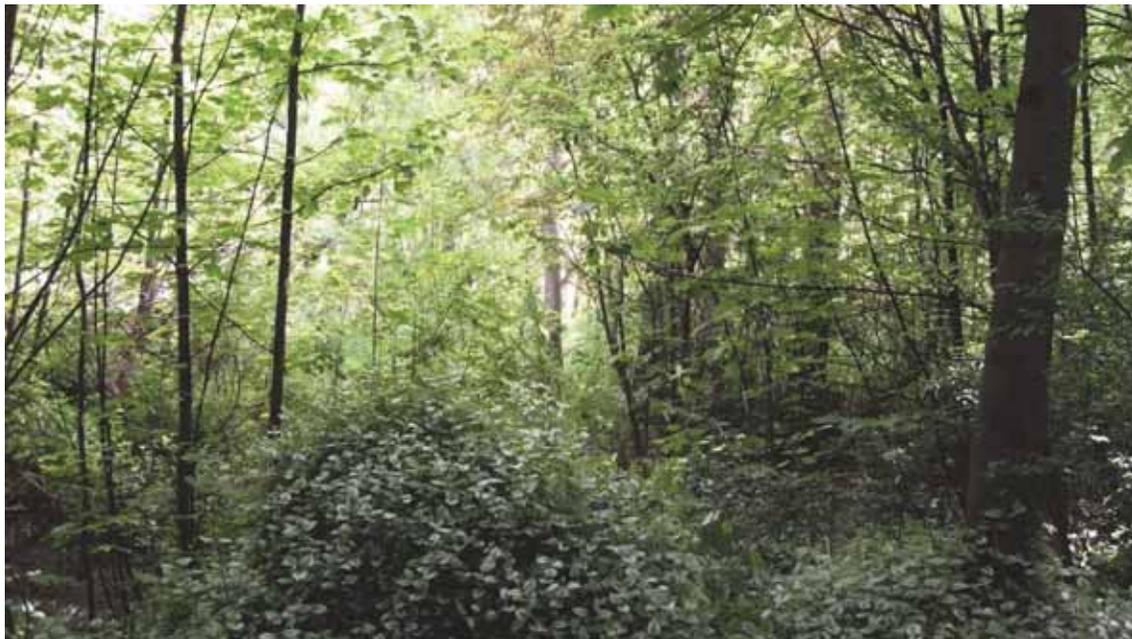
Figure 38. View of the well-vegetated, true-right part of the floodplain at cross-section 2/2, November 2011
