Natural hazards in Glenorchy

Summary Report May 2010

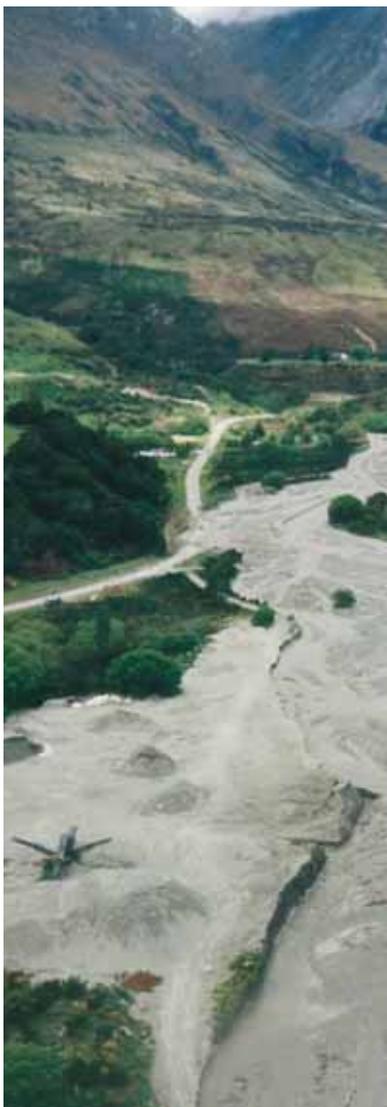
Lower Buckler Burn November 1999.

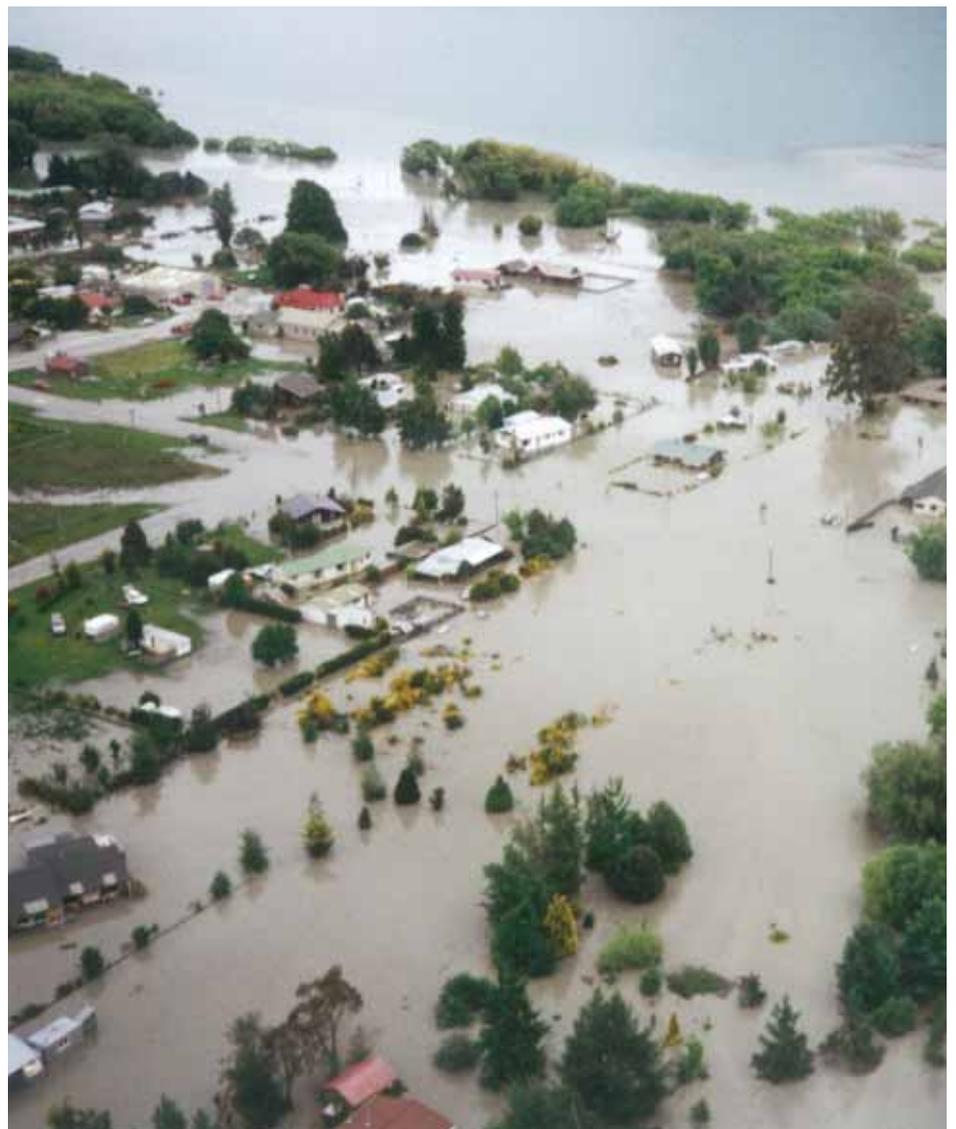
The lower margins of Glenorchy showing lake inundation on 19 November 1999.

Inundation from high lake levels, as seen in the November 1999 flood event, is a risk due to the lake remaining at high levels for prolonged periods, usually days to weeks. The lower parts of Glenorchy begin to be inundated when the lake level reaches 311 metres above mean sea level. This level is approximately 1 metre higher than the annual average lake level of 310 metres. The nature of lake flooding and how the community can cope with the associated effects are described in a joint strategy prepared by Otago Regional Council and Queenstown Lakes District Council (ORC & QLDC, 2006).

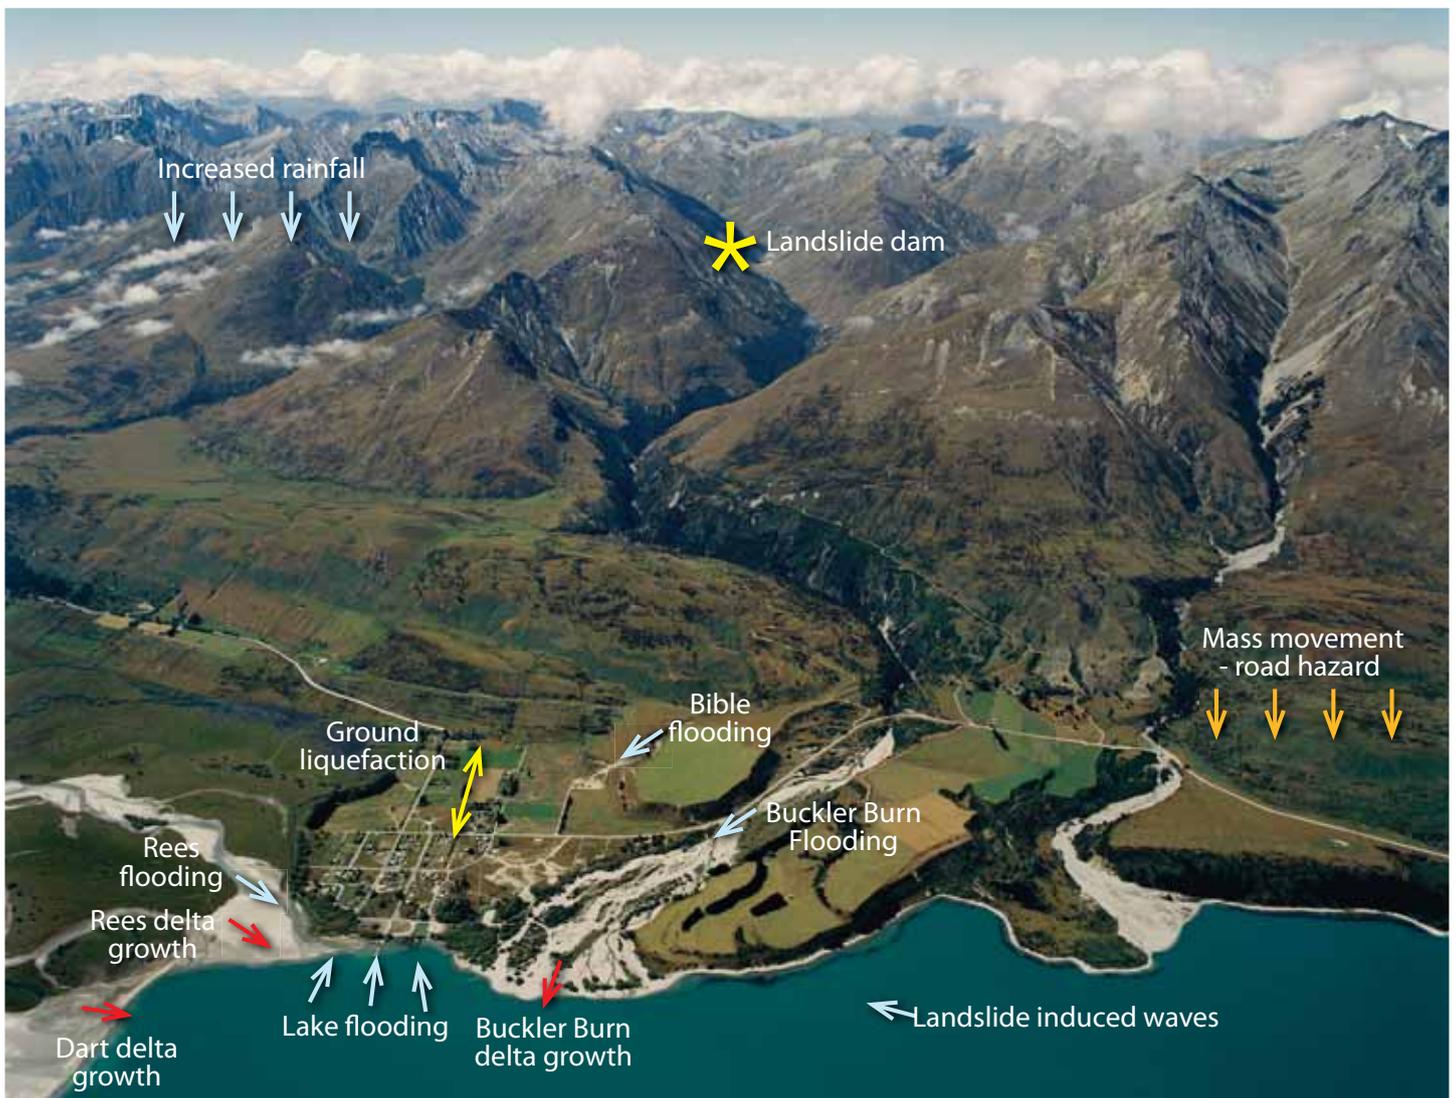
Figure 1: Glenorchy and its surrounding hazardscape (Background image courtesy of GNS Science).

Glenorchy and its surrounding environment have a complex hazard setting (Figure 1). The township is at risk of inundation from high lake levels, as well as debris flows and flooding from the Buckler Burn, Bible Stream and the Rees and Dart Rivers. Mass movement and earthquake - related hazards also have the potential to affect not only the township, but infrastructure and access routes that the community is dependent upon.

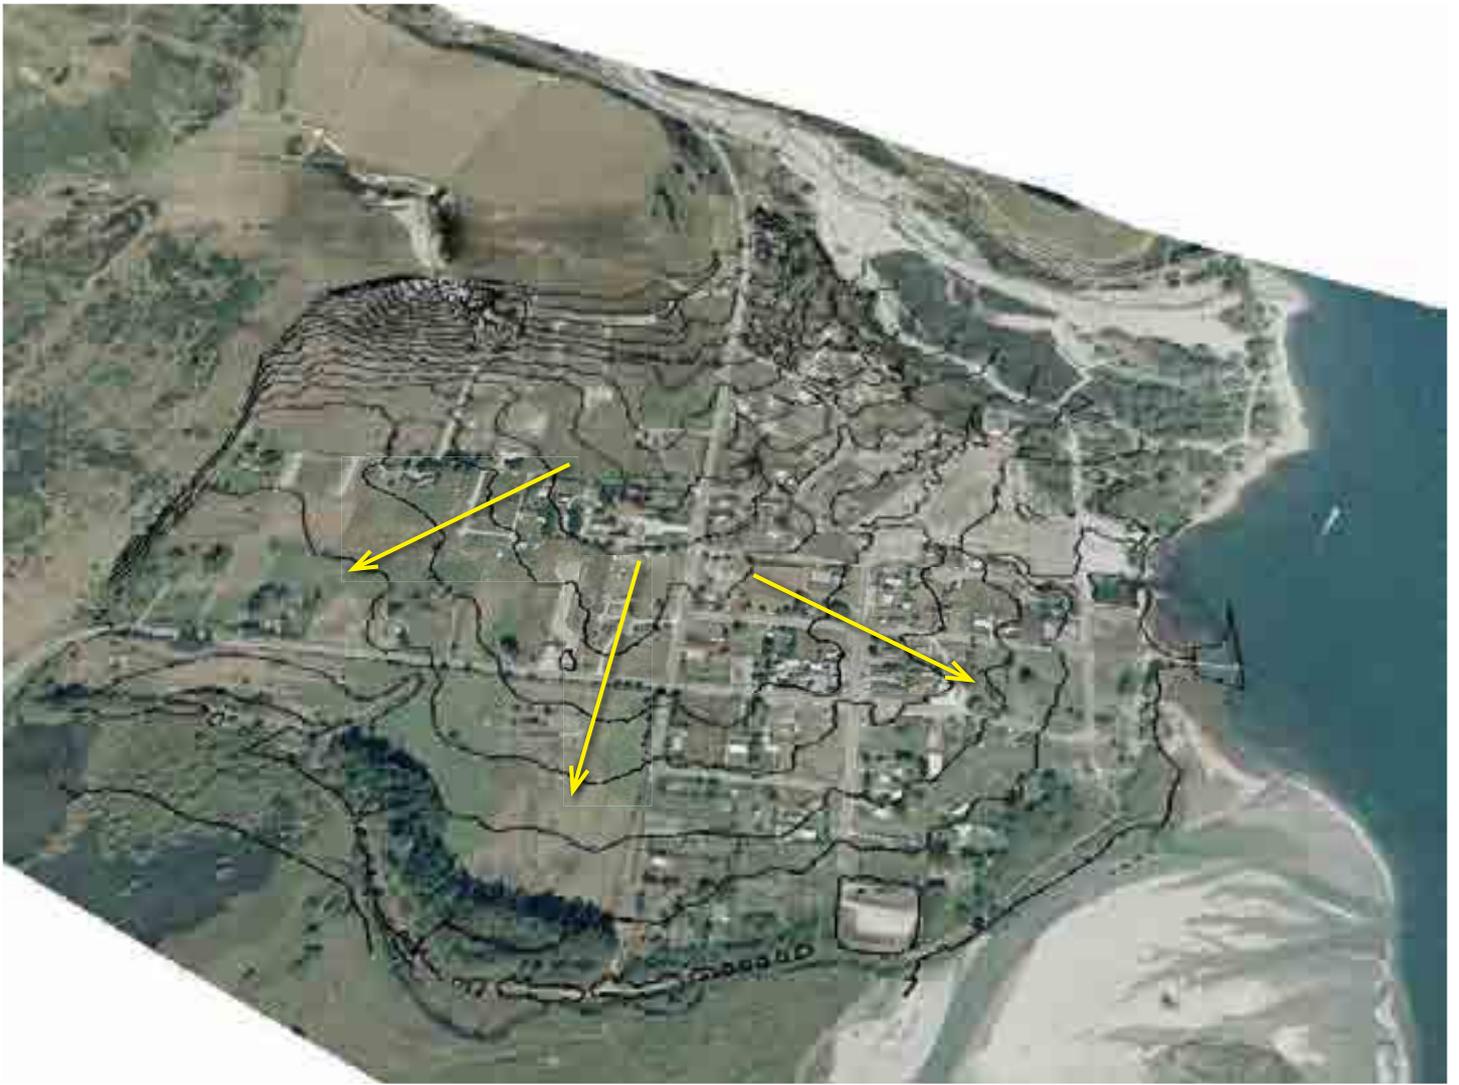
Figure 3: Digital Elevation Model and contour information representing the underlying topography of Glenorchy; yellow arrows indicate the slope of the land.

The highest part of the alluvial fan is the section of the township located beside the main Queenstown – Glenorchy road. The land slopes away on either side of this higher section; towards the lake to the west, and towards the Richardson Mountains to the east (Figure 3). It is these lower-lying areas which can be most affected by floodwaters, either from lake or river flooding.

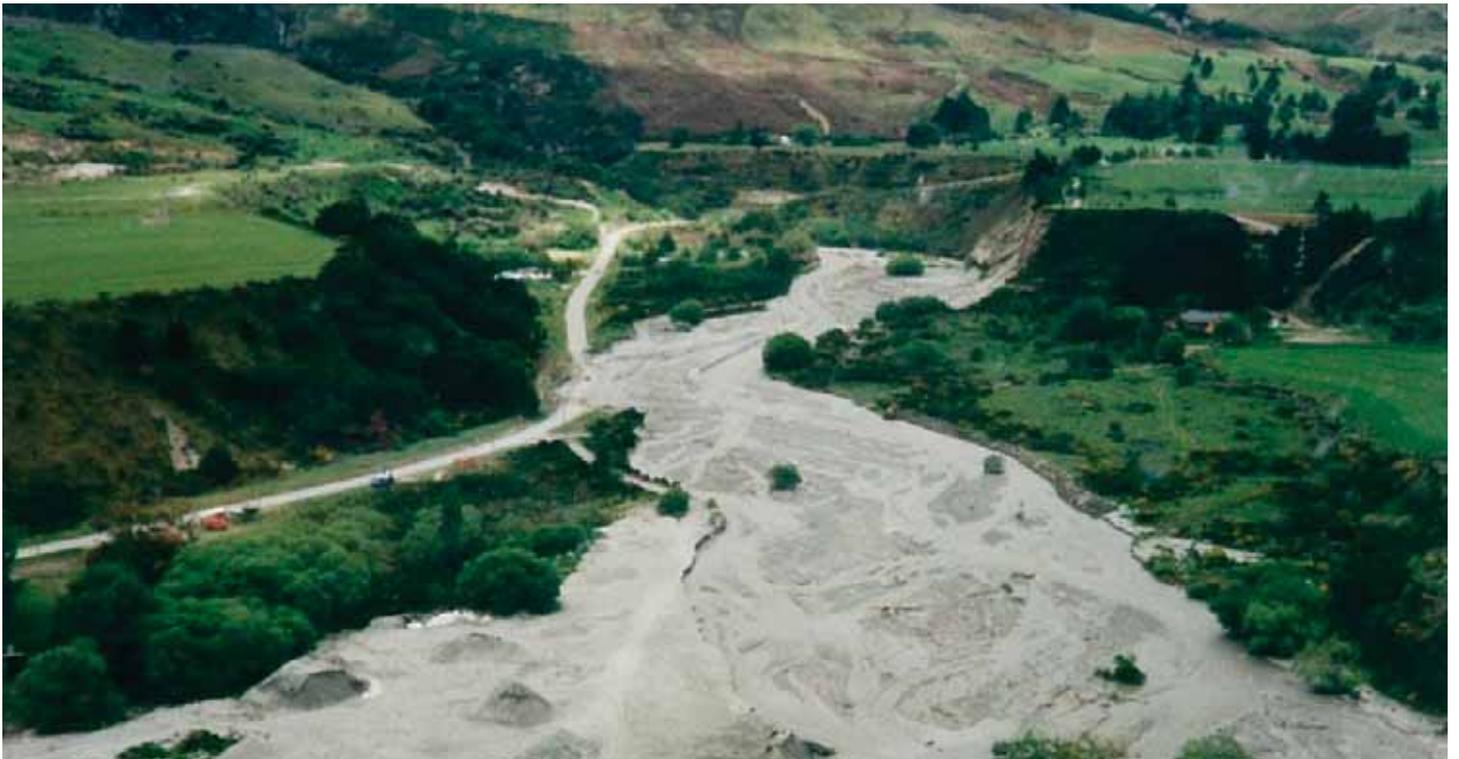
Figure 4: The lower Buckler Burn showing significant sedimentation following the November 1999 flood event.

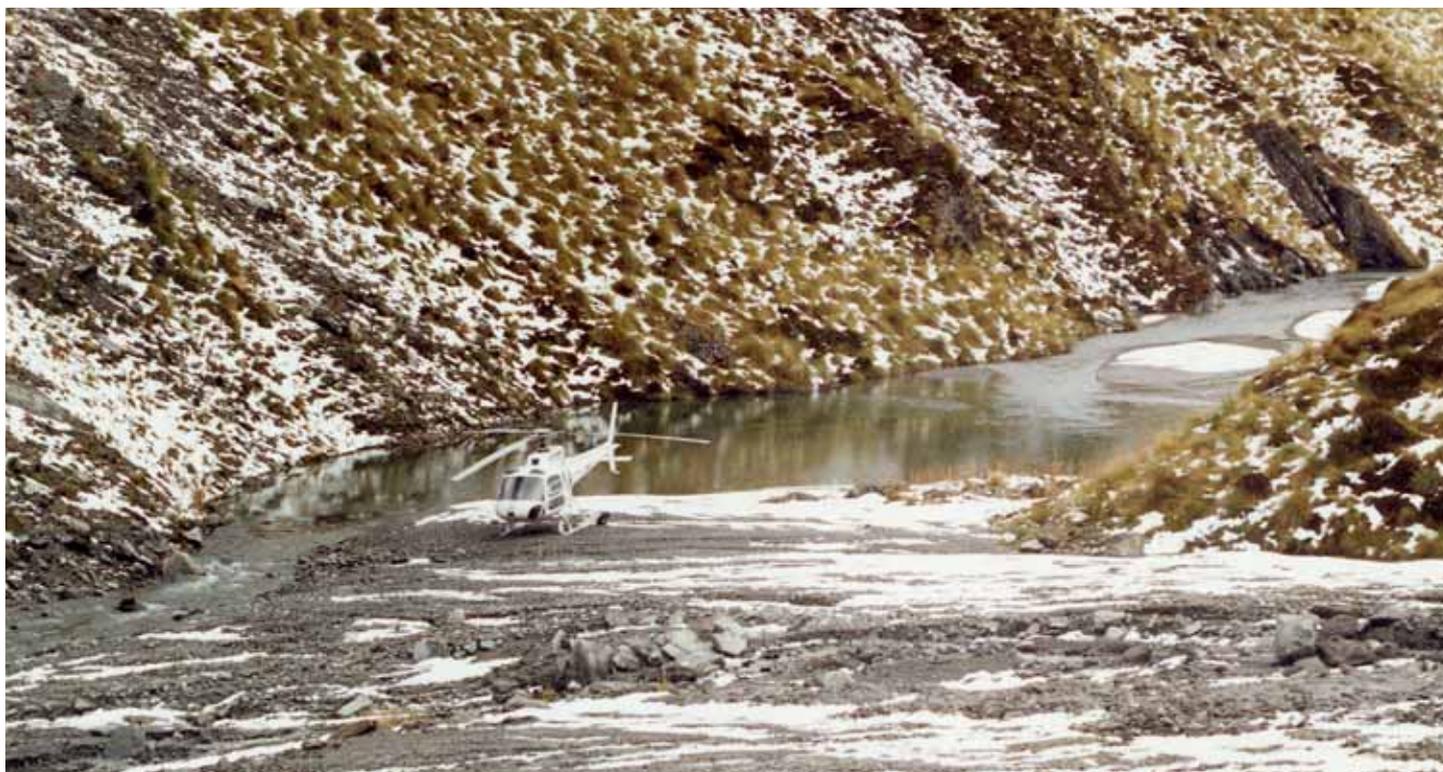
Figure 5: The Buckler Burn Landslide Dam in 2004 looking upstream.

Flooding from the Rees River, the Buckler Burn and the Bible Stream also have flood hazards that may impact Glenorchy. The Rees River and Buckler Burn deltas are steadily advancing into Lake Wakatipu. As these features continue to advance they are expected to combine into one large delta complex, raising the level of the river bed adjacent to Glenorchy and possibly causing the Rees River to alter its course towards the township. Also, large amounts of sediment from the Buckler Burn can raise its bed significantly (Figure 4) and could cause the channel to flow down the main road towards Glenorchy. A landslide dam in the upper Buckler Burn catchment (Figure 5) was discovered in 2004.

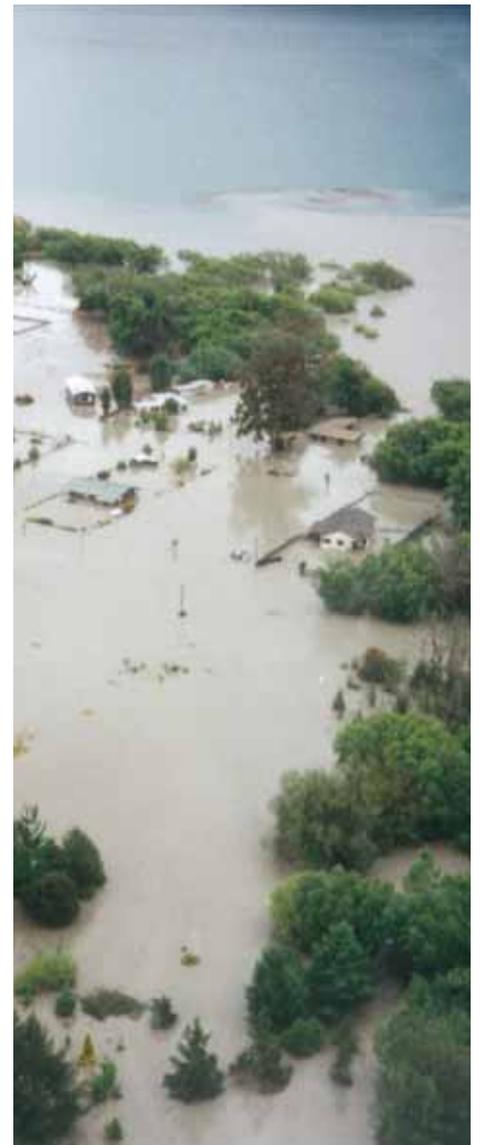
The lower margins of Glenorchy showing lake inundation on 19 November 1999.

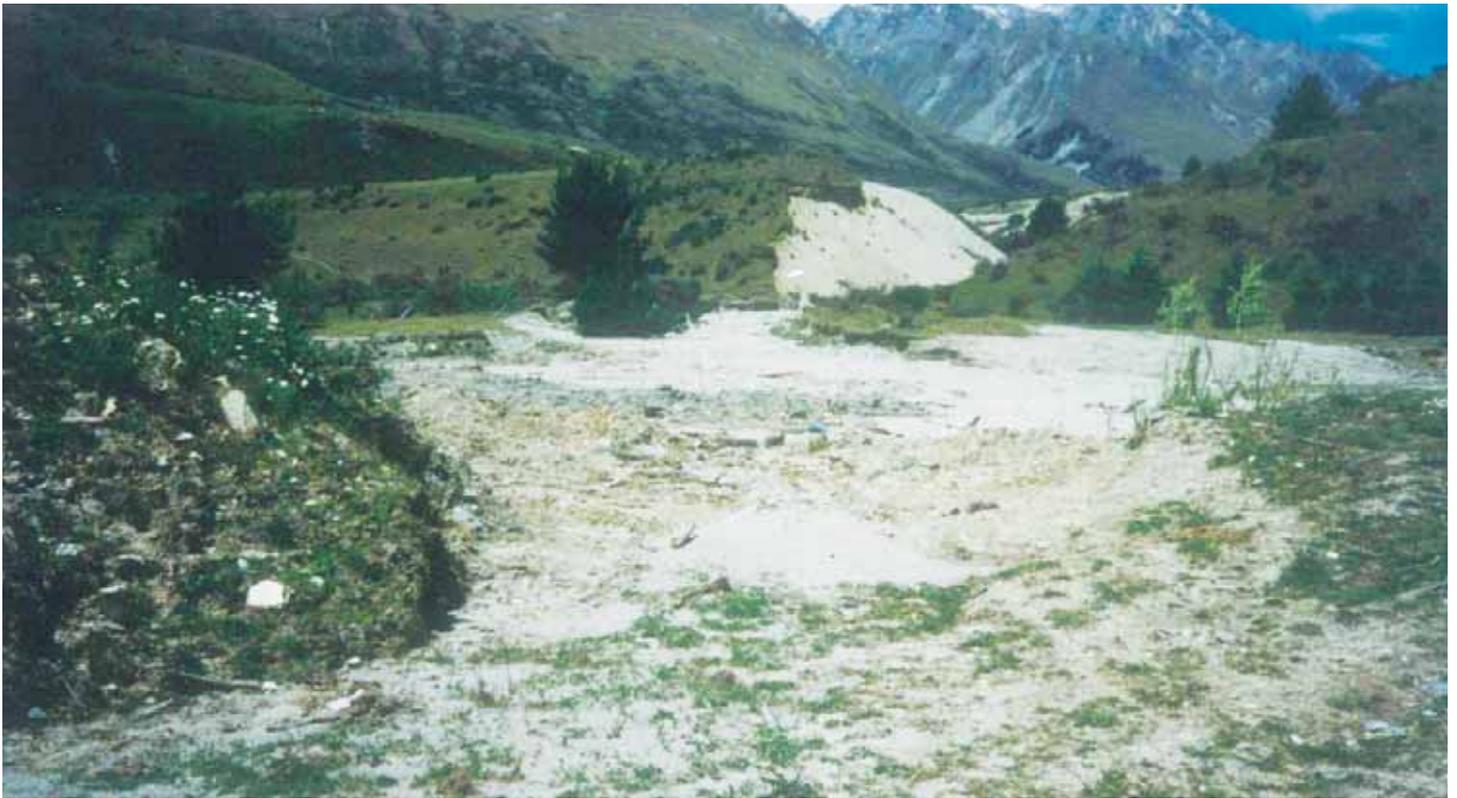
Sedimentation resulting from the November 1999 flood event across the Bible Stream alluvial fan.

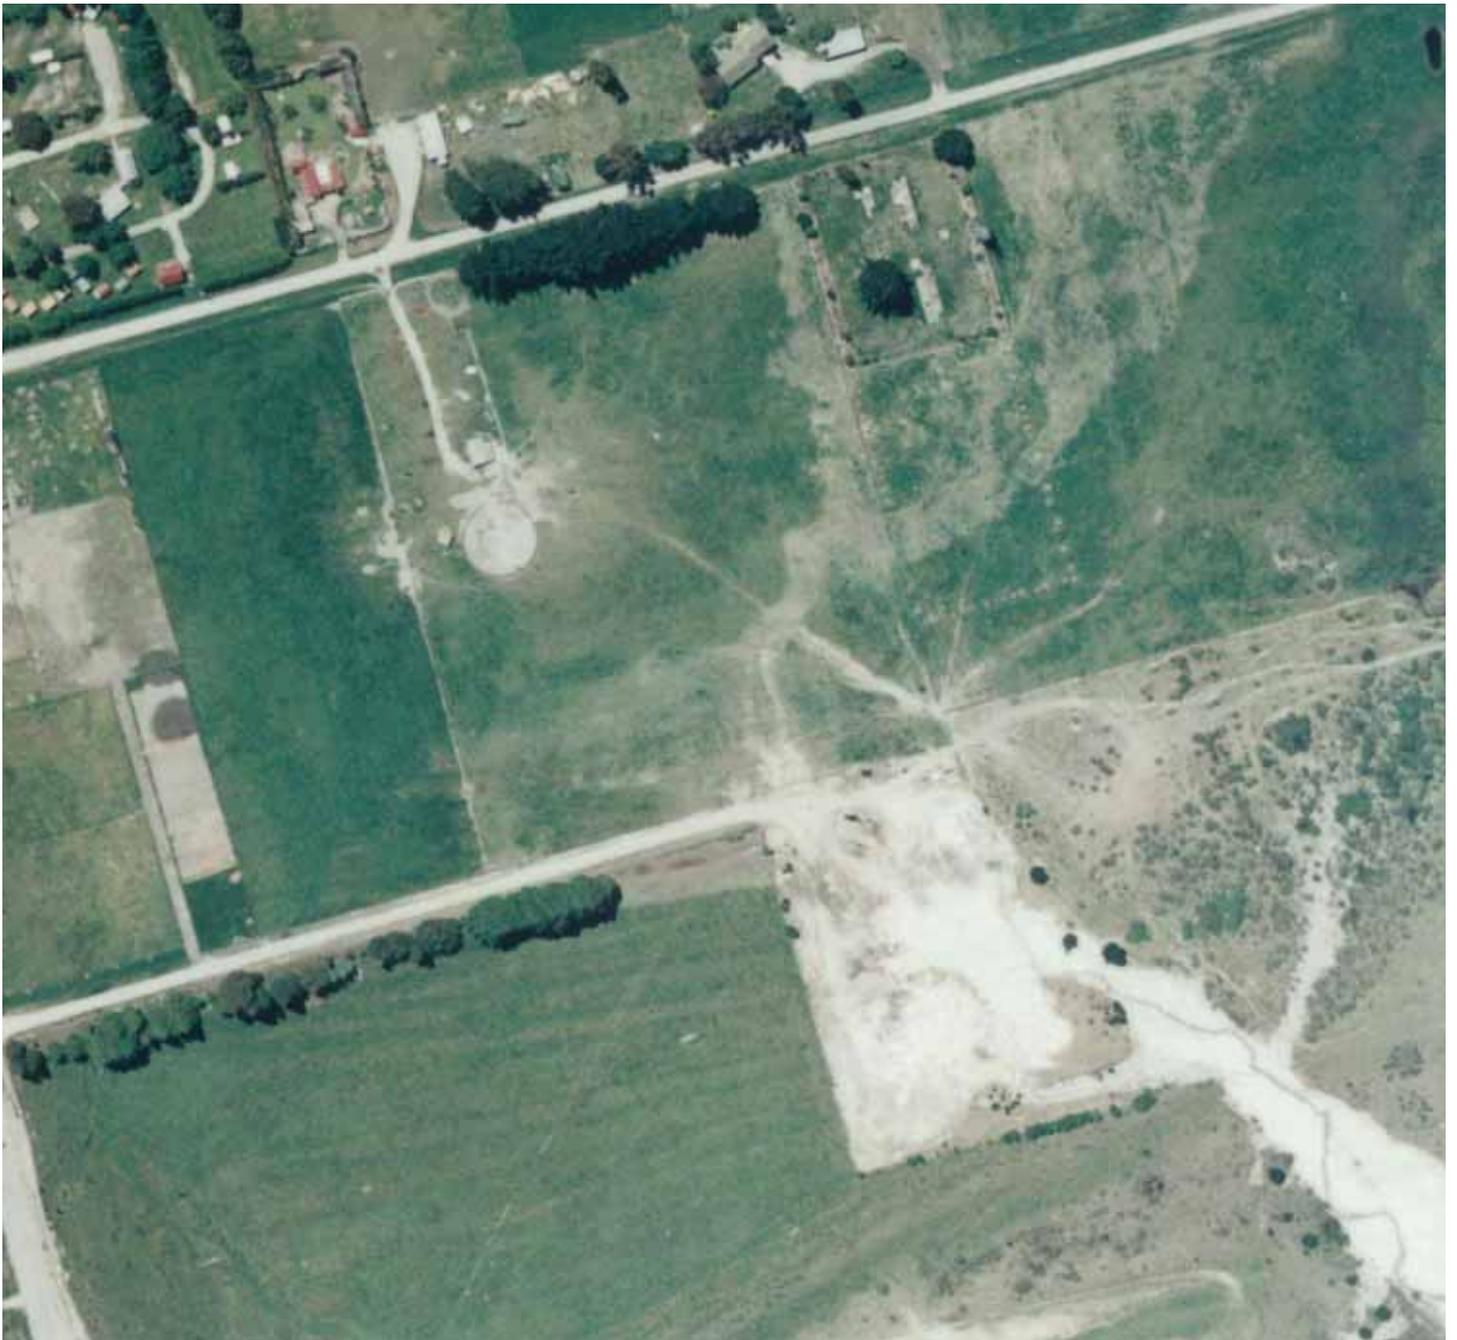
Sedimentation resulting from the November 1999 flood event across the Bible Stream alluvial fan.
