Waste Futures – Green Island Landfill Closure

**Groundwater Technical Assessment –
October 2024 Update**

Dunedin City Council

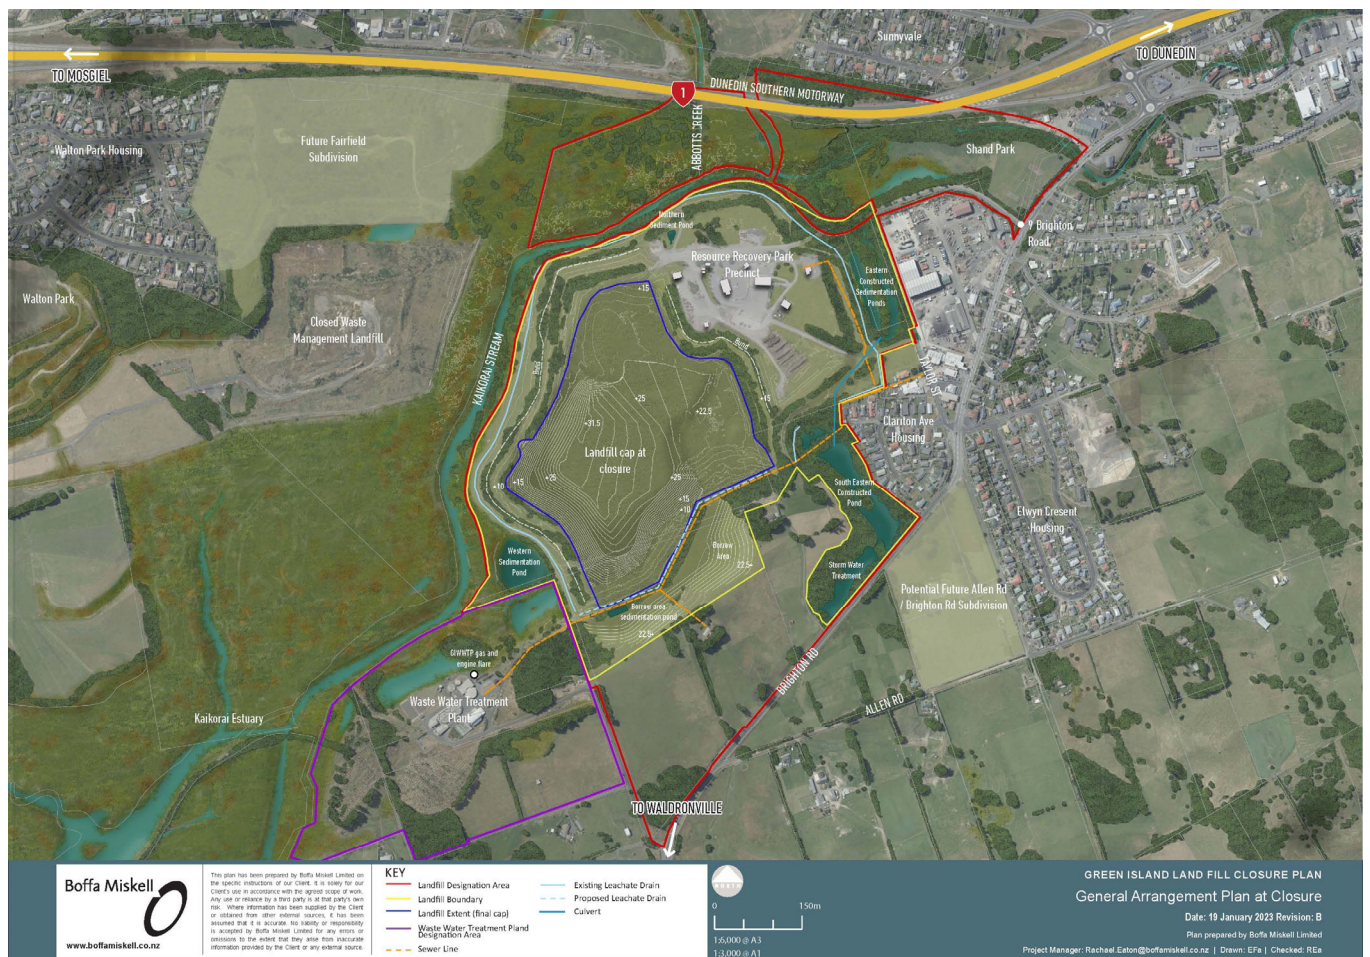
Figure 2.1 Site Layout

The Green Island Landfill site is located in the suburb of Green Island, approximately 8.8 km by road southwest of Central Dunedin. The landfill site comprises a total area of 75.6 Ha. The site is generally bound by State Highway 1 to the north, the Kaikorai Stream and Estuary to the west, the Green Island Wastewater Treatment Plant (GIWWTP) to the southwest, Brighton Road to the south, and the Clariton Ave residential area and Brighton Road industrial area to the east.

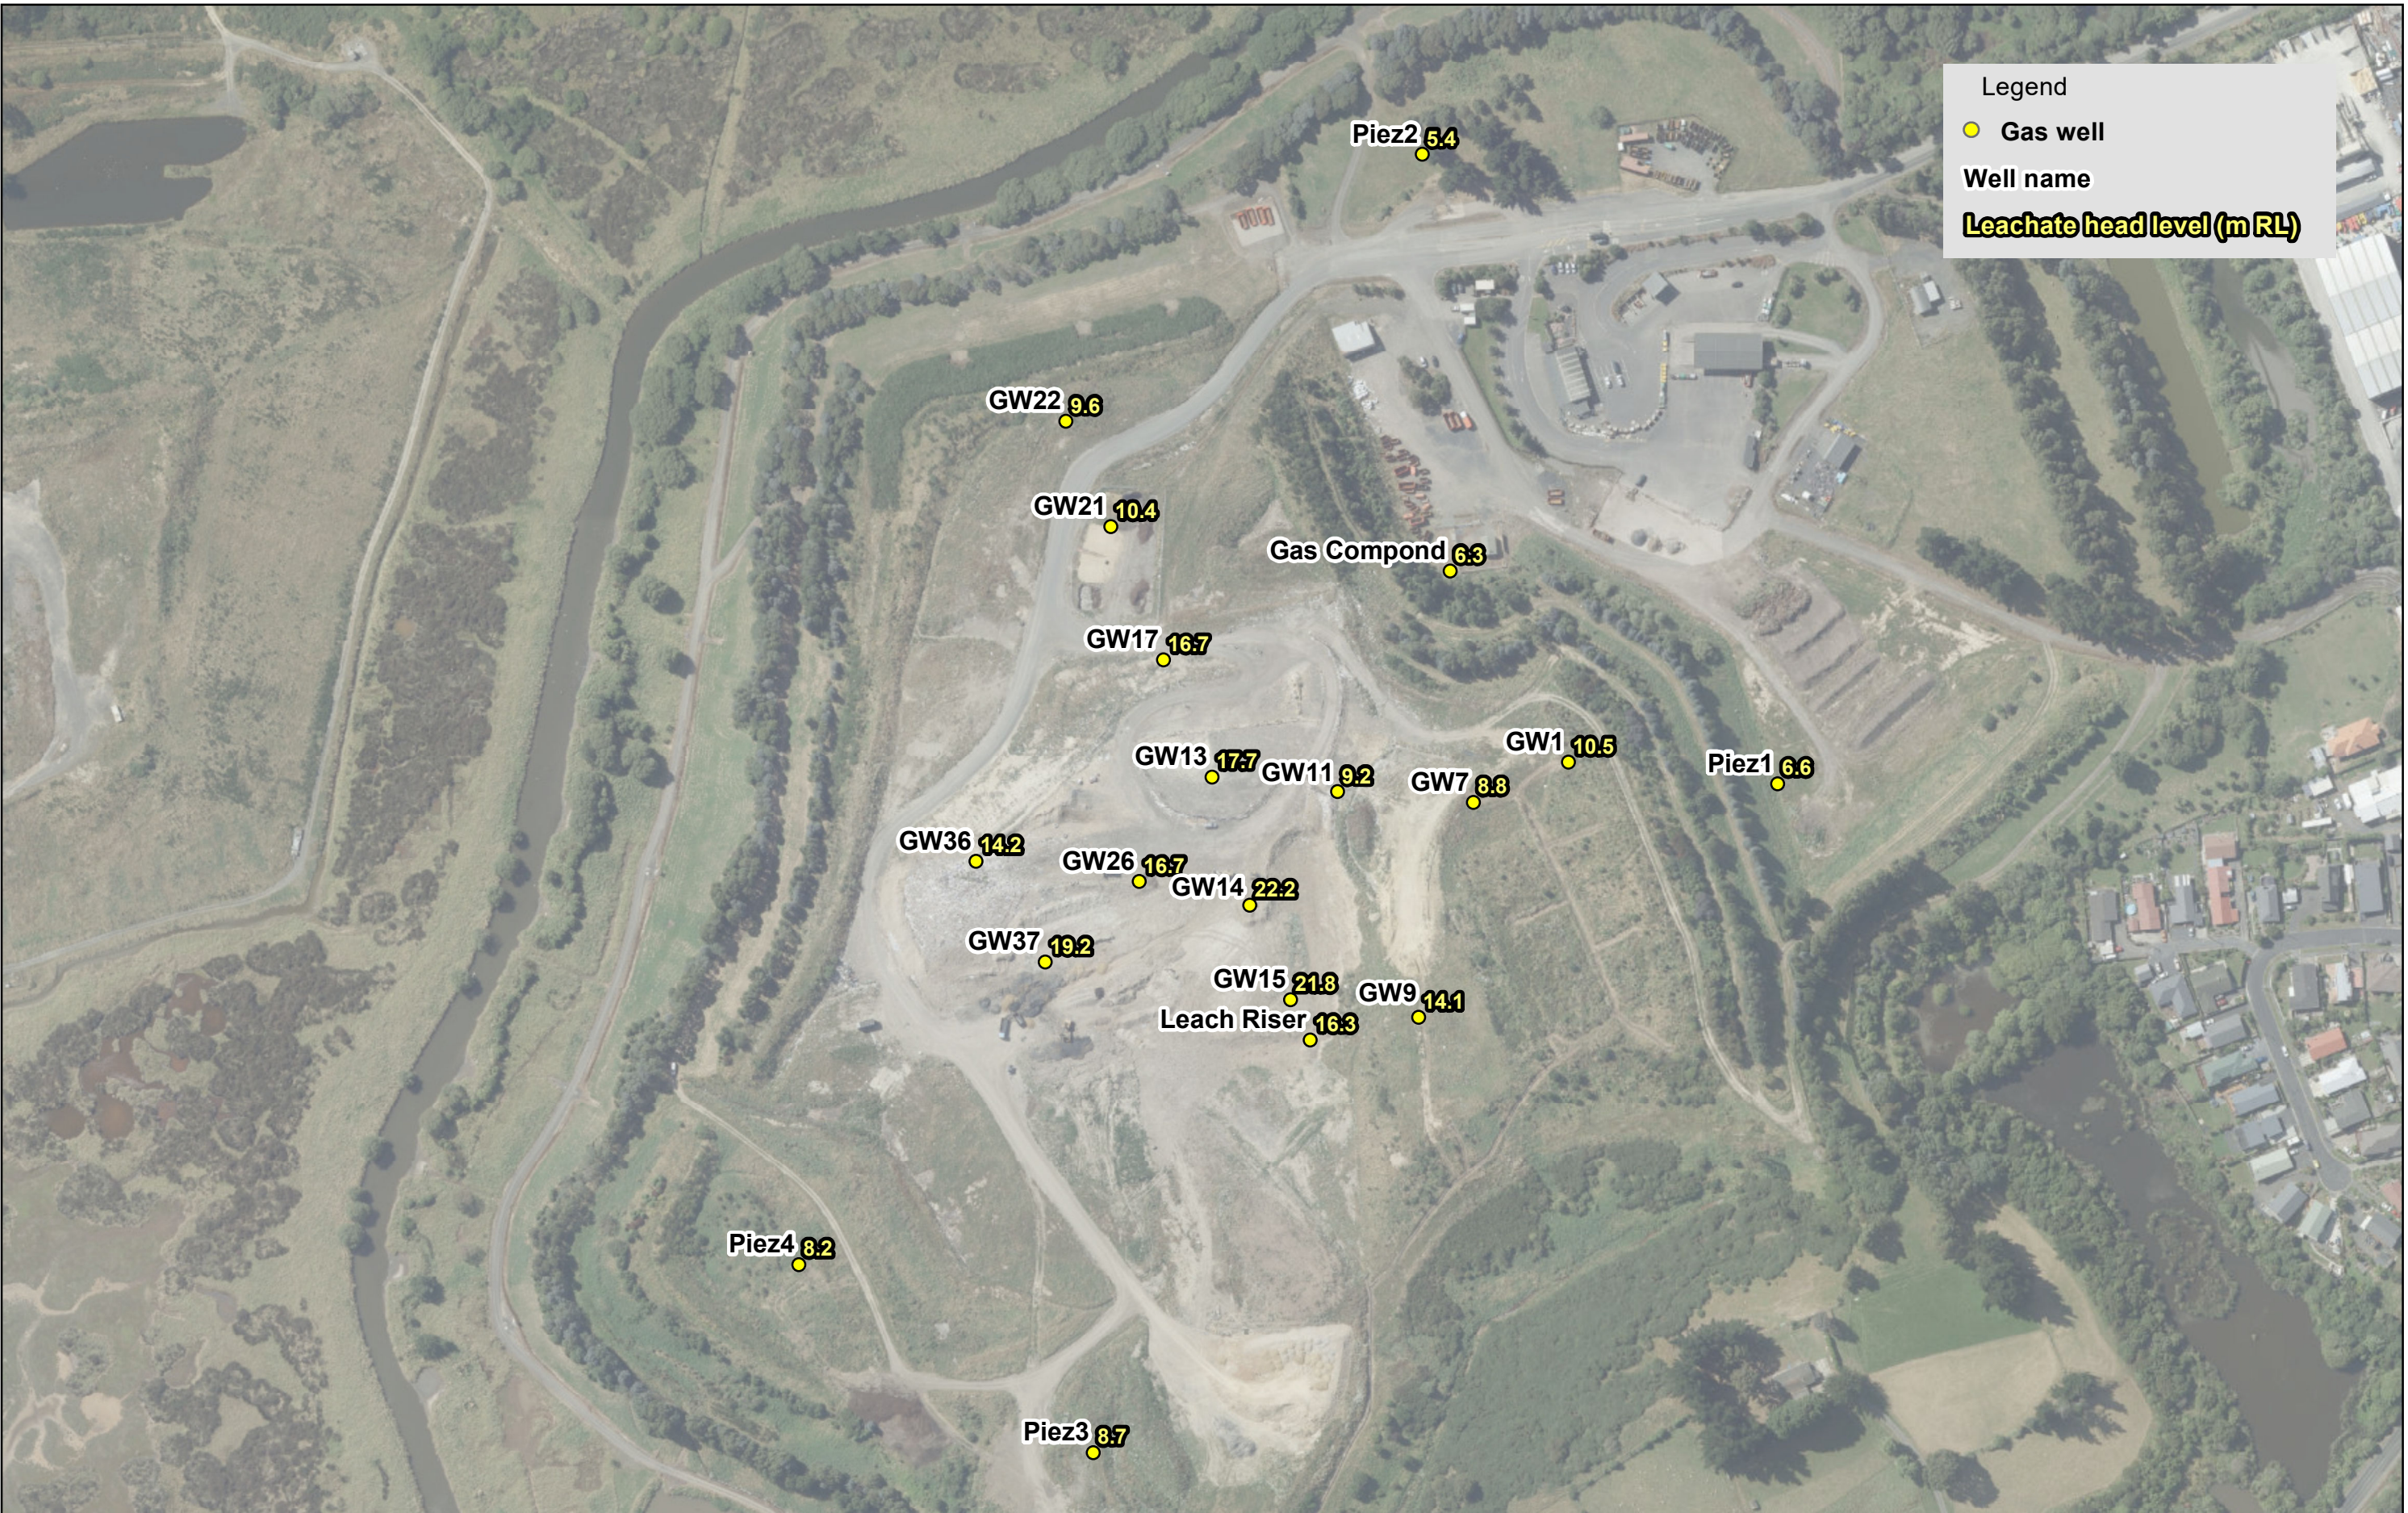
Figure 2.17

Leachate levels were measured in the landfill by dipping existing gas wells and groundwater monitoring wells within the landfill footprint. The leachate survey was completed in August 2022 by a site contractor. These data are included in Appendix D and shown in Figure 2.17. There is some variability in leachate measurements, this is likely due to the heterogeneity of the fill. As of August 2022, the leachate level in the centre of the landfill is on average 16 or 17 amsl over completed areas of landfill and cap, with two wells over 20 m amsl.

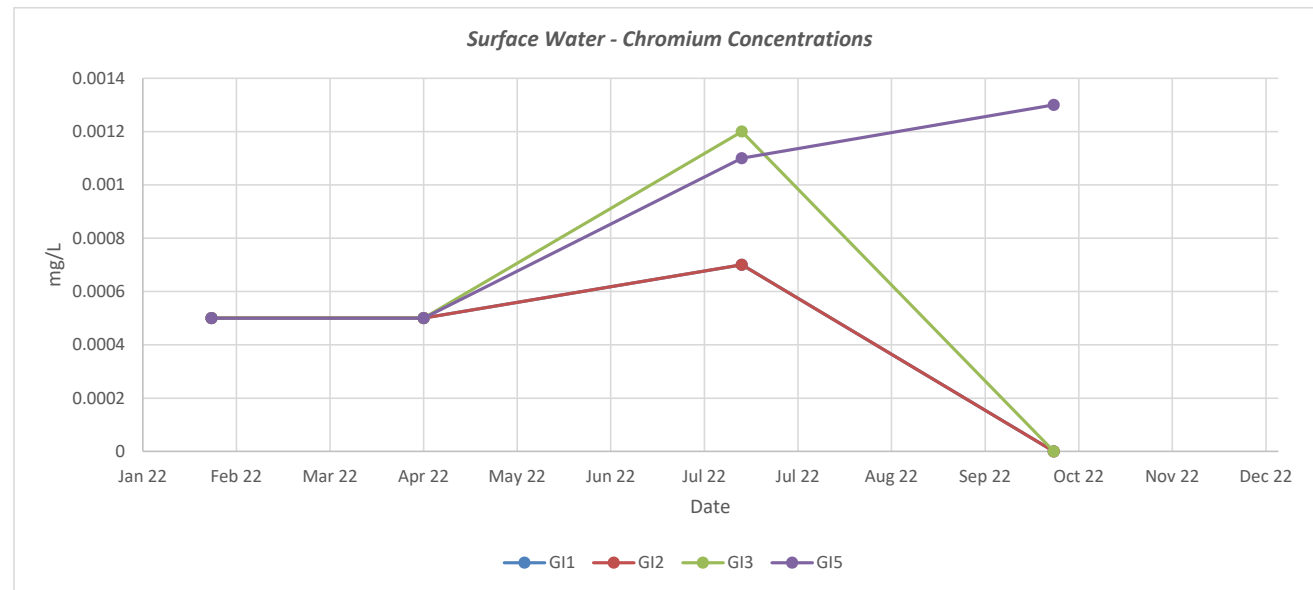
Figure C1-4 Chromium

Note: Flood event during the July monitoring round - dilution is likely cause of reduced concentrations in surface water sampling locations

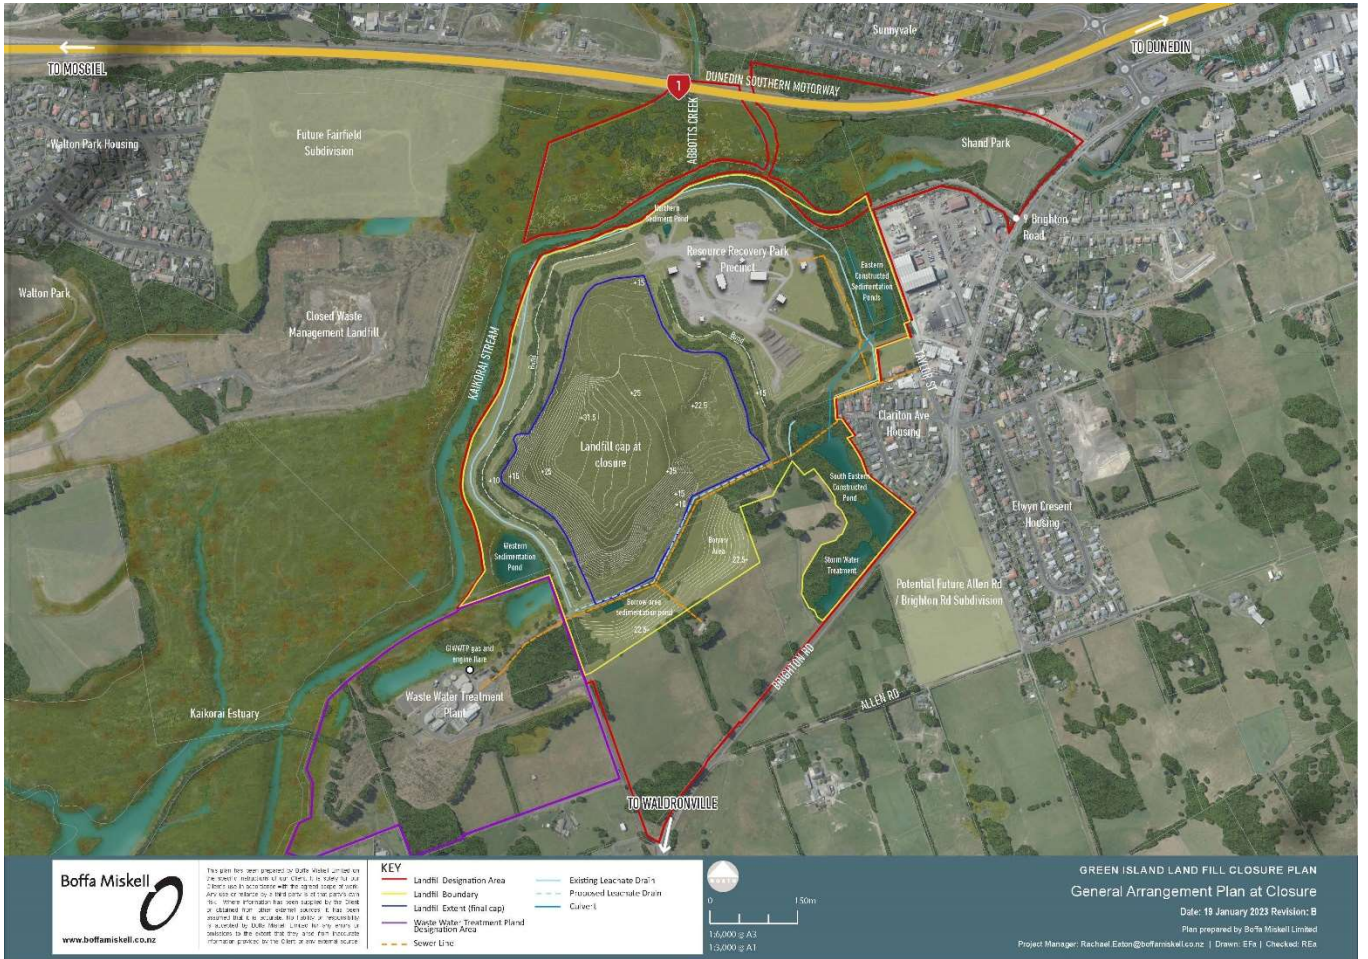
Figure 2: Site layout Plan

As can be seen on Figure 2, the working face is currently located towards the centre-south of the landfill, the composting area is located near the eastern boundary and the waste transfer station and recycling station in the north-eastern portion of the landfill. Landfilling is complete over the northern and eastern portion and continues over the remainder of the Landfill.

Two stormwater sedimentation ponds are located on the landfill, one on the southwestern site boundary (West Pond) and one on the northeast site boundary (East Pond), see Figure 2 overleaf.

Several activities are currently being undertaken within the boundaries of the landfill including municipal waste disposal, compost production, liquid waste and sludge disposal alongside the operation of a waste transfer station and a recycling centre. A Site layout plan is presented as Figure 2, overleaf.

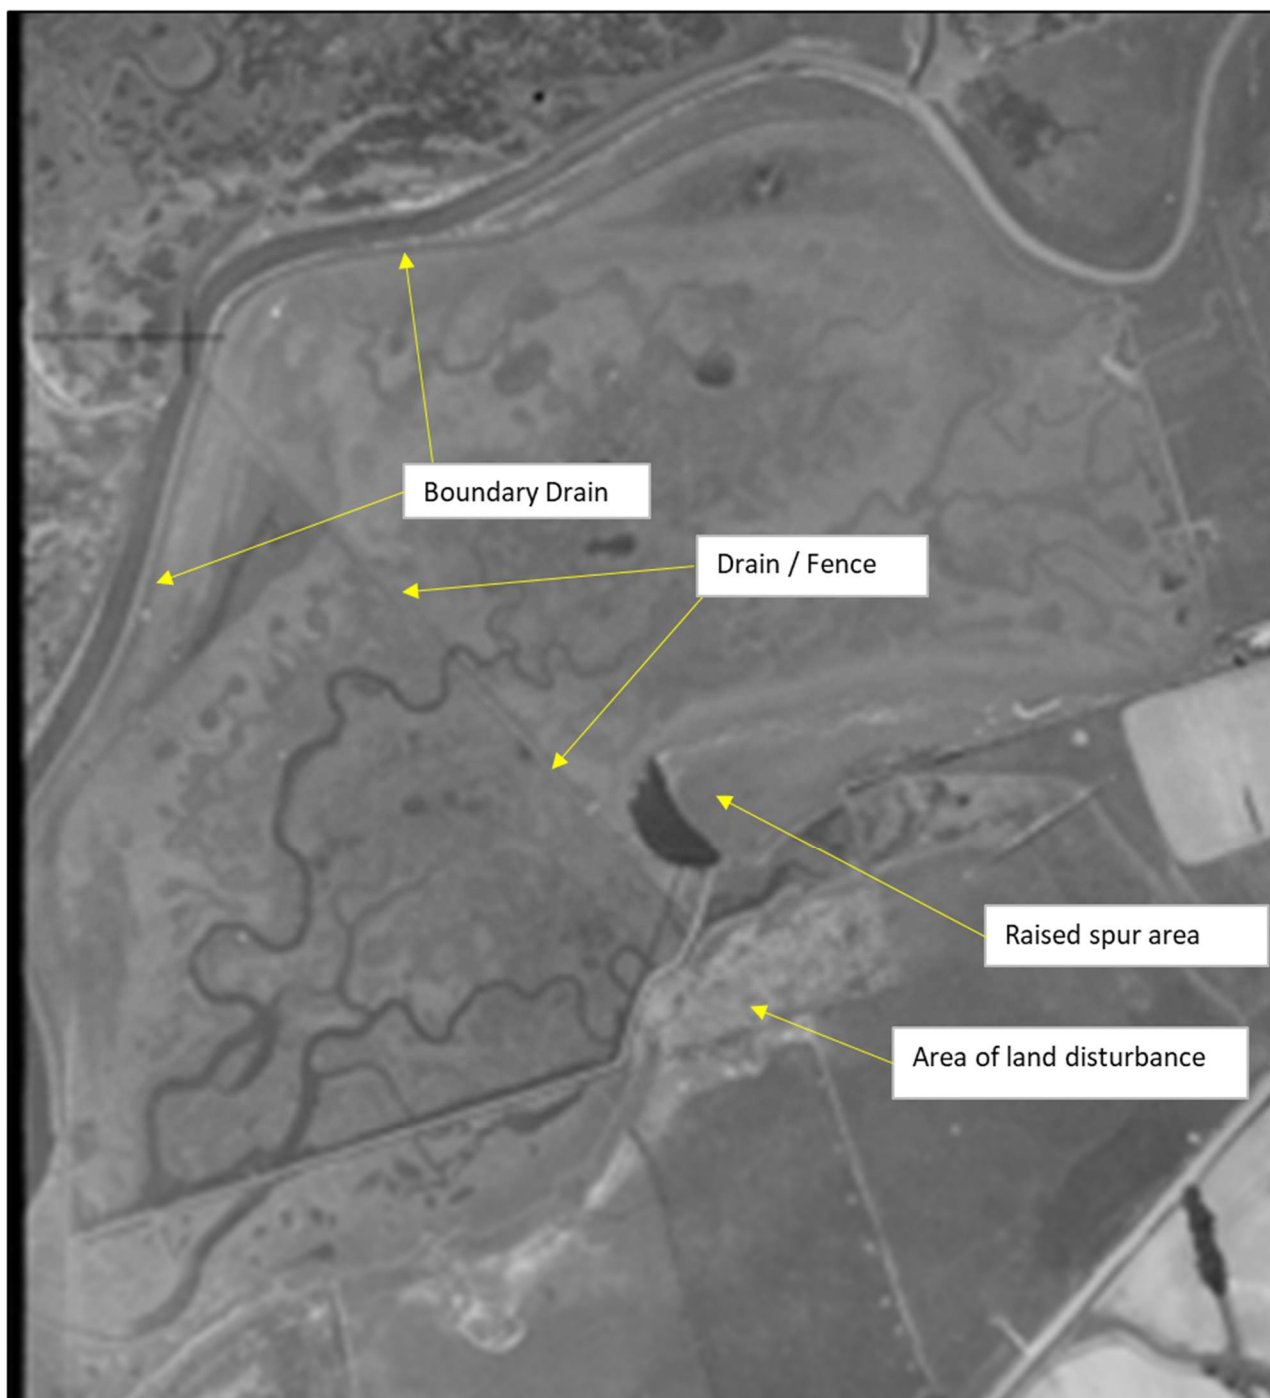
There appears to be a drain / trench that runs on the inside of the Kaikorai Stream and continues around the boundary of the existing landfill property. There also appears to be another drain or fence which crosses the Site diagonally from northwest to southeast across the wetland.

A raised spur can be noted on the southern site boundary.

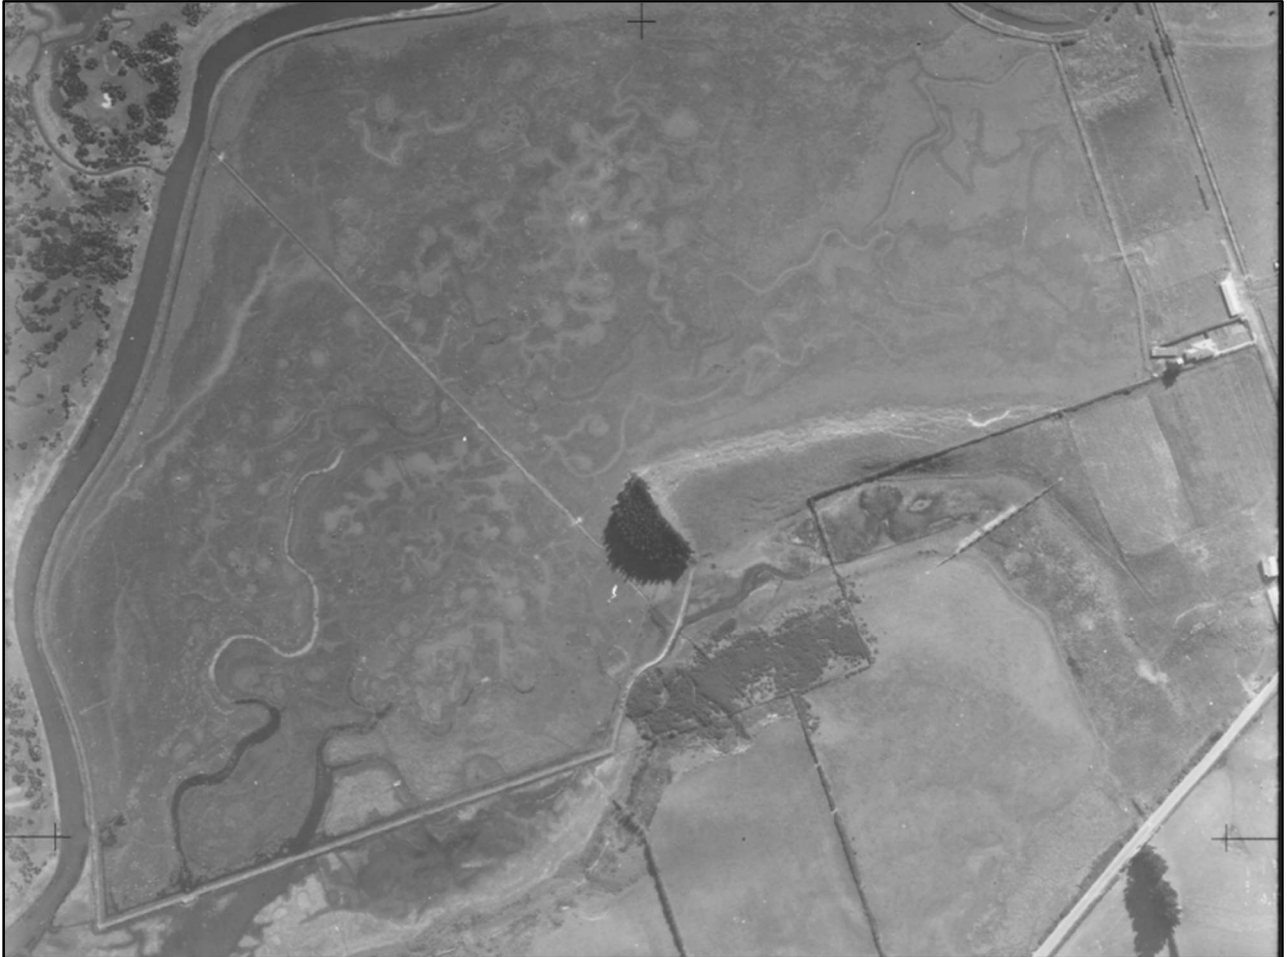
It can be noted that there appears to be a spur of raised ground in the southern portion of the Site with trees at the top. It appears that this portion of the Site increases in height towards the west.

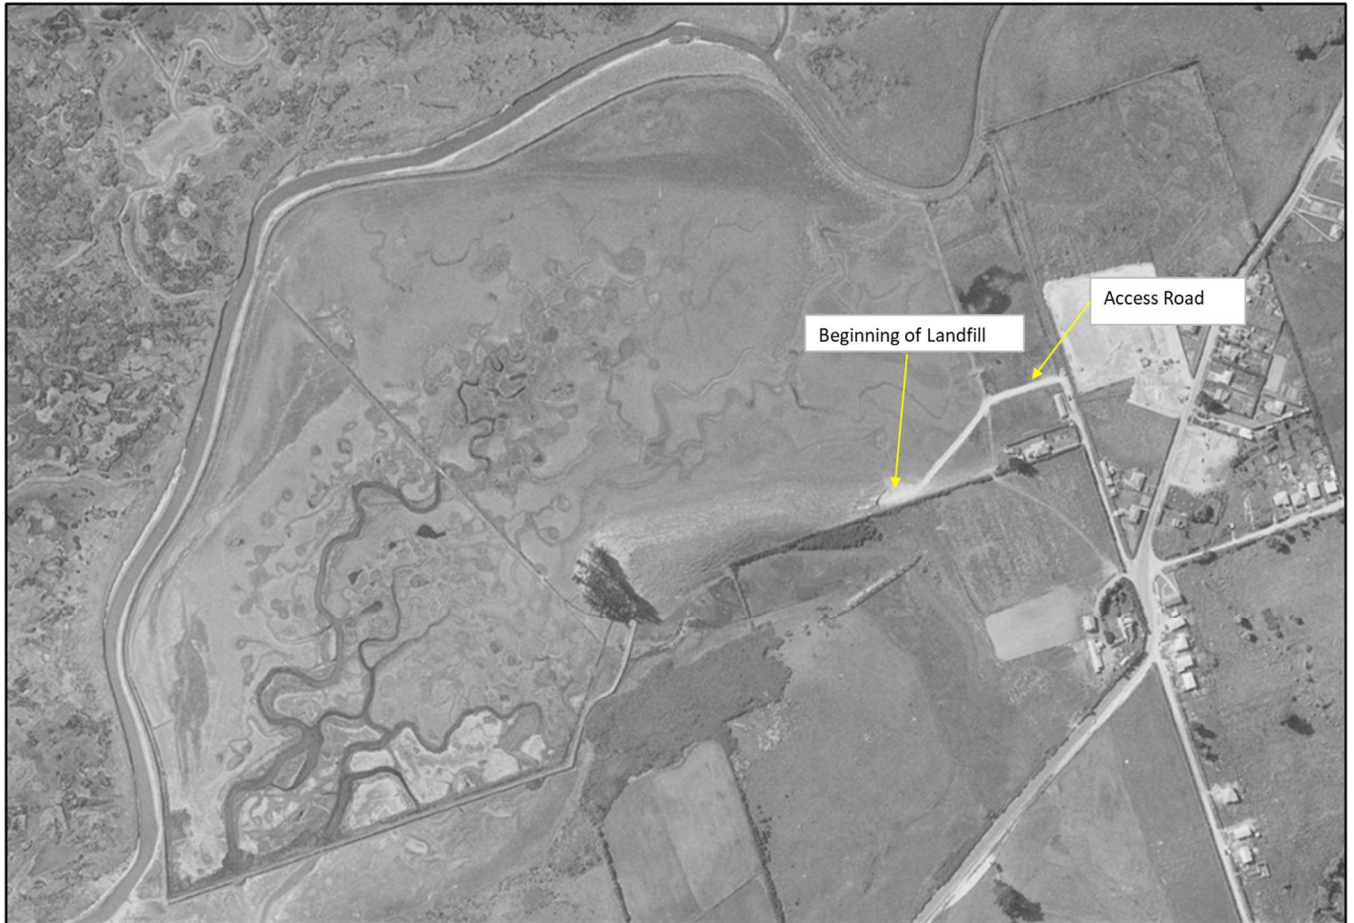
There appears to be an access road into the future landfill at the southeast corner of the current facility. At the end of the access road, it appears that landfilling or initial site development has commenced at the site. It is likely that the area on the southern boundary is being raised / built up to create a road to allow access into the landfill.

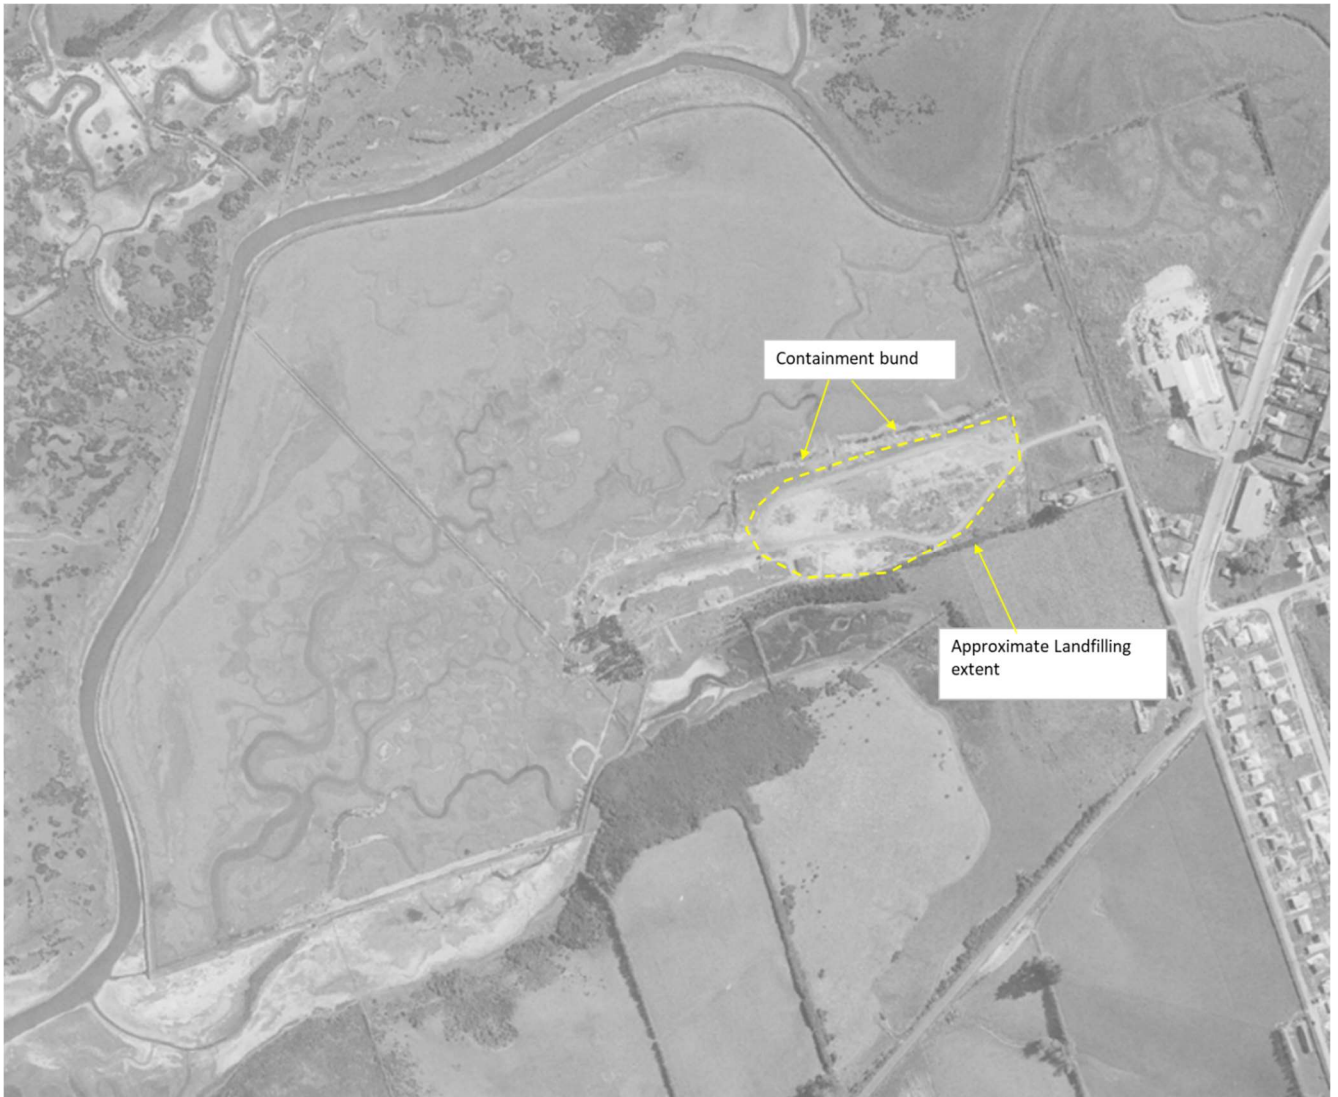
Landfilling has extended westwards along the southern boundary. A structure, maybe a containment bund, is present on the northern boundary of the landfilling area.

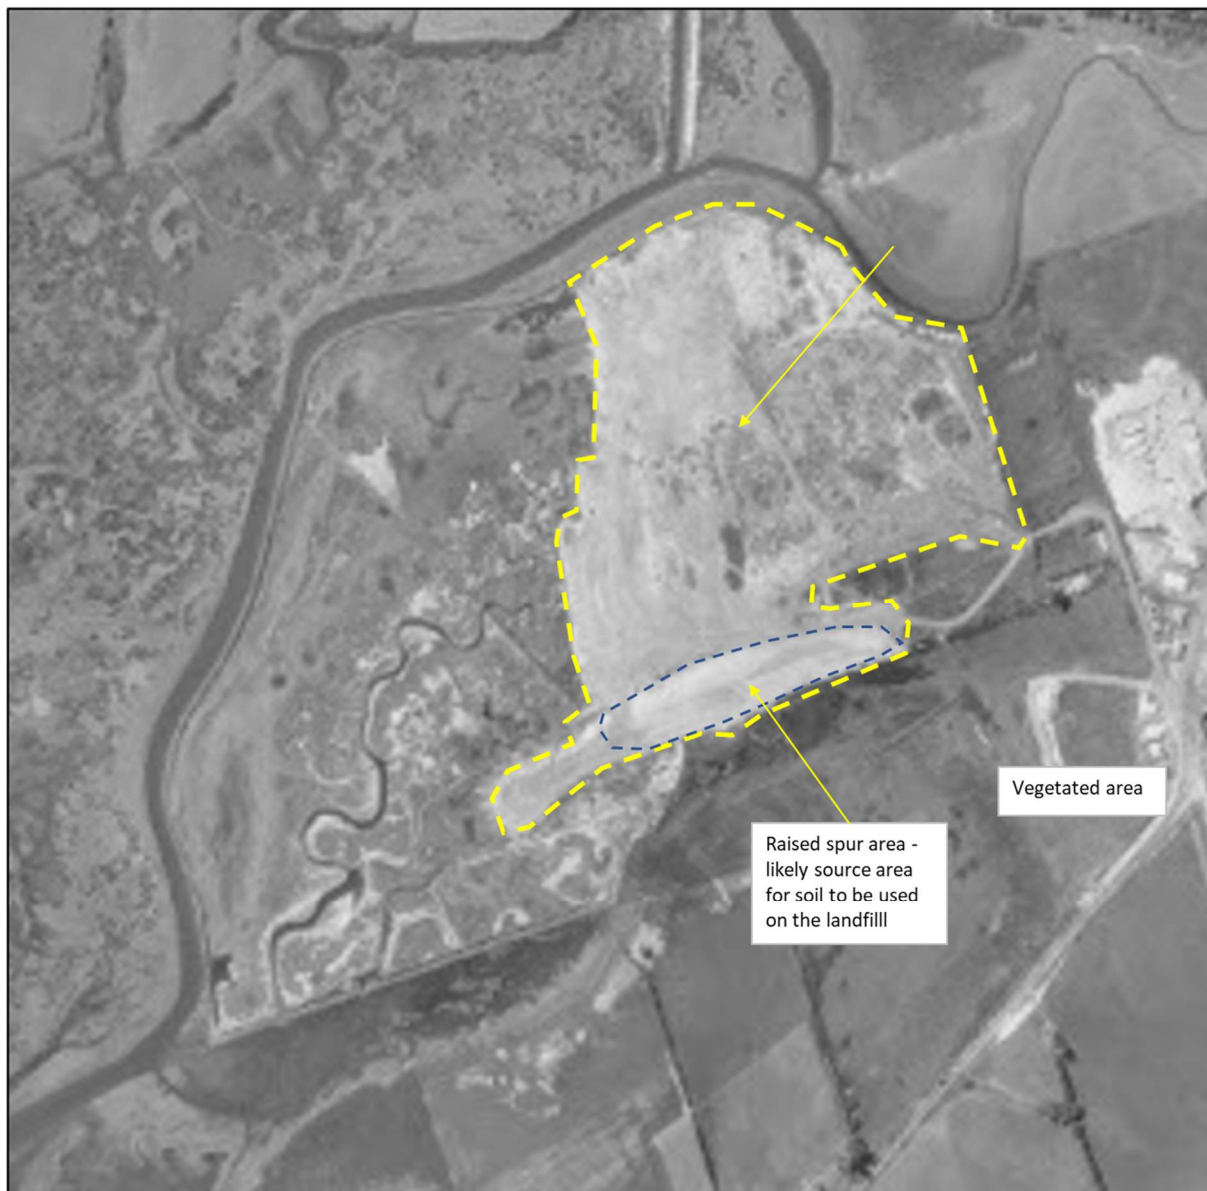
Landfilling has continued on the southern boundary of the site and has extended to the north to the edge of the boundary drain. The area of the higher spur of land from the 1940's and 1950's is clearly obvious as a different colour (lighter) along the southern boundary, indicating that this area continues to be used as a source of soil material used during landfilling works.

The southeast corner of the landfill (where filling began) has vegetation growing on it, indicating that filling in that area was complete by 1970.

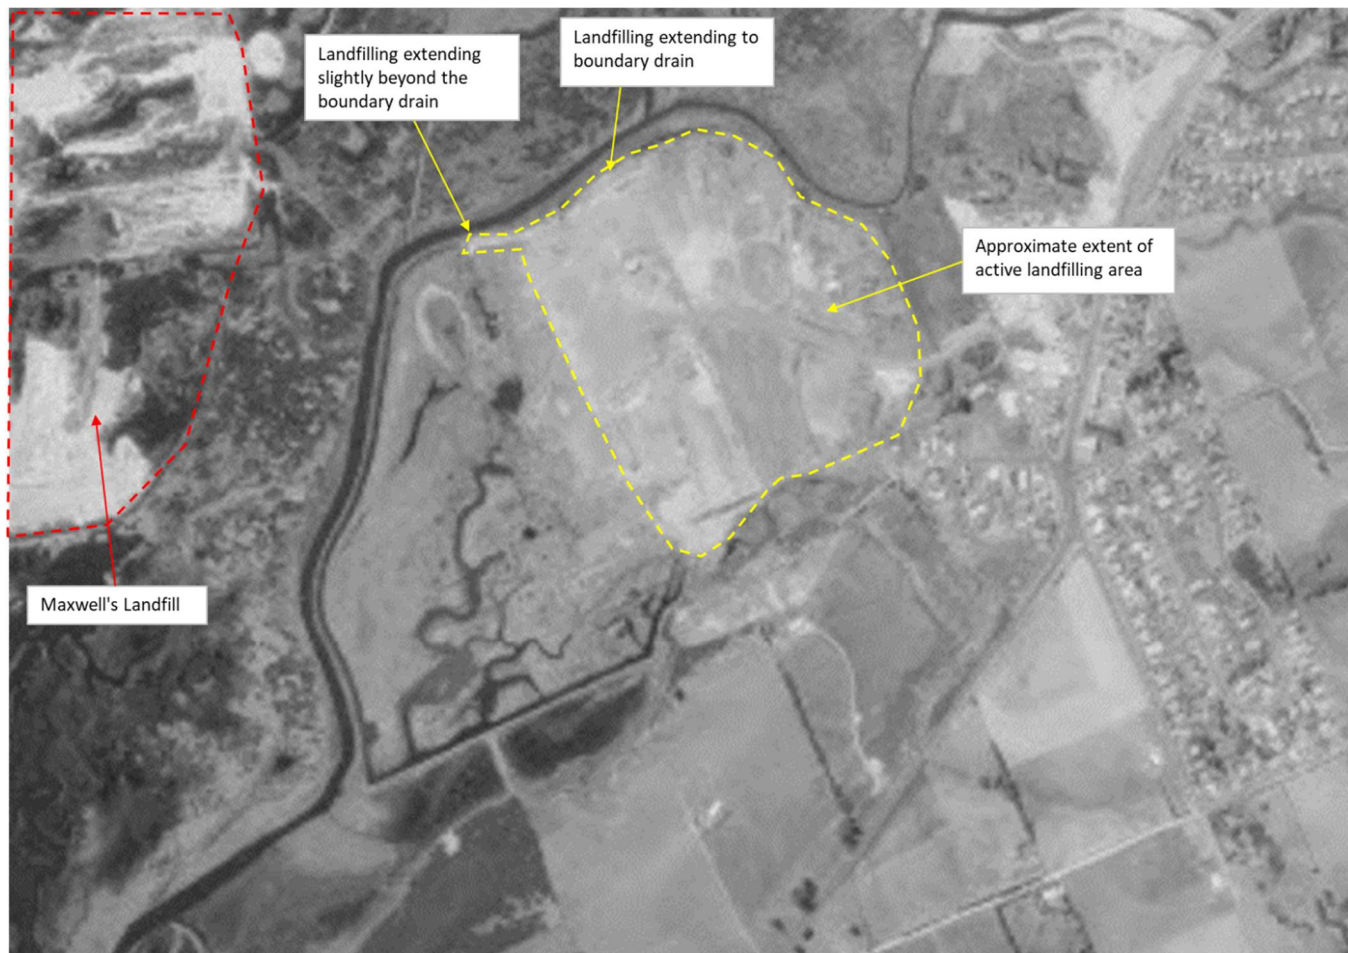
Filling appears to have progressed north-eastwards across the footprint of the landfill area, with minimal expansion to the west. Waste appears to have infilled the boundary drain along the central portion of the northern boundary and likely extend beyond it towards the Kaikorai Stream in isolated areas.

Maxwell's Landfill is present on the opposite side of the Kaikorai Stream.

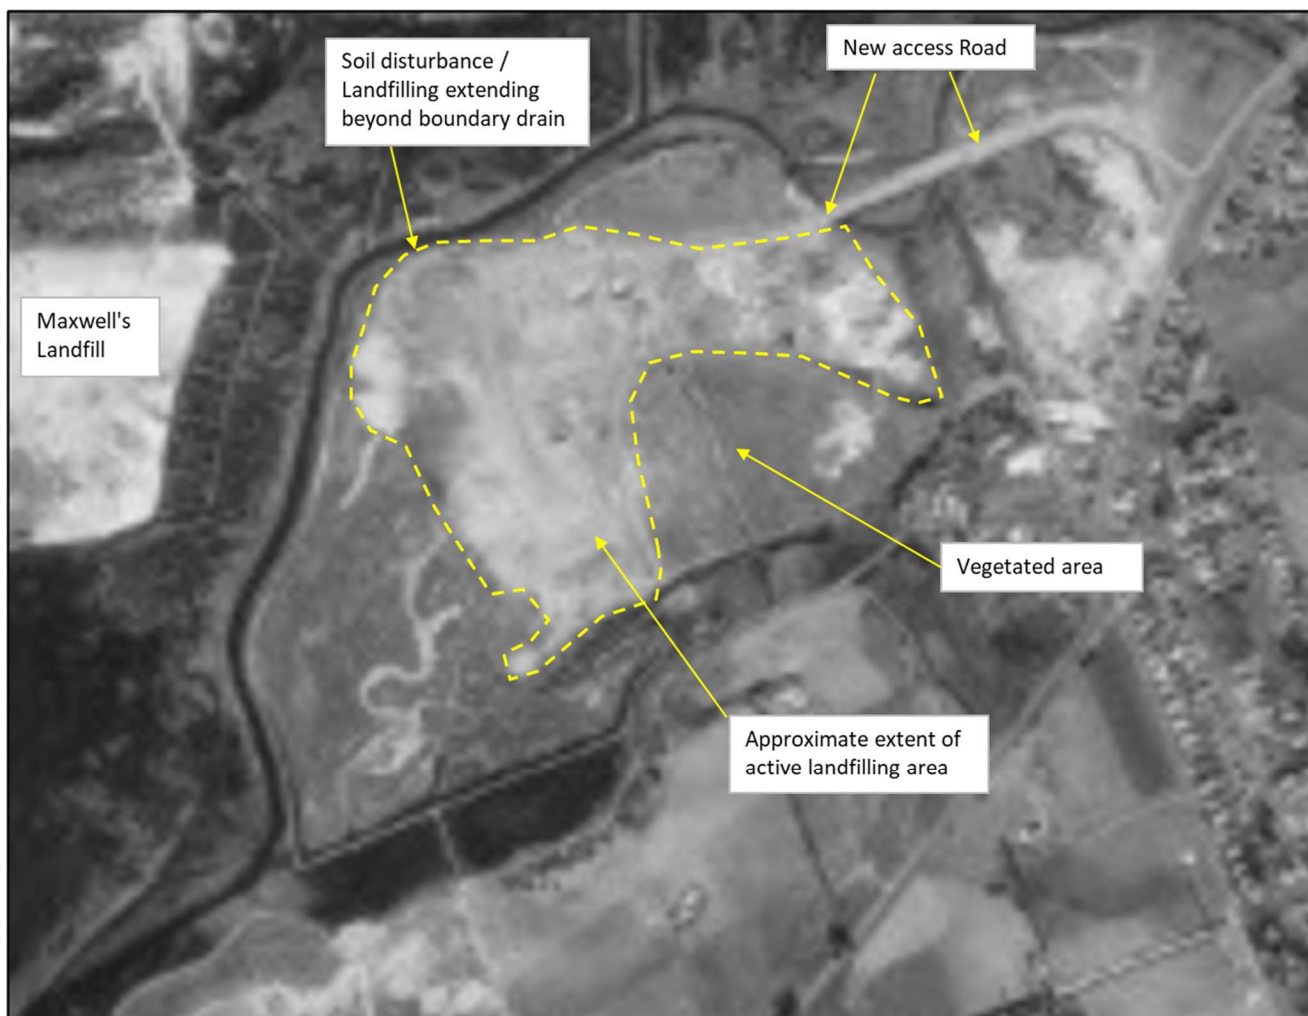
3.3.8 1990 Aerial Photograph

The access road was moved to the northern portion of the Site since 1985. Areas of revegetation are visible on the southeast portion of the site. Fill has expanded to the west especially in the northern half of the landfill. It appears that the boundary drain has been infilled further westwards along the northern boundary with evidence of soil disturbance / landfilling on the northern side of it in one area.

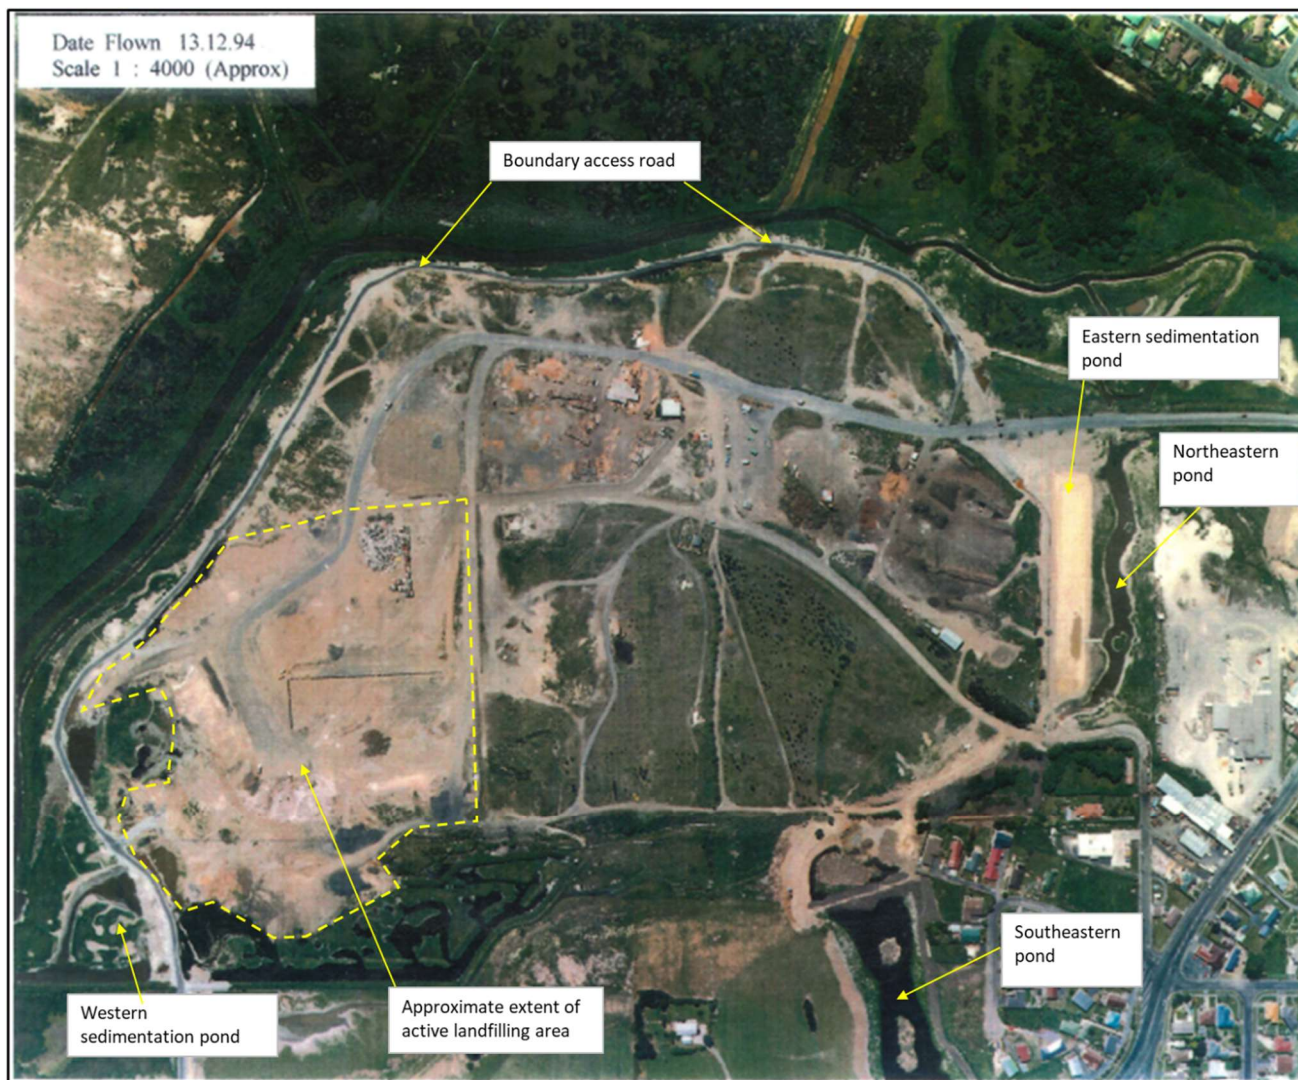
It appears that the Eastern and Western sedimentation ponds are under construction and that the north-eastern and south-eastern ponds have been construction.

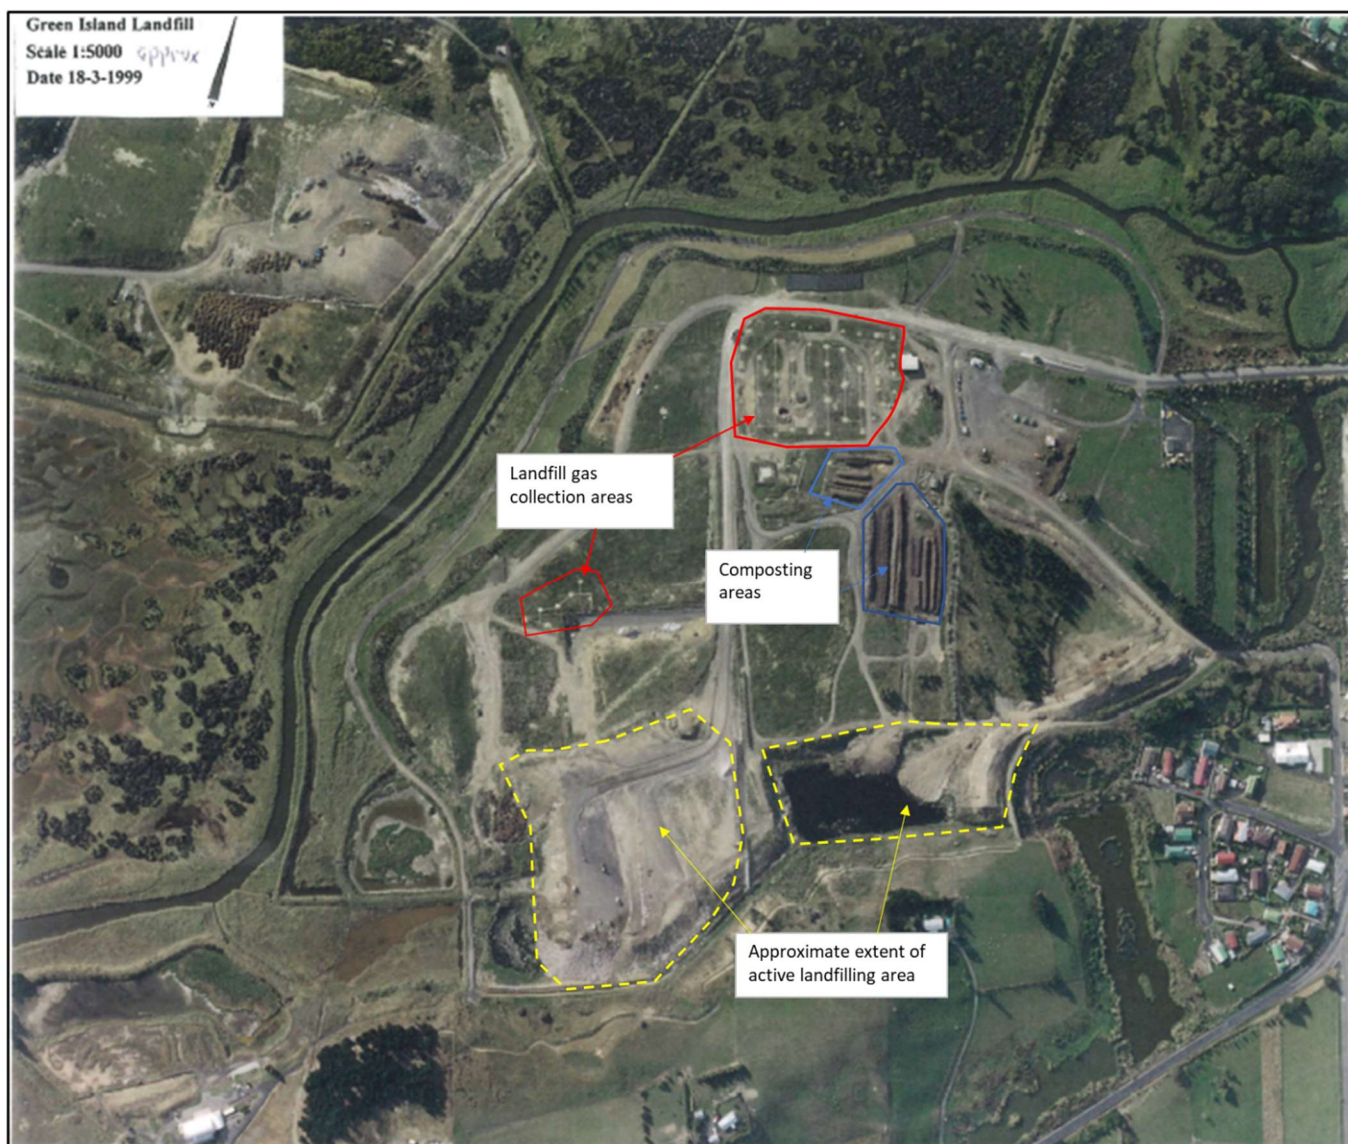
There appears to be a landfill gas collection network under construction or use in the northern and part of the western portion of the site.

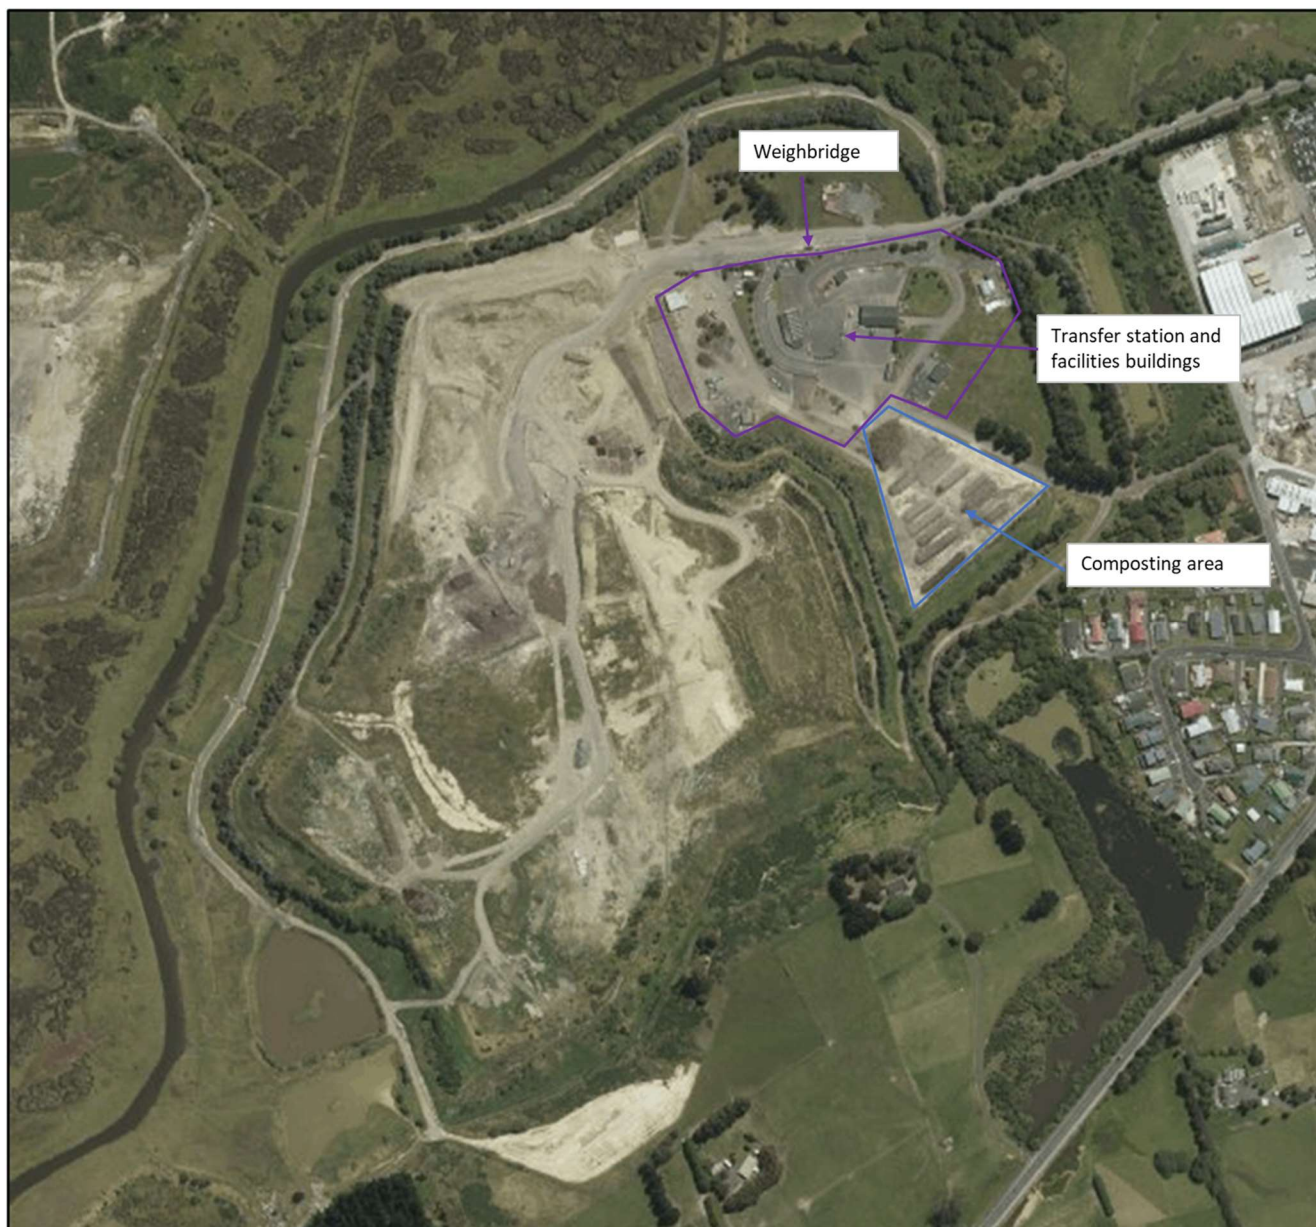
3.3.11 2013 Aerial Photograph

By 2013, the Site is generally in its current configuration. The resource recovery facility / transfer station, wind break planting, the access track (and interceptor trench), and the compost facility are all visible in this aerial photograph. Landfilling appears to be active in the northern portion of the Site. The area of capping completed in 2009 / 2010 is noticeable as vegetated (green) in the southeast corner of the landfill, as is an area of capping underway at that time immediately adjacent to the west.
