Waste Futures – Green Island Landfill Closure

**Groundwater Technical Assessment –
October 2024 Update**

Dunedin City Council

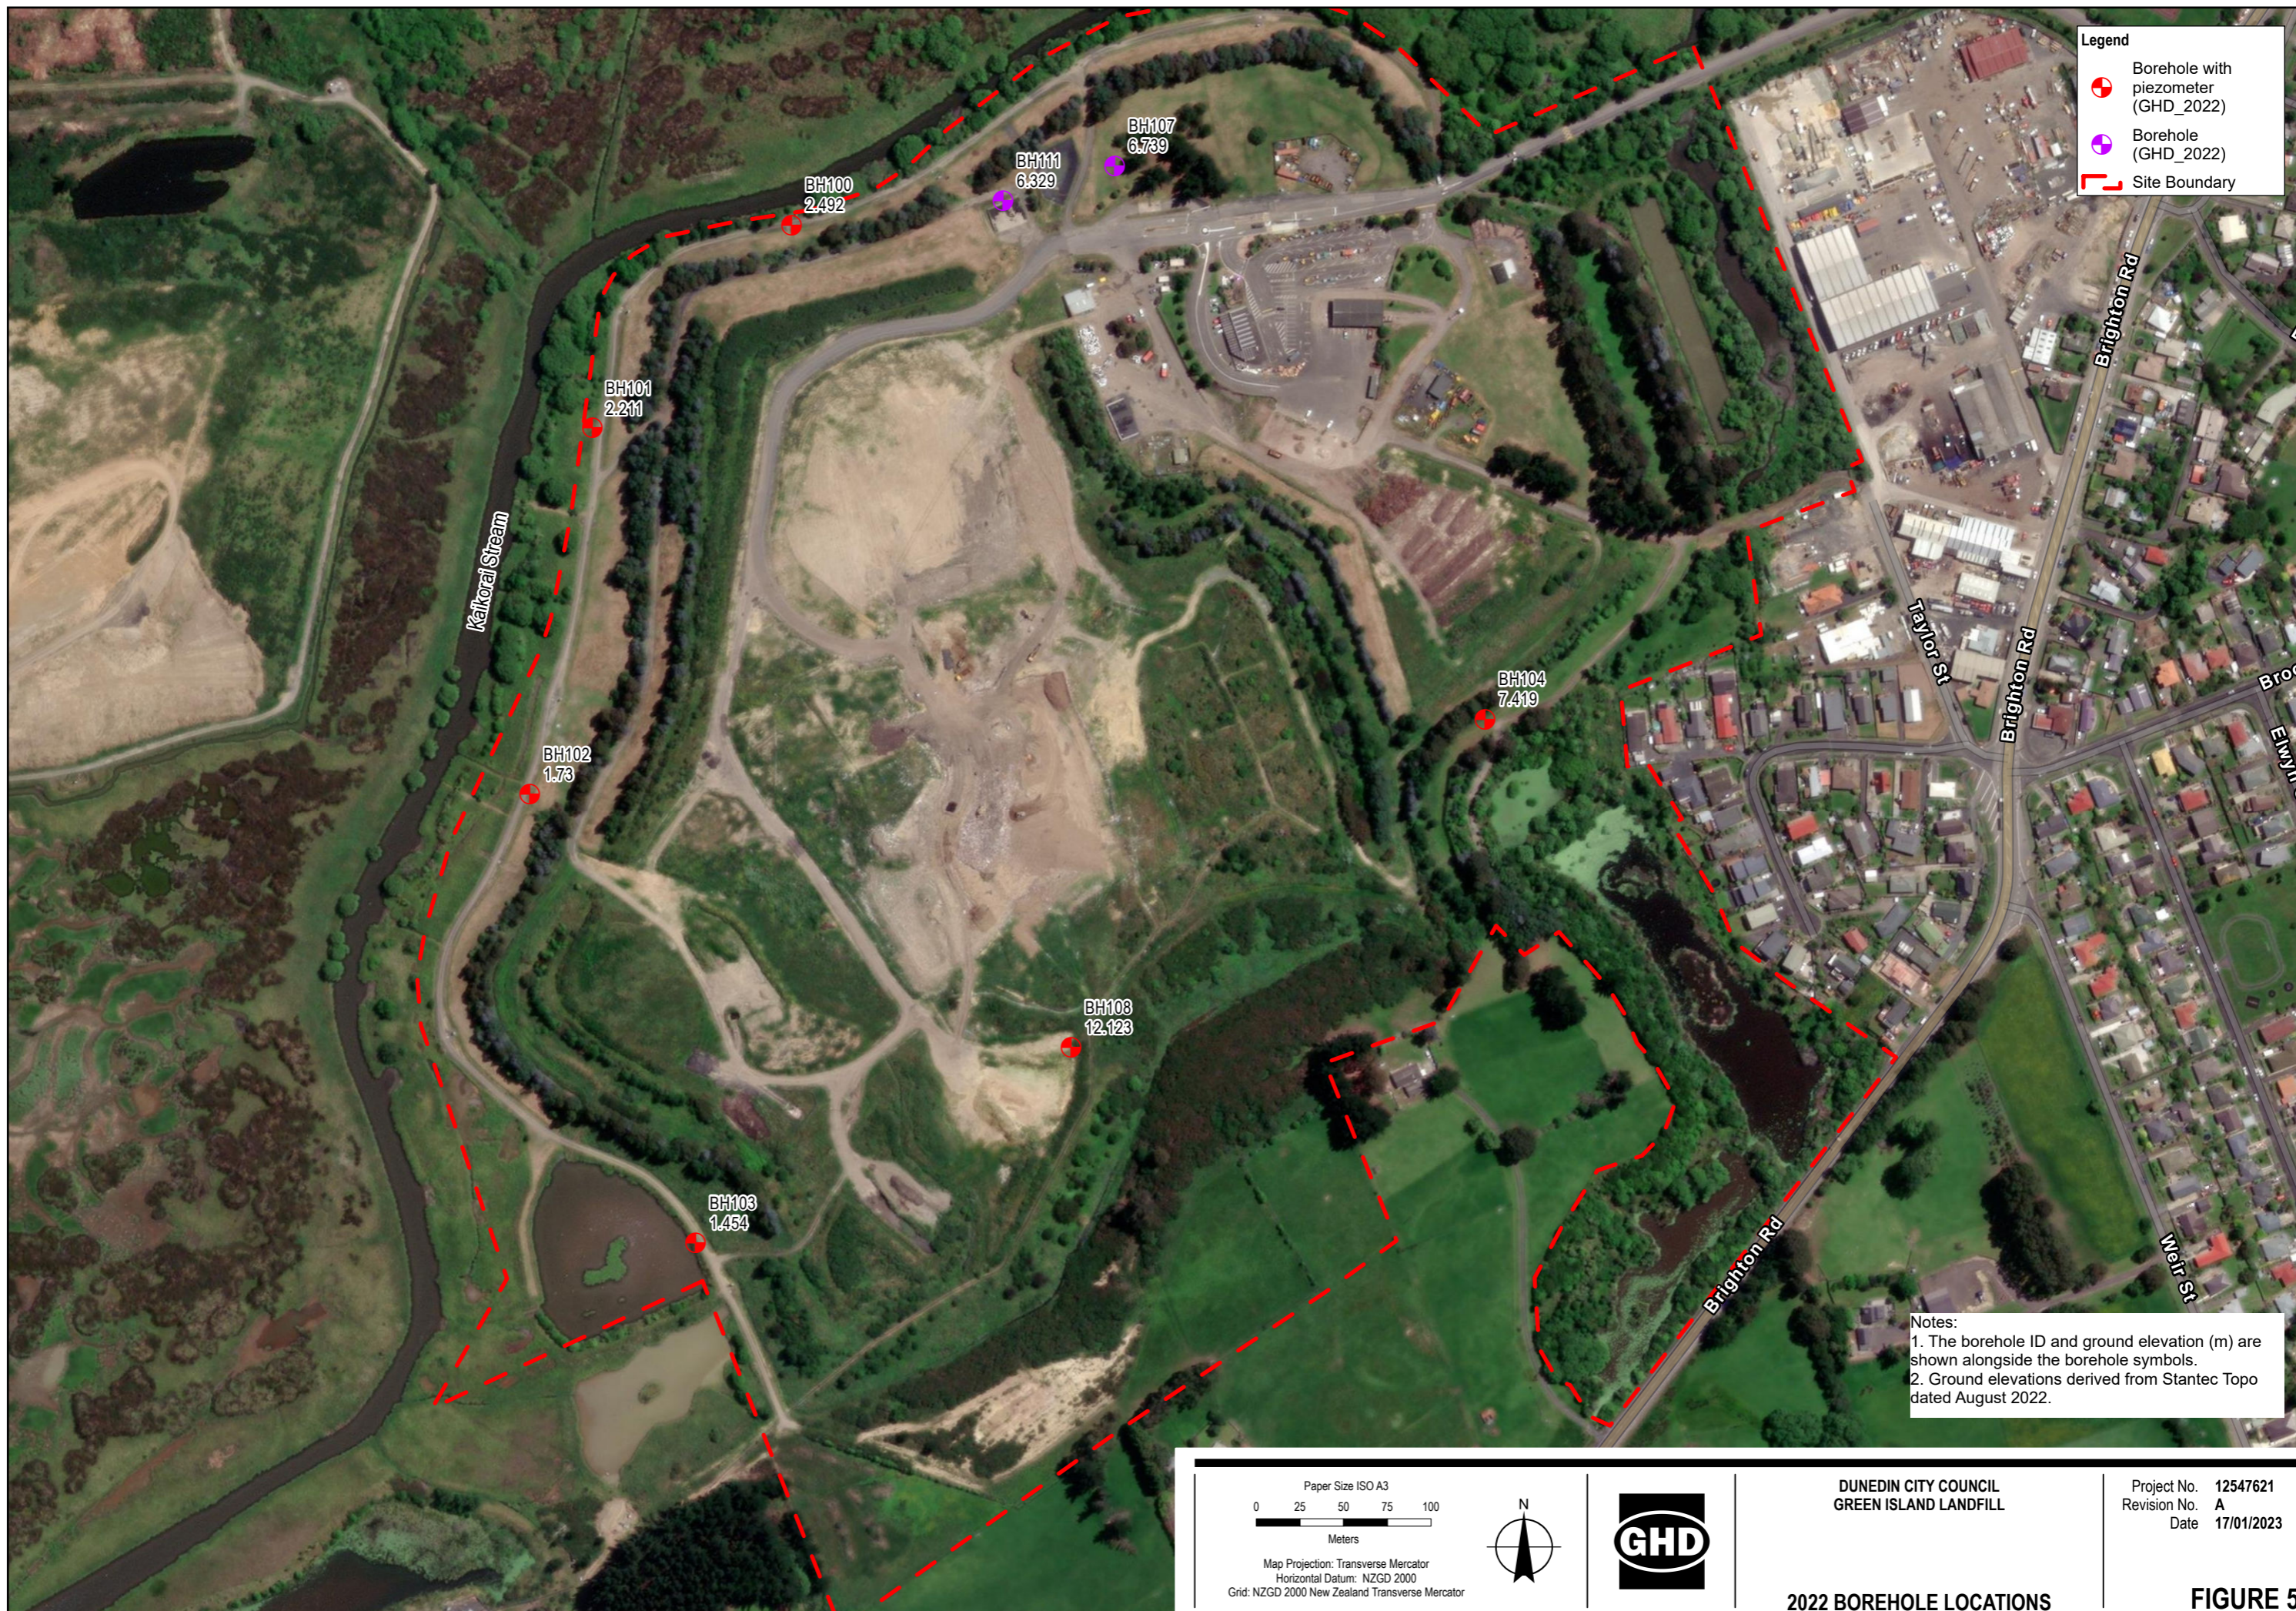
Prior to breaking ground, subsurface utilities clearance was undertaken by a specialist contractor (Fulton Hogan), using both a Cable Avoidance Tool (CAT) and Ground Penetrating Radar (GRP) at all borehole locations. A Ground Penetration Permit to Work was issued by an authorised GHD permitter.
