MAP NO: FLOOD-5665-11

PROJECT: **MACRAES GOLD PROJECT**

CAMP CREEK DAM  
 INUNDATION MAP  
 FOR BREACH ASSOCIATED  
 WITH 1 in 100 AEP FLOOD EVENT

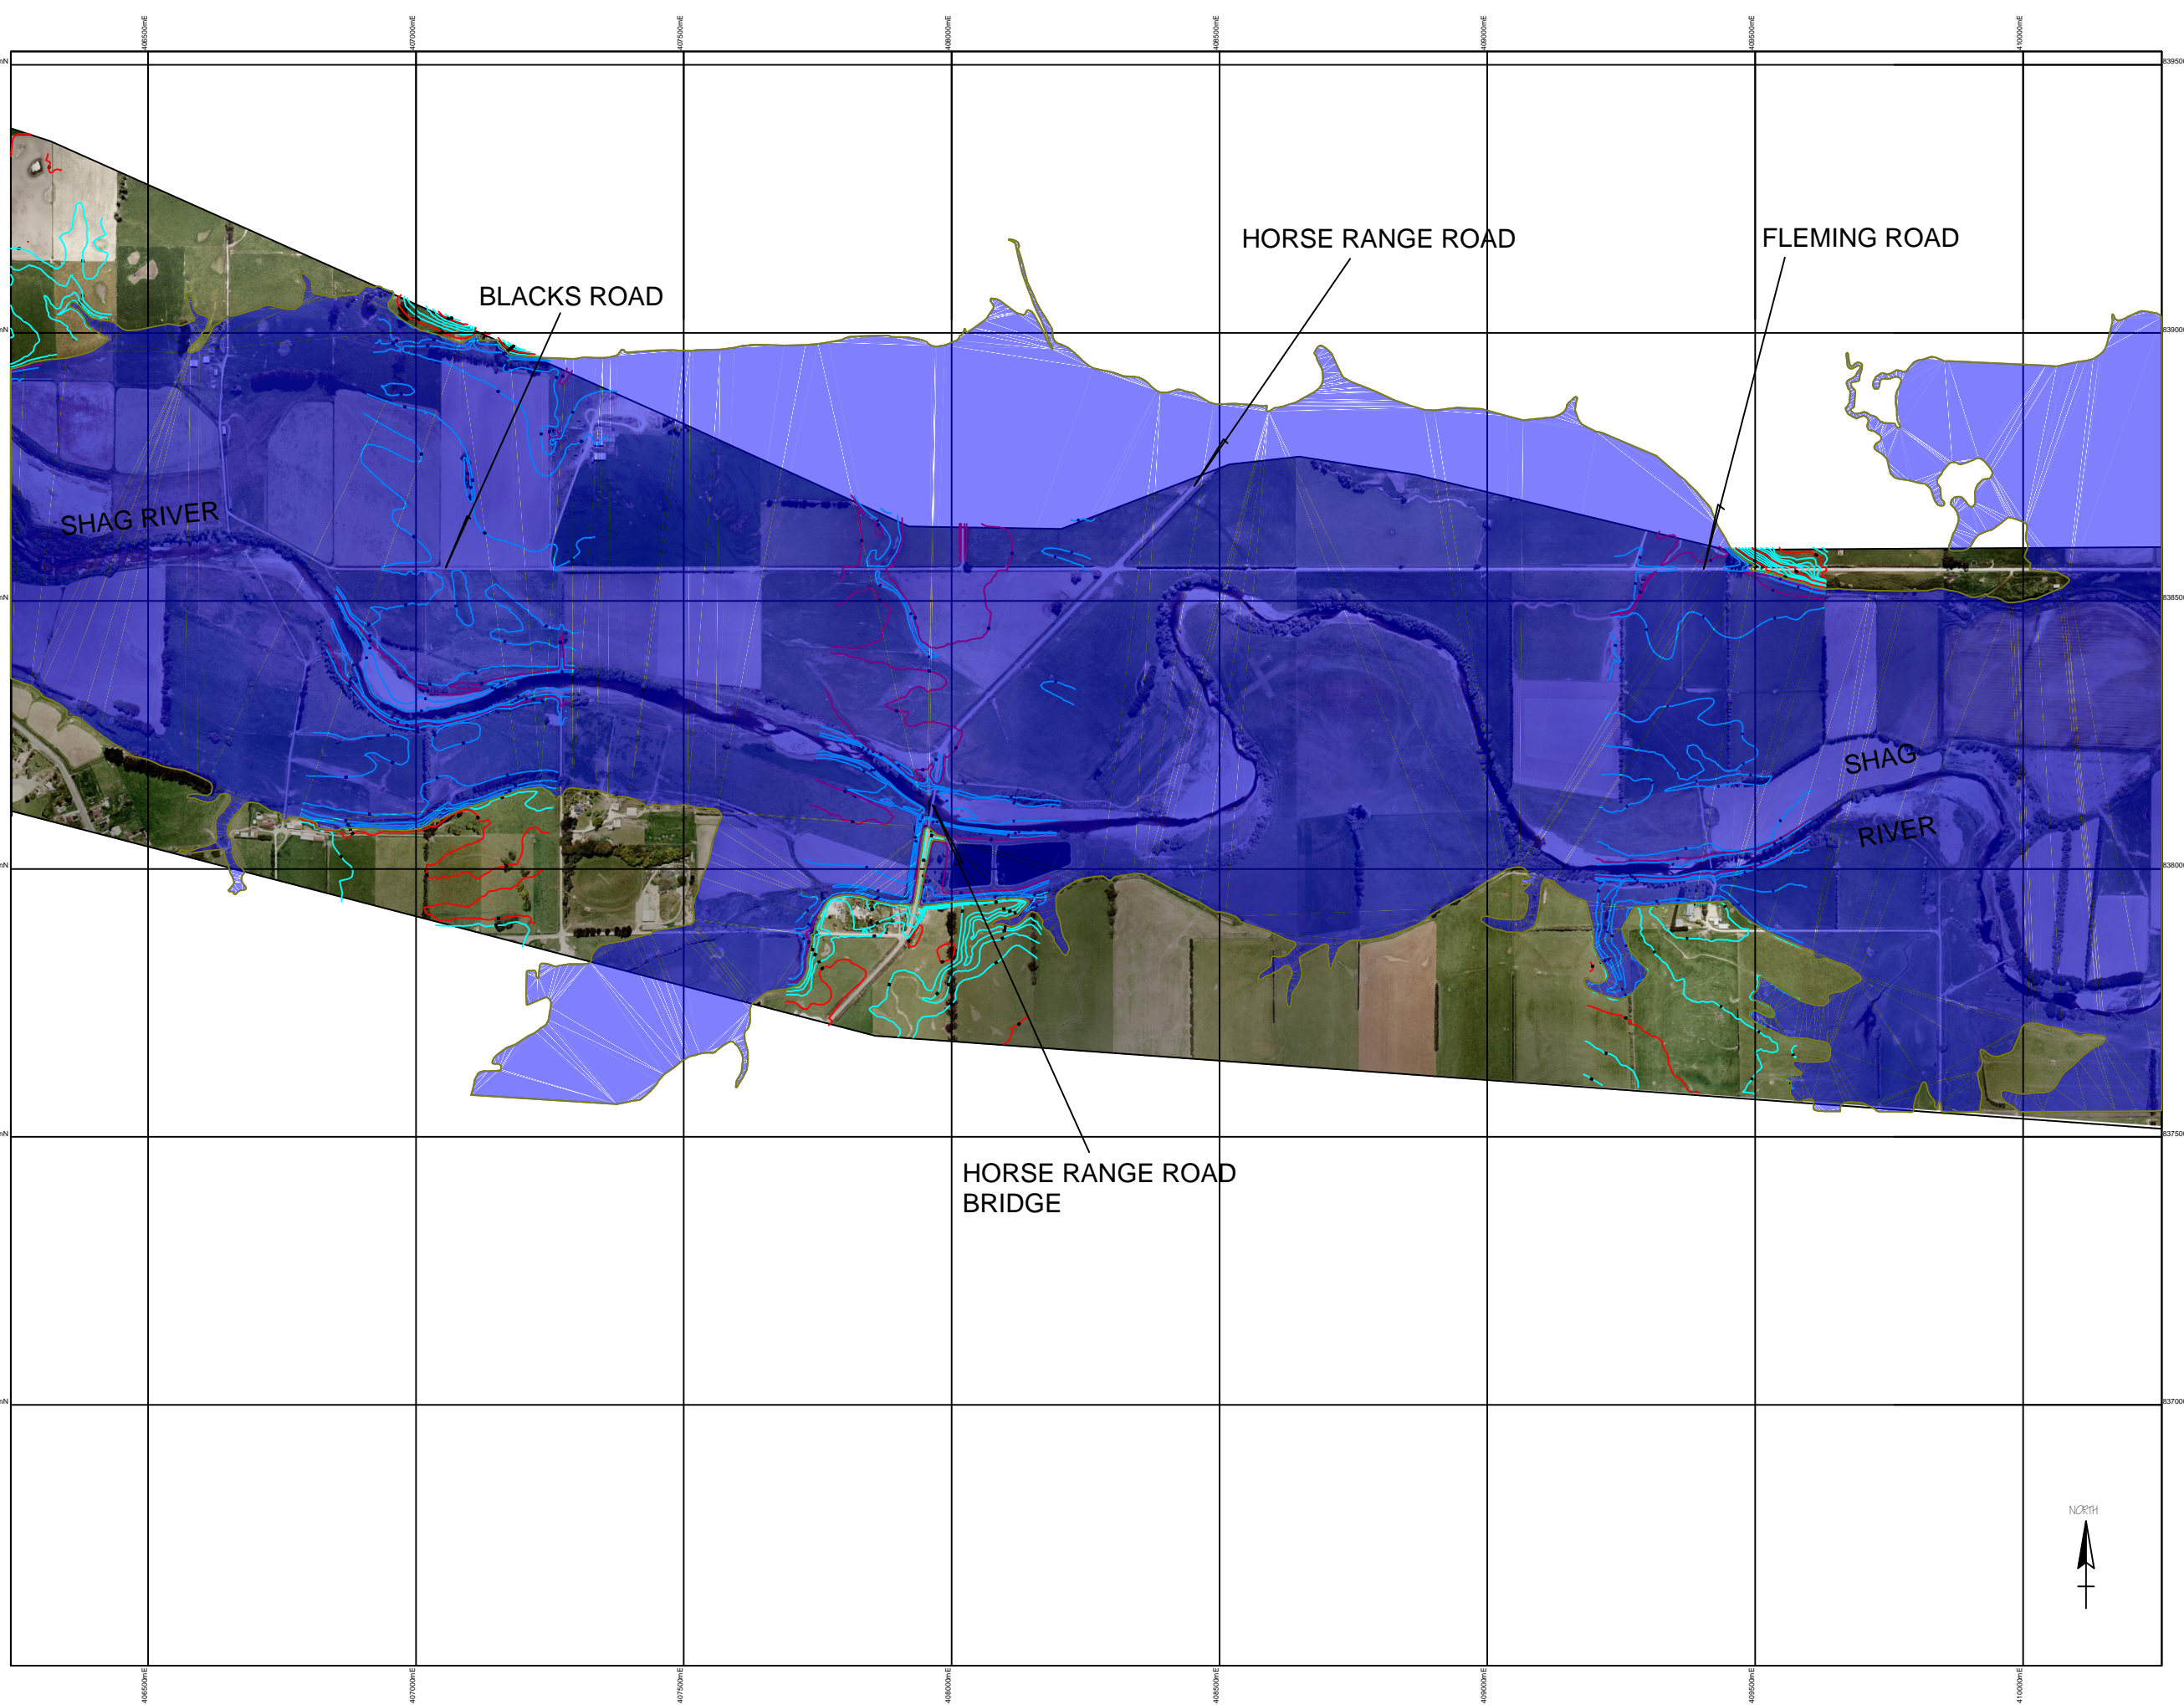
APPROXIMATE EXTENT OF INUNDATION
