Groundwater Quality in Kingston and Glenorchy

Groundwater quality in Kingston and Glenorchy

August 2006

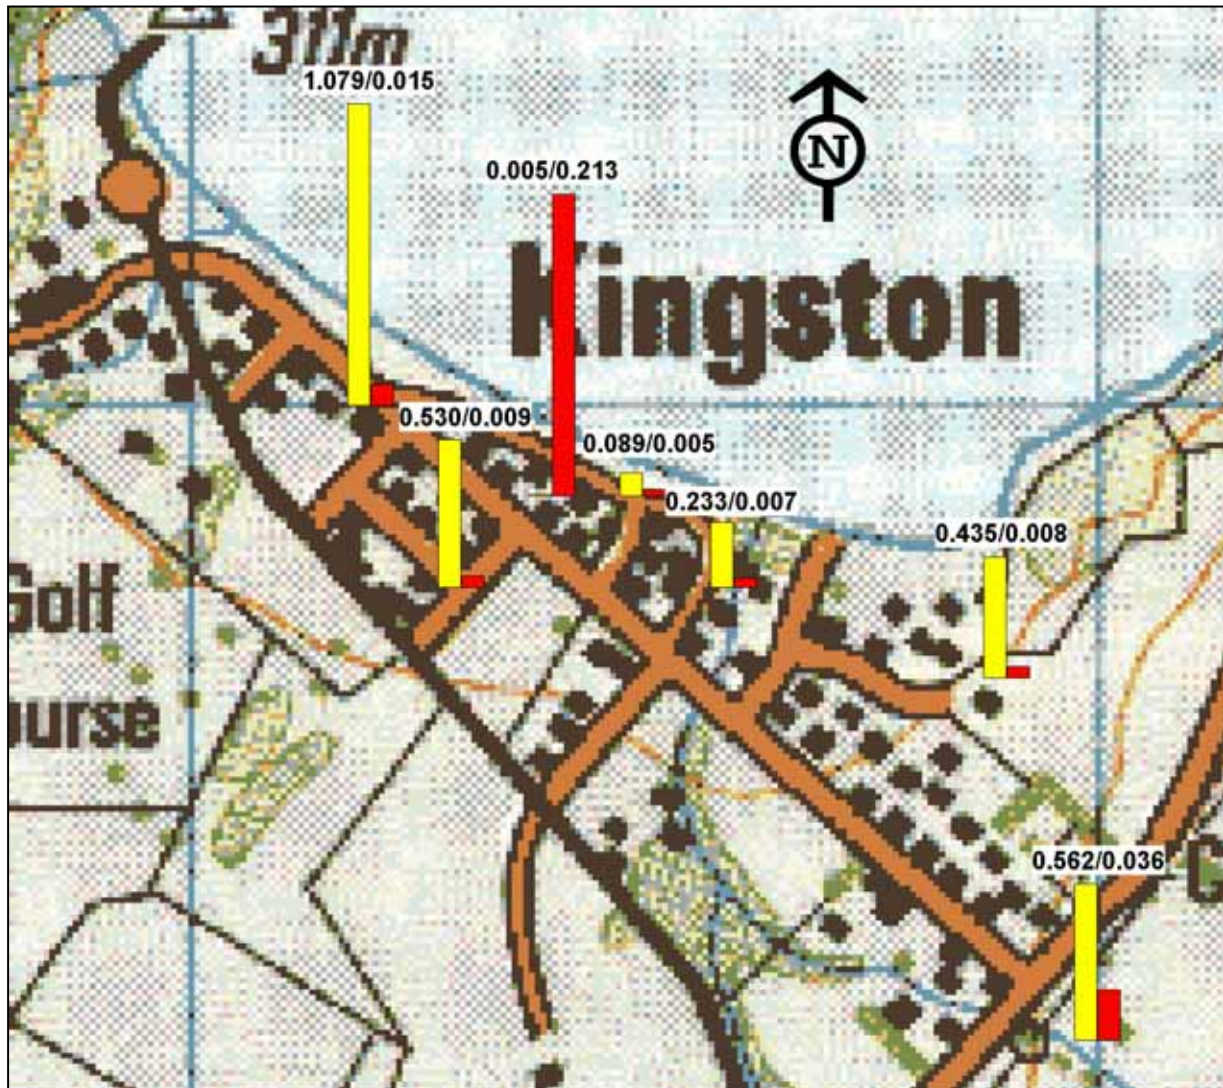
Figure 3.1 Distribution of mean concentrations over the period of 1996 to 2003 for nitrite-nitrate nitrogen (NNN; mg/L) and ammoniacal nitrogen (NH₄-N; mg/L) in Kingston

Notes:
 Yellow bars represent NNN concentrations
 Red bars represent NH₄-N concentrations
 Figures denote actual concentration in mg/L as NNN/NH₄-N

Very low nitrite-nitrate nitrogen (NNN) levels have been measured from most Kingston groundwater samples (Figure 3.1), which points to low natural environmental levels. Higher individual values (1.9 – 2.4 mg/L) may indicate possible influence from garden fertiliser application or septic tanks. Phosphorus levels in Kingston groundwater samples indicate some possible agricultural (fertiliser) and/or urban (fertiliser, detergents) contamination (Table 3.1).

Consistently higher ammoniacal nitrogen (NH₄-N) levels have been found at Kingston bore F42/0113, with an average concentration of 0.213 mg/L (Figure 3.1). This level of contamination may point to an influence from septic tank effluent disposal.

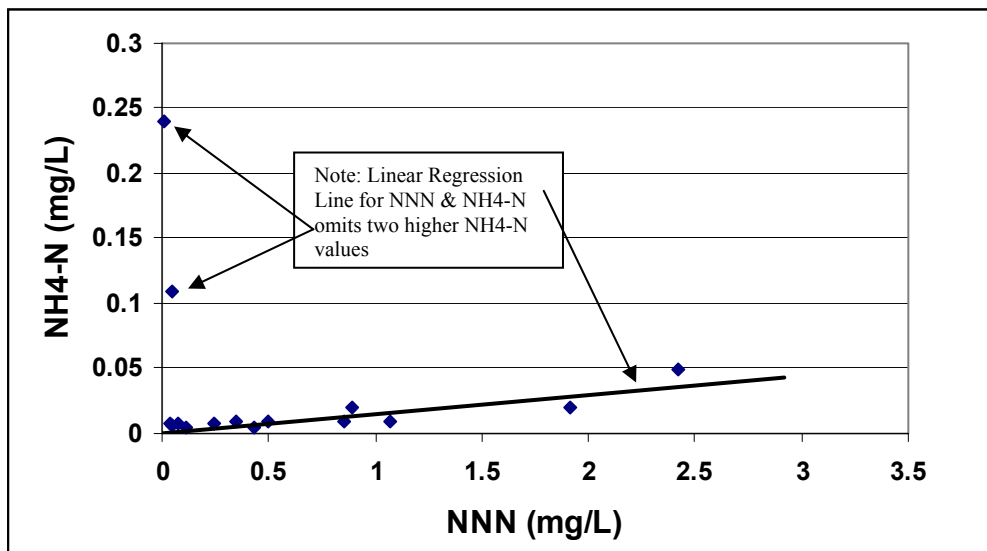
Figure 3.2 NNN (mg/L) versus $\text{NH}_4\text{-N}$ (mg/L) for Kingston groundwater sites sampled from 1996 to 2003 and linear regression line ($y=0.0147x$, $R^2 = 0.62$)

The plot of NNN versus $\text{NH}_4\text{-N}$ for Kingston groundwater samples (1996 – 2003), on Figure 3.2, shows a typical land-use trend. Concentrations of both nutrients typically increase and reflect the variation of land use in the immediate area. There were, however, two occasions where $\text{NH}_4\text{-N}$ was elevated in relation to NNN. The two samples, rather than indicating heavily reducing conditions in groundwater, probably reflect some contamination from a septic tank source (one of the two samples also detected faecal coliform bacteria (1cfu/100mL)).

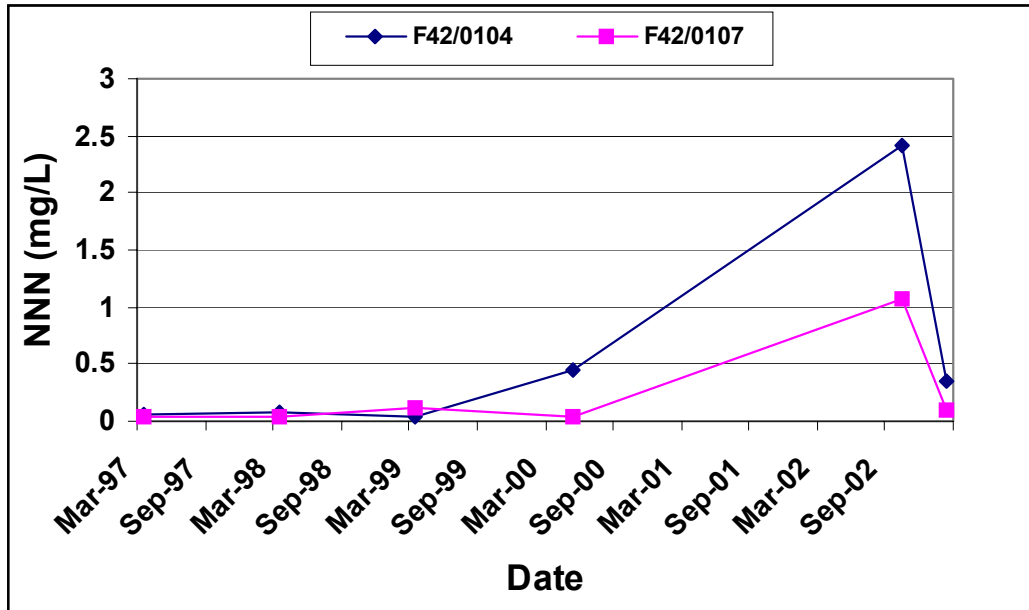
Figure 3.3 Time series for NNN (mg/L) for bore sites F42/0104 and F42/0107 in Kingston from 1997 to 2003

Time series NNN plots (Figure 3.3 and Figure 3.4) for Kingston and Glenorchy have been produced where successive samples have been taken at sites from 1997 to 2003. Only two sites in Kingston (F42/0104 and F42/0107) and one site in Glenorchy (E41/0100) have been sampled sufficiently to allow time series evaluation of the data.

Figure 3.3 shows that Kingston groundwater generally has low NNN over time. However, the resource is vulnerable to periodic contamination, as concentration highs occur on Figure 3.3, corresponding to changes in climatic conditions.

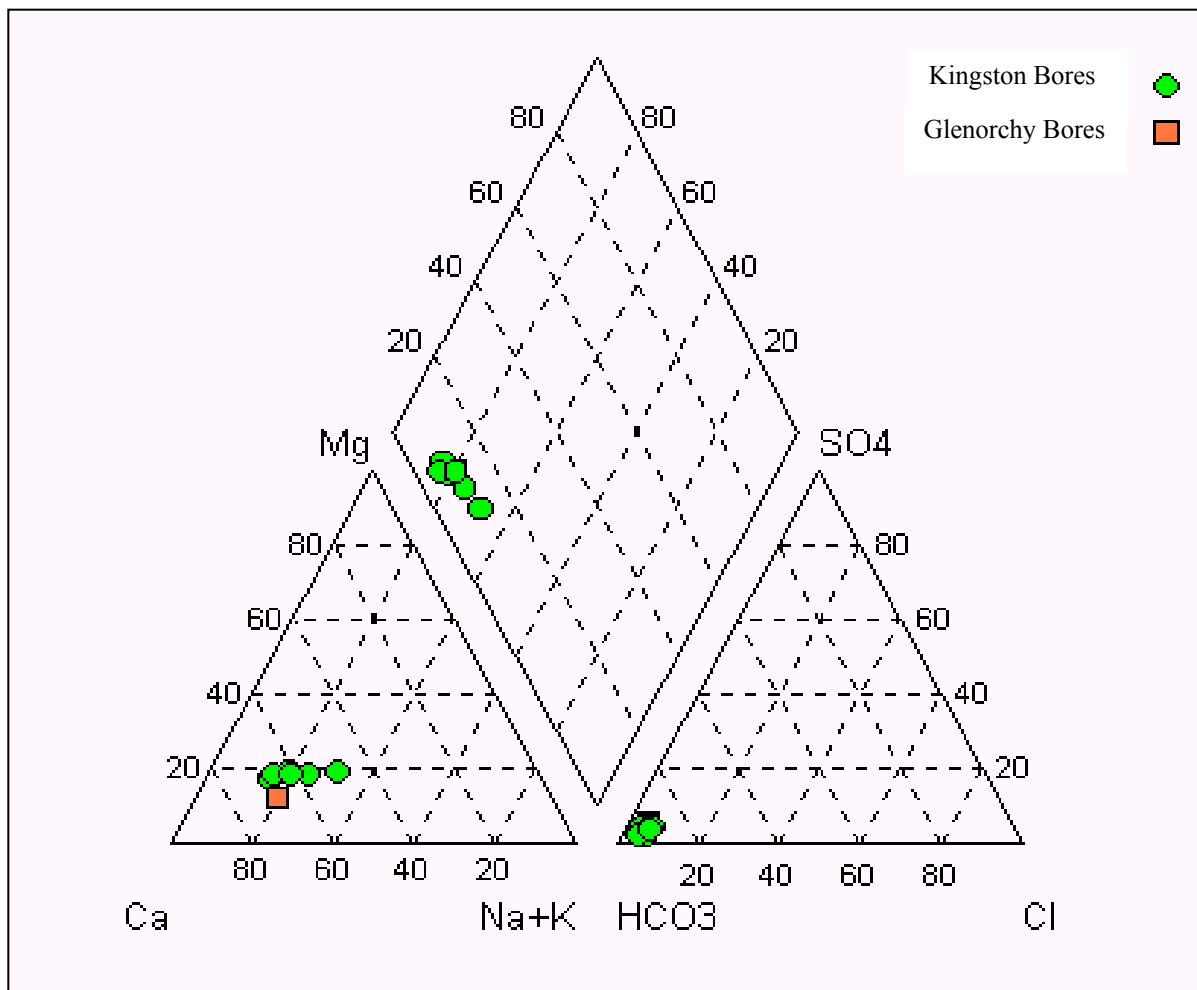
Figure 3.5 Trilinear diagram of major ions (% meq/L) in Kingston and Glenorchy groundwater

The relative concentrations of the major cations (Ca²⁺, Mg²⁺, Na⁺ and K⁺) and anions (HCO₃⁻, Cl⁻ and SO₄⁻) in Kingston and Glenorchy groundwater is shown on a standard Tri-Linear Piper diagram in Figure 3.5.

If the proportion of the respective cations and anions in a groundwater sample were balanced, the sample would plot in the middle of the respective cation and anion

triangles in Figure 3.5. If one particular parameter or a combination of constituents has a greater proportion than the others, then the sample would plot nearer to the corner of the triangle representing the higher concentration for those particular constituents.

The cation triangle in Figure 3.5 indicates that for all bores sampled, the relative proportion of calcium is high compared to the proportions of magnesium, sodium and potassium. Similarly, for the anions plot the relative proportions of bicarbonate are high, while chloride and sulphate are low. All samples plot within a similar range and thus are of similar background composition. The groundwater chemistry may be broadly classified as Calcium-Bicarbonate type water which indicates that the groundwater is of recent evolution and/or is recently recharged.

Considering the Piper and Schoeller diagrams in Figure 3.5 and Figure 3.6 and the results of baseline monitoring (Table 3.1 and Table 3.2), it can be shown that for both Kingston and Glenorchy the aquifer systems are reasonably vulnerable to direct land use impacts. The situation in Glenorchy is that the water supply is sourced from a well adjacent to the Buckler Burn, away from the township itself. The site is then not affected by local land use impact and or discharges via septic tank disposal fields. Kingston appears to be most vulnerable from local septic tank discharges, as they are directly adjacent to many shallow wells used for domestic water supply.

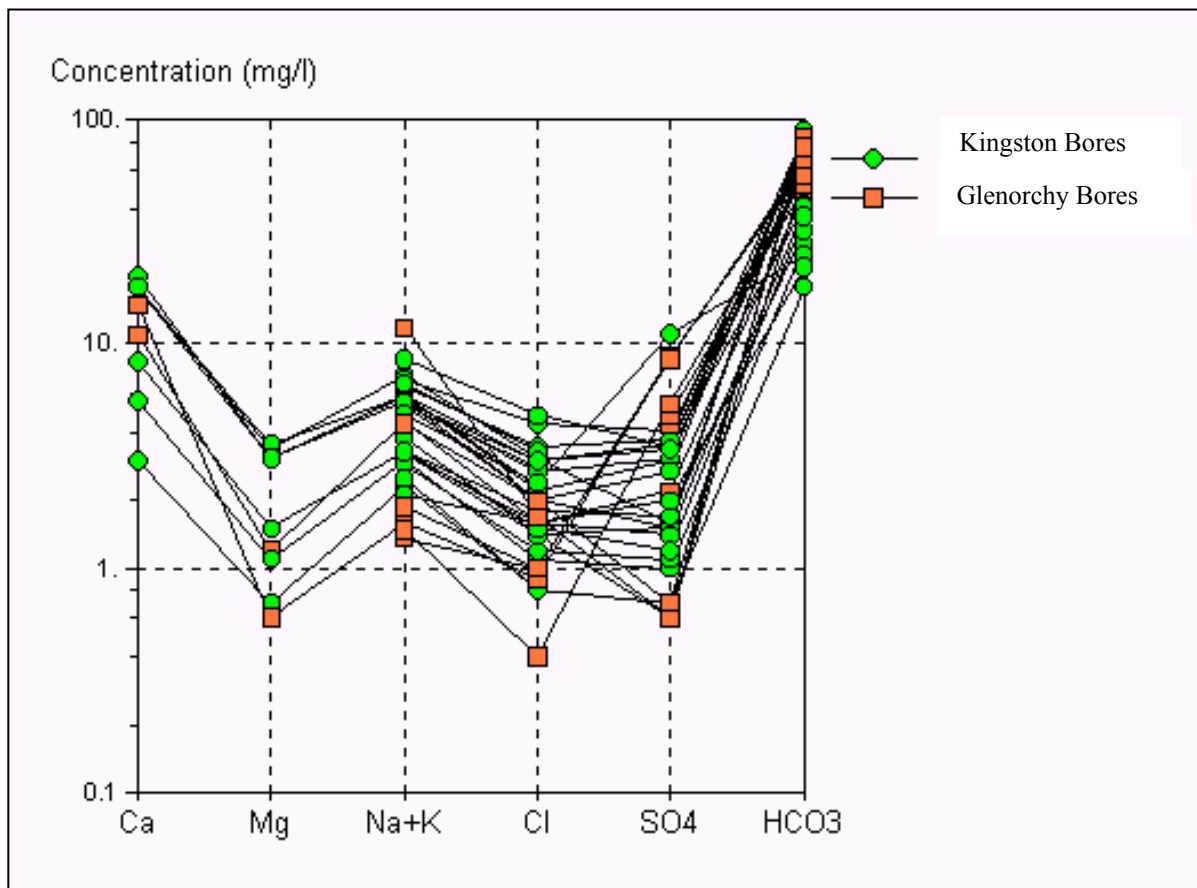
Figure 3.6 Schoeller diagram of major ions (mg/L) in Kingston and Glenorchy groundwater

The Schoeller diagram shown on Figure 3.6, represents major ion concentrations to show hydrochemical water types. From Figure 3.6, it can be seen that the concentration of most constituents (Mg^{2+} , Na^+ , K^+ , Cl^- and SO_4^-), generally lie within 1 – 10 mg/L, and the dominant ions of Ca^{2+} and HCO_3^- between 10 – 100+ mg/L. This shows again, that Kingston and Glenorchy groundwater is of a relatively recent (recharge), evolutionary path.
