Channel morphology of the Shag River, North Otago

Report writer: Jacob Williams, Natural Hazards Analyst
Reviewed by: Michael Goldsmith, Manager Natural Hazards

Published September 2014

Technical summary

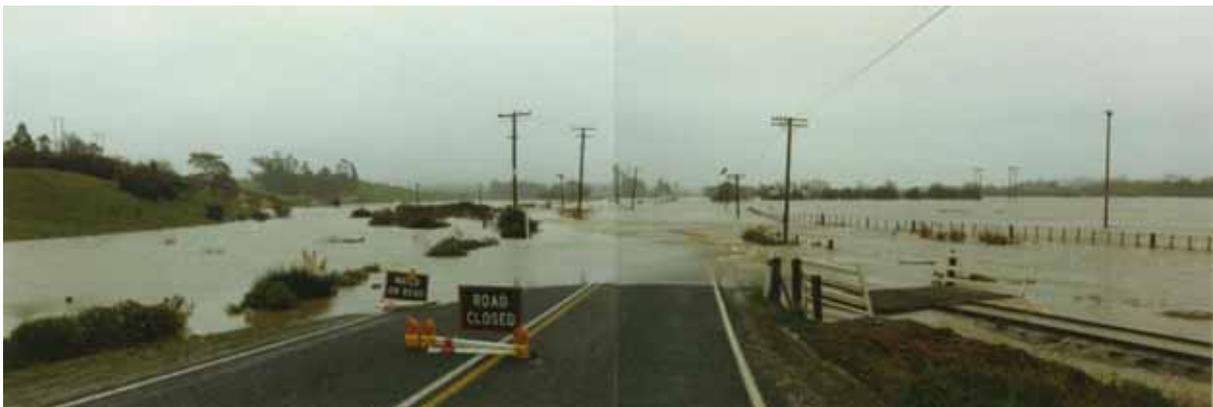
Figure 3. Flooding of the Shag River/Waihemo at SH85 near Palmerston on 5 June 1980.

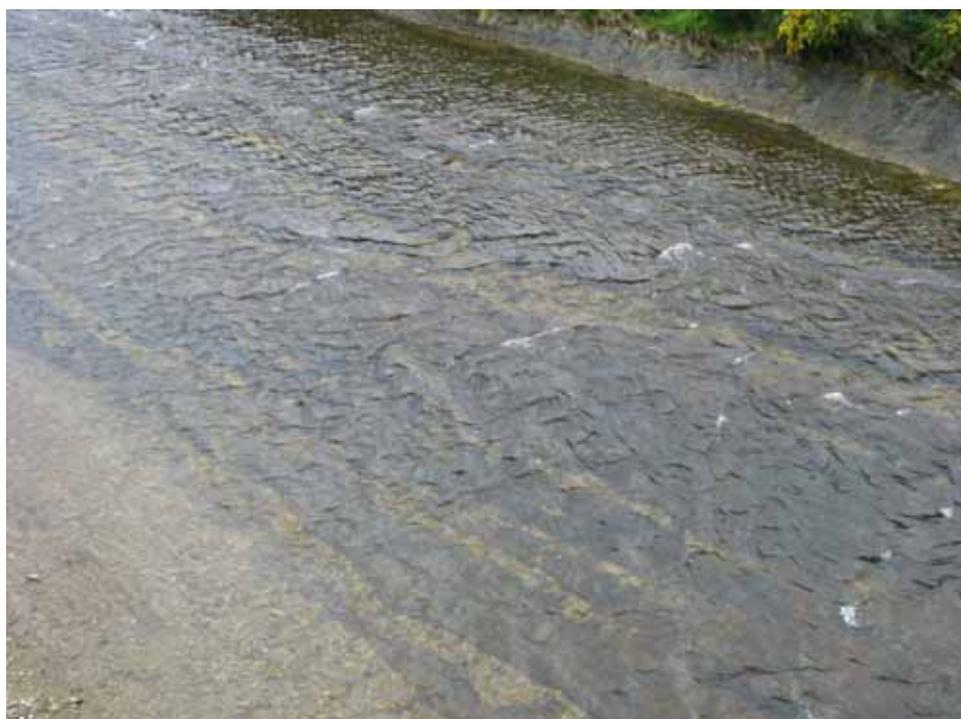
ORC (2004)⁶ identified that bedrock was exposed in the Shag River/Waihemo channel upstream and downstream of McLew Road, bedrock was also exposed at this location in October 2013 (Figure 10). Bedrock was also exposed at Craig Road bridge in October 2013. Bedrock channels form where the supply of sediment to the channel is insufficient to keep the channel mantled with an alluvial cover and can represent a limited sediment supply (Howard, 2013).⁷

Figure 10. Exposed bedrock upstream of McLew Road bridge, October 2013

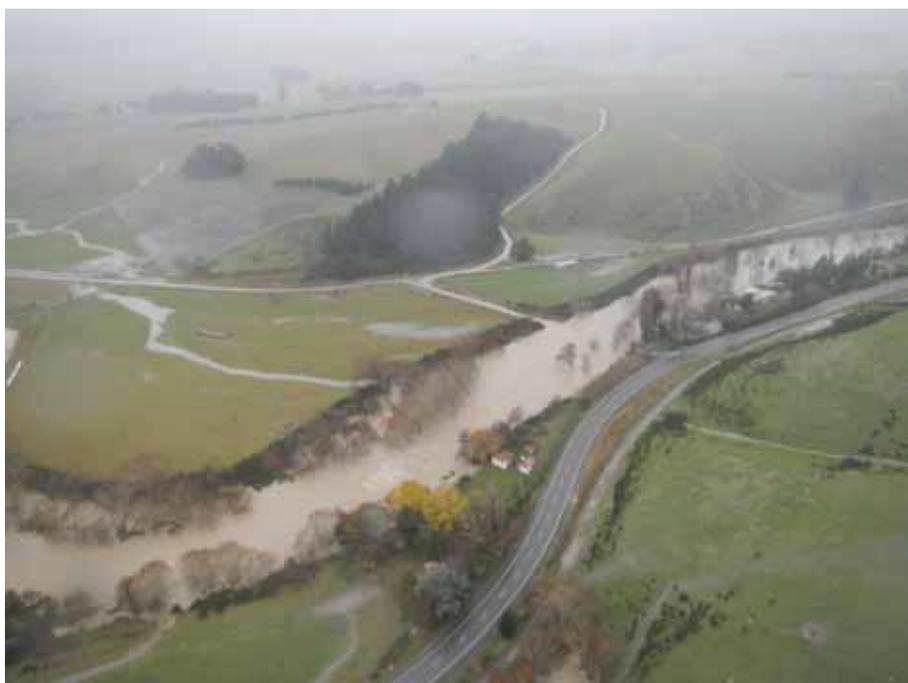
Figure 20. 7 June 2013, flooding, Shag River/Waihemo, looking downstream to the junction of Craig Road and SH85.

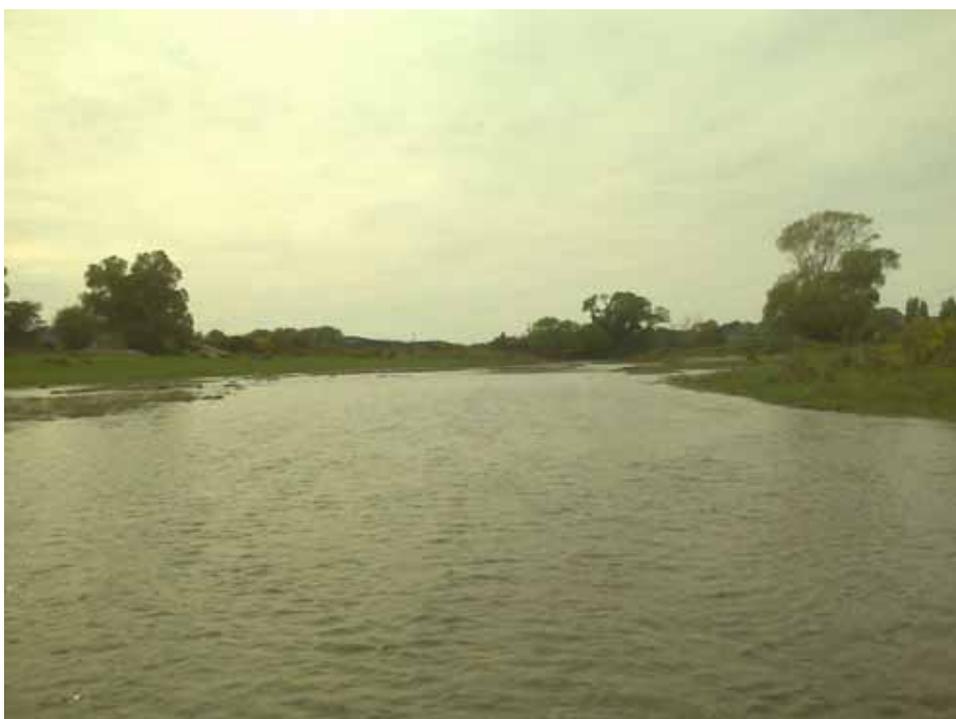
Shag River/Waihemo : S17

Cross-section S17 is located 10.3km upstream of the Shag River/Waihemo mouth and 0.4km downstream of Horse Range Road bridge. The channel bed remained similar between April 2004 and April 2009. Between April 2009 and October 2013 the channel bed aggraded between approximately 0.25 and 0.5m with minimal change in the over bank deposits. The thalweg level increased by 0.2m between 2009 and 2013.

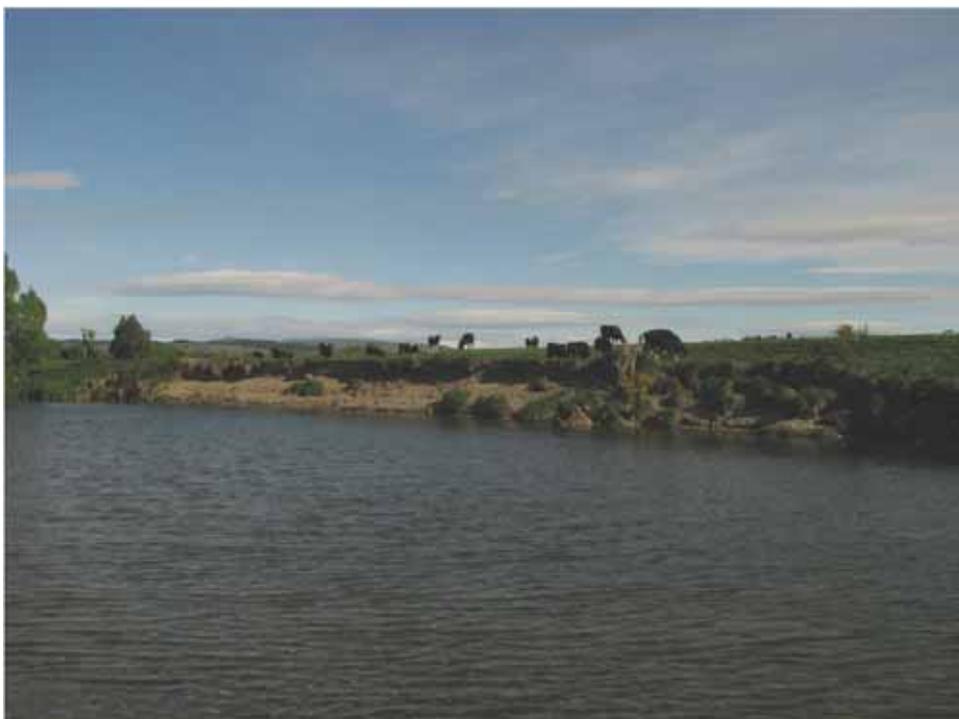
Shag River/Waihemo : S18

Cross-section S18 is located 10.6km upstream of the Shag River/Waihemo mouth and 0.75km upstream of Horse Range Road bridge. The channel bed remained similar between April 2004 and April 2009 with a small amount of degradation occurring on the left of the channel bed and the right bank. Between April 2009 and October 2013 the channel bed and right bank aggraded approximately 0.5m, and the left bank has eroded by approximately 5m. The thalweg remained in the same position between 2009 and 2013.

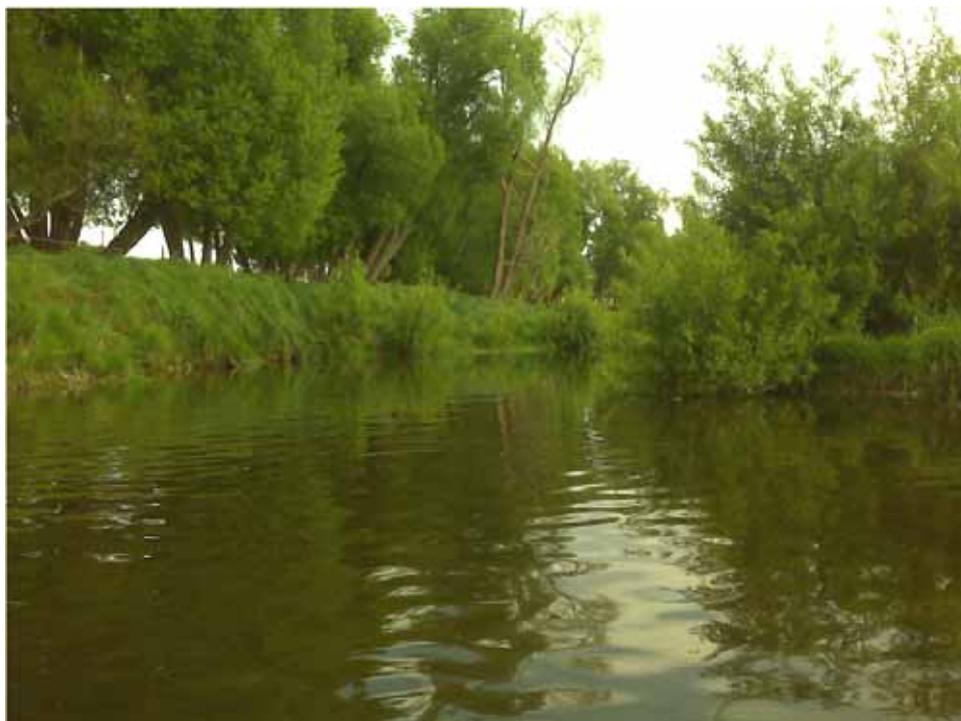
Shag River/Waihemo : S18/1

Cross-section S18/1 is located 11km upstream of the Shag River/Waihemo mouth and 1km upstream of Horse Range Road bridge. The main channel bed remained similar between April 2004 and April 2009 with a small amount of aggradation occurring on the left bank of the high flow channel. Between April 2009 and October 2013 the main channel bed degraded approximately 0.1m, and the left bank of the high flow channel aggraded by approximately 0.5m. The thalweg remained in the same position between 2004 and 2013.

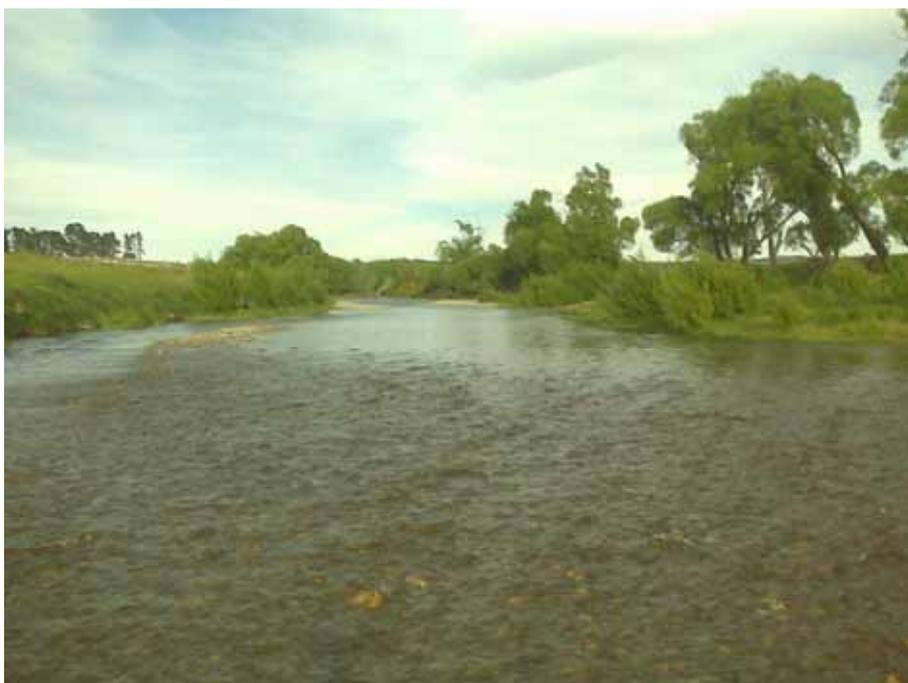
Shag River/Waihemo : S19

Cross-section S19 is located 11.45km upstream of the Shag River/Waihemo mouth and 1.5km upstream of Horse Range Road bridge. The main channel bed remained similar between April 2004 and April 2009 with a small amount of aggradation occurring on the left and right banks of the main channel. Between April 2009 and October 2013 the main channel bed aggraded approximately 0.05m, and the left bank of the high flow channel aggraded by approximately 0.5m. The wider floodplain shows minimal change between 2004 and 2013. The thalweg remained in a similar position between 2004 and 2013.

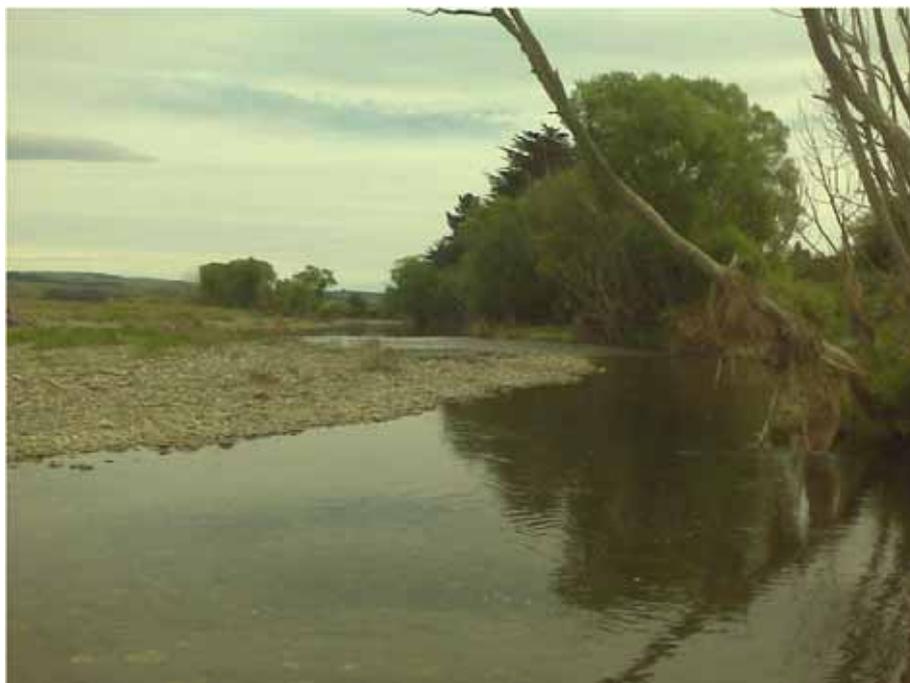
Shag River/Waihemo : S20a

Cross-section S20a is located 12.1km upstream of the Shag River/Waihemo mouth and 0.6km downstream of Switchback Road bridge. The main channel bed remained similar between April 2004 and April 2009 with the creation of a secondary channel occurring on the left bank and a small amount of degradation on the right bank. Between April 2009 and October 2013 the main channel bed aggraded approximately 0.5m on the right, and approximately 0.5m on the left. The wider floodplain shows minimal change between 2004 and 2013. The thalweg remained in a similar position between 2004 and 2013.

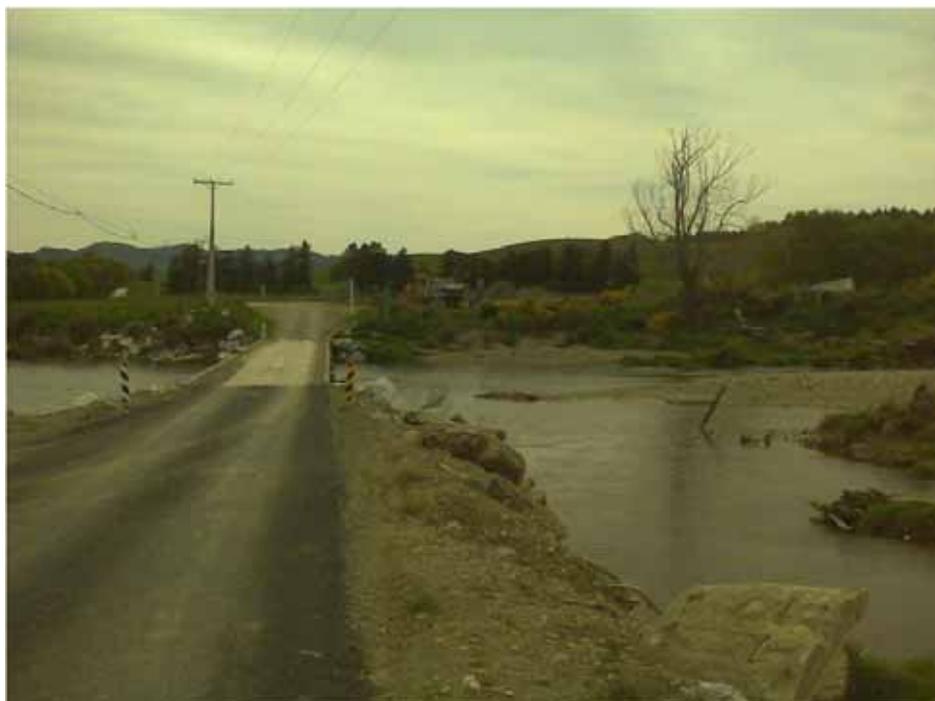
Shag River/Waihemo : S21

Cross-section S21 is located 12.67km upstream of the Shag River/Waihemo mouth at Switchback Road bridge. The main channel bed and the top of the right bank degraded between April 2004 and April 2009 with the creation of three low flow channels. Between April 2009 and October 2013 the bed aggraded approximately 1m on the left and right side of the main channel. Aggradation and degradation occurred on the left and right banks between 2009 and 2013. The thalweg aggraded 0.38m between 2009 and 2013 and is located in a similar position (vertically) to 2004.

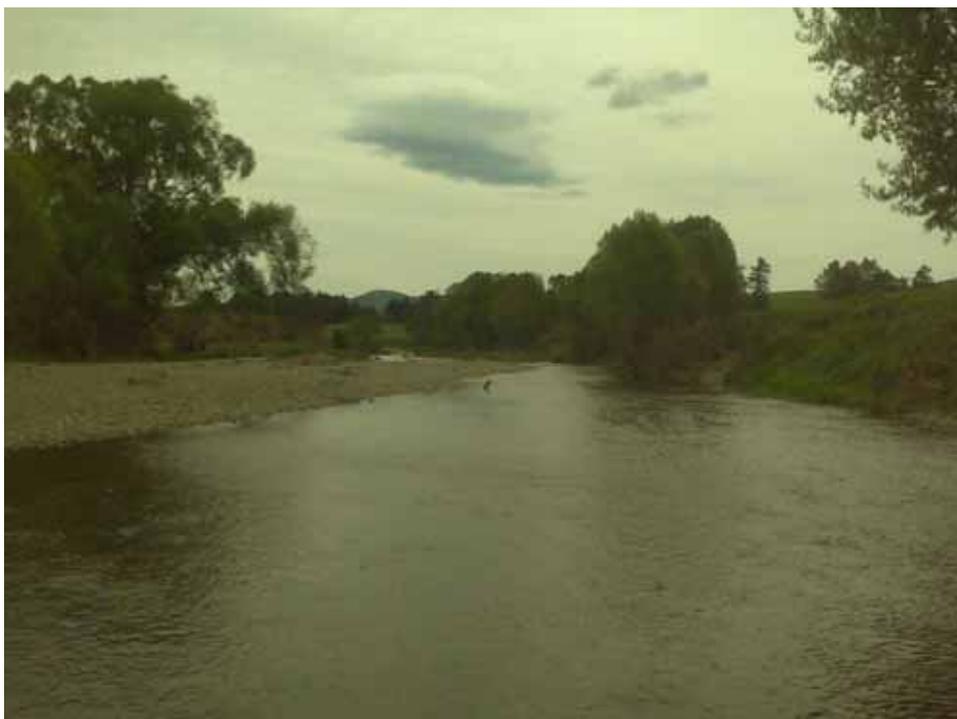
Shag River/Waihemo : S22a

Cross-section S22a is located 12.74km upstream of the Shag River/Waihemo mouth and 0.1km upstream of Switchback Road bridge. The main channel bed degraded on the left bank between April 2004 and April 2009 as well as the top of the left bank losing approximately 1m of material. Between April 2009 and October 2013 the main channel bed aggraded approximately 1m and moved towards the left bank. The wider floodplain shows minimal change between 2009 and 2013. The thalweg aggraded 0.41m between 2009 and 2013.

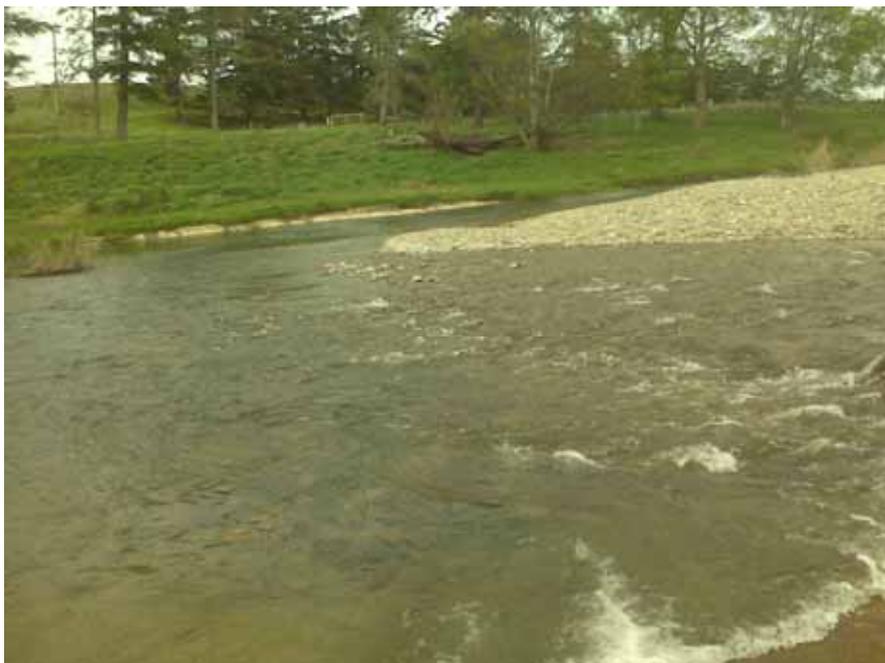
Shag River/Waihemo : S22b

Cross-section S22b is located 13.1km upstream of the Shag River/Waihemo mouth and 0.42km upstream of Switchback Road bridge. The main channel bed aggraded between April 2004 and April 2009, creating a smoother channel form. The right bank floodplain experienced aggradation of approximately 1m (at the point labelled A) and degradation of approximately 1.5m (at the point labelled B). Between April 2009 and October 2013 the main channel degraded approximately 1m with the right bank continuing to aggrade and erosion of the left bank. The wider floodplain shows minimal change between 2009 and 2013. The thalweg degraded 0.53m between 2009 and 2013.

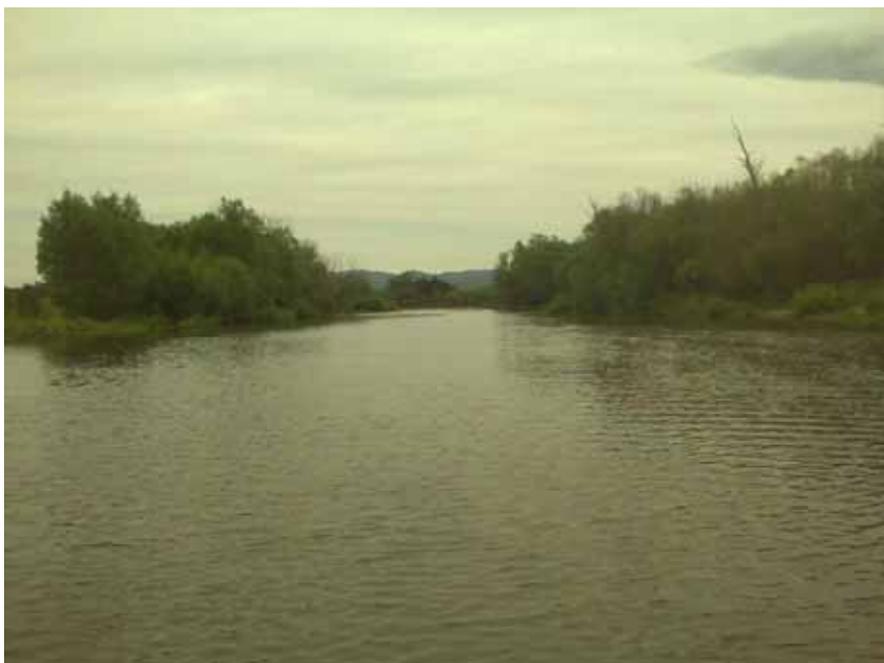
Shag River/Waihemo : S24

Cross-section S24 is located 13.77km upstream of the Shag River/Waihemo mouth and 1.1km upstream of Switchback Road bridge. The main channel bed remained in a similar position between April 2004 and April 2009 with a small amount of bed aggradation occurring. The right bank floodplain experienced degradation of approximately 0.4m. Between April 2009 and October 2013 the main channel degraded approximately 1m with aggradation of the left of the main channel. The wider floodplain showed a general lowering of the left bank and both degradation and aggradation of the right bank between 2009 and 2013. The thalweg degraded 0.57m between 2009 and 2013.

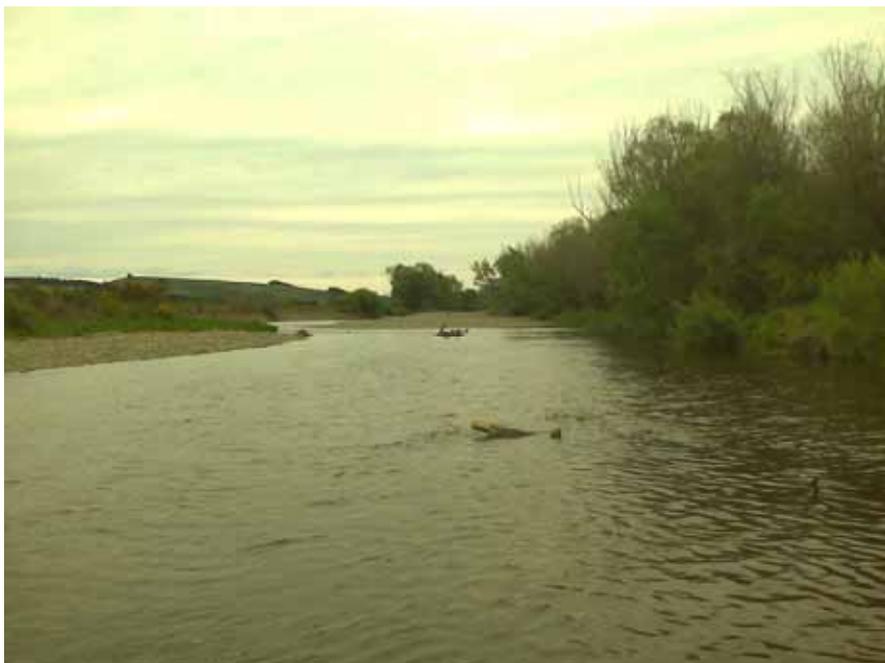
Shag River/Waihemo : S25

Cross-section S25 is located 14.25km upstream of the Shag River/Waihemo mouth and 1.6km upstream of Switchback Road bridge. The main channel bed remained in a similar position between April 2004 and April 2009 with a small amount of bed aggradation and degradation occurring. The left bank experienced minor degradation and the right bank secondary flow channel widened. Between April 2009 and October 2013 the main channel degraded approximately 0.5m with aggradation on the left of the main channel. The wider floodplain remained in a similar position between 2009 and 2013 with minor aggradation of the left bank occurring. The thalweg degraded 0.53m between 2009 and 2013.

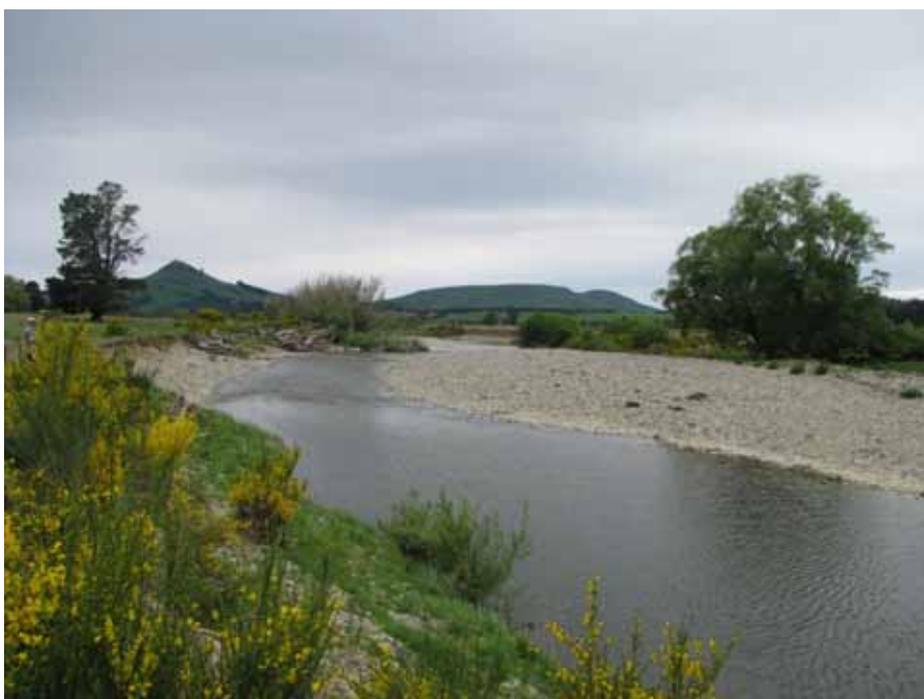
Shag River/Waihemo : S26

Cross-section S26 is located 14.76km upstream of the Shag River/Waihemo mouth and 2.1km upstream of Switchback Road bridge. The right bank of the main channel eroded between April 2004 and April 2009 with the rest of the floodplain remaining similar. Between April 2009 and October 2013 the main channel divided into two low flow channels separated by a gravel bar. A build-up of material on the left bank created a 1m high bank. The wider floodplain remained in a similar position between 2009 and 2013. The thalweg degraded 0.2m between 2009 and 2013.

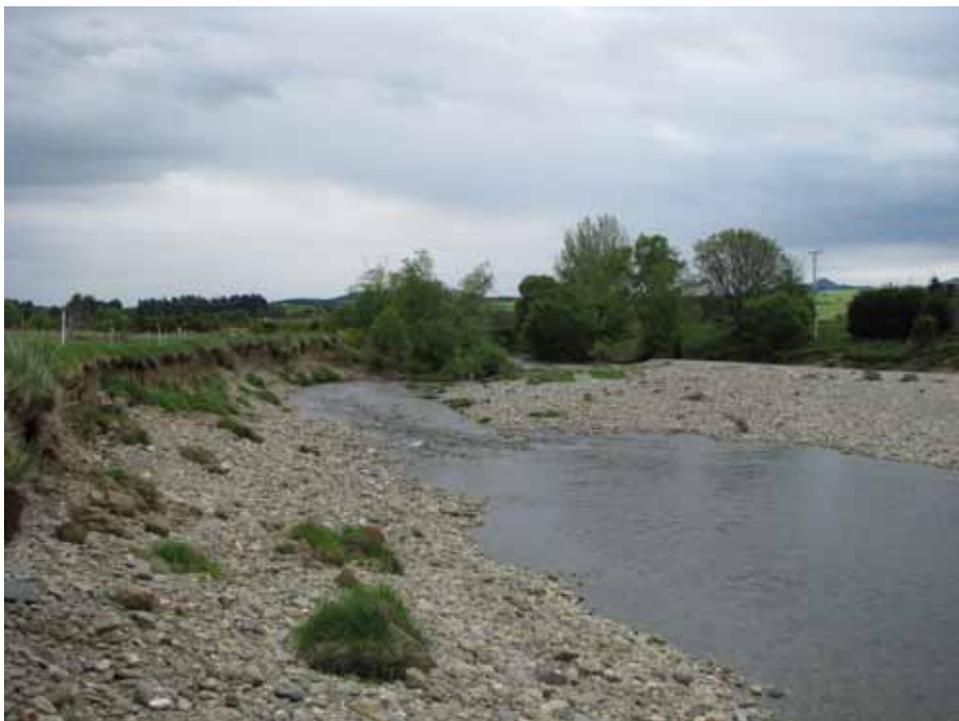
Shag River/Waihemo : S27

Cross-section S27 is located 15.2km upstream of the Shag River/Waihemo mouth and 2.55km upstream of Switchback Road bridge. The main channel bed degraded between April 2004 and April 2009 with a small amount of degradation and aggradation occurring in the wider floodplain. The main channel bed continued to degrade between April 2009 and October 2013 with erosion of the left bank by approximately 5m. The wider floodplain remained in a similar position between 2009 and 2013. The thalweg degraded 0.05m between 2009 and 2013.

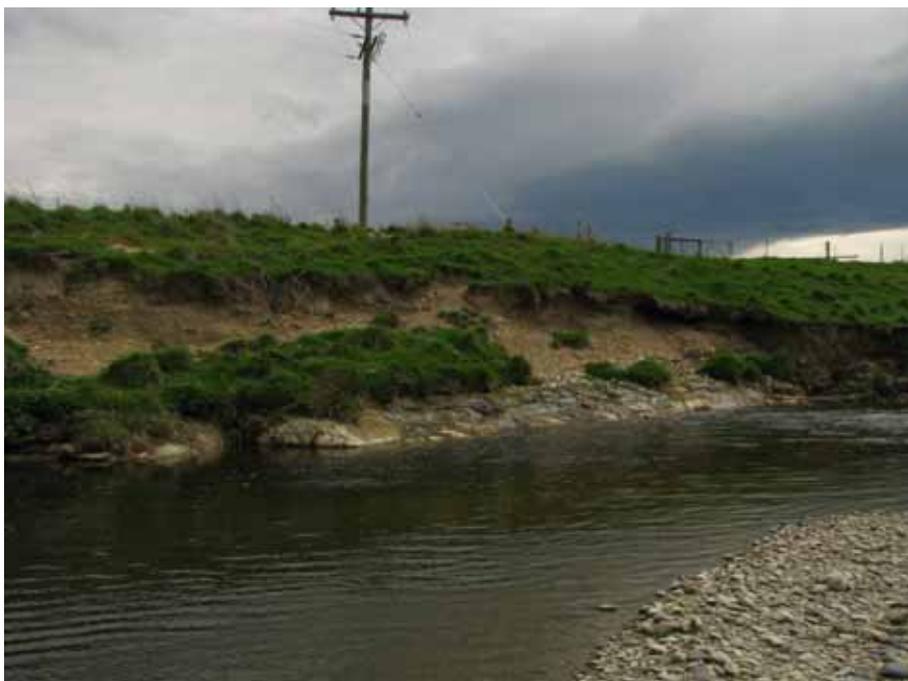
Shag River/Waihemo : S28

Cross-section S28 is located 15.95km upstream of the Shag River/Waihemo mouth and 3.3km upstream of Switchback Road bridge. The main channel bed degraded and moved towards the right bank between April 2004 and April 2009 with predominantly degradation occurring across the wider floodplain. The main channel bed continued to degrade and move towards the right bank between April 2009 and October 2013 with erosion of the right bank occurring by approximately 10m. The wider floodplain showed predominantly degradation between 2009 and 2013. The thalweg degraded 0.63m between 2009 and 2013.

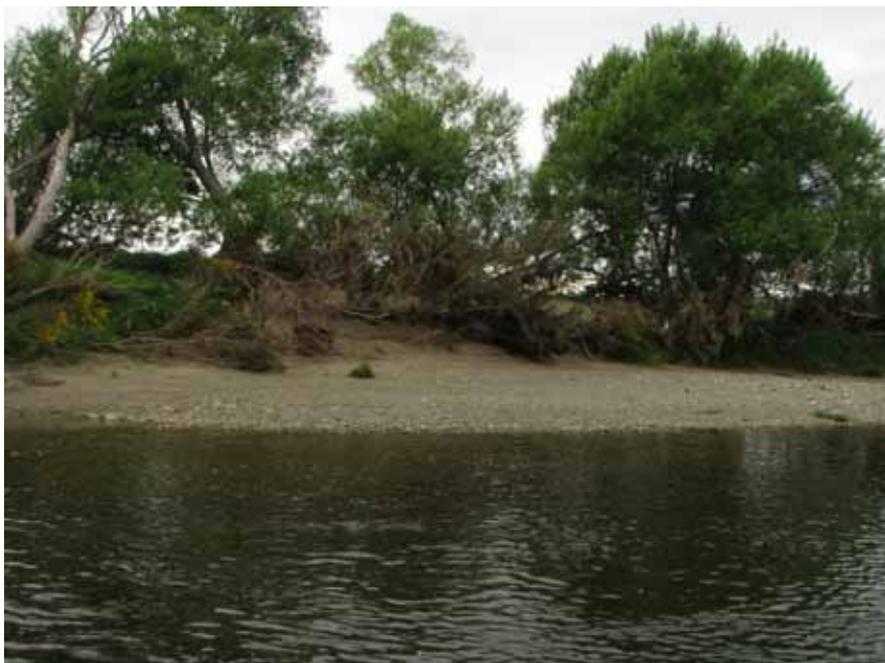
Shag River/Waihemo : S29

Cross-section S29 is located 16.8km upstream of the Shag River/Waihemo mouth and 4.2km upstream of Switchback Road bridge. The main channel bed degraded by approximately 1.75m between April 2004 and April 2009 with a small amount of degradation occurring on the left terrace and wider left floodplain. The main channel bed aggraded between April 2009 and October 2013, but it is still lower than the 2004 channel bed level. Aggradation occurred on the left bank terrace and wider left floodplain between 2009 and 2013 with levels predominantly being higher than those in 2004. The thalweg aggraded 1.2m between 2009 and 2013.

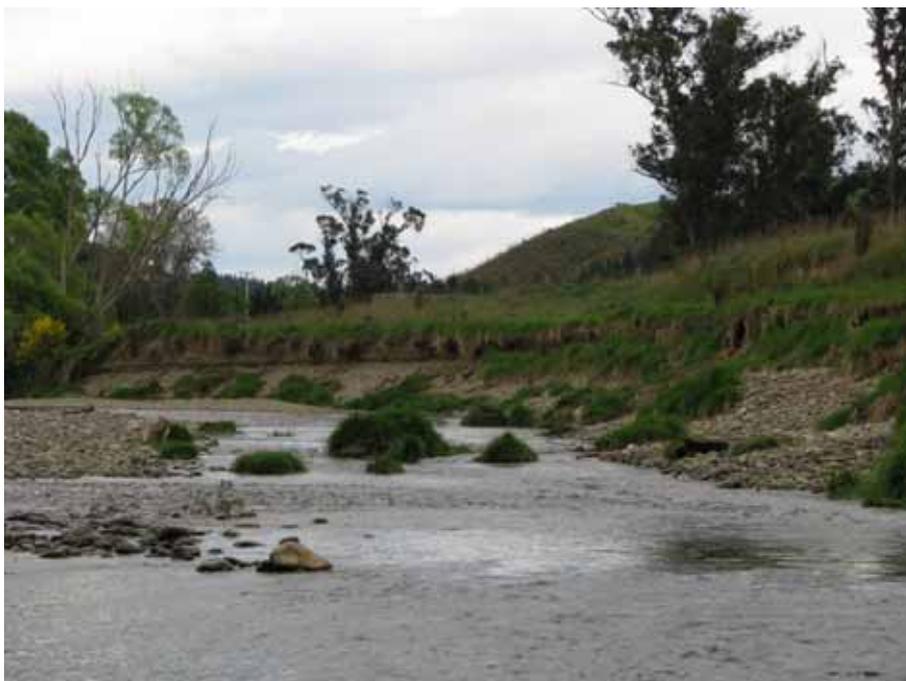
Shag River/Waihemo : S30

Cross-section S30 is located 17.27km upstream of the Shag River/Waihemo mouth and 4.6km upstream of Switchback Road bridge. The main channel bed degraded between April 2004 and April 2009 with erosion of the left bank by approximately 13m occurring. The main channel bed aggraded and widened between April 2009 and October 2013, eroding the right bank by approximately 10m. The top of the left bank shows aggradation and the creation of two natural levees (at the point labelled A), and the wider floodplain remained similar between 2009 and 2013. The thalweg aggraded 1m between 2009 and 2013.

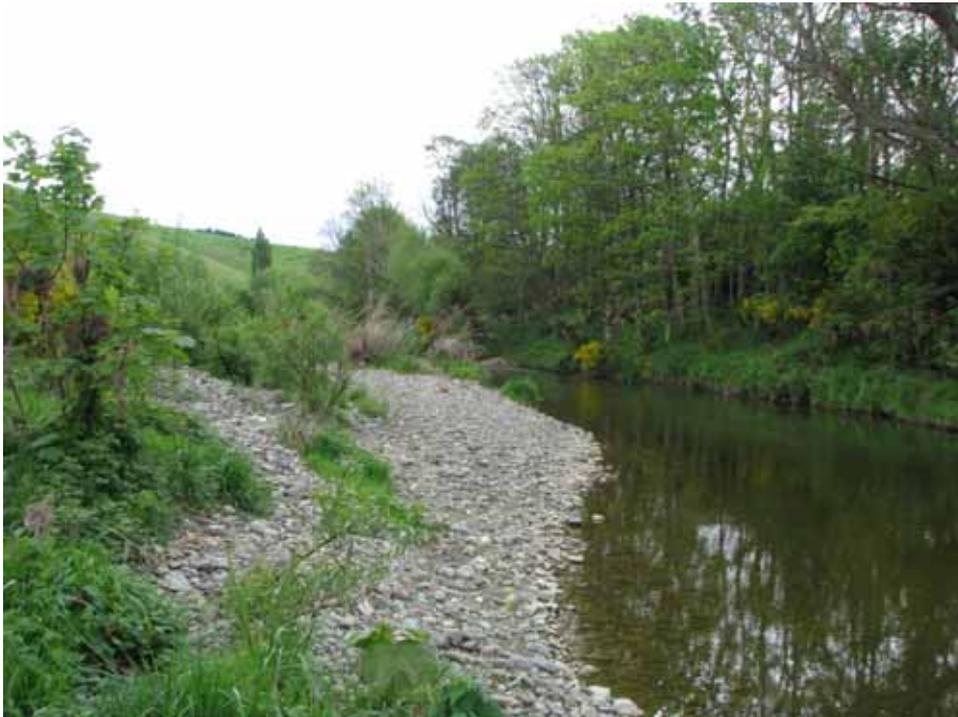
Shag River/Waihemo : S31

Cross-section S31 is located 17.6km upstream of the Shag River/Waihemo mouth and 1km downstream of Craig Road bridge. The main channel bed aggraded between April 2004 and April 2009 with erosion of the right bank and both aggradation and degradation of the wider floodplain. The main channel bed aggraded, degraded and widened between April 2009 and October 2013. The wider floodplain remained similar between 2009 and 2013. The thalweg aggraded 0.15m between 2009 and 2013.

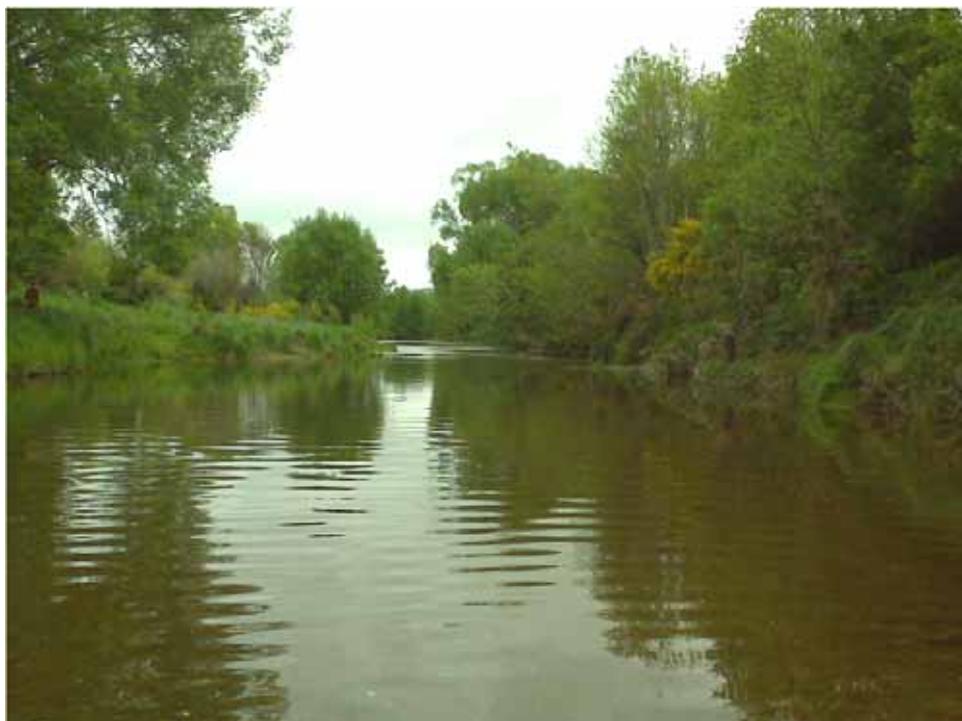
Shag River/Waihemo : S32

Cross-section S32 is located 18km upstream of the Shag River/Waihemo mouth and 0.57km downstream of Craig Road bridge. The main channel bed degraded and narrowed between April 2004 and April 2009 with aggradation of the left and right banks. The main channel bed degraded between April 2009 and October 2013 with erosion of the left bank by approximately 6m occurring. The wider floodplain remained similar between 2009 and 2013. The thalweg degraded 0.3m between 2009 and 2013 and is now located on the left of the main channel.

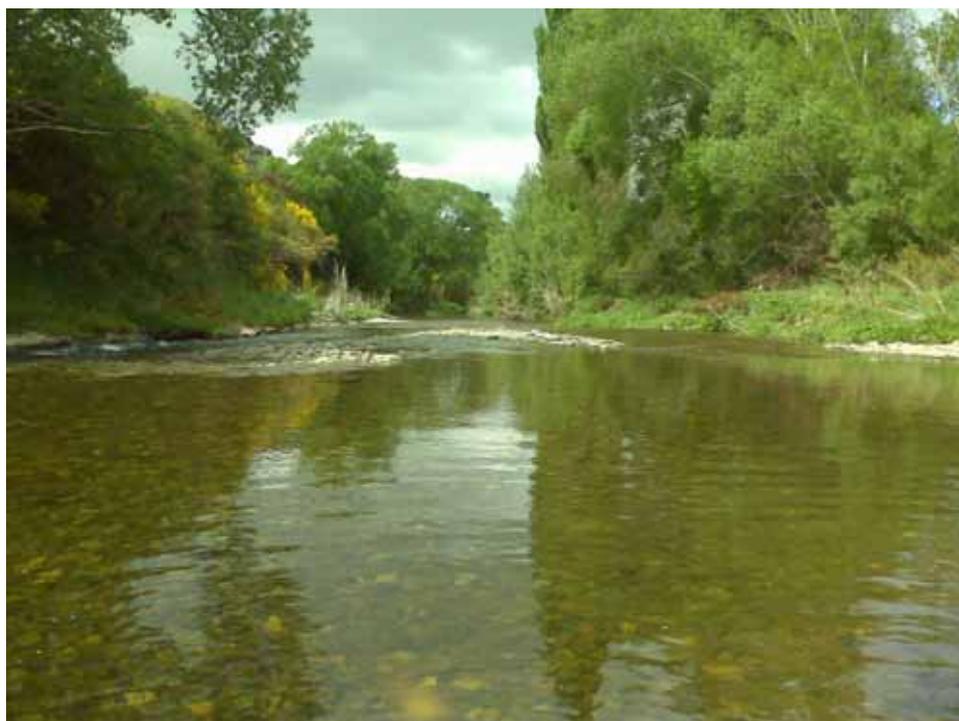
Shag River/Waihemo : S33

Cross-section S33 is located 18.6km upstream of the Shag River/Waihemo mouth at Craig Road bridge. The main channel bed aggraded on the right and degraded on the left, causing the thalweg level to decrease between April 2004 and April 2009. The main channel bed aggraded by 1m between April 2009 and October 2013, causing the low flow channel to narrow. The wider floodplain remained similar between 2009 and 2013. The thalweg aggraded 0.93m between 2009 and 2013.

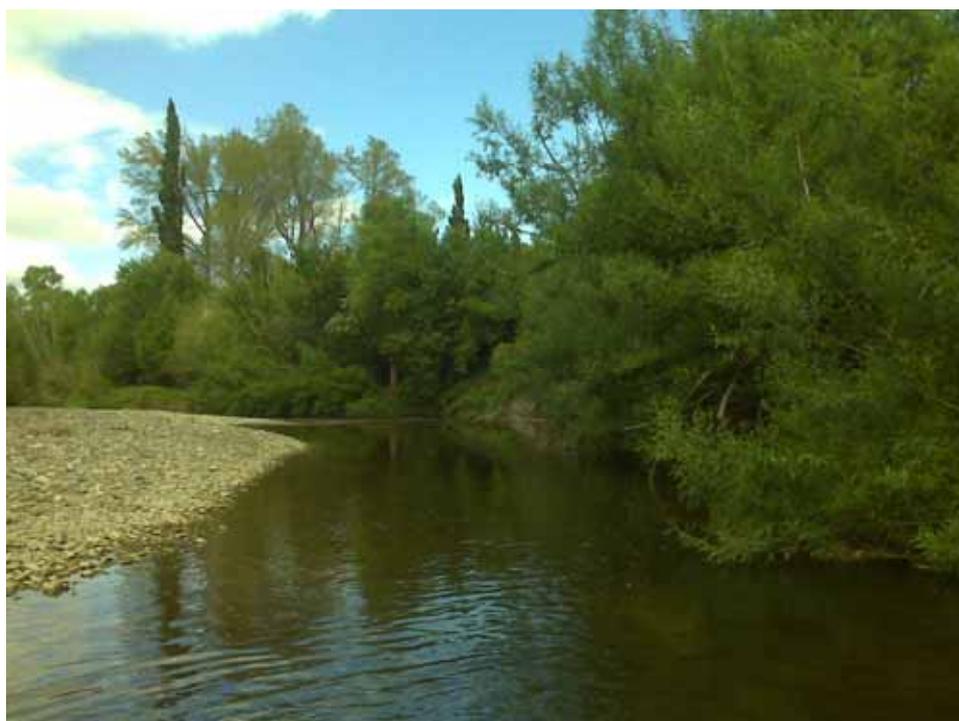
Shag River/Waihemo : S34

Cross-section S34 is located 19.24km upstream of the Shag River/Waihemo mouth and 0.65km upstream of Craig Road bridge. The main channel bed aggraded on the left bank, narrowing the channel, while the left side floodplain showed degradation or limited change between April 2004 and April 2009. The main channel bed in October 2013 remained similar to the 2009 bed with a small amount of aggradation on the left bank. The left side floodplain aggraded between 2009 and 2013. The thalweg stayed in the same position between 2009 and 2013.

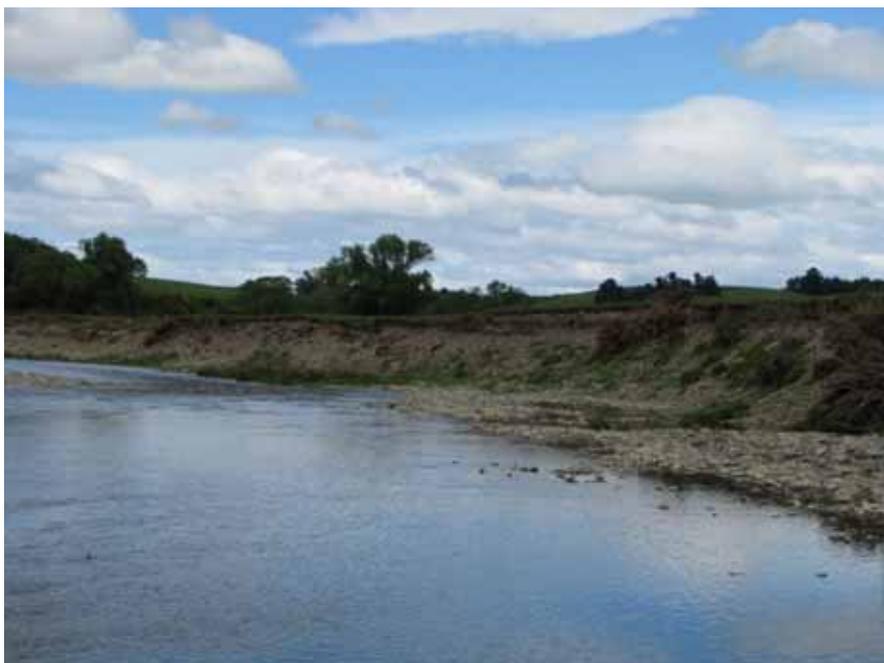
Shag River/Waihemo : S36

Cross-section S36 is located 20.5km upstream of the Shag River/Waihemo mouth and 0.39km downstream of McLew Road bridge. The main channel bed is divided into two low flow channels. Between April 2004 and April 2009 the left channel widened with the right channel narrowing, and the right side floodplain both aggraded and degraded. Between April 2009 and October 2013 the left channel became narrower and deeper with the right channel aggrading approximately 1m. The right side floodplain remained similar between 2009 and 2013 with some minor aggradation and degradation occurring. The thalweg remained in a similar position (vertically) between 2004 and 2013.

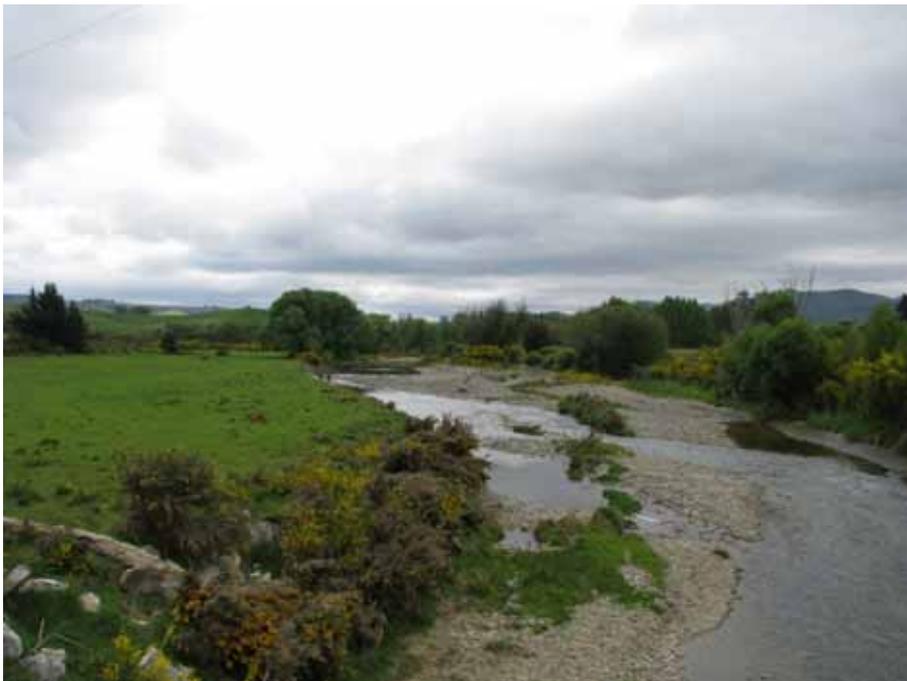
Shag River/Waihemo : S37

Cross-section S37 is located 20.9km upstream of the Shag River/Waihemo mouth at McLew Road bridge. The main channel bed both aggraded and degraded but became smoother between April 2004 and April 2009. The right bank eroded approximately 6m with both aggradation and degradation occurring across the wider floodplain between April 2004 and April 2009. The main channel bed and right bank aggraded between April 2009 and October 2013 with predominantly aggradation occurring across the wider floodplain. The thalweg aggraded 0.4m between 2009 and 2013.
