# **Channel morphology of the Rees River, Otago**

September 2013

Otago Regional Council

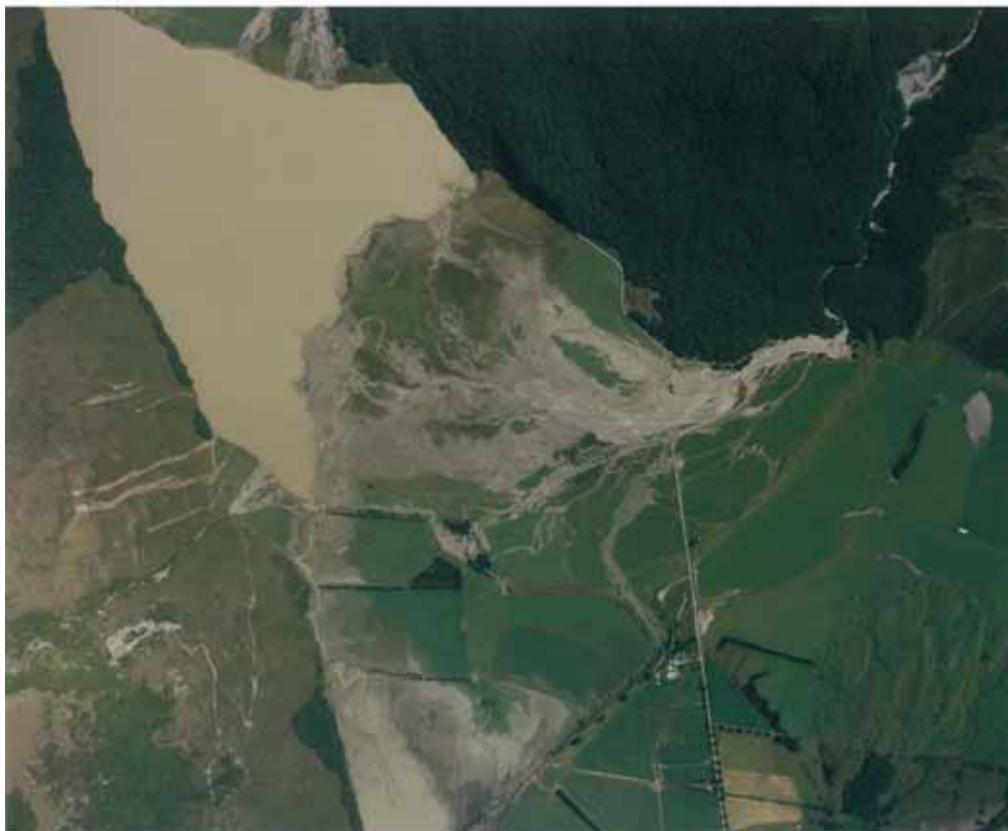
**Figure 2** Sedimentation on the Earnslaw Burn alluvial fan following an extreme rainfall event in January 1994. Diamond Lake is at the top left of the image.

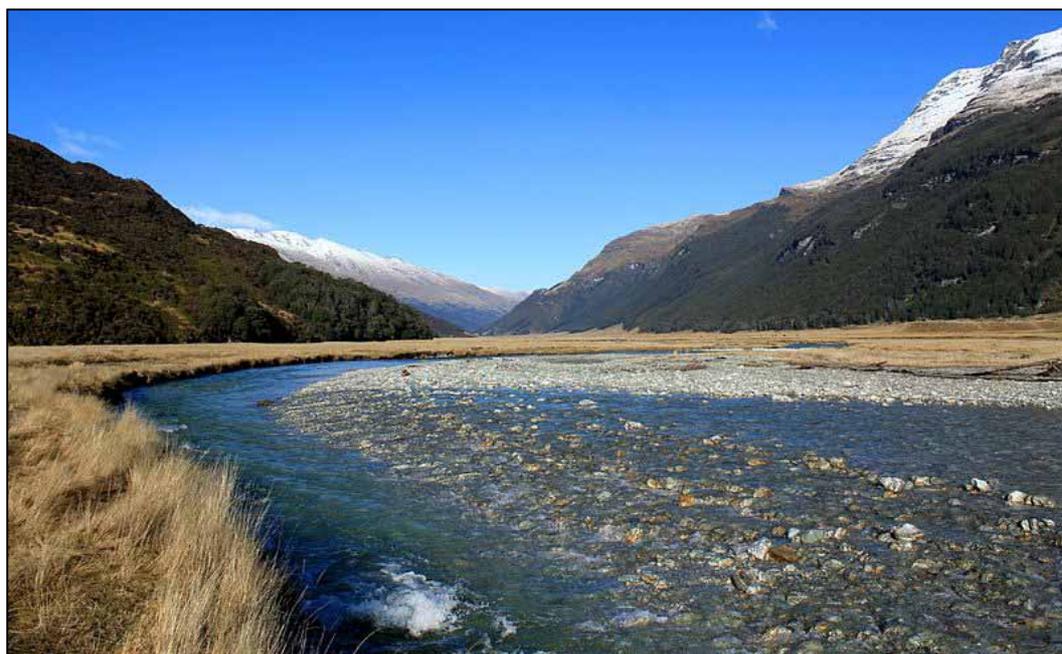
Figure 5 View of the channel, floodplain and flanking mountains, looking downstream in the mid-reaches of the Rees River (above Lovers Leap)

Figure 4 shows a longitudinal profile along the Rees River, from Rees Saddle to Lake Wakatipu. This graph shows the steep nature of the Rees River in its upper reaches and that it has a much shallower gradient in its mid- to lower reaches (Figure 5 to Figure 7). The main tributaries to the Rees River follow a similar profile, and include Precipice Creek, Invincible Creek, 12 Mile Creek<sup>6</sup> and 25 Mile Creek.

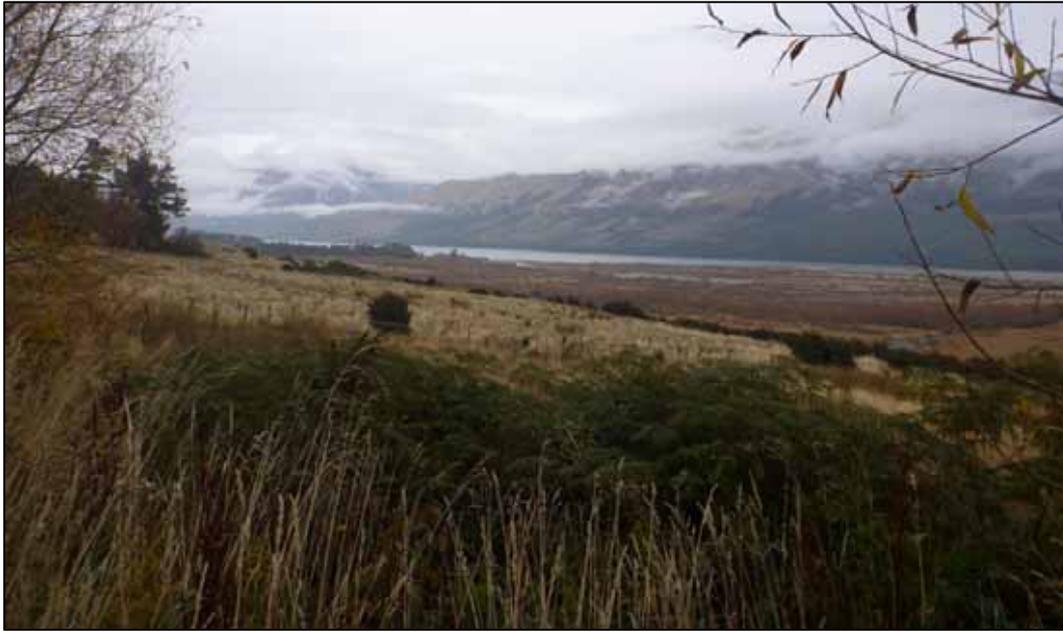
Figure 6 Lower Rees River catchment, looking towards Lake Wakatipu

The Rees and Dart rivers have together formed a 2.5km-wide delta where they discharge into Lake Wakatipu (Figure 6 and Figure 7). The townships of Glenorchy and Kinloch lie to the east and west, respectively, of this delta. ORC (2008) describes the channel morphology of the lower Rees River as consisting of a braided channel form with an extremely mobile bed load. The lateral migration of channel position within the active channel<sup>7</sup> margins occurs frequently,

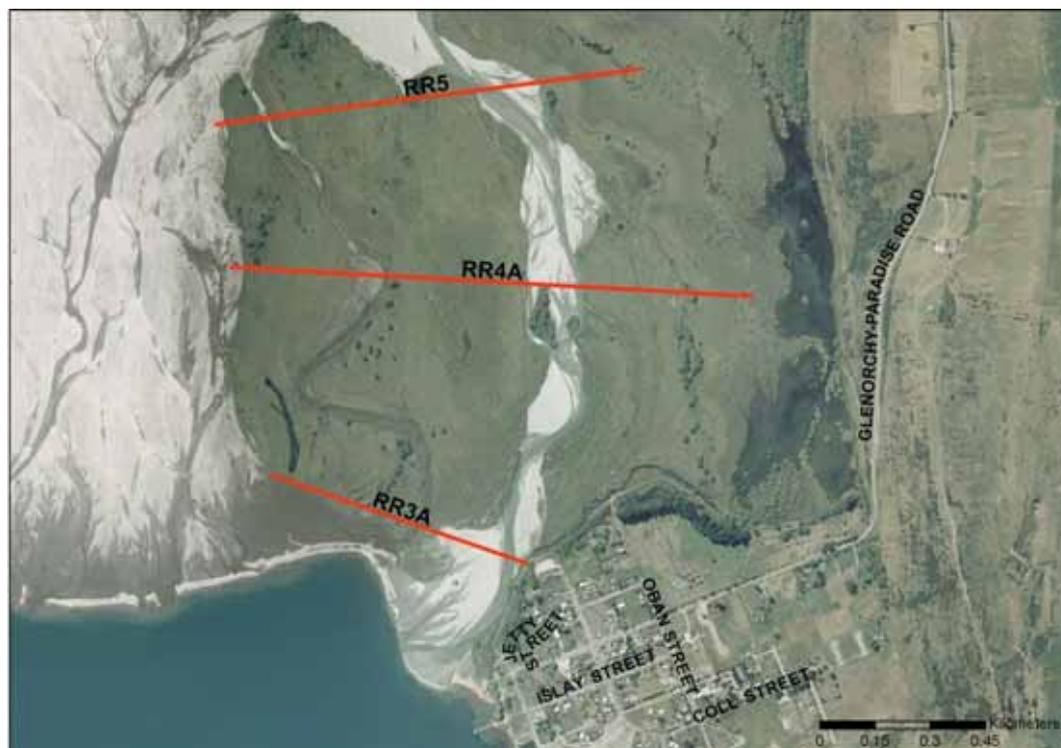
Figure 12 Location of cross-sections near Glenorchy, aerial photo dated February 2006

Figure 12 shows the location of the three surveyed cross-sections next to, and upstream of, Glenorchy. Appendix 1 (Figure 29 to Figure 34) shows the survey data collected at these locations between 1990-2011 (RR5) and 1999-2011 (RR4A and RR3A).<sup>9</sup> Two graphs are provided for each location: one showing the entire cross-section, and one showing the active channel. ORC (2008) noted minor net aggradation of the channel in this lowest reach of the Rees River since records began until December 2006.

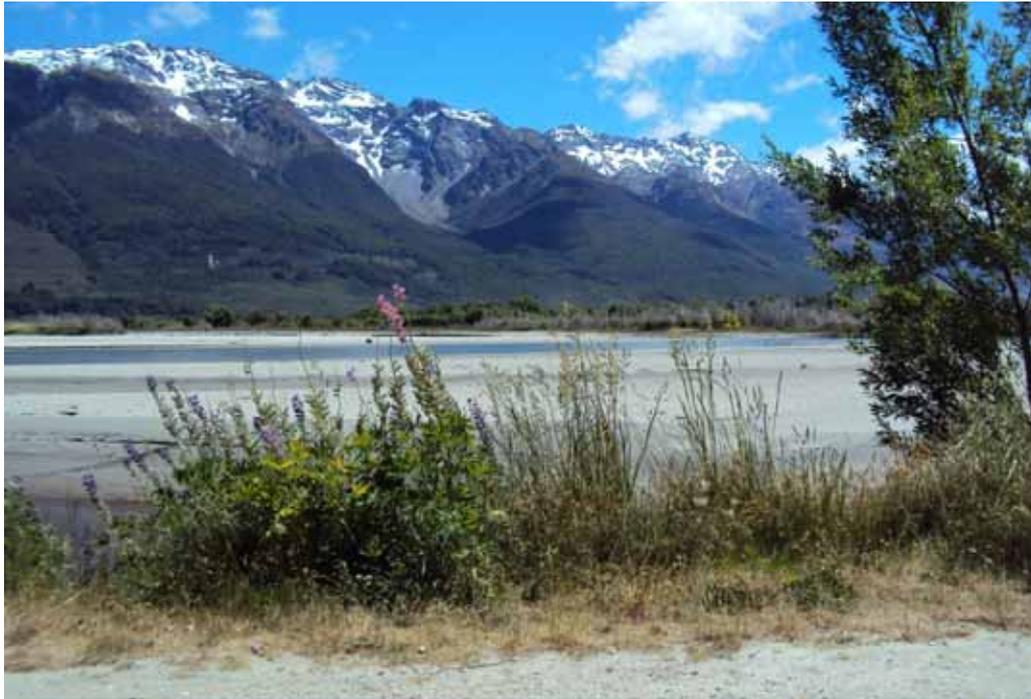
Figure 13 View along cross-section RR3A, looking from the true-left (Glenorchy) side towards the true-right side (December 2010)

At cross-section RR3A, degradation of the bed occurred across much of the active channel between 2006 and 2011. Other parts of the bed aggraded during this period: in particular, a bank of sediment that lies 35-65m from the true-left bank, which built up by as much as 1m between 2006 and 2011. This feature was present during the cross-section surveys in May and December 2010 (Figure 30). Figure 30 also shows no net change in bed level between 1999 and 2011, with areas of degradation generally balanced by aggradation elsewhere in the channel. The active channel at RR3A is about 200m wide (Figure 13), and, for much of its width, it is 0.5 to 1m higher than the flood plain to the west (Figure 29).

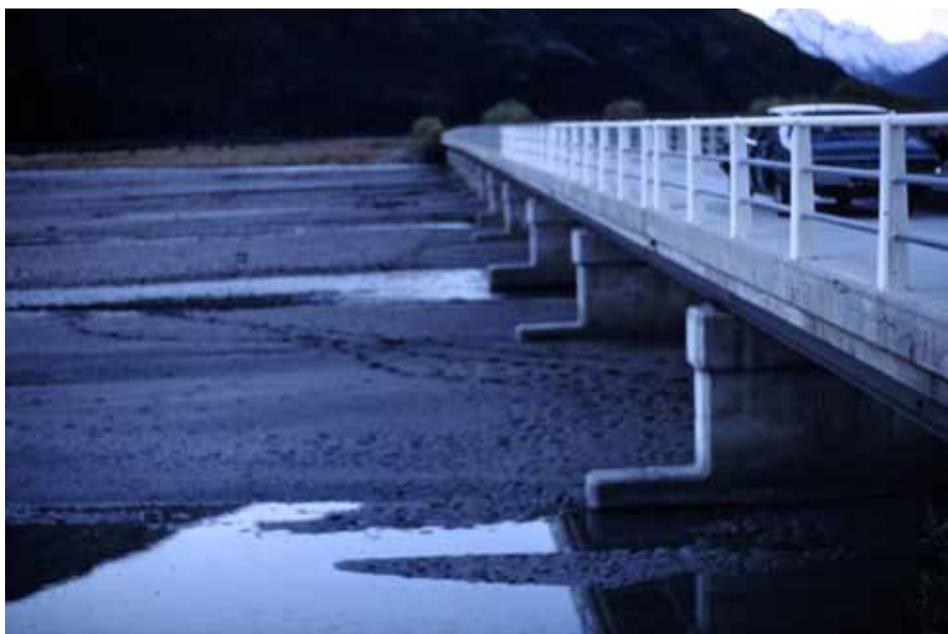
Figure 20 Rees River Bridge, November 1973

Overall, the 2011 survey data shows that, since 2006, the river bed has aggraded slightly, near the Rees River Bridge. Other anecdotal evidence and photos confirm that this has been a trend for some time. Mabin (2007) reports that 'local reminiscence suggests it was possible to drive a bulldozer under the bridge when it was first built.' The images shown in Figure 20 to Figure 22 give an indication of the aggradation that has occurred since that time.<sup>11</sup> Figure 23 also shows the overall aggradation that has occurred at the closest cross-section to the bridge (RR12) between the first survey in 1984 and the most recent one in 2011.<sup>12</sup>

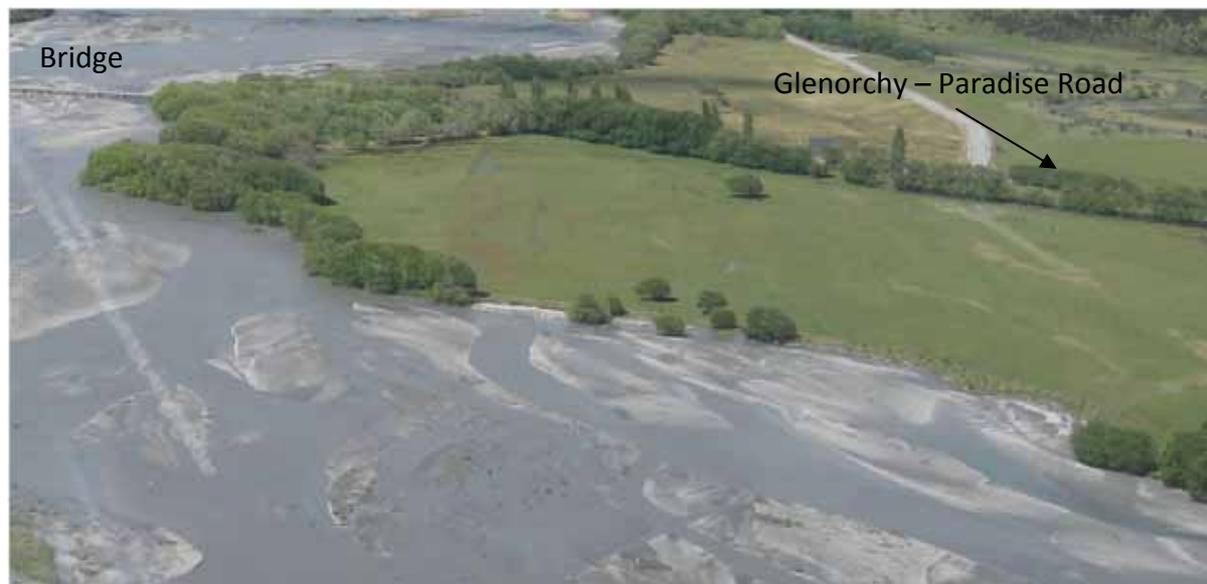
Figure 25 Aerial view of the true right of the Rees River about 10am on 11 January 2013. Ponding on the lowest river terrace, between the active channel and Glenorchy-Paradise Road, is evident.

However, the overall net aggradation that continues to occur across the width of the active channel will have a detrimental effect on the capacity of the channel to contain larger flows. On-going aggradation will result in the Rees River Bridge being overtopped and the adjacent river terraces being inundated, at progressively lower flows. Observations after high flows in January 2013 suggest that flood water may have spilled out onto the true-right bank, upstream of the bridge (Figure 25), although neither the bridge nor the road was closed during this event.

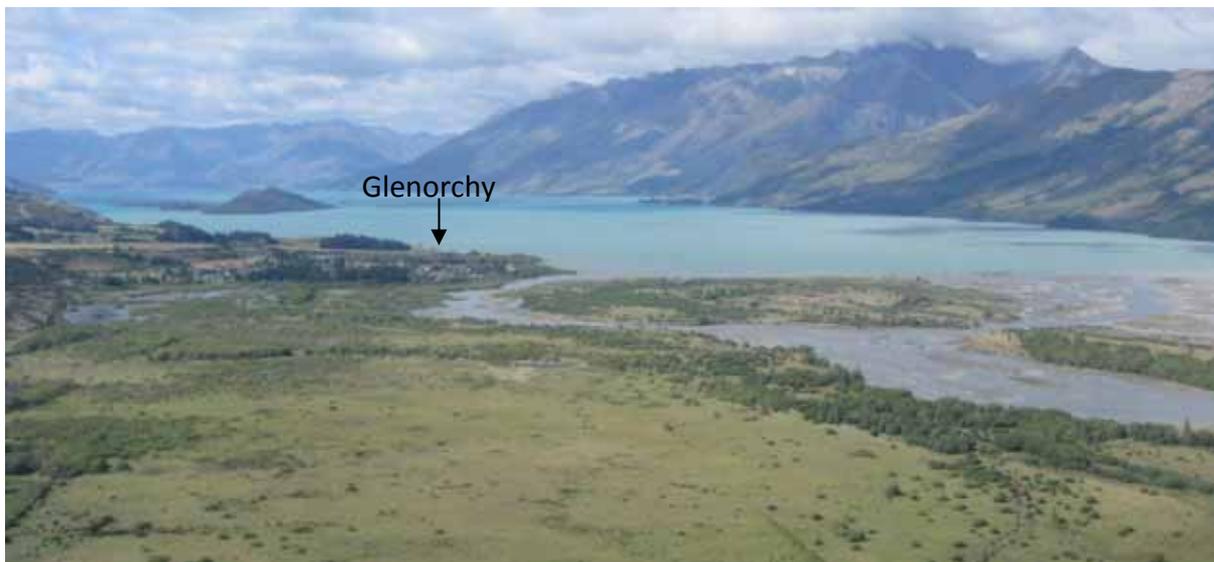
Figure 28 Aerial view towards Glenorchy and the lower Rees River about 10am on 11 January 2013

The constantly changing morphology of the channel and floodplain makes it difficult to determine any long-term trends (or lack thereof). However, the analysis undertaken for this report suggests that there has not been any obvious aggradational or degradational trend at the three cross-sections closest to Glenorchy since the first cross-section surveys were obtained in the 1990s. LiDAR information has helped to show that the lower part of the Rees River is perched (elevated above adjacent land) in its floodplain, suggesting that the Rees River has the ability to change its course towards the lateral margins of its floodplain, either west towards the Dart River, or further east, towards Glenorchy (Figure 28).
