**Channel morphology and sedimentation
in the Kakanui and Kauru Rivers,
North Otago**

October 2010

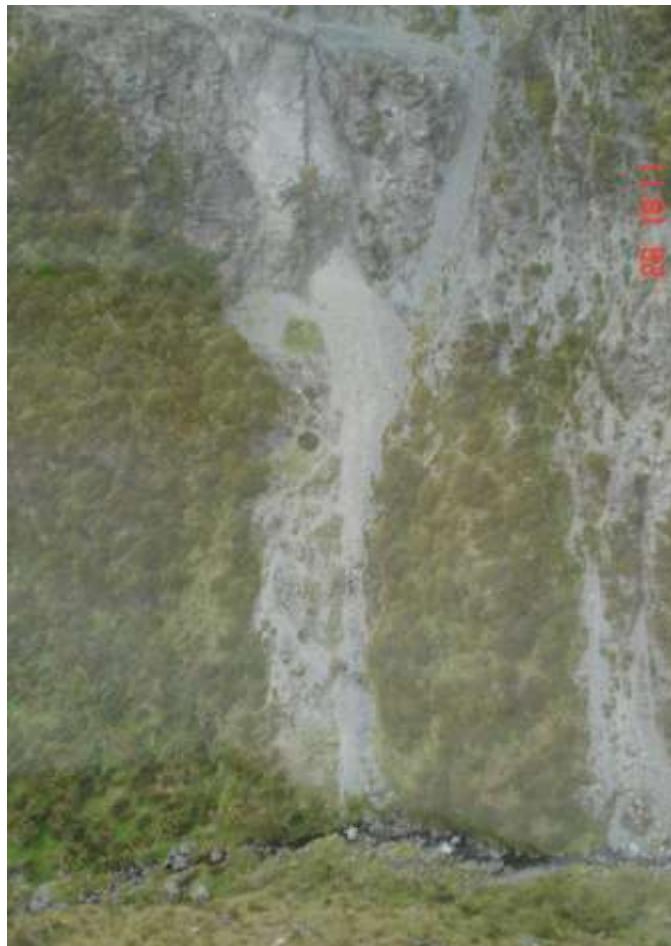
Figure 2.2 An upper catchment hillside showing exposed, mobile weathered material above the incised river channel. Taken January 2008

The historic and present floodplains of the Kakanui River and its tributaries comprise Pleistocene weathered gravel and sand in alluvial terraces with loess cover (Forsyth, 2001). The current floodplain areas comprise recent transported gravels from the upper reaches of the rivers as well as reworked alluvium from the banks.

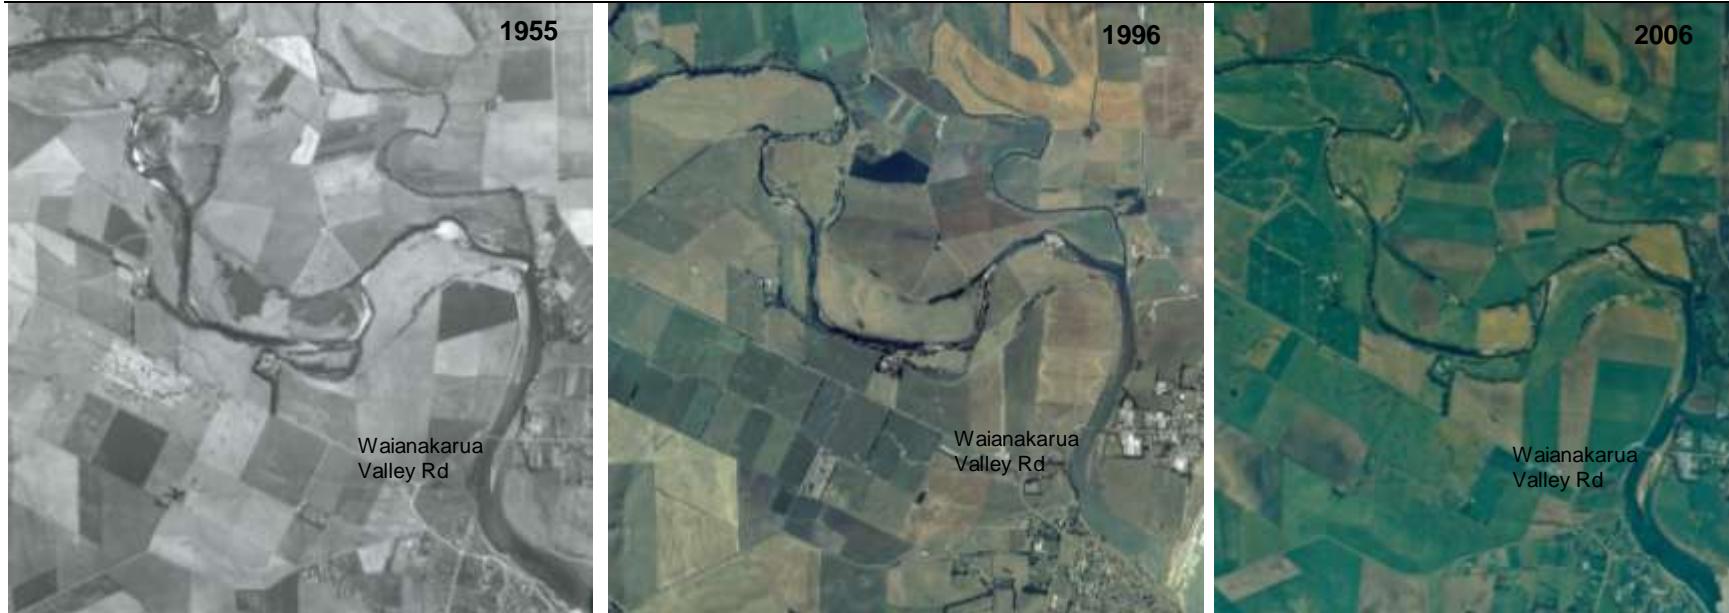
Figure 2.4A Aerial photographs of Kakanui River in 1955, 1996 and 2006 from the river mouth upstream approximately 7km

The active channel is located across the full extent of the cross-section and has a width of 150m. Mean bed level analysis shows that this location has experienced net degradation of 0.78m between 1987 and 2009 (refer Table 3.2). Since 2000 the bed level has lowered and the channel has established itself on the true left. There has been little morphological change in this reach since the 1950s (Figure 2.4A).

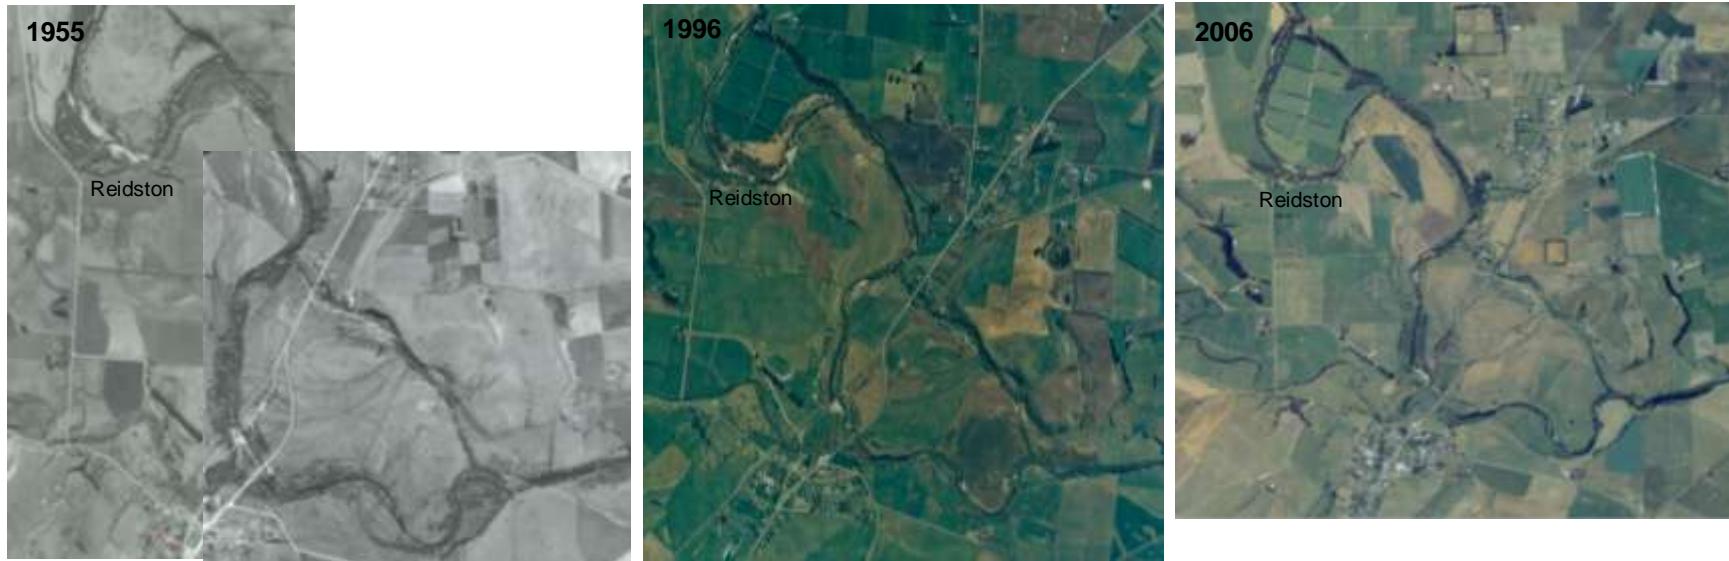
Figure 2.4B Aerial photographs of Kakanui River in 1955, 1996 and 2006 between 7 and 12km upstream of the river mouth

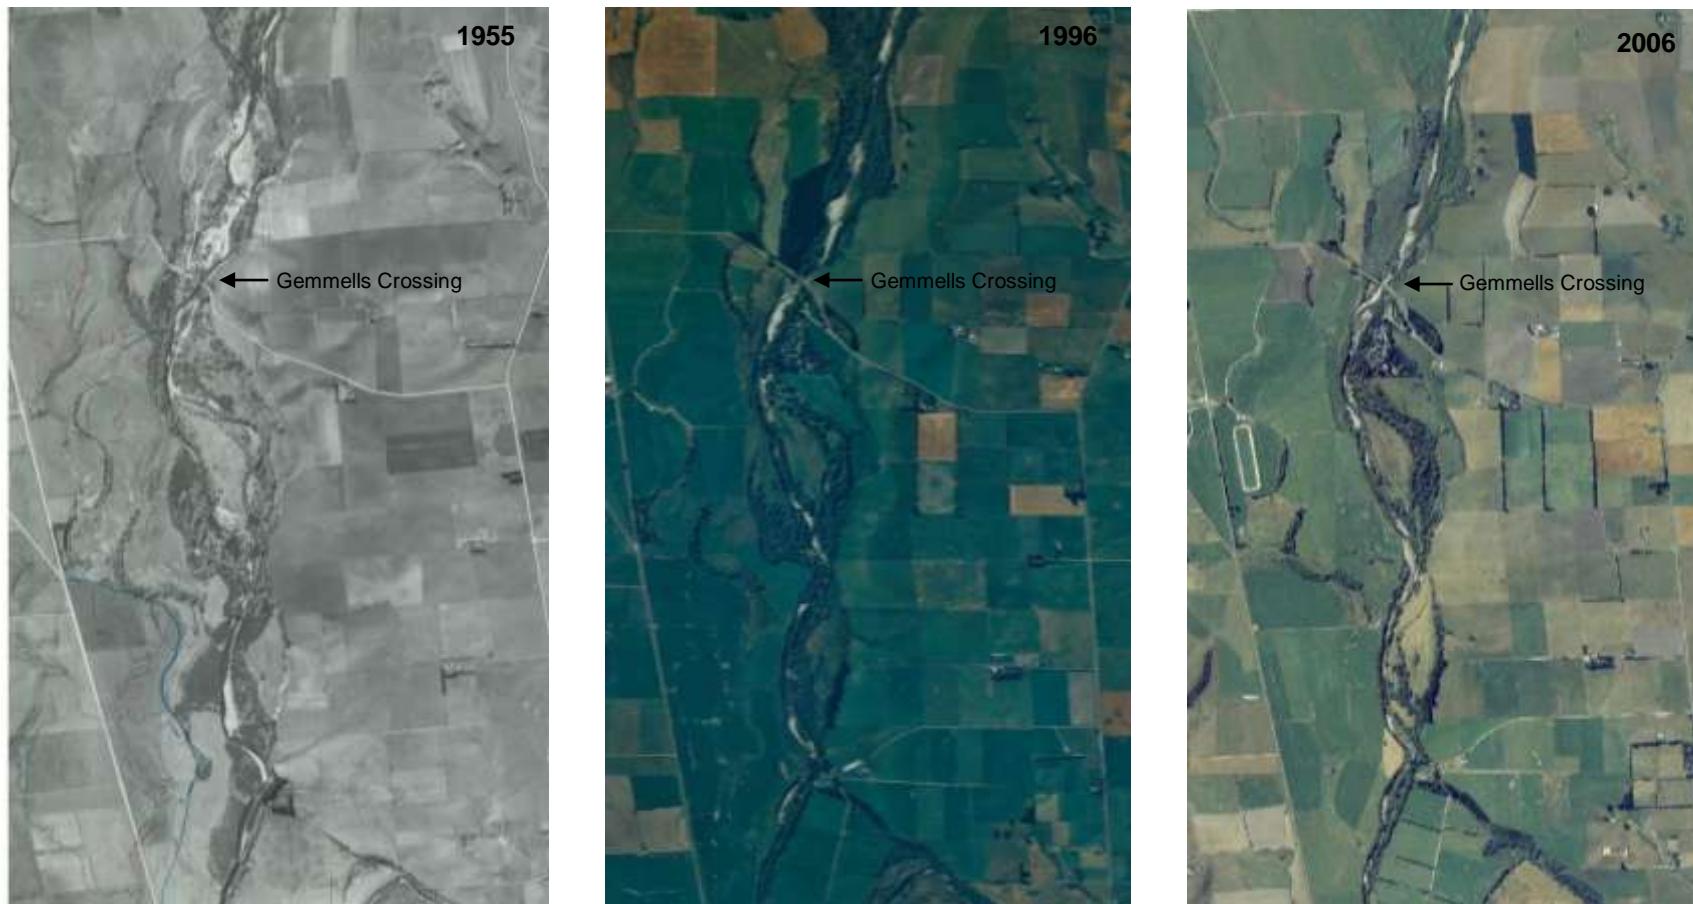
Figure 2.4C Aerial photographs of Kakanui River in 1955, 1996 and 2006 from 12 to 19km upstream of the river mouth.

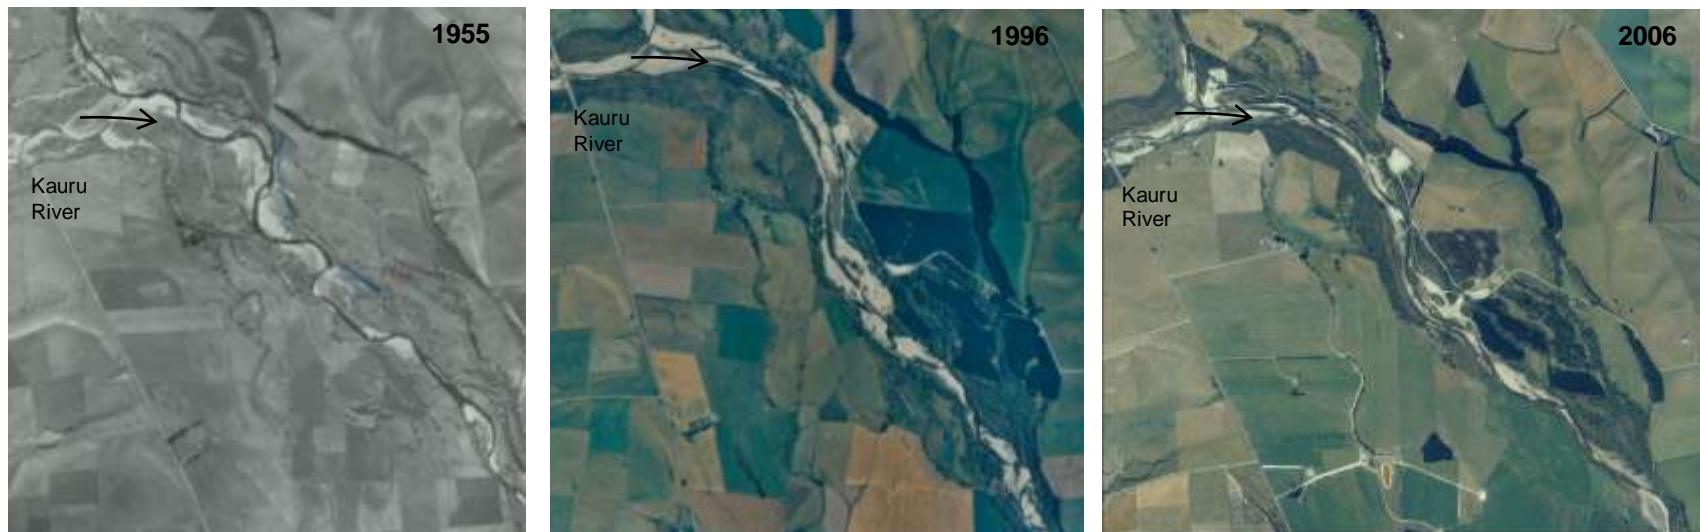
Figure 2.4D Aerial photographs of Kakanui River in 1955, 1996 and 2006 from 19 to 23km upstream of the river mouth.

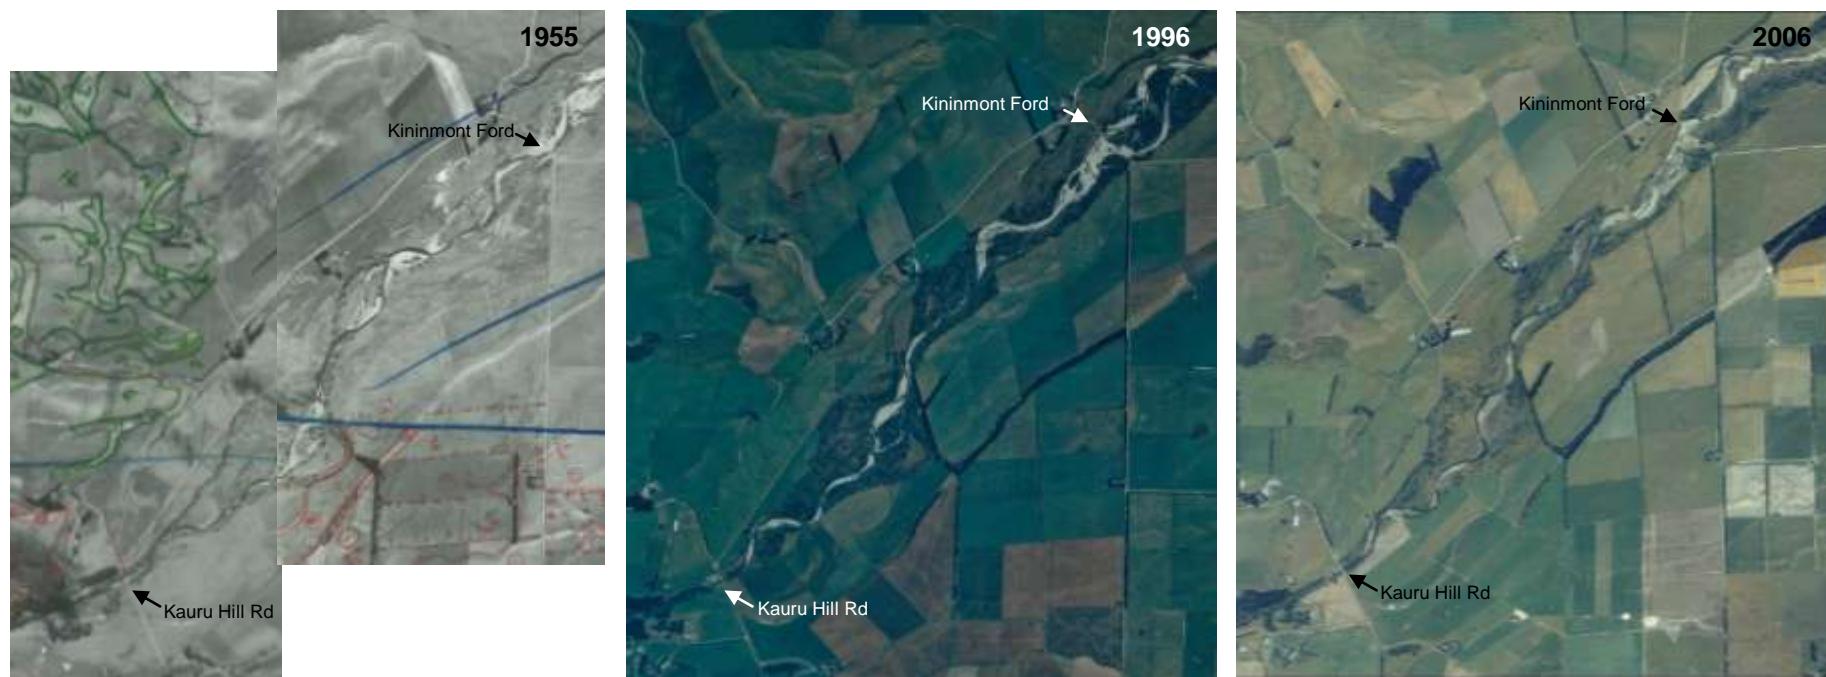
Figure 2.5B Aerial photographs of Kauru River from Kininmont Ford up to Kauru Hill Road.

Between Kininmont Ford and Kauru Hill Road there has been less obvious morphological change than the lowermost reaches of the river, although the main channel has still migrated laterally between its banks (Figure 2.5B). The active channel in the vicinity of the Ford has widened between 1955 and 1996 and appears to have become braided; in 2006 the channel was still a similar width to 1996 but had reverted to a meandering river form. Downstream of Kauru Hill Road the river appears to have increased in sinuosity and, where it was evident as a single-threaded channel down to about 1km below Kauru Hill Road in the 1955 aerial, it is now partially braided similarly to the rest of the river downstream. Changes to both sediment supply rates and gradient of the river bed can induce such changes in river form.

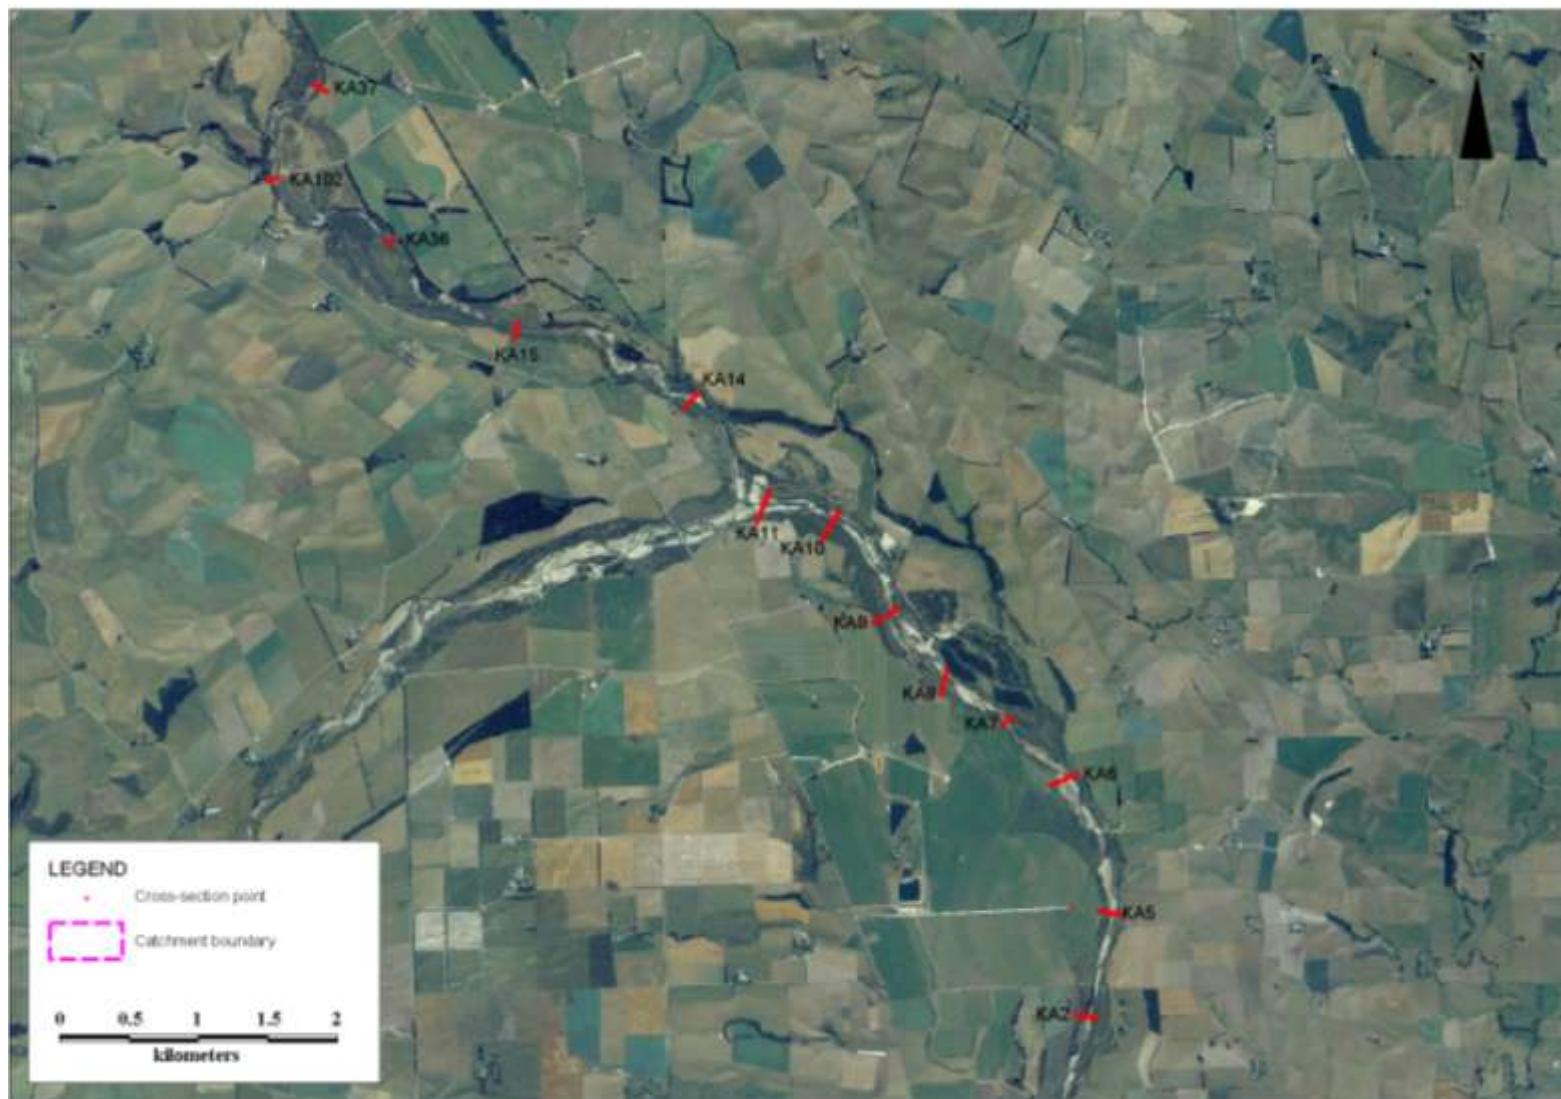
Figure 3.1A Location of surveyed cross-sections for the upper Kakanui River superimposed on 2006 aerial photograph.

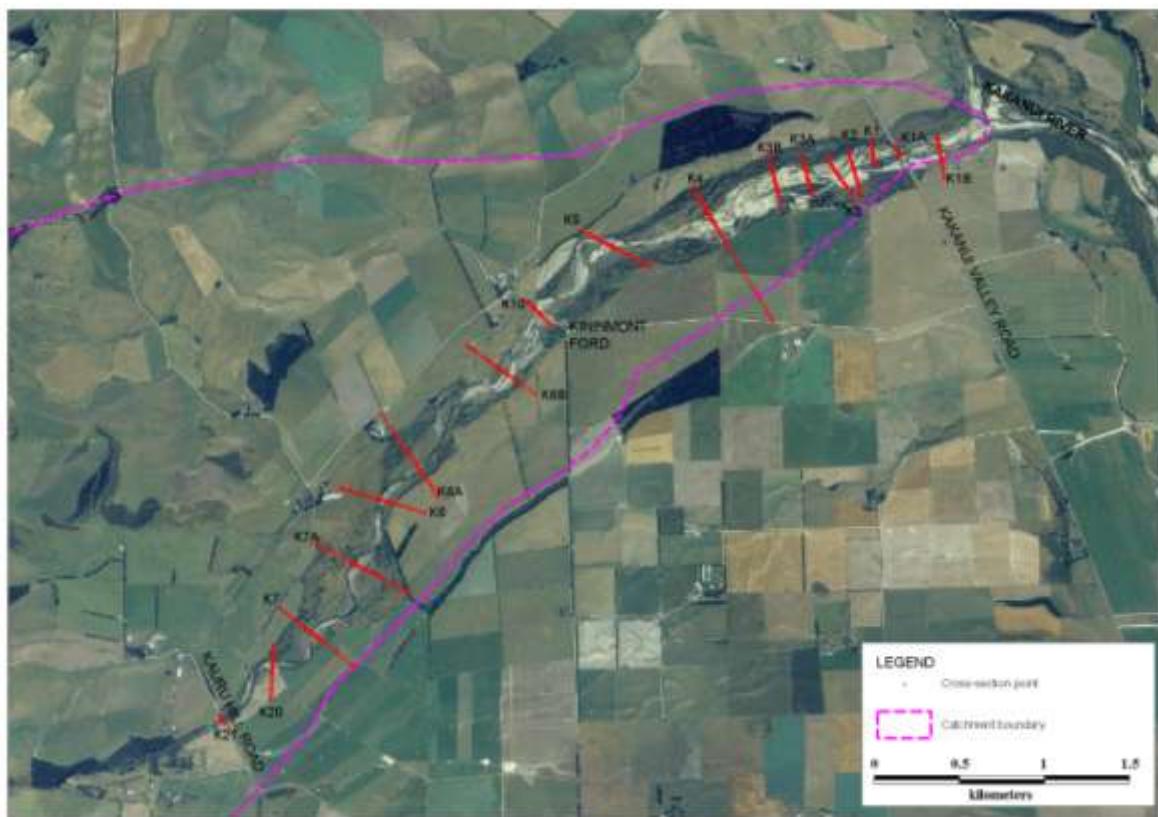
Figure 3.3 Location of surveyed cross-sections for the Kauru River superimposed on 2006 aerial photograph.

Seventeen cross-section locations have been surveyed on the Kauru River (Figure 3.3) between 1978 and 2008. Four new cross-sections were established during the latest survey (K6B, K6A, K7A, and K20) but will not be analysed in this report. Table 3.3 shows each year surveyed and the respective mean bed level calculation for each cross-section. The net change in mean bed level over the different survey periods is then presented in Table 3.4.
