Channel morphology and sedimentation in the Rees River

Published in October 2008

This report explores how the morphology and sedimentation of the Rees River has changed over the surveyed periods, while providing a synthesis of the study's results to guide management strategies into the future.

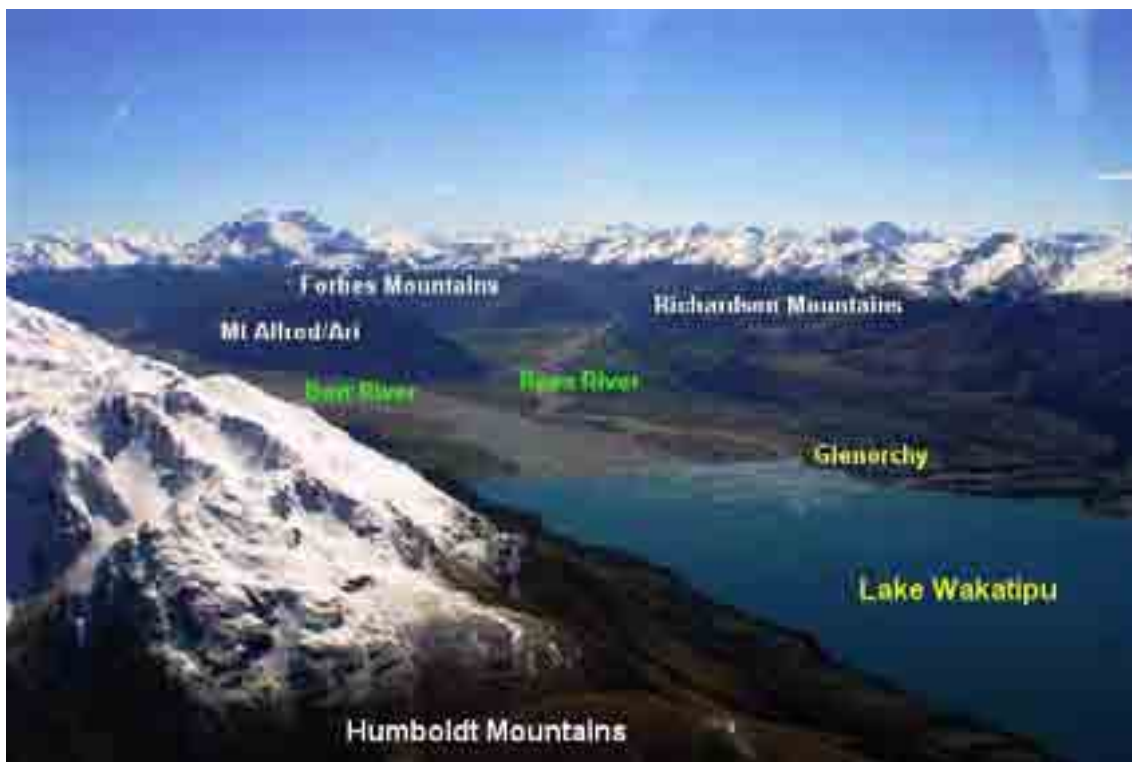
Figure 2.2 Oblique view of the lower Rees and Dart valleys and surrounding landscape

The Rees River basin was carved out by a larger Tyndall Glacier during the Pleistocene (about 12,000 years ago). This basin is typical of a previously glaciated, U-shaped valley with a flat valley floor and gentle lower slopes which lead up to the near vertical peaks of the flanking mountain ranges. On either side of the Rees River Catchment lie the Richardson Mountains to the east and the Forbes mountains to the west, which steeply rise to over 2000m above sea level (Figure 2.2).

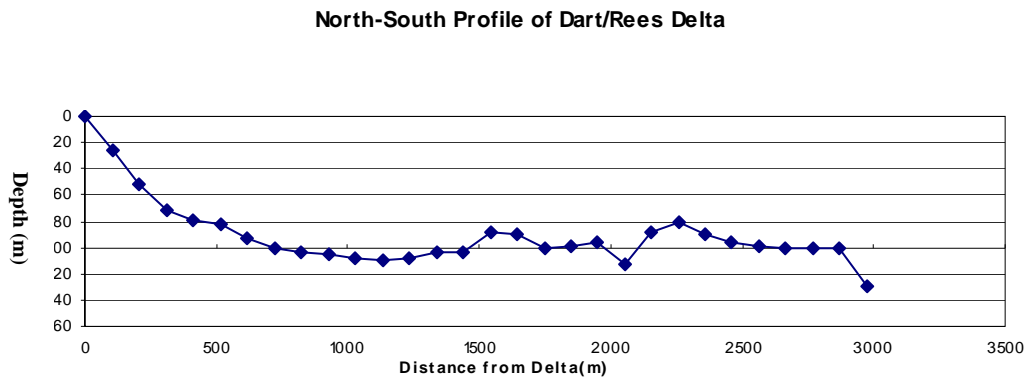
Figure 2.4 Longitudinal profile of the subsurface Rees/Dart delta complex extending into the head of Lake Wakatipu, surveyed November 2007

The progradation¹ of the Rees River delta into Lake Wakatipu is also evident in these images (Figure 2.3). Aerial photography and anecdotal records indicate that the delta has prograded 90-175m since 1890. Figure 2.4 shows a subsurface longitudinal profile of this feature extending 3km down to the bottom of Lake Wakatipu, surveyed in November 2007.

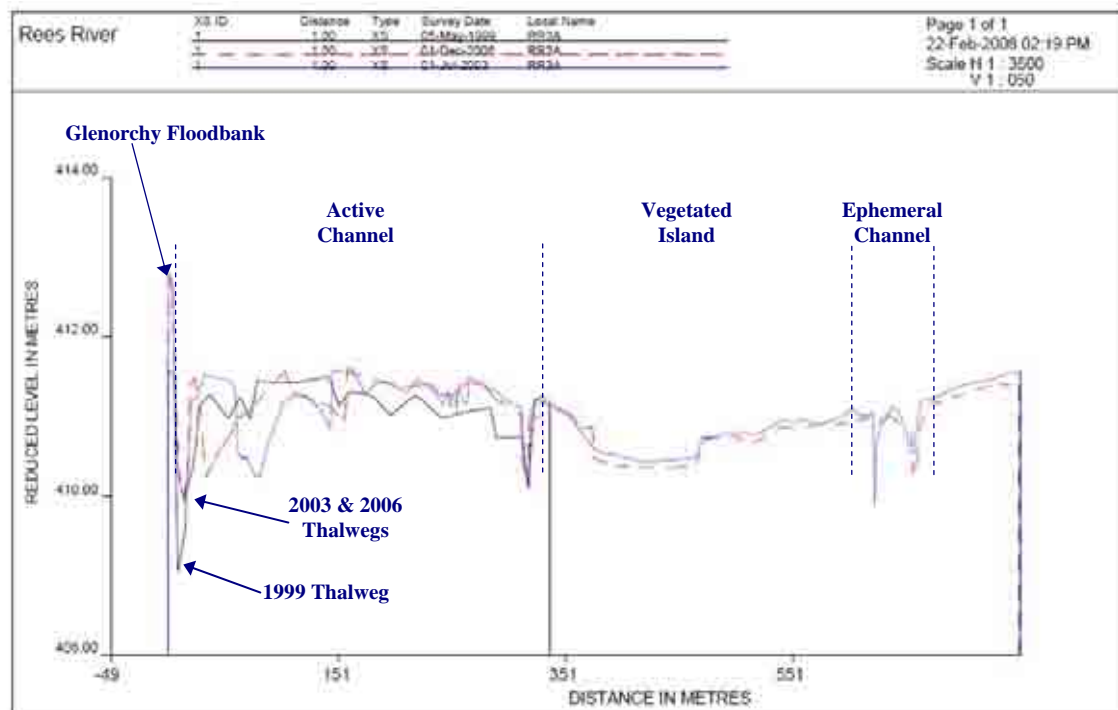
Figure 3.2 Cross-section RR3A, looking downstream

Cross-section RR3A is located near the end of the Rees River delta, which deposits into the head of Lake Wakatipu (Figure 3.1). The construction of the Glenorchy floodbank in 2000 can be seen with the height of the left bank increasing by 1.23m between the 1999 and 2003 surveys. Figure 3.2 shows a plot of cross-section RR3A for the 1999, 2003 and 2006 surveys.

The active Rees River channel is located adjacent to the Glenorchy floodbank, on the true left of the cross-section, and covers a width of 311 m. Mean bed level analysis shows that this location has experienced net aggradation of 0.09 m between 1999 and 2006 (Table 3.1). Most of this aggradation occurred during the period 1999 to 2003, which could be indicative of sedimentation resulting from the November 1999 flood event (the May 1999 survey predated this flood event). Additionally, the thalweg experienced notable aggradation of 0.87 m during this same period, which may be attributed to deposition from the 1999 flood event or channel modification from the construction of the adjacent floodbank.

Figure 2.3 shows the secondary channel on the true right of this cross-section that is no longer active. The 1937 imagery shows an active braided channel at this location, while by 2006 this channel has been succeeded by vegetation (Figure 2.3). This location has been annotated on Figure 3.2 as an ephemeral channel.

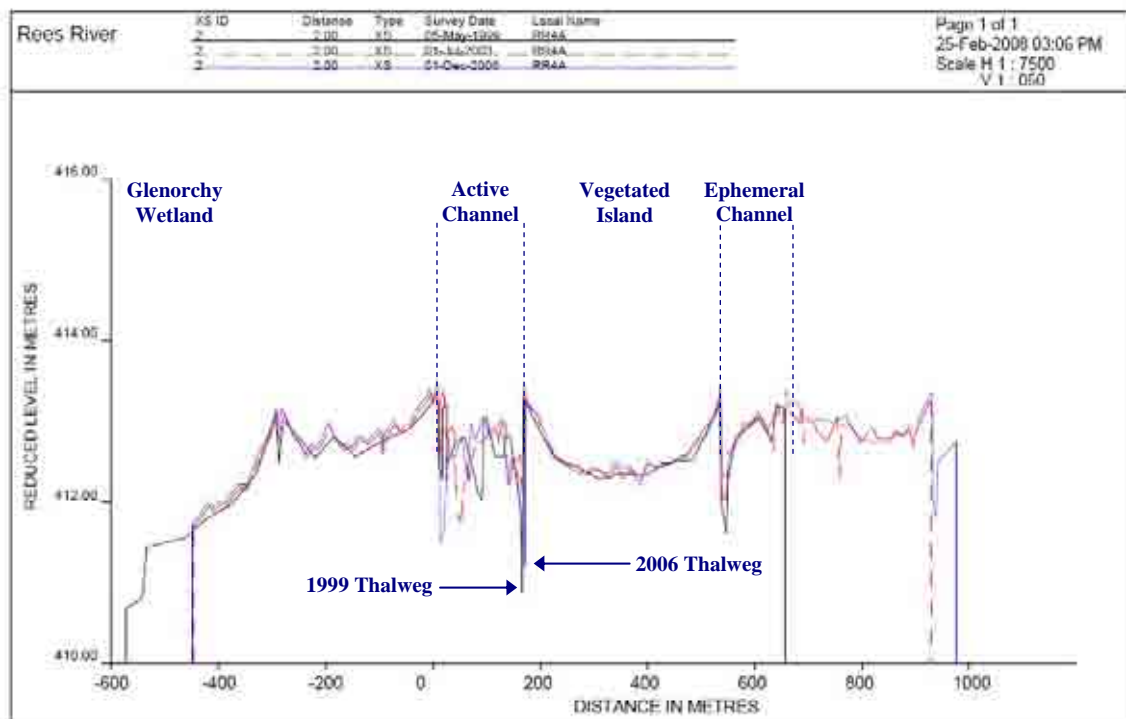
Figure 3.3 Cross-section RR4A, looking downstream.

Cross-section RR4A is located approximately 0.77 km upstream of cross-section RR3A. Comparative analyses between both of these sections indicate that the geomorphological state and sedimentation characteristics of these cross-sections are similar. Figure 3.3 shows a plot of cross-section RR4A for the 1999, 2003 and 2006 surveys.

The active channel in this cross-section covers a width of only 160m in comparison to the entire 1.425km surveyed in 2006. Mean bed level analysis shows that this location has experienced net aggradation of 0.08m between 1999 and 2006 (Table 3.2). Like cross-section RR3A, most of this aggradation occurred between the 1999 and 2003 surveys, which could be indicative of sedimentation from the November 1999 flood event. The thalweg has experienced significant lateral movement between surveyed periods, reflecting the dynamic braided form of the active channel margins at this location.

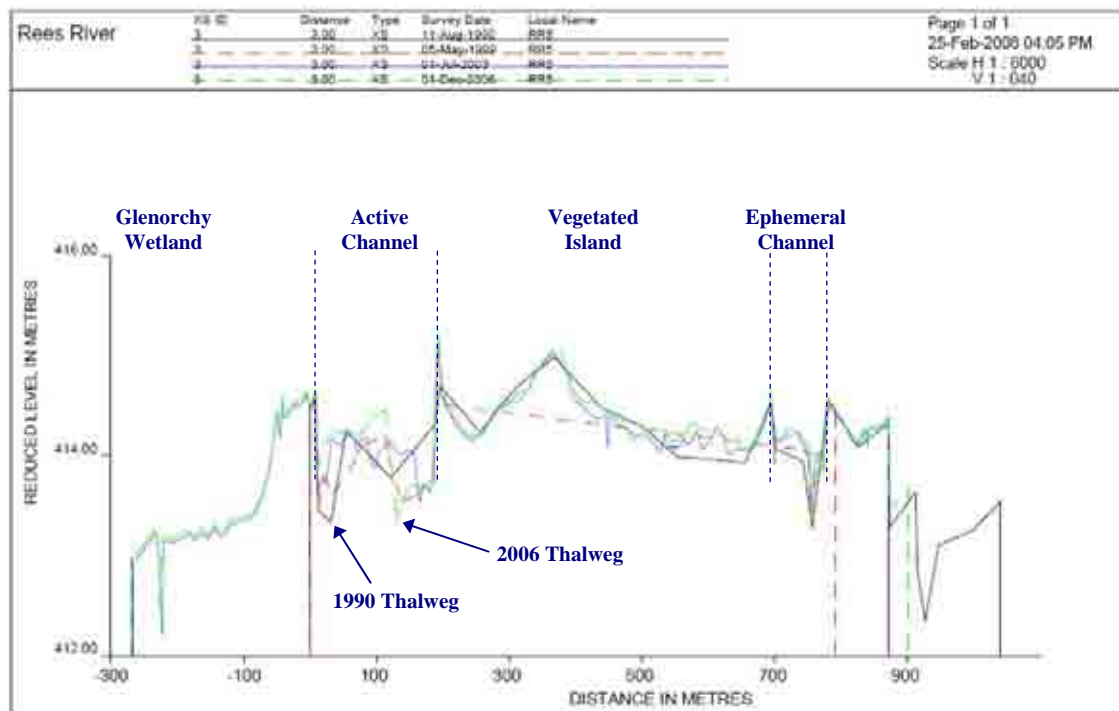
Figure 3.4 Cross-section RR5, looking downstream

Cross-section RR5 is located approximately 1.33km upstream of cross-section RR3A. Like cross-sections RR3A and RR4A, this survey covers the primary active channel and secondary ephemeral channel on the true right (Figure 2.3). Figure 3.4 shows a plot of cross-section RR5 for the 1990, 1999, 2003 and 2006 surveys.

The active channel in this cross-section covers a width of only 184m compared to the entire 1.17km surveyed in 2006. Mean bed level analysis shows that this location has experienced net aggradation of 0.10m between 1990 and 2006 (Table 3.2). Similar to both cross-sections downstream, the most significant period of aggradation occurred during the period 1999 to 2003. Figure 3.4 indicates that the banks of the active channel margin have been relatively stable over the period 1990 to 2006. Additionally, the thalweg during this period has repositioned from the true left to the true right.

The large delineation that extends from approximately 200m to 750m distance in the 1999 survey does not represent the topography at this location. Rather, this section was not surveyed in 1999 as it was not part of the active channel margins.

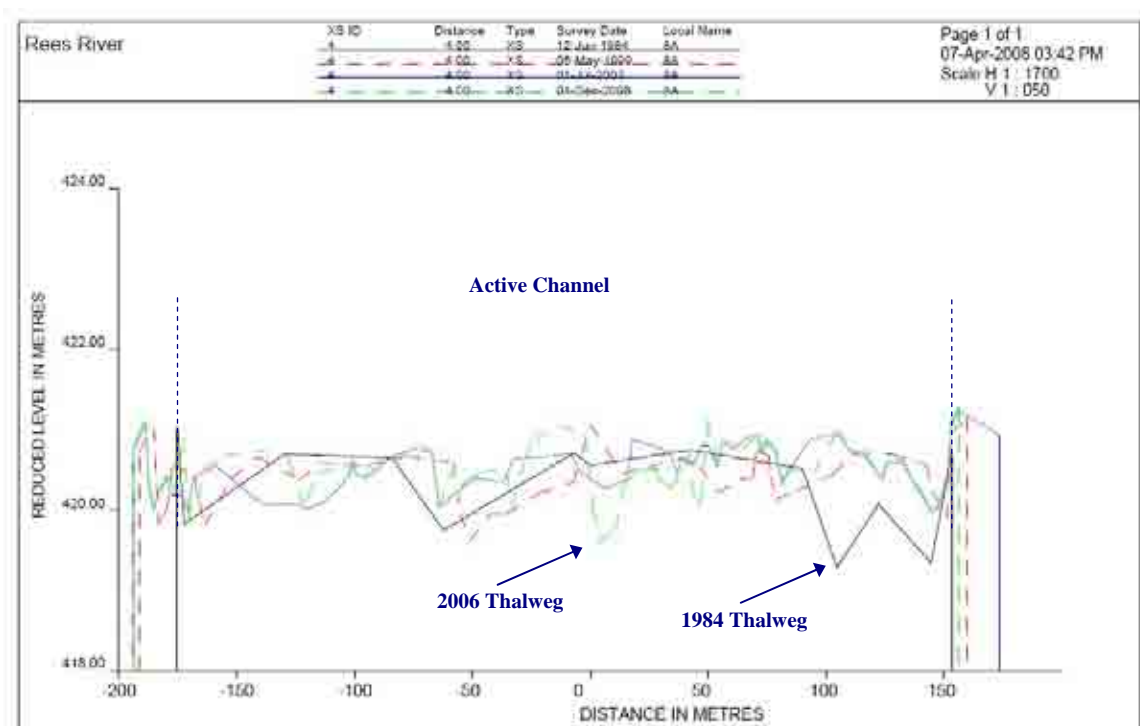
Figure 3.5 Cross-section 8A, looking downstream

Cross-section 8A is located approximately 3.89km upstream of cross-section RR3A. Surveys were taken in 1984, 1999, 2003 and 2006 with the 1984 survey only consisting of 13 spot heights over 328m. Figure 3.5 shows a plot of cross-section 8A for each of these surveys.

The active channel in this cross-section covers 328m, equal to the 1984 width of survey. Mean bed level analysis shows that this location has experienced net aggradation of 0.22m between 1984 and 2006 (Table 3.2). Visual inspection of Figure 3.5 shows considerable variability in the location of the thalweg and secondary channels between each period surveyed. This variability is symptomatic of the dynamic braided form of the Rees River channel at this location. Additionally, bank erosion of approximately 18.5m occurred on the true left between 1984 and 2003.

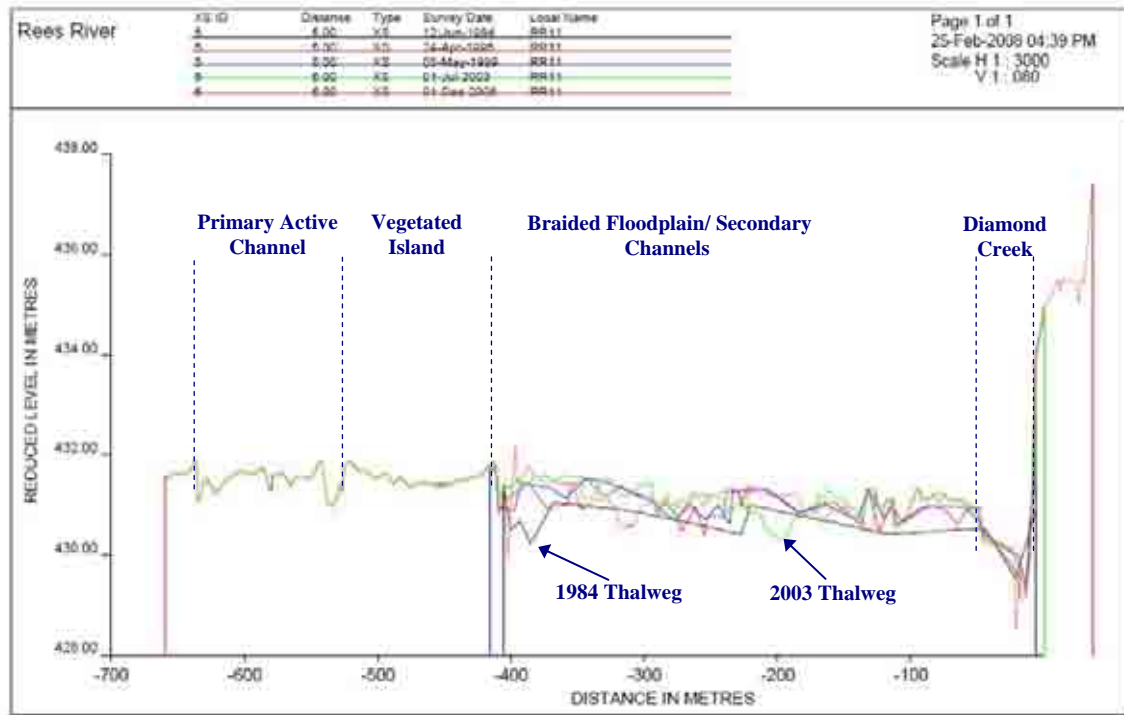
Figure 3.7 Cross-section RR11, looking downstream

Downstream of the bridge, the primary Rees River channel flows to the true left of a large island located in the mid-section of the floodplain. During periods of high flow, the Rees River may migrate across the wider floodplain, although aerial photography indicates it usually resumes its initial course. The Diamond Creek channel flows onto the true right of the Rees River floodplain before confluenting with the main Rees channel downstream of the large island. Figure 3.7 shows a plot of cross-section RR11 for each of the surveyed years.

Located on the true left of the cross-section, the primary channel of the Rees River has only been surveyed in 2003 and 2006. Mean bed level analysis covered a width of 110m for this channel and showed that this location experienced net aggradation of 0.04m during this period.

The rest of the cross-section covers a width of 400 m, equivalent to the width of the 1984 survey. This area extends from the true right of the island to the true right bank, including Diamond Creek (Figure 3.7). Mean bed level analysis showed that net aggradation of 0.36m occurred during the period 1984 to 2006 for this part of the cross-section. A large proportion, 0.30m, of aggradation was measured over the period 1984 to 1996. High channel mobility and lateral migration across the floodplain is evident on this wider part of the cross-section (Figure 3.7).

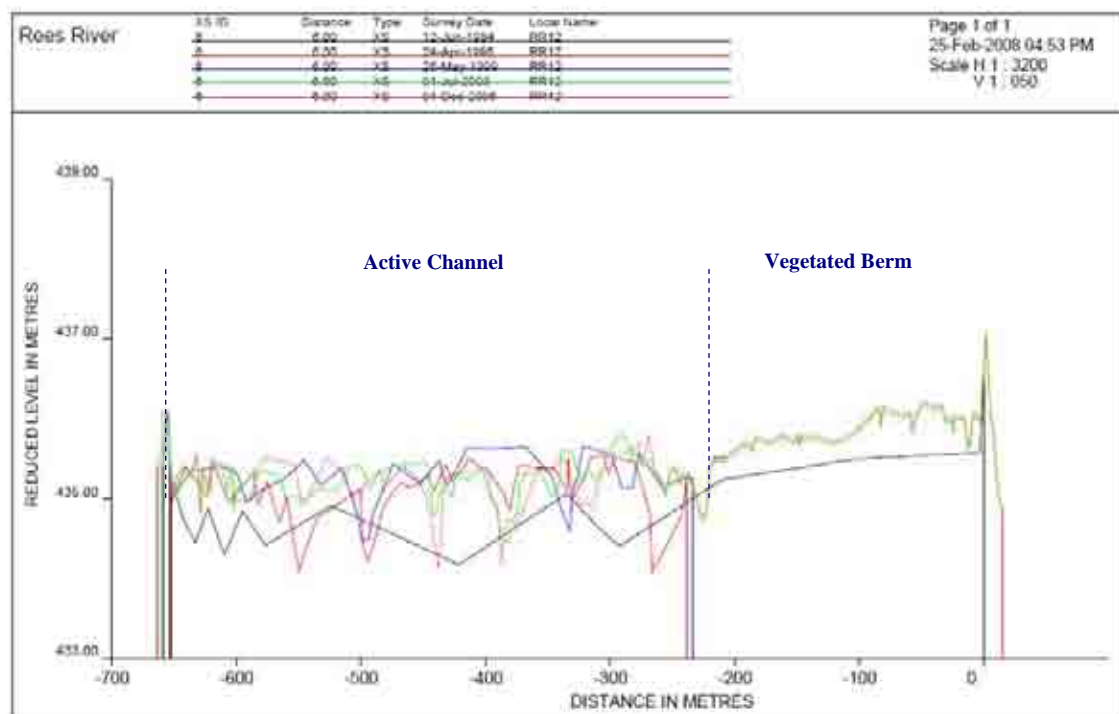
Figure 3.8 Cross-section RR12, looking downstream

Cross-section RR12 is located approximately 8.01km upstream of cross-section RR3A and 0.36km upstream of the Rees River bridge. Surveys were taken in 1984, 1996, 1999, 2003 and 2006 with the 1984 survey only consisting of 16 spot heights over a distance of 653m. Figure 3.8 shows a plot of cross-section RR12 for each of these surveys.

The active channel in this cross-section covers a width of 443m and excludes the true right of the surveyed cross-section (Figure 3.8). Mean bed level analysis shows that this location has experienced net aggradation of 0.57m between 1984 and 2006. As with cross-section RR11, a large proportion of this aggradation was measured during the period 1984 to 1996. There is no definitive trend in thalweg change at this location due to the high mobility of braided channels.

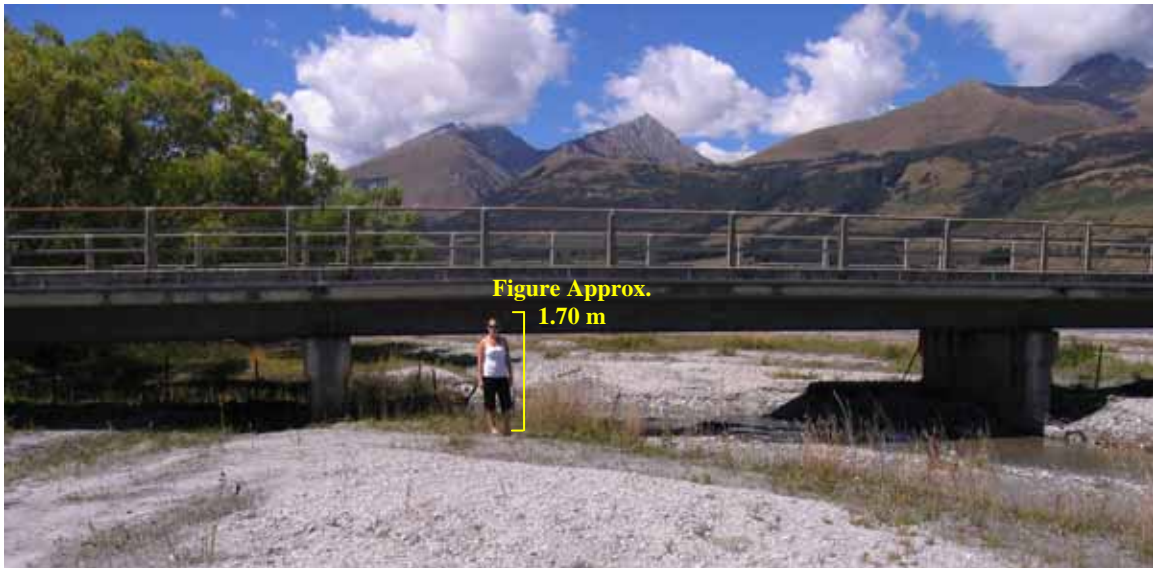
Figure 3.9 Photograph showing the Rees River bridge on the true right bank looking upstream, February 2008

Figure 3.9 and Figure 3.10 show photographs of the Rees River bridge taken in February 2008. Anecdotal records note the reduction of freeboard under the Rees River bridge from significant sedimentation during the 20th century. Mean bed level analysis indicates that cross-section RR12 (upstream of the bridge) has experienced minor net degradation of 0.06m between 1999 and 2006 but experienced net aggradation of 0.63m between 1984 and 1999. Downstream of the bridge, cross-section RR11 experienced net aggradation of 0.39m in the period 1984 to 2003 and net degradation of 0.03m between 2003 and 2006.

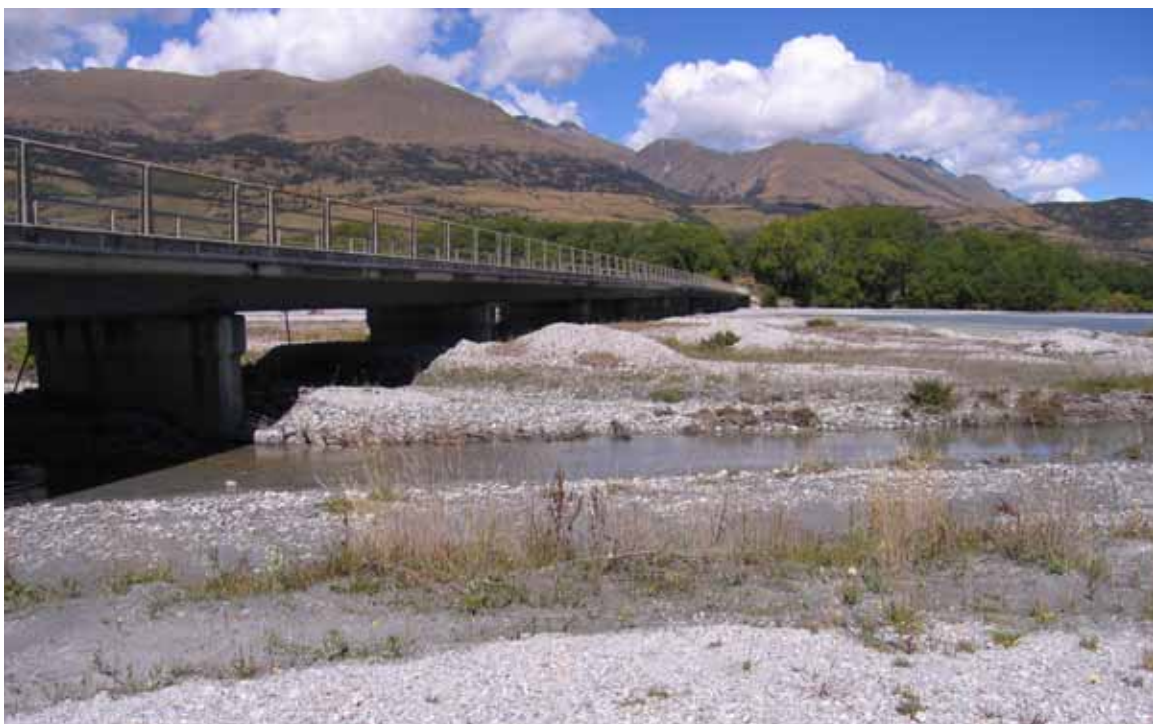
Figure 3.10 Photograph showing the Rees River bridge on the downstream side looking towards the true left, February 2008

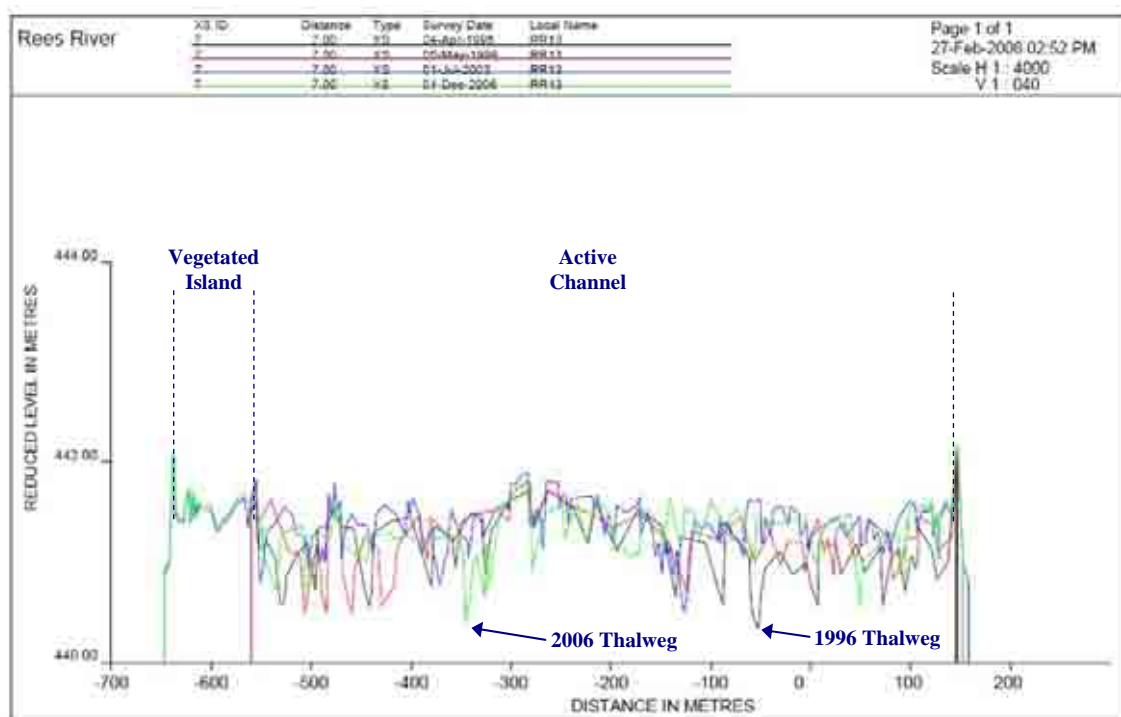
Figure 3.11 Cross-section RR13, looking downstream

Cross-section RR13 is located approximately 9.09km upstream of cross-section RR3A and about 1.44km upstream of the Rees River bridge. Figure 3.11 shows a plot of cross-section RR13 for the 1996, 1999, 2003 and 2006 surveys.

The active channel in this cross-section covers a width of 706m, equal to the distance of the 1996 survey. Mean bed level analysis shows that this location has experienced net aggradation of 0.11m during the period 1996 to 2006. However, part of this net change includes net degradation of 0.09 from 2003 to 2006.

There is no definitive trend in thalweg change at this location due to the high mobility of braided channels. While there has been substantial lateral movement of the channel, banks at this location have been relatively stable over the survey periods.

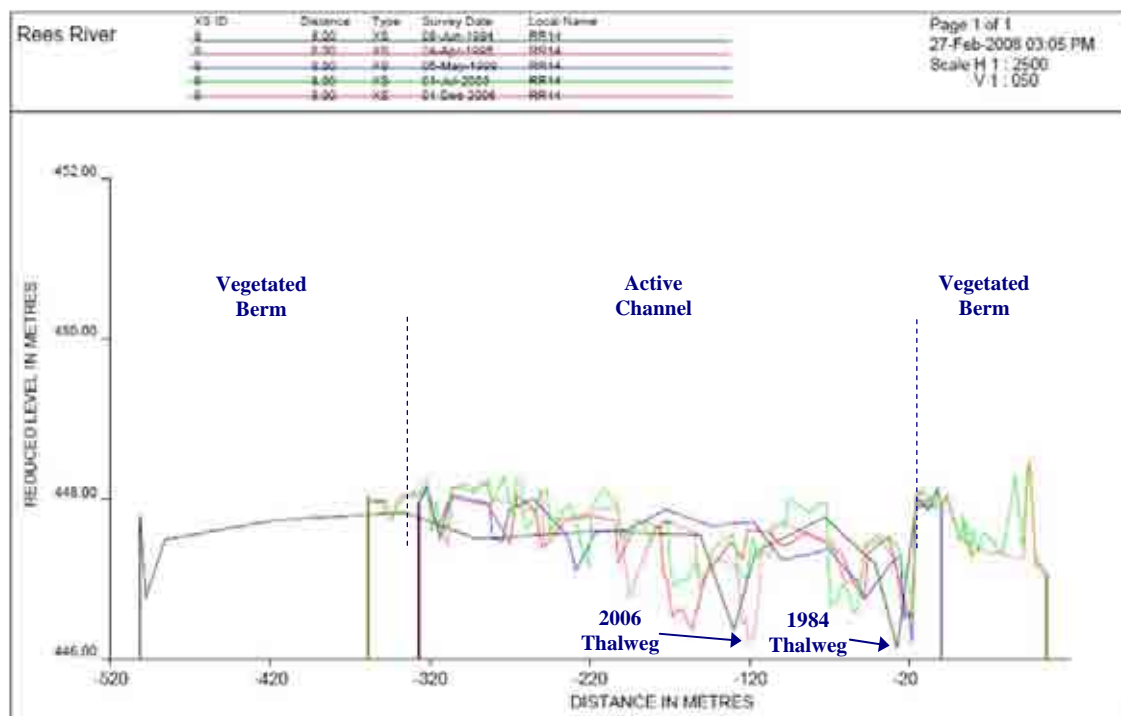
Figure 3.12 Cross-section RR14, looking downstream

Cross-section RR14 is located approximately 10.17km upstream of cross-section RR3A and 2.52km upstream of the Rees River bridge. Figure 3.12 shows a plot of cross-section RR14 for the 1984, 1996, 1999, 2003 and 2006 surveys.

The active channel in this cross-section covers a width of 336m, with vegetated berms on each side of the channel. Mean bed level analysis shows that this location has experienced net aggradation of 0.09m between 1984 and 2006. Surveys indicate that lateral migration of the channel is common at this location. The thalweg moved about 90m to the left between 1984 and 2006.

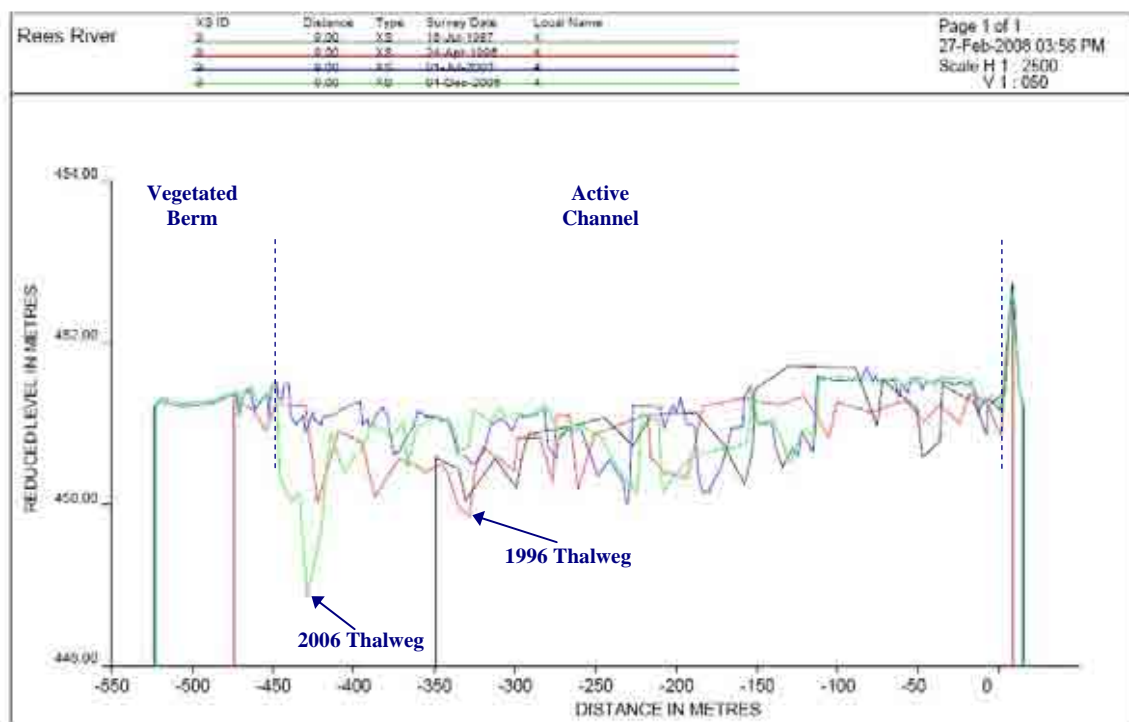
Figure 3.13 Cross-section 4, looking downstream

Cross-section 4 is located approximately 10.75km upstream of cross-section RR3A and about 3.1km upstream of the Rees River bridge. Figure 3.13 shows a plot of cross-section 4 for the 1987, 1996, 2003 and 2006 surveys.

The active channel in this cross-section covers a width of 462m. Comparatively, the 1987 section was only surveyed for a width of 357m. Mean bed level analysis shows net aggradation of 0.07m over the entire channel width between 1996 and 2006 (Table 3.2). The channel on the true left deepened 2.24m between 2003 and 2006.

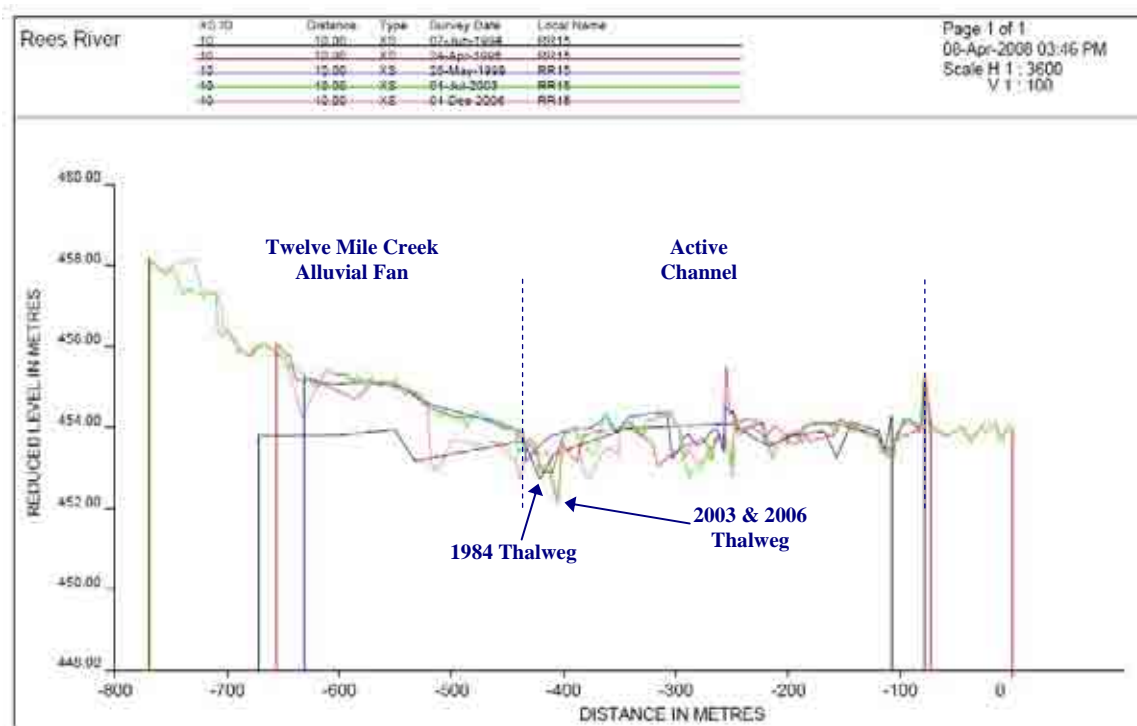
Figure 3.14 Cross-section RR15, looking downstream

Cross-section RR15 is located approximately 11.21km upstream of cross-section RR3A and 3.56km upstream of the Rees River bridge. A large portion on the true left of this cross-section is a longitudinal profile of the Twelve Mile Creek alluvial fan that debouches onto the Rees River floodplain. Figure 3.14 shows a plot of cross-section RR15 for the 1984, 1996, 1999, 2003 and 2006 surveys.

The active Rees River channel lies near the middle of the cross-section, adjacent to the Twelve Mile Creek alluvial fan toe. During periods of high flow, toe-cutting of this alluvial fan by the axial Rees channel may occur. Mean bed level analysis shows that this location has experienced net degradation of 0.07m during the period 1984 to 2006 (Table 3.2). While mean bed level analyses show relatively minor net degradation at this location, variation from aggradational to degradational environments is significant.

Bed levels at this cross-section are interpreted to be significantly affected by the depositional sediment flux of Twelve Mile Creek. Where the active channel margins of the Rees River may be affected by encroachment of the alluvial fan, depositional phases of the Twelve Mile Catchment may contribute intermittent sediment fluxes across the Rees floodplain.

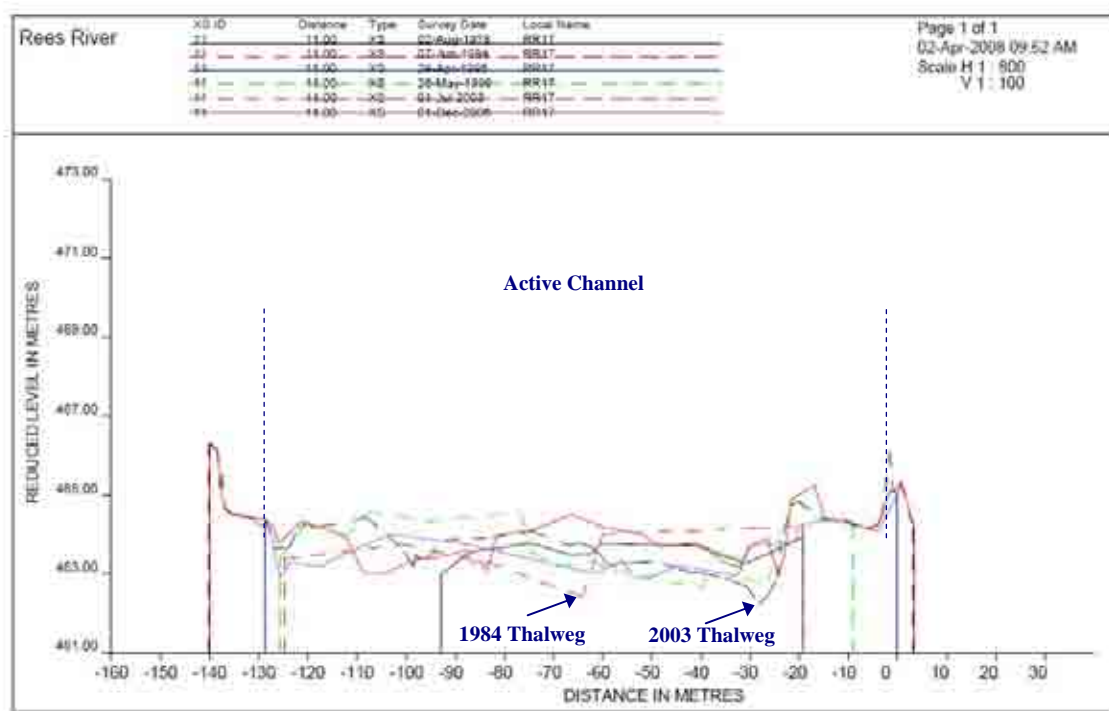
Figure 3.15 Cross-section RR17, looking downstream

Cross-section RR17 is located approximately 12.7km upstream of cross-section RR3A and about 5.05km upstream of the Rees River bridge. Figure 3.15 shows a plot of cross-section RR17 for the 1978, 1984, 1996, 1999, 2003 and 2006 surveys.

The active channel in this cross-section covers a width of 129m. Comparatively, the 1978 section was only surveyed over 74m. Table 3.2 shows the results of mean bed level analysis for both channel widths. The 1978 survey is not comparable to the rest of the survey periods due to the limited distance. Mean bed level analysis shows that net aggradation over the entire channel width of 0.34m occurred between 1996 and 2006.

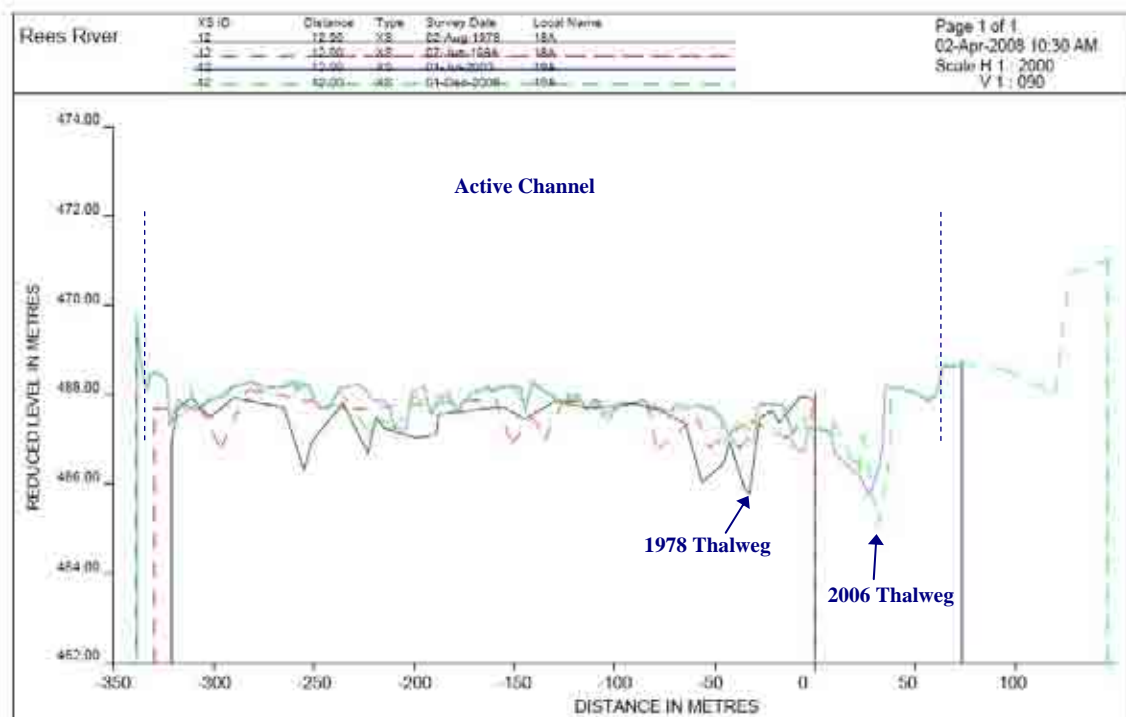
Figure 3.16 Cross-section 18A, looking downstream

Cross-section 18A is located approximately 13.24km upstream of cross-section RR3A and about 5.59km upstream of the Rees River bridge. Figure 3.16 shows a plot of cross-section 18A for the 1978, 1984, 2003 and 2006 surveys.

The active channel in this cross-section covers a width of 401m. Comparatively, the 1978 section was only surveyed over 321m. Table 3.2 shows the results of mean bed level analysis for both channel widths. The 1978 survey is not comparable to the rest of the survey periods due to the limited distance. Mean bed level analysis shows that net aggradation of 0.37m occurred over the 321m width. The thalweg of the channel in the 2006 survey is located on the true right in an area that was not covered in the 1978 and 1984 surveys.

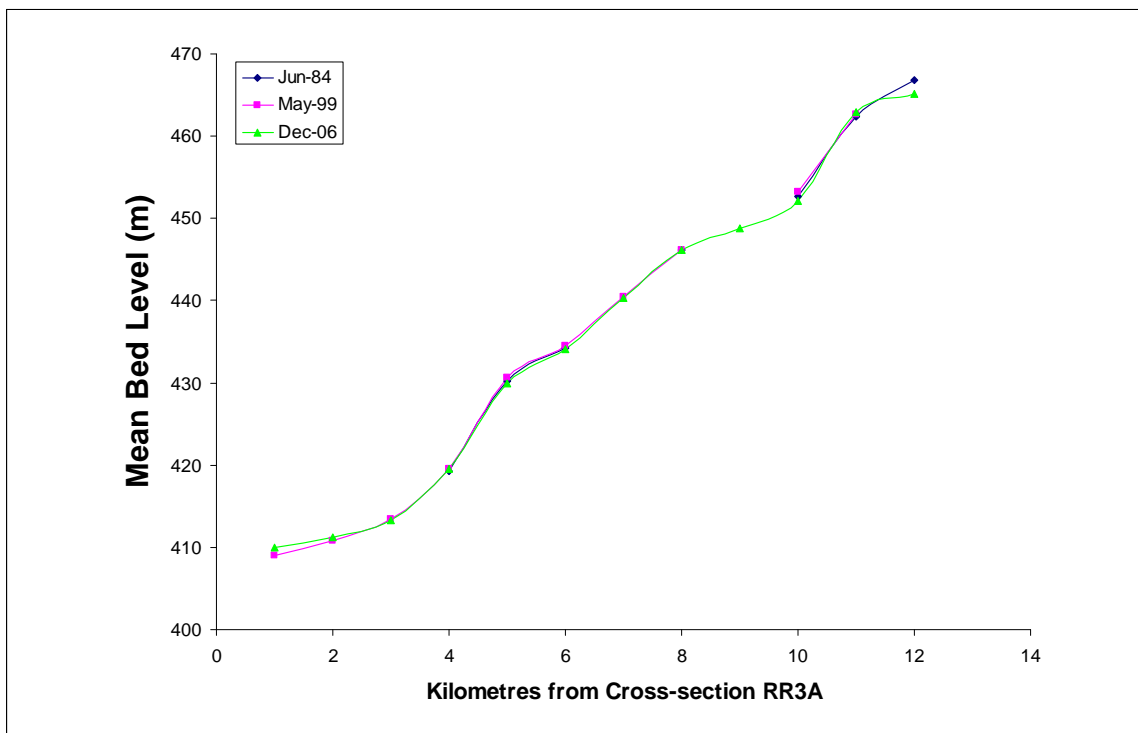
Figure 3.17 Longitudinal profile of the Rees River mean bed levels for 1984, 1999 and 2006

Figure 3.17 shows a longitudinal profile of mean bed level for 1984, 1999 and 2006. These three years were chosen as they covered a suitable temporal range and number of cross-sections surveyed. The longitudinal profile shows that mean bed levels have remained relatively stable over the period 1984 to 2006.

Figure 3.17 indicates that mean bed levels near the upper range of the surveyed catchment have lowered marginally from 1984 to 2006. While in the lower part of the catchment, mean bed levels have risen slightly between 1999 and 2006. Observations derived from the longitudinal profile should be viewed as indicative due to the intermittent number of surveys and survey locations.

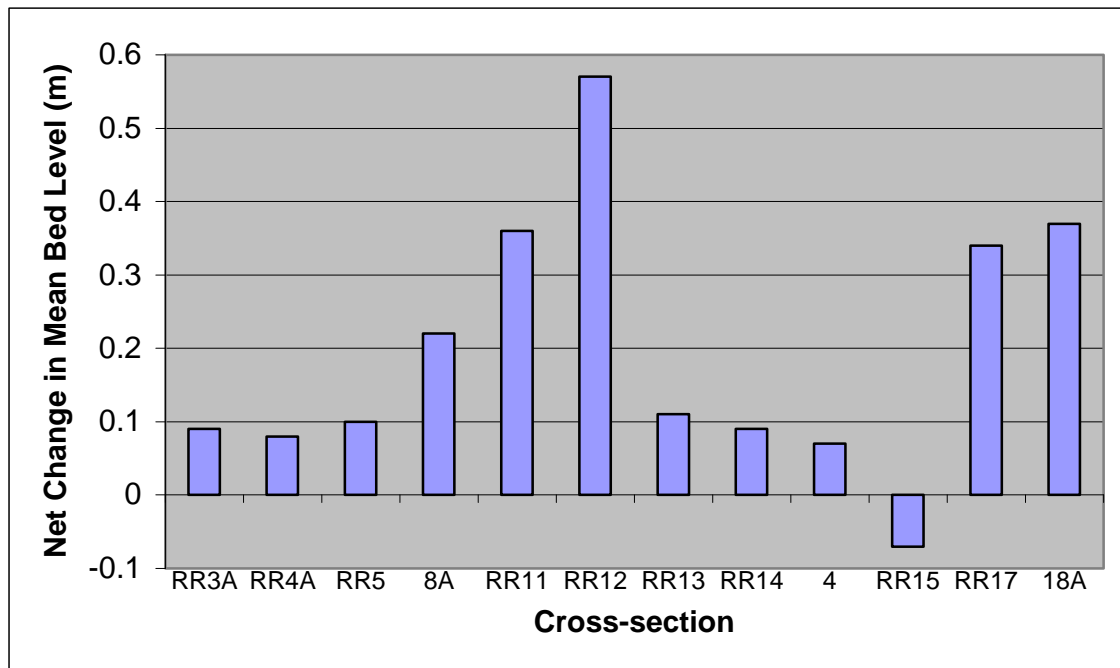
Figure 4.1 Graph showing net change in mean bed level across all survey periods for each cross-section location

Figure 4.1 shows a graphical representation of the net change in mean bed levels quantified for each cross-section over each respective period of survey. An holistic interpretation of mean bed level results indicates that the upper (RR17, 18A) and mid (8A, RR11, RR12) cross-sections are experiencing net aggradation while other surveyed locations are experiencing minor fluctuations in net mean bed levels.
