**Channel morphology and sedimentation  
in the Waianakarua River**

Published November 2008

This report explores how the morphology and sedimentation of the Waianakarua River has changed over the surveyed periods, while providing a synthesis of the study's results to guide management strategies into the future.

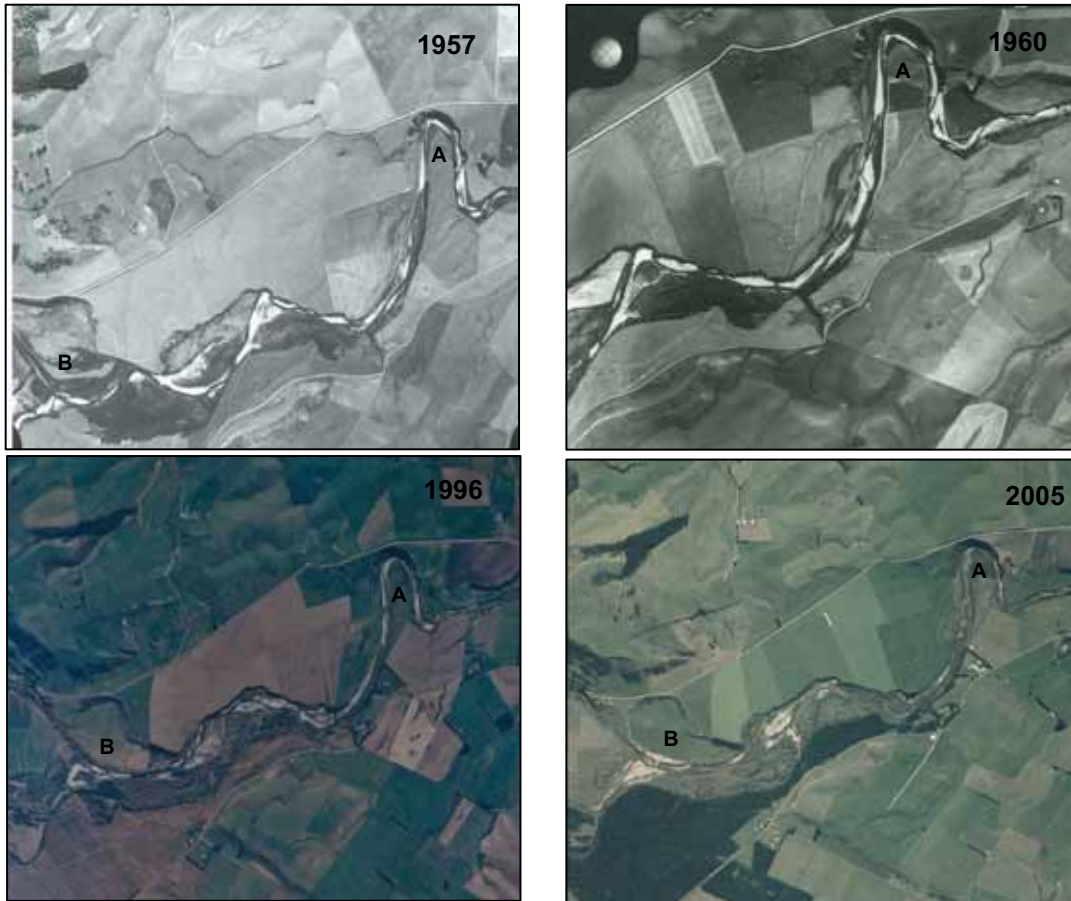
**Figure 2.3** Aerial images of the Waianakarua River-main branch in 1957, 1960, 1996 and 2005

Aerial photography is used to indicate changes in the river form over time. On the main branch (from the river mouth upstream to the confluence of the North and South branches) the active channel has stayed within the confines of its banks (Figure 2.2). The 2005 aerial photograph shows that the active channel has become more vegetated and potentially reduced in width compared to the 1960 and 1996 aerial photographs.

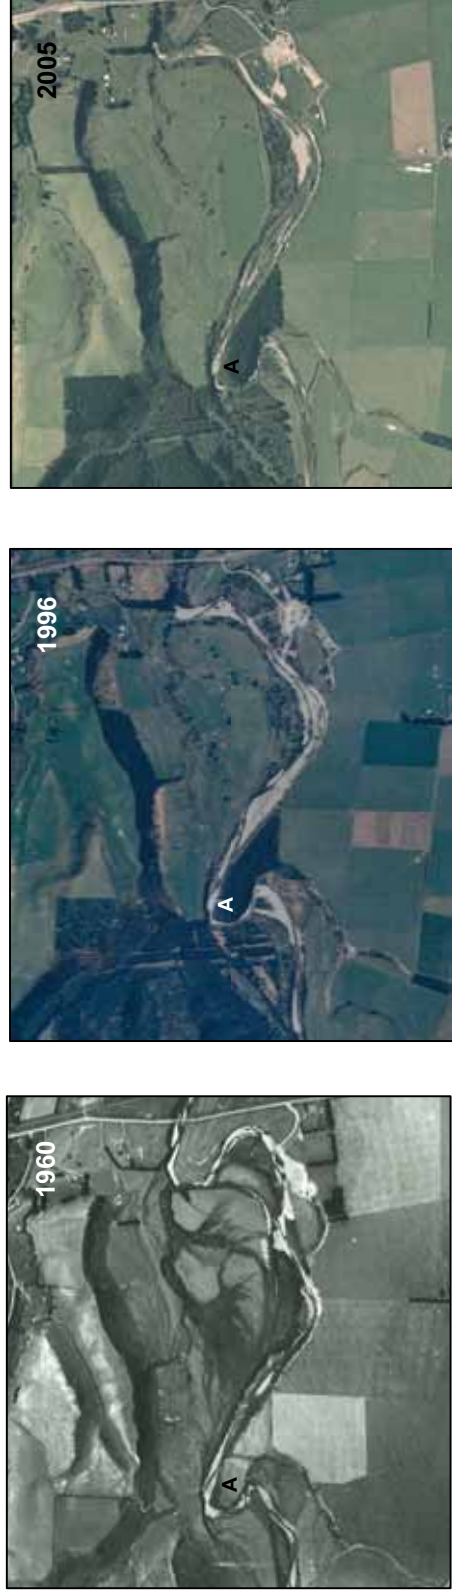
Figure 2.4 Aerial images of the Waianakarua River-South branch in 1960, 1996 and 2005

On the South branch of the river (Figure 2.3), the active channel has changed course since the 1960 photograph. Paleochannels are visible in the 1960 photograph across the entire terrace and, by 1996, this area was well established as pastoral land with grass and scrub. As with the main branch, the active channel has become more vegetated, compared to the situation in 1960 and 1996.

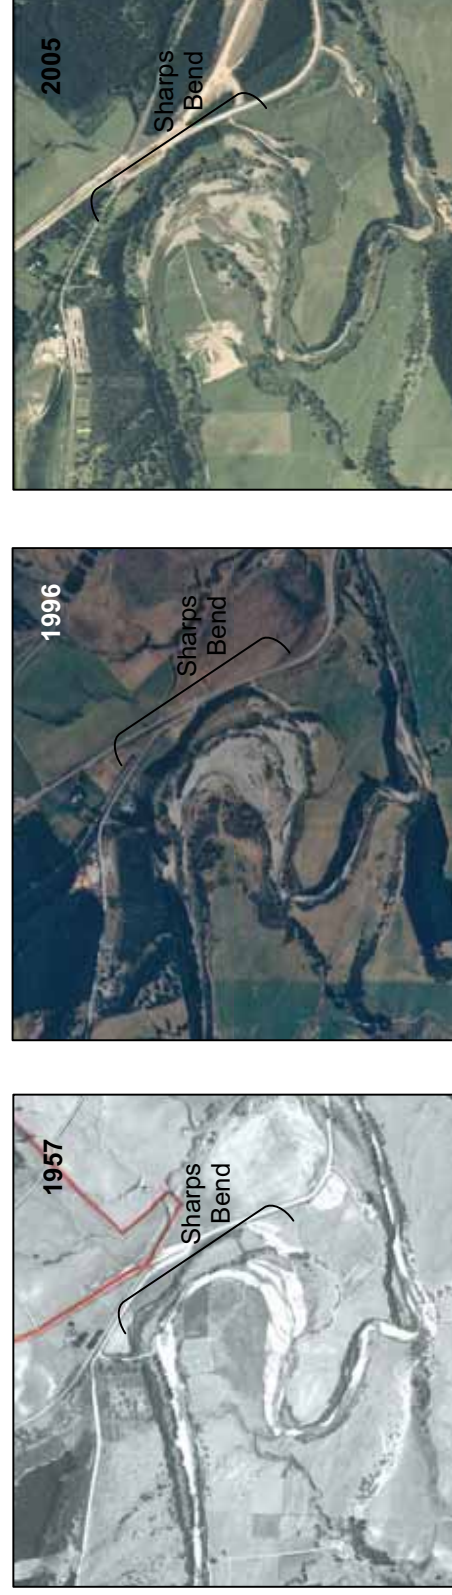
Figure 2.5 Aerial images of the Waianakarua River-North branch in 1957, 1996 and 2005

On the North branch of the river (Figure 2.4), around Sharps Bend, the active channel has widened since 1960, but still remains a braided channel. The active channel has also become more vegetated compared to 1996, similarly to the main branch and the North branch.
