Assessment of post-fire debris flow hazard, Hillend Station, Wanaka

Prepared for: Otago Regional Council

May 2018

Contract Report: LC3162

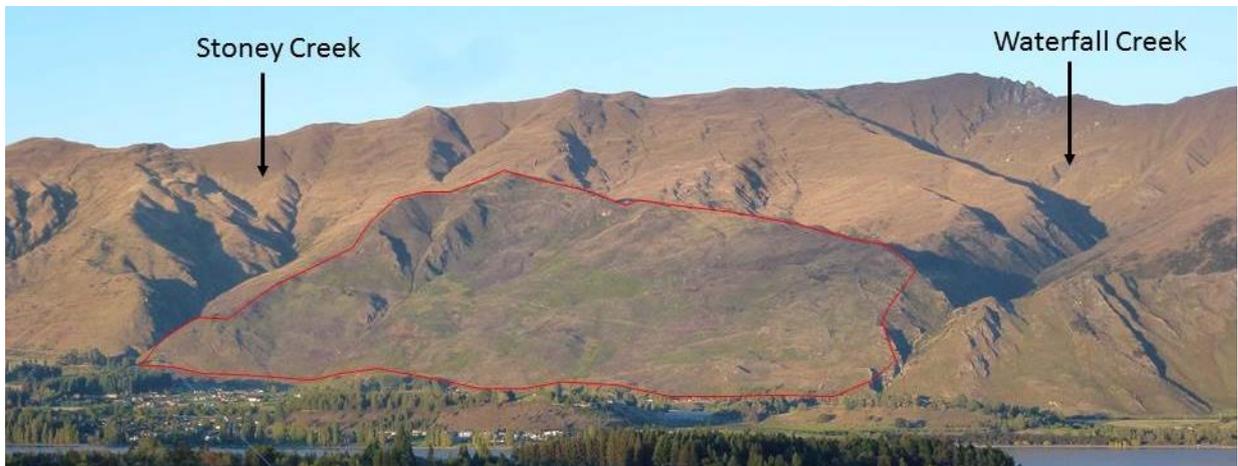
Figure 1 View of the burn area (outlined by red line) and adjacent catchments of Stoney Creek and Waterfall Creek.

Streams to either side of the burnt area (Stoney Creek and Waterfall Creek – see Fig. 1) have historically carried debris flows (ORC 2011) and immediate post-fire inspection of the burn area showed evidence of highly localised soil movement by rill erosion as well as by possible mudflow (Fig. 2). These may have been triggered by the dumping of water from monsoon buckets during firefighting.

Debris flow activity has been reported in catchments adjacent to the Hillend Station burn. Stoney and Waterfall Creeks are incised into the West Wanaka ranges and located either side of the burn area (Fig. 1). In the Stoney Creek catchment, extensive slope instability, including shallow landsliding, present a debris flow hazard (ORC 2011). Large storm events in 1999 and 2004 generated debris flows that deposited material across roads (Opus 2009). The 2004 storm was estimated at less than a 50-year recurrence interval. Following the magnitude 6.7 earthquake west of Milford Sound on 16 October 2007, surficial debris flows were generated by the sudden release of water from the headscarp of a pre-existing large landslide (Woods 2007). As in Stoney Creek, there is widespread slope instability present in Waterfall Creek catchment, and past debris flow deposits were observed during a site visit in November 2007 (ORC 2011). This report also notes the potential for formation of a landslide debris dam in this catchment, potentially triggered by a large seismic or high intensity storm event leading to slope failure impounding the channel.

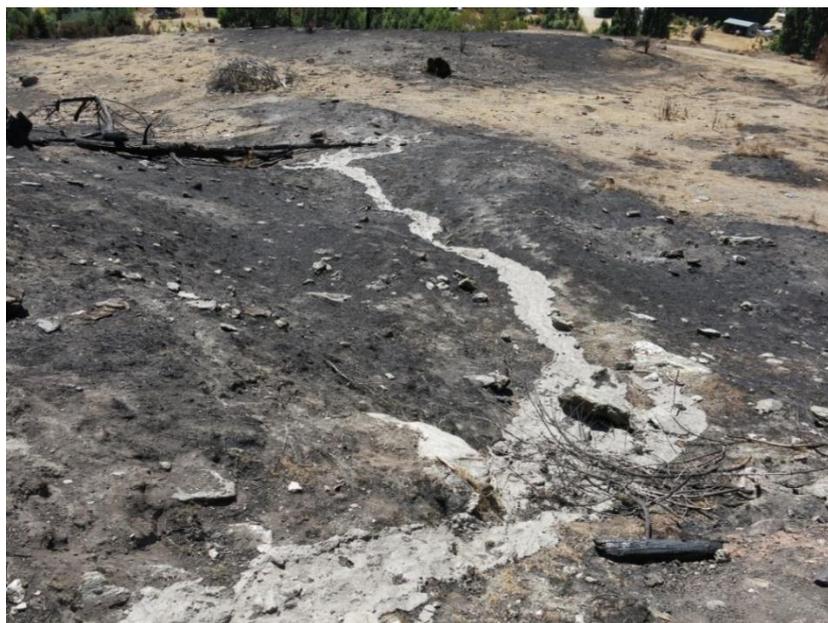
Figure 2 Evidence of localised small mudflow soon after the fire (Photo: Ben Mackey).

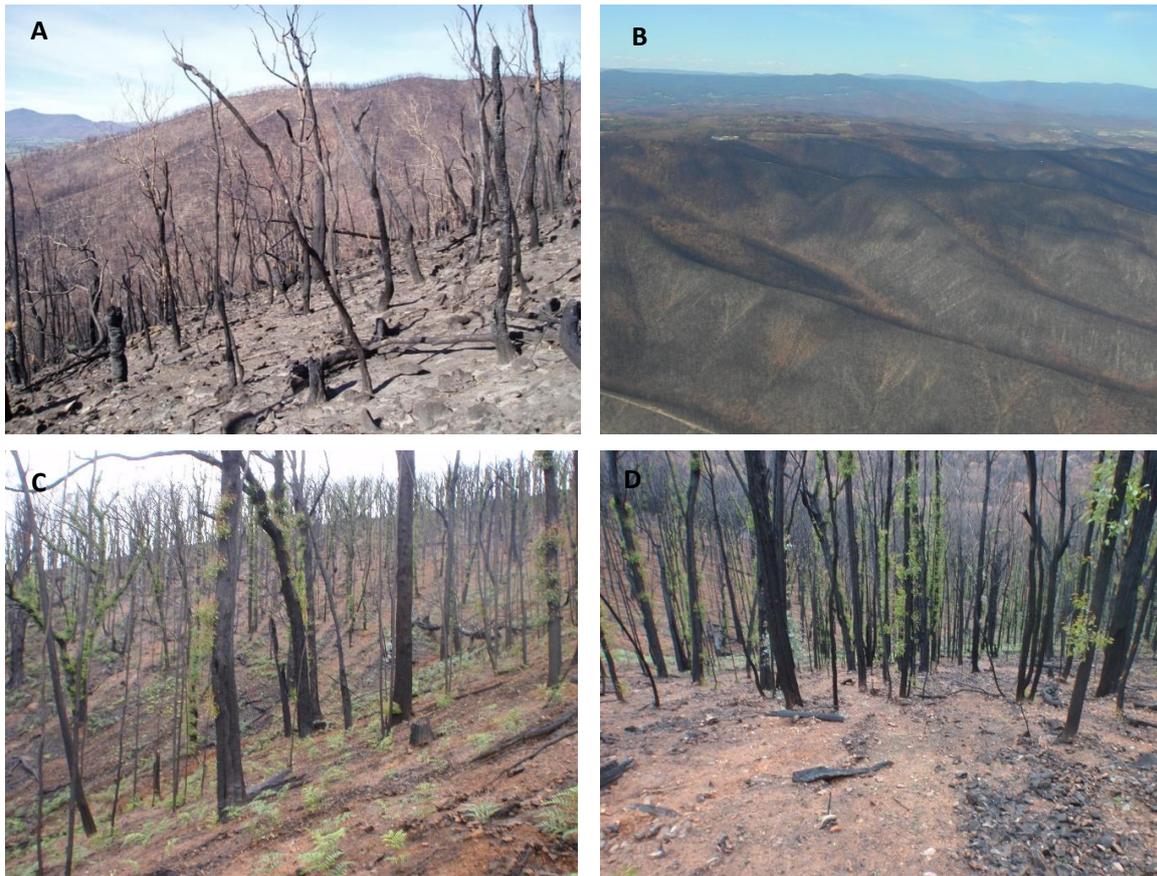
shows burnt and debris flow affected landscapes in Victoria following the 2009 wildfires. Figure 3B and 3C clearly show flow lines and rills converging within headwaters towards channel initiation points.

Figure 3 Post-fire landscapes that produce runoff-generated debris flows in Victoria, Australia. These photographs are included here to highlight the contrast with the Hillend Station burn area in terms of burn severity, soil surface condition, and visual evidence of hillslope surface erosion. Note the evidence of convergent surface runoff in zero order headwater catchments.

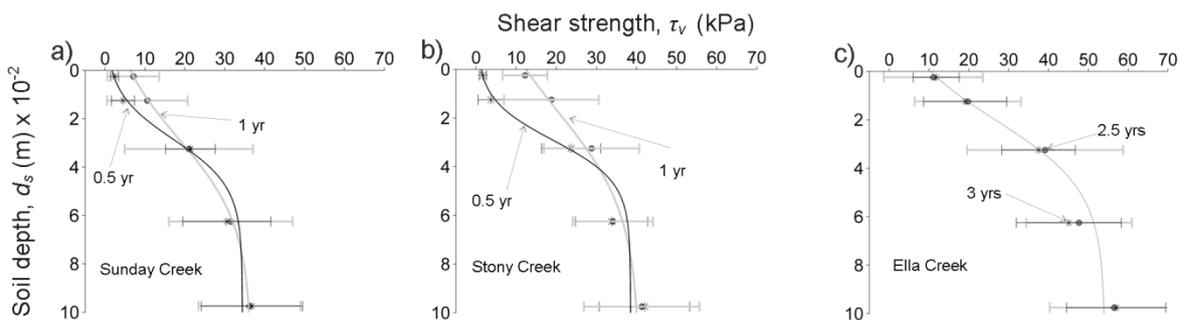
Figure 4 Changes in soil shear strength (τ_v) with soil depth (d_s) at different stages of recovery (0.5–3 years) after high severity wildfire at three sites in Victoria, Australia (source: Nyman et al, 2013).

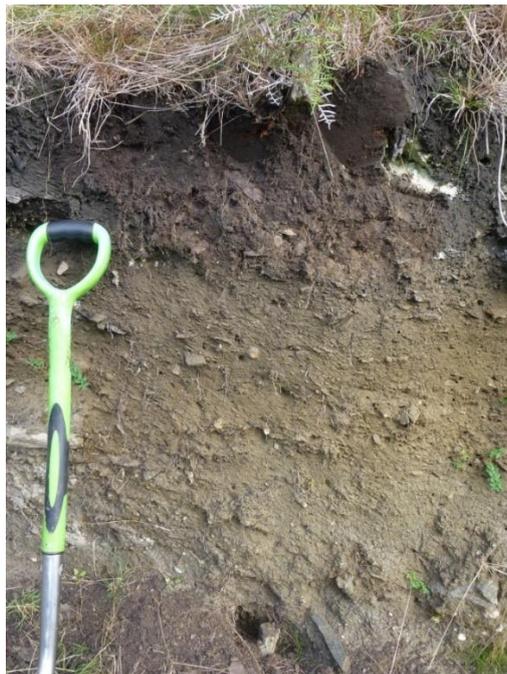
Soils are mapped as Pedal Immature Pallic soils of the Arrow Steepland soil set. Examination at several places on the slope showed these are weakly developed, moderately stony soils with weakly developed soil structure in both the topsoil and subsoil (Fig. 5). Soil depth is highly variable but typically appeared to be 0.5–1 m deep near rock outcrops, and on ridges soils were very shallow (<0.5 m). While no measurements of soil hydrologic properties are available, they probably have high infiltration and permeability rates. Areas with shallow soils would be prone to saturation during large storms.

Figure 5 Typical soil on the burnt slope.

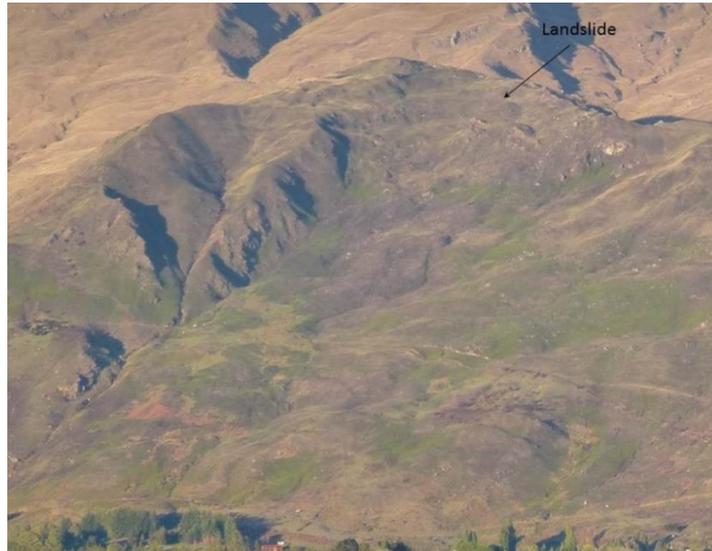
A large, deep-seated landslide is present at the southern end of the burnt area (Fig. 6) and it appears to have been recently active with several scarps present in the middle section of the landslide (Fig. 7). This recent instability appears similar to that described in Stoney Creek as a result of the October 2007 Fiordland earthquake (ORC 2011) and may have been triggered by the same earthquake.

Figure 6 Burn area and location of large deep seated landslide.

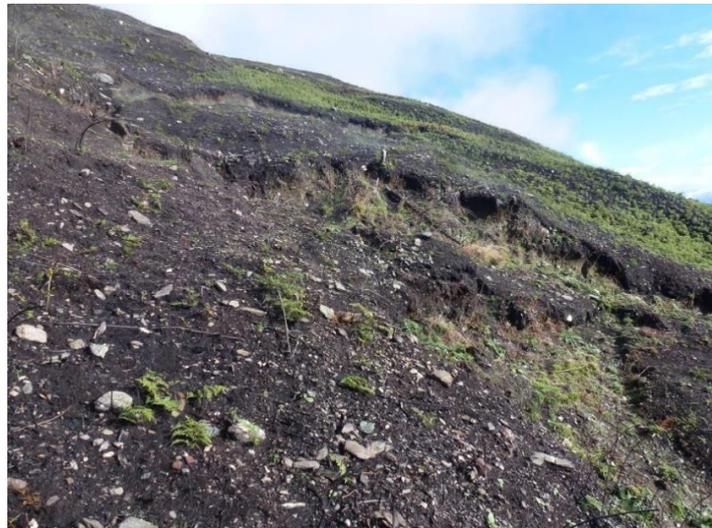
Figure 7 Recent scarps with shallow slumping on the landslide shown in Figure 4.

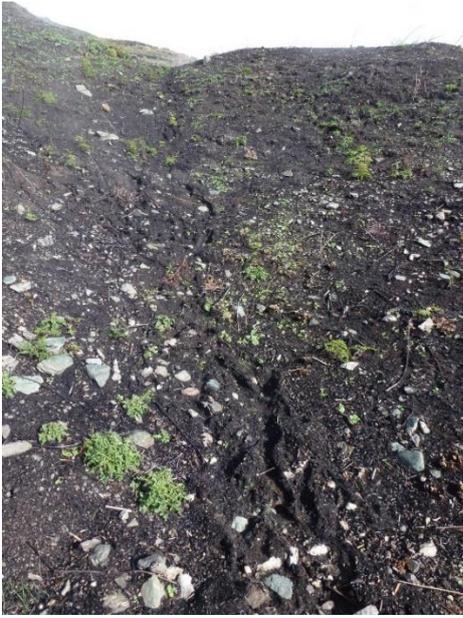
Evidence of localised post-fire rill erosion was observed in several places but its extent was very small (Fig. 8). There was also some evidence of localised small-scale rockfall from rock bluffs, and one shallow translational failure was seen (Fig. 9) – it is not known if this post-dates the fire. The ephemeral channel at the southern end of the burnt area appears to have carried small debris flows prior to the fire (Fig. 10). In its lower reaches there are small levees and the exposed sediments show a poorly sorted, matrix-supported deposit with very large clasts characteristic of debris flows (Fig. 10). There is a small debris flow fan at the base of this channel that extends to within about 50 m of the nearest house.

Figure 8 Localised small scale rill erosion.

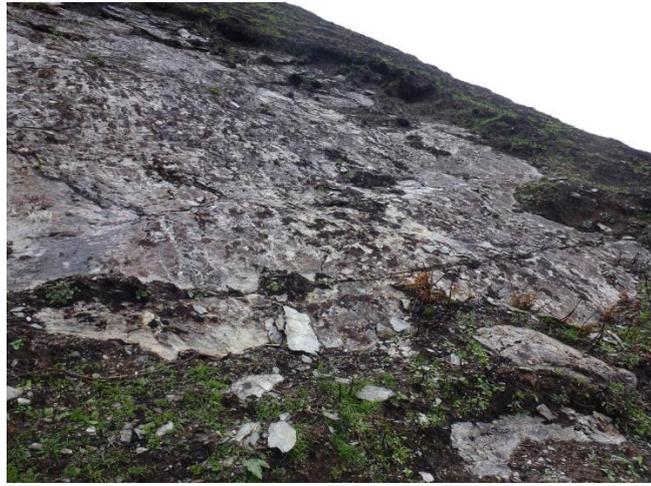
Figure 9 Shallow translational landslide.

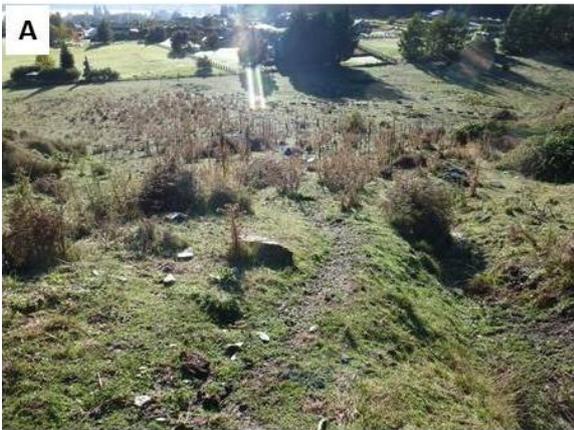
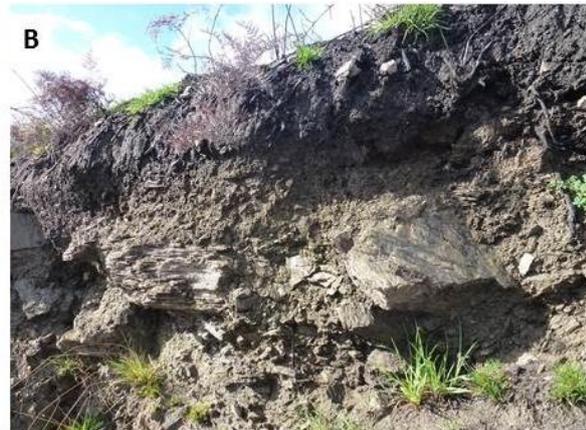
Figure 10 Evidence for debris flow in ephemeral channel. (A) small levee adjacent to the channel and large surface rocks; (B) matrix-supported deposit with large clasts.

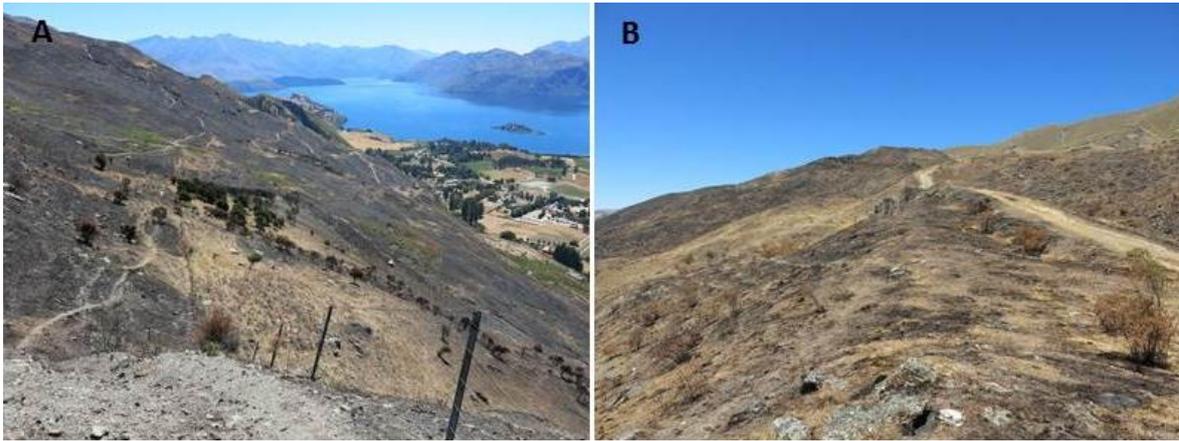
Immediately after the fire much of the burnt area was completely denuded of vegetation but there were also areas that were less affected, particularly towards the upper limit of the burn, or which did not burn at all (Fig. 11). There was a small area on the lower slope with higher burn severity resulting from woody vegetation that fuelled higher burn temperatures (Fig. 12). Evidence of localised overland flow and rill erosion was notable in the area affected by higher burn severity with sediment deposits observed a short distance downslope (Fig. 13). By the time the site was visited in late March vegetation was beginning to recover (grass, weeds and fern) but there was still extensive bare ground (Figs 14, 15).

Figure 11 Range of vegetation condition immediately after the burn. Most of the slope was completely denuded (A) but burn severity was lower, particularly towards the margins of the burn (B) (Photo: Ben Mackey).

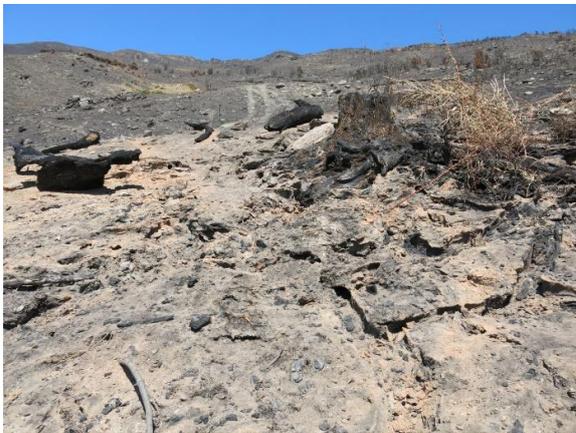
Figure 12 Area of high burn severity where soil surface has been scorched and tree roots have been completely burnt (Photo: Ben Mackey).

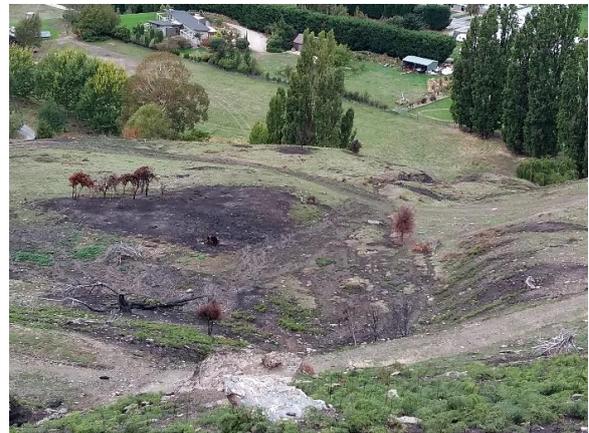
Figure 13 Evidence of localised post-fire overland flow and sediment deposition below the area of higher burn severity shown in Figure 10.

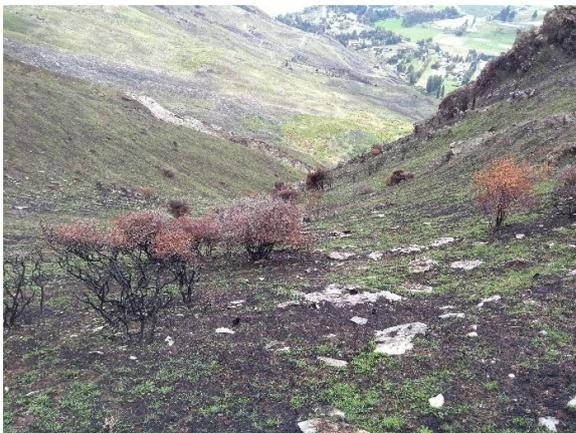
Figure 14 Convergent slopes in the headwater of the ephemeral channel at the southern end of the burn area.

Slopes within the burn area are steep and exceed the estimated threshold slope (approximately $>25^\circ$) observed in landscapes susceptible to post-fire debris flows. However, most of the burn area lacks convergent slopes, with the exception of an ephemeral channel located towards the southern end (Fig. 14).

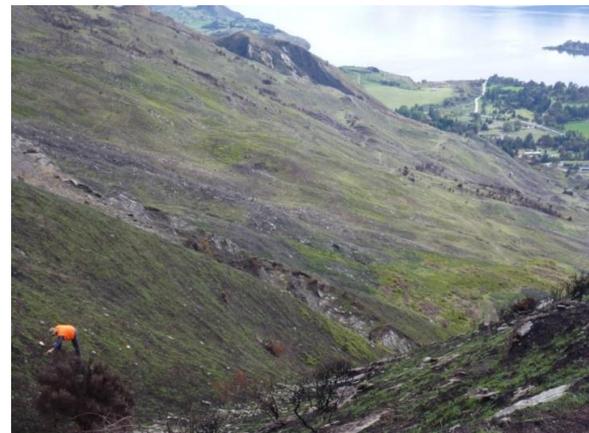
Figure 15 Vegetation condition in late March.

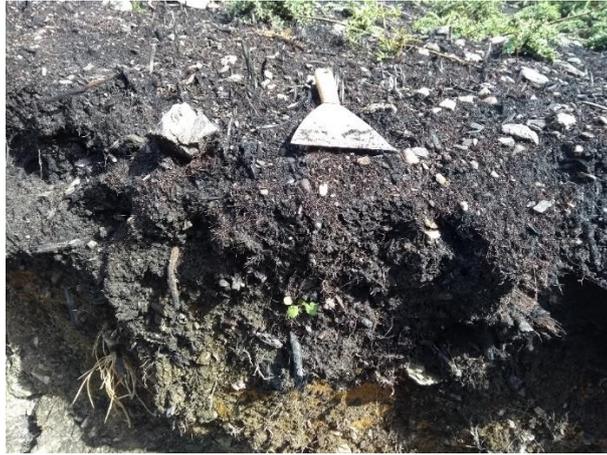
We sought to characterise possible fire-related changes to the internal resistance of the surface soil. This resistance depends on inter-particle cohesion and the contribution of fine roots to soil strength (Nyman et al. 2013), and not the effect of above-ground vegetation. The results indicate that the fire is unlikely to have had much effect on the erodibility of the soil. This finding is consistent with our field observations, which indicated that the fine root layer present within the upper few centimetres of the burnt soil remained largely intact (Fig. 16).

Figure 12 Intact fine roots were observed in surface soils on the burn area.
