ORC Update for Glenorchy Community Association

October 2019

ORC Natural Hazards Team

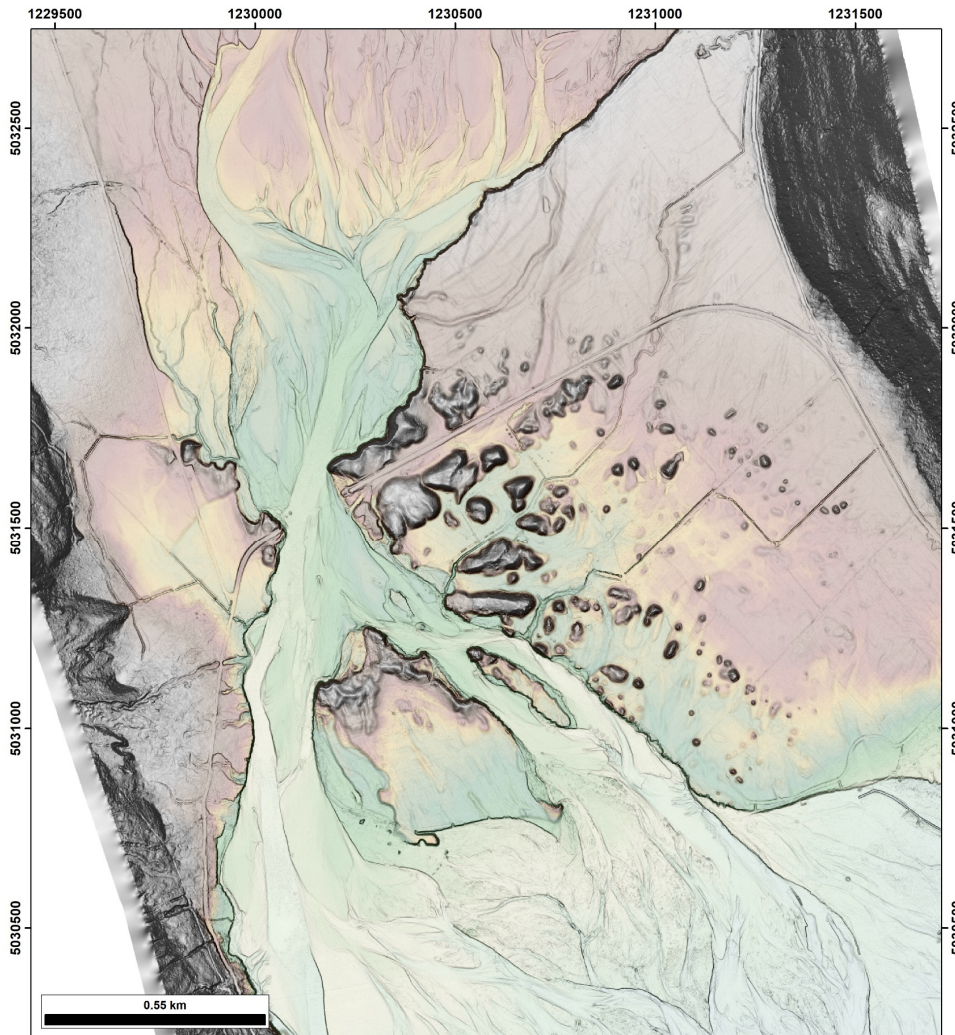
Dart Bridge & the Hillocks

LiDAR survey (Light Detection And Ranging)

- Detailed topographic survey

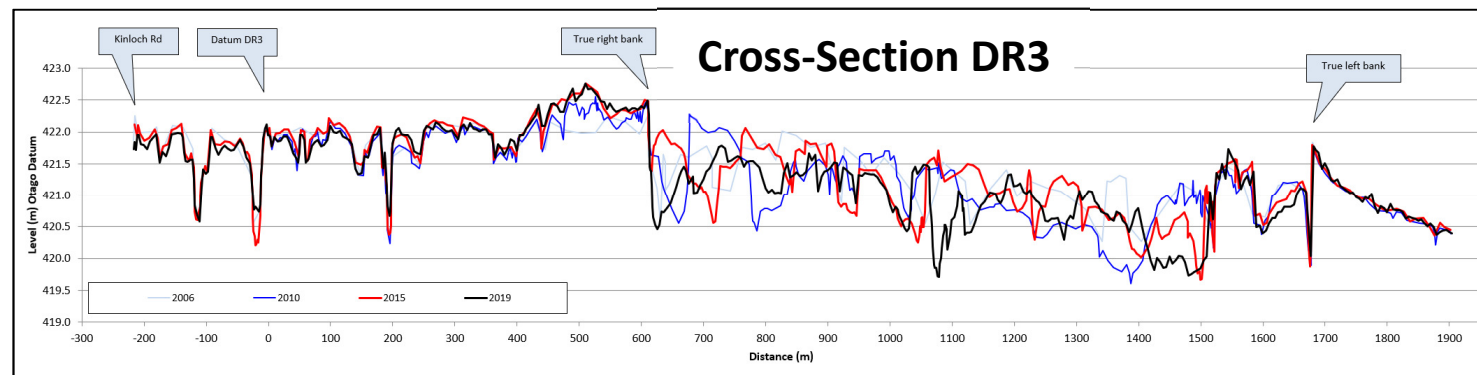
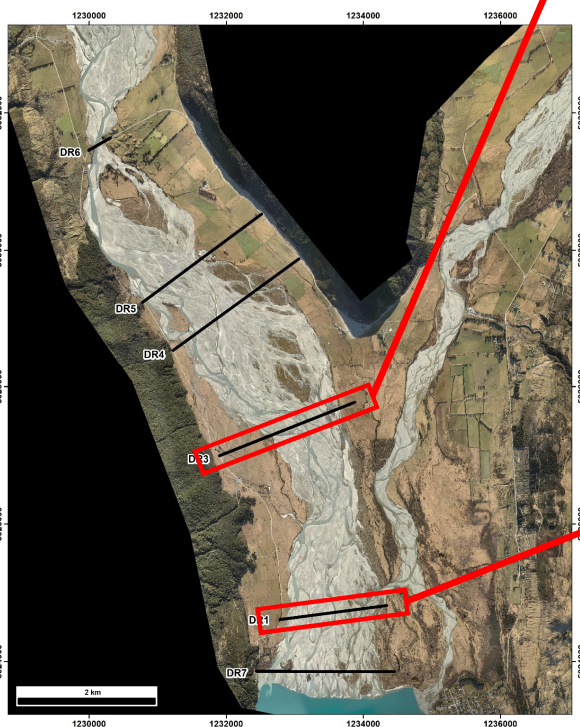
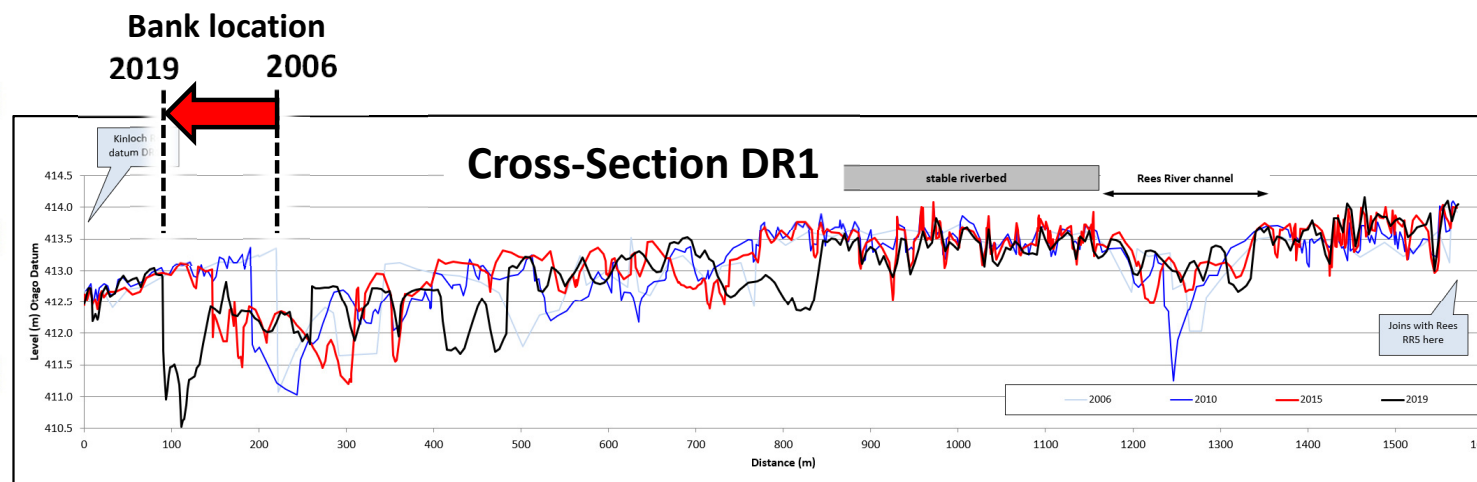
River Channel Cross-Section surveys

- Show changes to river form
- Bank positions, location and depth of main channels

River channel in
2006 2010 2015 2019

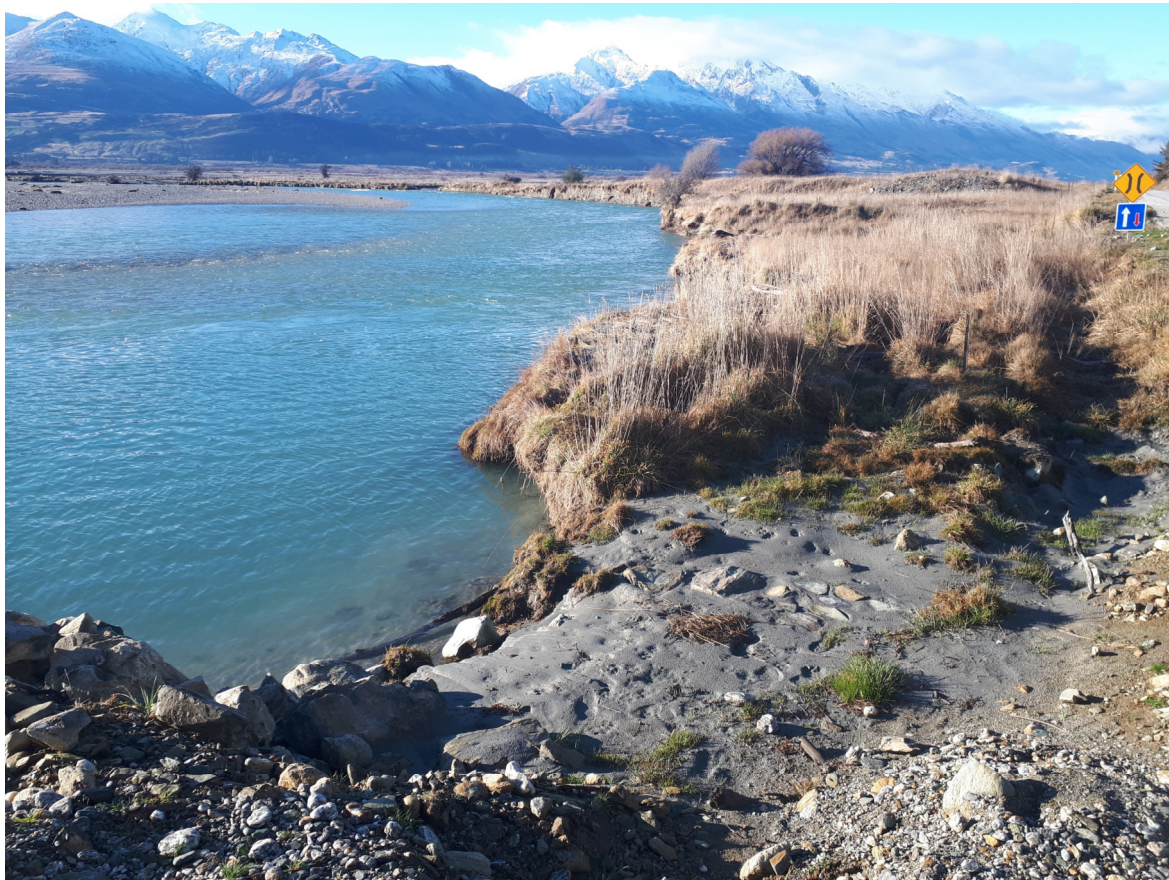
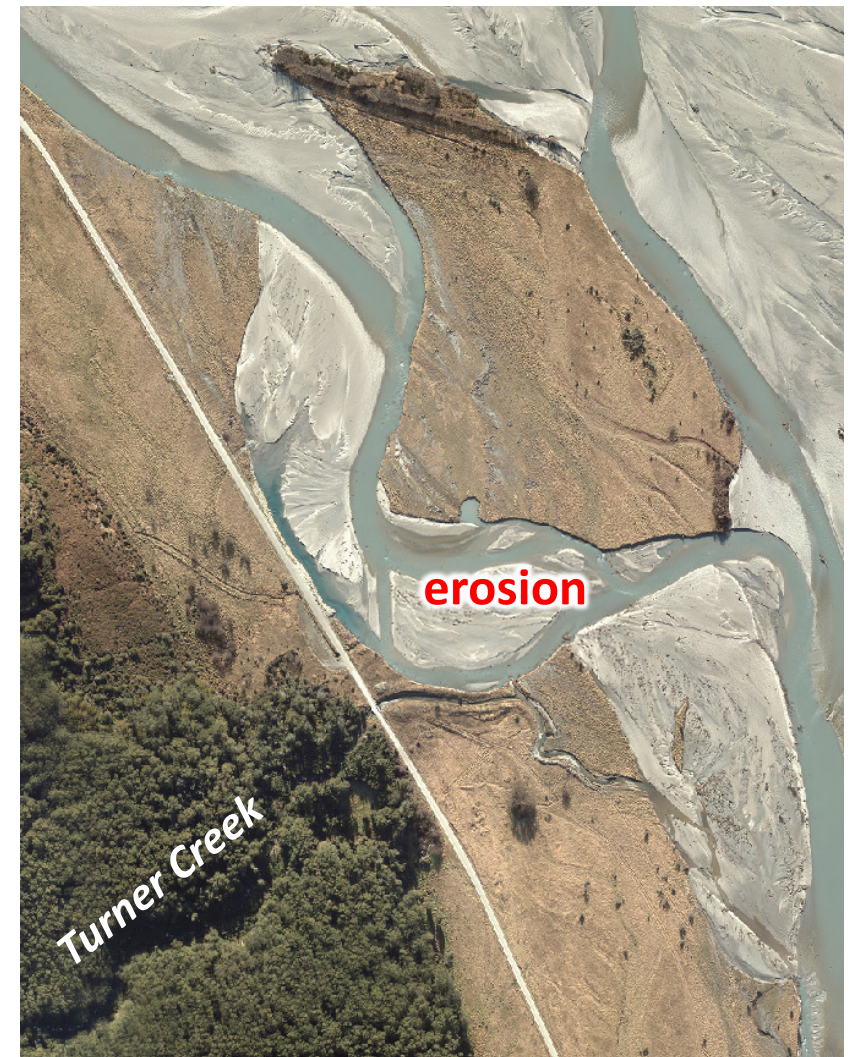
Dart River erosion and Kinloch Road flooding

- Erosion immediately north of Turner Creek
- Highest priority – focus for short-term bank protection works

By end of October: Geotechnical assessment and recommendations for bank protection in the Turner Creek area.

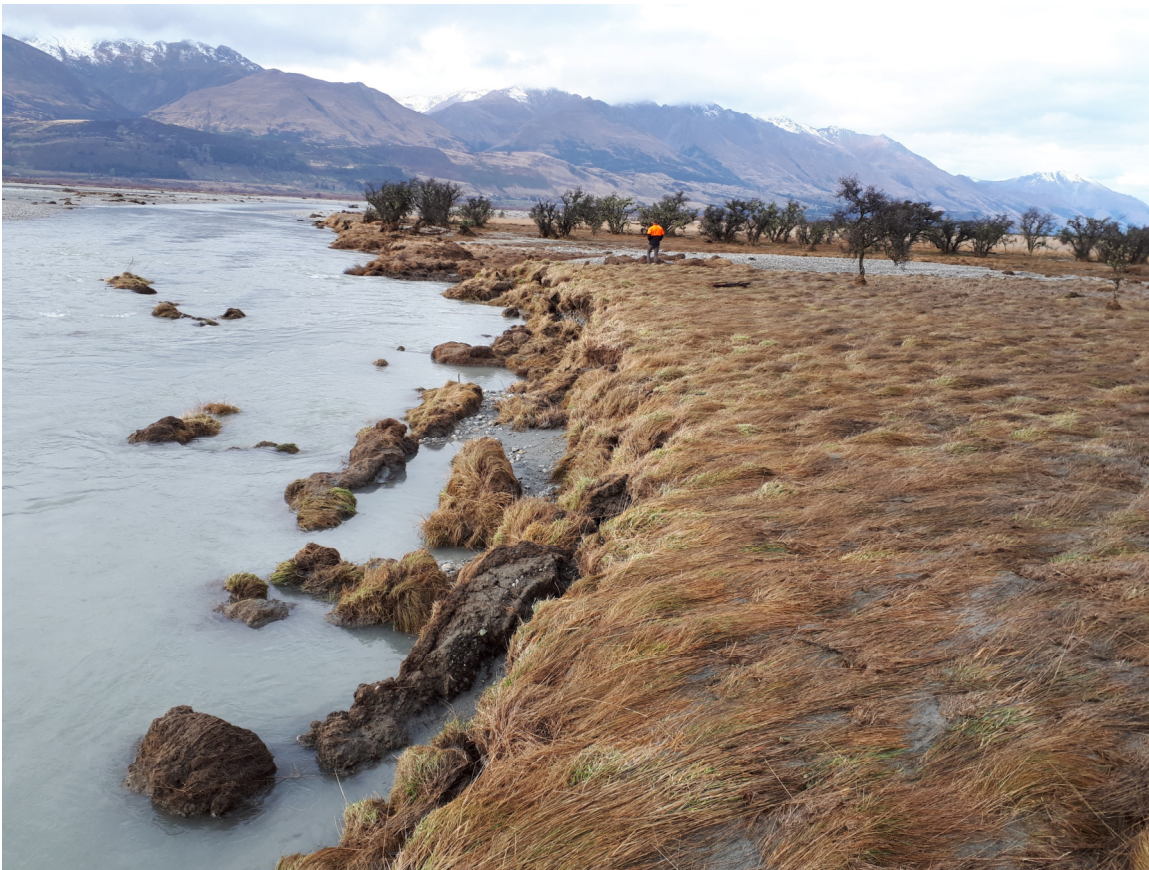
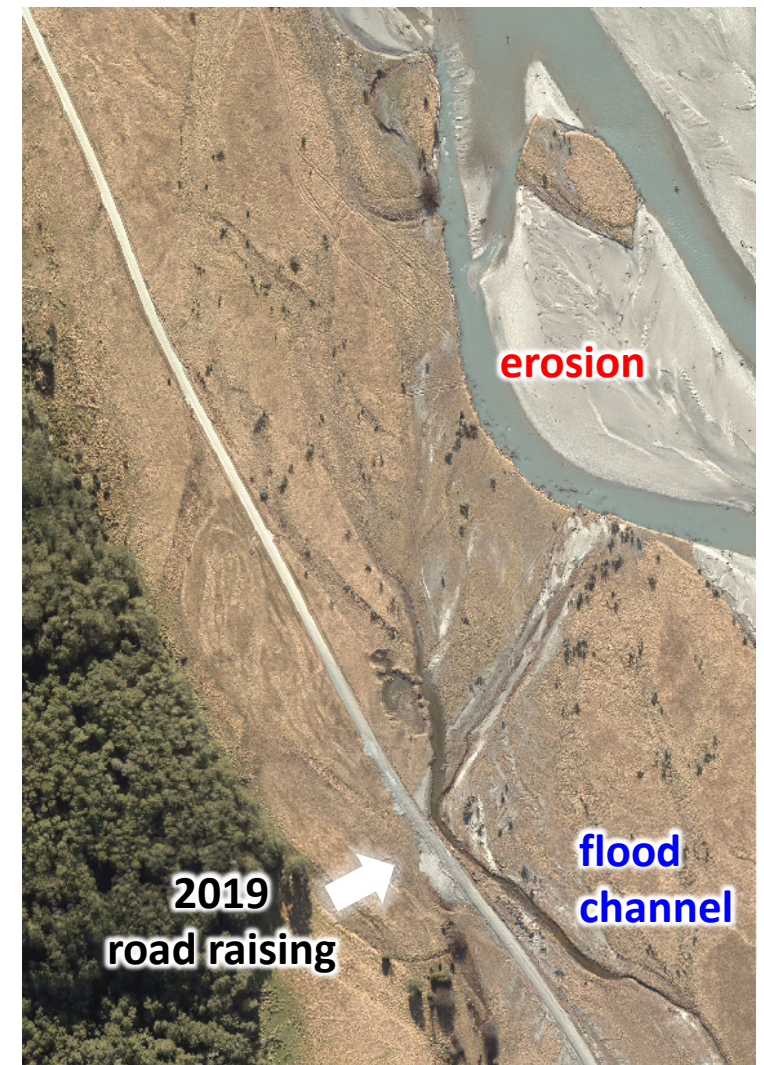
Dart River erosion and Kinloch Road flooding

- Continuing erosion of Dart River western banks to south of Turner Creek
- High flows into old river channel next to road
- Will assess effectiveness of QLDC's road raising over coming months
