**OCEANA GOLD (NEW ZEALAND) LIMITED
MACRAES OPERATION
TRIMBELLS WASTE ROCK STACK
CLOSURE STABILITY REPORT**

Title	OCEANA GOLD (NEW ZEALAND) LIMITED MACRAES OPERATION TRIMBELLS WASTE ROCK STACK – CLOSURE STABILITY REPORT
Revision	1
Date	23 August 2024
EGL Reference	9745
Client Reference	-
File Name	Trimbells WRS Closure Stability Report Rev 0.docx

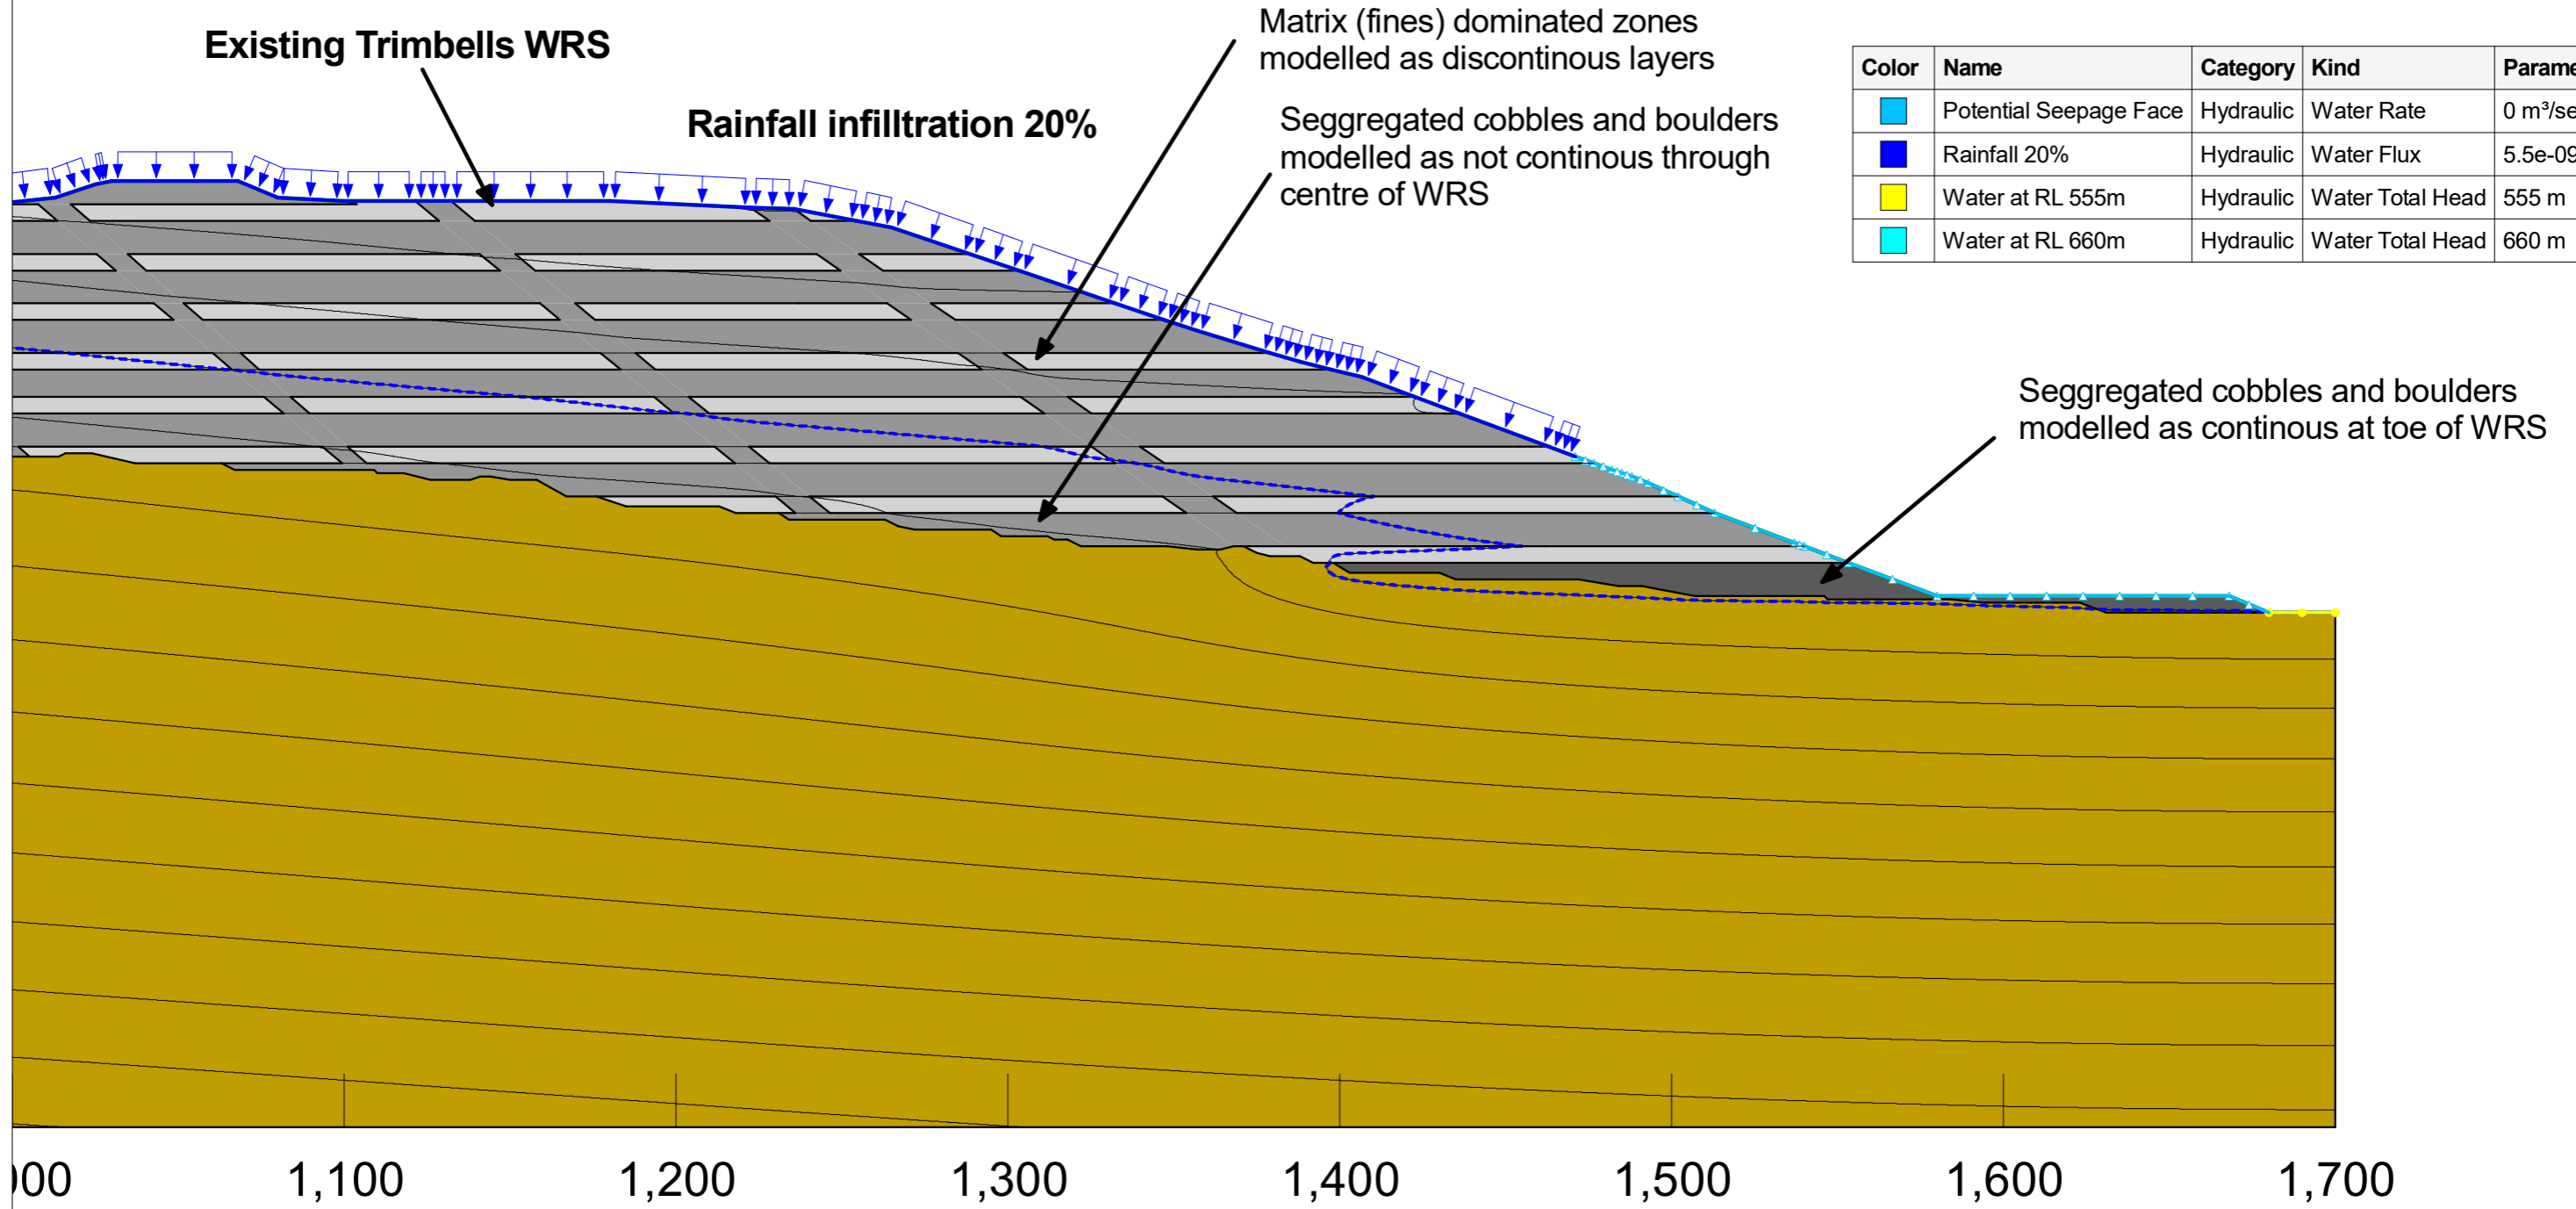
Figure A01

Color	Name	Hydraulic Material Model	Sat Kx (m/sec)	Ky/Kx' Ratio
■	Unweathered Schist	Saturated Only	5e-09	0.1
■	Zone C - Rockfill - Seggregated Cobbles/Boulders 1E-2	Saturated Only	0.01	1
■	Zone C - Rockfill - Silty Sandy Gravel 1E-6 (Peak)	Saturated Only	1e-06	1
■	Zone C - Rockfill - Well Graded Sandy Gravelly Rockfill 1E-4	Saturated Only	0.0001	1

Color	Name	Category	Kind	Parameters
■	Potential Seepage Face	Hydraulic	Water Rate	0 m³/sec
■	Rainfall 20%	Hydraulic	Water Flux	5.5e-09 m/sec
■	Water at RL 555m	Hydraulic	Water Total Head	555 m
■	Water at RL 660m	Hydraulic	Water Total Head	660 m

Seepage analysis for pore pressure profile

A seepage analysis has been undertaken assuming a Coronation Pit Lake long-term level of 660m RL. This level is controlled by the proposed spillway to the south and results in a head of approximately 23m above the low point in the Coronation pit wall. A rainfall infiltration rate of 20% is assumed for the WRS. The analysis is undertaken for the Model Section. Permeability contrasts expected in the WRS have been considered. The purpose of the seepage modelling is only to determine the likely pore pressure regime for stability analysis. The permeability values applied are summarised in Table 3 and the figures in Appendix A.

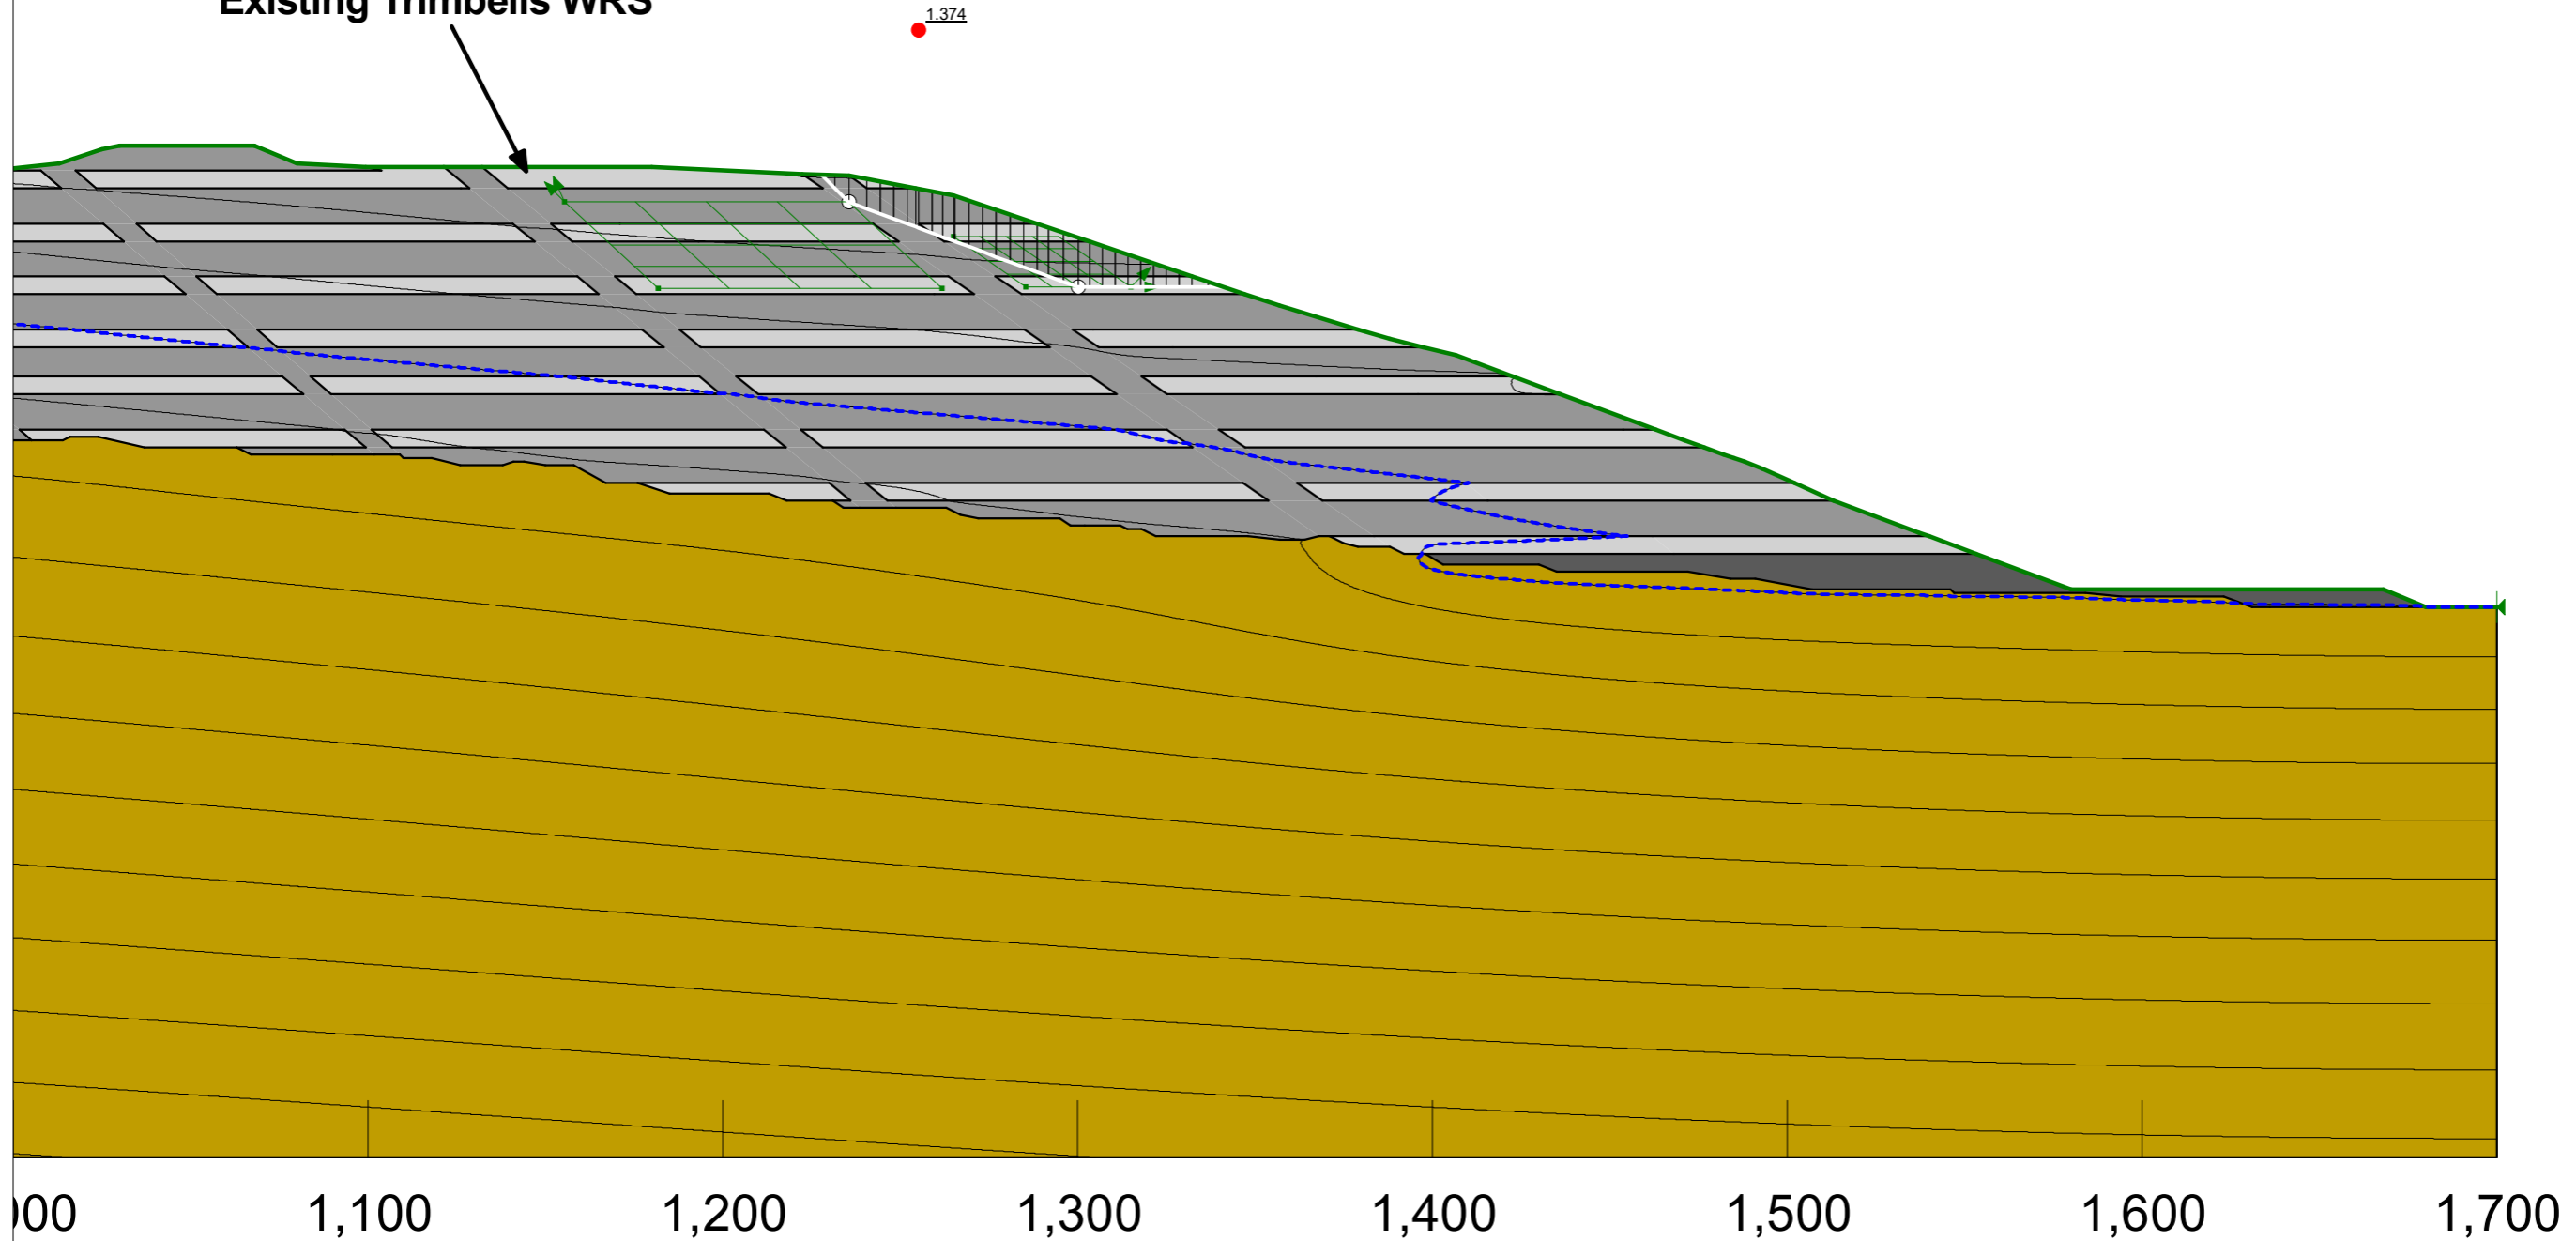
Figure A07

Stability - EQ150yr - Peak - Planar - 1/3rd H

3. Estimated seismically induced displacements under a 1 in 150 year earthquake loading condition are unlikely.
4. Estimated seismically induced displacements under 1 in 2500 year earthquake loading are estimated to be less than 5 cm for the downstream slope.
5. Estimated seismically induced displacements are small and the post-earthquake stability is adequate.

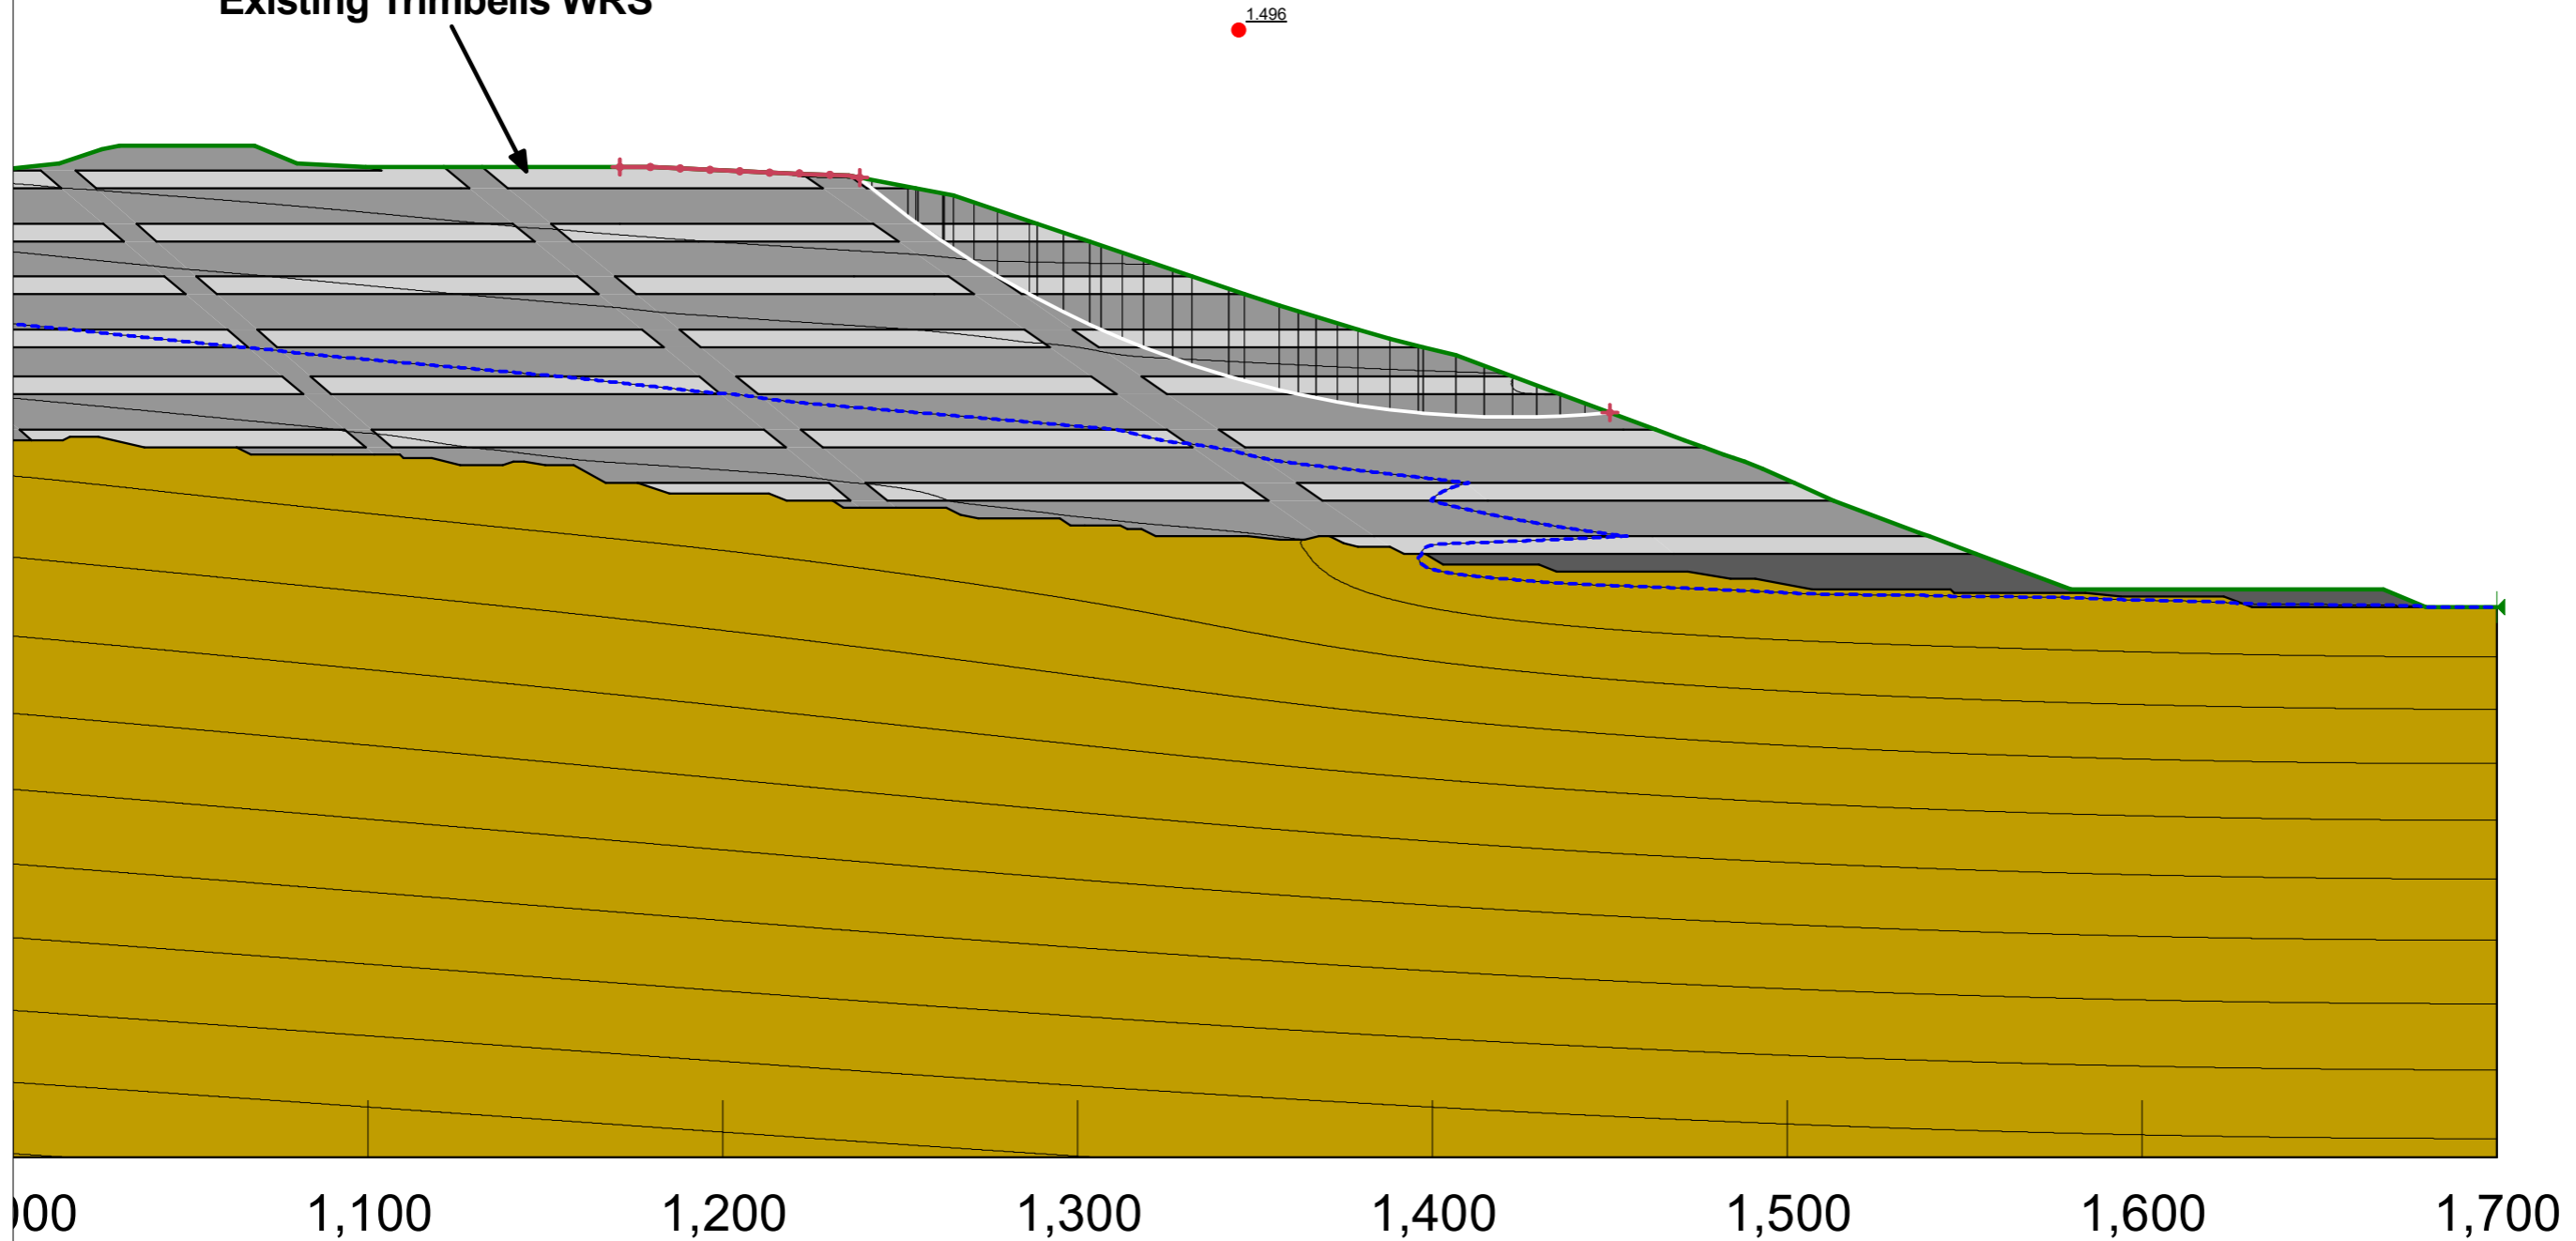
Figure A08

Stability - EQ150yr - Peak - Circular 2/3rd H

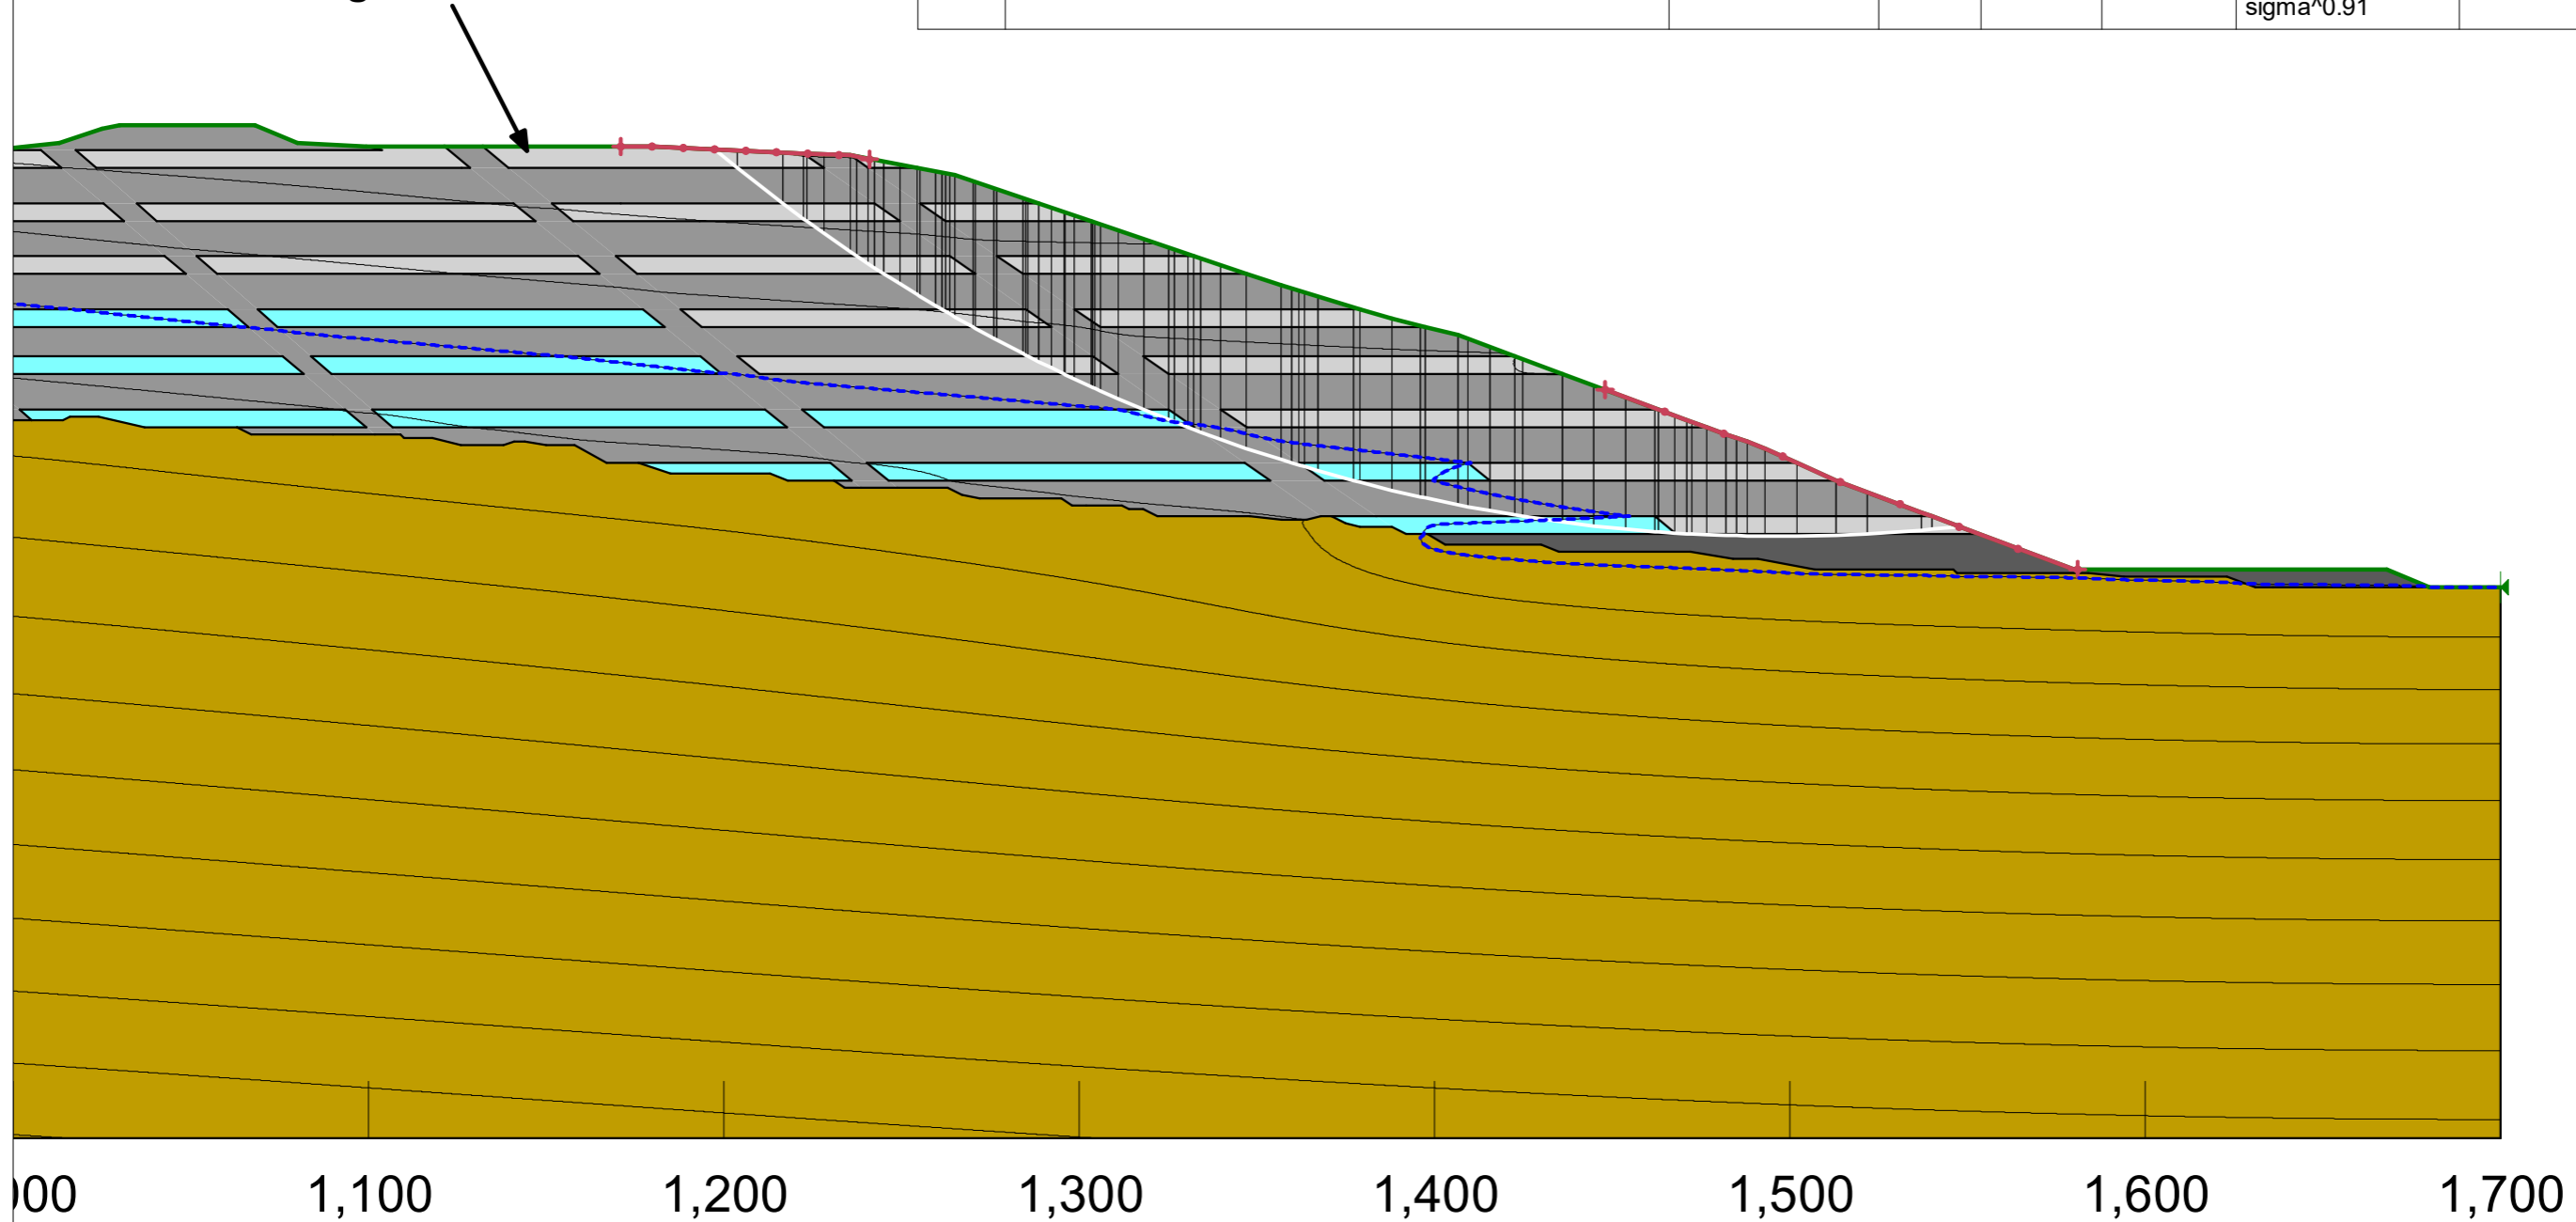
Figure A16

Stability - ky - Residual - Circular H

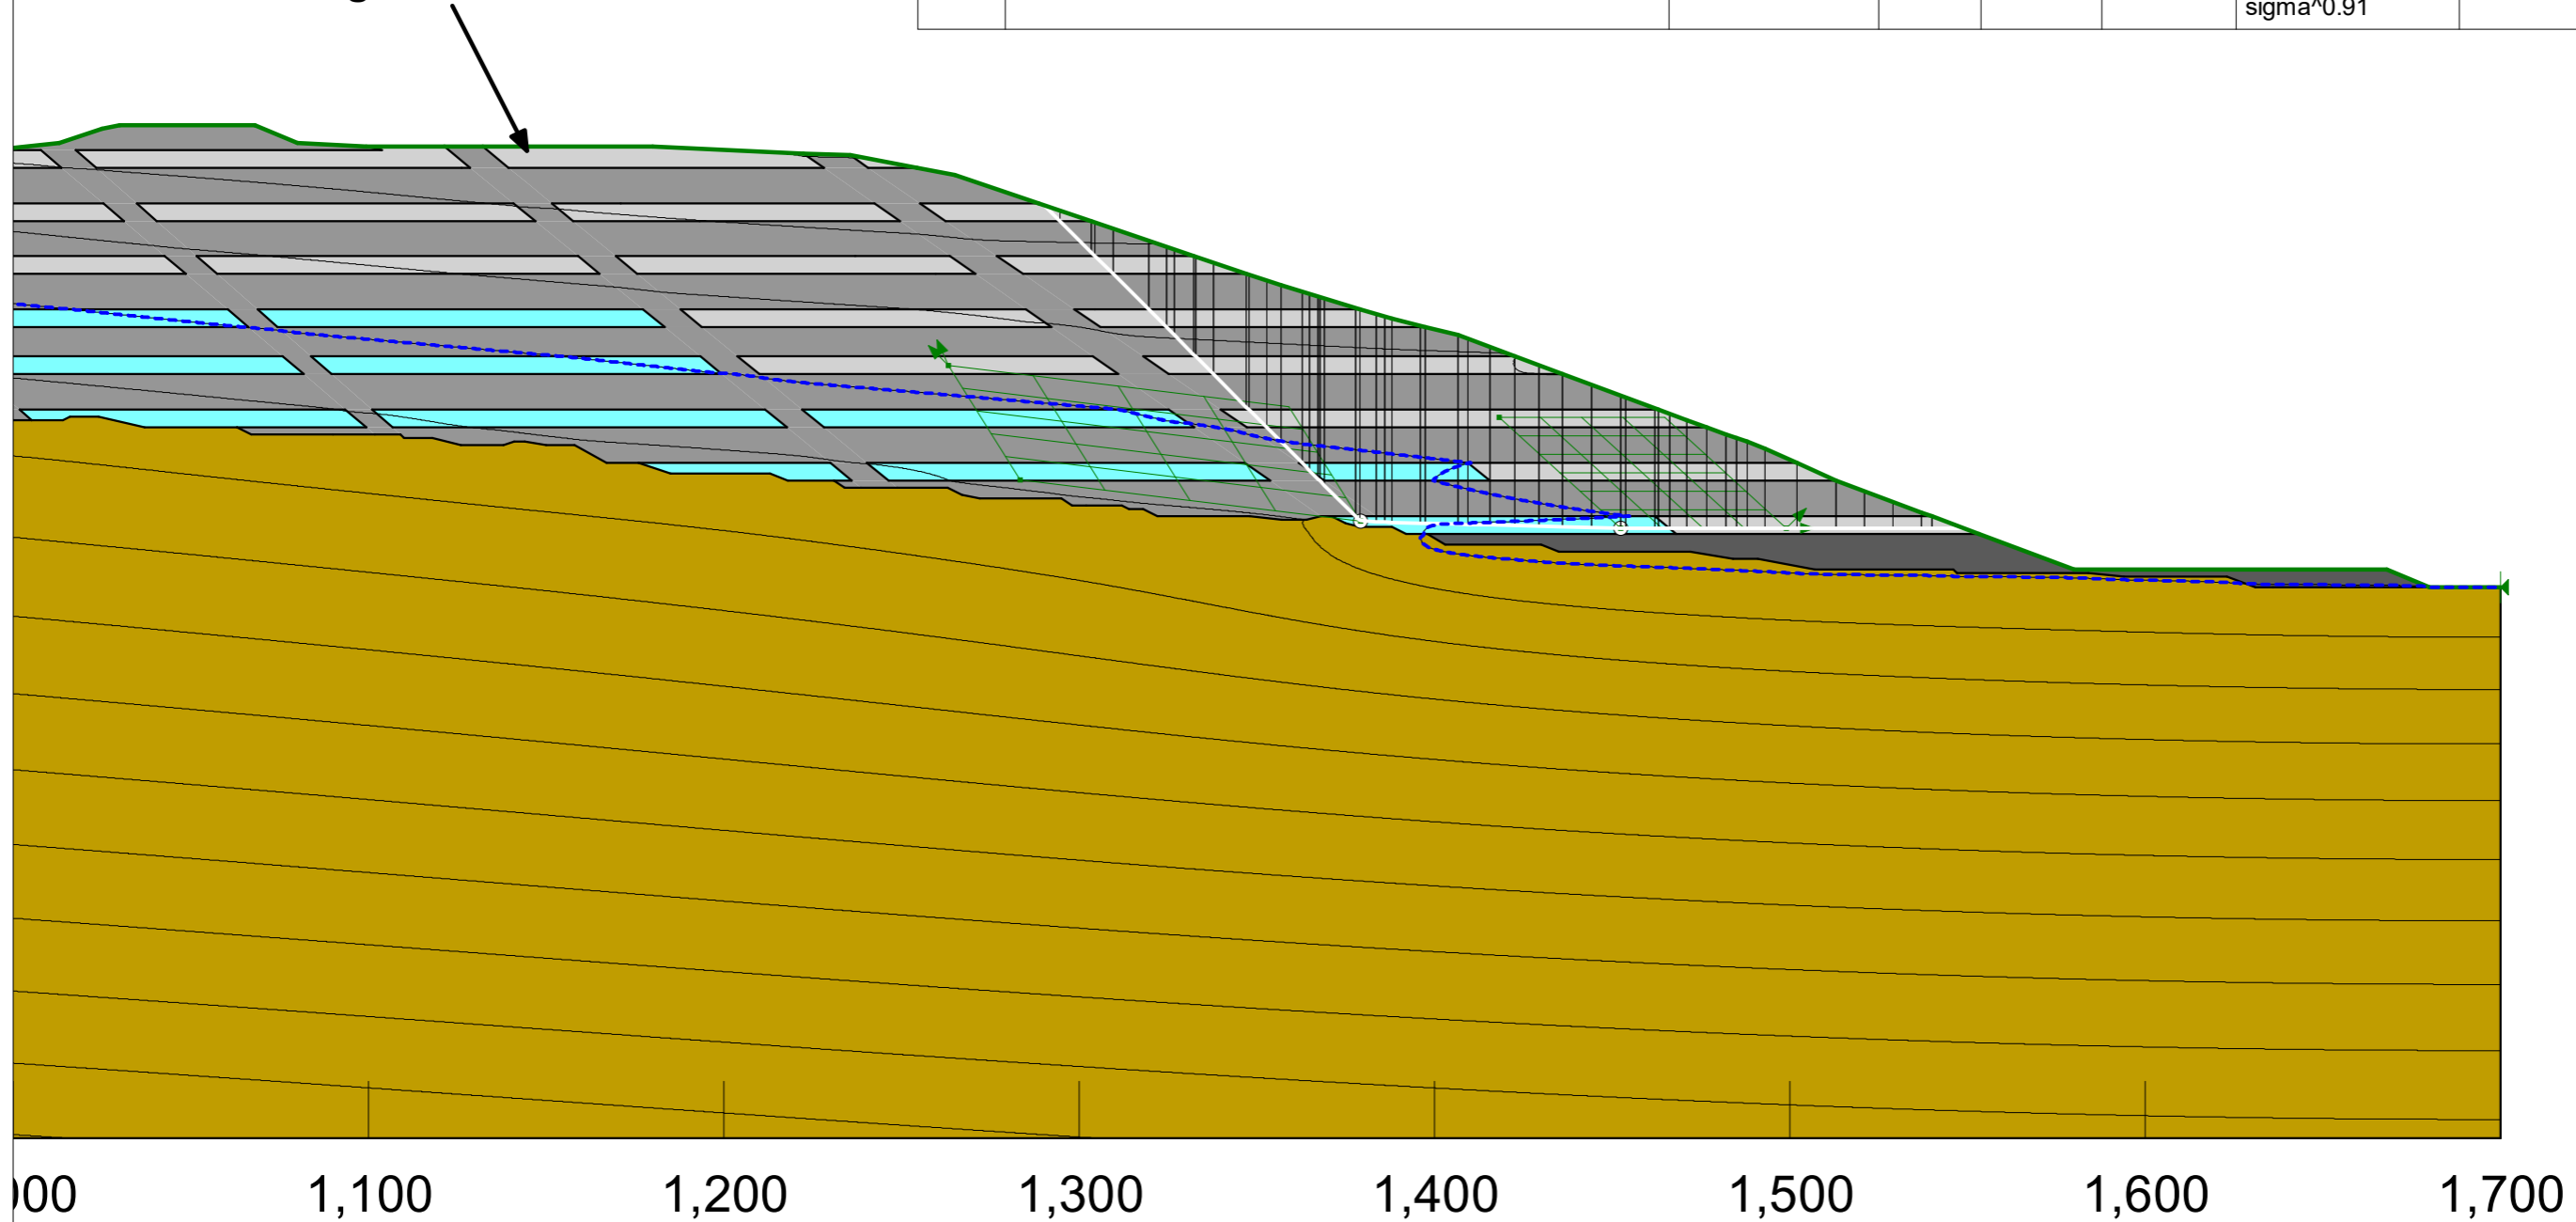
Figure A17

Stability - ky - Residual - Planar - H
