Waste Futures – Green Island Landfill Extension

2022 Geotechnical Investigation Factual Report

Dunedin City Council

20 February 2023

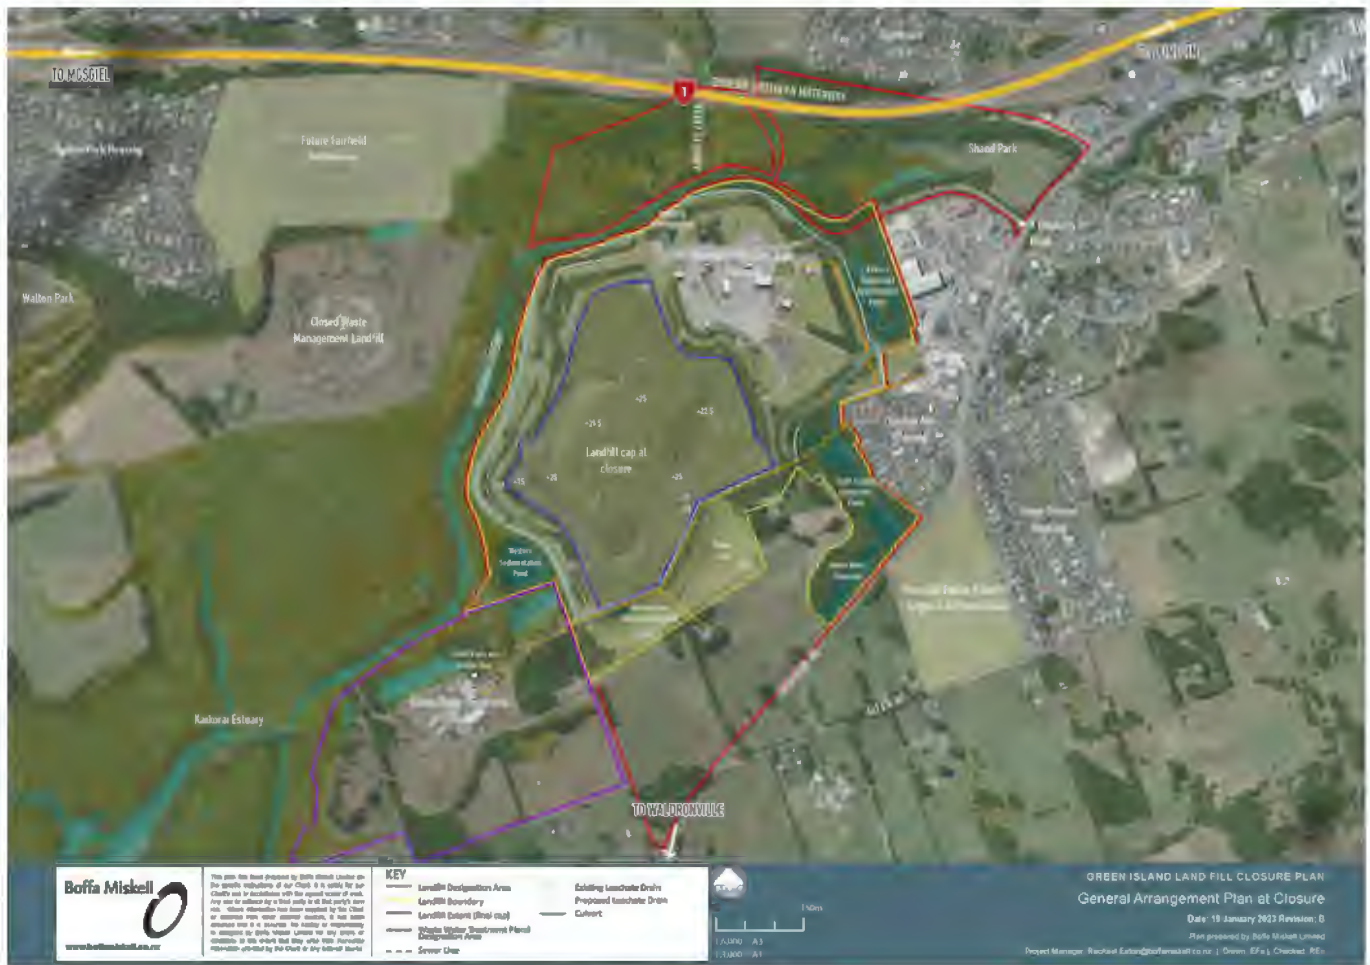
Figure 1 Broad location.

Several activities are currently being undertaken within the boundaries of the landfill including municipal waste disposal, compost production, liquid waste and sludge disposal alongside the operation of a waste transfer station and a recycling centre. The location of the site is shown below in Figure 1.

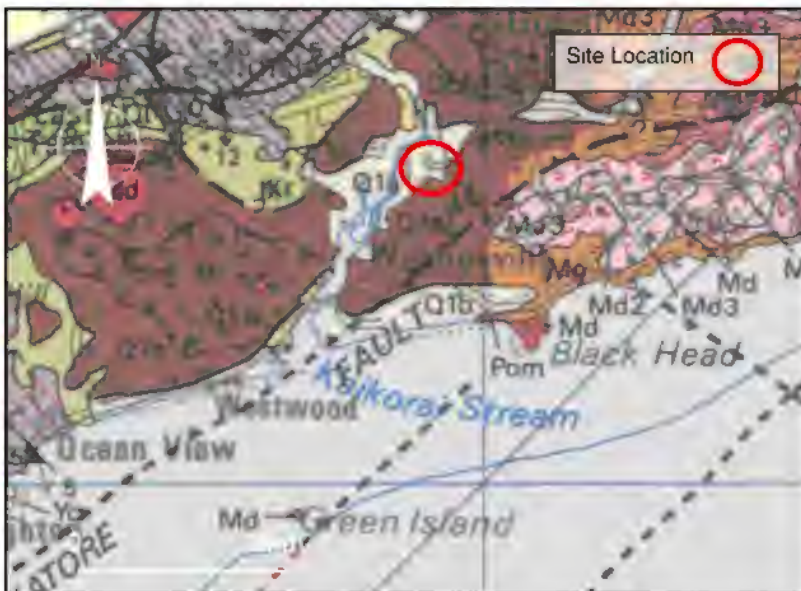
Figure 3 Geological map excerpt (Bishop & Turnbull, 1996).

Local geology is described in accordance with the geological map "Geology of the Dunedin Area, Scale 1:250,000. Institute of Geological & Nuclear Sciences, Geological Map 21, 1996" (Bishop & Turnbull, 1996). An excerpt of the 1:250,000 geological map is included below in Figure including an indication of the site location.

Figure 3 shows the Green Island Landfill site is located nearby to two primary geological formations. A quick summary of these geological formations has been included in Table 1.

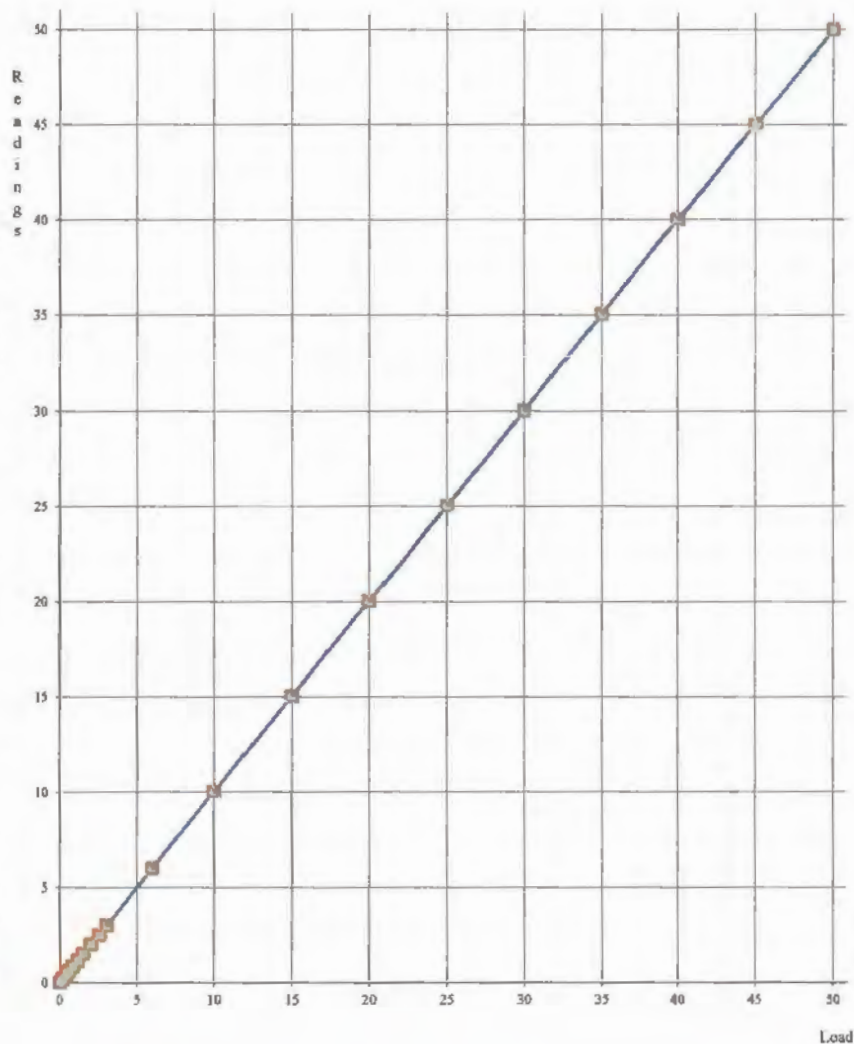
Factory calibration in accordance with **ASTM D5778-12**

Ascending		Descending	
	Load	Readings	Load	Readings
1	0,00	0,01	0,00	0,01
2	0,03	0,02	0,03	0,03
3	0,20	0,20	0,20	0,20
4	0,40	0,40	0,40	0,40
5	0,60	0,60	0,60	0,60
6	0,85	0,85	0,85	0,85
7	1,15	1,15	1,15	1,15
8	1,50	1,50	1,50	1,50
9	2,00	2,00	2,00	2,00
10	2,50	2,51	2,50	2,51
11	3,00	3,00	3,00	3,01
12	6,00	6,01	6,00	6,01
13	10,00	10,02	10,00	10,03
14	15,00	15,03	15,00	15,04
15	20,00	20,04	20,00	20,05
16	25,00	25,04	25,00	25,05
17	30,00	30,04	30,00	30,04
18	35,00	35,03	35,00	35,04
19	40,00	40,02	40,00	40,04
20	45,00	45,01	45,00	45,02
21	50,00	50,00	50,00	50,00

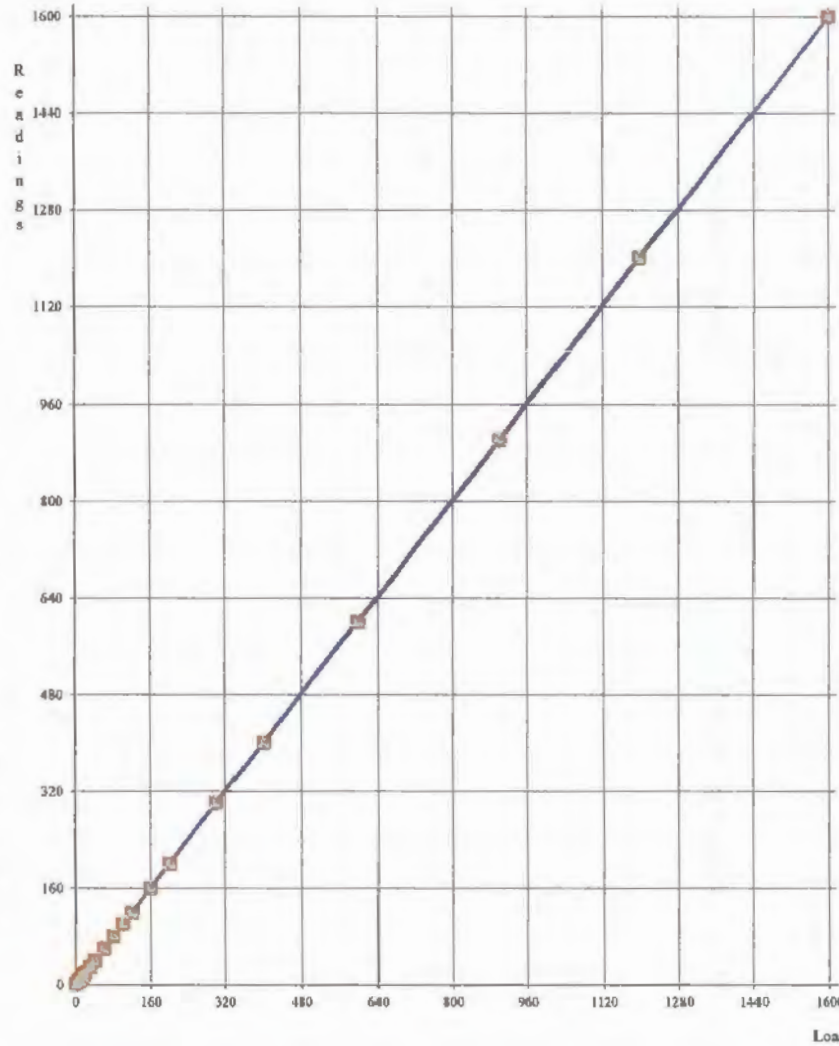
Factory calibration in accordance with ASTM D5778-12

Ascending		Descending	
	Load	Readings	Load	Readings
1	0,00	0,73	0,00	1,13
2	2,00	1,07	2,00	2,33
3	5,00	4,80	5,00	5,33
4	7,00	6,80	7,00	7,33
5	10,00	9,80	10,00	10,40
6	16,00	15,60	16,00	16,27
7	20,00	19,53	20,00	20,33
8	30,00	29,67	30,00	30,60
9	40,00	39,67	40,00	40,67
10	60,00	59,80	60,00	60,87
11	80,00	79,93	80,00	81,07
12	100,00	100,07	100,00	101,27
13	120,00	120,20	120,00	121,40
14	160,00	160,33	160,00	161,73
15	200,00	200,47	200,00	202,00
16	300,00	300,87	300,00	302,47
17	400,00	401,00	400,00	402,80
18	600,00	601,47	600,00	603,60
19	900,00	902,00	900,00	904,40
20	1200,00	1201,73	1200,00	1204,20
21	1600,00	1600,00	1600,00	1600,33

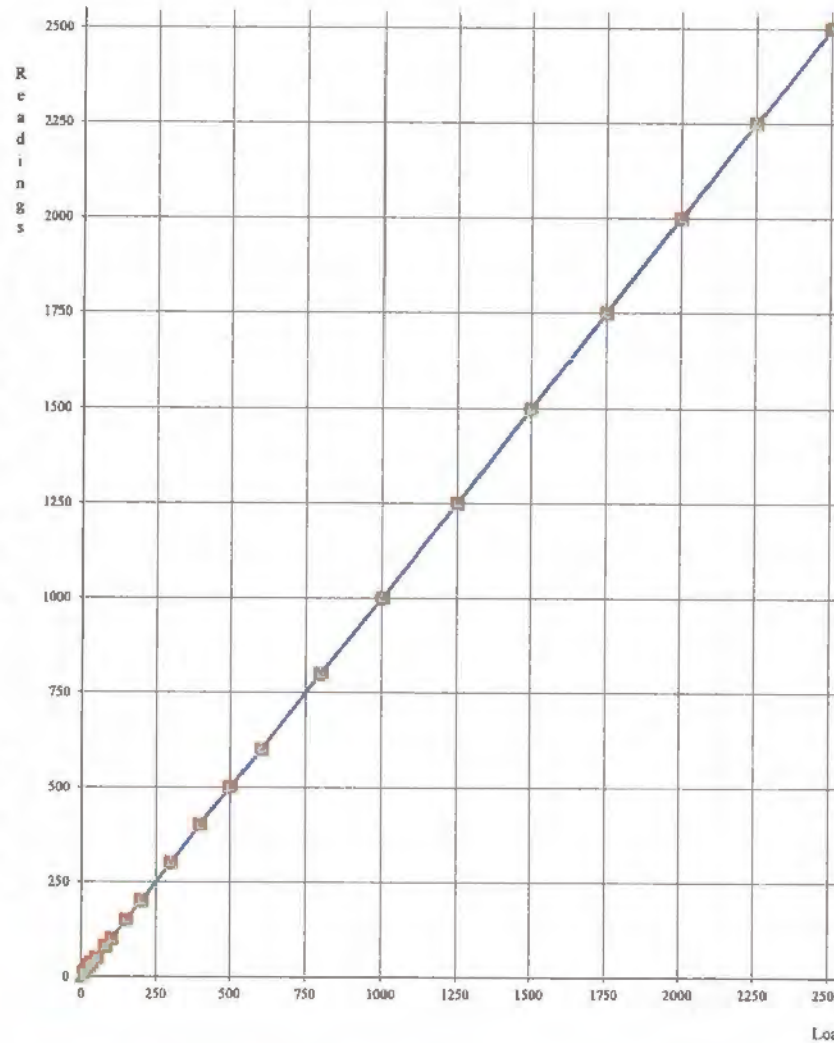
Factory calibration in accordance with **ASTM D5778-12**

Ascending		Descending	
	Load	Readings	Load	Readings
1	-0,10	0,00	0,00	0,00
2	10,00	10,00	10,00	10,00
3	25,00	24,80	25,00	24,90
4	35,00	34,80	35,00	34,70
5	50,00	49,60	49,90	49,50
6	80,00	79,50	80,00	79,80
7	100,00	99,70	100,00	99,90
8	150,00	149,90	150,00	150,00
9	200,00	200,10	200,00	200,00
10	300,00	300,20	300,00	300,00
11	400,00	400,10	399,90	399,80
12	500,00	500,00	499,90	499,70
13	600,00	599,80	599,90	599,60
14	800,00	799,50	799,90	799,10
15	1000,00	999,30	999,90	998,70
16	1250,00	1249,00	1250,00	1248,60
17	1500,00	1498,90	1499,80	1498,10
18	1750,00	1749,00	1750,00	1748,50
19	2000,00	1999,10	2000,00	1998,70
20	2250,00	2249,50	2250,00	2249,40
21	2500,00	2500,00	2500,00	2500,20

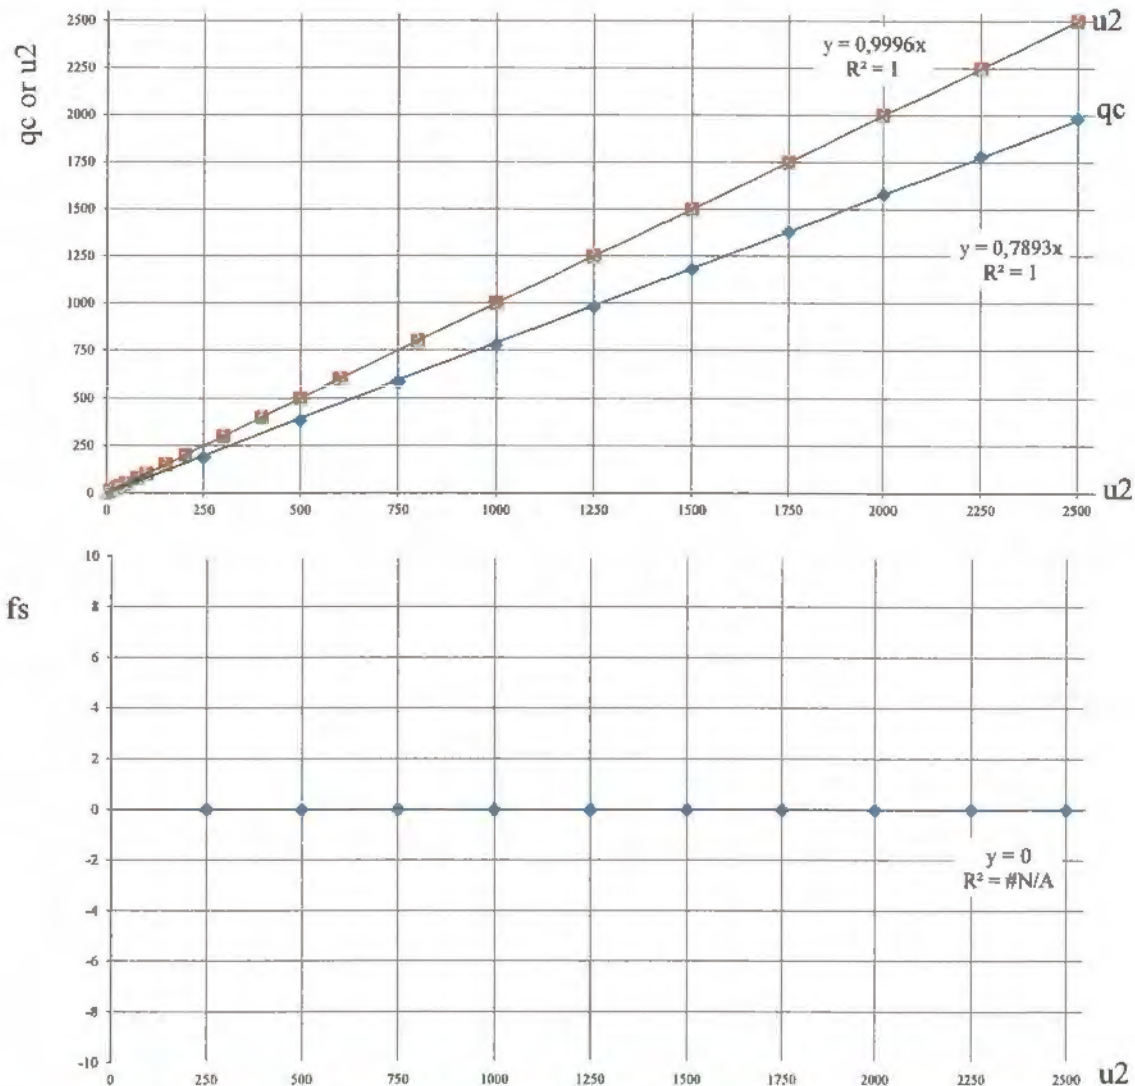
Factory calibration in accordance with *ASTM D5778-12*

The adopted calibration procedure has been developed according to the suggestions given by Prof. Paul W. Mayne (Georgia Institute of technology) and Prof. Diego Lo Presti (University of Pisa)

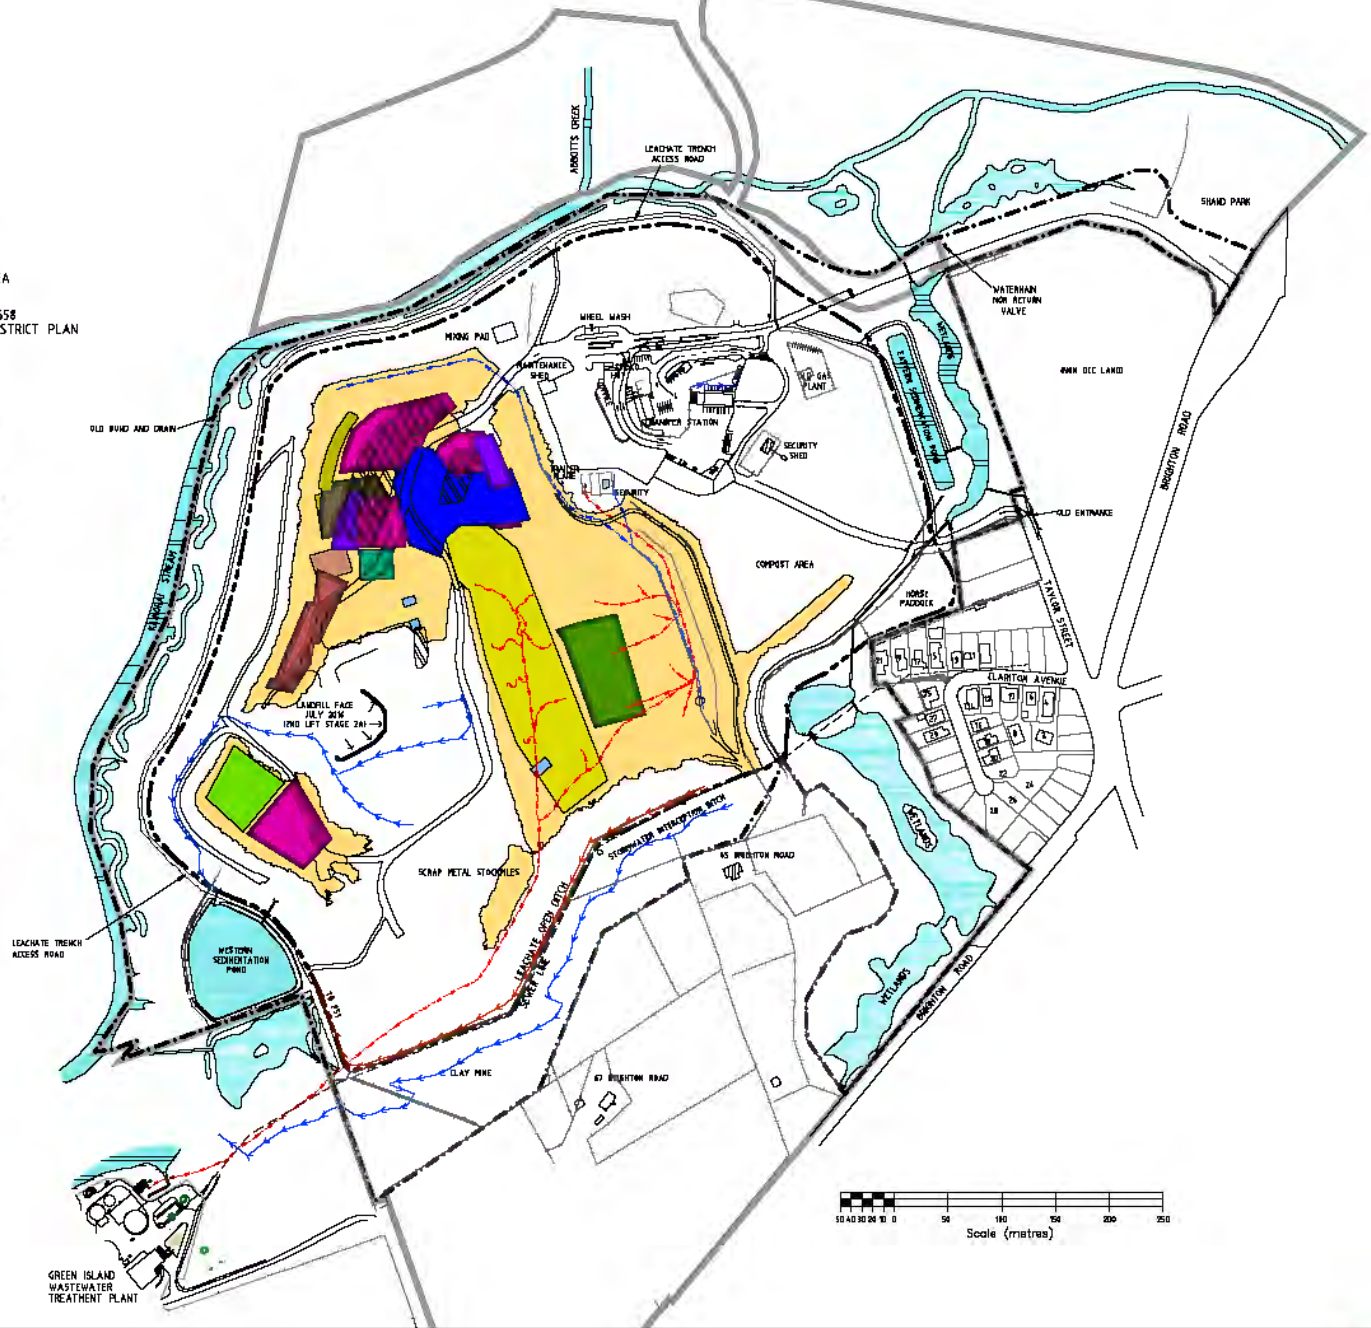
EXTENT OF LANDFILLED AREA

-   BOTTOM OF LIFT 2
-   SLUDGE PITS 2003
-   SLUDGE PITS 2003/2004
-   SLUDGE PITS 2004/2005
-   SLUDGE PITS 2006/2007
-   SLUDGE PITS 2007/2008
-   SLUDGE PITS 2008/2009
-   SLUDGE PITS 2009/2010
-   SLUDGE PITS 2010/2012
-   SLUDGE PITS 2012/2013
-   SLUDGE PITS 2013/2014
-   SLUDGE PITS 2014/2015
-   SLUDGE PITS 2nd LIFT
2015/2016
-   ASBESTOS

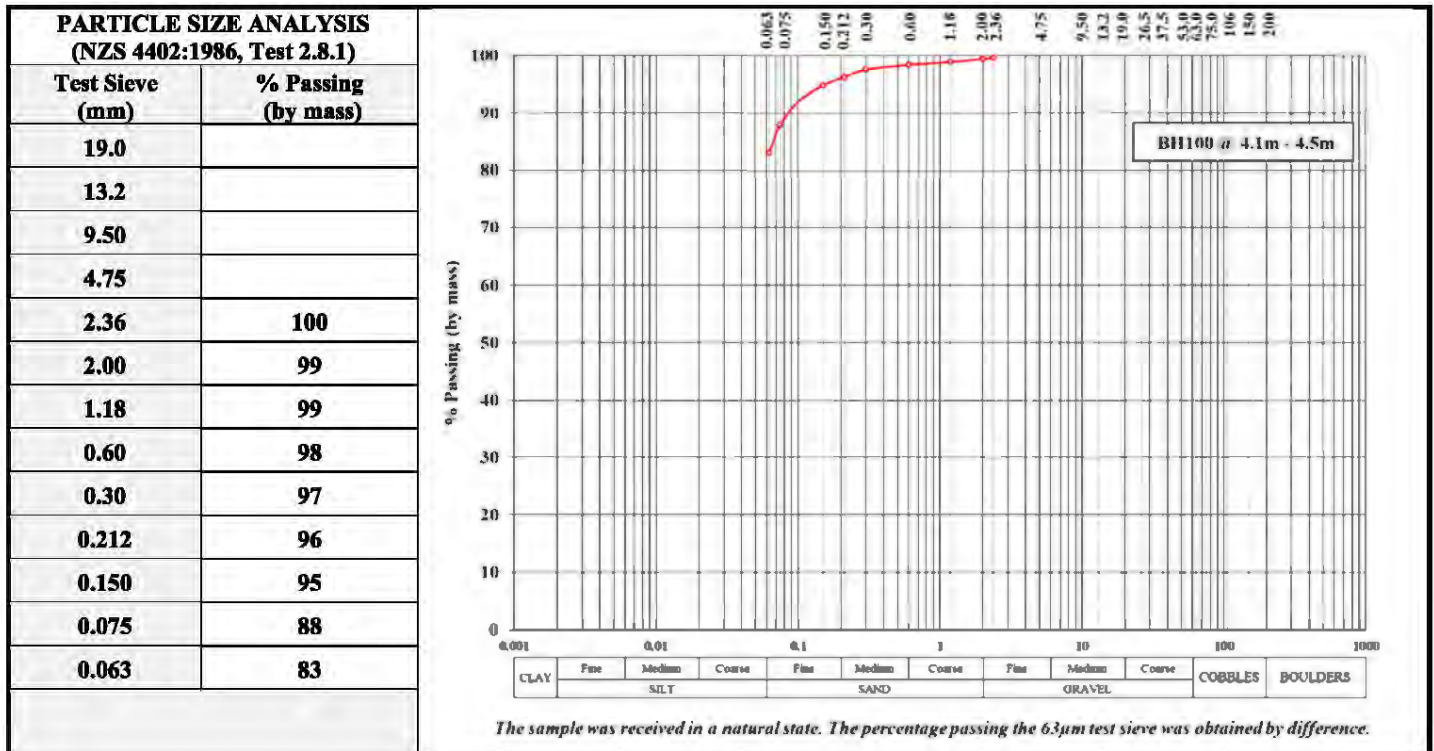
WATER CONTENT & PLASTICITY INDEX RESULTS - NZS 4402:1986, Test 2.1, 2.2, 2.3 & 2.4	
Water Content: (As Received)	20.3 %
Liquid Limit: (LL)	70
Plastic Limit: (PL)	30
Plasticity Index: (PI)	40

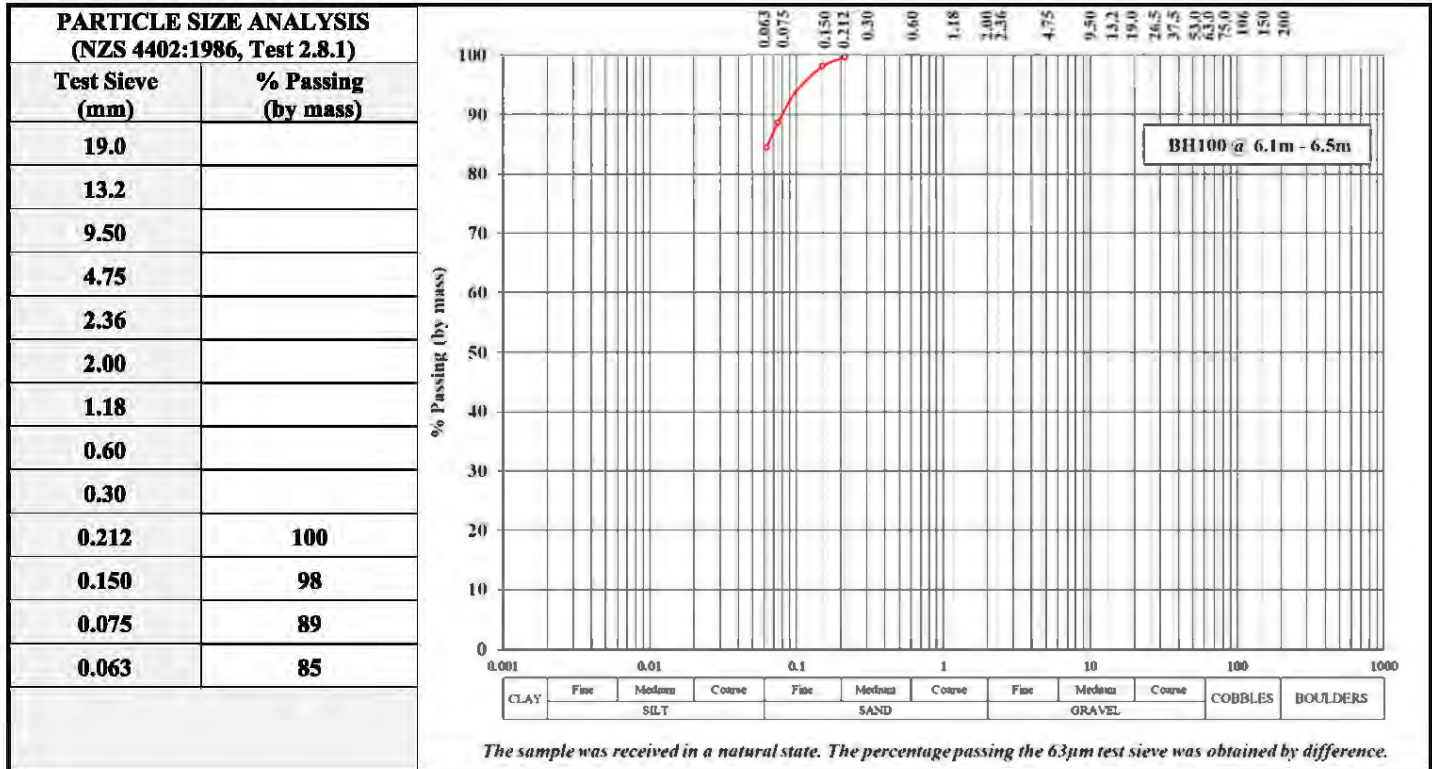
WATER CONTENT & PLASTICITY INDEX RESULTS - NZS 4402:1986, Test 2.1, 2.2, 2.3 & 2.4	
Water Content: (As Received)	36.7 %
Liquid Limit: (LL)	53
Plastic Limit: (PL)	24
Plasticity Index: (PI)	29

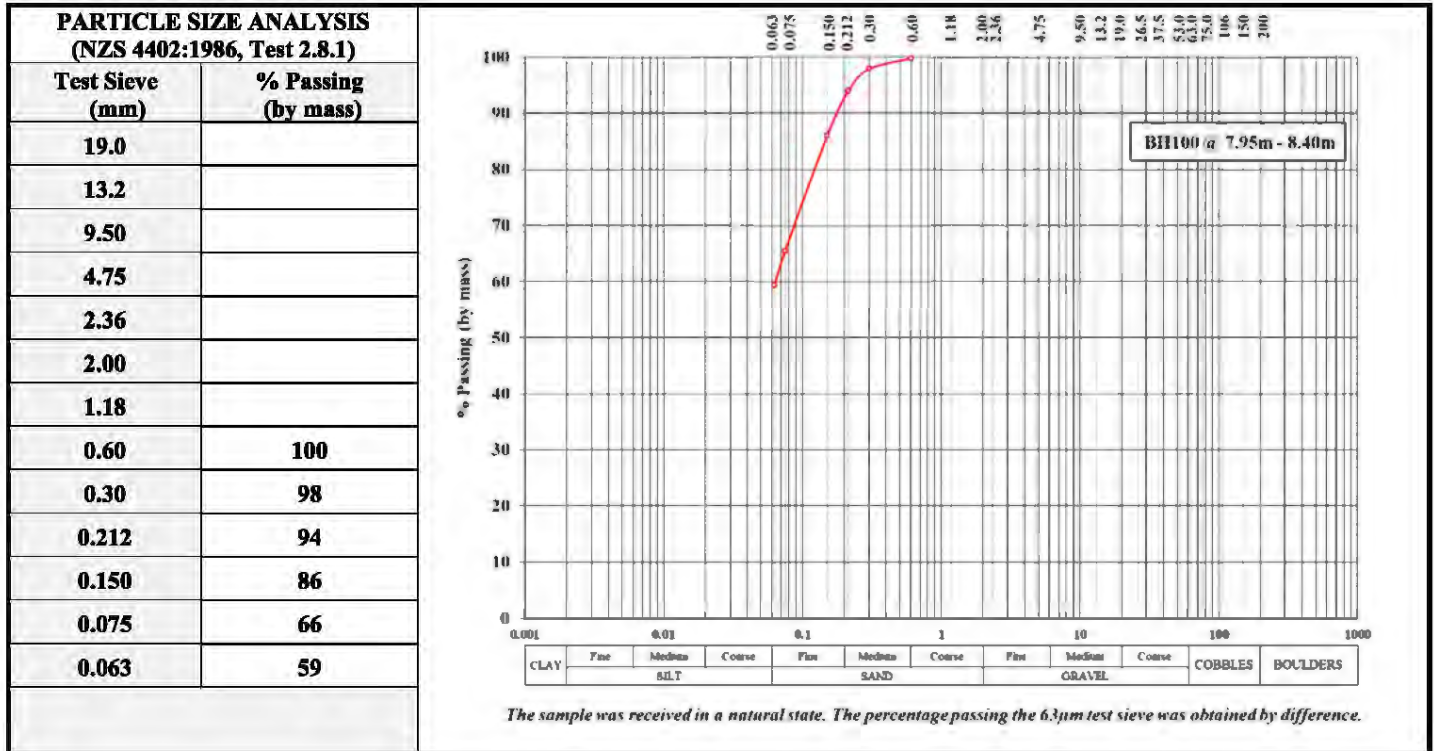
WATER CONTENT & PLASTICITY INDEX RESULTS - NZS 4402:1986, Test 2.1, 2.2, 2.3 & 2.4	
Water Content: (As Received)	24.6 %
Liquid Limit: (LL)	28
Plastic Limit: (PL)	23
Plasticity Index: (PI)	5

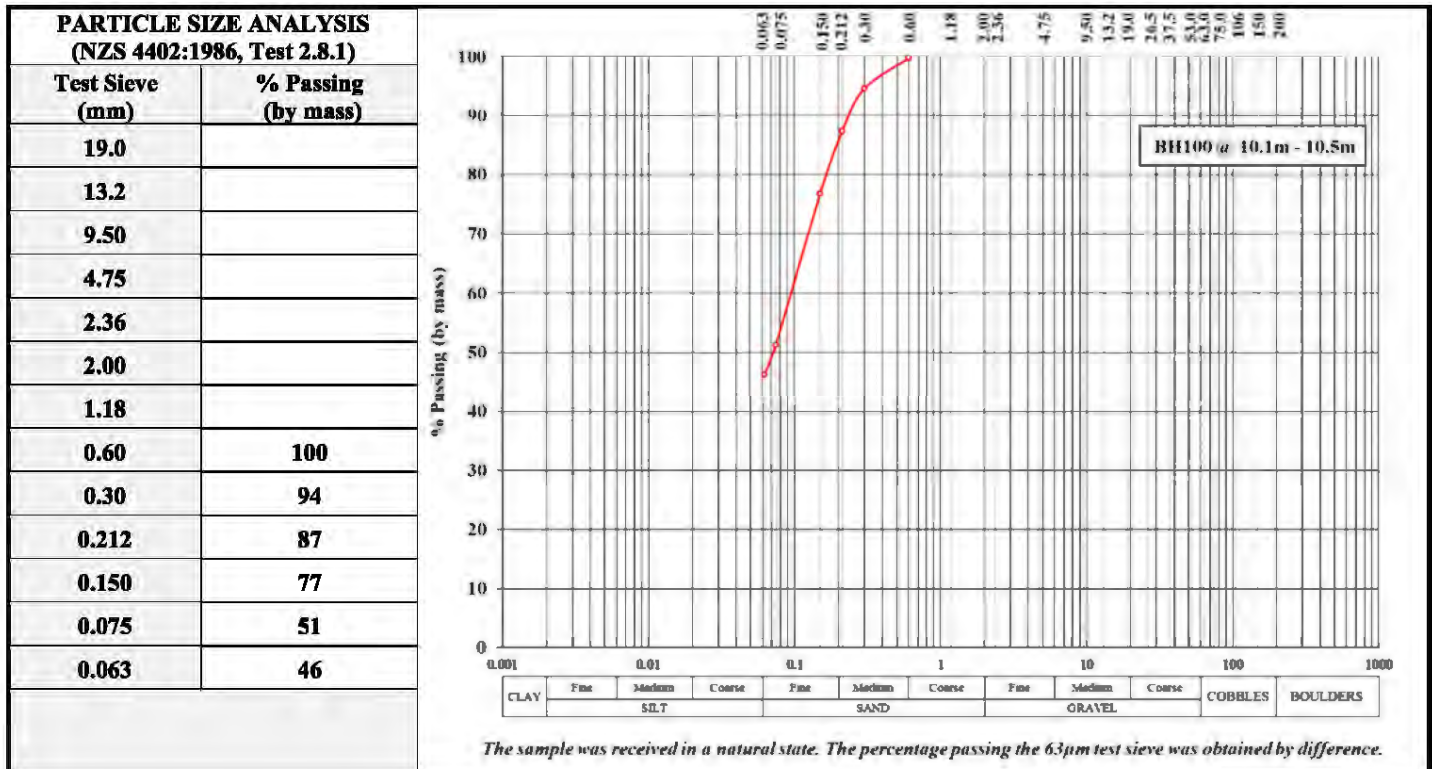
WATER CONTENT & PLASTICITY INDEX RESULTS - NZS 4402:1986, Test 2.1, 2.2, 2.3 & 2.4	
Water Content: (As Received)	28.5 %
Liquid Limit: (LL)	33
Plastic Limit: (PL)	27
Plasticity Index: (PI)	6
