**MT COOEE LANDFILL EXPANSION AREA:  
TERRESTRIAL, WETLAND, AND WATERWAY  
ASSESSMENT**

For WSP

April 2023

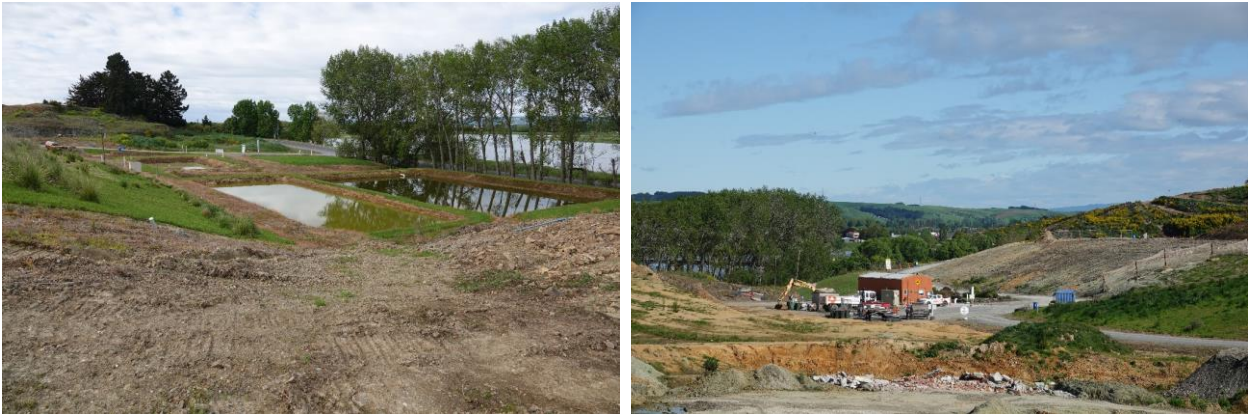
Figure 2: Stormwater retention ponds and plantings (left), and buildings and roads (right).

The existing landfill area contains buildings, sealed roads, gravel roads, bare earth, open tip face with disturbed waste, two stormwater retention ponds, exotic grasses and herbs, plantings (toetoe, flax, and copper tussock) and patches of exotic trees (including willow, poplar, and eucalyptus) (Figure 2).

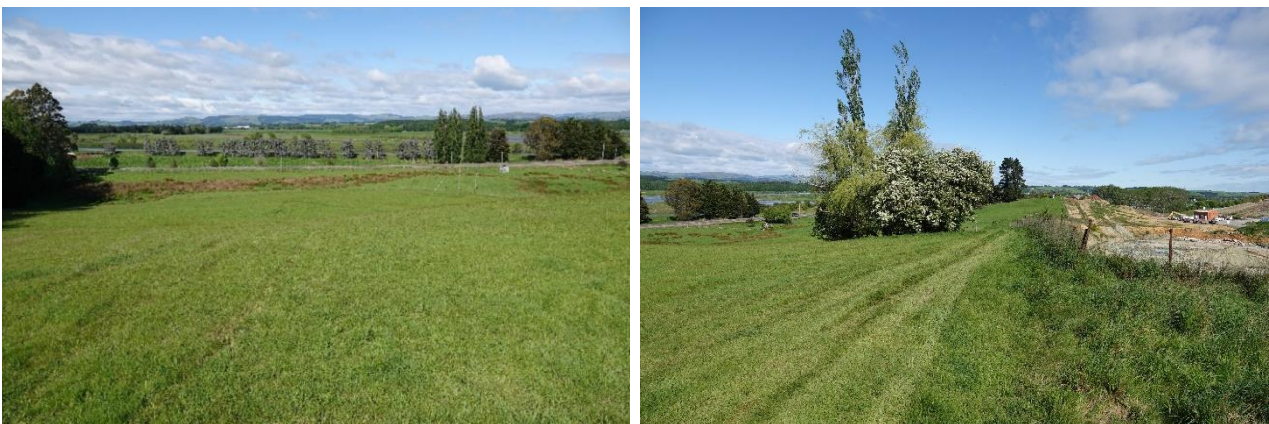
Figure 3: Most of the proposed Surplus Fill Disposal Area comprises grazed pasture, with a small patch of trees near the Borrow Area (right).

Most of the area proposed for expansion of the Mt Cooe landfill comprises low hillslopes covered in pasture which were grazed by sheep during the site visit (Figure 3). The pasture was dominated by perennial ryegrass (*Lolium perenne*) and sweet vernal (*Anthoxanthum odoratum*) with occasional browntop (*Agrostis capillaris*) and white clover (*Trifolium repens*), and patches of cocksfoot (*Dactylis glomerata*) east of the Borrow Area. A small clump of trees, containing willow (*Salix* sp.), hawthorn (*Crataegus monogyna*), and Lombardy poplar (*Populus nigra*), is present south of the Borrow Area. The hedge just over the boundary with the rail line contains hawthorn, broom (*Cytisus scoparius*), elder (*Sambucus nigra*), and gorse (*Ulex europaeus*), with bracken (*Pteridium esculentum*) and cocksfoot on the ground. A shelter belt, just beyond the edge of the expansion area to the east, comprises tall macrocarpa (*Cupressus macrocarpa*). A list of plant species observed in the survey area is provided in Appendix B.

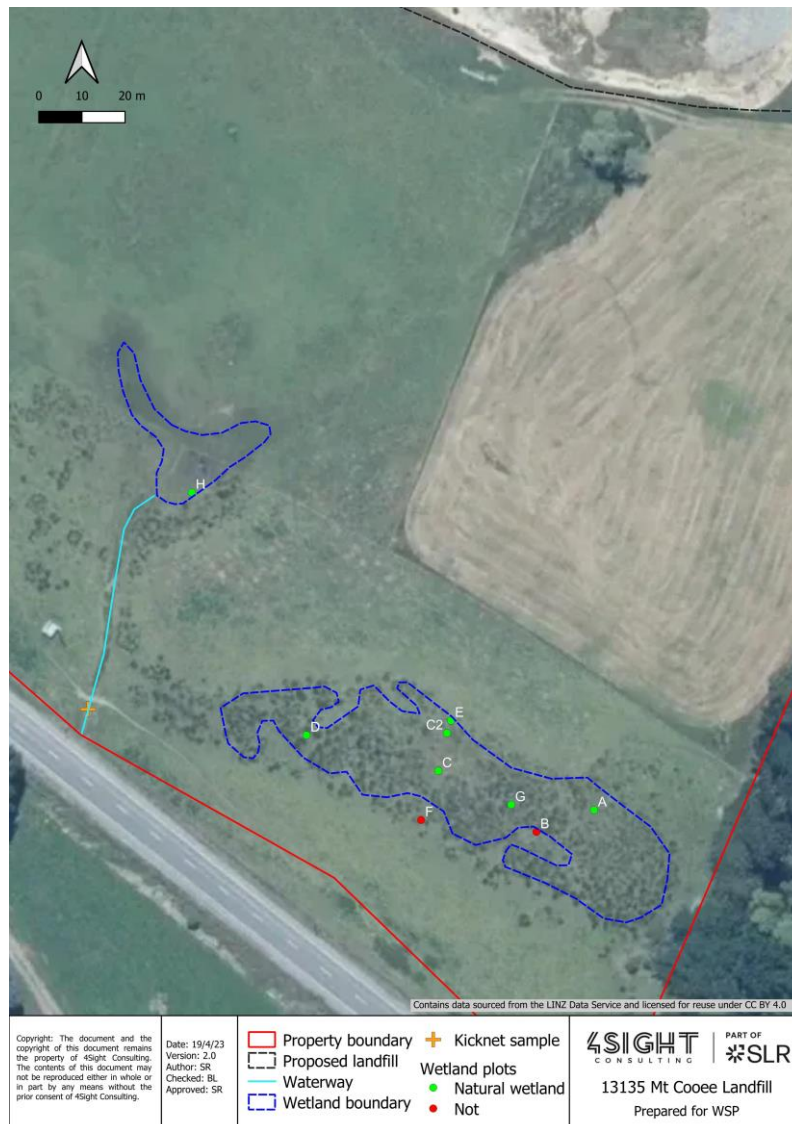
Figure 4: Wetland delineation plots and waterway south of the proposed landfill expansion area.

Nine wetland delineation plots were established in the area of tall rushes and in the headwaters of the stream (Figure 3). Photographs of the plots are provided in Appendix C and wetland delineation work sheets are provided in Appendix D.

Seven plots were determined to have hydrophytic vegetation present and on this basis a natural wetland is present at these sites. These plots included a moderate to high cover of wetland obligate species and facultative wetland species such as kneed foxtail (*Alopecurus geniculatus*), floating sweetgrass (*Glyceria fluitans*), creeping bent (*Agrostis stolonifera*), and spearwort (*Ranunculus flammula*), and/or a high cover of the facultative wetland species soft rush (*Juncus effusus*) and Edgar’s rush (*J. edgariae*).

Two plots met the pasture exclusion test (>50% of pasture species) and therefore did not demonstrate the presence of a natural wetland. These plots were located in areas of relatively low rush density and higher pasture cover.

Based on the results of the wetland delineation assessments, field observations, and an estimation of rush density from aerial imagery, the likely boundary of the natural wetland has been determined (Figure 4). Groundwater level mapping indicated that the wetlands and stream are likely to be groundwater fed and flows are likely to reduce during lower groundwater levels (WSP 2023b).

A natural wetland, albeit of low ecological value, is located at the foot of the slope below the proposed landfill expansion area. As this wetland is proposed to be at least 100 m from the proposed landfill expansion area, the works are not subject to the Resource Management (National Environmental Standards for Freshwater) Regulations 2020.

Silt and sediment control measures shall be adhered to during works to ensure these do not discharge into this wetland.

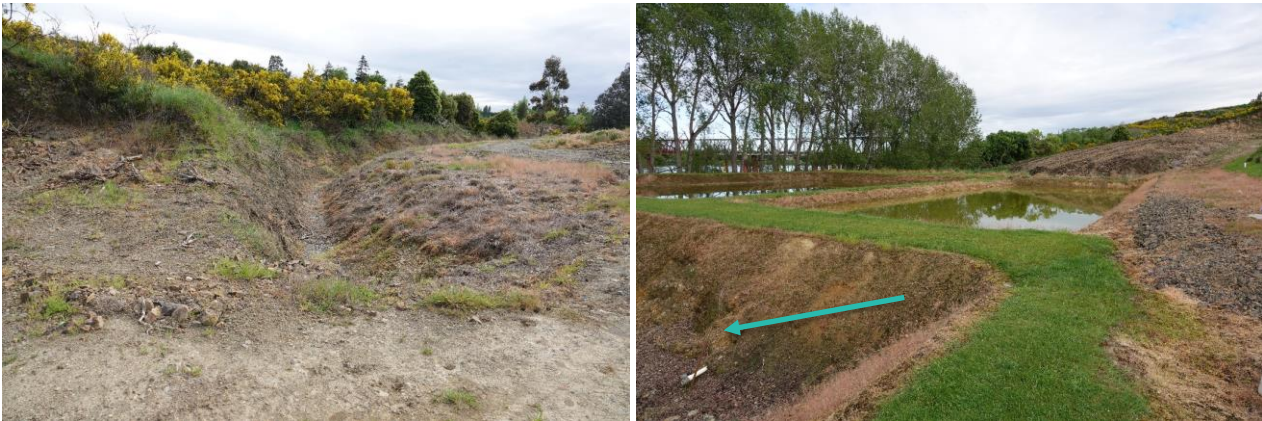
Figure 5: Stormwater diversion drain (left) and detention pond overflow drain (right, arrowed).

A channelised, open stormwater diversion drain runs along the northern boundary of the landfill area and this is intended to flow to the existing sediment retention ponds (WSP 2023a). The drain was dry at the time of survey, and there was little vegetation present due to recent spraying with herbicide (Figure 5, left).

An overflow drain from the existing sediment retention ponds flows under the Kaitangata Highway to the Clutha River. Within the landfill area, the drain was dry in its upper reaches with little vegetation present due to spraying with herbicide, although monkey musk (*Erythranthe guttata*) has been recorded here (Opus 2011). Water pools occasionally near the culvert, and is present when the ponds are overflowing (WSP 2022c). On the other side of the highway, rank grass and weeds (such as great bindweed *Calystegia silvatica* and Yorkshire fog) grow on the banks and overhang the channel, and water cress and water are present (Opus 2011, WSP 2022b).

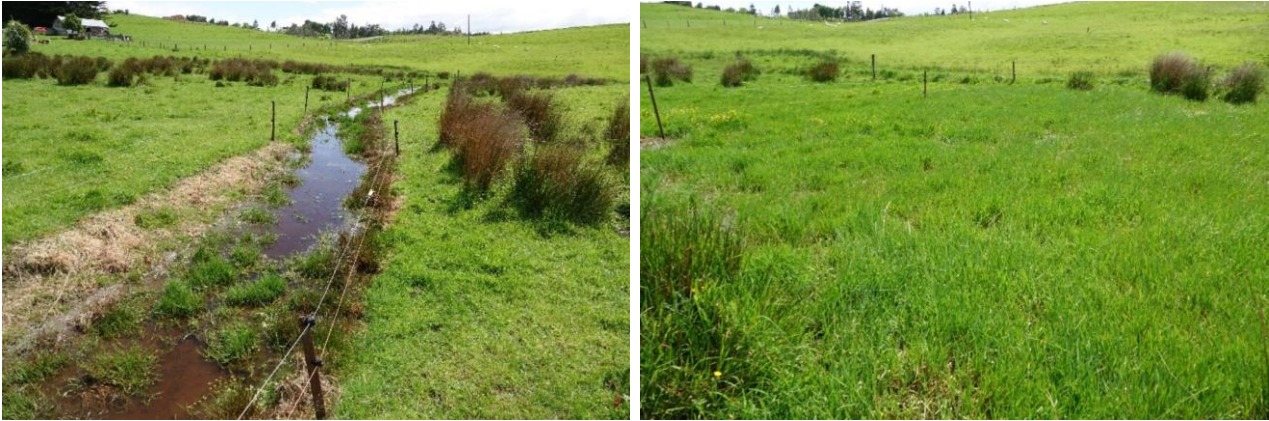
Figure 6: Lower (left) and upper (right) reaches of the small waterway downslope of the proposed landfill expansion area. 4 November 2022

A small waterway extends from the foot of low hillslopes to the Kaitangata Highway. The waterway had low flow of water at the time of the survey, with 5-10 cm water depth and the wetted channel about 1 m wide (Figure 6, left). The soft mud substrate was approximately 5 cm deep at the kicknet sample site (Figure 4, Figure 7, left).

In the mid to lower reaches, open areas of water were separated by patches of jointed rush (*Juncus articulatus*), which also extended along the margins of the waterway. Starwort (*Callitriche stagnalis*) and floating sweetgrass (*Glyceria fluitans*) were also present in low abundance.

Little open water was visible in the upper reaches of the waterway, which was covered in dense floating sweetgrass with a few soft rushes (*Juncus effusus*), and occasional patches of spearwort (*Ranunculus flammula*) (Figure 6, right). The upper reaches have been identified as wetland (see section 5 above). The margins of the waterway appeared to have been sprayed with herbicide in some areas.

The stream is already compromised by stock access and has poor water quality as indicated by the low MCI score for the site. It is however important to ensure this will not be further impacted by the proposed landfill expansion. The proposed new stormwater sediment retention pond is proposed to discharge to the existing retention ponds and not to the stream. However, all works shall be designed in accordance with best practice and the area of earthworks managed to minimise potential silt and sediment discharge to the channel.

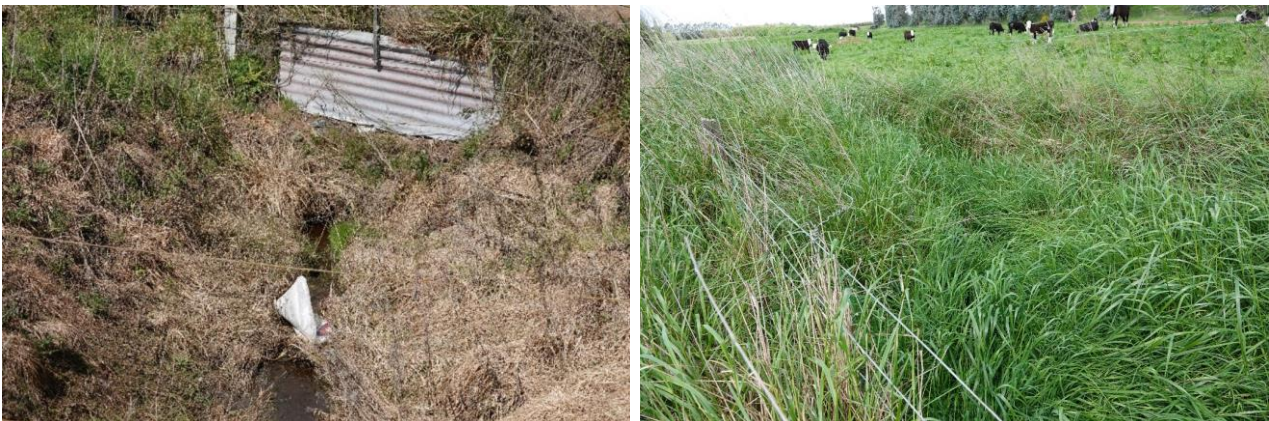
Figure 7: Culvert inlet (left) and drain on the other side of Kaitangata Highway (right). 4 November 2022.

The waterway passes through a culvert under Kaitangata Highway, after which it joins a drainage ditch running parallel to the road (Figure 3, Figure 7, right).

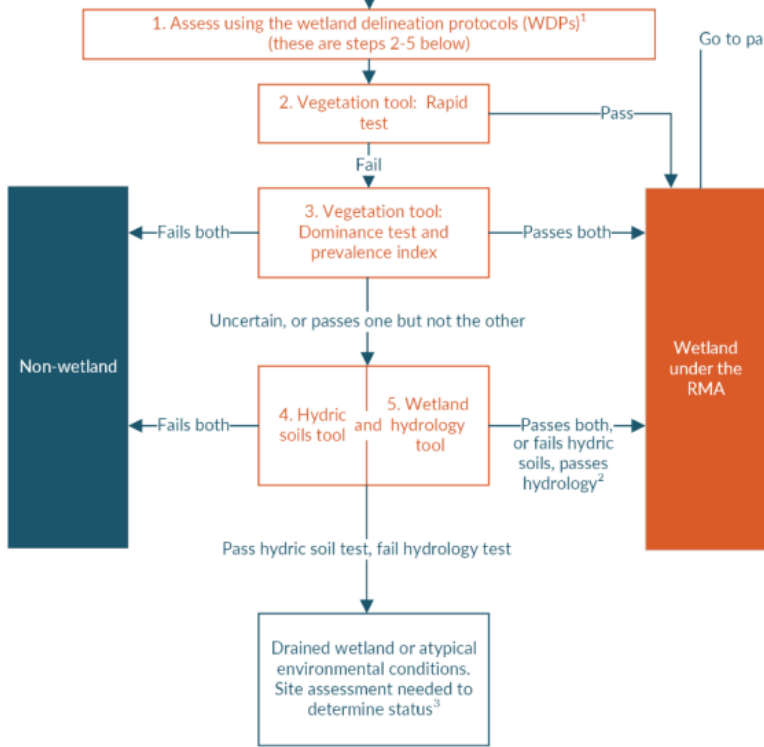
**Part 1: Assess wetland status under the RMA**  
*Start here if there is uncertainty or doubt about:*  
 a. whether a wetland meets the RMA definition of a wetland and/or  
 b. the extent of the wetland area

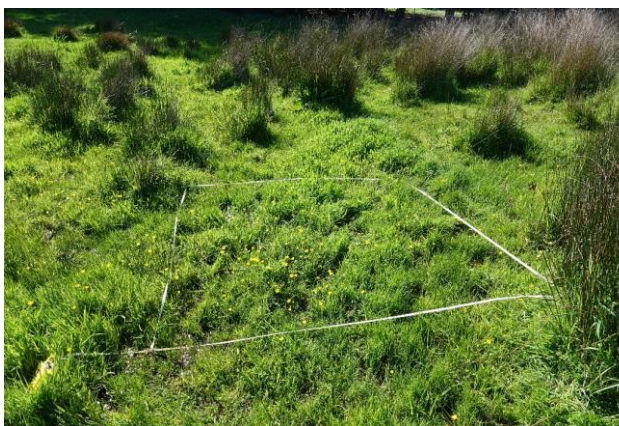
Wetland delineation Plot A

Site comprises pasture	Yes											
Is the sample area within a wetland?	YES

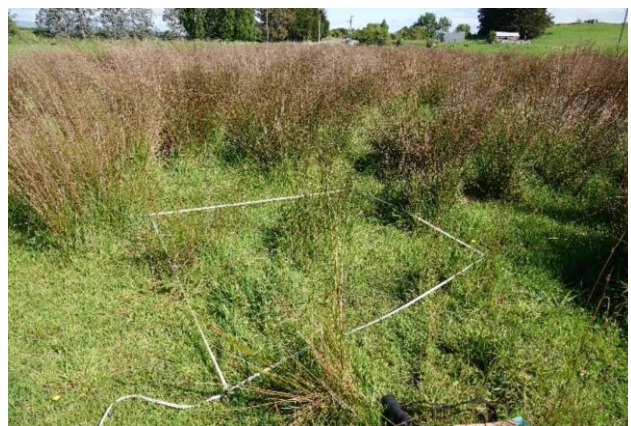
Wetland delineation Plot B

Site comprises pasture	Yes											
Is the sample area within a wetland?	NO

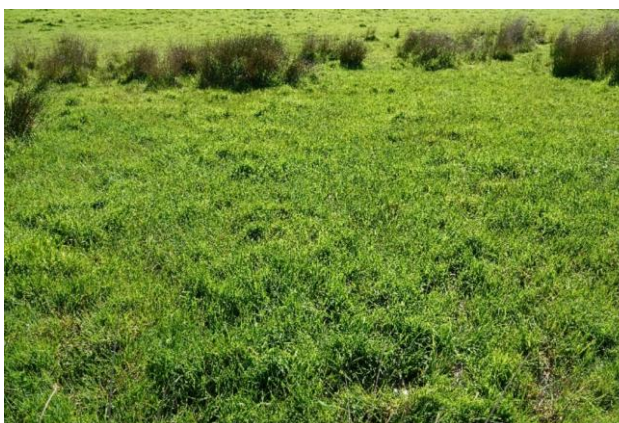
Wetland delineation Plot C

Climatic/hydrological conditions typical for time of year?	Y								Hydrophytic Vegetation Indicators			
Vegetation disturbed?	N								Yes/No			
Soil disturbed?	N								Dominance Test is >50%			
Hydrology disturbed?	N								Prevalence Index is ≤3.0			
Normal circumstances present?	Y								Morphological Adaptations (Provide supporting data in Remarks)			
Vegetation naturally problematic?	N								Problematic Hydrophytic Vegetation (Explain)			
Soil naturally problematic?	N								Hydrophytic Vegetation Present?			
Hydrology naturally problematic?	N								Remarks			
Summary of Findings	Yes/No/N/A								Pasture Exclusion Test			
Hydrophytic Vegetation Present?	Yes								Summed cover of pasture species			
Hydic Soil Present?	Not assessed								Pasture species ≥50% cover			
Wetland Hydrology Present?	Not assessed											
Site comprises pasture	No											
Is the sample area within a wetland?	YES

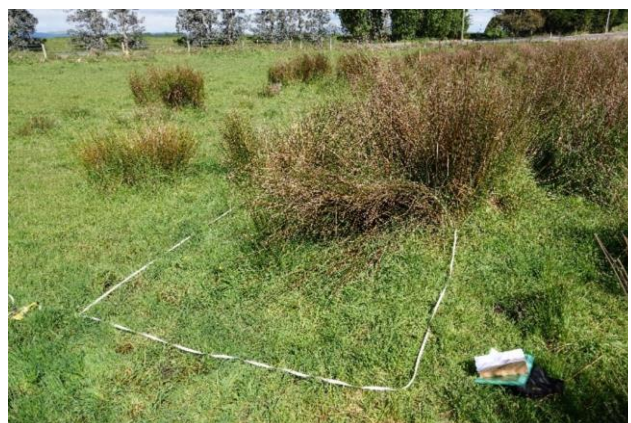
Wetland delineation Plot D

<b>Summary of Findings</b> Yes/No/N/A									
Hydrophytic Vegetation Present?	Yes								
Hydric Soil Present?	Not assessed								
Wetland Hydrology Present?	Not assessed								
Site comprises pasture	No								
Is the sample area within a wetland?	YES

Prevalence Index Worksheet			
OBL species	0	x 1	0
FACW species	25	x 2	50
FAC species	39	x 3	99
FACU species	2	x 4	8
LPL species		x 5	0
Column totals	110	(C)	257
Prevalence Index = D/C =	2.34

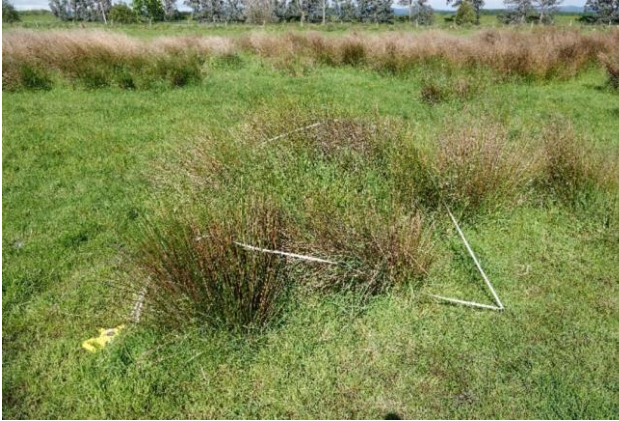
Wetland delineation Plot E

Hydrology naturally problematic?	N								
<b>Summary of Findings</b> Yes/No/N/A									
Hydrophytic Vegetation Present?	Yes								
Hydric Soil Present?	Not assessed								
Wetland Hydrology Present?	Not assessed								
Site comprises pasture	No								
Is the sample area within a wetland?	YES

Prevalence Index Worksheet			
OBL species	0	x 1	0
FACW species	62	x 2	124
FAC species	27	x 3	81
FACU species	14	x 4	56
LPL species		x 5	0
Column totals	103	(C)	261
Prevalence Index = D/C =	2.53

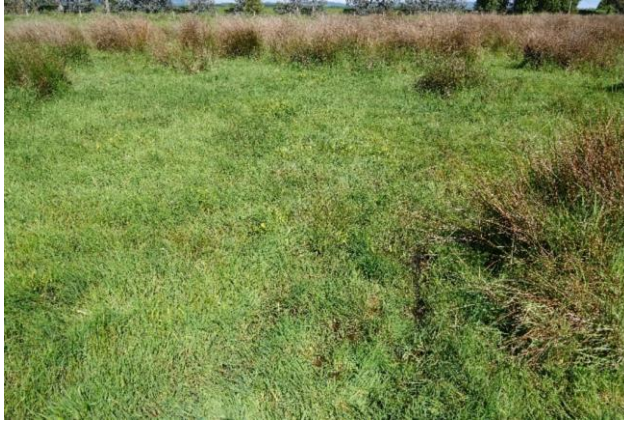
Wetland delineation Plot C2

Is the sample area within a wetland?	YES

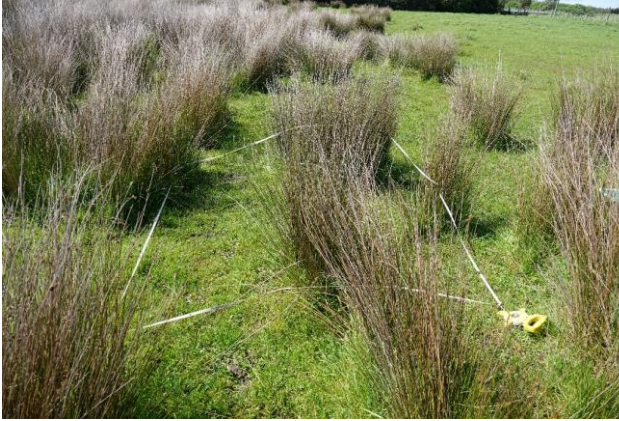
Wetland delineation Plot F

Soil naturally problematic?	N								
Hydrology naturally problematic?	N								
<b>Summary of Findings</b> Yes/No/N/A									
Hydrophytic Vegetation Present?	No								
Hydric Soil Present?	Not assessed								
Wetland Hydrology Present?	Not assessed								
Site comprises pasture	Yes								
Is the sample area within a wetland?	NO

Prevalence Index Worksheet			
OBL species	0	x 1	0
FACW species	25.5	x 2	51
FAC species	11	x 3	33
FACU species	67	x 4	268
LPL species		x 5	0
Column totals	103.5	(C)	352
Prevalence Index = D/C =	3.4
