**OCEANA GOLD (NEW ZEALAND) LIMITED  
MACRAES OPERATION  
GOLDEN BAR WASTE ROCK STACK – STAGE 2  
DESIGN REPORT**

<b>Title</b>	Oceana Gold (New Zealand) Limited, Macraes Operation, Golden Bar Waste Rock Stack – Stage 2, Design Report
<b>Revision</b>	0
<b>Date</b>	23 May 2023
<b>EGL Reference</b>	9642
<b>Client Reference</b>	-
<b>File Name</b>	EGL9642 Golden Bar WRS Design Report Rev0.docx

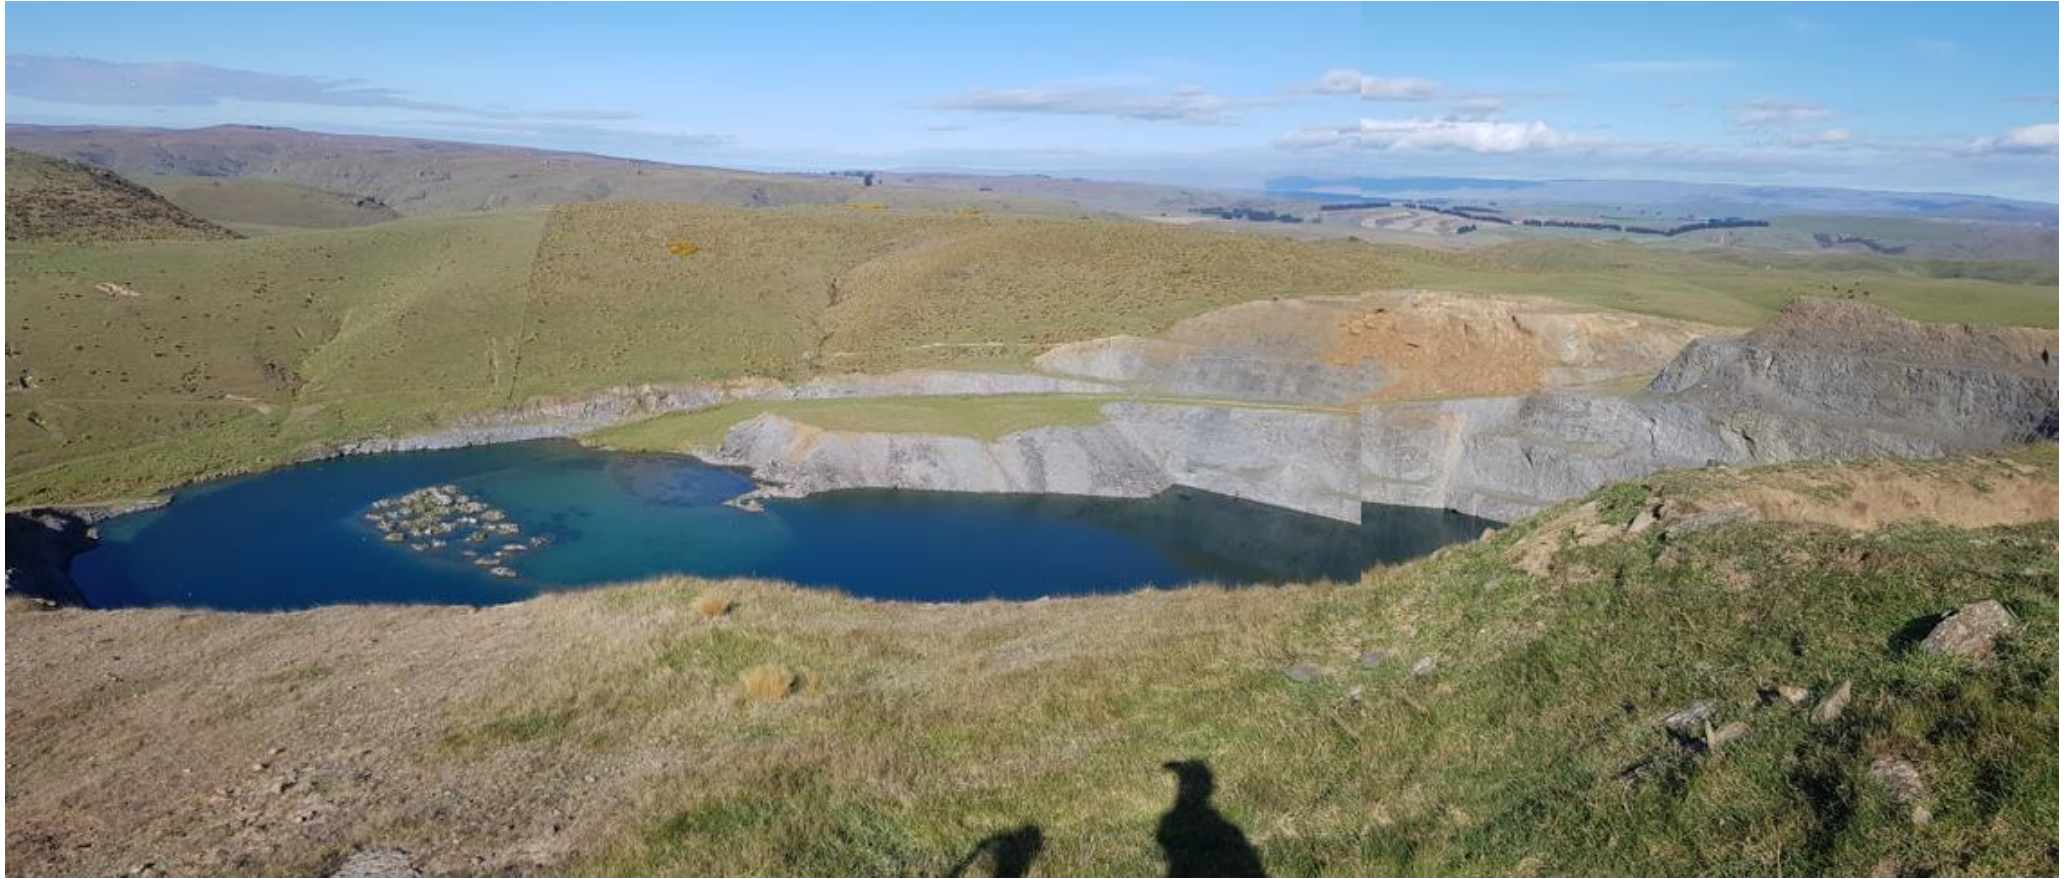
**Photo 1: Golden Bar Pit and proposed southwestern extension area**

The existing Golden Bar Pit and WRS Stage 1 have been in place since 2006. EGL undertook a walkover of the site on 8 November 2022. Photo 1 shows the pit and Photo 2 shows the downstream slope of the WRS. At the toe of the WRS is the Clydesdale Silt Pond as seen in Photo 3, 6 and 7. The existing slopes are at approximately 2.35H:1V or 23 deg. There was no evidence of major instability or deformation of the WRS. The rehabilitated surface of the WRS was in good condition with little surface erosion. Minor seepage was observed out the toe of the WRS into the silt pond and localised minor slumping or minor backward erosion of the toe of the slope (due to seepage) was visible as is shown in Photo 7.

Photo 1 shows a small slip on the cut face above the ramp into the pit in the more weathered schist material. No notable slips were observed on the northern and eastern slopes of the Stage 1 pit.

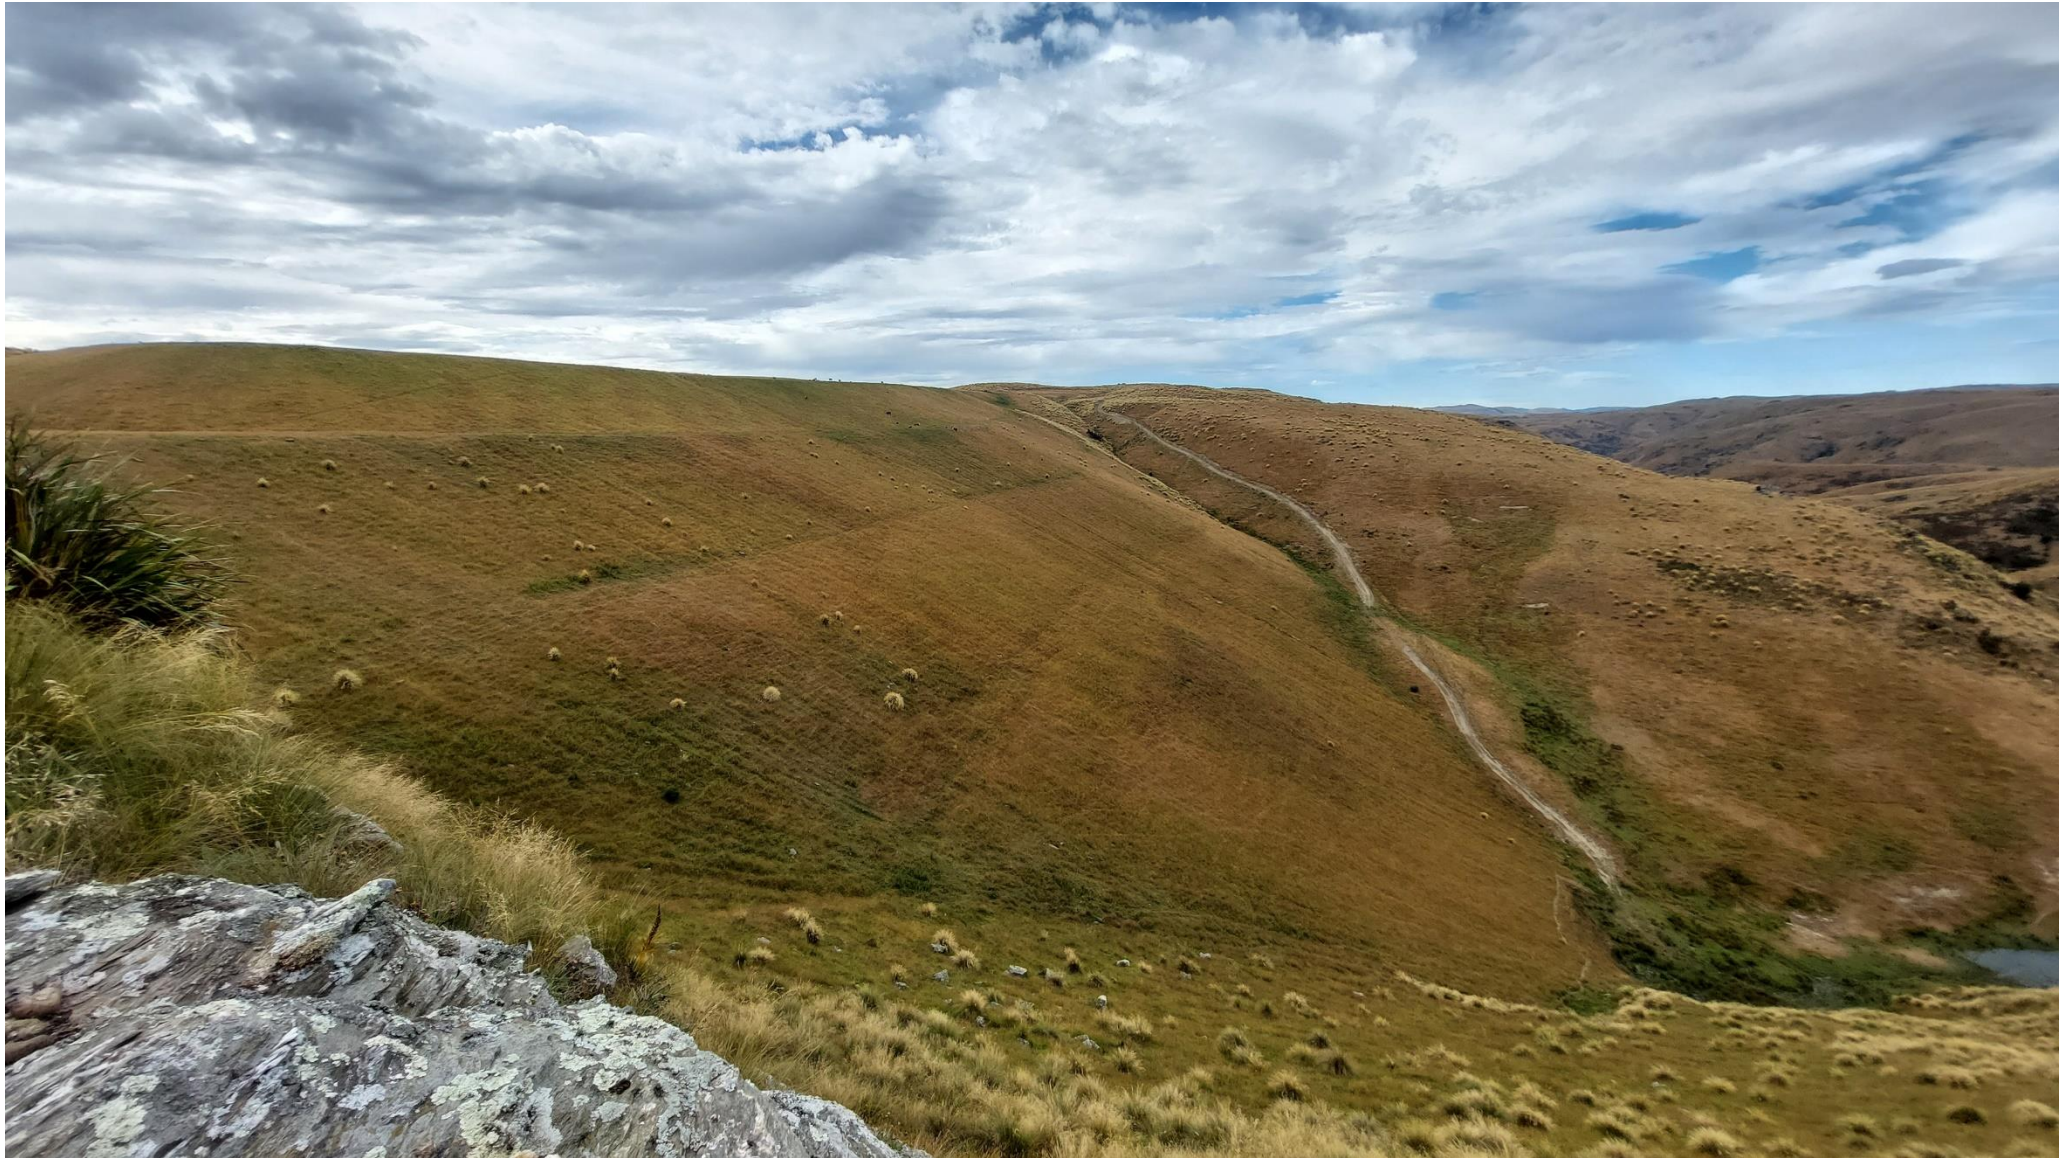
**Photo 2: Golden Bar WRS Stage 1 Northern Face and proposed northern extension area**

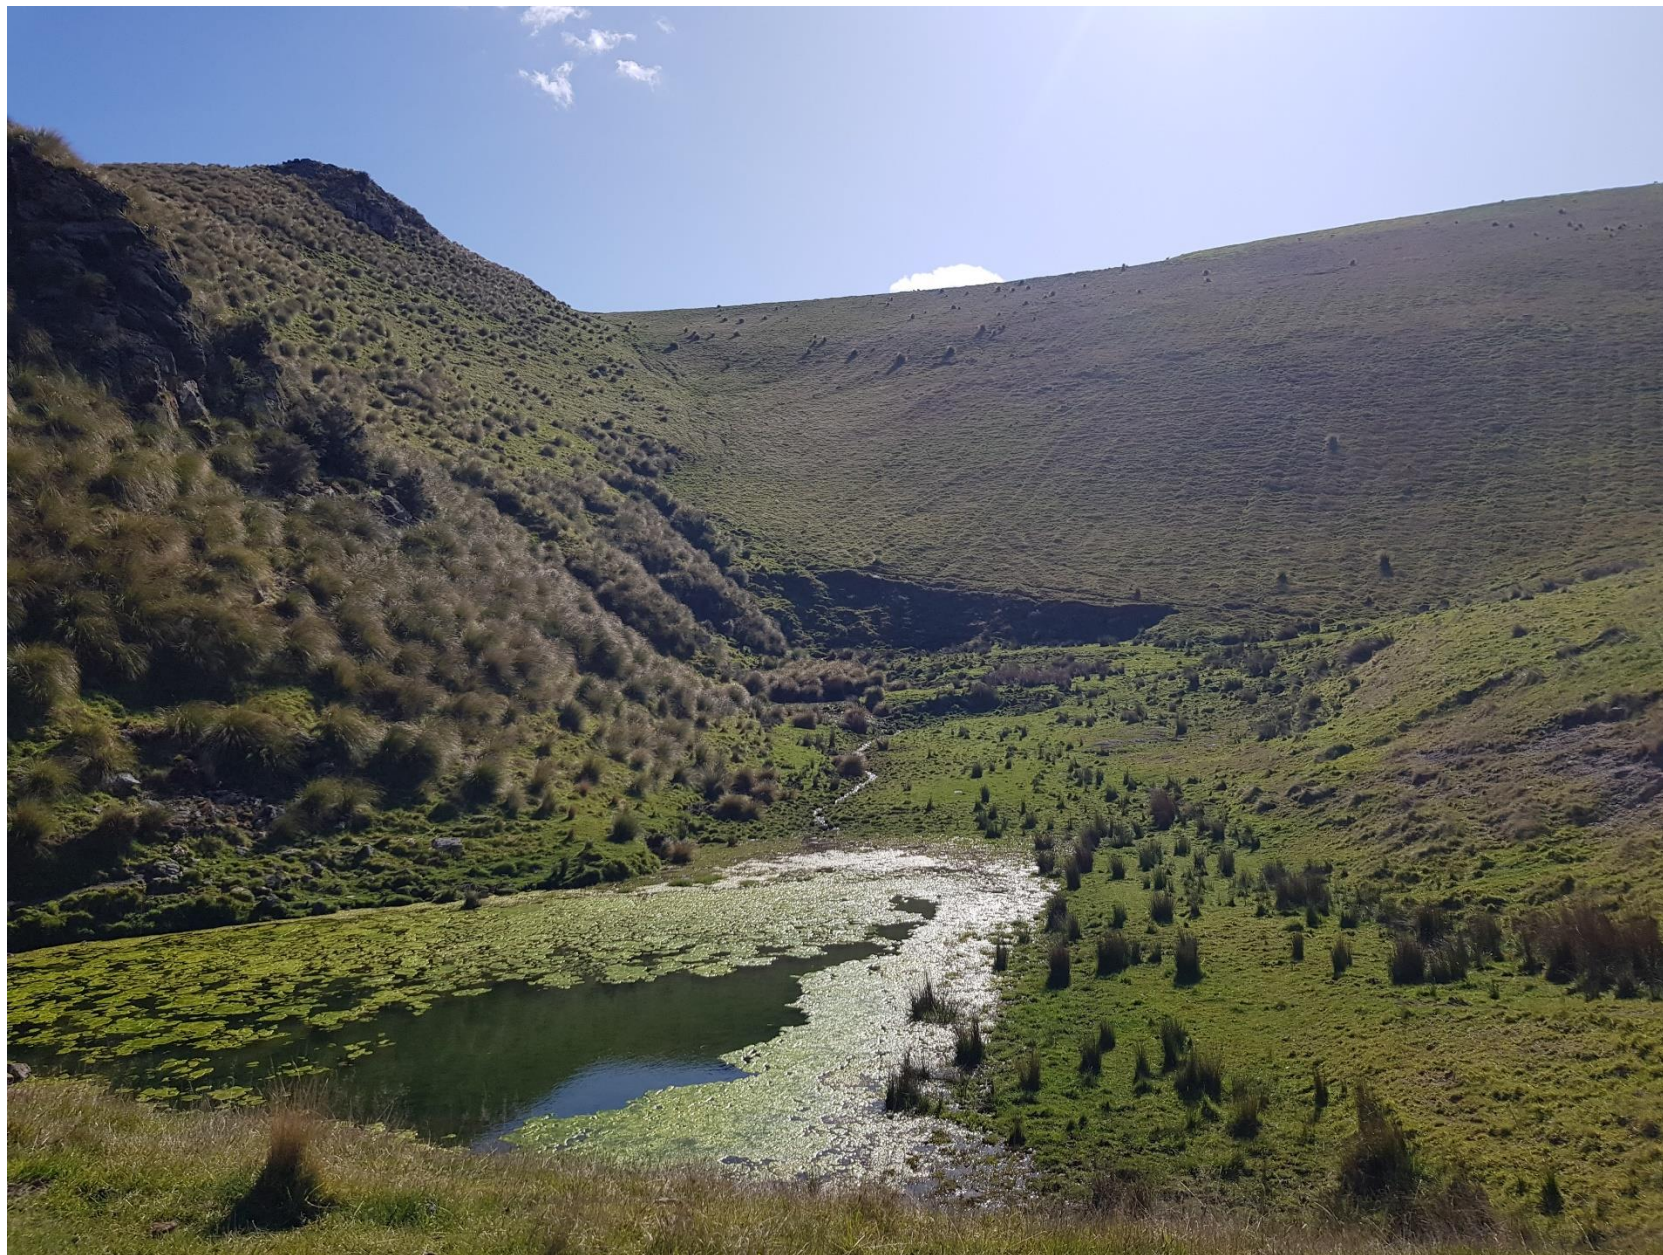
**Photo 7: Clydesdale Silt Pond and Golden Bar WRS**
