Green Island Landfill

Ecological Impact Assessment
Prepared for Dunedin City Council

16 March 2023 (Updated October 2024)

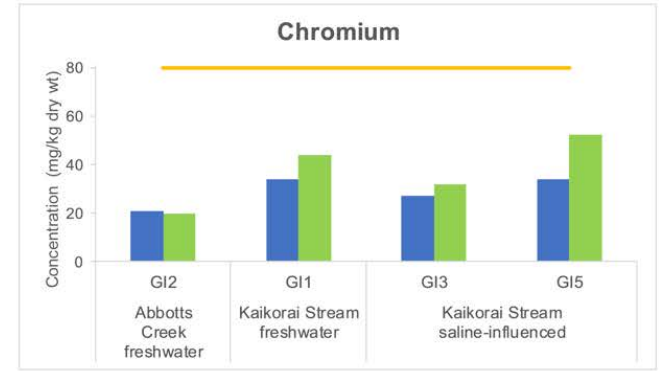
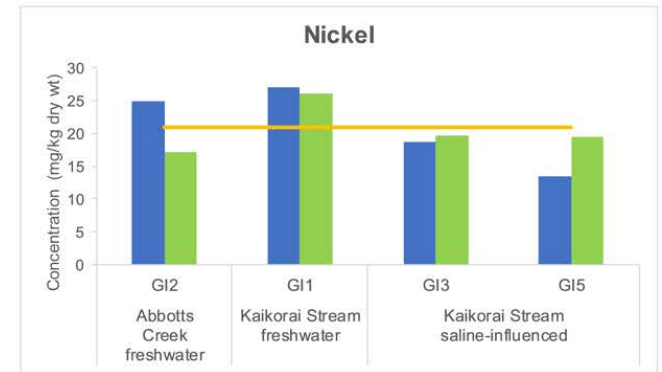
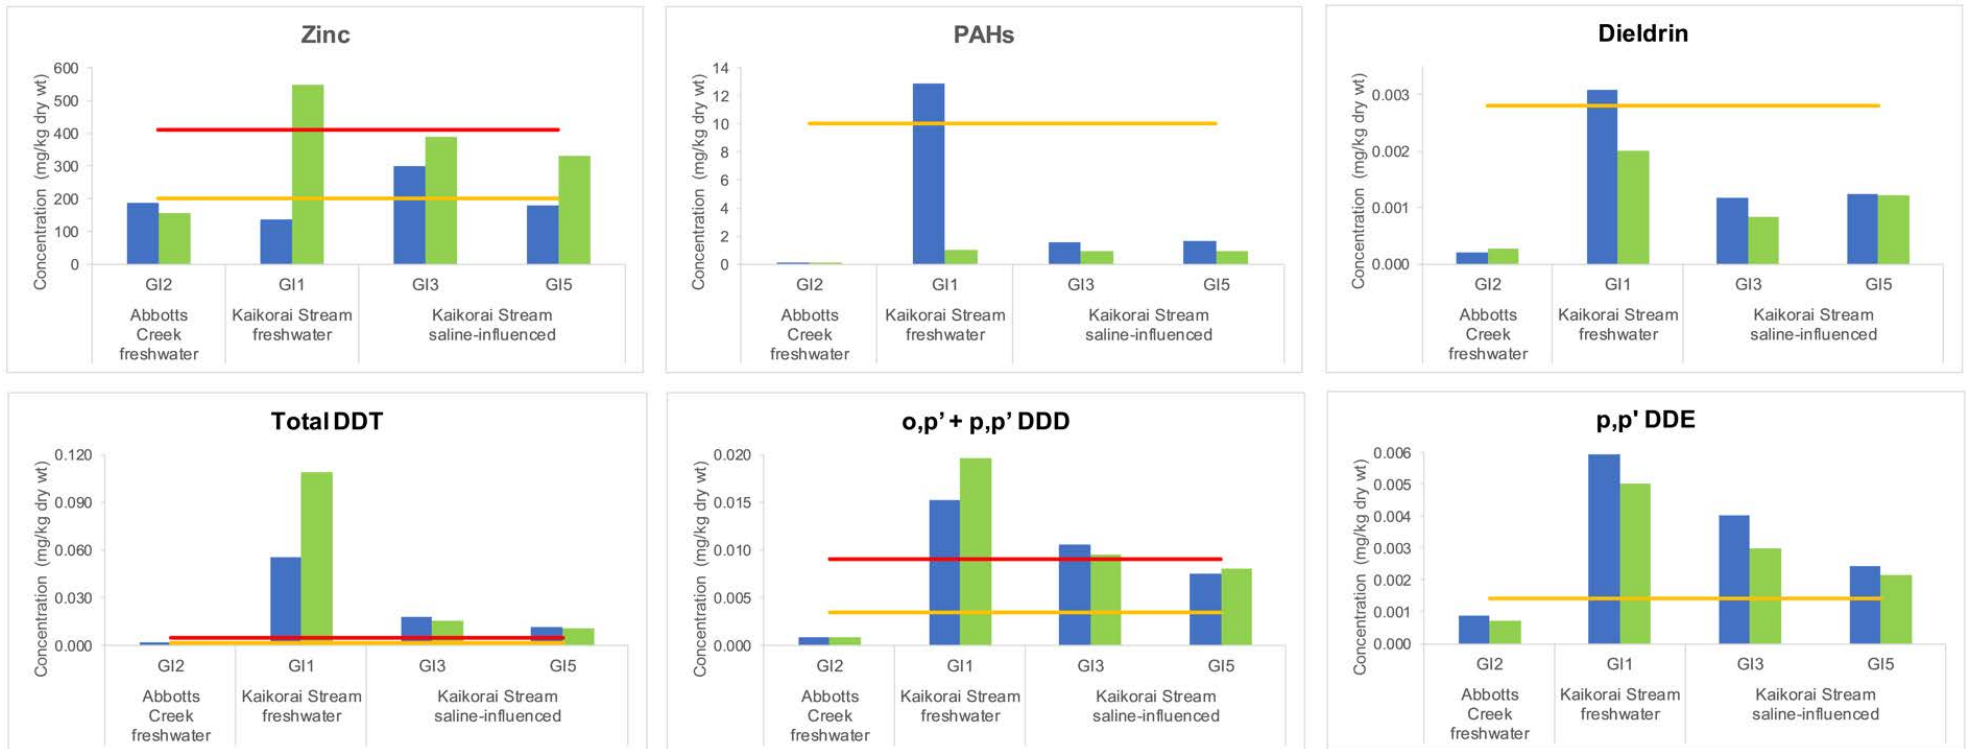
Figure 6. (This page and previous page). Toxicant concentrations in the <2 mm (blue bars) and <63 µm (green bars) particle size fraction of surface sediment samples (top 2-3 cm) collected at Kaikorai Stream and Abbotts Creek monitoring sites, GI1, GI2, GI3, and GI5. Default guideline values (DGV) are included in each panel, shown by the orange line. Upper guideline values (GV-High) are also included when exceeded, shown by the red line. The concentration of hydrophobic organic contaminants (PAHs, Dieldrin, Total DDT, o,p' + p,p' DDD, and p,p' DDE) was normalised to 1% of the total content of organic carbon.

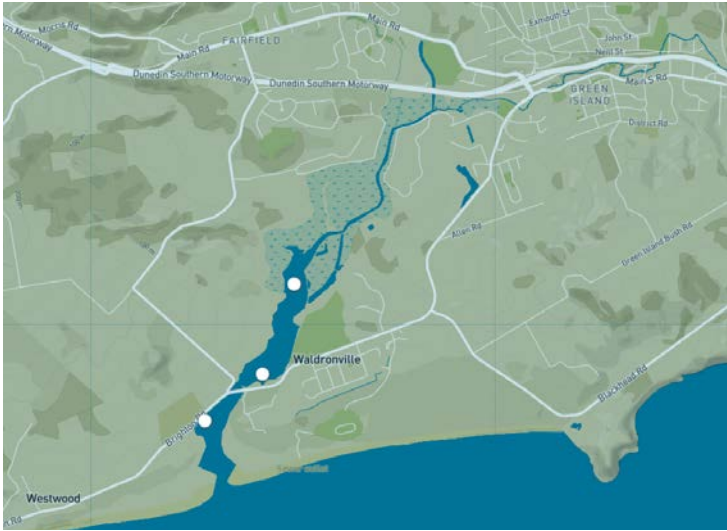
Figure 7. Site locations, (upstream to downstream) Kaikorai-D, Kaikorai-B, Kaikorai-A monitored by Otago Regional Council and reported by LAWA.

Table 17: The latest annual mean estuary macrofauna BHM score (2019) for three locations within the Kaikorai lagoon, compared to other similar estuaries in Otago, from LAWA. Kaikorai Lagoon sites are listed from furthest to closest to the coast / lagoon mouth.

Site	Estuarine macrofauna BHM score	State Category
Kaikorai-D	4.28	Poor
Kaikorai-B	3.68	Fair
Kaikorai-A	4.24	Poor

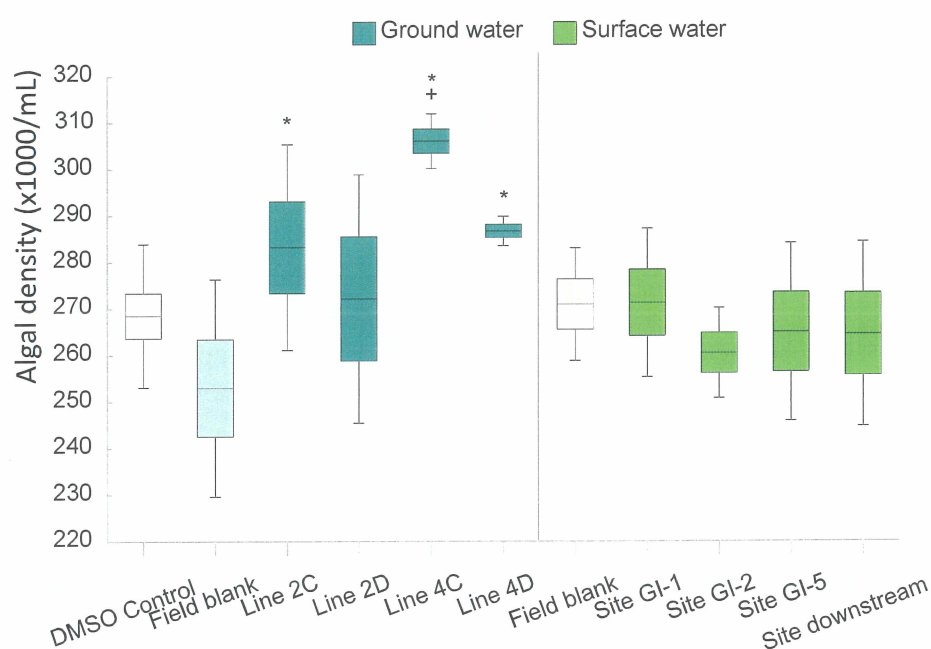
Figure 6. Box plots showing effects of passive sampling device extracts (0.0313%) on algal growth density after a 96-hour exposure. Asterisks (*) indicate a significant difference from the related field blank and the plus sign (+) a significant difference from the control ($P < 0.05$).

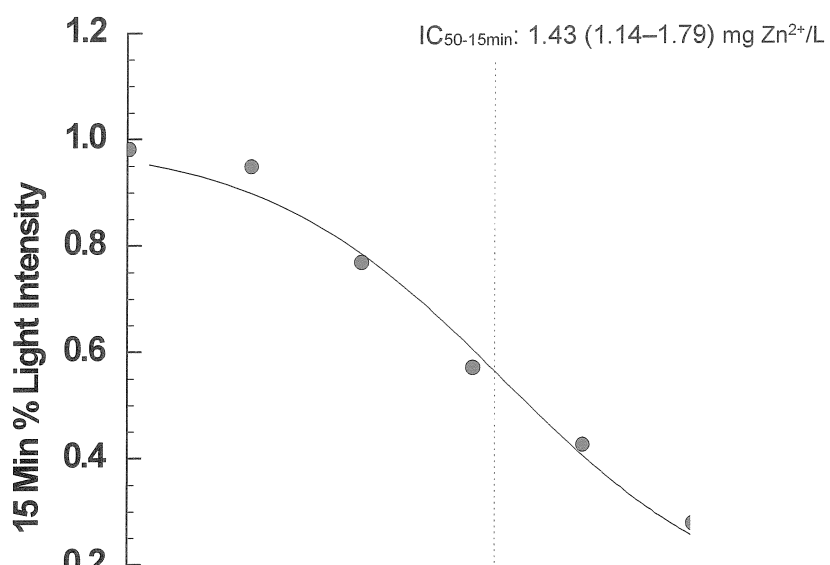
Figure A1.1. Average (red dots) light intensity after a 15-minute exposure, with 95% confidence interval (dashed line) for the dose response to the reference toxicant (zinc as Zn²⁺).

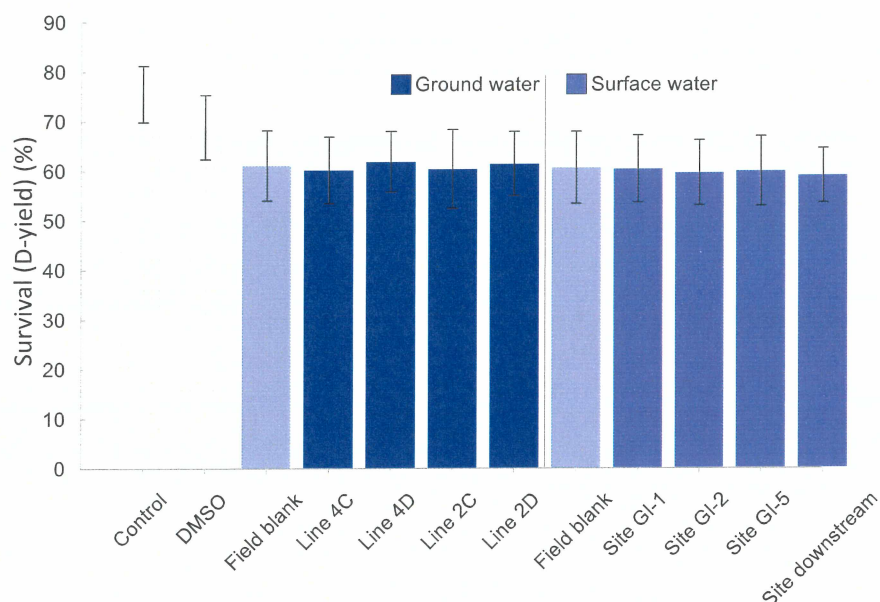
Figure 1. Blue mussel larvae survival (% D-yield) (average \pm standard deviation).

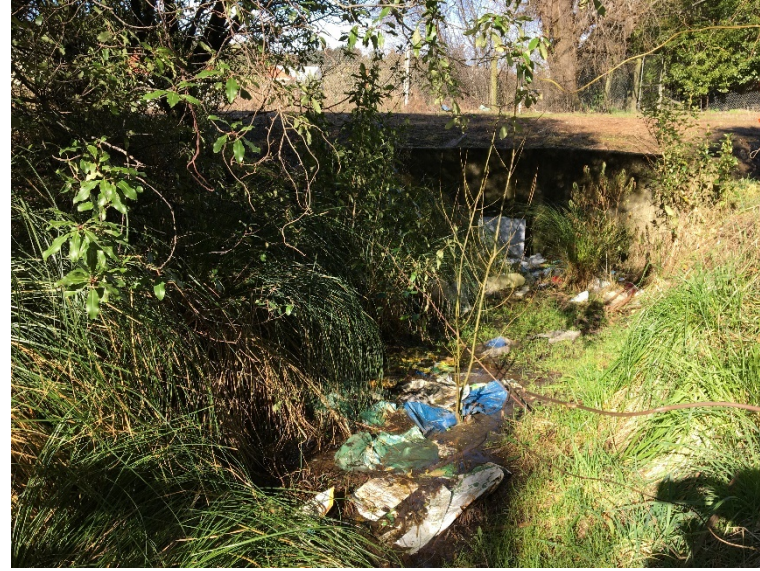
Figure 27: Culvert inflow to the constructed wetland from Taylor Street. Image taken 11th August 2021.
