Clutha Delta flood hazard study

**NIWA Client Report: CHC2005-146
November 2005**

Graeme Smart
Maurice Duncan
Jochen Bind

Otago Regional Council

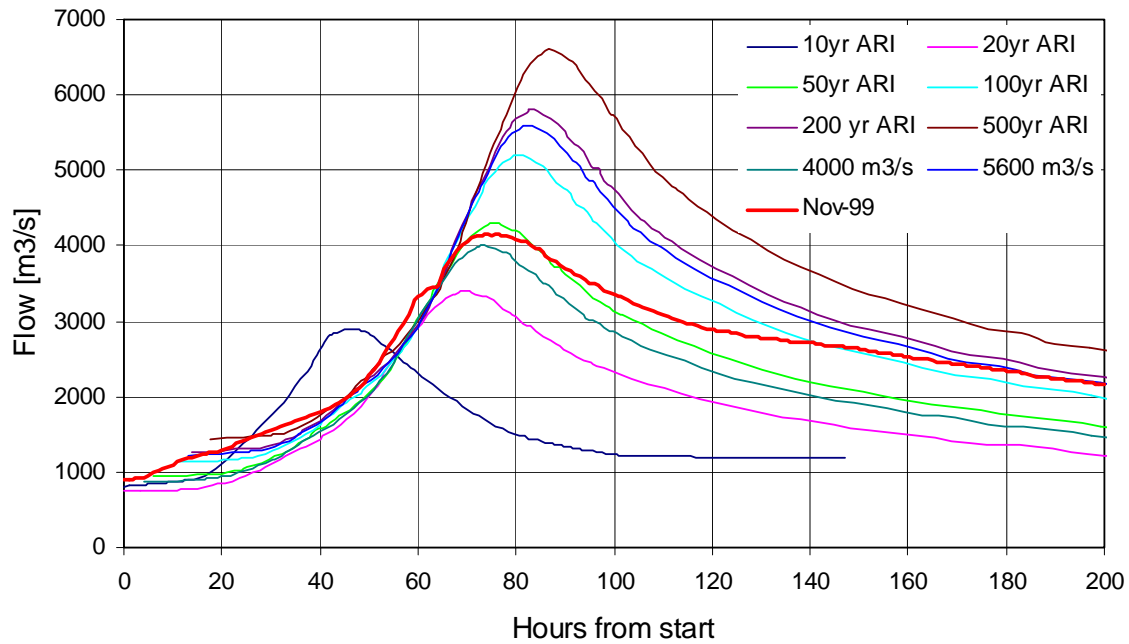
Figure 1: Hydrographs used in inundation modelling.

Eight design flow hydrographs were specified by ORC. The hydrographs are identified by their Average Recurrence Interval (ARI) or peak flow as follows:

These hydrographs are shown on Figure 1.

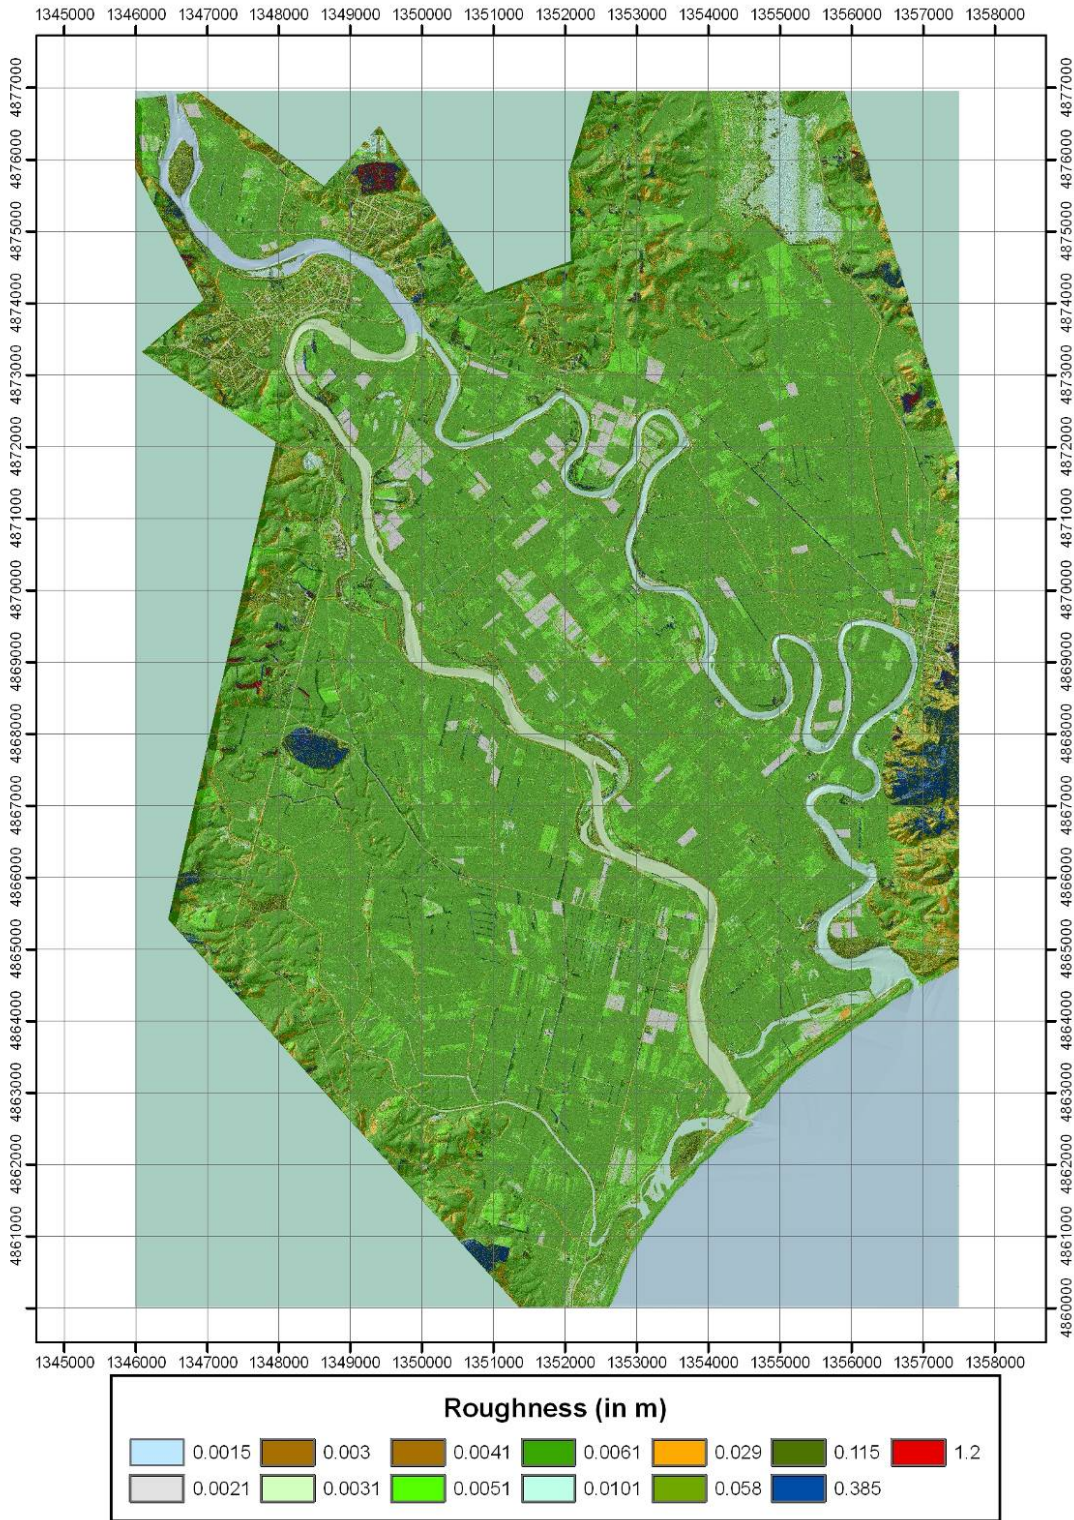
Hydraulic Roughness Used for Calculations

Figure 7: Roughness length scales used for hydraulic modelling.

Boundary conditions used for calibration were the DEM measured in 2004, the 1999 flood hydrograph measured at the Balclutha water-level recorder and the ocean tide at the time, calculated using the NIWA NZ tidal model. There was no significant storm surge for the duration of the calibration flood. Hydraulic resistance of the channels was estimated from gauging records made in the Clutha, Koau and Matau channels. Out of channel (floodplain) roughness was based on interpretation of ground cover and, once classified, was not adjusted for calibration purposes. The surface roughnesses used are shown in Figure 7.

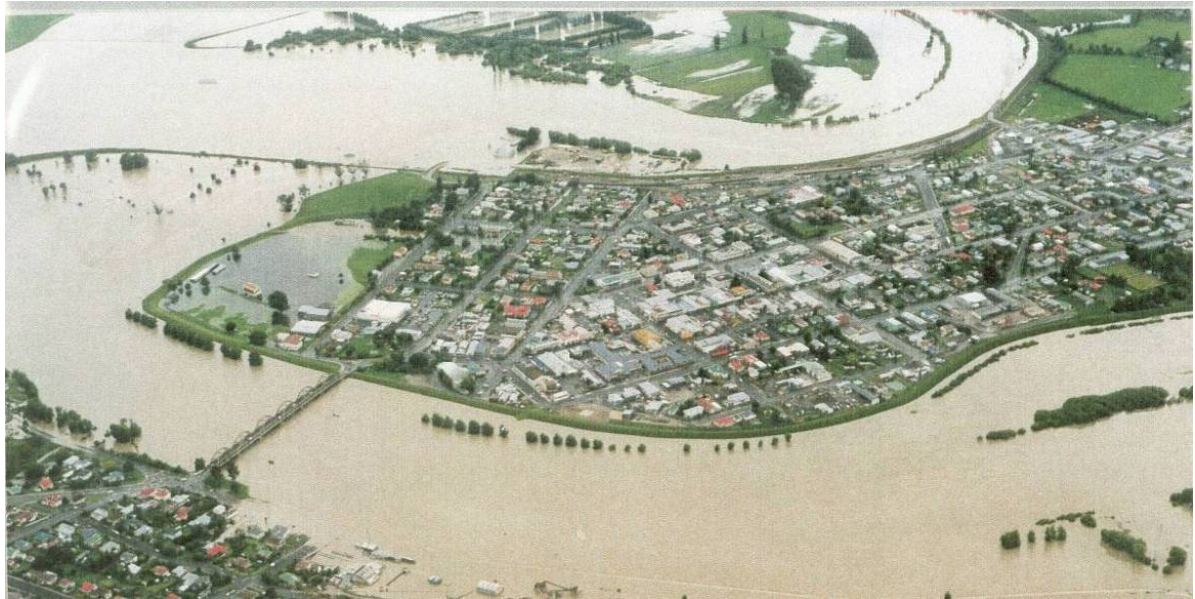
Figure 9: Comparison of 1999 flood photo (top) with model predicted water levels (below) for the Balclutha area.

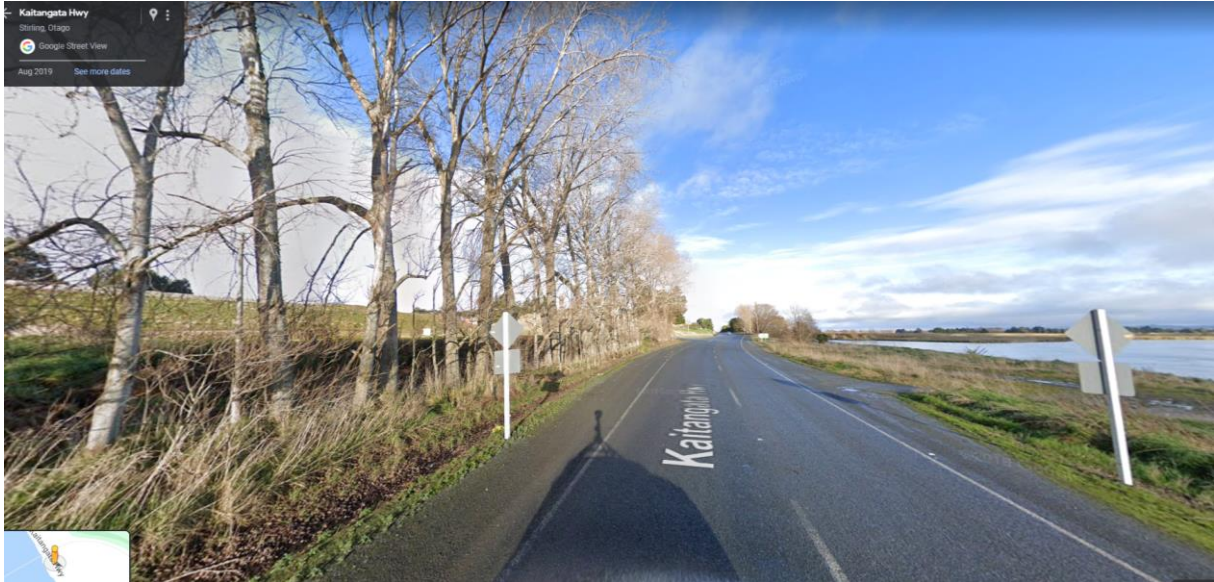
Figure 1-1 View of the Mt Cooee area from the Kaitangata Highway, showing the river and berm area to the right, and the landfill face to the left (through the trees). Source: Google Maps.

The current flood hazard area mapped by ORC (Figure 3-1) extends well up into the landfill and does not take into account the infilling of the small catchment which has occurred as the landfill has been formed over the last few decades. This area is now considerably higher (Figure 1-1) and the landfill itself is therefore less likely to be inundated during a flood event of the magnitude seen during the last 70 years (Figure 2-2).

An aerial view of the landfill site during the November 1999 flood is shown in Figure 3-4 and Figure 3-5. Although not necessarily taken at the peak of the flood, these photos show that flooding was limited to the berm area, including the Kaitangata Highway, and the area around the stormwater sedimentation ponds. Although the landfill was only partly developed at this time, the photos show evidence of landfill activity underway, and that this area was not affected by flooding from the Clutha River. Additional infilling has occurred since this time, particularly at the front face (Figure 1-1).

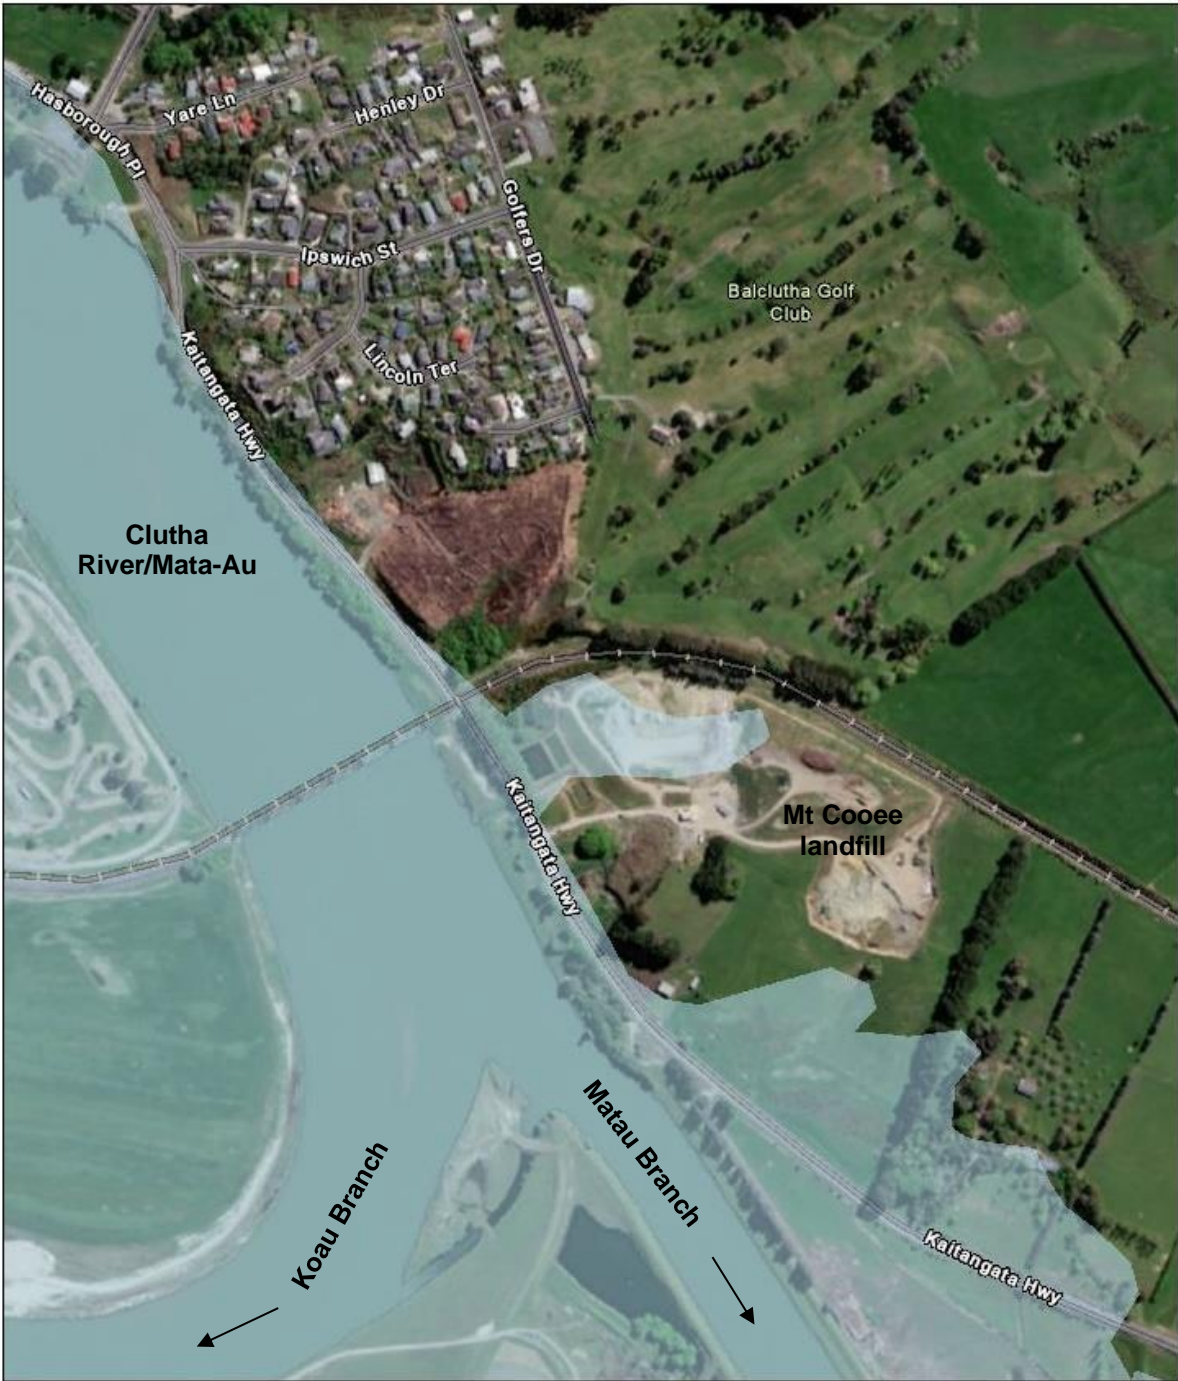
Figure 3-1 Lower Clutha Flood hazard area in the vicinity of the Mt Cooe landfill. Flood hazard area is based on the estimated extent of the May 1957 flood (2,160 m³/s). Source: ORC Natural Hazards Portal.

A map of the 1A flood hazard area is not available through the ORC's Natural Hazards Portal. However, the extent of this area appears to be based on an earlier flood hazard assessment prepared by ORC in 1999³ which in turn is based on the mapped extent of the May 1957 flood. The mapped extent of this flood in the vicinity of Mt Cooee is shown in Figure 3-1.

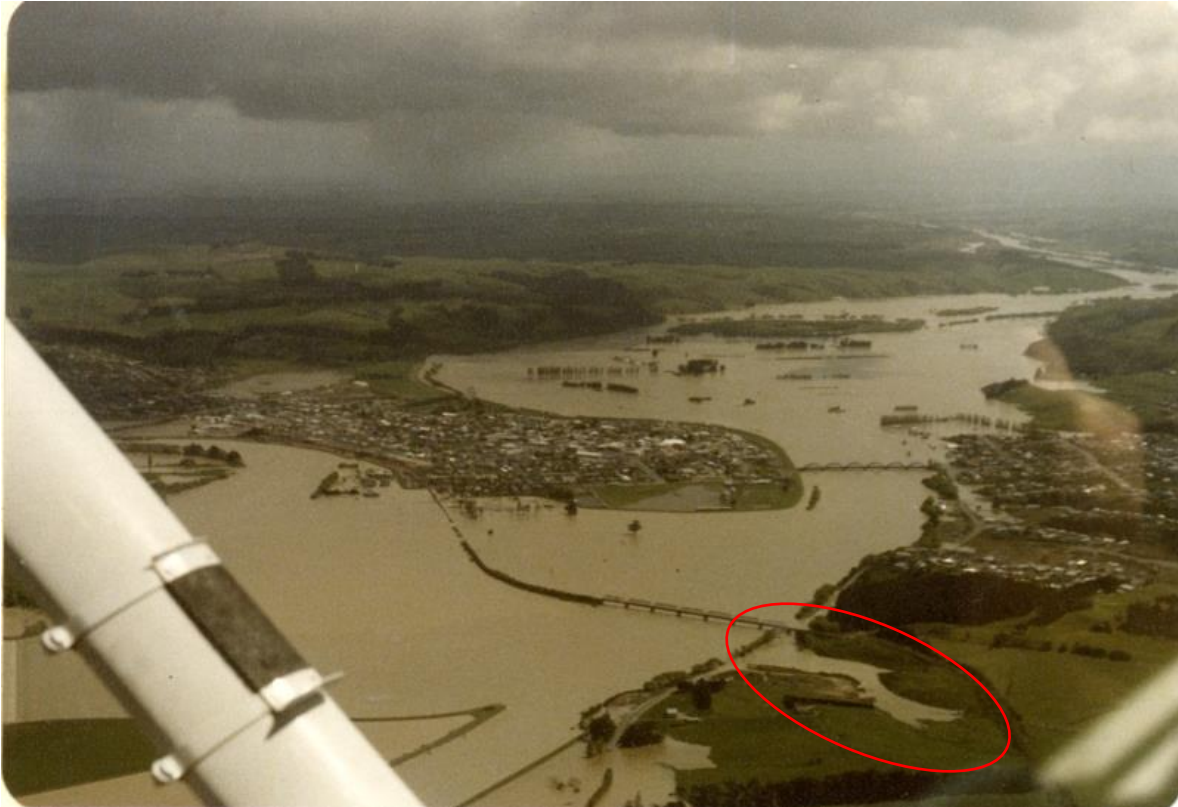
Figure 3-2 The October 1978 flood event, looking upstream towards Balclutha. The current site of the Mt Cooe landfill is circled in red. The photo was not necessarily taken at the peak of the flood. Source: ORC.

A larger flood occurred in October 1978 and an aerial view of the area is shown in Figure 3-2. The extent of flooding during this flood is similar to the mapped hazard area shown in Figure 3-1, although it is noted that infilling of the creek (due to landfill development) had not occurred at that time.

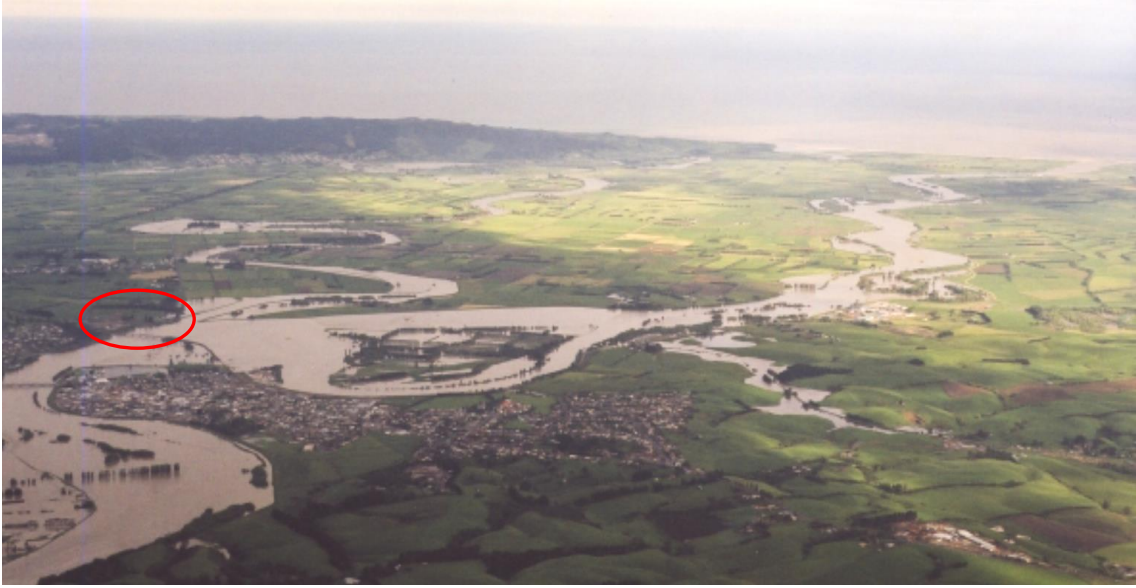
Figure 3-3 The November 1999 flood event, looking downstream across Balclutha. Photo not necessarily taken at the peak of the flood. The study area is circled in red. Source: ORC.

A general view of the Clutha Delta during the November 1999 flood is shown in Figure 3-3. This photo helps to confirm the description of flood hazard on the Clutha Delta, with the landfill lying on the margins of a broad floodplain, with more elevated land to the northeast.

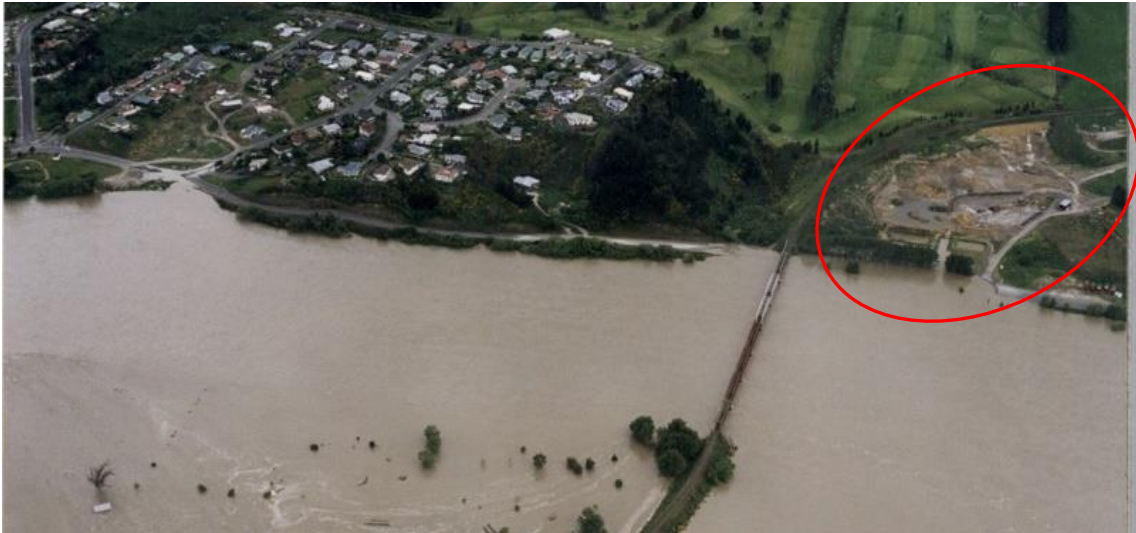
Figure 3-4 View of the Mt Cooee landfill looking north during the November 1999 flood. Source: ORC.

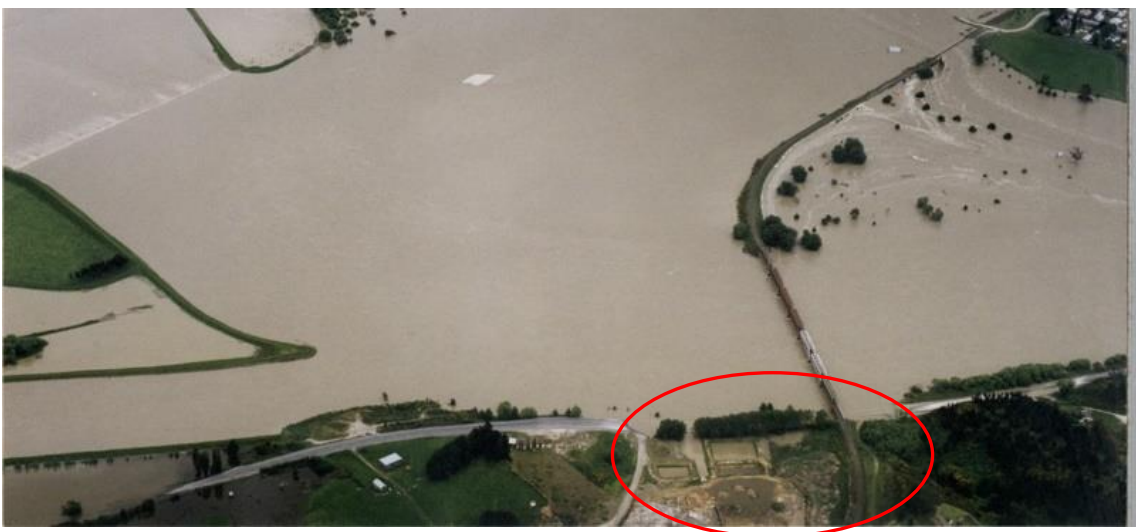
Figure 3-5 View of the Mt Cooee landfill looking south during the November 1999 flood. Source: ORC.

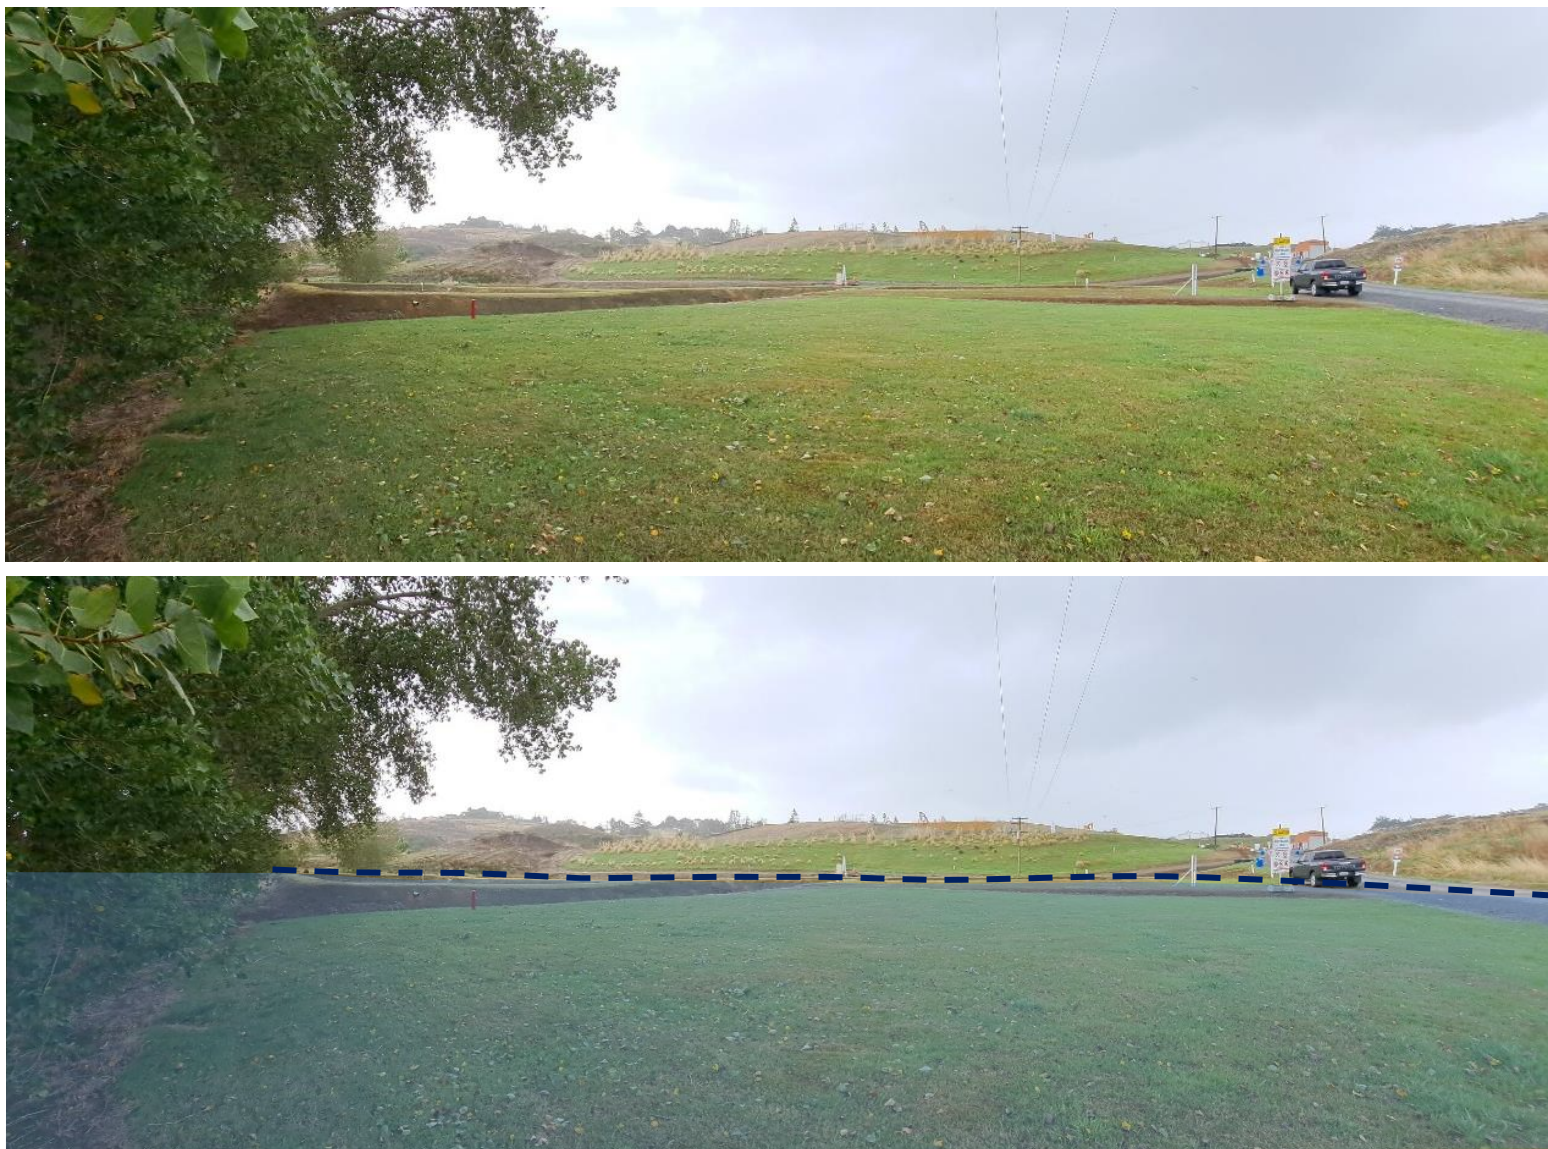
Figure 3-11 Top: view of the berm area and ponds in front of the Mt Cooee landfill. Bottom: showing the boundary of the berm area mapped by GHC.
