Didymo in Otago: A Summary

July 2007

Executive Summary

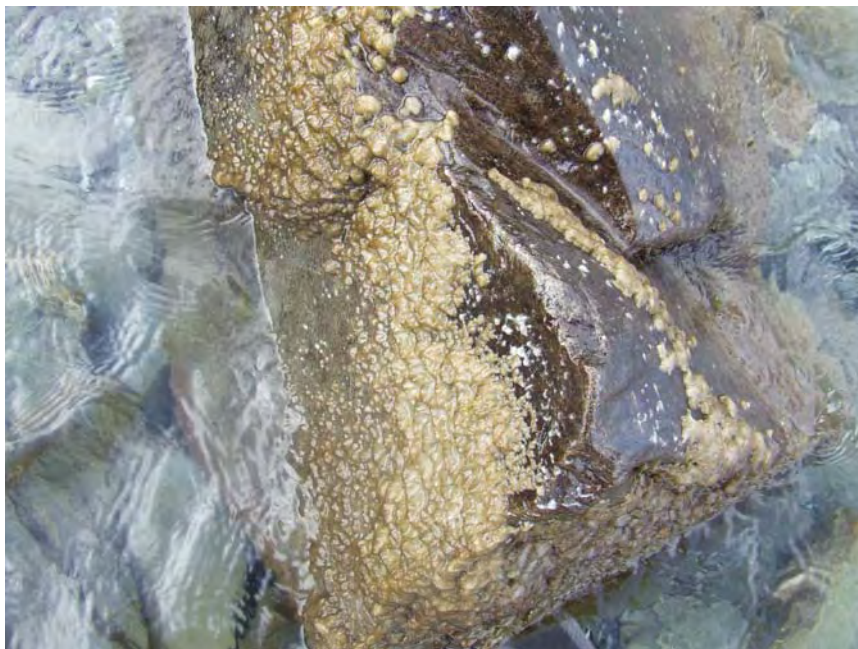
There are several observations of Didymo growing along lake edges in Europe, and there is evidence in Otago and Southland that this is also the case in New Zealand. Didymo has been observed growing along the edges of Lake Wakatipu near the mouth of the Von River, opposite the mouth of the Greenstone River near Pigeon Island, Queenstown Bay (Figure 2.5) and at the Clutha arm of Lake Dunstan. Indications are that Didymo in lakes may be limited to areas of high wave action and/or some degree of flow.

Figure 2.5 Didymo growing on rocks in the wash zone in Queenstown Bay, Lake Wakatipu

Didymo was first observed growing on the margins of Lake Wakatipu near the mouth of the Von River in November 2005. Subsequent colonies have also been found opposite the mouth of the Greenstone River near Pigeon Island and Queenstown Bay (Figure 2.5). There are nine consented takes from Lake Wakatipu; three for irrigation and six for domestic or communal supply. As with Lake Dunstan and the Clutha/Mata-Au, water takes less than 100 l/s are considered a permitted activity under the Regional Plan: Water so the actual number of takes from the lake are likely to be substantially higher.

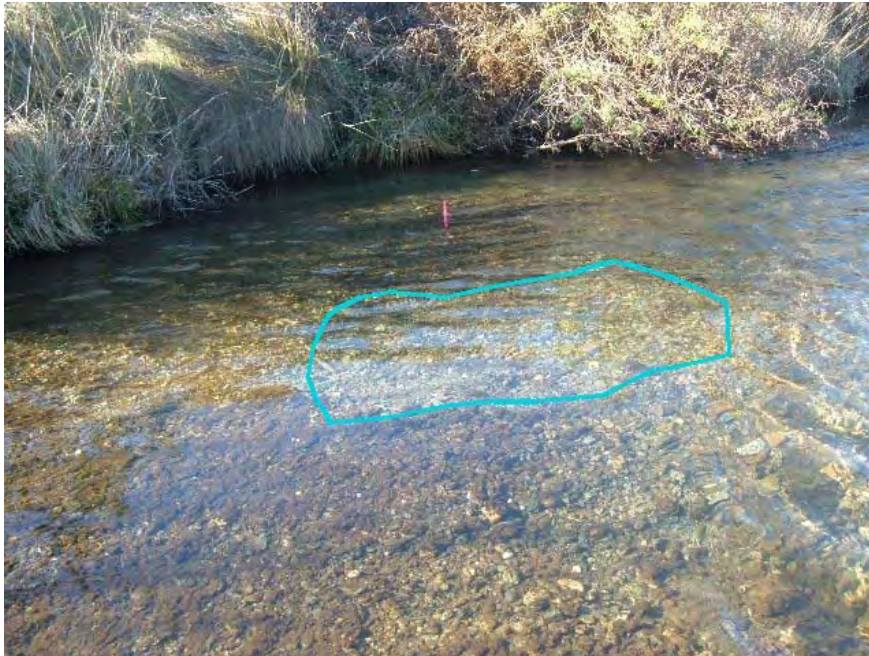
It is unlikely that Didymo will have a negative impact on spawning as trout are easily able to dig through Didymo mats to reach the gravel below (Figure 3.1). Once spawning is completed however, Didymo is able to very quickly re-colonise trout redds and accumulate mats up to 3 cm thick in a matter of weeks (Figure 3.2). It is this buildup of Didymo biomass on top of redds that may have a serious negative impact on recruitment.

Figure 3.1 Newly dug trout redd in the Fraser River

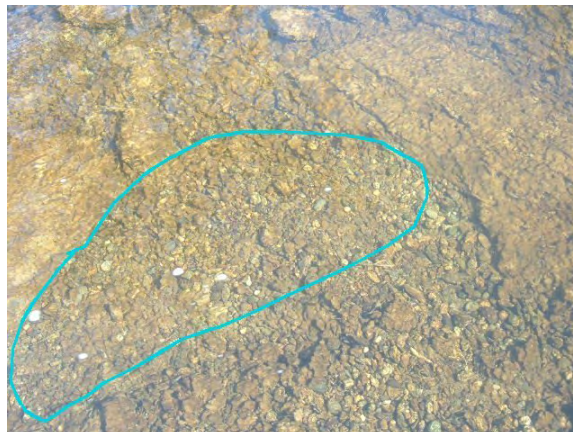
Figure 3.2 Trout redd covered with a 20 mm thick mat of Didymo after 10 days in the Fraser River

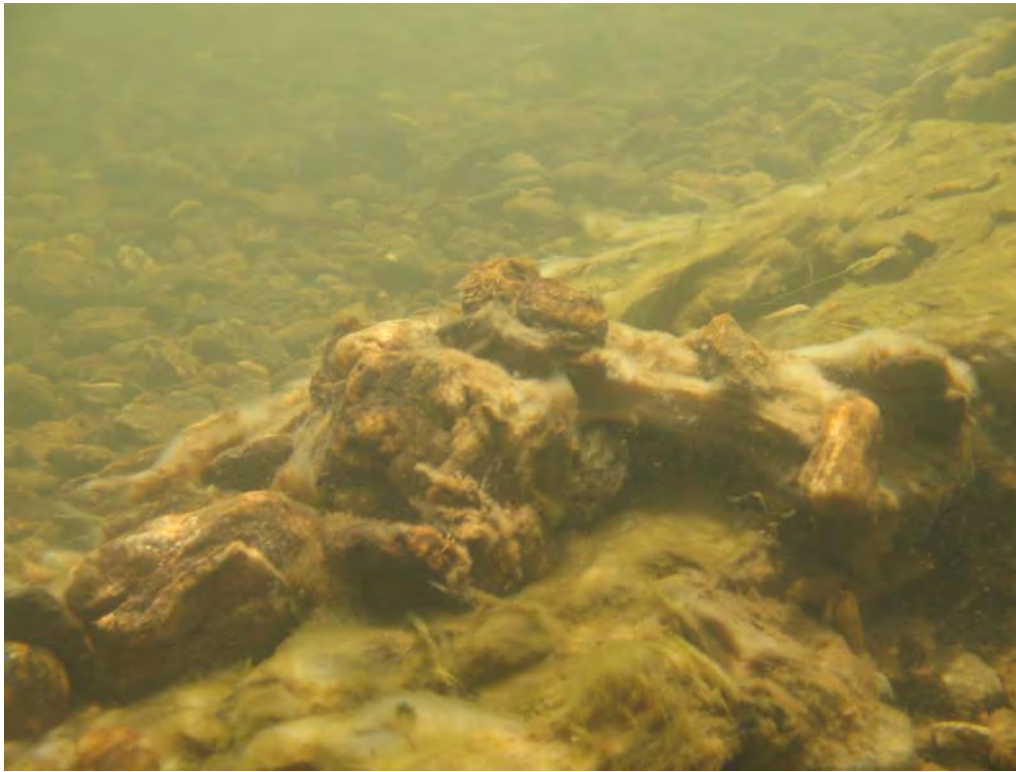
Thick Didymo mats may prevent oxygen from flowing through the gravel and may lead to the death of larvae and fry. It is also possible that these mats of Didymo may effectively armour the stream bed, preventing fry from reaching the surface (Figure 3.3).

Figure 3.3 Gravel bound together by Didymo at Laing Rd, forming a matrix which armours the substrate

The lack of response of biomass to moderate increases in flow at Laing Rd in September is most likely due to the armoring of the gravel by thick mats of Didymo (Figure 3.3), and the relatively wide channel which reduces near-bed velocity and allows a large buildup of Didymo biomass. Near-bed velocities during the 17 cumec event in October were much higher than at any other time since Didymo's incursion into the Fraser River, and was enough to scour away all but a few fragments of the Didymo-gravel matrix (Figure 5.18).

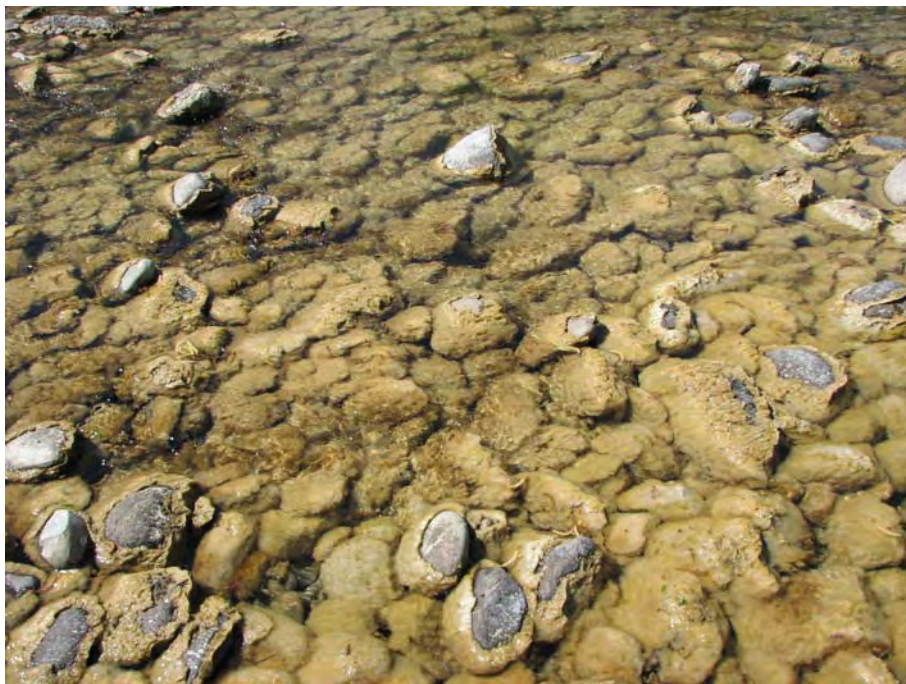
Due to large flow fluctuations in the Hawea River, Didymo is only present in the permanently wetted area of the river (Figure 4.2) and not visible from the bank during high flows.

Figure 4.2 Thick cover of Didymo in the Hawea River visible at low flows (G. Martin)

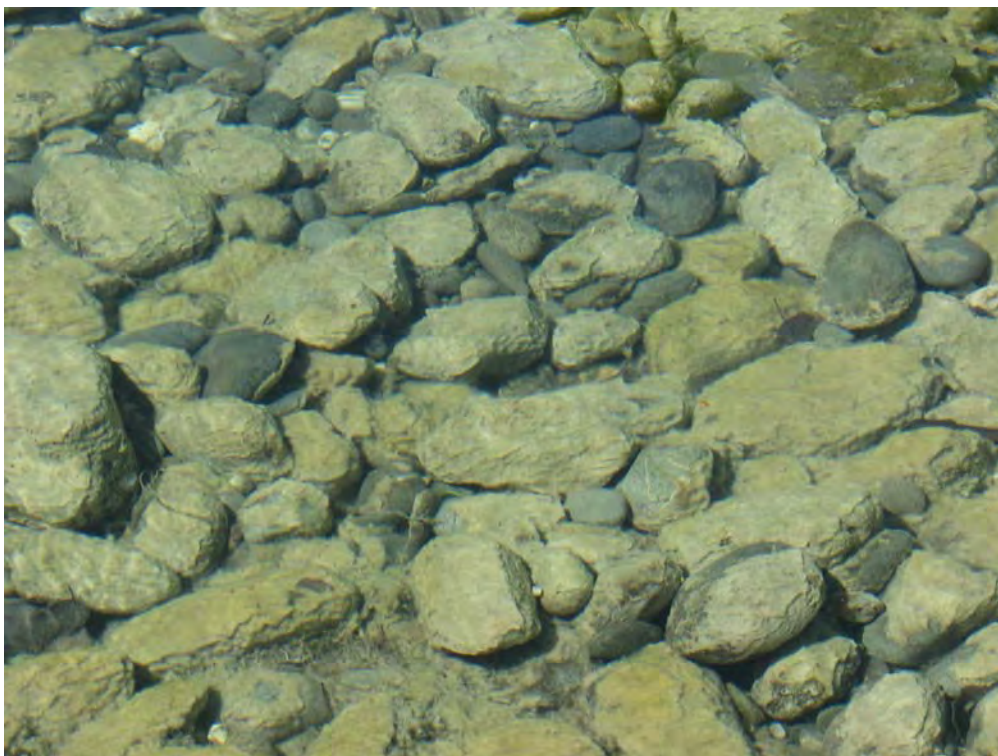
There have been several observations of unusual thin grey mats of Didymo in the lower Hawea River near Hawea Domain. Laboratory analysis revealed that the mats were comprised almost entirely of dead stalk material and cells. It is likely that these mats were baked onto rocks during lower than normal flows when they were exposed to the air for an extended period of time (Figure 4.3). A subsequent high flow event appears to have caused a moderate amount of bed movement as shown by the clean rocks in Figure 4.3.

Figure 4.3 The unusual growth form of *Didymo* observed in the lower Hawea River (G. Martin)

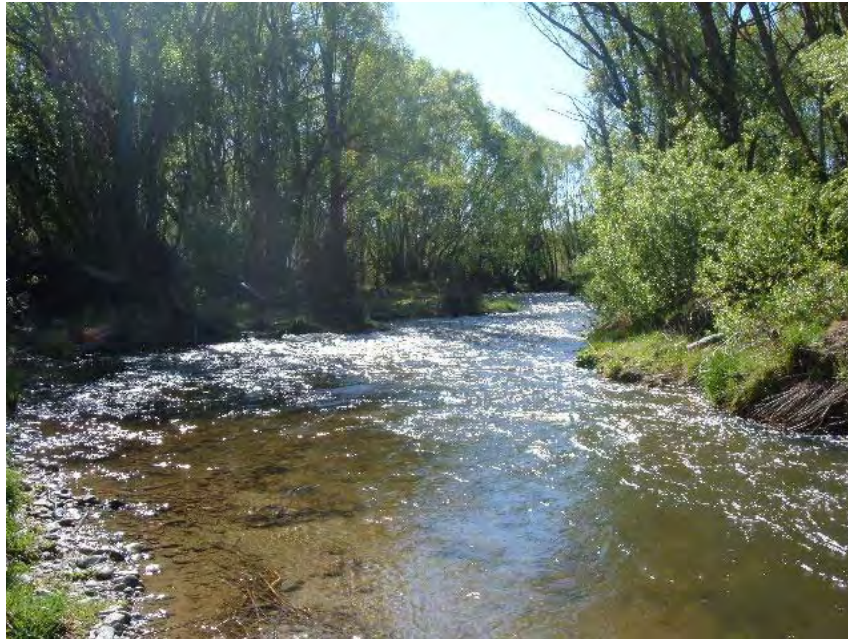
The Marshall Rd monitoring site (Figure 5.5) is located approximately 300m upstream of the confluence of the Fraser River and Clutha River/Mata-Au Rivers. This site differs from those further upstream by its relatively narrow confined channel ($\approx 6\text{m}$) and high velocities towards the middle of the channel. It is also the most shaded of the sites, with willows lining most of the bank.

Figure 5.5 Marshall Rd monitoring site

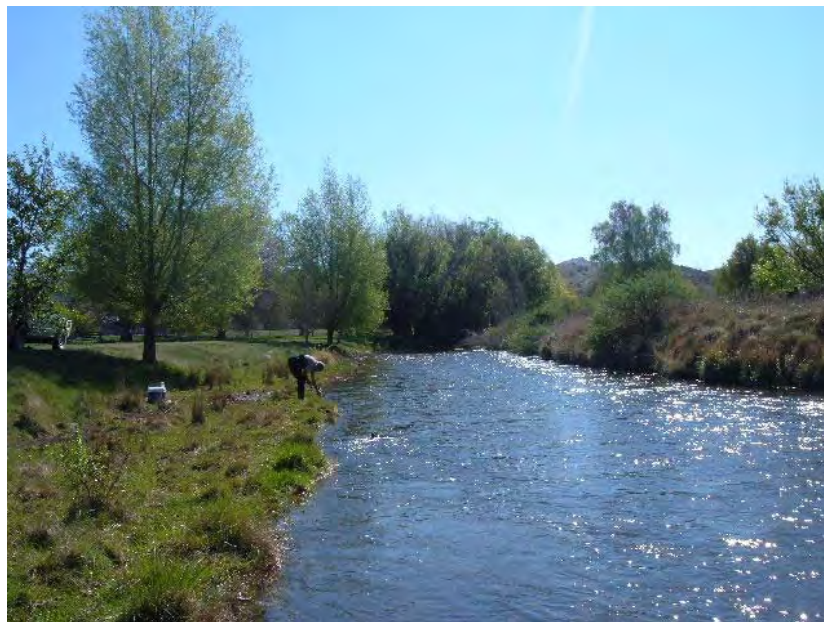
The Earnsclough Rd site (Figure 5.6) is located approximately 50m upstream of the Earnsclough Rd Bridge, with a relatively wide channel ($\approx 10\text{m}$). Shading is minimal and channel velocities are low with more laminar flow across the entire channel.

Figure 5.6 Earnsclough Rd monitoring site

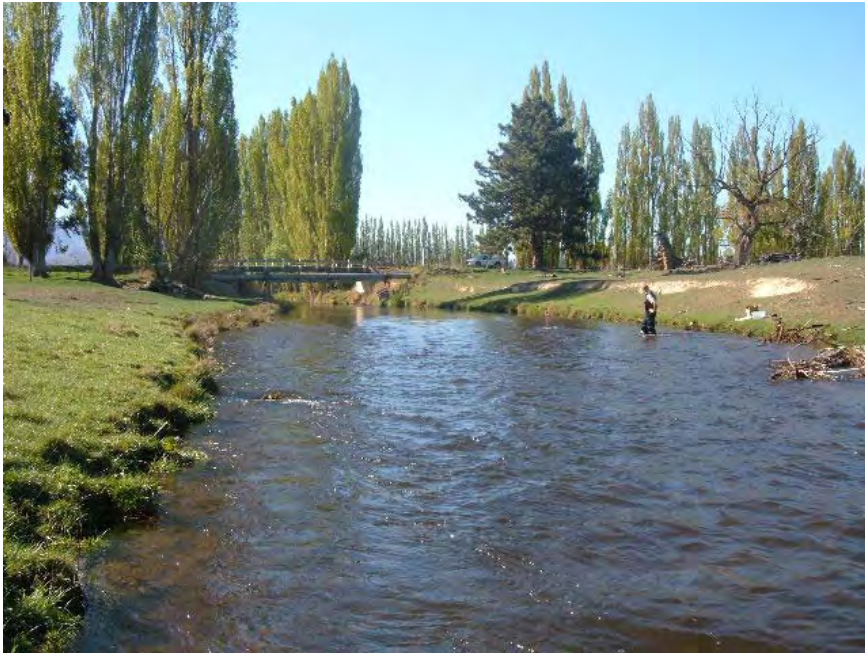
The Laing Rd monitoring site (Figure 5.7) is located approximately 50m downstream of the Laing Rd Bridge and is characterised by its shallow, wide (>15 m), and un-shaded channel.

Figure 5.7 Laing Rd monitoring site

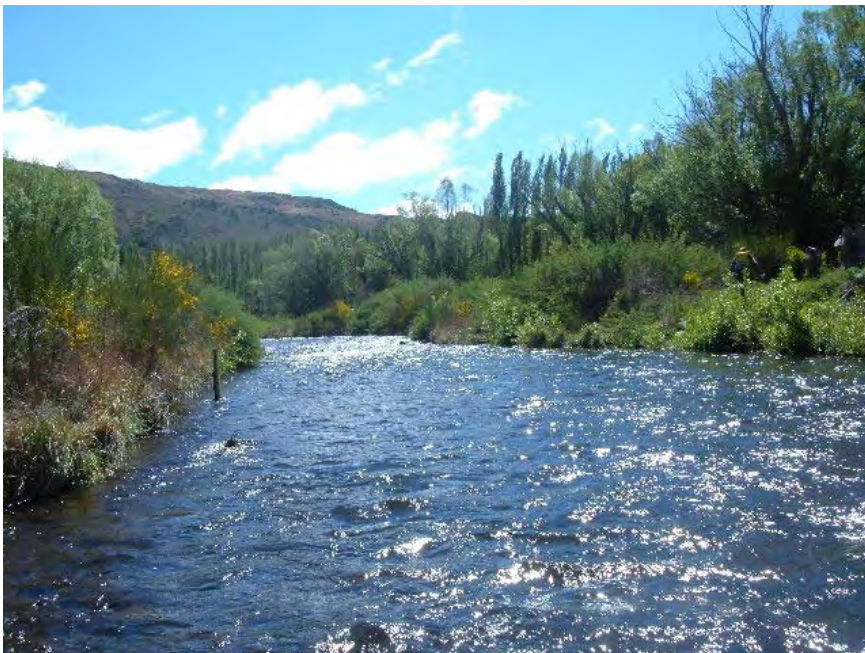
The Fraser Rd site (Figure 5.8) is located 30m upstream of the Fraser Rd Bridge and is characterised by its narrow (<8 m) channel and large substrate size (Figure 5.9). Due to this narrow channel, flows are relatively high but the substrate is very stable with minimal bed movement during high flows.

Figure 5.8 Fraser Rd monitoring site

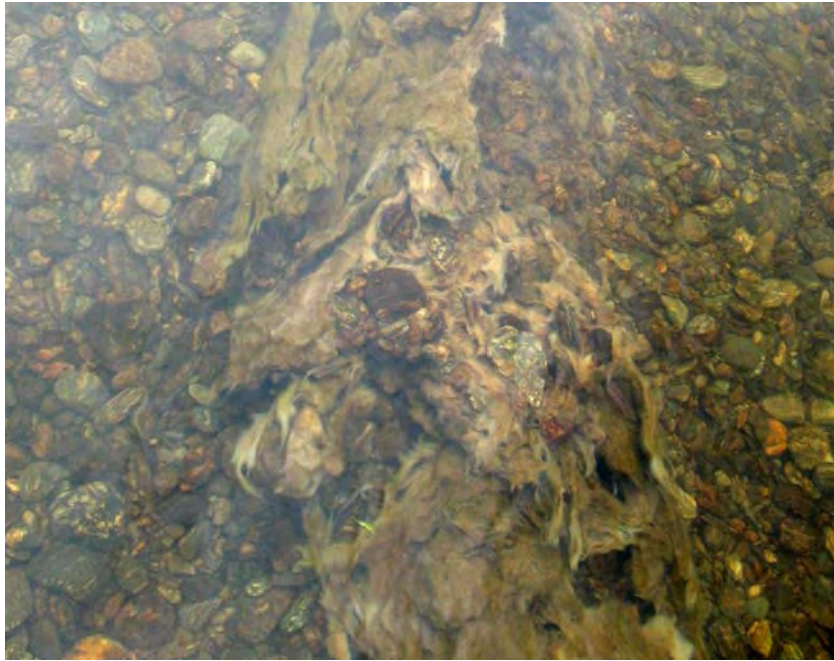
Figure 5.18 Remnant Didymo-gravel matrix at Laing Rd after high flows in October

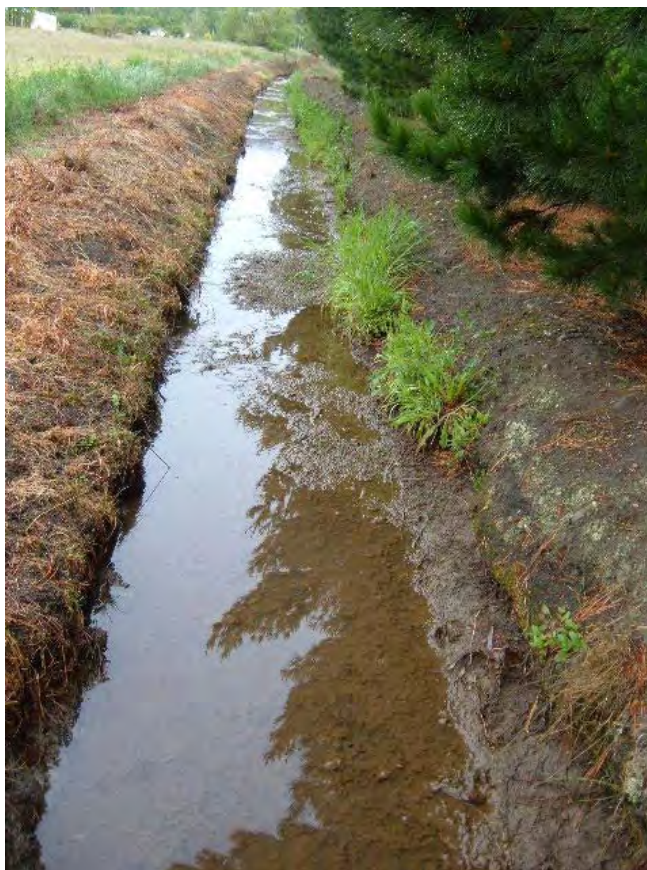
It was initially thought that Didymo would not attain high biomass in irrigation races due to the small substrate (clay or silt) found in most races. Anecdotal evidence from the Earnsclough irrigation scheme has indicated that Didymo is able to attain very high biomass in predominantly sand/gravel bottomed races (Figure 6.1) as long as there is a small amount of gravel to which it can attach.

Figure 6.1 Thick cover of Didymo in Earnsclough irrigation race
