Project Number: 6-XQ148.00/USCH0

Rees River Bridge

Options Assessment

1 June 2023

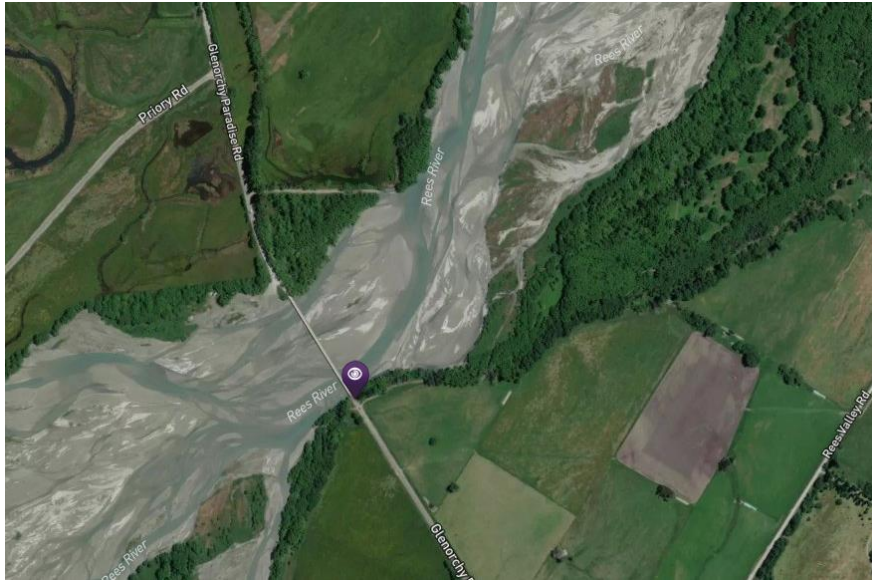
Figure 1. Aerial view of Rees River Bridge

The Rees River Bridge is a 207 m long 15-span single lane structure across the Rees River. The bridge is located along the Glenorchy-Paradise Road, approximately 8 km north of the Glenorchy township and is owned by the Queenstown Lakes District Council (QLDC). An aerial view of the site is shown in Figure 1 with a typical elevation shown in Figure 2.

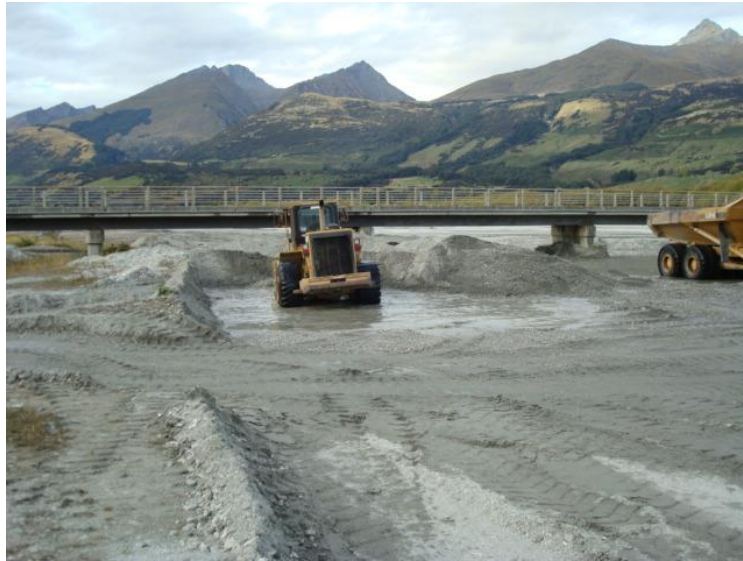
Figure 3. Rees Riverbed circa 2021

In 2022, the Otago Regional Council (ORC) commissioned a study into the Dart and Rees floodplains, which identified potential risks to the Rees River Bridge from continued bed aggradation and the potential for the Rees River to avulse upstream of the bridge. This has followed recent observation of bed aggradation in the Rees River, as shown in Figure 3, which has resulted in QLDC extracting gravel from the riverbed. While the extracted gravel has previously

been used to raise neighbouring Kinloch Road, there is concern that current reactive measures may be unsustainable given the rate of bed level rise observed and potential funding limitations.

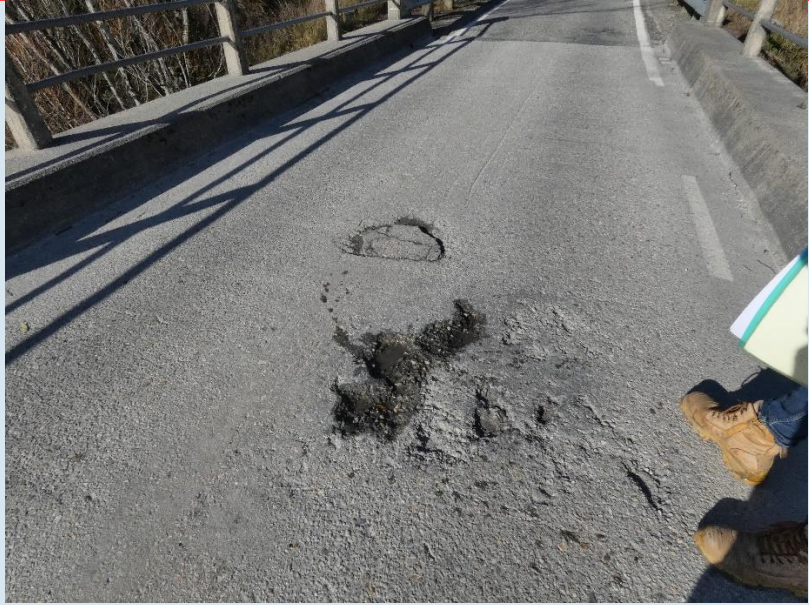
rutting in pavement on True Right approach.

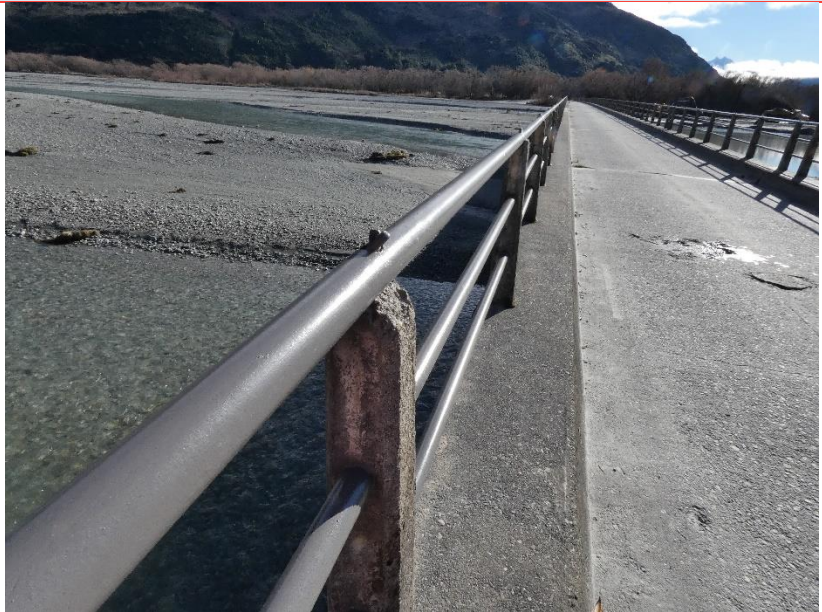
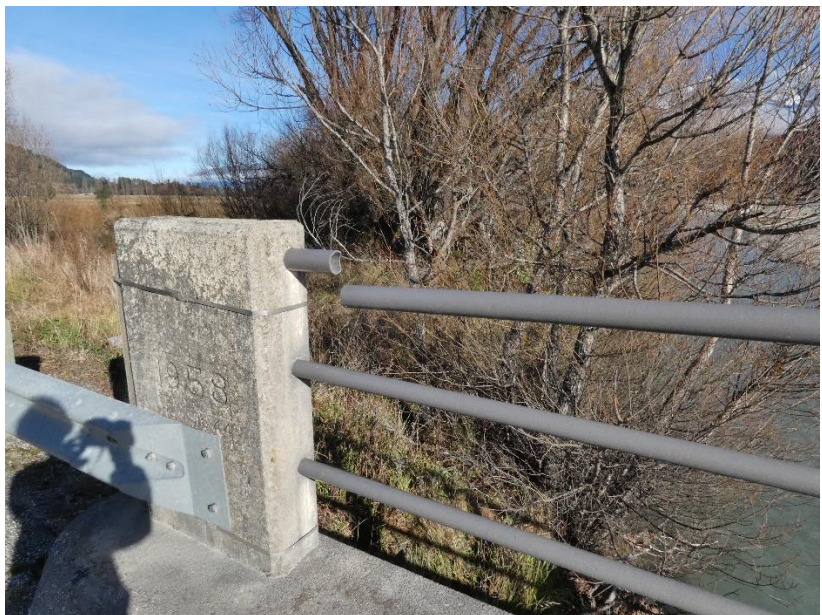
Minor damage to handrails and concrete posts

Some minor spalling on the concrete piers and debris build up were also noted but these are relatively minor and did not warrant remediation at the time of inspection. Based on the noted defects, it can be concluded that the bridge is in a good condition with an expected remaining life in the order of 40 years based on structural condition.

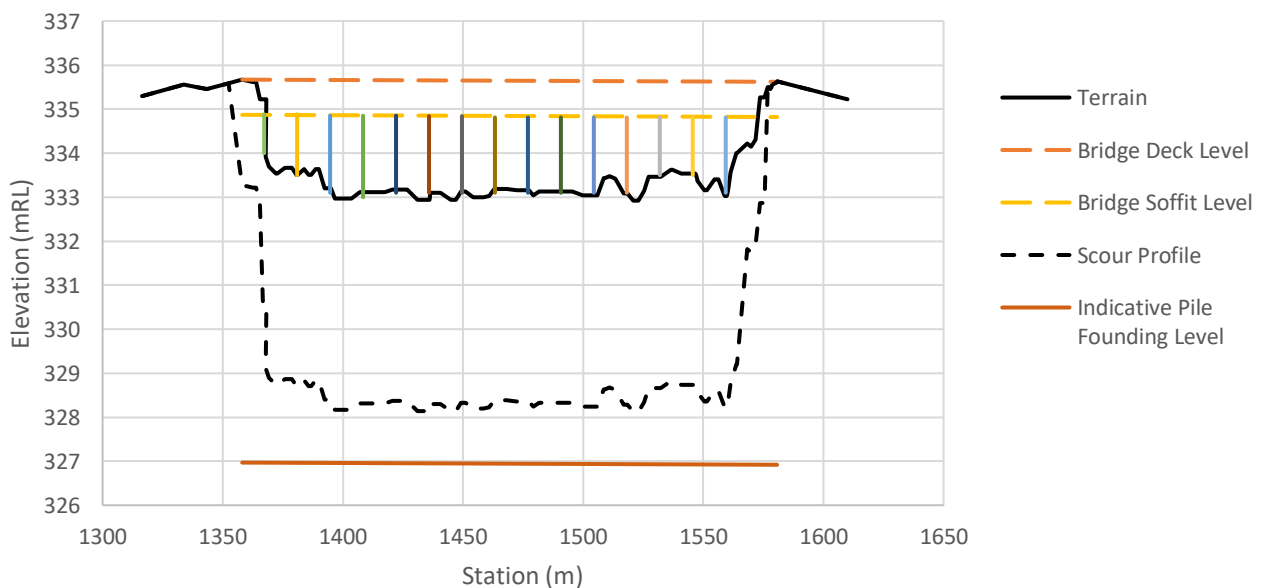
Figure 7. Total scour plot

Given that the predicted contraction scour is negligible at this site, the abutment and pier scour depths are considered to be total scour depths. Figure 7 presents the plot of the total predicted scour depth based on the existing ground levels at the abutment and pier locations. Note that as local scour is dominates the total scour, it is anticipated that any scour occurring will be concentrated at pier/abutment locations and not uniform across the width of the channel. It is important to note that the persistent aggradation in the river can lead to less total scour depth than calculated in this assessment. Based on the currently assumed minimum founding depths, there is not an immediate undermining risk at this bridge. However, this will need to be considered if longer term measures have the potential to increase local scour effects.

- The maximum scour depth predicted is 4.8 m at the piers and 2.4 m at the abutments. Based on available drawings, the minimum founding depths of the existing piles are below the predicted scour depths. However, the scour assessment has indicated that the scour depths could be sufficient to expose a large portion of the piles during a flood event, especially with debris accumulation at the pier. The level of risk is hard to quantify as the exact depth of the piles is unknown and is currently based off a minimum pile level assumed from available drawings. Given the alluvial nature of the site, it is expected that the piles rely on end bearing primarily. Hence the predicted scour should not compromise their load carrying abilities provided that they are able to resist hydraulic pressures acting on them.

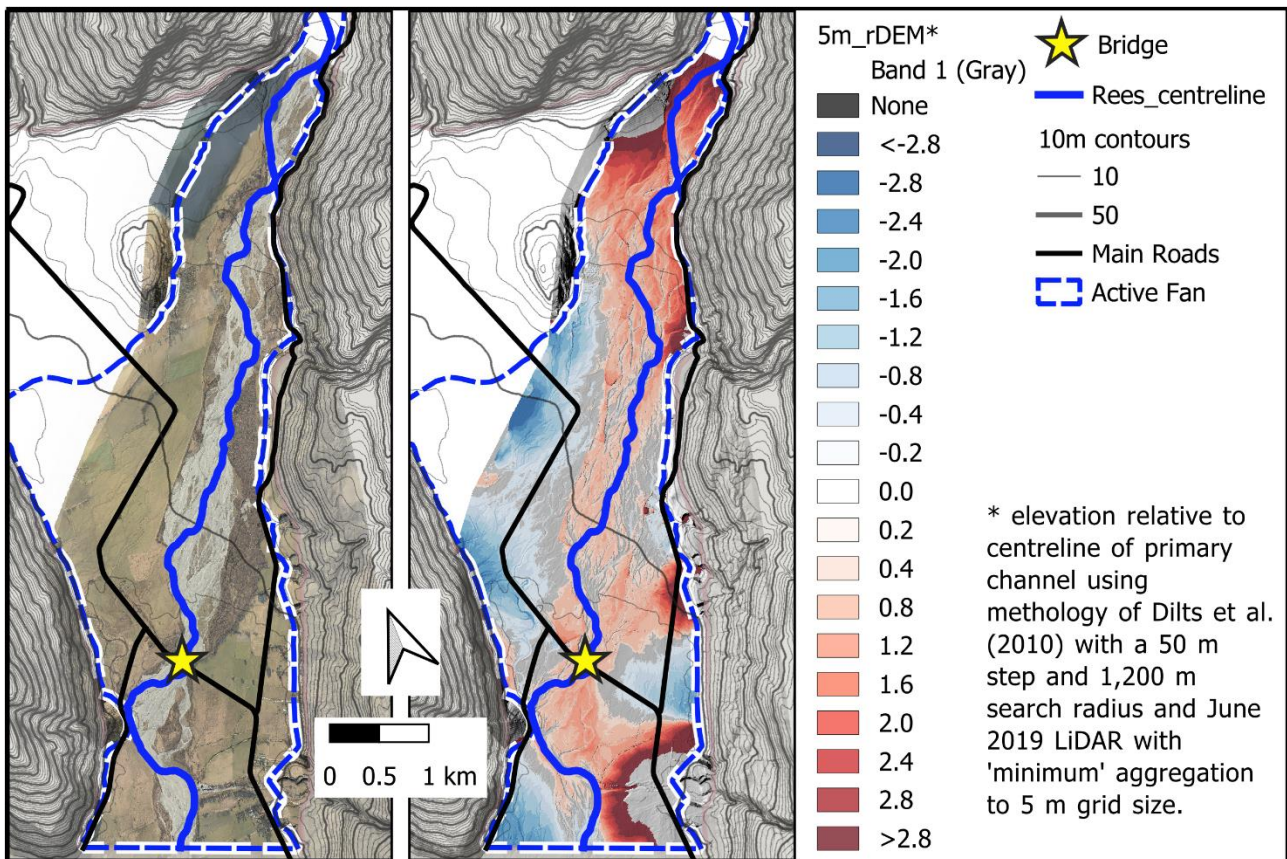
Figure 10. 2019 Aerial orthoimage (left) and relative elevation DEM based on June 2019 LiDAR. The “centreline” represents the location of the primary channel’s centreline.

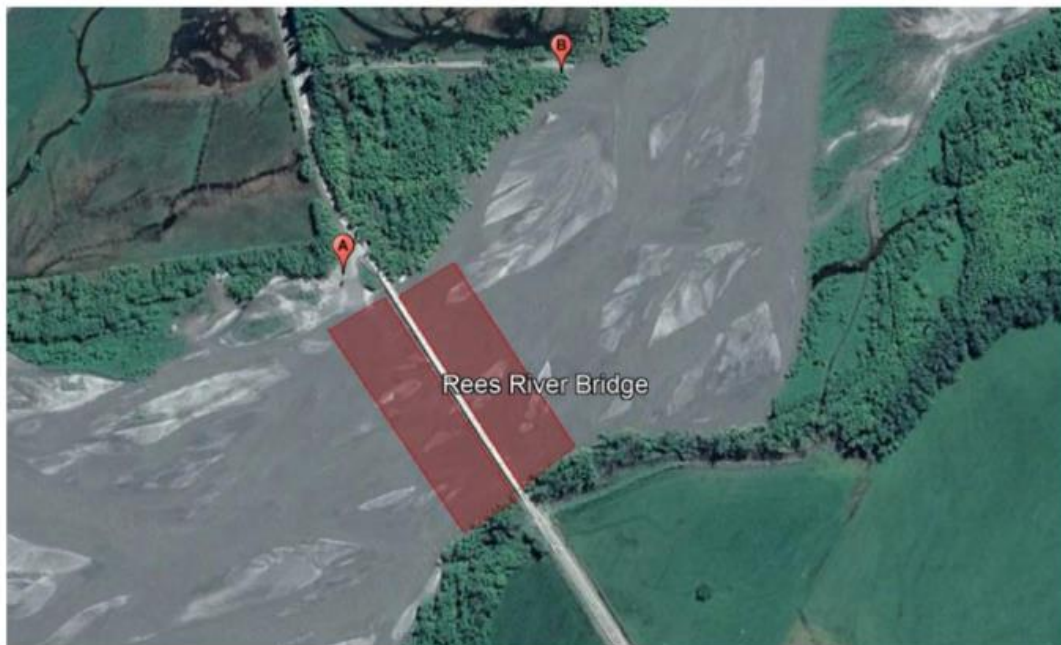
The Queenstown Lakes District Council hold a land-use consent from the Otago Regional Council (RM 20.205.01) to disturb the bed for purpose of remobilisation and redeposition of bed materials for the purpose of removing alluvium and debris around Rees River bridge. The consent authorises the removal of alluvium and debris within a 50 metre radius of the Rees River bridge as shown in Figure 11 below. The conditions of this consent place limits on the amount of gravel extraction of 20,000 m³ per event & once per calendar year within the gravel extraction zone. In addition, the conditions specify the methodology and timing of works and include conditions on the notification of affected parties, on-going monitoring and reporting requirements.

Figure 11. RM 20.205.01 Access point to Rees River (A & B) and extraction area (red shaded area)
