MT COOEE LANDFILL BIRD MANAGEMENT PLAN

For WSP

November 2022

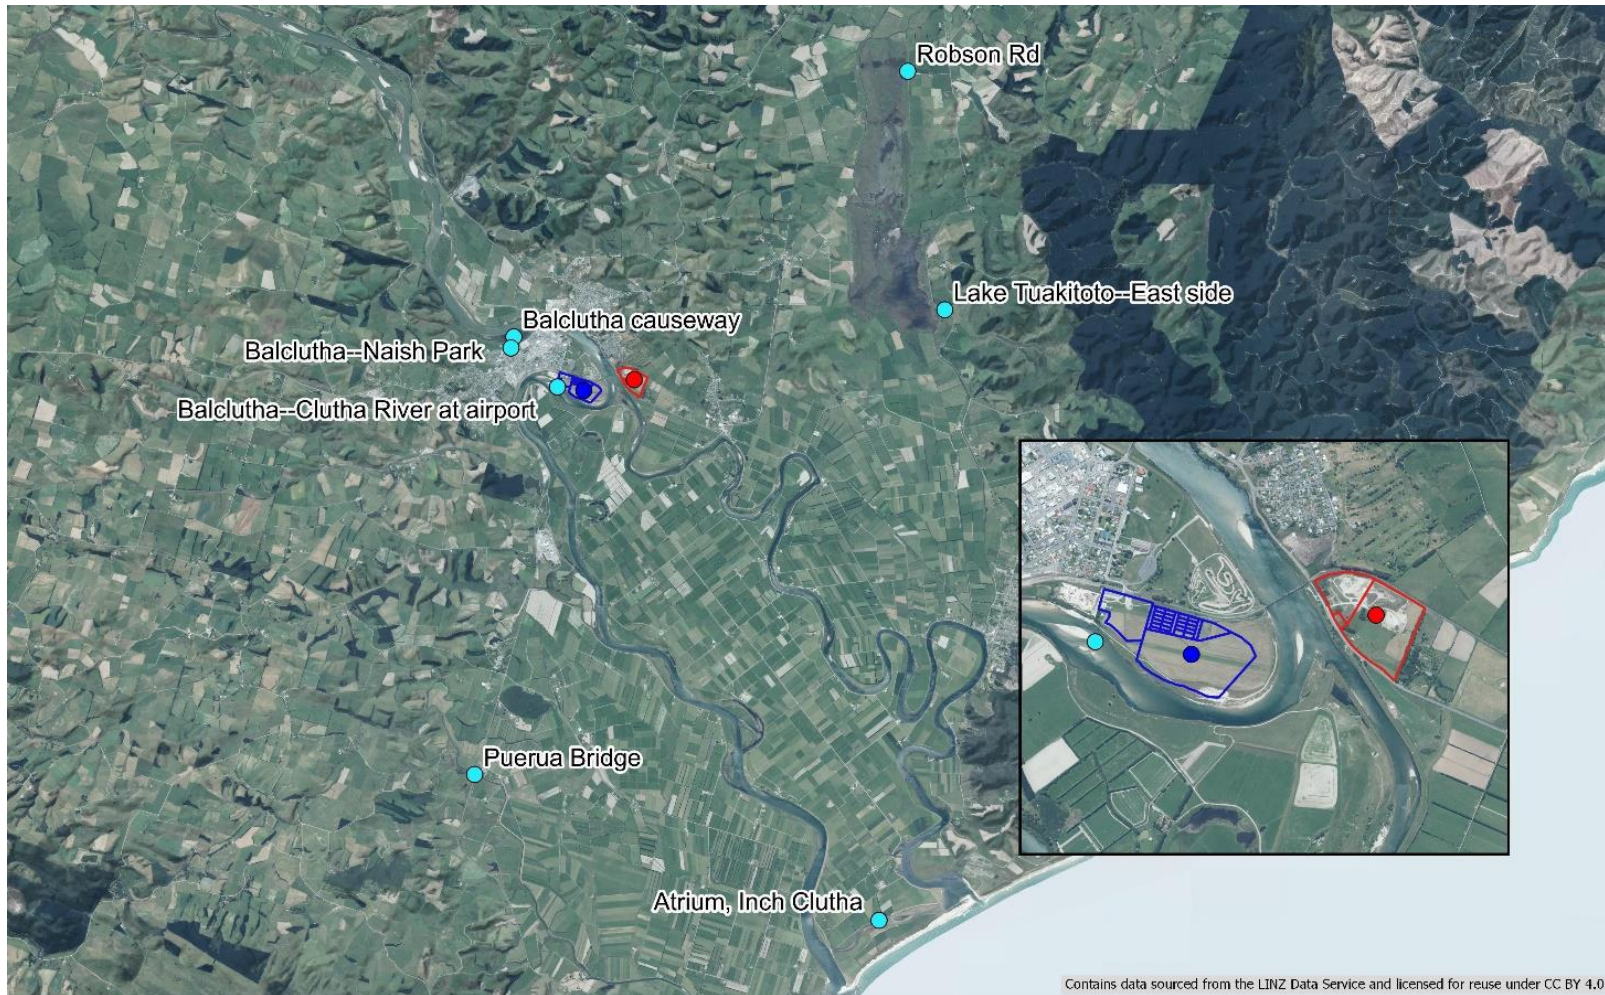
Figure 2: Bird survey sites.

To establish the range and relative abundance of bird species present near the aerodrome, bird records from seven eBird sites within 13 km of the aerodrome were collated and reviewed (Figure 2). This distance is based on the International Bird Strike Committee’s best practice standards (2006) which recommend the establishment of a 13 km circle from an airfield, within which an inventory of wildlife hazards should be established, and risk assessments completed, to determine the level of contribution to strike risk (Australian Airports Association 2016)³. The assessed eBird records were from 1963 to October 2022, although 87% of the 103 survey dates were from 2017 or later. Seventy-seven bird taxa were recorded over this period. The maximum number of each bird species recorded at each site during the surveys is presented in Appendix A.

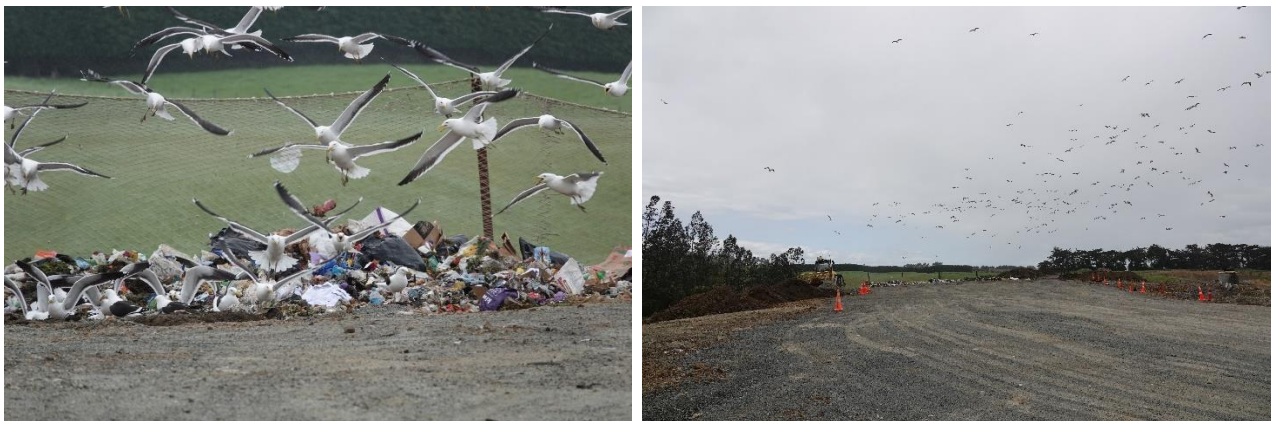
Figure 3: Black-backed gulls at the Mt Cooe landfill competing for a piece of meat (left) and flocking above the landfill (right). 4 November 2022.

Birds recorded in and adjacent to the open landfill face included abundant black-backed gulls, and common starlings (*Sturnus vulgaris*) and house sparrows (*Passer domestica*) (Appendix A). Earlier in the morning, there were few black-backed gulls present, but when dumping and movement of waste was occurring, approximately 100 black-backed gulls were present competing for food scraps, soaring above the landfill, or waiting on gravel/bare earth for the next load of waste to arrive. Starlings and house sparrows were quick to access disturbed waste. One red-billed gull (*Larus novaehollandiae*) was seen resting on the edge of the dumping area, and one Australasian harrier (*Circus approximans*) was flying over the margins of the landfill. Trees adjacent to the fill site supported small passerines.

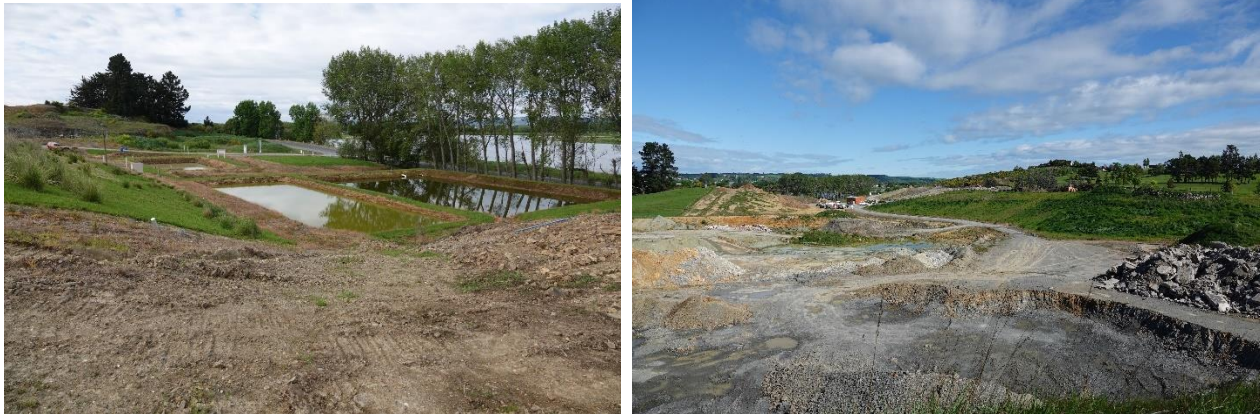
Figure 4: Settling ponds (left) and the borrow pit (right) provide low quality habitat for birds. 4 November 2022.

Only a few small passerines were seen in open areas such as the borrow pit and in grassed/weedy areas. The perimeter drain, which was dry during the site visit, did not appear to provide good habitat for birds. The settling ponds also did not provide good habitat for birds, with only one welcome swallow (*Hirundo neoxena*) observed briefly at the site. The other passerines present near the ponds were associated with adjacent trees and grassland.

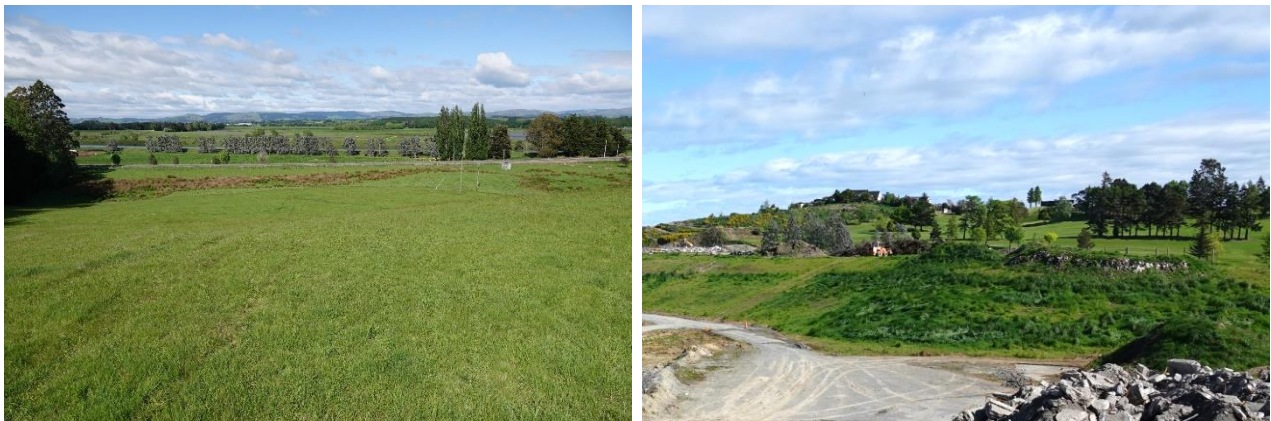
Figure 5: The proposed expansion area at the Mt Cooee landfill largely comprises pasture, with some trees and small buildings on its margins (left). Exotic grassland is also present on the adjacent Balclutha Golf Club course (right) and surrounding farmland. 4 November 2022.

Spur-winged plovers, starlings, and several other small passerine species were recorded in and adjacent to the proposed expansion area (Appendix A). Starlings were nesting in small buildings adjacent to the expansion area. A range of other species flew over the site, including black-backed gulls on route to the landfill. Extensive similar habitat is present nearby on farmland and the Balclutha Golf Club course. A wet area at the foot of the hillslope (dominated by rushes) and a small, muddy stream provided low quality habitat for wetland birds.

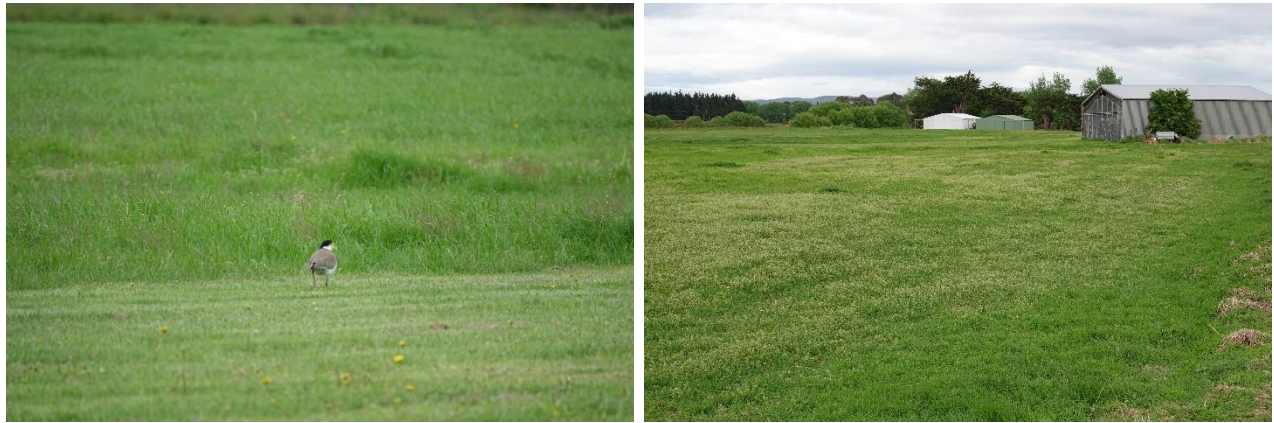
Figure 6: Spur-winged plover on the runway (left) and hangers at the western end of the aerodrome (right). 4 November 2022.

The commonest bird species observed on the aerodrome were starlings and house sparrows (Appendix A), which utilised buildings for perching and nesting and grassland for feeding. However, spur-winged plovers were observed on the runway, and several additional species were observed flying across the airfield at lower altitudes, including red-billed gulls, black-backed gull, Australasian harrier, mallards (*Anas platyrhynchos*), an oystercatcher (*Haematopus* sp.), a white-faced heron (*Egretta novaehollandiae*), paradise shelducks (*Tadorna variegata*), and pied stilts (*Himantopus himantopus*). Flight paths and height above ground level (1-50 m) were variable. A range of small passerines and an Australian magpie (*Gymnorhina tibicen*) were also recorded in trees on the margins of the aerodrome (Appendix A).

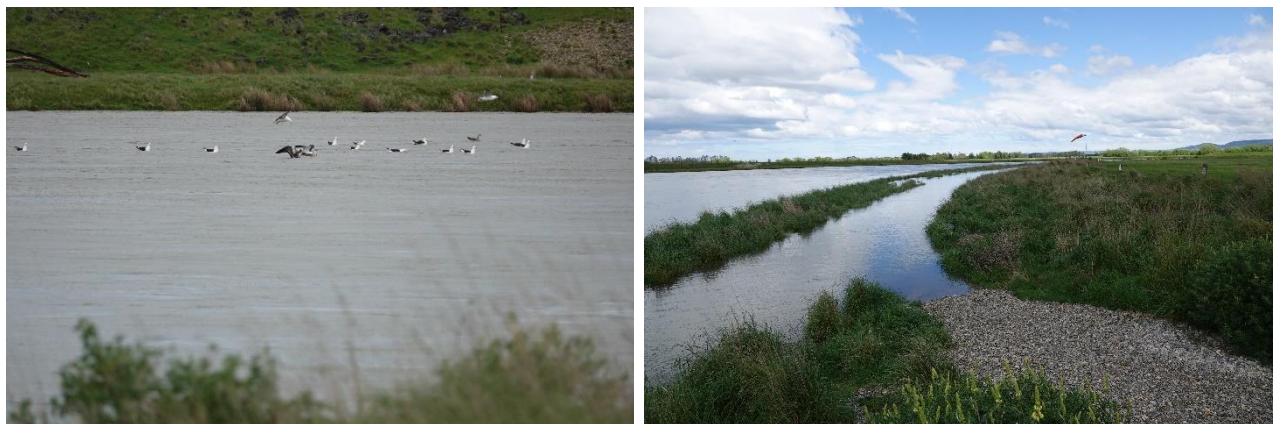
Figure 7: Black-backed gulls on the Balclutha River between the aerodrome and Kaitangata Highway (left) and the eastern end of the runway where it abuts the river (right). 4 November 2022.

Numerous black-backed gulls were observed floating and flying down the river. Mallards were observed in the river at the eastern end of the runway (Figure 7). Occasional oystercatchers could be heard flying along the river. Several rock pigeons (*Columba livia*) were perched on the railway bridge which passes over the Clutha River between the landfill and the aerodrome.
