Appendix 7: Green Island Landfill Resource Recovery Precinct Ecological Assessment Report

Green Island Landfill Resource Recovery Park Precinct

Ecological Impact Assessment
Prepared for Dunedin City Council
12 February 2024

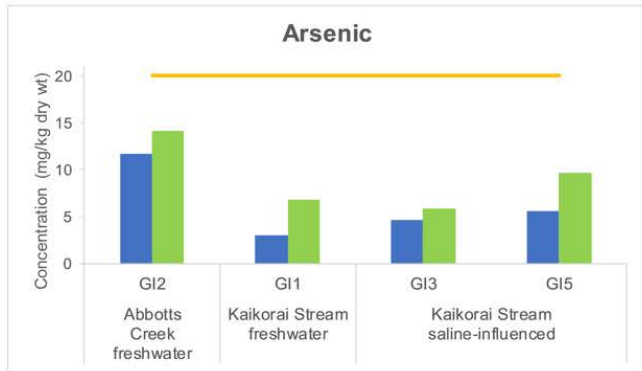
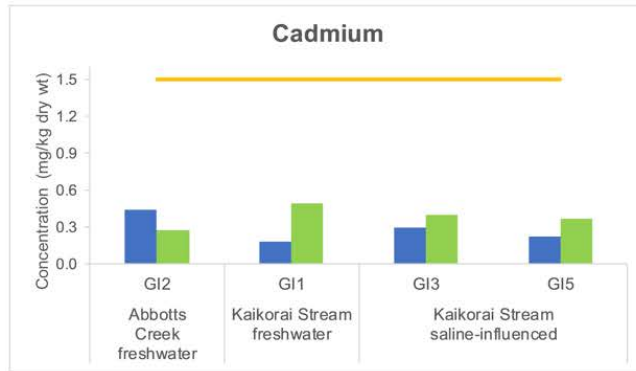
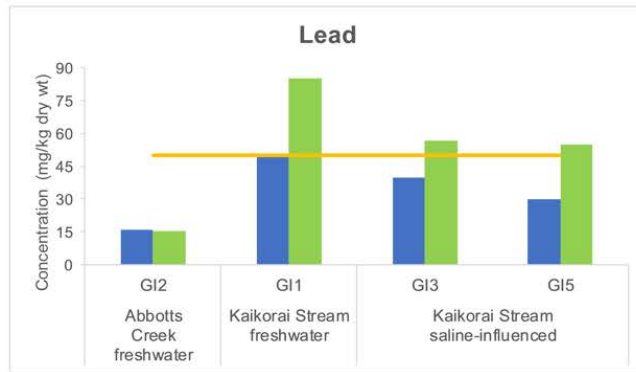
Figure 6. (This page and previous page). Toxicant concentrations in the <2 mm (blue bars) and <63 µm (green bars) particle size fraction of surface sediment samples (top 2-3 cm) collected at Kaikorai Stream and Abbotts Creek monitoring sites, GI1, GI2, GI3, and GI5. Default guideline values (DGV) are included in each panel, shown by the orange line. Upper guideline values (GV-High) are also included when exceeded, shown by the red line. The concentration of hydrophobic organic contaminants (PAHs, Dieldrin, Total DDT, o,p' + p,p' DDD, and p,p' DDE) was normalised to 1% of the total content of organic carbon.

Concentrations of polycyclic aromatic hydrocarbons (PAHs) and of the organochlorine pesticide dieldrin were above DGV in the <2 mm sediment fraction at site GI1 and below DGV elsewhere (Figure 6). Contamination from other organochlorine pesticides (i.e., DDT and its DDD / DDE metabolites) was widespread in the Kaikorai Stream (Figure 6). DDT levels were above GV-high and DDD / DDE concentrations above DGV in both grain size fractions at all Kaikorai Stream sites. DDD concentrations were also above GV-high at GI1 and GI3 (Figure 6). GI1 had higher concentrations of DDT / DDD / DDE relative to the other Kaikorai Stream sites. In particular, DDT levels in the <63 µm fraction at GI1 were almost ten times higher than the GV-high (Figure 6). GI2 (Abbotts Creek) had lower levels of contamination from DDT and its derivatives than the Kaikorai Stream sites, with DDT concentrations just above DGV and DDD / DDE below guideline levels (Figure 6).

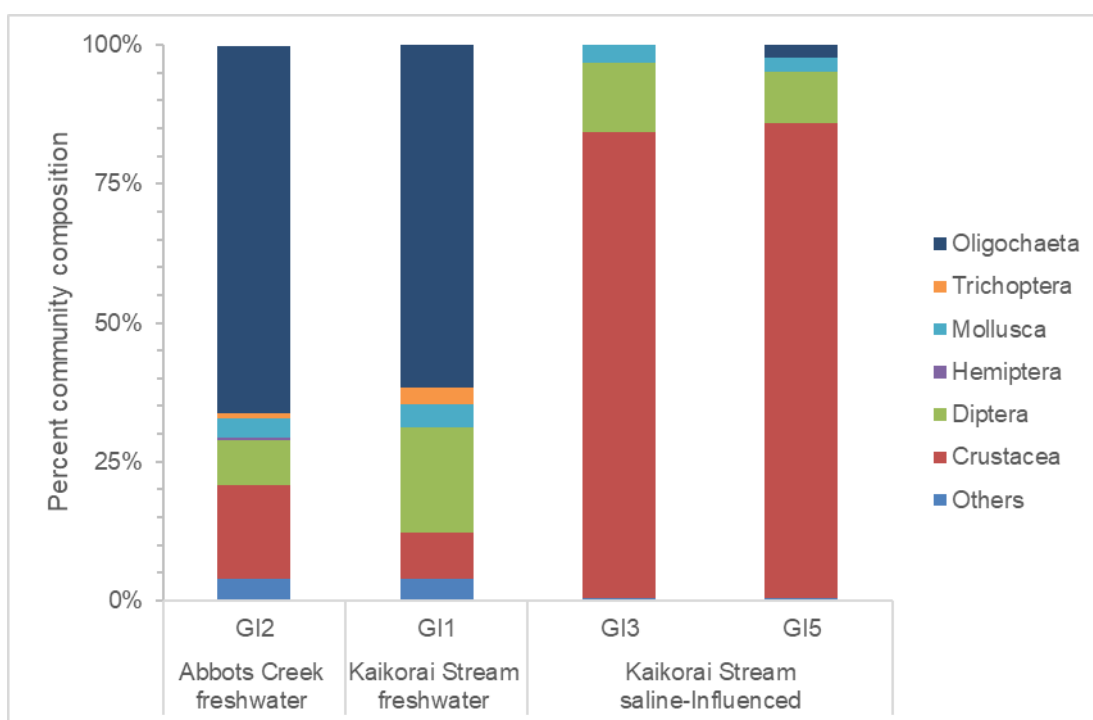
Figure 8: Community composition of benthic macroinvertebrates at GI1 and GI2 upstream reference sites alongside GI3 and GI5 sites adjacent to the landfill.

The most abundant macroinvertebrate groups comprised mostly tolerant taxa (Figure 8). GI1 was dominated by oligochaetes (aquatic worms) and true-fly larvae (Diptera), mostly *Chironomus* ‘blood worms’ or larvae of the non-biting midge. GI2 was dominated by oligochaetes (aquatic worms) and Crustacea (especially water fleas). Sites GI3 and GI5 were dominated by crustacea (mysid shrimps).

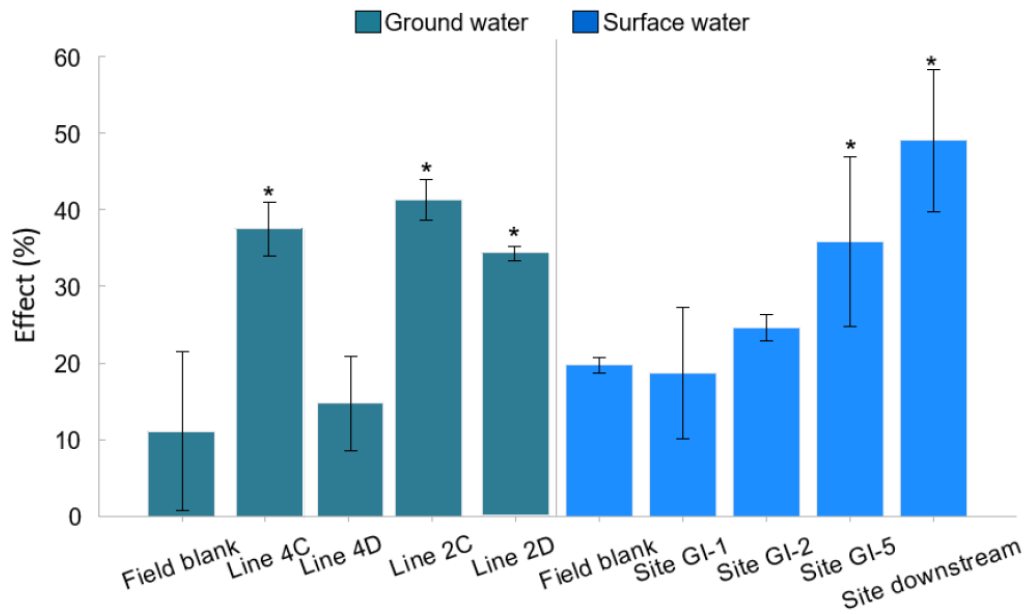
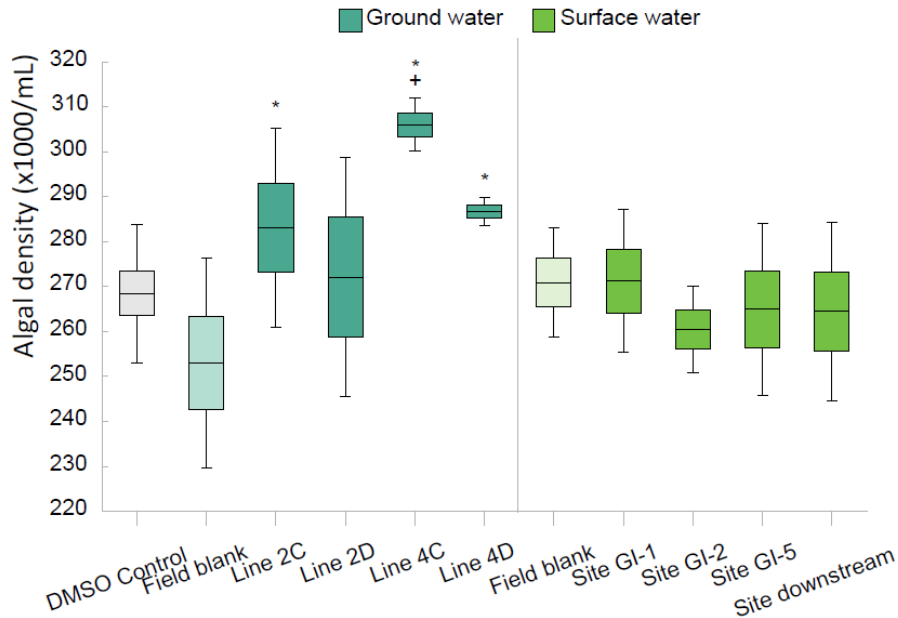
Figure 9: Copy of Cawthron Institute's ecotoxicology bioassays on (top) bacterial bioluminescence and (middle) algal density and (bottom) blue mussel bioassays from groundwater and surface water sites. From Cawthron Institute (2023). See Appendix 1 for full results.

There was no significant difference in blue mussel embryo survival rates between field blanks and the surface water sites, suggesting no or low toxicity of the extracts to blue mussels.

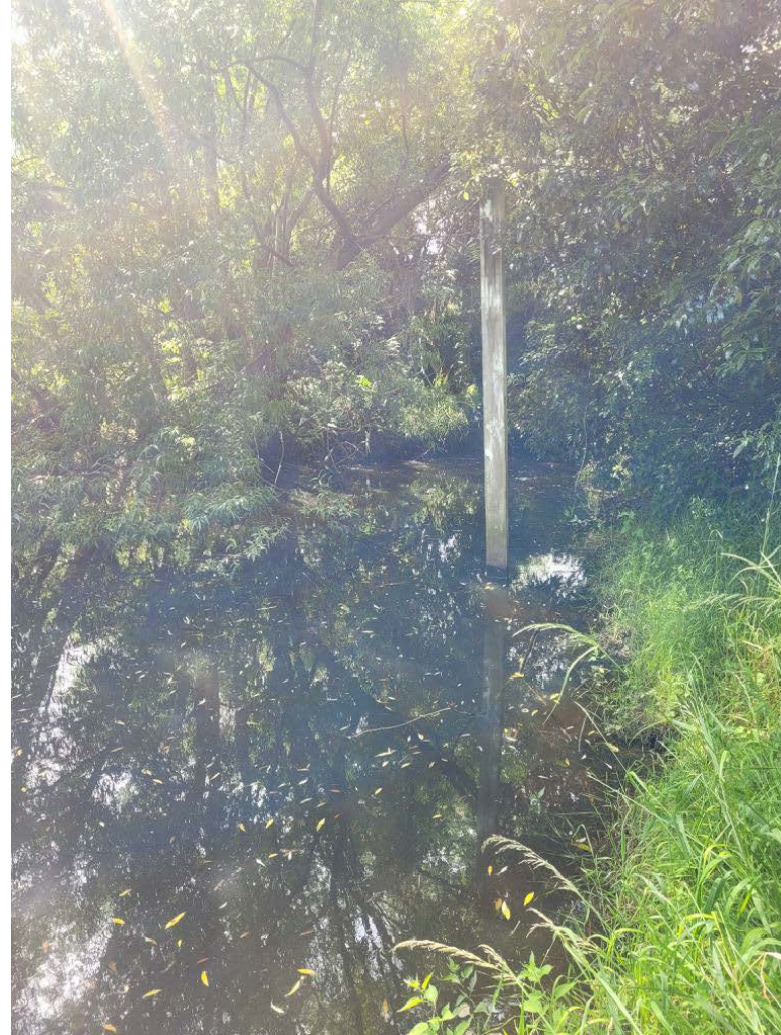
Figure 15: Additional aquatic sampling site in Kaikorai Stream near culvert outlet from Eastern Sedimentation Pond. Image taken 13th December 2022.

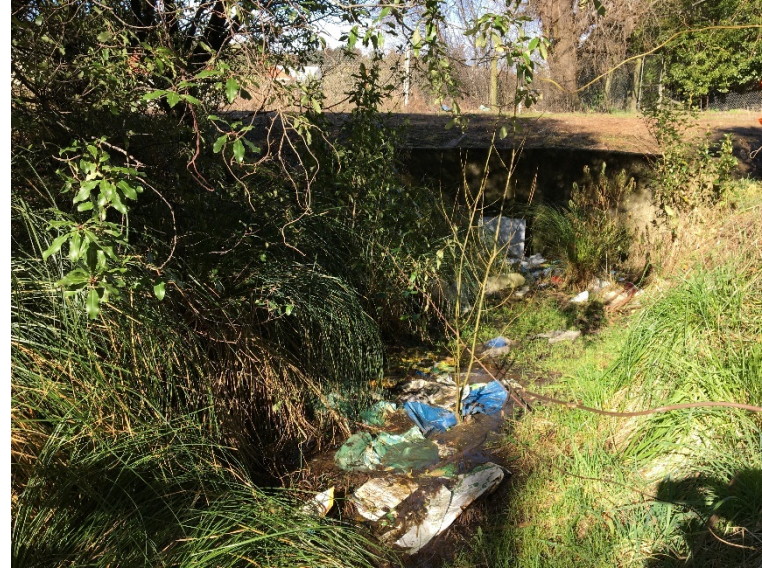
Figure 27: Culvert inflow to the constructed wetland from Taylor Street. Image taken 11th August 2021.
