Project Number: 6-CO082.00

# Mt Cooee Landfill Resource Consent Application

Assessment of Effects on Groundwater and Surface Water

27 April 2023

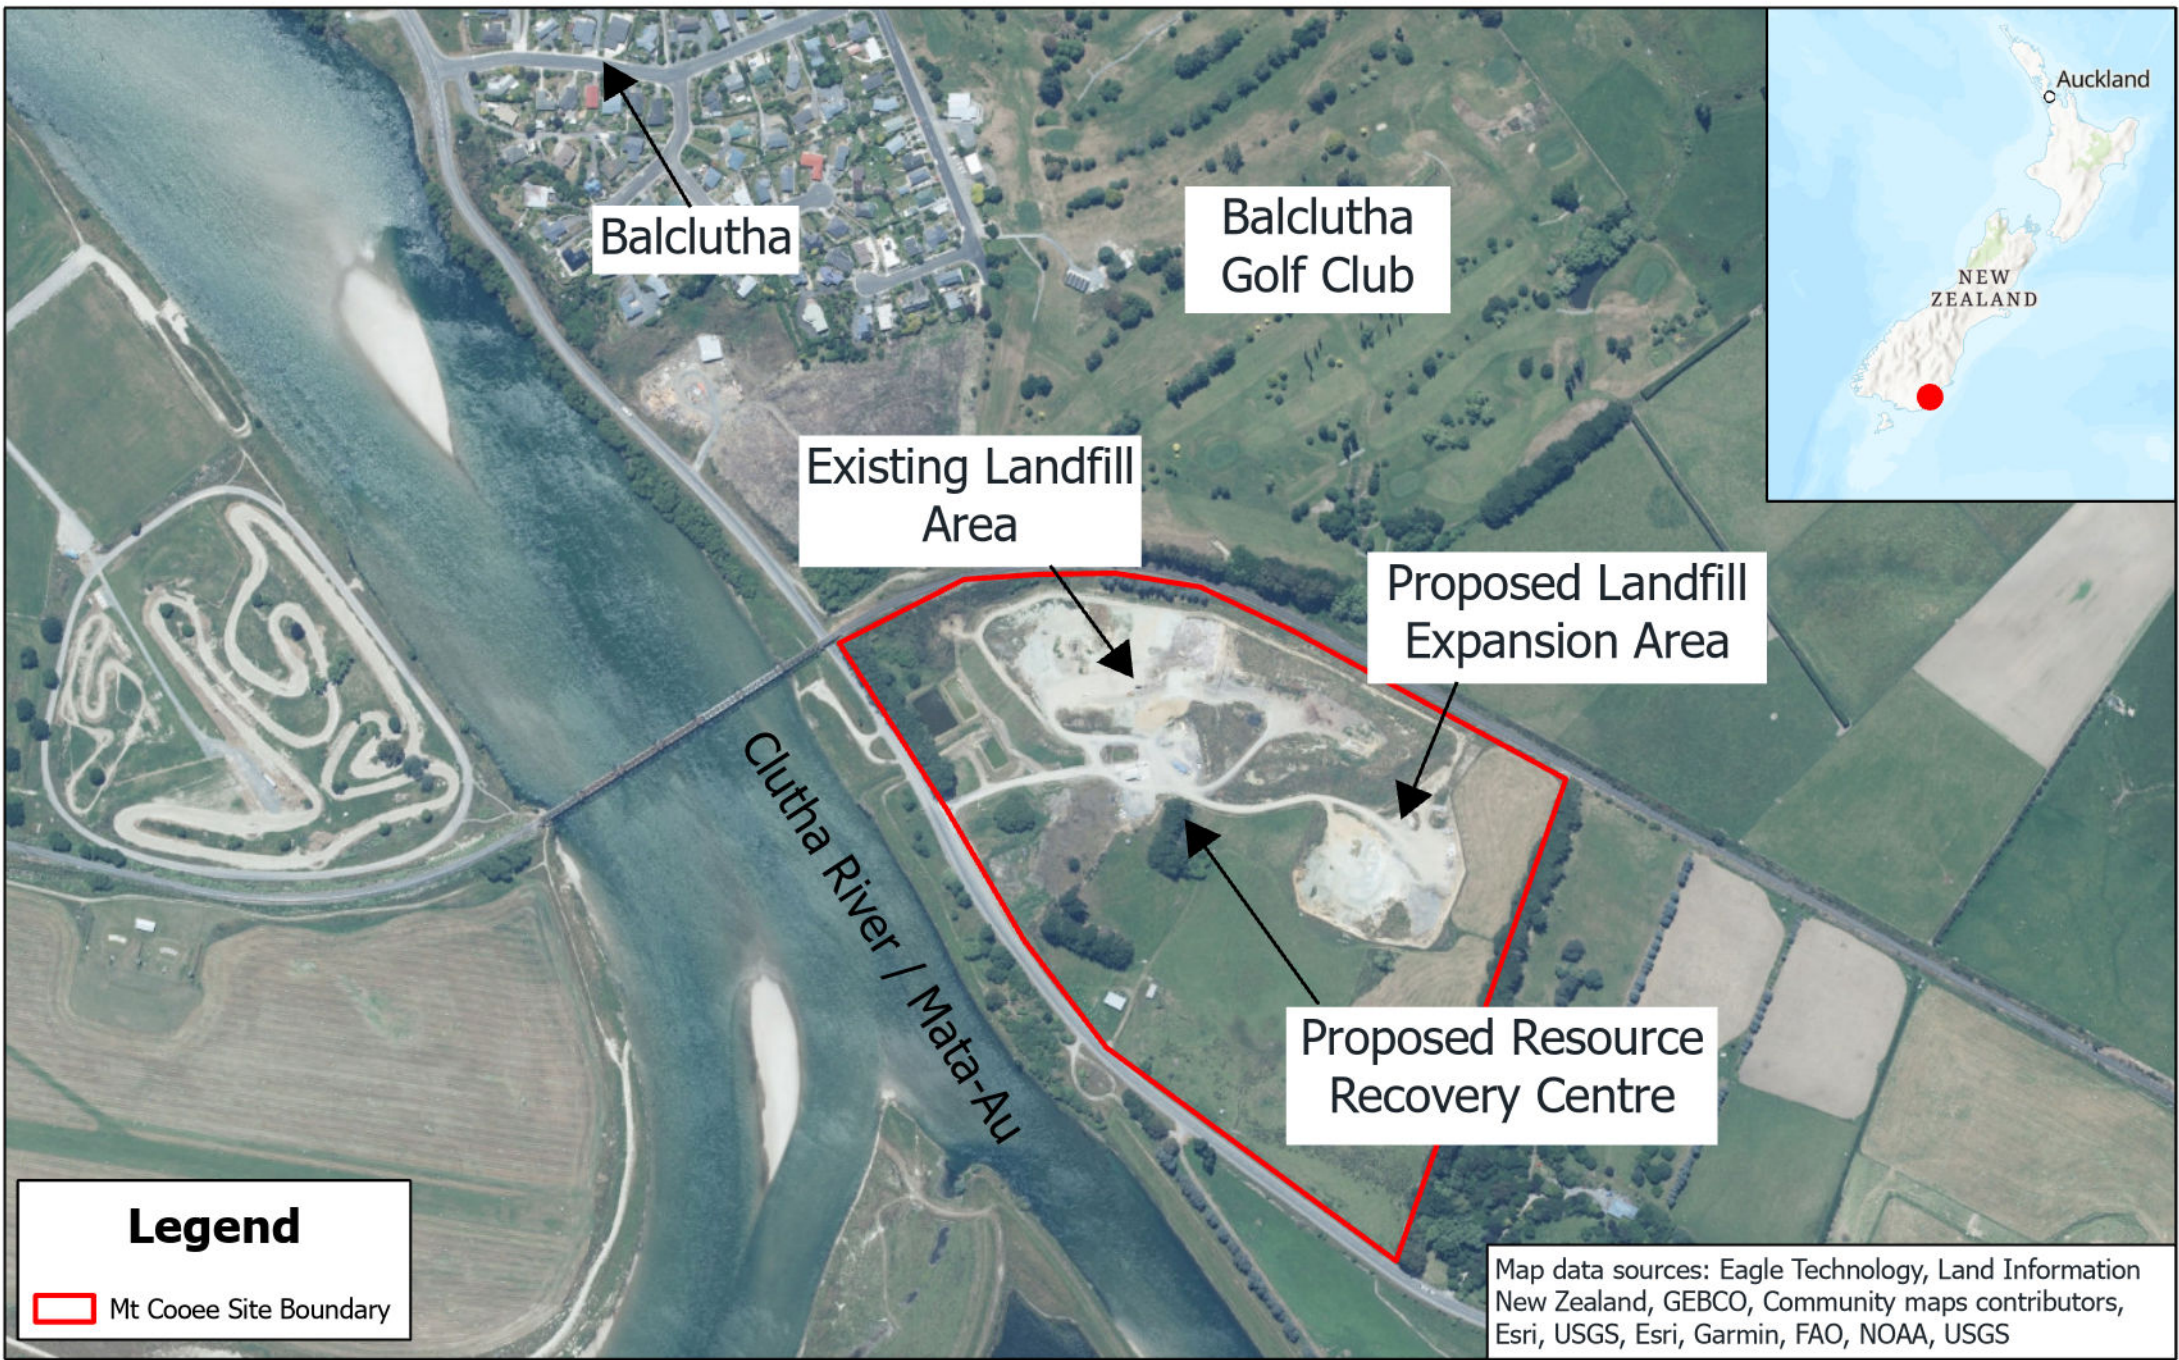
**Mt Cootee Landfill Development Plan**  
**Mt Cootee Location Map**

The landfill site is approximately 16.5 ha. in total. The existing landfill cells and associated facilities have been built within a shallow stream valley orientated northeast to southwest. The proposed expansion area on the eastern side of the site comprises outcropped bedrock, grazing paddocks and a wetland area to the southeast. A small rock quarry is located on the south side of the site, to the south of the public road entrance from the highway. The northern and western boundaries of the site are bordered by the South Island main trunk railway and its railway reserve. The Balclutha Golf Course is located beyond the railway corridor to the north. The site is bordered to the east by private farmland and a residential property. To the south, the landfill site is adjacent to the Clutha River/Mata-Au.

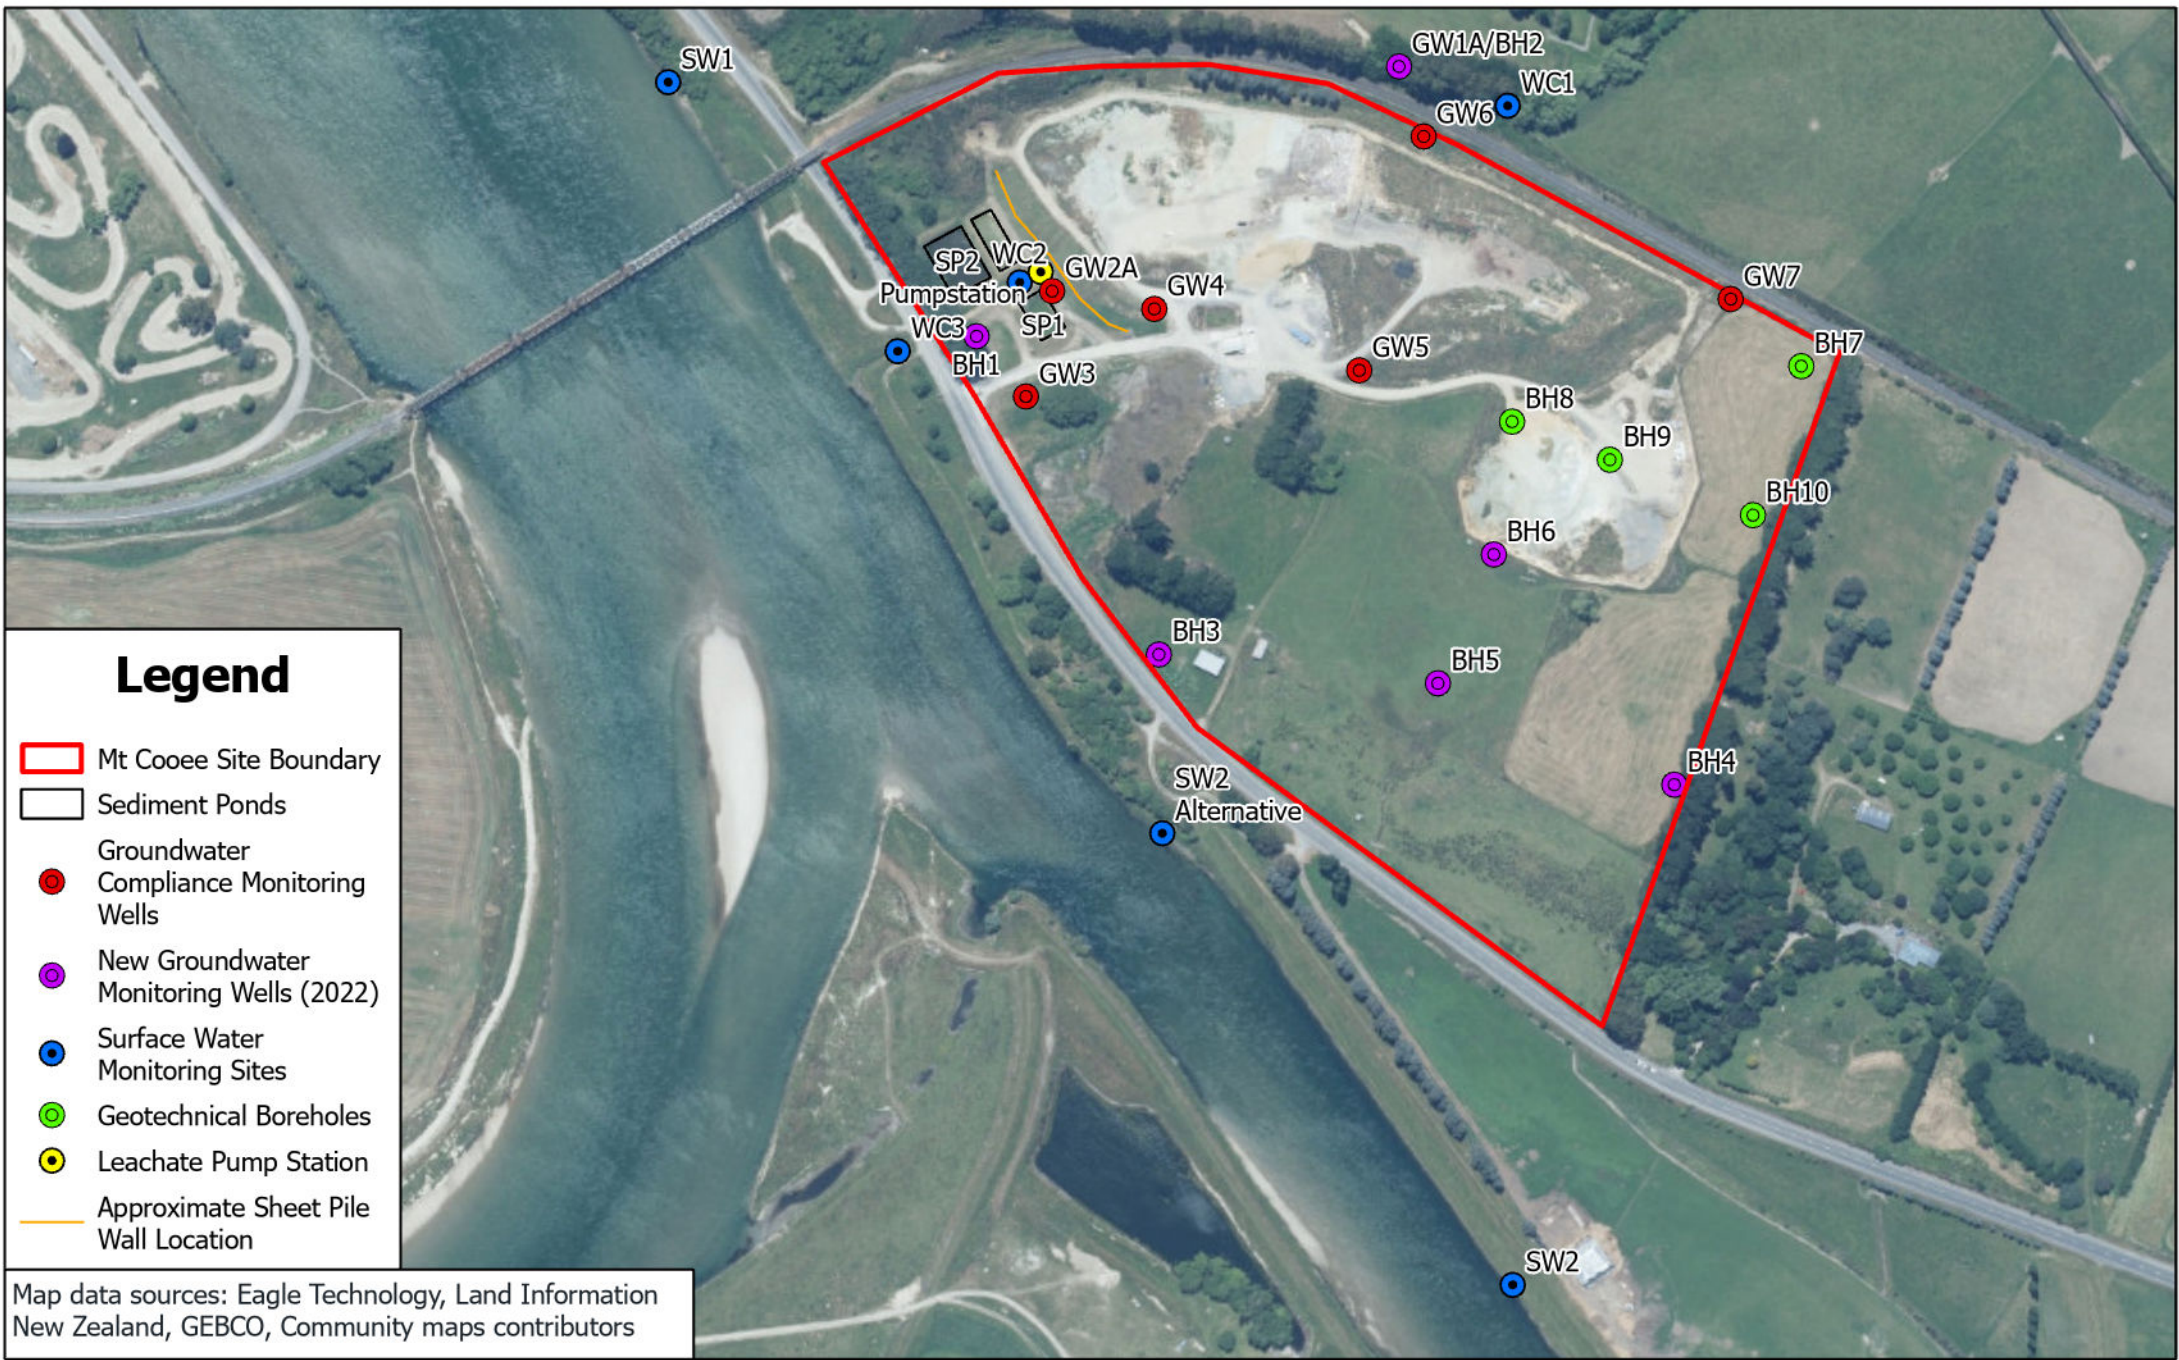
**Mt Cooee Landfill Development Plan  
Mt Cooee Sampling Location Map**

In addition to the compliance monitoring specified in the resource consents, WasteCo is required to undertake additional monitoring and sampling under its contract with CDC. These contractual monitoring requirements include the following analysis in groundwater wells:

- Quarterly analysis for potassium, nitrate-nitrogen (NO<sub>3</sub>-N) and soluble boron.
- Annual (in October) analysis at leachate monitoring wells GW2A, GW3, GW4 and GW5 for alkalinity, total organic carbon (TOC), total Kjeldahl nitrogen (TKN), dissolved reactive phosphorus (DRP), silica, and soluble trace elements (manganese, aluminium, arsenic, cadmium, chromium, copper and nickel).
- Biennial (in May) analysis for volatile organic compounds (VOCs), acid herbicides, and semi-volatile organic compounds (SVOCs) from the leachate sump at the pump station.

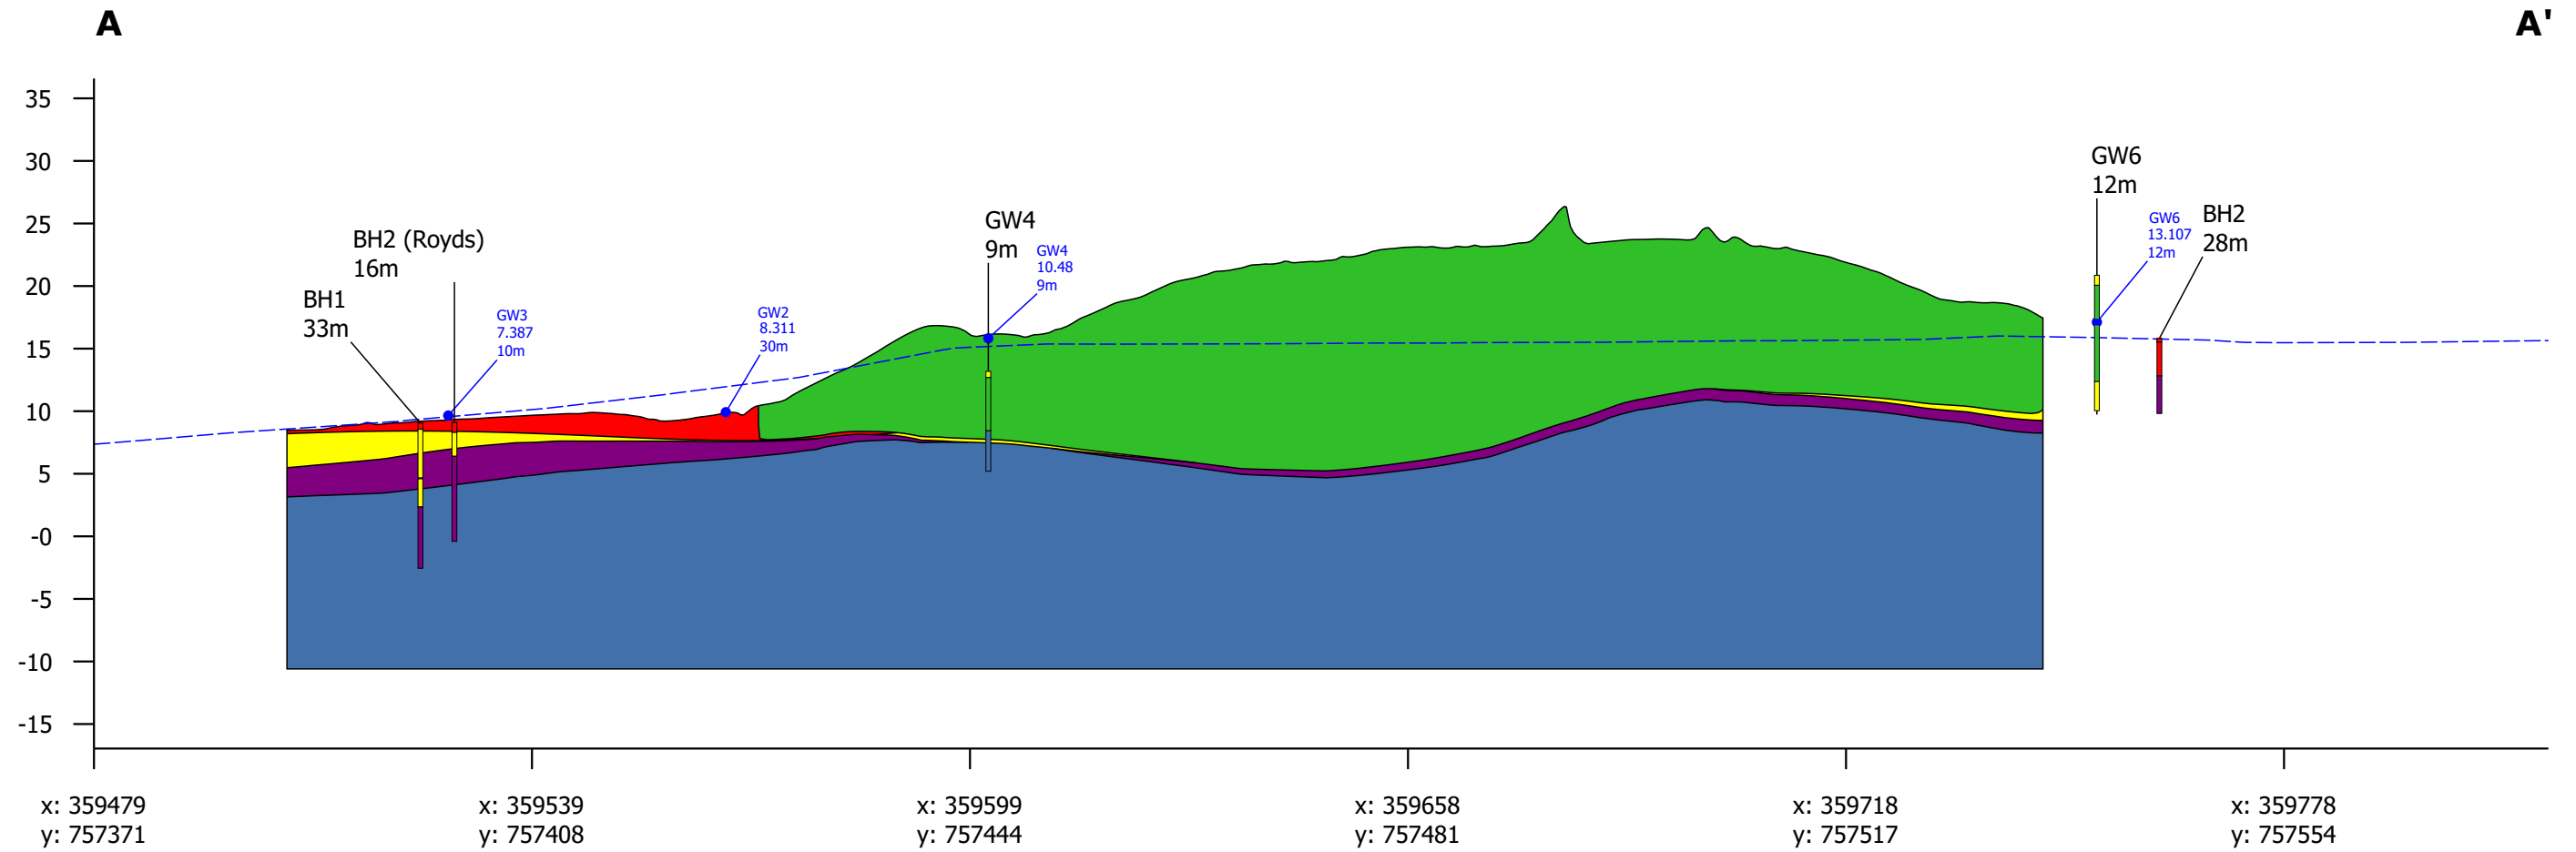
# Geological Cross-Section and Water Level Surface A - A'

Figure 6 to Figure 8 show cross-sections based on the ground model developed from the geotechnical site investigations overlaid with an interpolated water level surface from a piezometric survey on 29 November 2022. We produced the interpolated water level surface using Leapfrog Works software, which was used to build the ground model.

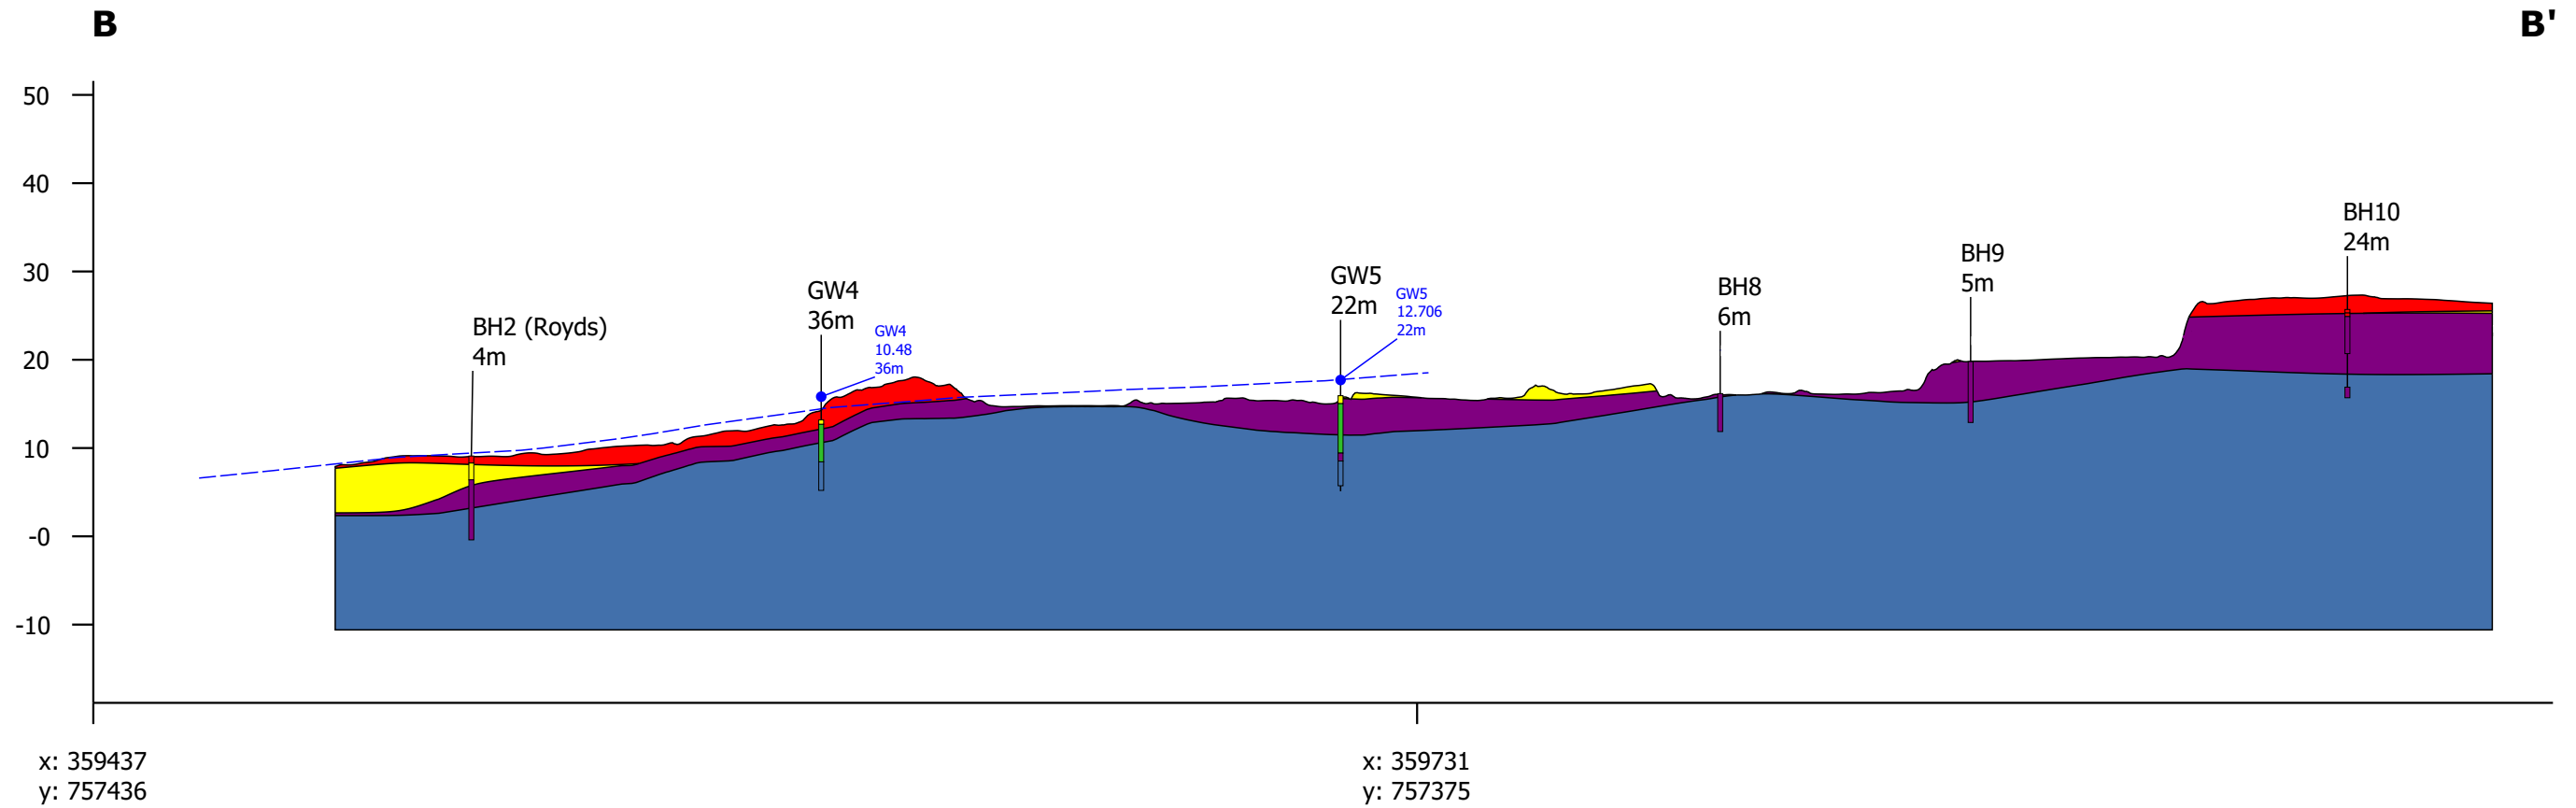
# Geological Cross-Section and Water Level Surface B - B'

Note: Groundwater surface has only been drawn where there are sufficient water level observations. Groundwater surface interpolated using Leapfrog Works.

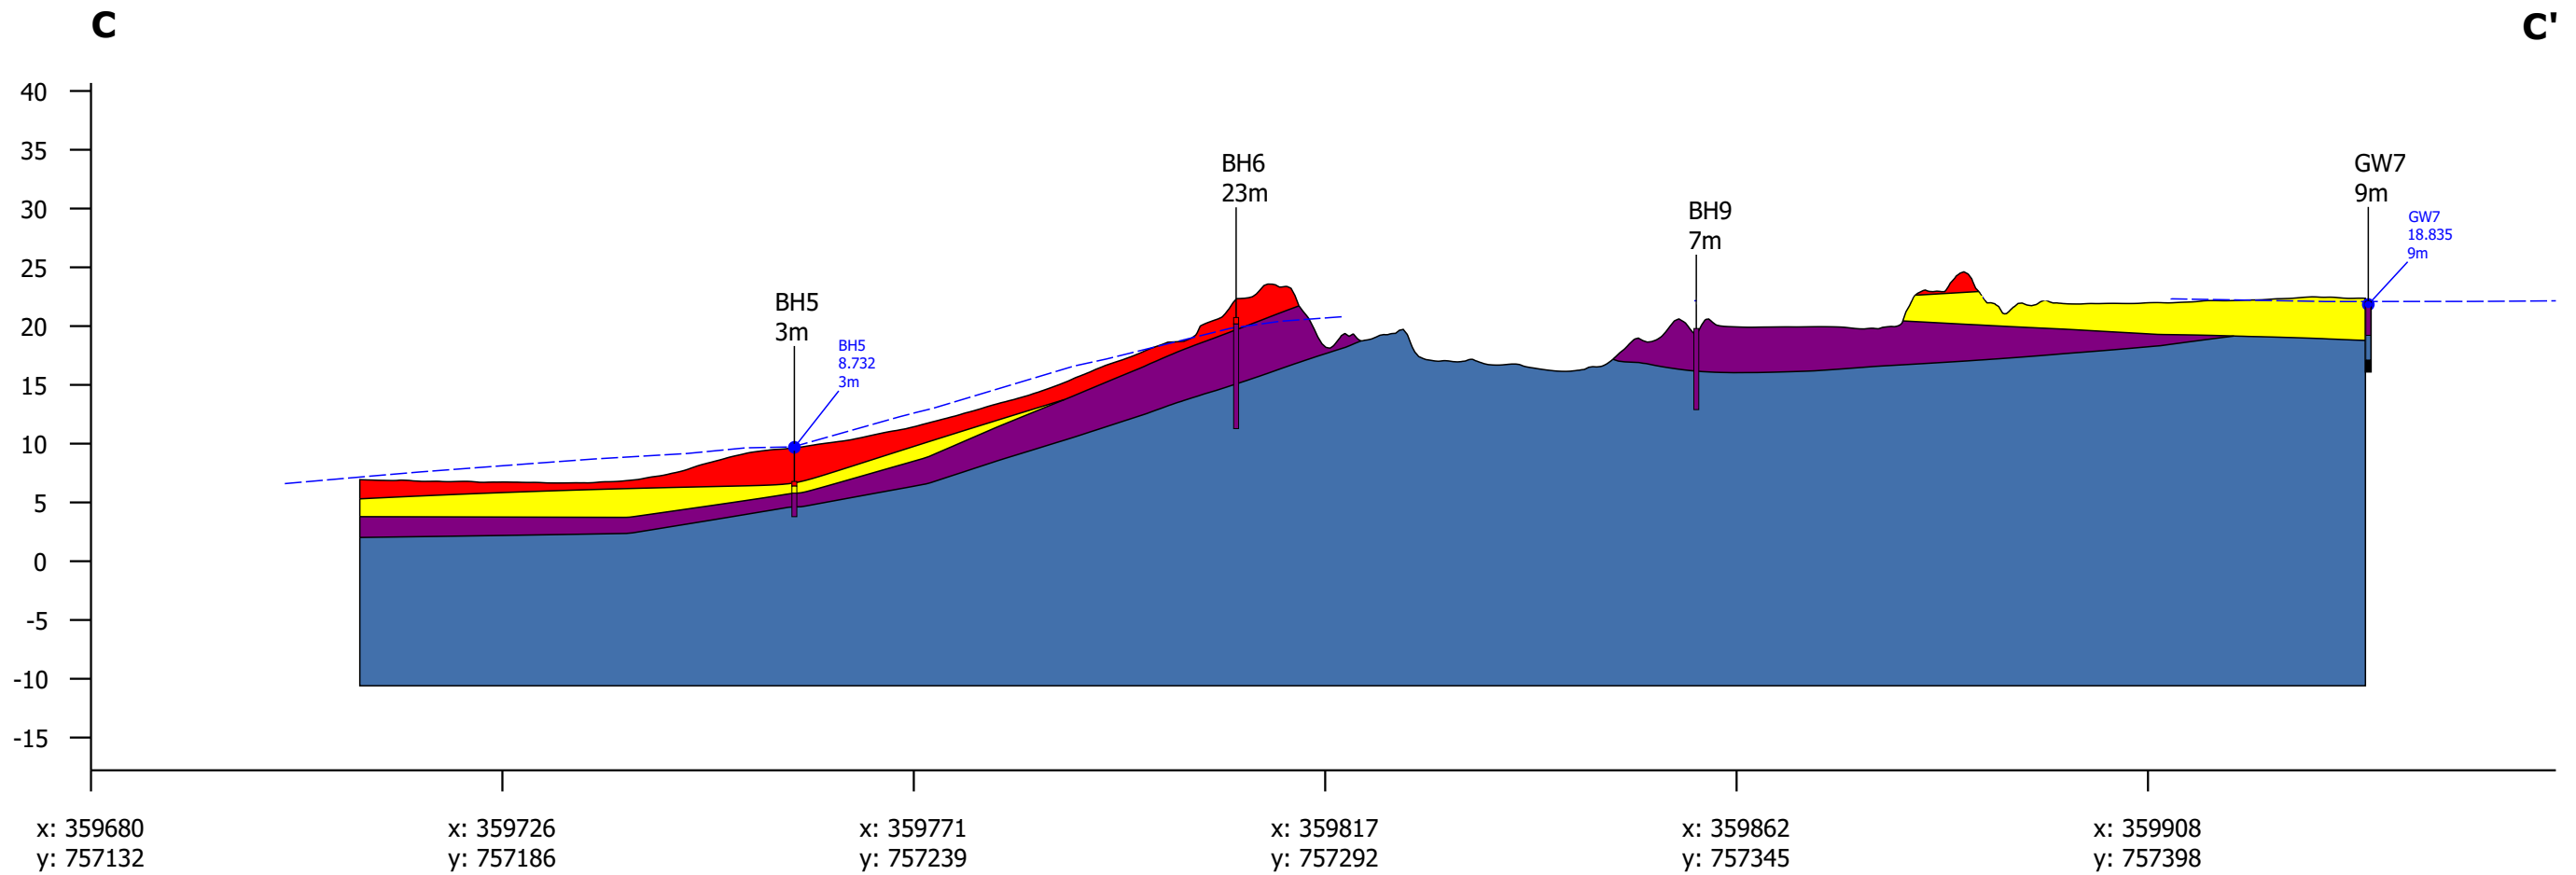
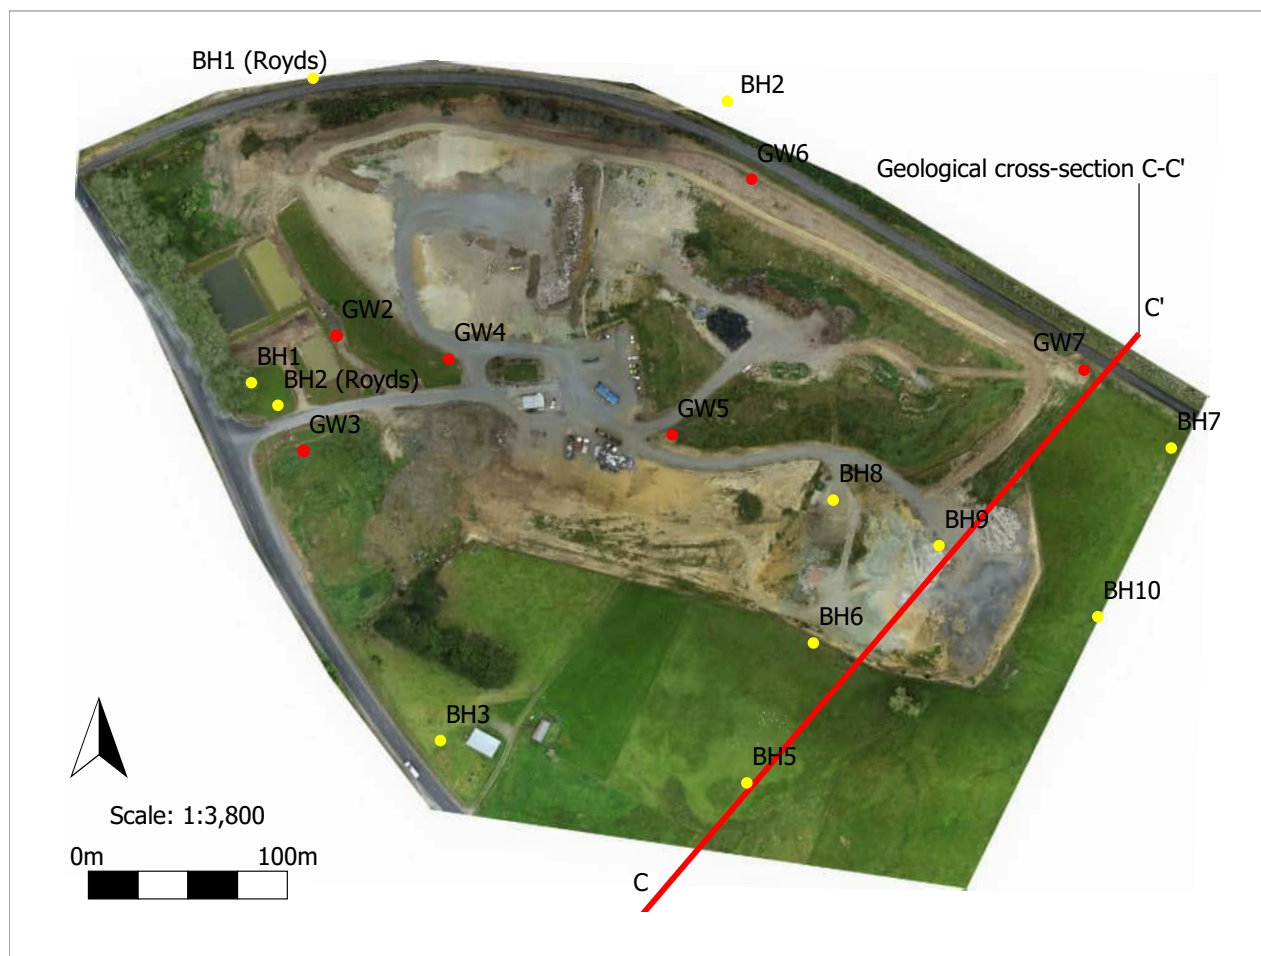
# Geological Cross-Section and Water Level Surface C - C'

Note: Groundwater surface has only been drawn where there are sufficient water level observations. Groundwater surface interpolated using Leapfrog Works.

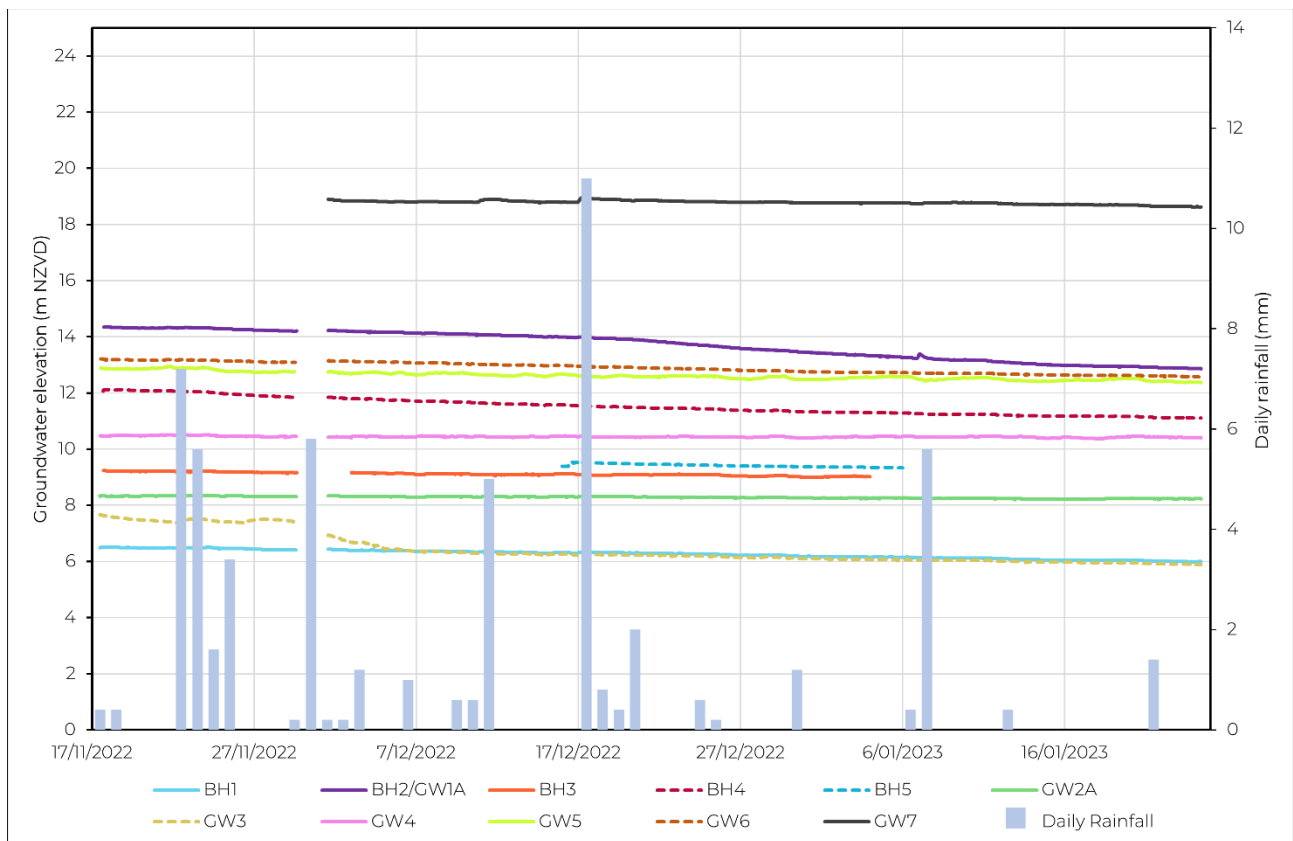
Figure 9: Groundwater elevations measured at 15-minute intervals from 16 November 2022-24 January 2023. Rainfall data sourced from NIWA Cliflo Balclutha Finegand station. Data notes: Gap in data on 29-30 November 2022 during permeability testing. Data record for GW7 begins on 1 December 2022. Additional gaps for BH3 and BH5 when wells were dry. BH6 was dry for entire period and is not shown on the plot.

Continuous groundwater levels were recorded from 16 November 2022 to 24 January 2023. Solinst Levelloggers (i.e., non-vented pressure transducers) were installed in all monitoring wells on site on 16 November 2022 to record groundwater levels at 15-minute intervals (Figure 9). We installed a Barologger in BH1 to record barometric pressure changes for atmospheric compensation of the water level data. We took manual water level measurements when the loggers were downloaded to calibrate the water level record. Wells BH3 and BH5 were dry for part of the monitoring period, while BH6 was dry through the entire monitoring period.

The monitoring period coincided with a relatively dry period, particularly from 18 December 2022 to 22 January 2023 when there was only 13 mm of rainfall at the Balclutha Finegrand climate station (National Institute of Water and Atmosphere (NIWA), 2023). This small amount of rainfall is potentially linked to some of the monitoring wells being dry during November 2022 to January 2023. Over this period, groundwater levels were relatively stable or had a declining trend (Figure 9). The greatest groundwater level fluctuations were observed in GW3 (1.76 m decline) and GW1A (1.48 m decline). In terms of rainfall response, water levels in GW2A and GW7 had clear rainfall responses (i.e., abrupt groundwater level rises following rainfall), with GW7 having the most significant response of all wells. GW1A and BH4 had relatively small responses to rainfall. There may have been a small rainfall response in wells GW4, GW5 and GW7, however it is difficult to ascertain, likely because these wells are screened at least in part within landfill cells. There was no discernible rainfall response in BH1, BH3, BH5, BH6 or GW3. As the relative differences are small, it is difficult to view rainfall responses in Figure 9.

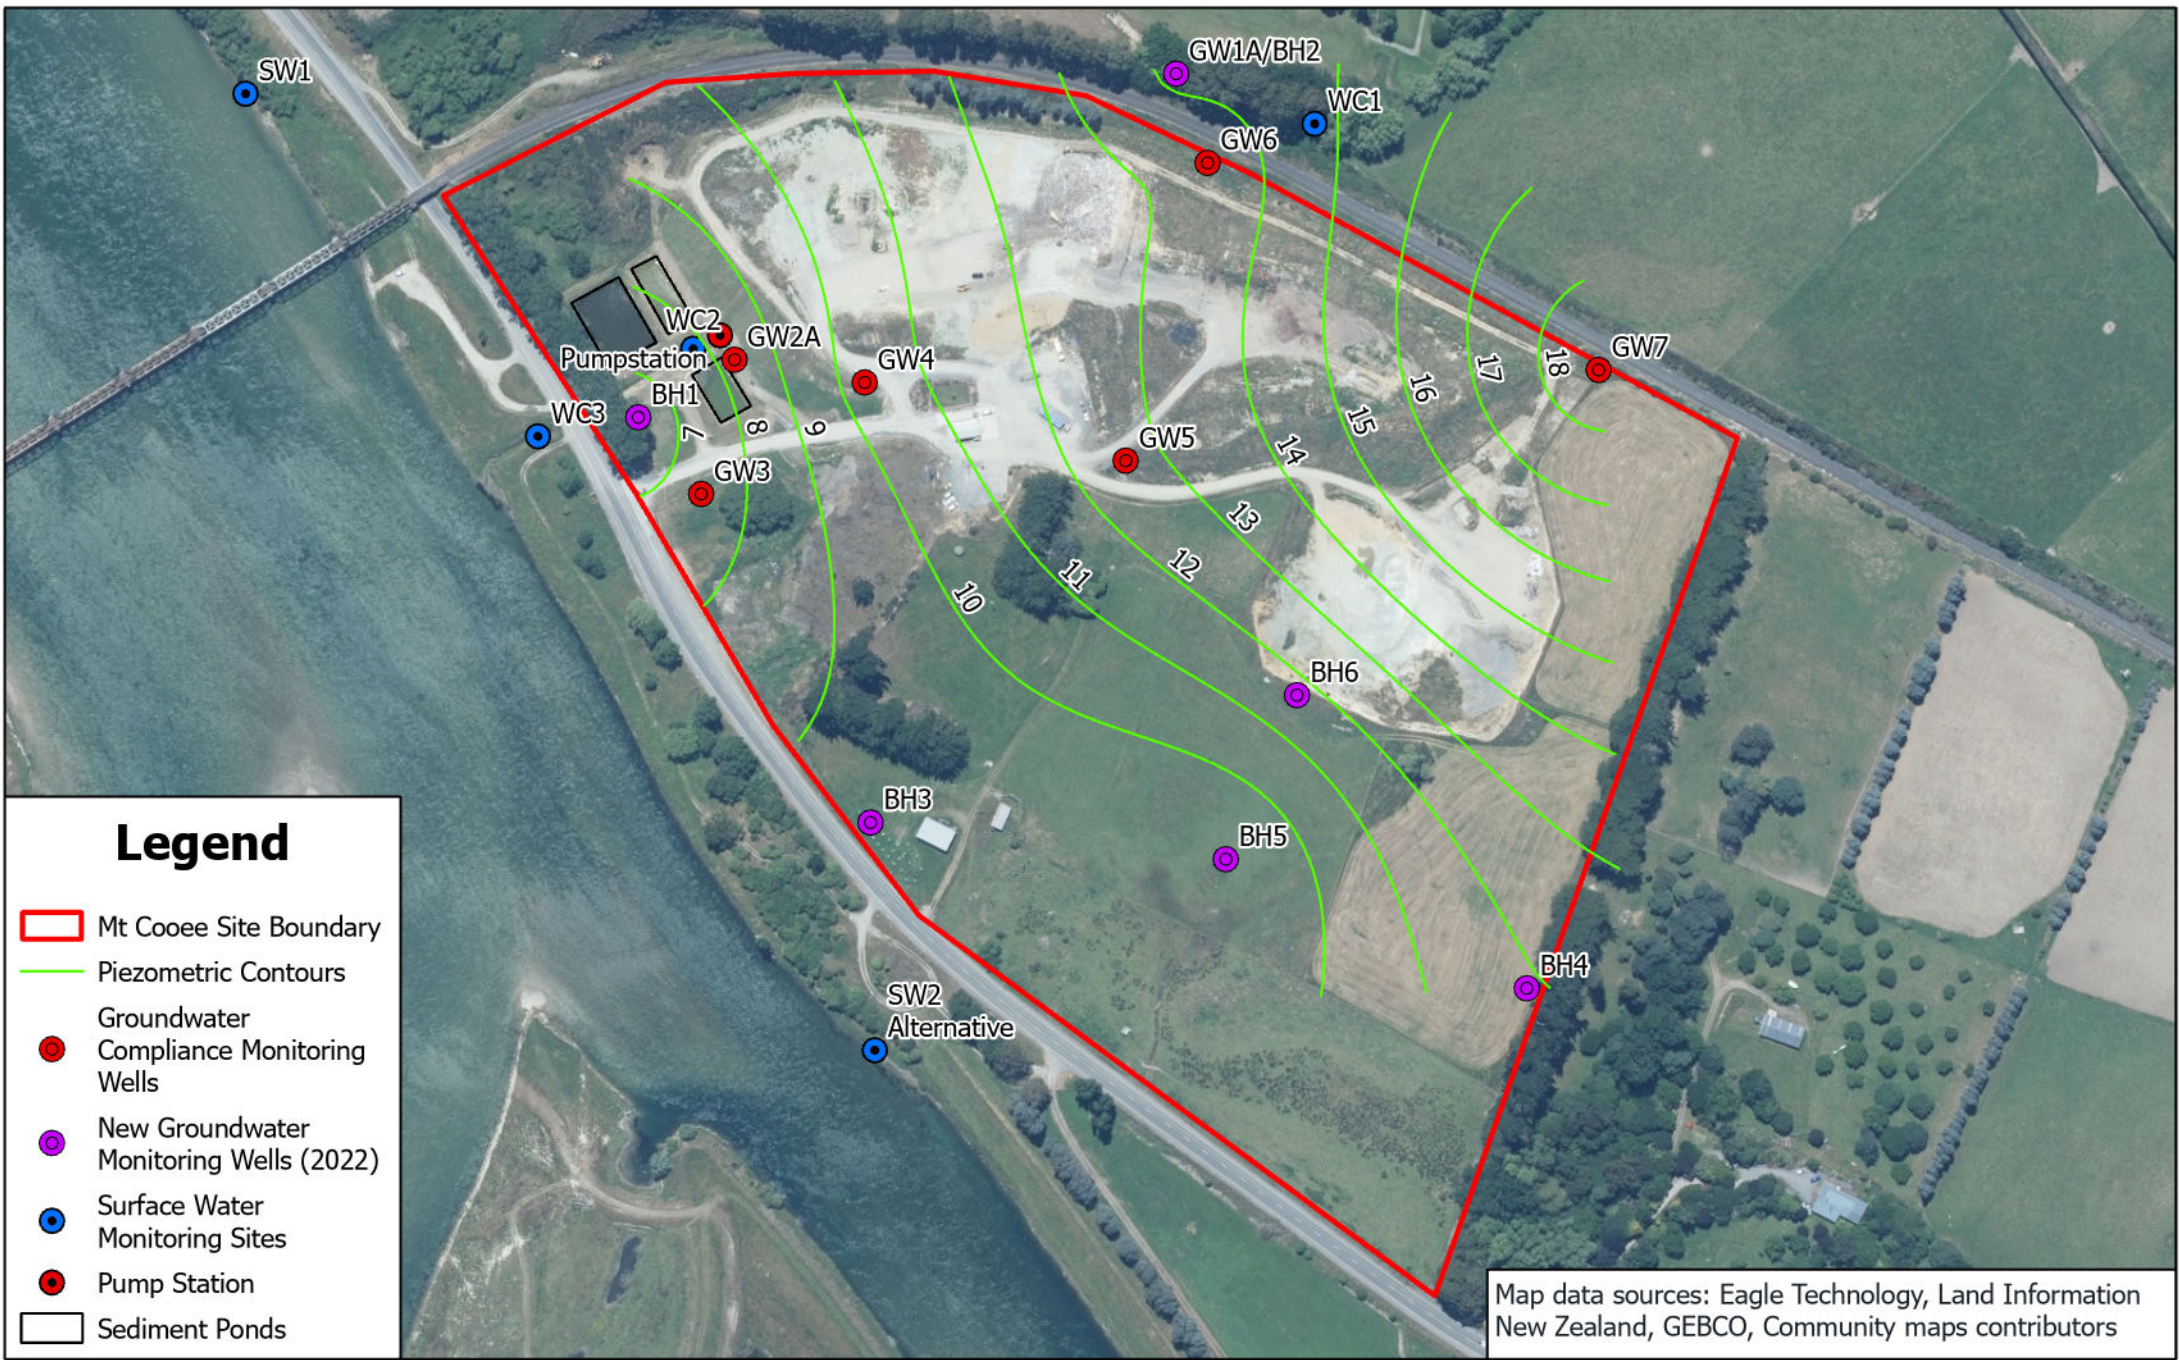
As shown in the water level contour map (Figure 10), there appears to be a horizontal hydraulic gradient within groundwater from the north of the site towards the Clutha River/Mata-Au. There are no groundwater wells clearly installed in different aquifer units adjacent to each other on the existing landfill site (i.e., nested wells), so on that basis, it is difficult to draw strong conclusions about the degree of vertical hydraulic gradients on site. As noted above, based on the water levels observed, it appears that groundwater level gradients largely follow topography, reducing in elevation southwest towards the Clutha River/Mata-Au.

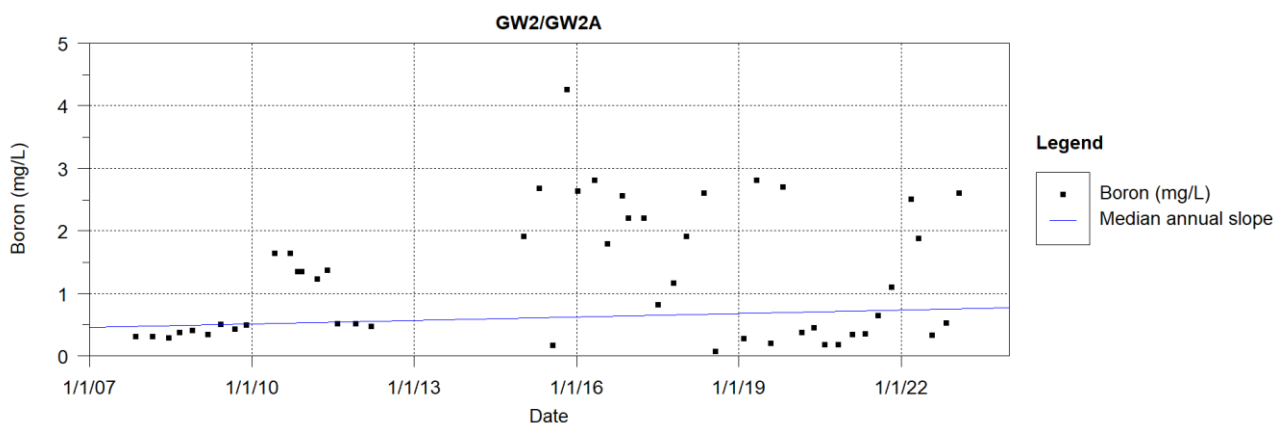
Figure 12 : Long-term trend analysis for boron in impact well GW2/GW2A.

For three key potential landfill contaminant indicators (boron, chloride and nitrate-nitrogen) we have analysed long-term trends (2007-2023) in impact wells GW2 and GW3 (Figure 12 to Figure 17). GW2 was replaced by GW2A in 2021 with the new located very close to the original well, so we have grouped results for both wells together. To analyse for long-term trends, we carried out Mann-Kendall analysis using NIWA Time Trends software and considered p values <0.05 as statistically significant. Table 7 summarises the trends for these three variables. There were strong increasing trends for nitrate-nitrogen in both GW2/GW2A and GW3. There was also an increasing trend in boron in GW3 but no trend in GW2/GW2A. Long-term data for chloride on the other hand showed a strong decreasing trend in GW2/GW2A but no significant trend in GW3.

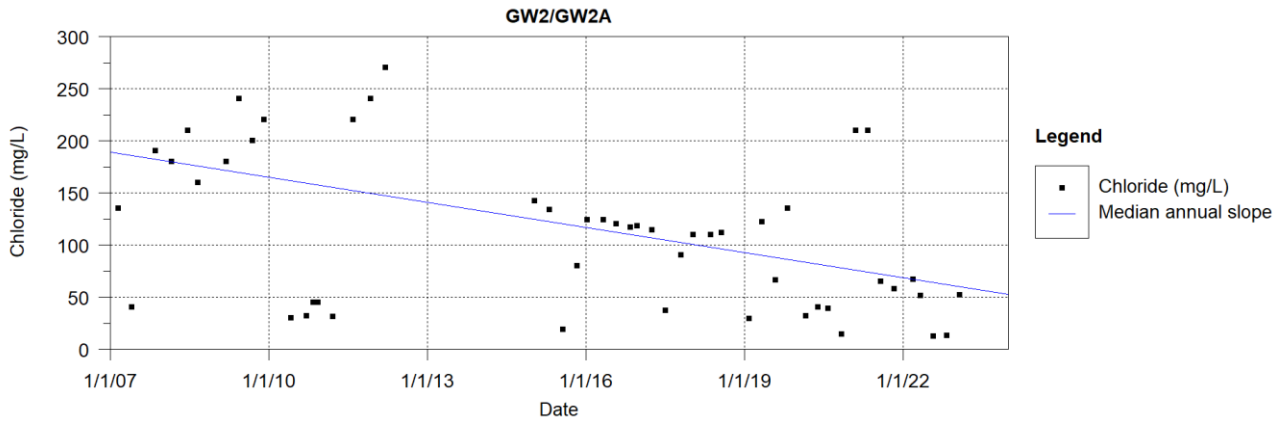
Figure 13: Long-term trend analysis for chloride in impact well GW2/GW2A.

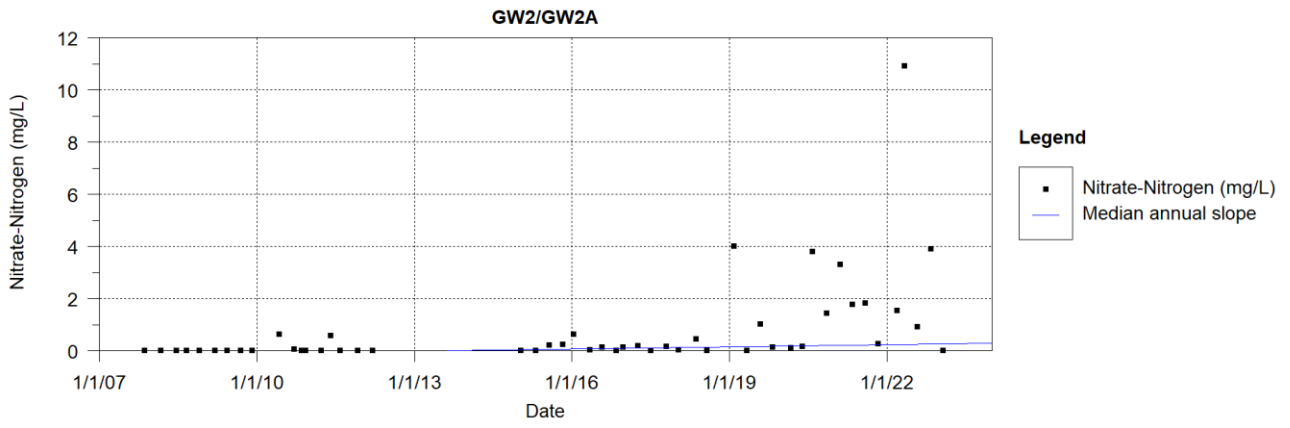
Figure 14: Long-term trend analysis for nitrate-nitrogen in impact well GW2/GW2A.

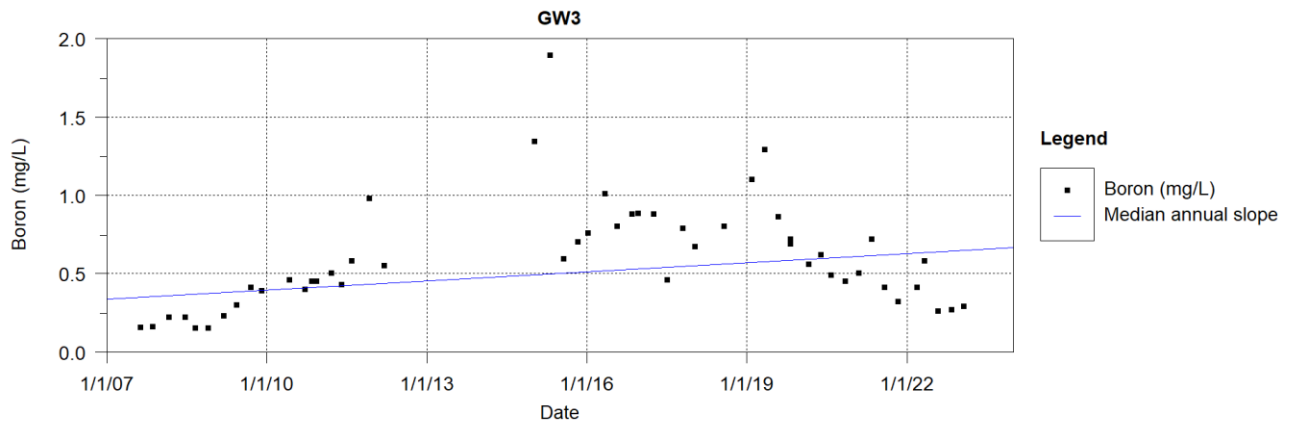
Figure 15: Long-term trend analysis for boron in impact well GW3.

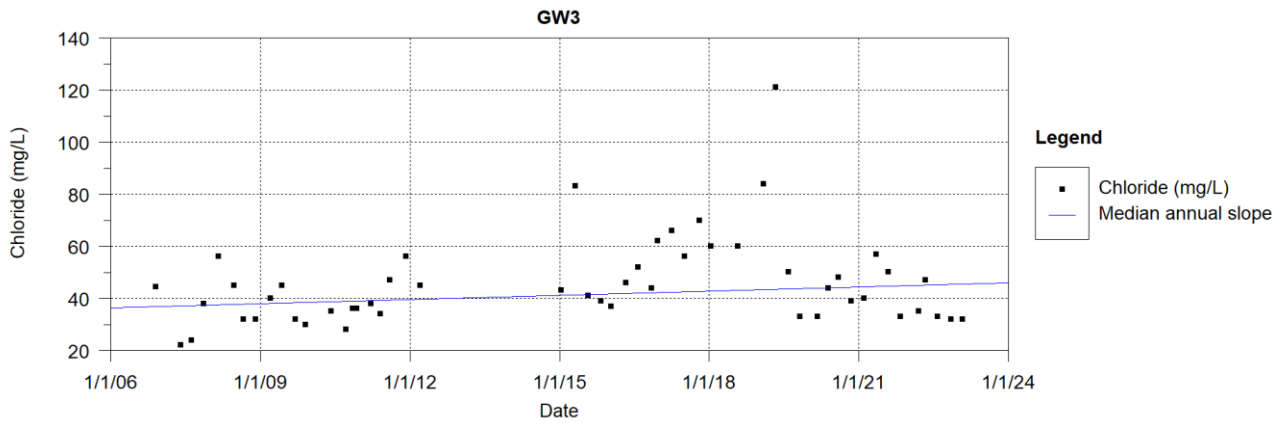
Figure 16 : Long-term trend analysis for chloride in impact well GW3.

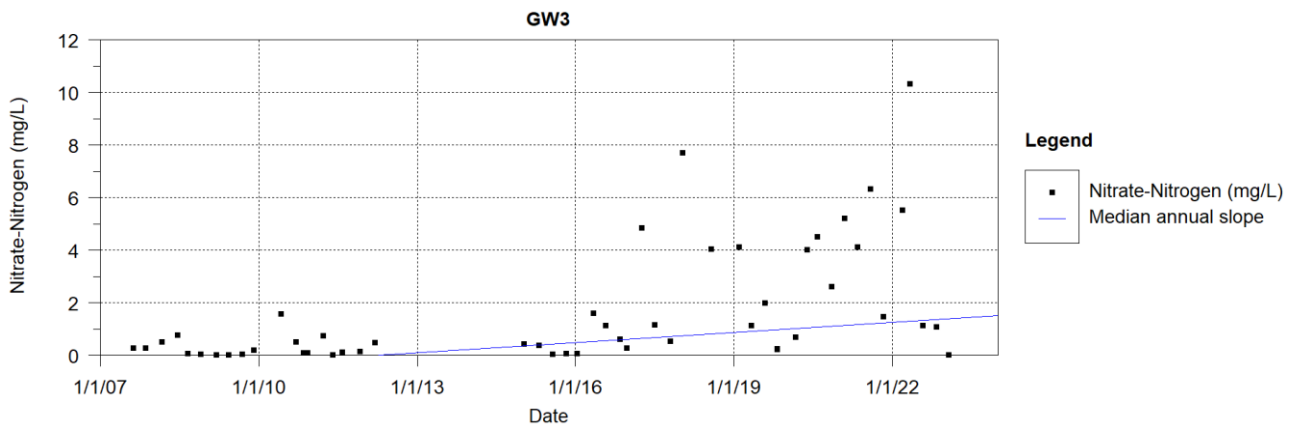
Figure 17 : Long-term trend analysis for nitrate-nitrogen in impact well GW3.
