Project Number: 6-CO082.00

# Mt Cooee Landfill Resource Consent Application

Assessment of Effects on Groundwater and Surface Water

27 April 2023

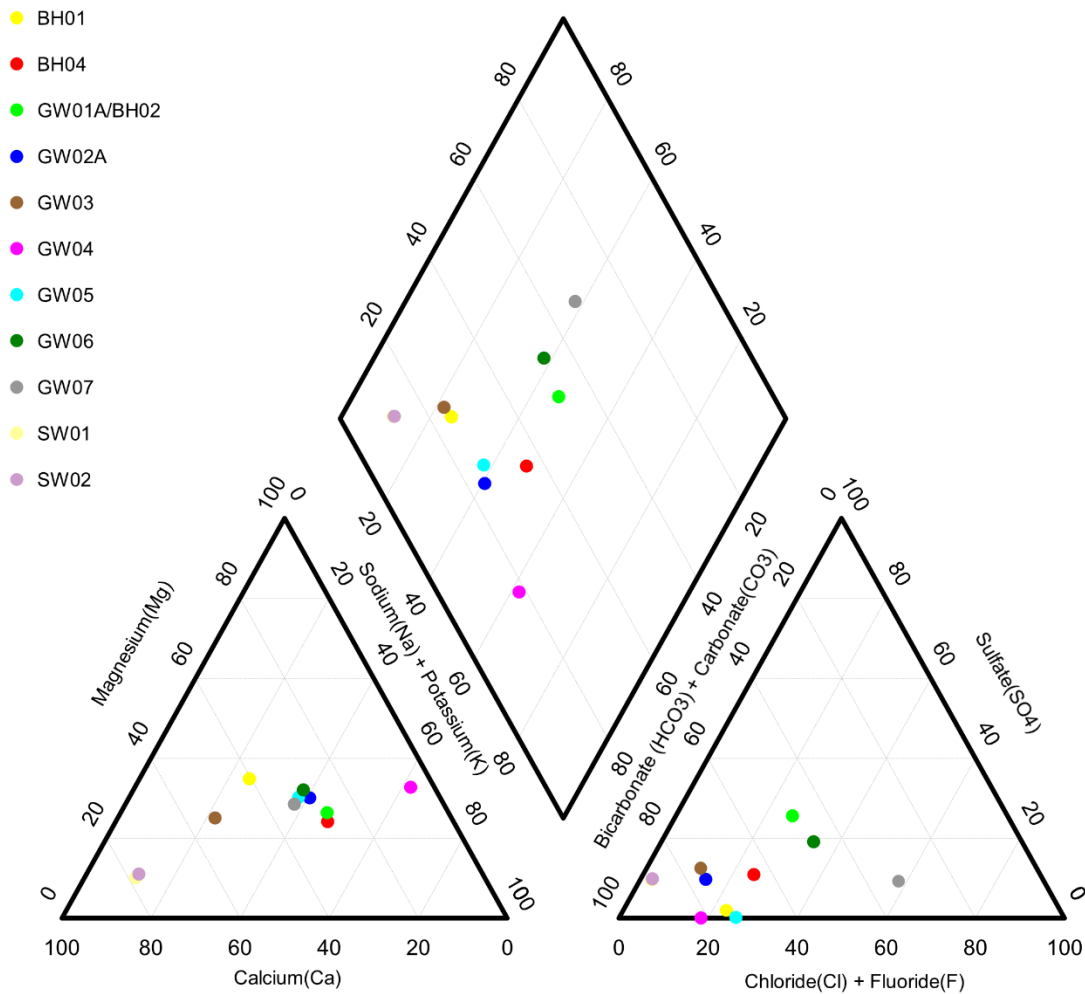
Figure 18. Piper plot showing major ion chemistry in groundwater and surface water sampling locations. Based on sampling data from 23-24 January 2023.

We note that BH1 is a new downgradient groundwater monitoring well, screened in the greywacke and deeper than GW2A and GW3; therefore, it is worthwhile looking generally at whether water chemistry in BH1 is similar to that of GW2A and GW3. Alternatively, it could be more reflective of upgradient water chemistry, i.e., representing deeper flowpaths within the greywacke that are not influenced by landfill leachate. However, when major ion chemistry is plotted on a piper plot to examine water types, it appears that water sampled in BH1 is similar to GW2A and GW3 (these samples plot to the left side of the top diamond in Figure 18. Upgradient wells GW7 and GW1A plot on other end of the piper plot (Figure 18) suggesting different water

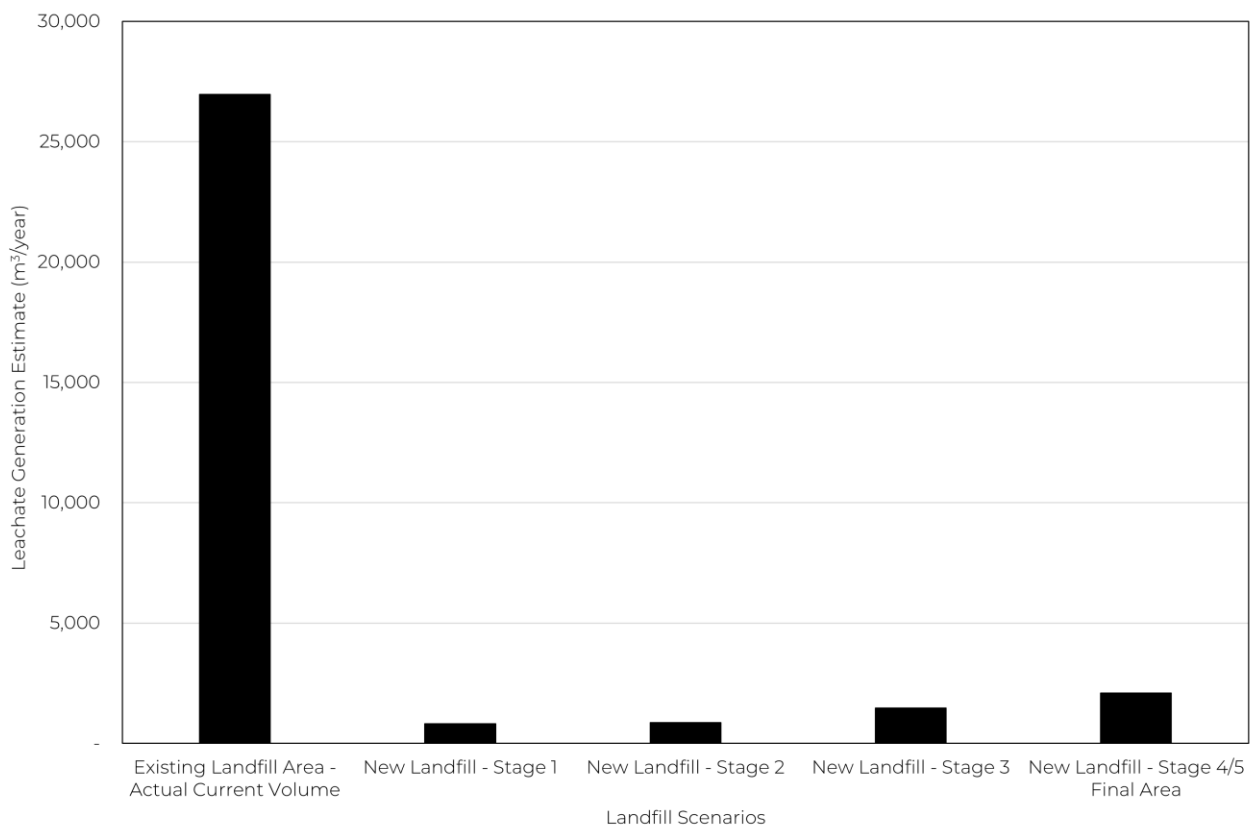
Figure 19 : Leachate generation estimates for five landfill scenarios at Mt Cooee. Note that for Stages 1 to 4/5 of the expansion area, leachate volumes are cumulative.

In this section we estimate leachate generated from the existing and expansion area landfill cells, as well as leachate leakage to groundwater underneath the cells (Table 10, Figure 19, Figure 20). We have used the same landfill scenarios, footprint areas and surface runoff estimates as in Table 9.

Leachate estimates are highest in the existing landfill area compared to the expansion area based on the actual pump station volumes (26,962 m<sup>3</sup>/year). This is likely due to upgradient groundwater inflow, which would not occur in the expansion area given it will be lined. We note that based on the actual leachate volumes collected at the pump station, the estimate of total groundwater catchment discharge of 34,485 m<sup>3</sup>/year (Table 5) is likely an underestimate. This is based on a number of assumptions, some with moderate to high uncertainty, and this estimate should be considered further. Adopting a higher hydraulic conductivity value in the catchment groundwater discharge estimate (as discussed in Section 4.4.3), could account for the actual pump station volumes.

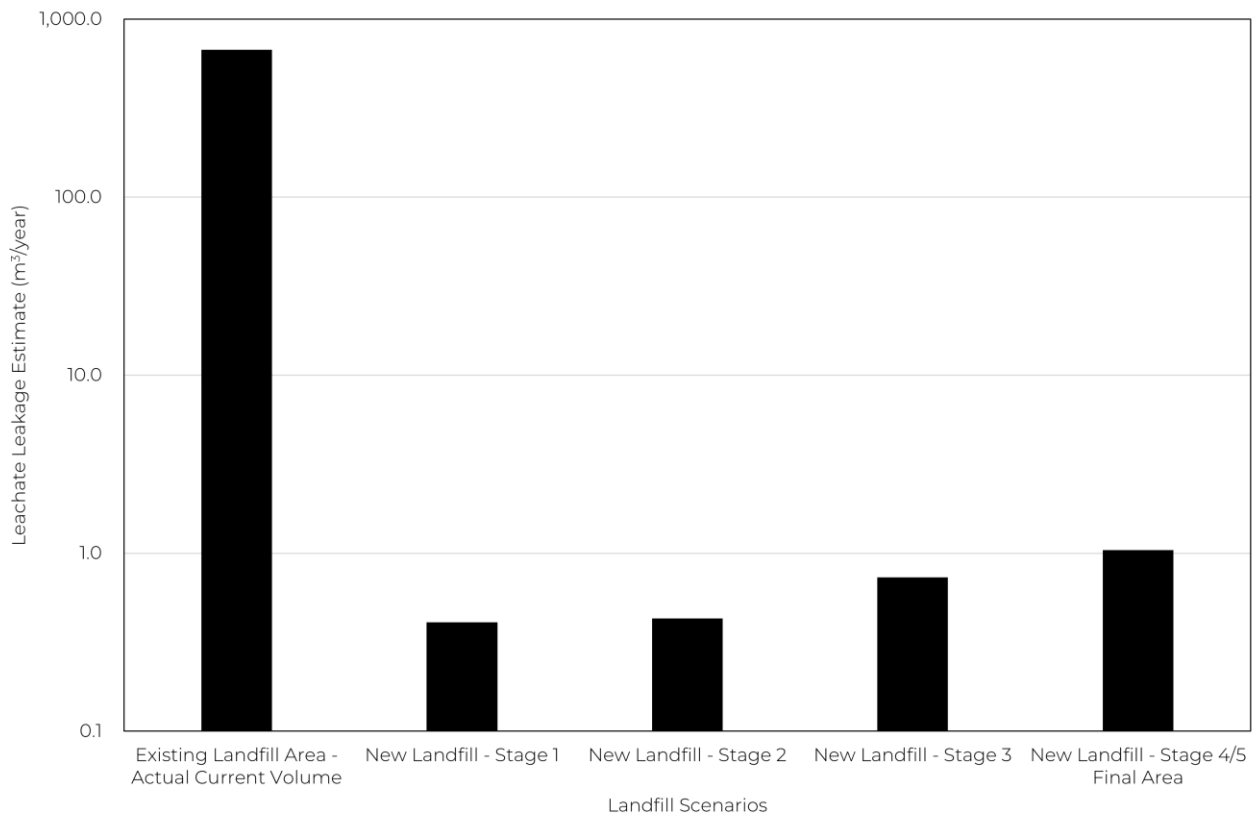
Figure 20: Leachate leakage estimates for five landfill scenarios at Mt Cooee. Note that data is presented on a log scale. Note that for Stages 1 to 4/5 of the expansion area, leachate volumes are cumulative.

We have also produced estimates of leachate leakage to groundwater below the landfill cells (Table 10 and Figure 20). Given the existing cells are unlined and the base of the landfill cells are greywacke, the permeability of this rock and hydraulic gradients will largely regulate leachate leakage rates. For leachate leakage to the underlying groundwater system, we have assumed a leakage rate of 2.5% resulting in an estimated 674 m<sup>3</sup>/year of leakage from the existing cells using the actual leachate collection volume as a basis for the calculation.

We have adopted an assumed maximum leachate rate from the Class 1 GCL liner proposed for the expansion area of 0.1 mm/year. This results in a maximum of 1 m<sup>3</sup>/year of leachate leakage from the final landfill area filled to full capacity (Stage 4/5). We based our estimates of leachate

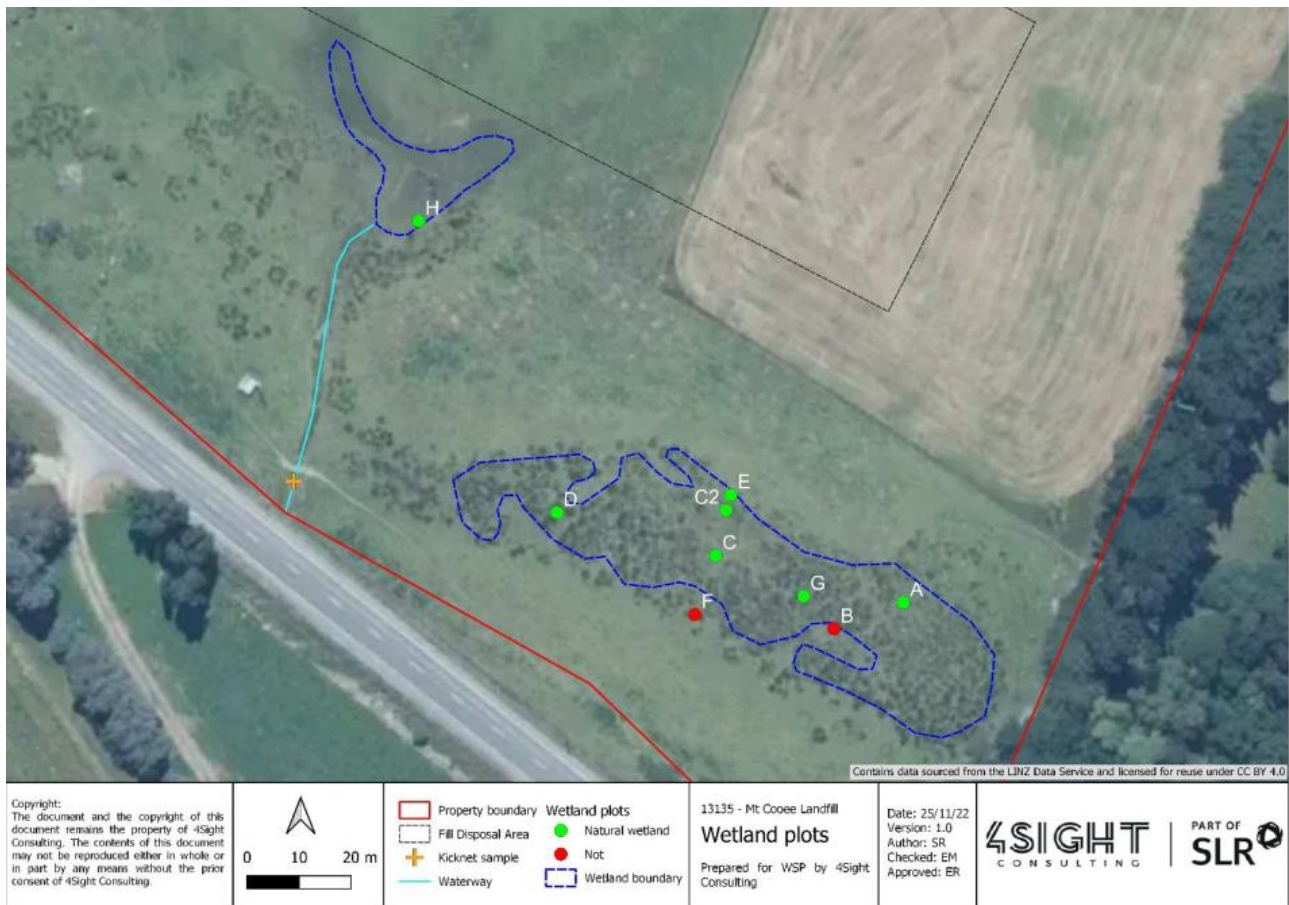
Figure 21: Small stream and wetlands identified on the southeast corner of the Mt Cooee site. Source: 4Sight Consulting (2022).

A small stream and wetland have also been identified in the southeast corner of the landfill site (4Sight Consulting, 2022). The head of the stream and wetland originate very close to the location of BH5. Groundwater level mapping indicates the groundwater level in this area is close to the land surface elevation at this location. Therefore, it is likely that the stream and wetland are groundwater fed to at least some degree. However, as observed on site, groundwater levels have been >1.5 m bgl in BH5 for an extended period of time during summer 2023. During periods of lower groundwater levels, groundwater flow to this stream and wetland could reduce.

Based on estimated reductions in groundwater levels and flow downgradient of the expansion area as discussed elsewhere, we do not anticipate a measurable impact on flows to the wetlands at the southeast corner of the site. As we have noted, the construction of the new landfill cells will block off some upgradient shallow groundwater flow, which would then naturally follow the path of least resistance and divert around the expansion area. As with impacts of this on the small stream (see Section 5.4.4), it is unclear with the current level of detail in this assessment how much of this diverted flow would still flow through the wetlands. Also, given the level of assumptions made in the water balance calculations in this assessment, it is not possible to say with high confidence what the water quantity effects would be on the wetlands.
