General distribution and characteristics of active faults and folds in the Waimate District and Waitaki District, South Canterbury and North Otago

D. J. A. Barrell

**GNS Science Consultancy Report 2015/166
Environment Canterbury Report R15/135
December 2016**

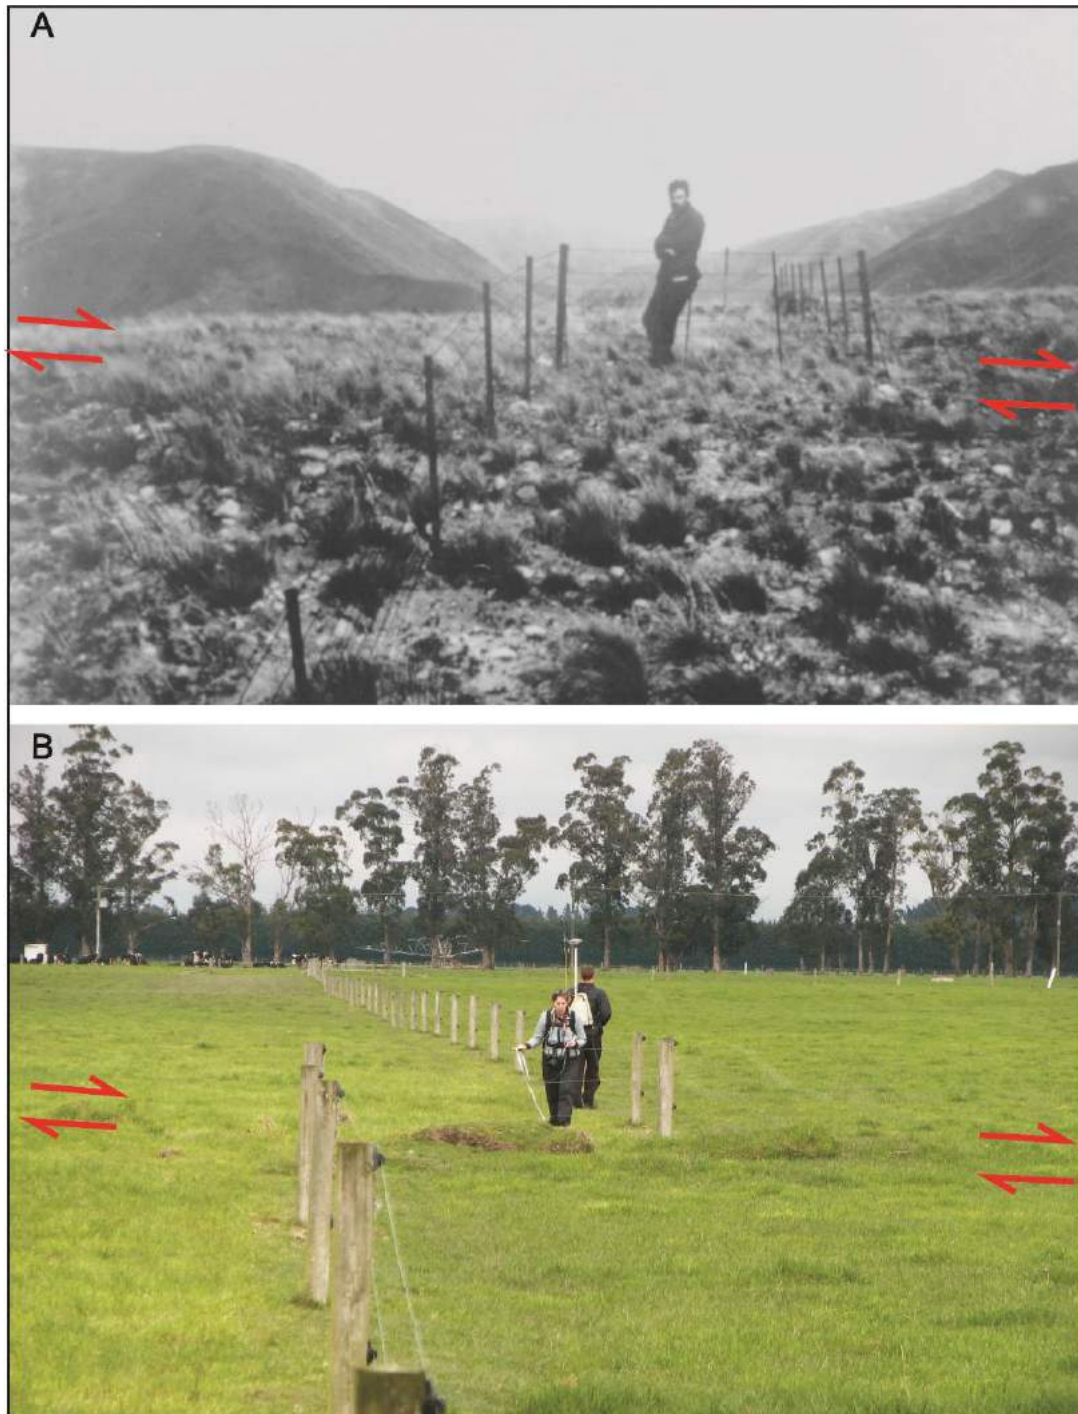
Figure 1.2 Illustrations of historical fault offsets of the ground surface in the Canterbury region. **A:** A fence offset sideways by ~2.4 m of strike-slip rupture on the Hope Fault west of Hanmer Springs during the 1888 North Canterbury Earthquake (Photo: A. McKay, GNS Science CN4852). **B:** A fence offset sideways by ~4.5 m of strike-slip rupture on the Greendale Fault during the 2010 Darfield Earthquake (Photo: N. J. Litchfield). Half-arrows either side of the fault indicate the direction of movement. In both cases, the movement is 'right-lateral', sometimes called 'dextral'. This means that to an observer, the ground on the far side of the fault has shifted sideways to the right. The effect is the same regardless of which side of the fault the observer is standing. The other type of strike-slip movement is 'left-lateral', sometimes called 'sinistral', but is not common in New Zealand.

Although the movement along the plate boundary is continuous over geological time, and can be measured by ground and satellite (GPS) surveying, rock of the Earth's crust is remarkably elastic and can accommodate a lot of bending before letting go and breaking suddenly (rupturing) along a fault, causing an earthquake. On large faults, the break may be big, and extend up to the Earth's surface, causing sudden offset and breakage (faulting), and/or buckling and warping (folding), of the ground surface, accompanied by a large earthquake. The 2010 Darfield Earthquake provided a good example of the nature and effects of a large, ground-surface-rupturing earthquake on a geological fault (e.g., Barrell et al. 2011; Villamor et al. 2011) (Figure 1.2).

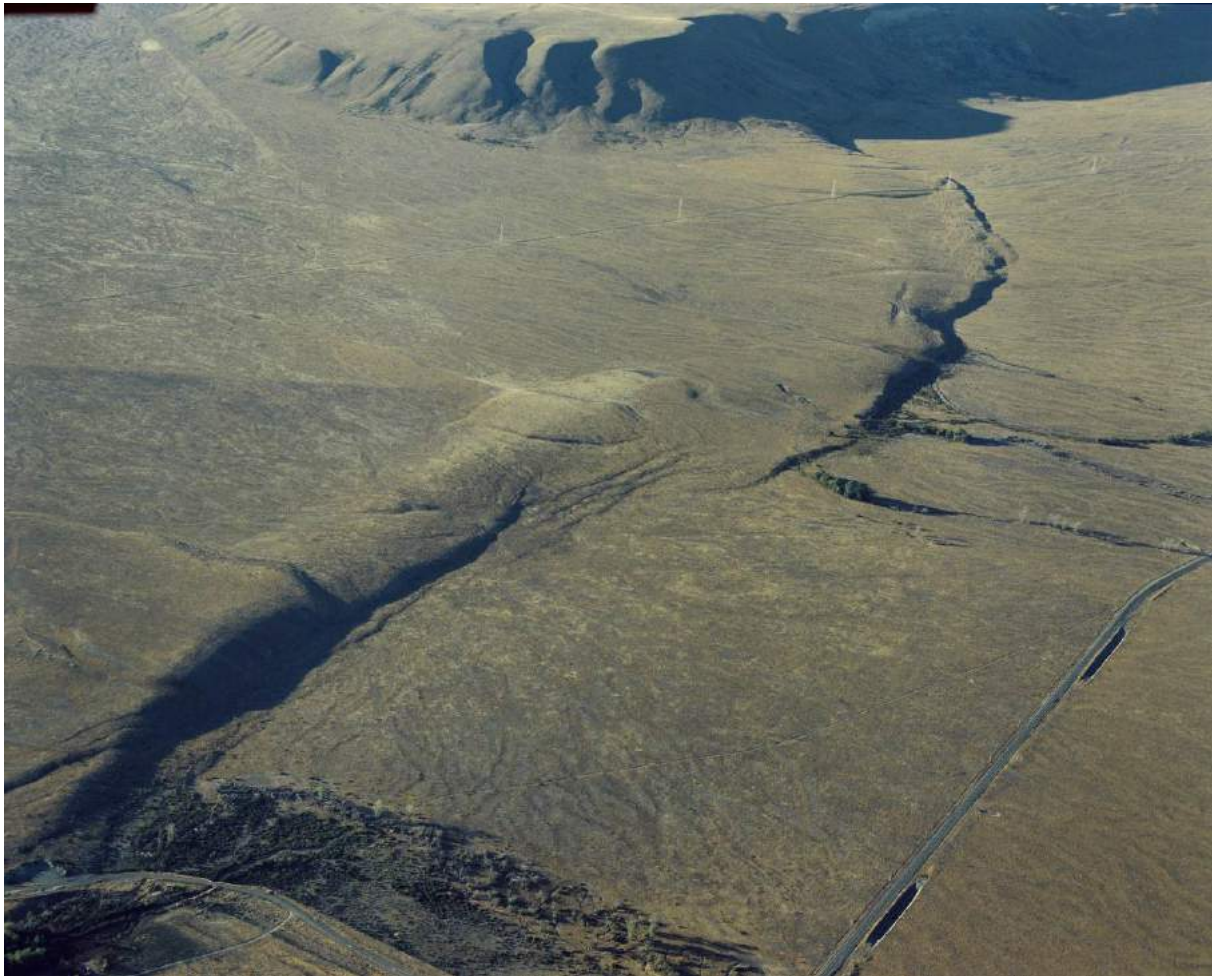
Figure 1.3 A northward oblique aerial view of the Ostler Fault Zone, about 12 km southwest of Twizel. The fault zone runs from lower left to upper right, and has offset and buckled a ~22,000 year old glacial meltwater outwash plain, with well-preserved relict braided channels, that was sourced from the Lake Ohau area. Lake Ohau Road is at lower left, and State Highway 8 is in lower right. At the lower left, the fault scarp (in shadow) is sharply defined. Heading towards the photo centre, the fault scarp evolves into a broad fold which peters out near the photo centre. At that point, another fault strand and associated fold has emerged 200 m or so in front of it (right) and, in somewhat serrated form, curves broadly to the left towards the shadow of a high uplifted terrace (Table Hill), and then curves along the foot of the hill (in shadow) to the upper right corner. Right of centre and right of the fault scarp, the three darker lines are the channels of spring-fed streams that emanate from the foot of the fault scarp. This view shows an array of 'definite' faults and folds which all form part of a single entity, the Ostler Fault Zone. In the generalised dataset accompanying this report, the Ostler Fault Zone at this location is represented by a single mapped fault line, and the folds and numerous small subsidiary fault strands are not differentiated in this regional-scale dataset. In contrast to the strike-slip faults shown in **Figure 1.2**, the Ostler Fault Zone is a dip-slip fault with a reverse sense of movement (see **Figure 3.1** for diagrammatic representations of these two different styles of fault movement). Photo: D.L. Homer, GNS Science CN576/B; taken 1995.

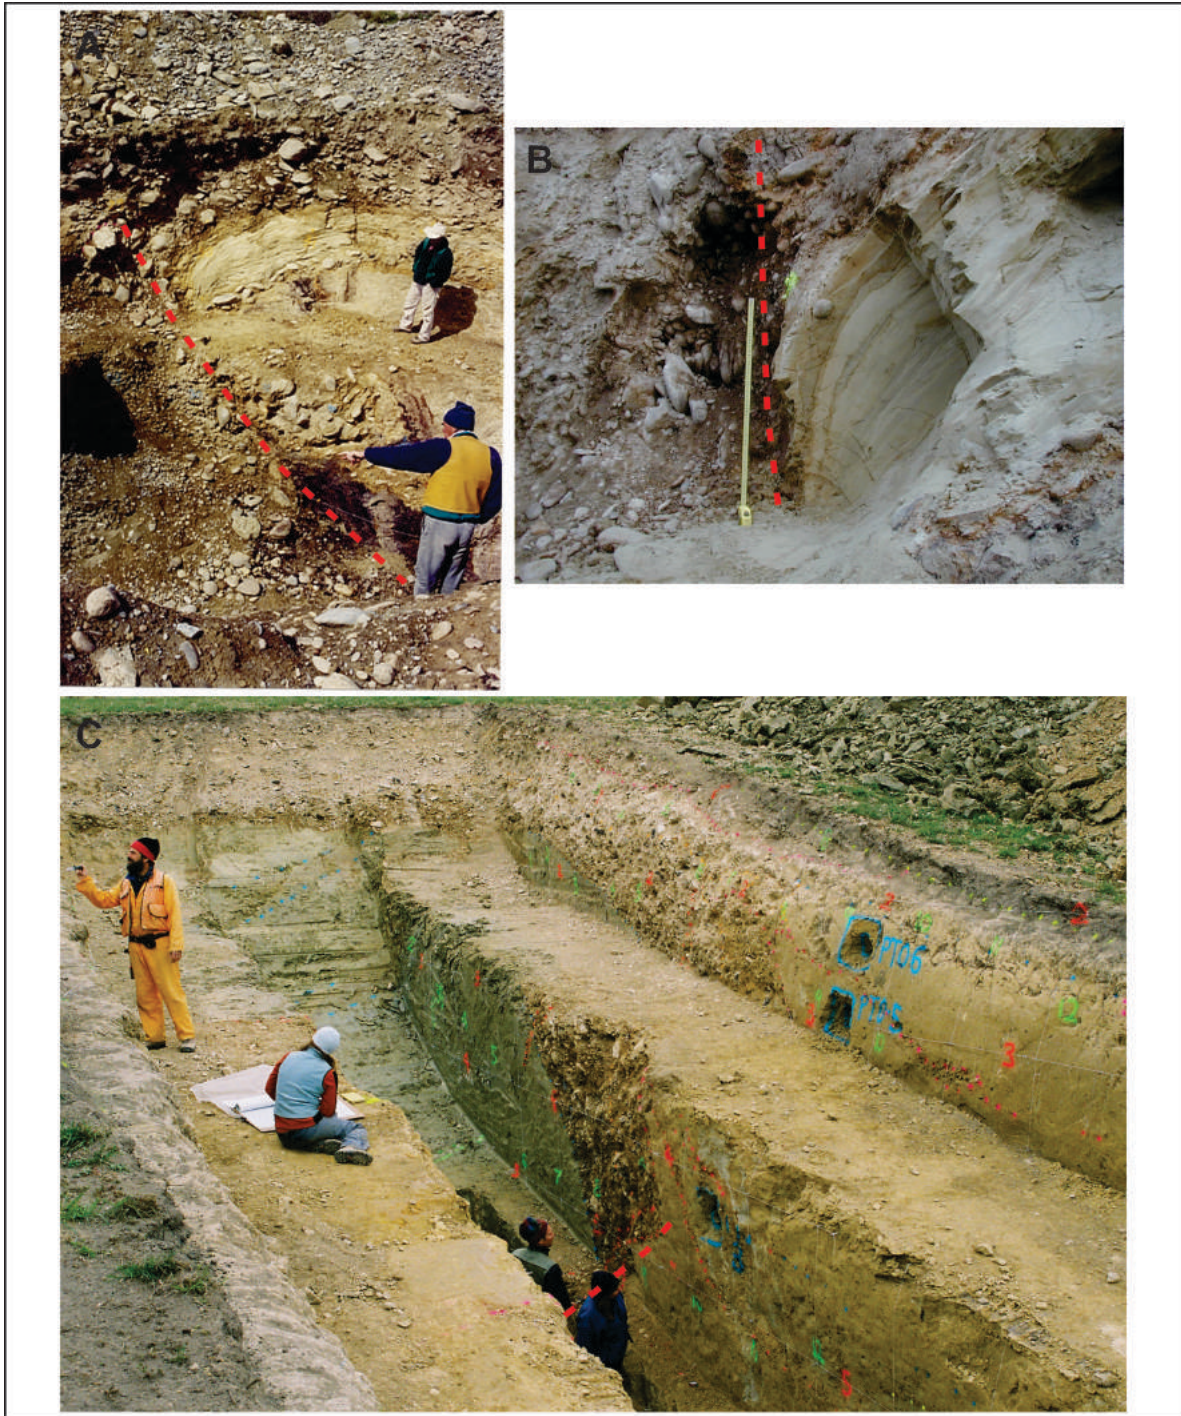
Figure 3.2 Illustrations of faults exposed in investigation trenches. Dashed red lines indicate the position of the fault in each photo. A & B: The Waitangi Fault (feature 12f – see Appendix 2) exposed in 1999 in a trench 700 m downstream of Aviemore Dam. A: the fault runs upper left to lower right and a bed of yellow sand has been pushed up and buckled over against river gravel to the left. B: detail of the fault contact after further excavation and cleaning. The yellow tape measure (extended 1 m) provides scale. Layering in the sand has been dragged down nearly vertical against the fault, while elongate river stones immediately left of the sand bed have been dragged up into vertical alignments. C: A trench excavated across the Kirkliston Fault Zone (feature 13 - see Appendix 2) in 2007, 14 km northeast of Kurow. The fault contact is beside the two people deep in the trench. Greenish-grey claystone overlain by yellow-brown stream gravel (left of centre) has been thrust up and buckled over against yellow-brown silt (loess) to the right. Detailed examination and mapping of the materials showed evidence for at least two separate rupture events. The blue-painted squares mark samples that were collected for luminescence dating to obtain age control on the rupture events. The dating showed that the most recent rupture most likely occurred between 12,900 and 22,000 years ago, and the recurrence interval for surface rupture is between 23,000 and 39,000 years. Photos A & B: D.J.A. Barrell; Photo C: S.A.L. Read.

An important message is that while landforms provide important clues as to the general location of active faults or folds, many details of these features which may be relevant to land-use, development and hazard mitigation cannot be obtained without more detailed site-specific investigations (e.g. Figure 3.2).

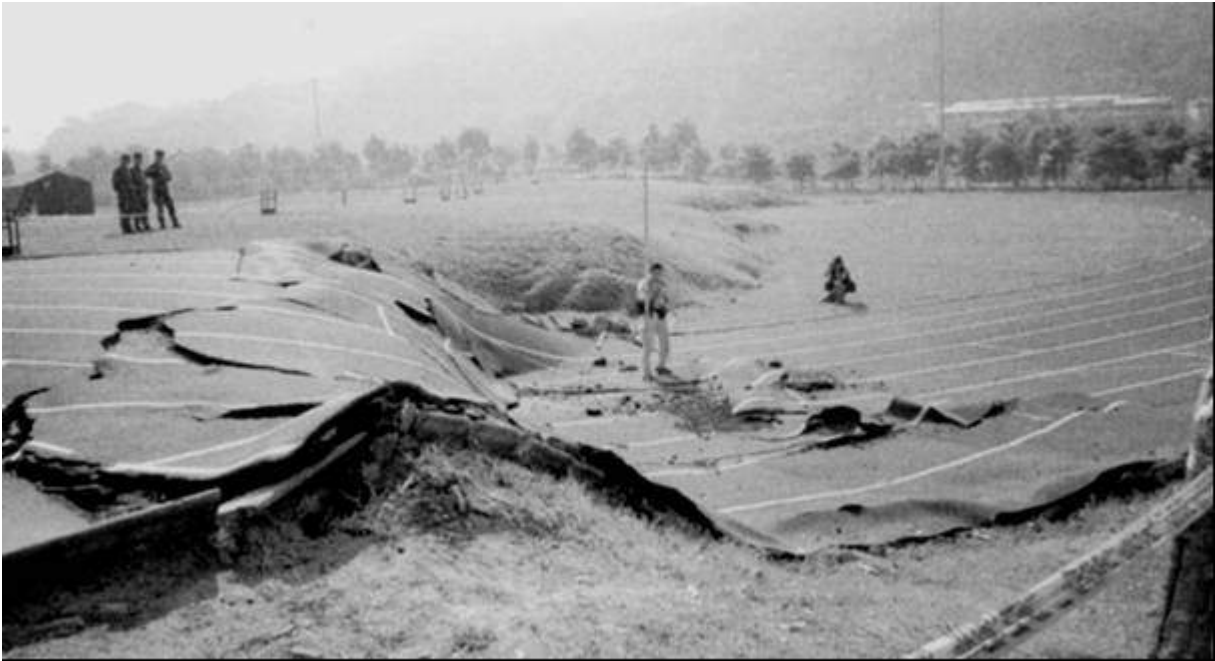
Figure 6.1 Fault scarp formed on the Chelungpu Fault during the magnitude 7.6 Chi-Chi Earthquake, Taiwan, 1999. The disrupted running track shows damage typical of a reverse fault ground-surface rupture, which is well expressed on the brittle surface (note the smoother rupture across grass behind). This location lies on a stream terrace that is younger than the previous rupture event on the fault, so that there was no scarp here before the earthquake. This example illustrates the sorts of effects that can be expected across fault scarps in the Waimate District or Waitaki District the next time any particular fault experiences a surface rupture earthquake. Photo from Kelson et al. (2001).
