Glenorchy flooding

Update for GCA, 2nd July 2020

HEAD OF LAKE WAKATIPU HAZARDS STRATEGY

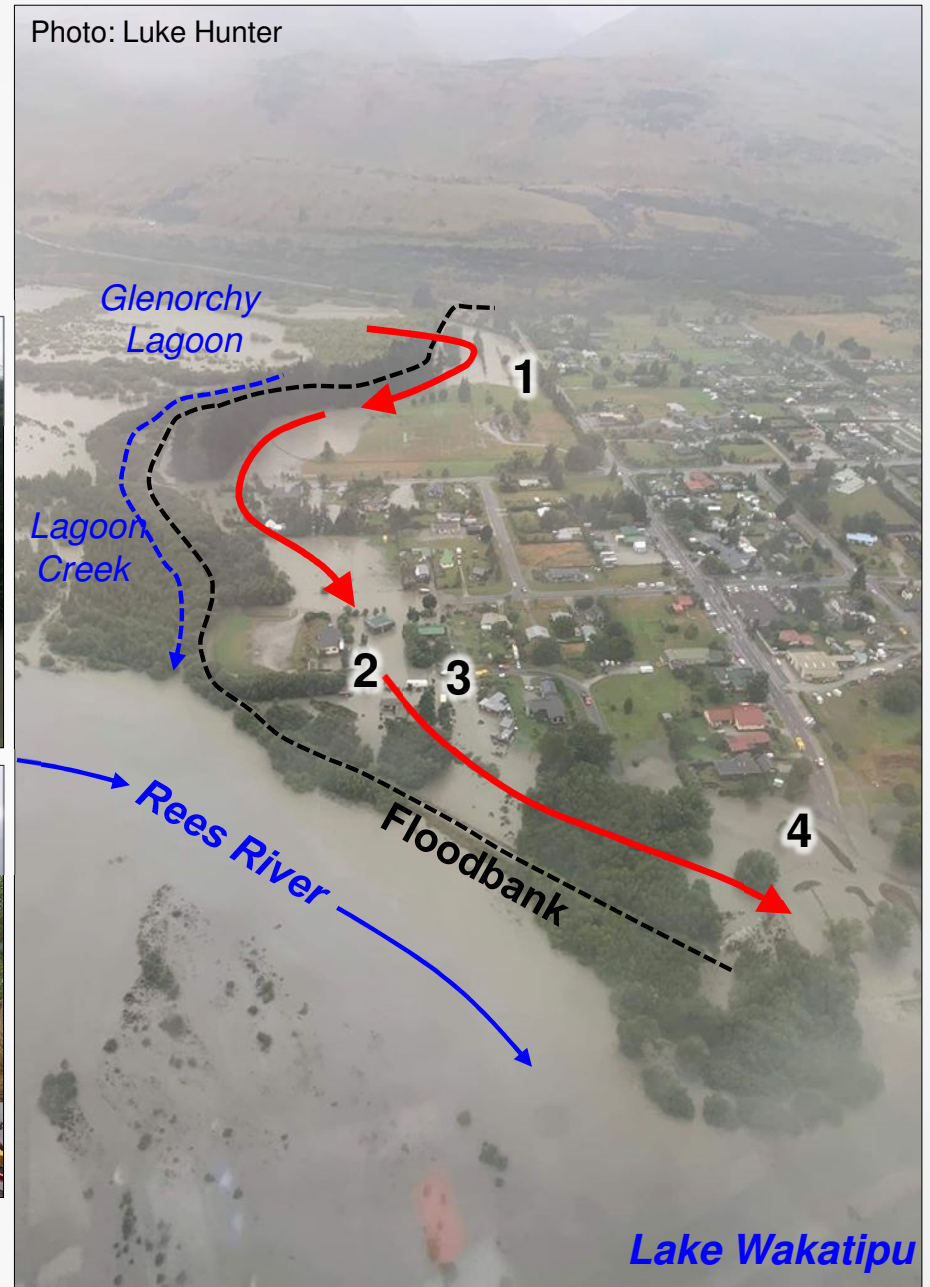
4th February 2020

*Note photos are not necessarily at flood peak
