# FISH PASSAGE ASSESSMENT OF THE HAKAPUPU (PLEASANT) RIVER

Prepared by Kāti Huirapa Rūnaka ki Puketeraki

Matt Dale (Waterscape Connections Ltd) and Julia Rata te Raki, 2024

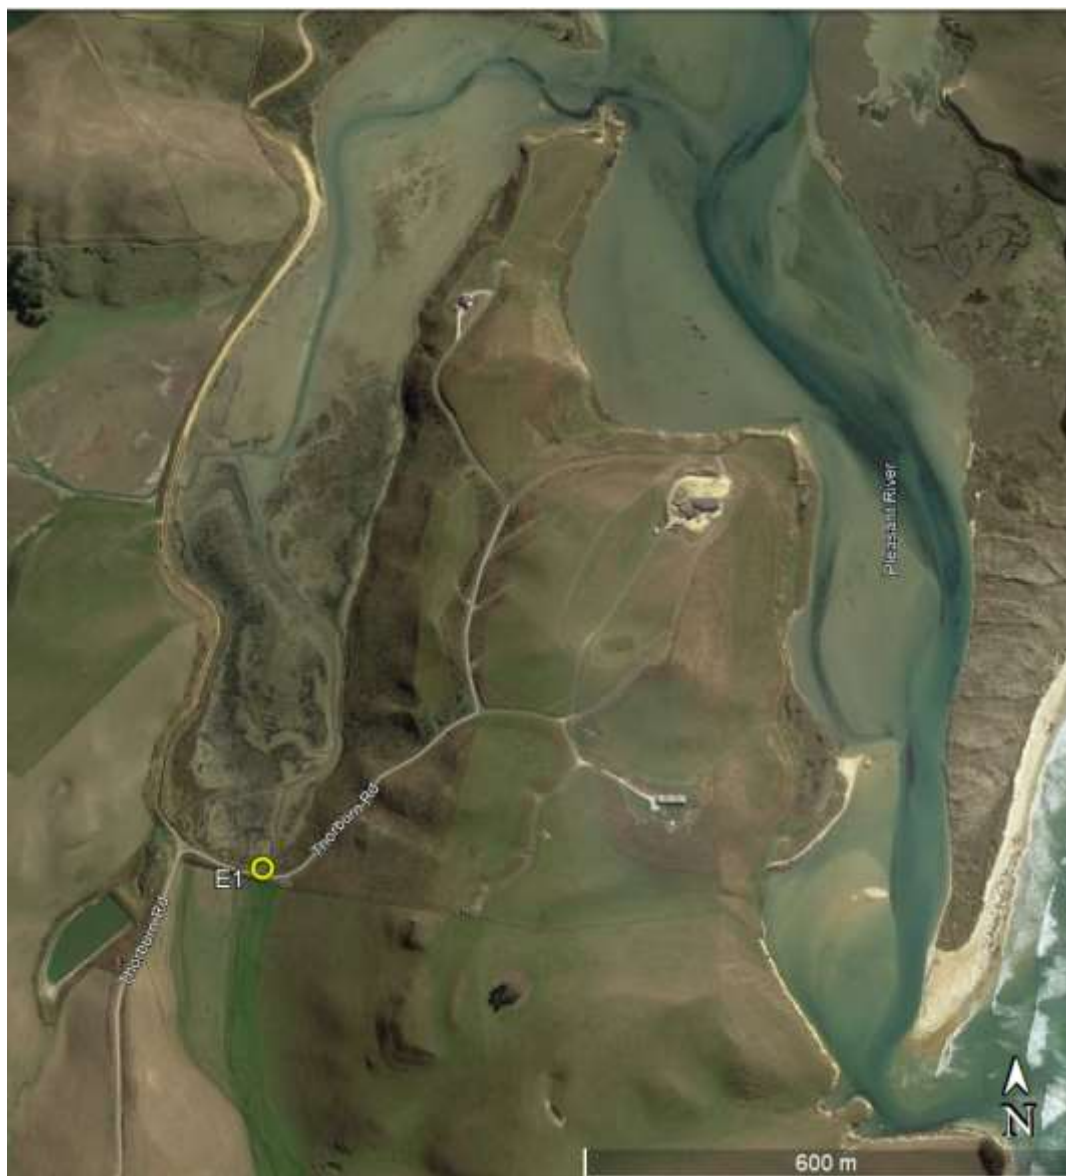
Figure 14 Location of site E1

The structure consists of a single 0.75m culvert with a flap gate attached to the downstream end. A small gap was present between the culvert lip and the flap gate which would have allowed passage for small fish at most (if not all) periods of the tide, however there was very little habitat upstream of the culvert meaning that its priority for replacement should be considered low.

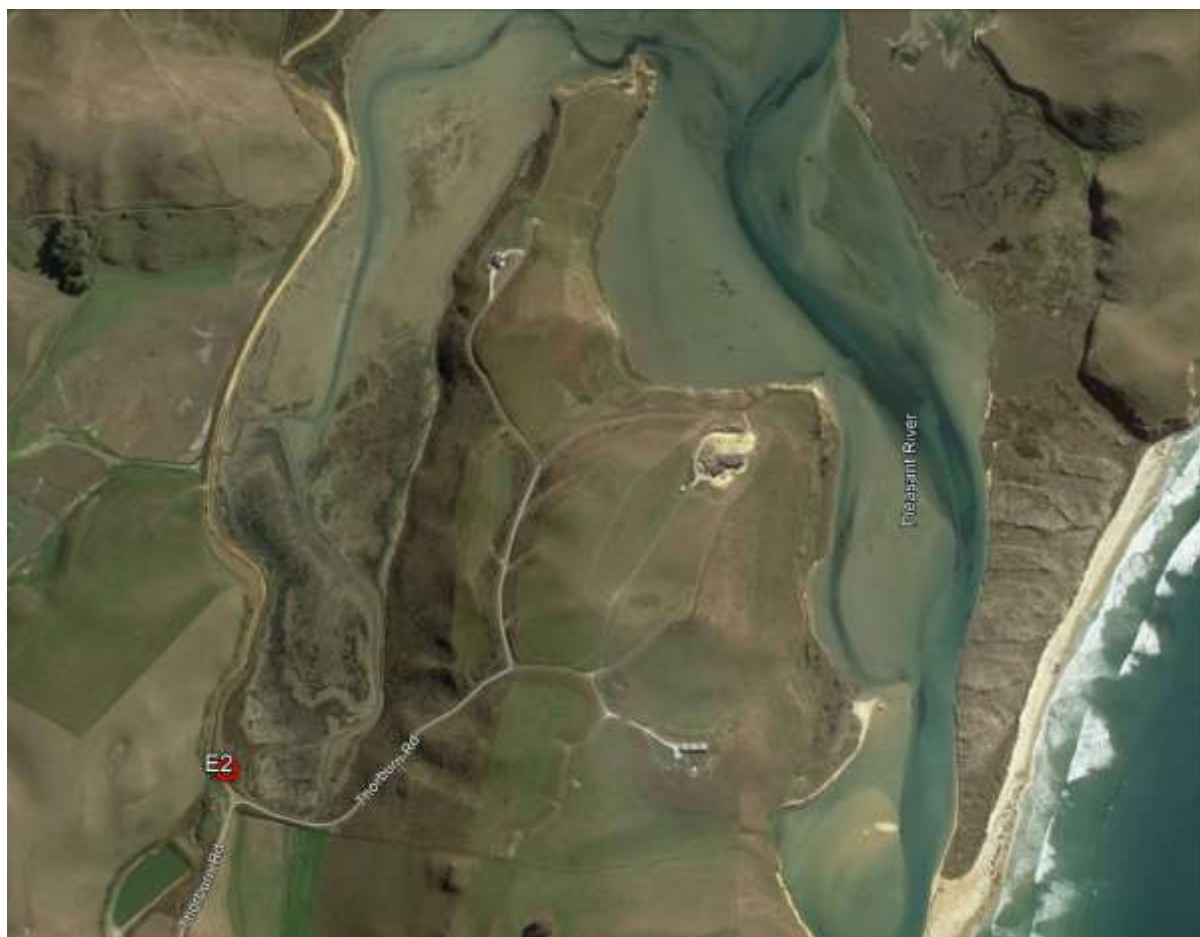
**Figure 17** Location of the E2 culvert

The structure consists of a single 0.45m culvert which has an overhang of 0.05m and a drop height of 0.1m at mid-tide. It is likely that fish passage would be possible during high tide, but the culvert would be considered perched for much of the tidal cycle. There is very little fish habitat upstream of the culvert meaning that its priority for replacement should be considered low.

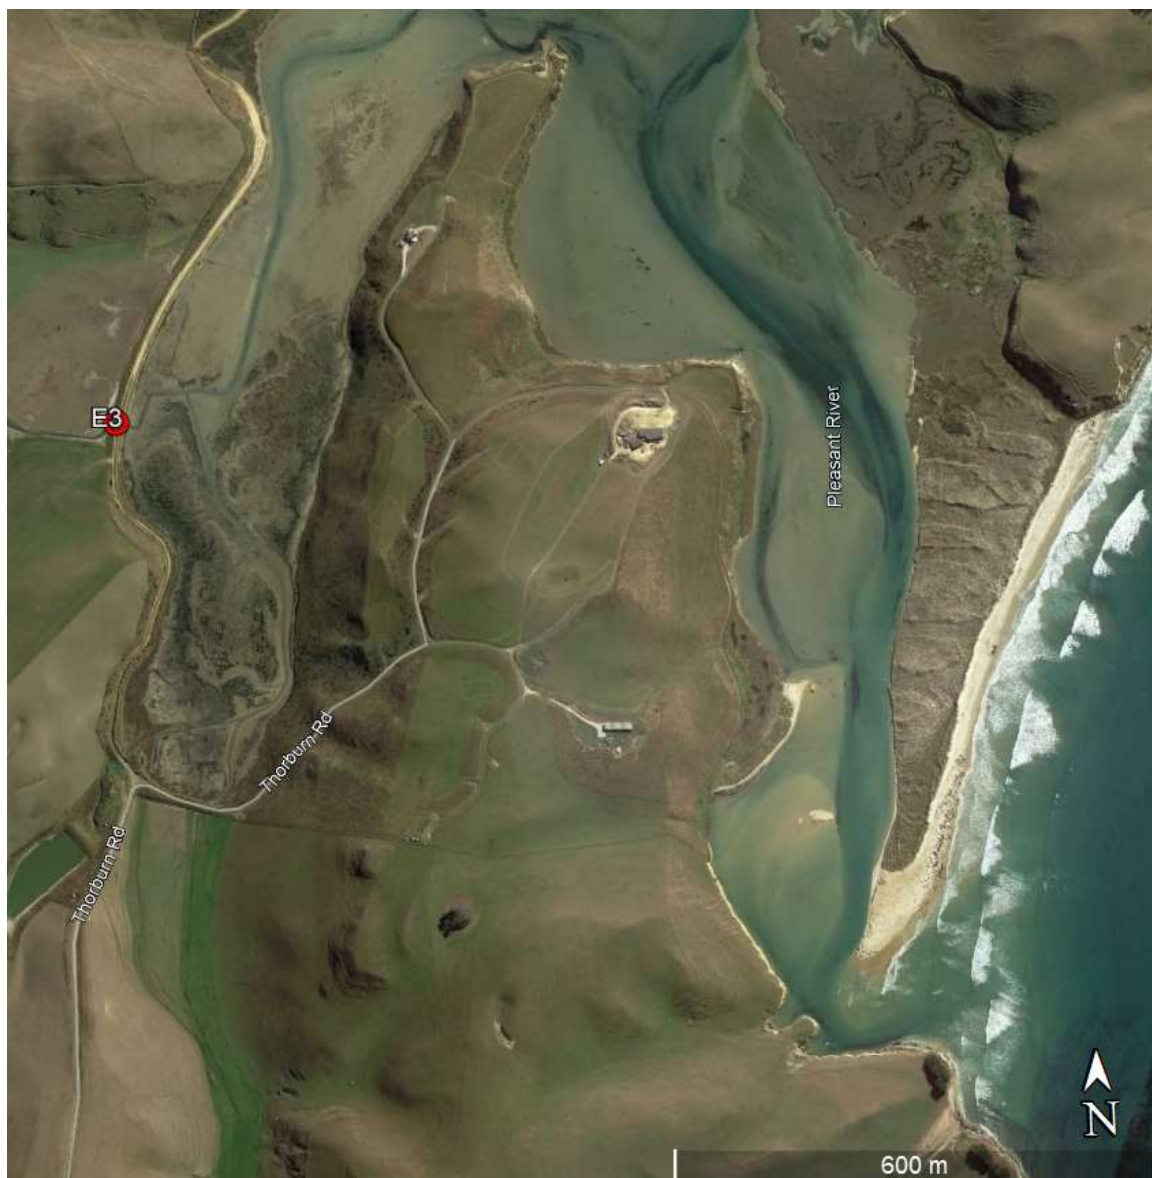
Figure 20 Location of the E3 flap gate

The structure consists of a 1m wide culvert with an attached flap gate with no fish passage remediation. The flap gate creates a strong seal with the culvert preventing fish passage for most, if not all, of the tidal cycle. This structure prevents fish passage to a significant tributary of the Hakapupu estuary. Although riparian habitat is significantly degraded due to stock grazing and channel modification, this tributary would be expected to provide īnaka spawning and adult habitat, should restoration activities be undertaken. The lower reaches of the tributary would also be expected to provide habitat for estuarine species such as mullet, while the upper reaches would be expected to provide habitat for tuna should fish passage be restored.

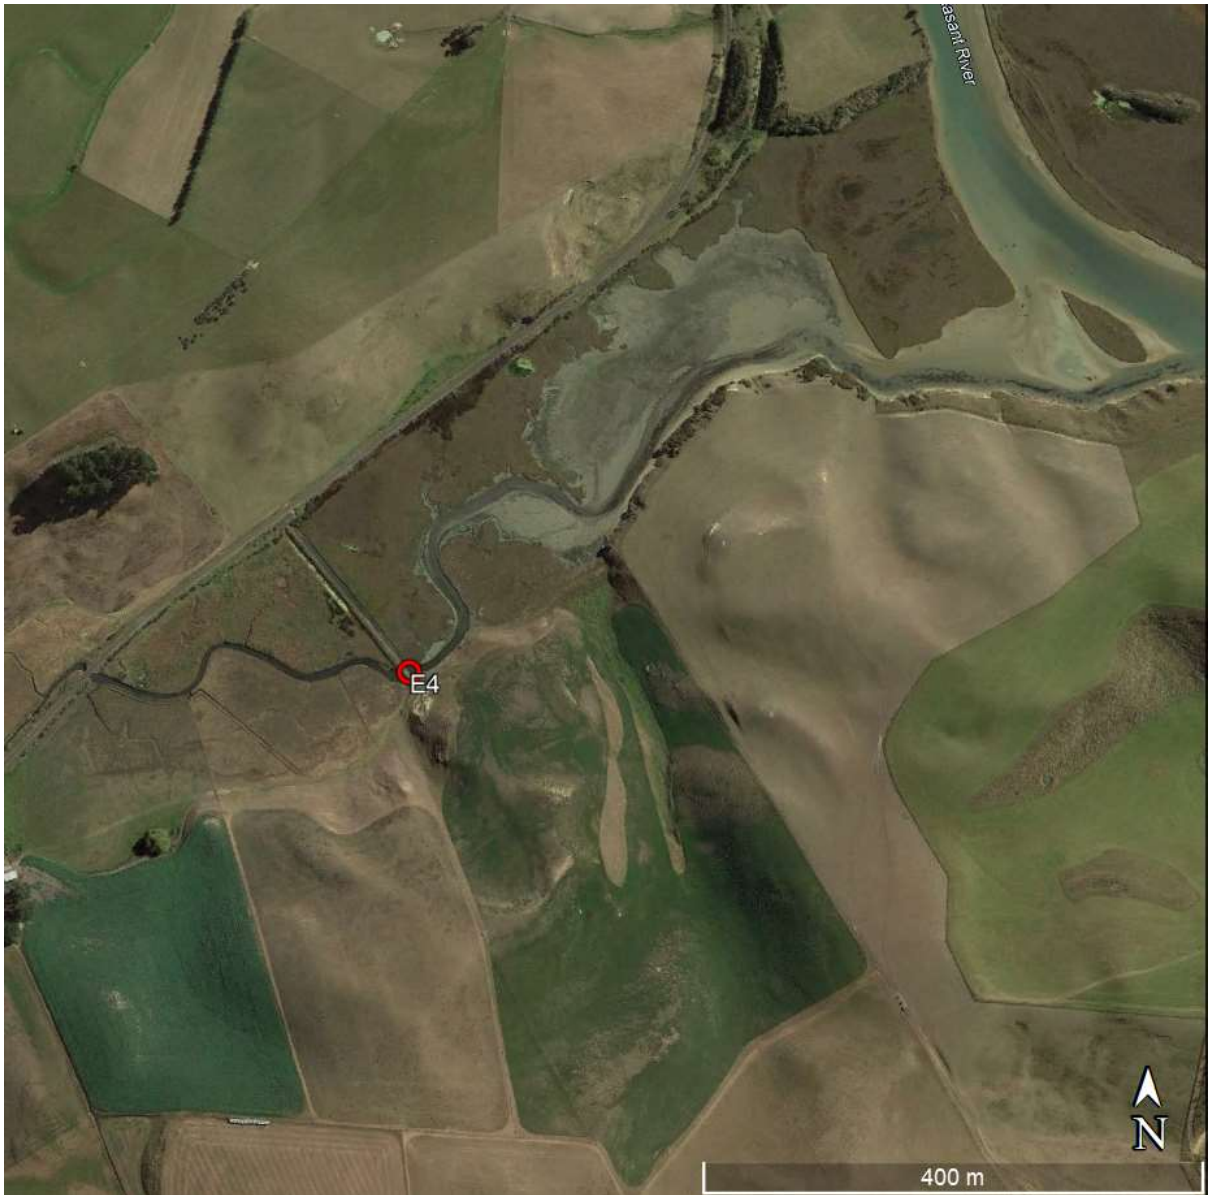
Figure 23 Location of the E4 flap gate

**Description:** Site E4 is a privately-owned structure located on the northwestern tributary of the Pleasant River estuary (Figure 23).

This site should be considered a priority for remediation due to the large upstream catchment and potential for restoration. Ideally, the flap gate would be removed from the culvert to allow for full tidal variation in the upstream catchment. This would allow tīnāka to access the area and provide sufficient tidal amplitude for spawning.

If removal of the flap gate is not possible/desirable, then remediation devices such as a cantilevered or offset “fish friendly” flap gate should be considered.

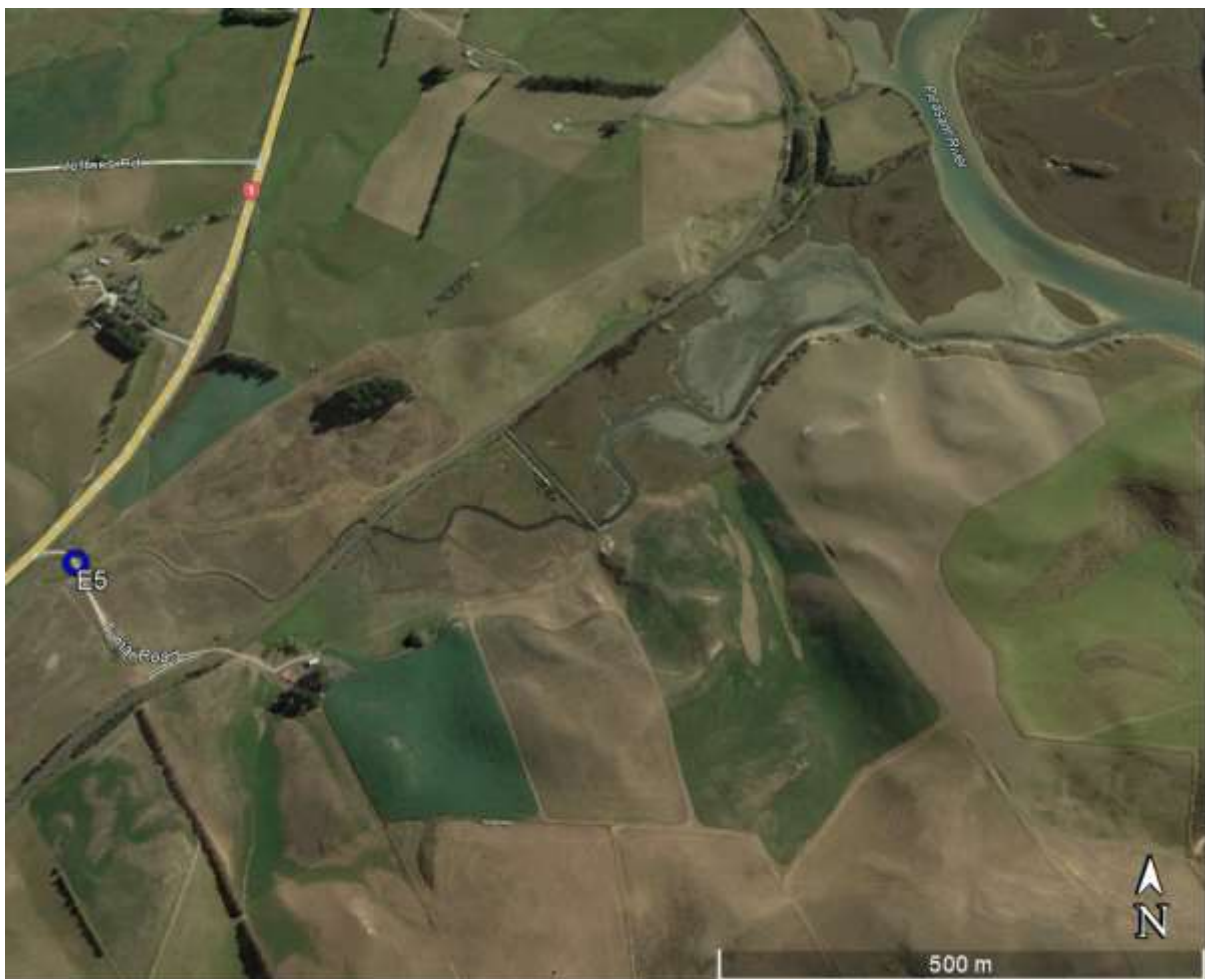
Figure 25 Location of the E5 culvert

Site E5 is located further upstream from E4 where Tumai Rd crosses the northern western tributary of the Pleasant River Estuary (Figure 25). The upstream catchment has very little standing water due to heavy modification, drainage, and stock damage.

The culvert itself is 0.75m high and half submerged within the wetted channel, providing good fish passage throughout the tidal cycle. No further remediation is required.

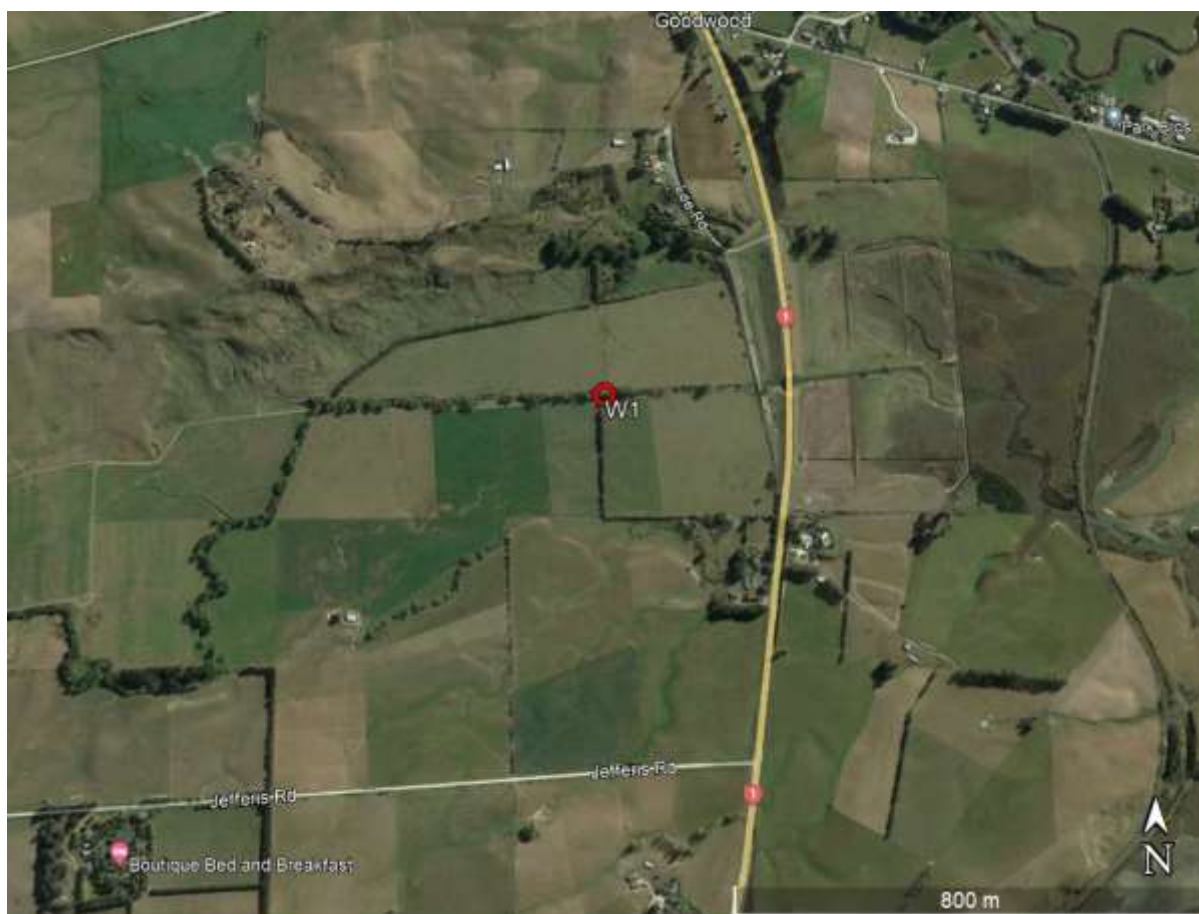
**Figure 28** Location of W1 ford and culvert

W1 is the most downstream instream structure in Watkin Creek and is located 300m west of SH1 (Figure 28). The culvert is 0.33 m wide and is perched with an estimated drop of 0.2 m and an undercut of 0.05 m, providing a significant barrier to upstream migrating fish. Due to the small size, water velocities through the culvert are particularly high and are likely to pose a significant barrier to upstream migration in addition to the perched culvert. Shoals of *tinaka* were observed immediately downstream of the culvert.

Due to the large amount of upstream habitat, and the presence of significant restoration projects occurring in the upstream catchment, this structure should be

considered as a high priority for replacement. Due to the small diameter of the culvert, it is recommended that it be replaced, as any remediation efforts such as fish ladders will not address the high water velocities currently occurring through the culvert. Rock ramps and baffles may be considered as a short-term remediation option, but should not be considered a permanent solution.

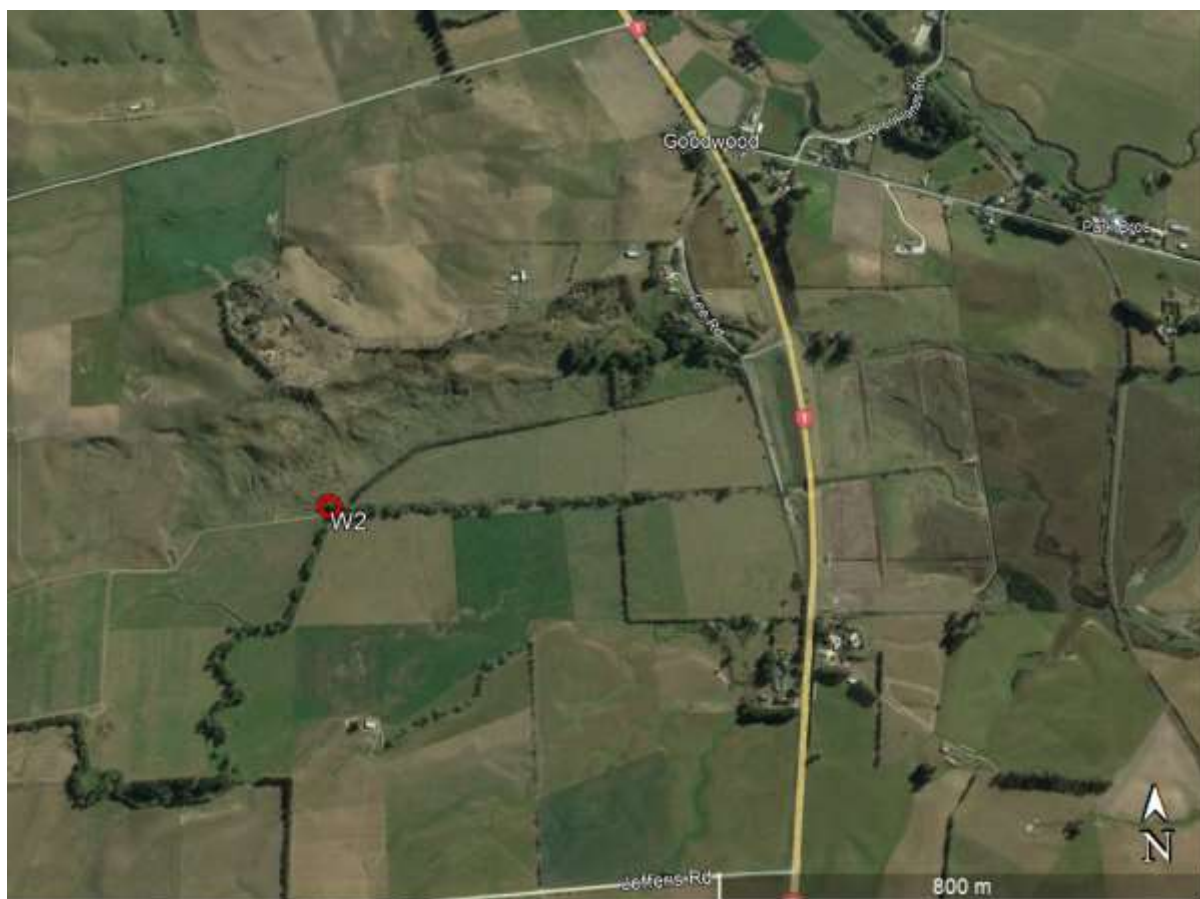
**Figure 31** Location of W2 structure

W2 is located 900m west of SH1 and consists of a large (1 m) corrugated iron perched culvert with a 0.2m drop and 0.1m undercut. The culvert is showing signs of rust and degradation, and likely poses a significant barrier to upstream migration. Large shoals of īnaka were observed immediately downstream of the structure.

Due to the large amount of upstream habitat, and the presence of significant restoration projects occurring in the upstream catchment, this structure should be considered as a high priority for replacement. Due to the large number of īnaka observed downstream of the site, it is recommended that the structure be replaced by a

similarly sized culvert that is imbedded at an appropriate depth in the stream bed. This is preferable over remediation efforts such as fish ladders, as they will not address the high water velocities currently occurring through the culvert and will be difficult to install and maintain due to the degraded nature of the culvert itself.

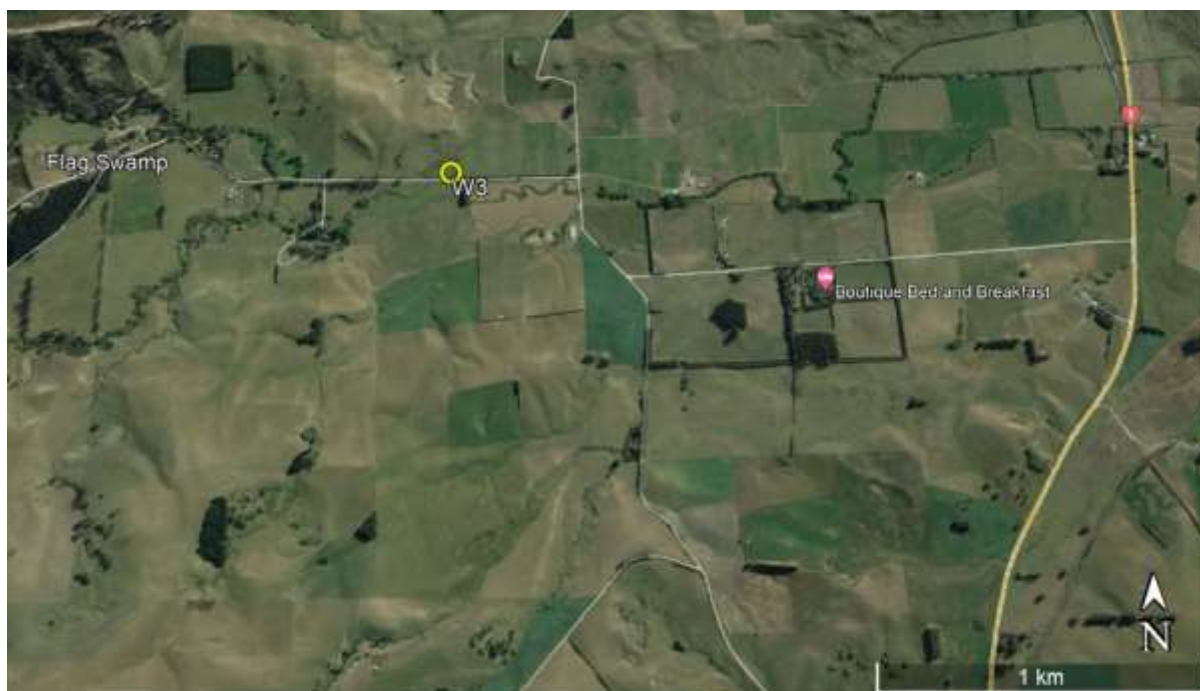
Figure 34 Location of structure W3

W3 is a large (1.2m) concrete culvert located on Galbraith Rd (Figure 34). The downstream end of the culvert has a small drop (0.1m) into the downstream pool, and although this can likely be navigated by most fish species present in the catchment (with some difficulty for īnaka), fish passage would be improved significantly though low-cost remediation measures such as a rubber matting/spat rope or a floating fish ladder.

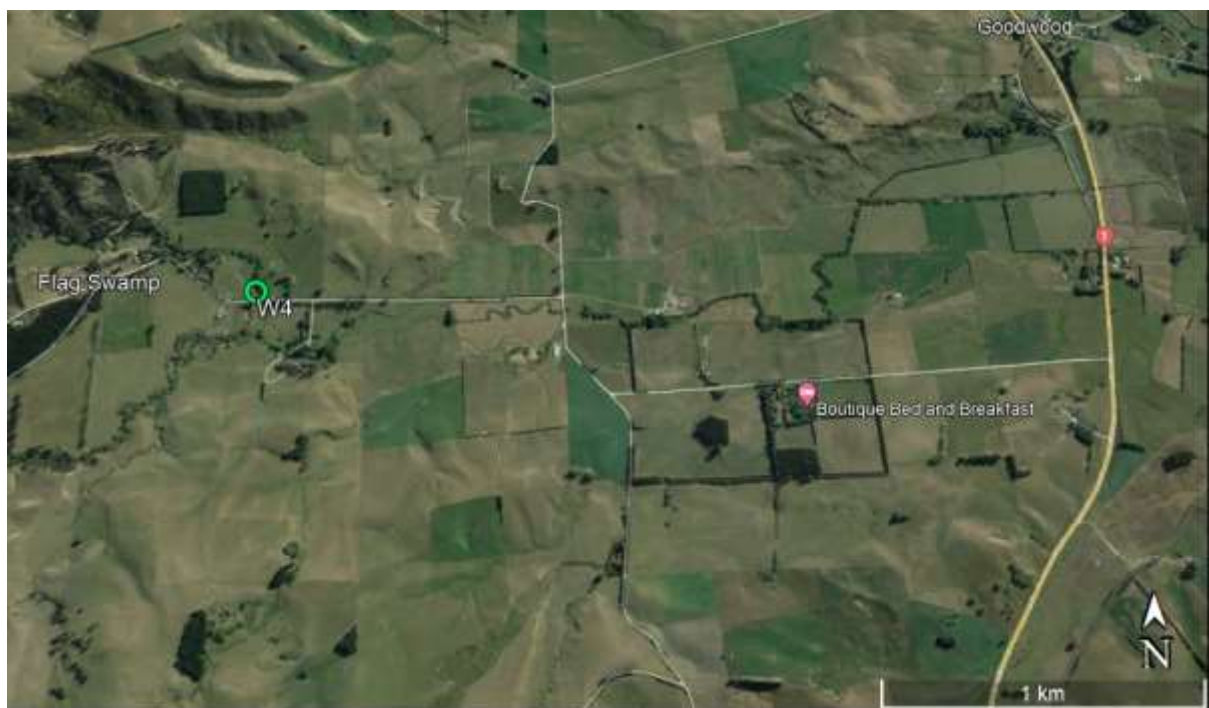
Figure 37 Location of site W4

W4 is a ford located immediately downstream of Galbraith Rd in the middle reaches of the Watkin Creek catchment (Figure 37). This ford provides no barrier to fish passage (Figure 38 & Figure 39) and should be considered low priority for mediation.

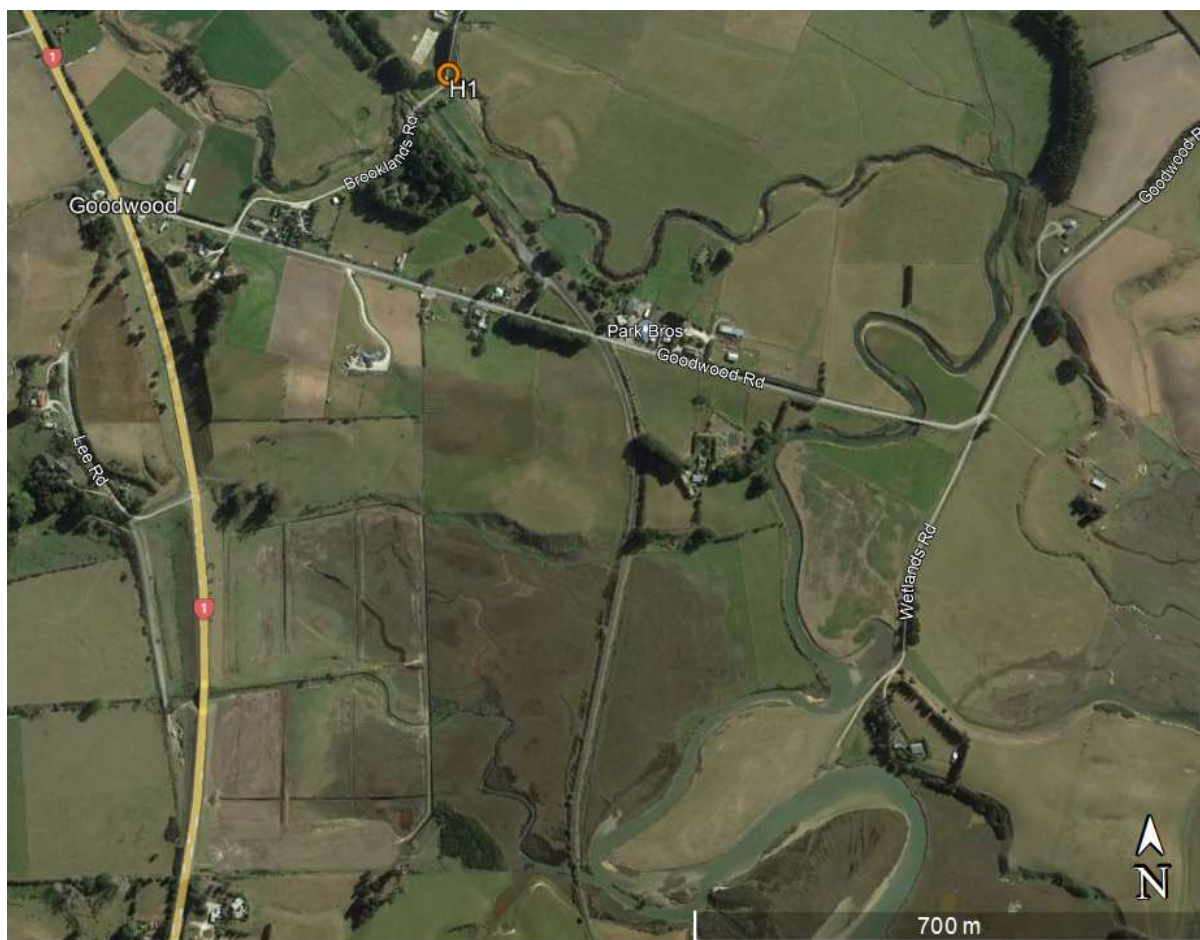
**Figure 40** Location of H1 culverted ford off Brooklands Rd

H1 is the most downstream structure on the main stem of the Hakapupu River, and is located on Brooklands Rd, northeast of Goodwood (Figure 40). The structure consists of a concrete ford with three culverts, with all three culvert barrels being perched well above the downstream water level (Figure 41).

Of the three culvert barrels within the structure, those on the true right and middle of the ford are perched and undercut, with flows passing over an undercut concrete apron and then under a large pile of rip rap. It is unlikely that fish passage is provided by either

of these culverts (Figure 41). Flows that pass through the third culvert on the true left pass down a 2m concrete apron, which is perched at the downstream end with a drop of 0.1m.

Large shoals of īnaka were observed downstream, however the presence of smaller numbers of īnaka at upstream sites suggest that some fish passage is occurring past this structure.

Due to the location of the Brooklands Rd ford and the high risk it poses to fish passage, this site should be considered one of the highest priorities for remediation in the Hakapupu catchment. Ideally, this structure would be completely replaced with a bridge or large box culvert in alignment with the New Zealand Fish Passage Guidelines (Franklin, 2018), and this should be considered the preferred approach for this site. In the event that these works cannot be undertaken quickly due to budgetary constraints, it is suggested that the rip rap is removed and a concrete/rock ramp is installed along with in-culvert baffles. Note that this should only be considered a temporary measure and should not be undertaken as a long-term alternative to replacement.

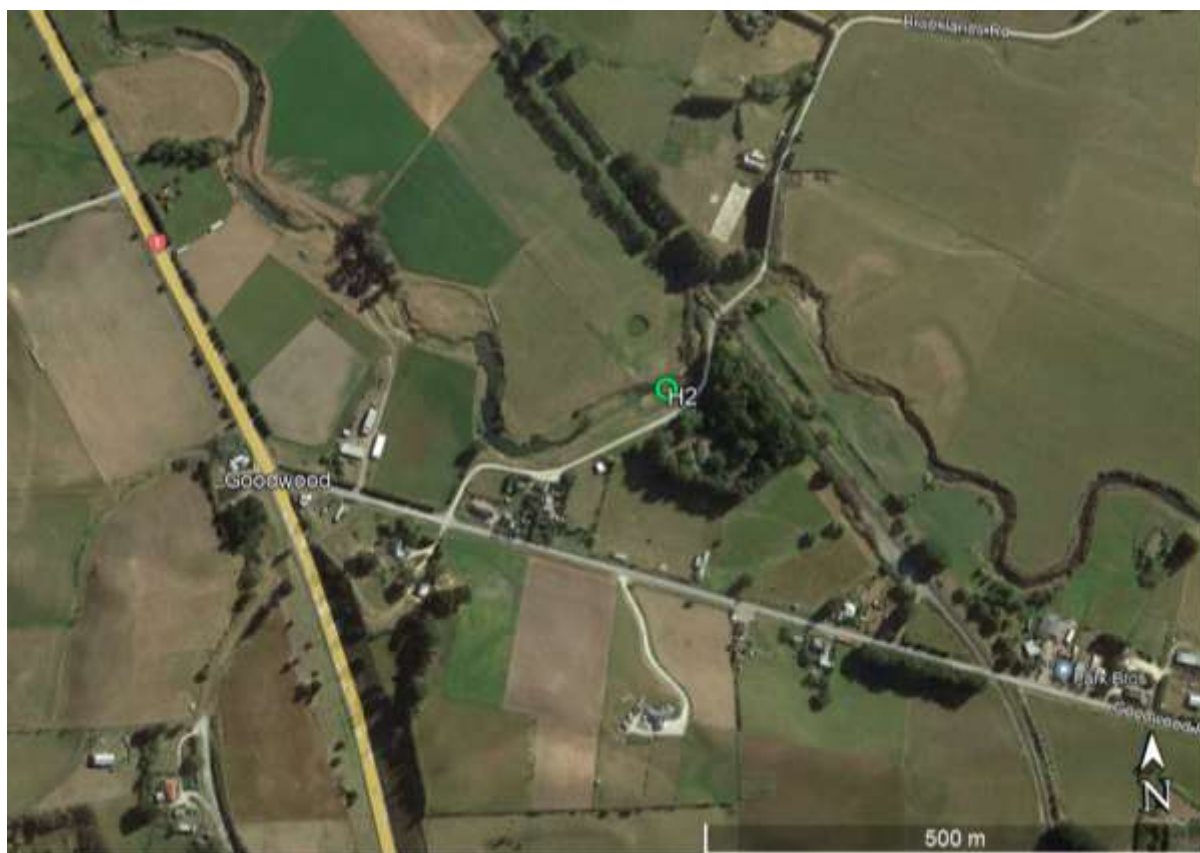
**Figure 43** Location of the H2 temporary culverted ford

H2 is a temporary two-barrel culverted ford placed to provide access to the construction site for the replacement of the adjacent rail bridge over the Hakapupu River. The site is located off Brooklands R, east of Goodwood (Figure 43).

The ford has been constructed by laying steel bridge piles along the stream bed and then covering them with rip rap and road metal. The culvert barrels have been laid at the same gradient as the stream bed with low water velocities and sufficient depth to provide fish passage.

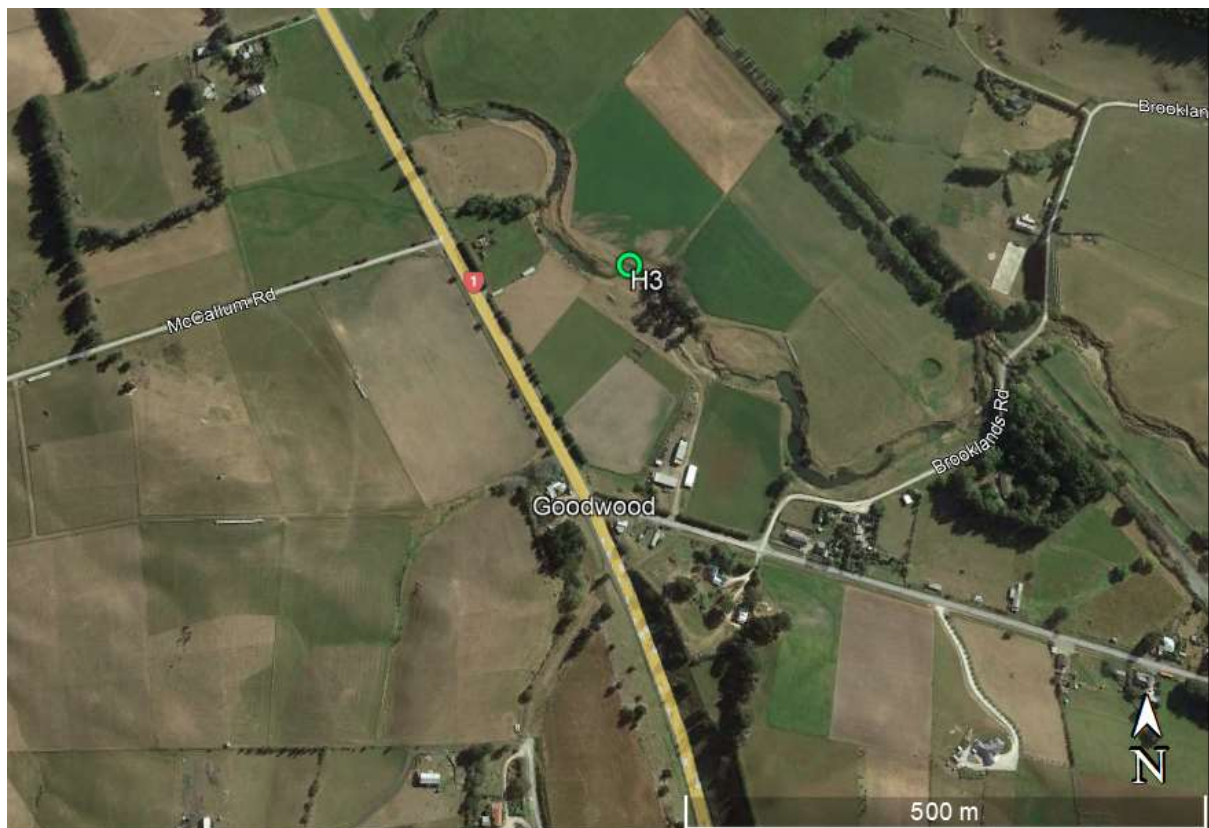
Figure 47 Location of H3 ford

Site H3 is a ford located north of Goodwood on the east side of SH1 (Figure 47). The ford poses no risk to fish passage and does not require any remediation.

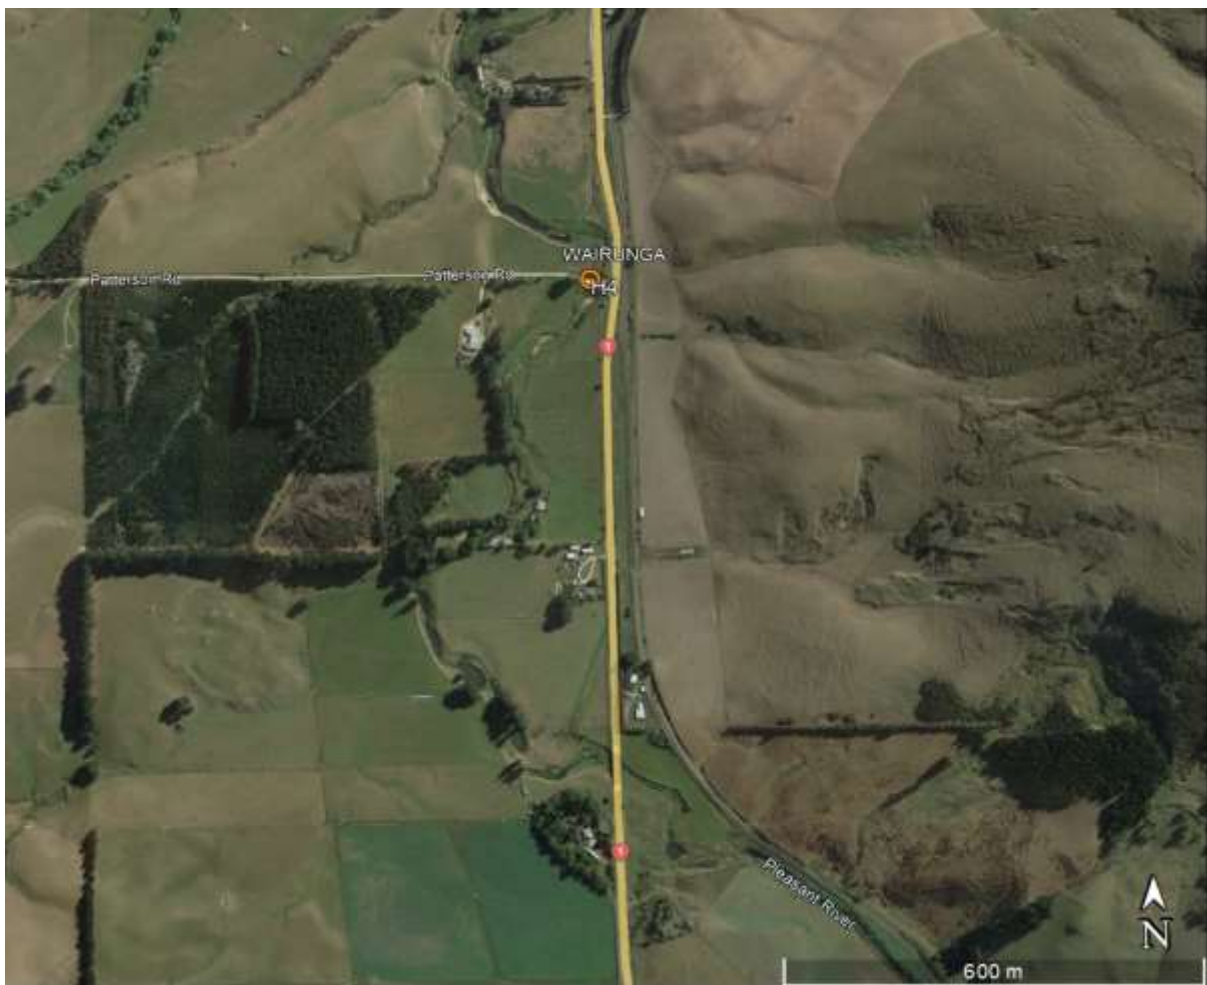
Figure 49 Location of the H4 culverted ford.

H4 is a three barrelled culverted ford located where Pattersons Rd crosses the Hakapupu River (Figure 49). Each culvert has a width of 0.65m, with the upstream side of the ford having a 2m apron with wooden baffles to guide low flows through the centre culvert to increase water depth for fish passage (Figure 50). The downstream side of the ford has a short apron with a 0.12m drop to the pool below (Figure 51).

Although the upstream baffles do increase the water depth within the central culvert, it also acts to prevent any fish that pass through the outer culverts from accessing the upstream channel. Several īnaka were observed trapped between the baffle and the bank while the assessment was being undertaken. It is also likely that the increased velocity in the central culvert caused by the baffles is preventing īnaka from navigating the full length of the barrel, and as such is recommended that the baffles be removed.

Due to the location of the Pattersons Rd ford on the main stem of the Hakaupupu, and the high risk it poses to fish passage, this site should be considered one of the highest priorities for remediation. Ideally, this structure would be completely replaced with a bridge or large box culvert in alignment with the New Zealand Fish Passage Guidelines (Franklin, 2018), and this should be considered the preferred approach for this site.

In the event that these works cannot be undertaken quickly due to budgetary constraints, it is suggested that a concrete/rock ramp be constructed, and internal culvert baffles are installed in all three barrels. Note that this should only be considered a temporary measure and should not be undertaken as a long-term alternative to replacement.

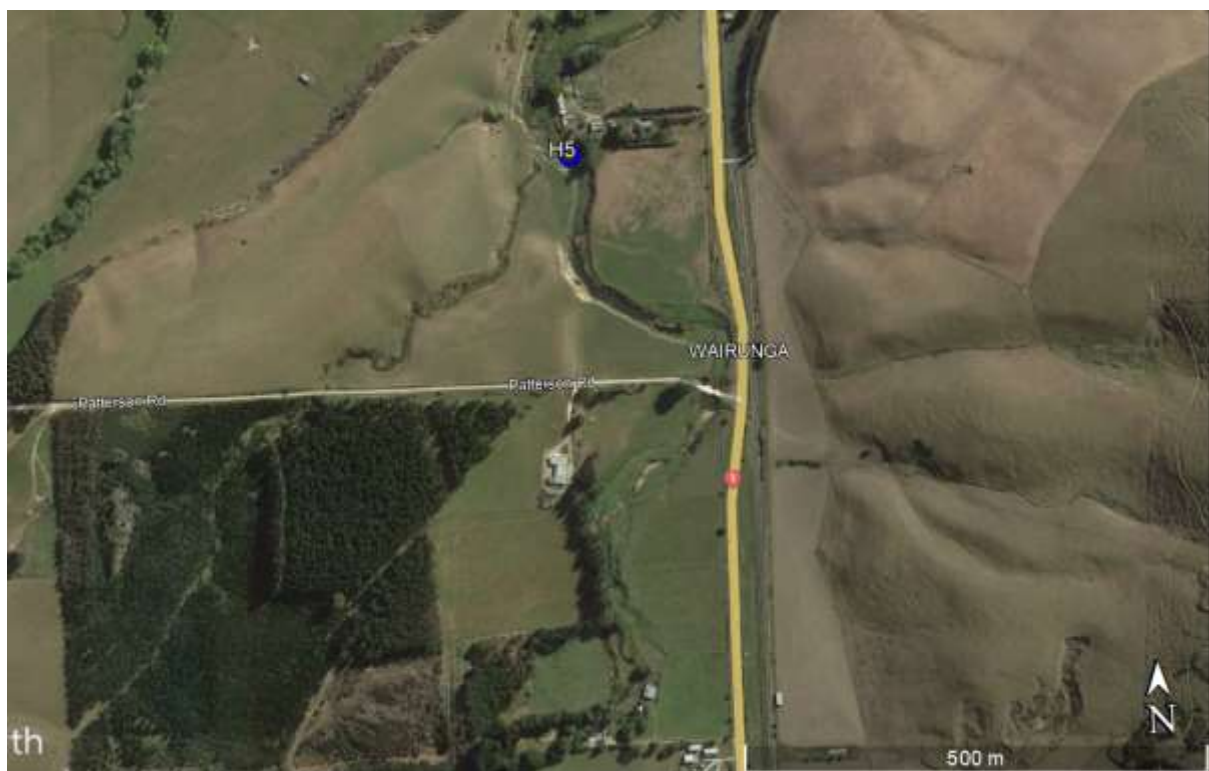
Figure 52 Location of the H5 bridge north of Pattersons Rd.

The H5 site is a small bridge located 250m north of Pattersons Rd (Figure 52). The bridge has no effect on fish passage and should be considered a low priority for remediation.

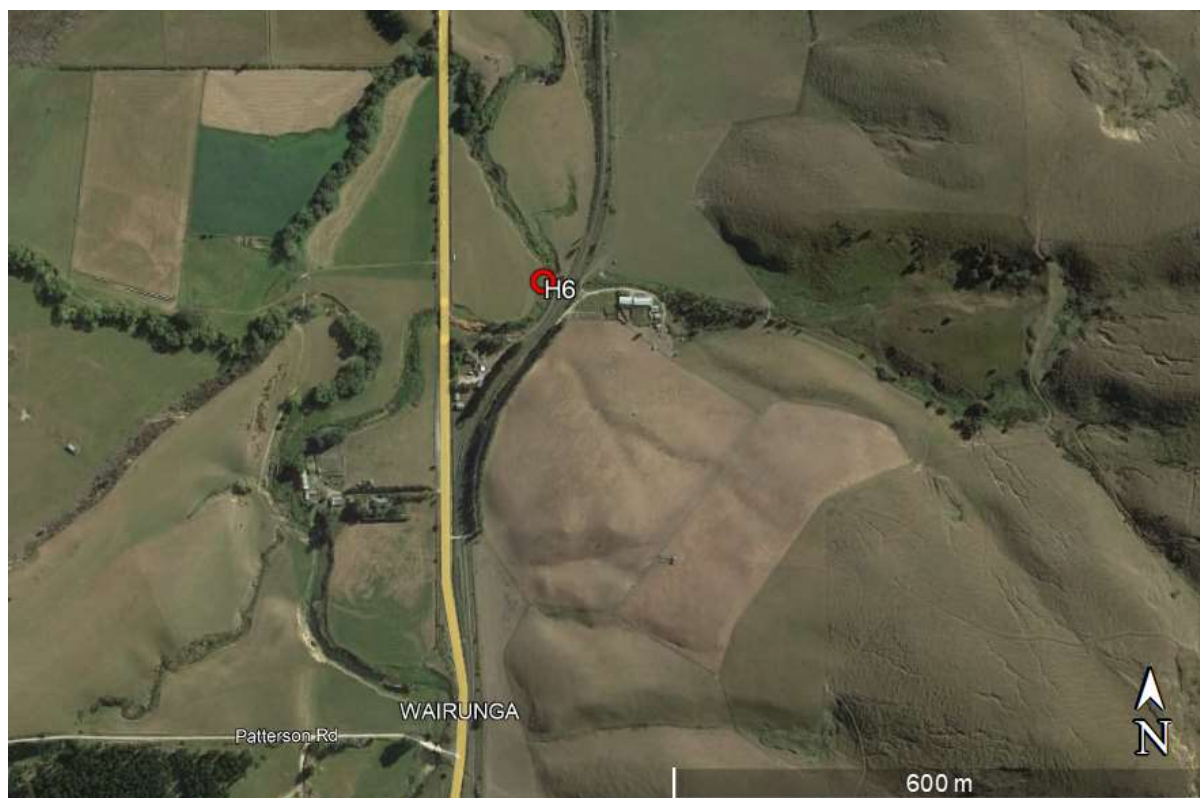
**Figure 55** Location of the H6 culvert

The H6 site is a two barrelled culverted ford located on a stock and vehicle crossing point on the Hakapupu River 100m east of SH1 (Figure 55). The ford itself is constructed from packed earth and the culvert barrels are constructed from welded truck wheel hubs (Figure 56) and are perched 0.2m above the stream with significant overhangs (Figure 57).

The internal structure of the culverts have internal baffles created by the connection points of the wheel hubs used in their construction. These baffles have the effect of reducing water velocities within the culvert barrel (Figure 56).

priority for replacement. Because of its location on the main stem of the Hakapupu with a large area of upstream habitat, this site should be prioritised for full replacement rather than remediation. It is suggested that the two culverts be replaced with a single large culvert fully embedded in the stream bed to ensure a natural substrate and water velocities.

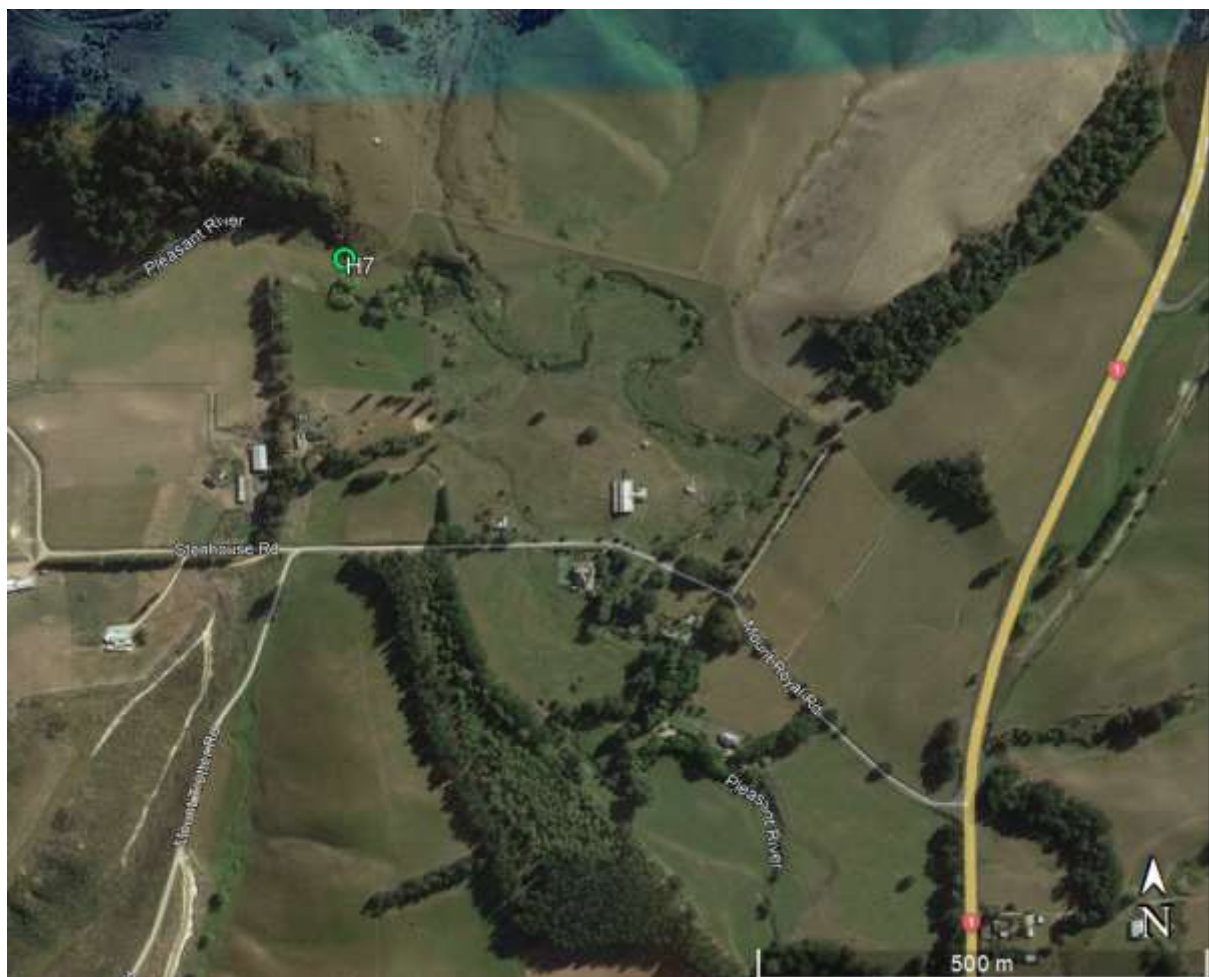
Figure 59 Location of site H7 on the main stem of the Hakapupu River

Site H7 is a partially collapsed bridge and adjacent ford on the main stem of the Hakapupu River 300m north of Stenhouse Rd (Figure 59). This structure is unlikely to have any impact on fish passage and should be considered a low priority for remediation.

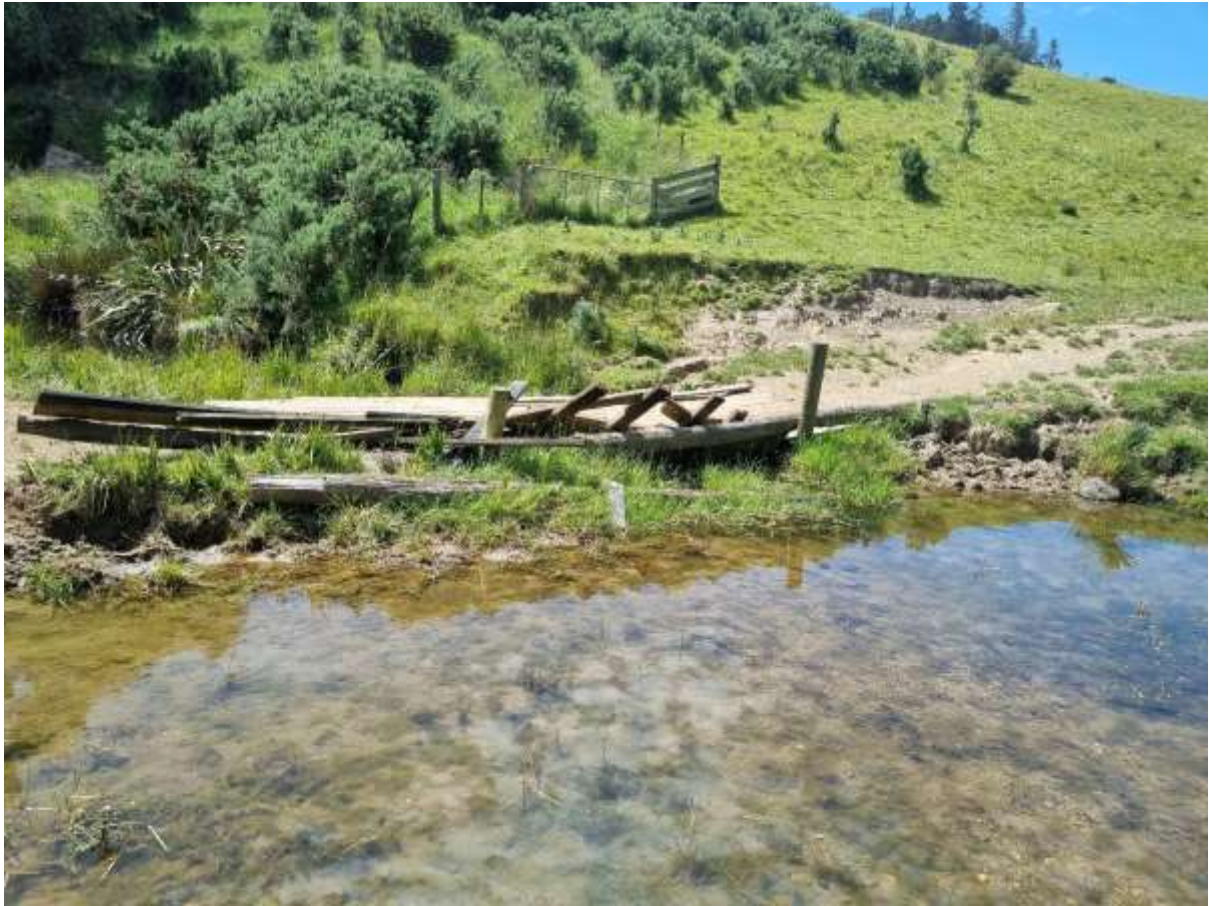
Figure 60 Downstream view of the H7 ford and bridge

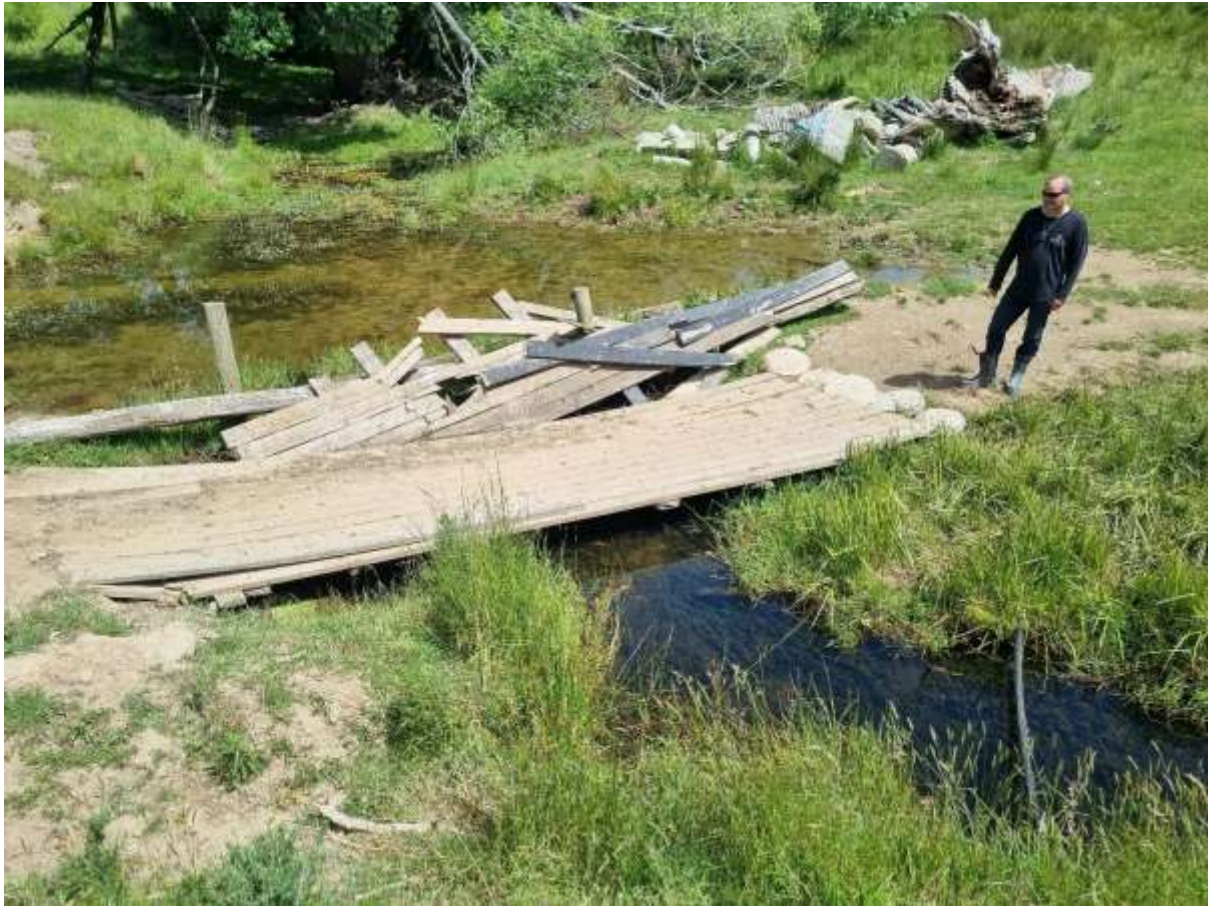
Figure 61 Upstream view of the H7 ford and bridge
