# FISH PASSAGE ASSESSMENT OF THE HAKAPUPU (PLEASANT) RIVER

Prepared by Kāti Huirapa Rūnaka ki Puketeraki

Matt Dale (Waterscape Connections Ltd) and Julia Rata te Raki, 2024

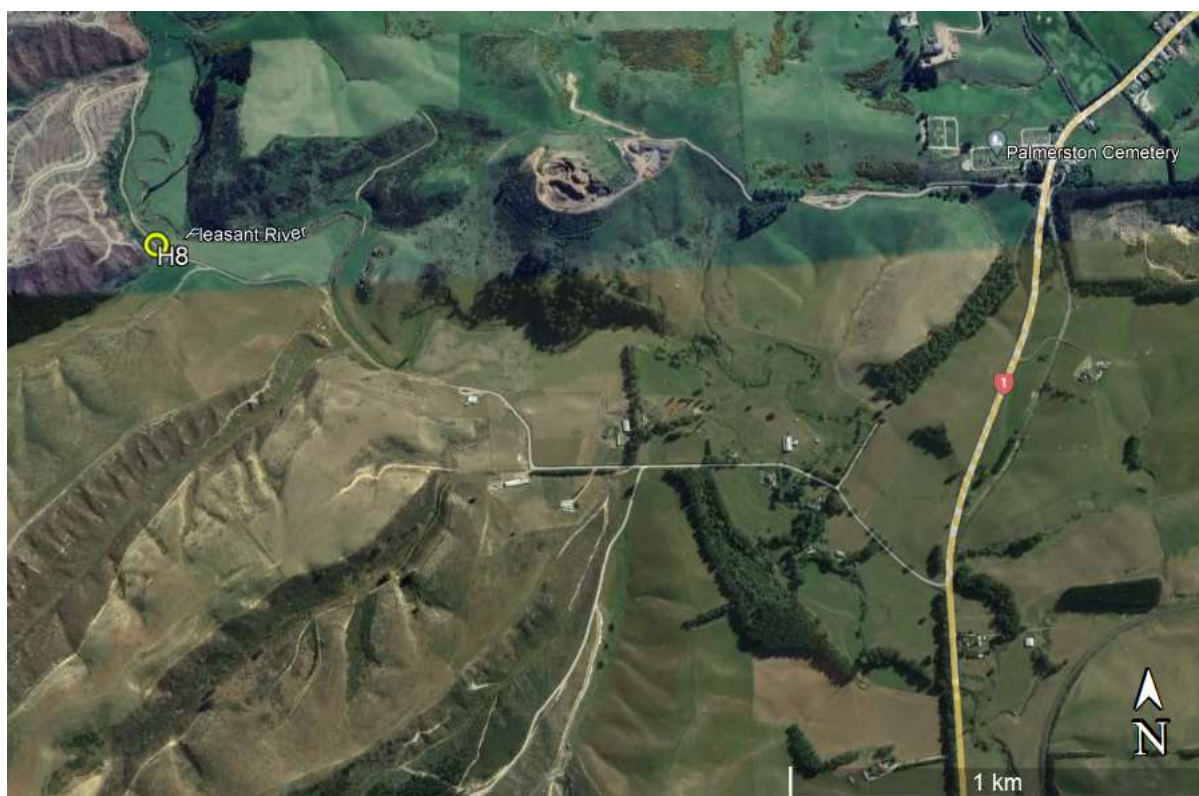
**Figure 62** Location of the H8 culvert in the middle reaches of the Hakapupu catchment.

Site H8 is located at the end of Stenhouse Rd on an intermittent tributary of the Hakapupu River, and has recently been installed as part of a road upgrade to support logging operations (Figure 62). At the time of assessment there were pools of water remaining at either end of the culvert, but the tributary was not flowing in the immediate reach (Figure 63 & Figure 64). Conversations with the forestry manager have indicated that this site is regularly damaged during flood events and has had to be repaired on several occasions in the past.

The gradient of the culvert is steeper than the surrounding stream bed and would likely restrict fish passage for species such as īnaka, therefore it is possible that the culvert would not meet the NESFW under conditions of continuous flow. However, the intermittent nature of the stream and a natural lack of fish passage over the summer months reduces the remediation priority for this structure.

It is unclear if there is permanently wetted habitat further upstream of the culvert, therefore as a precautionary measure the landowner should ensure that the culvert is installed in alignment with the NZ Fish Passage Guidelines when it is next repaired following a flood event.

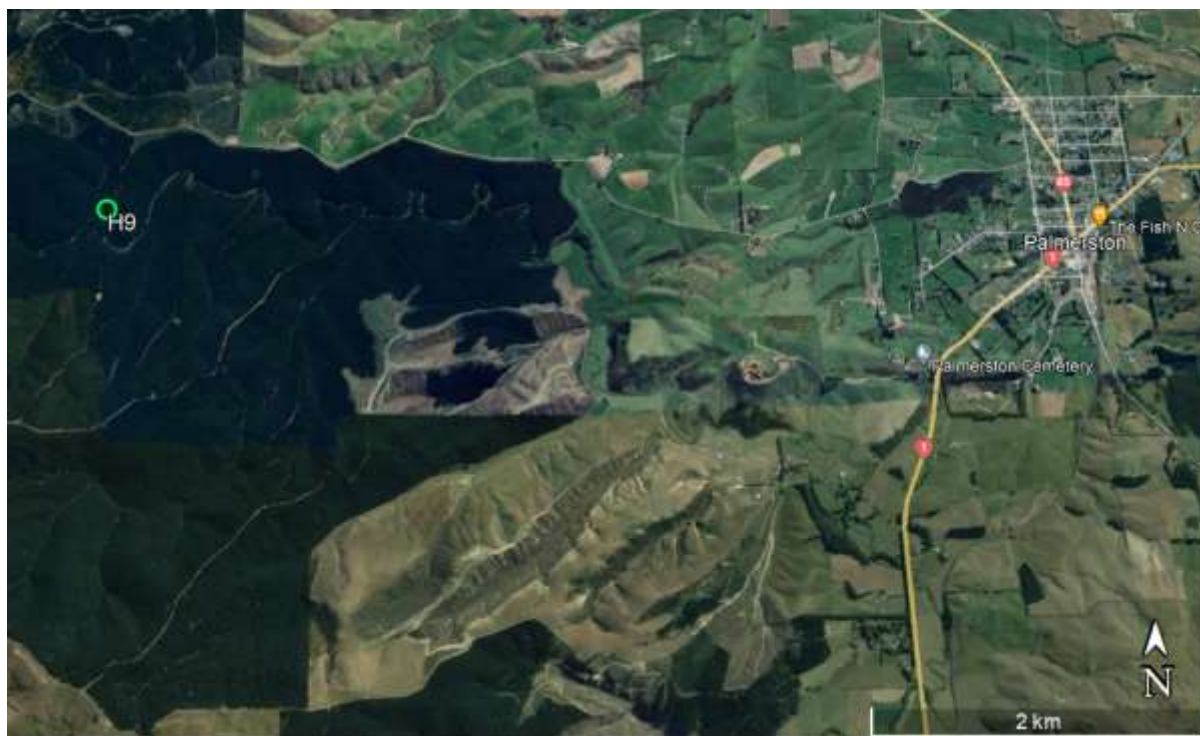
**Figure 65** Location of the H9 culvert

The culvert is 1m wide and located under a forestry access track. It has been damaged and partially collapsed by historic flood events. At the time of assessment surface flows had ceased in several locations either side of the culvert, however the presence of macrophytes, upland bully and stream invertebrates in the remaining pools indicate that they are perennial in nature.

Overall, this structure does not restrict fish passage any more than the surrounding stream bed at low flows. Although its remediation priority is low in its current state, the continued degradation of the culvert due to flood damage will likely result in fish passage issues in the future at which point it will need to be replaced.

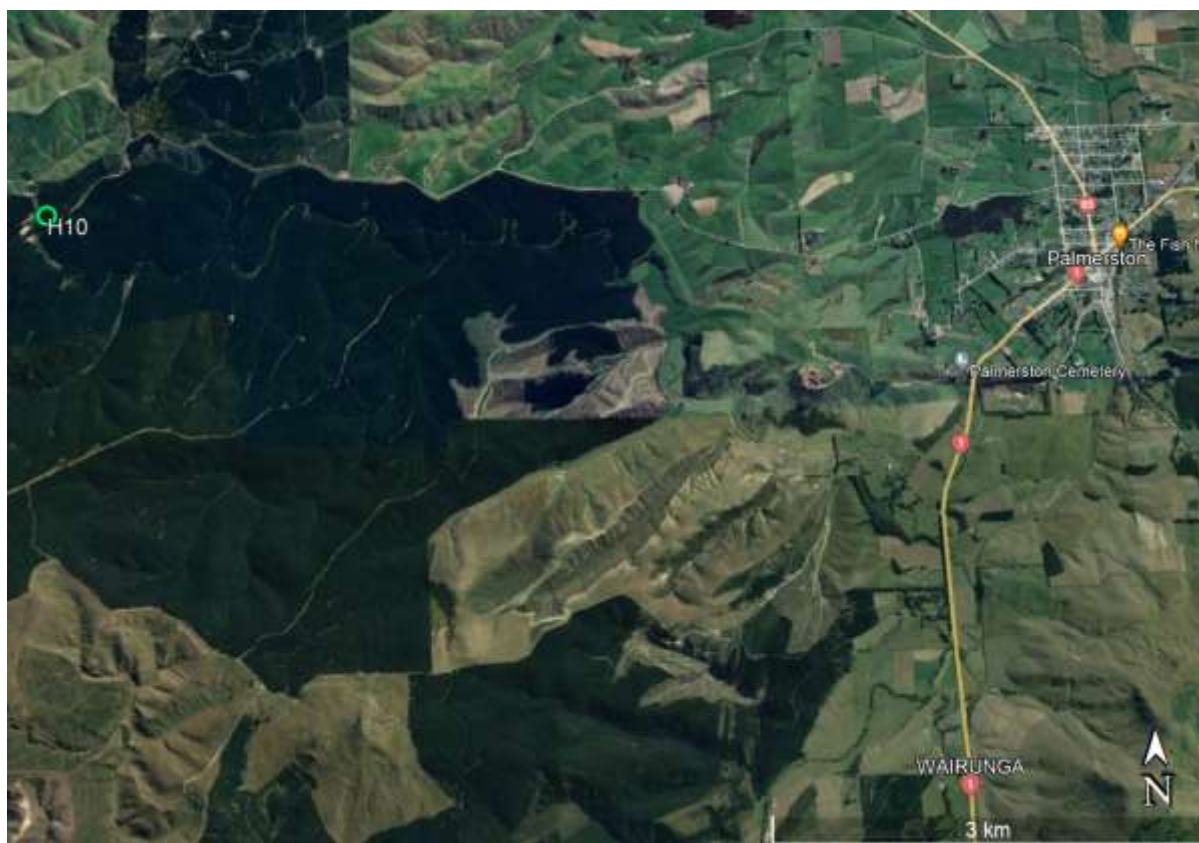
Figure 68 Location of the H10 culvert

H10 is a concrete culvert located in the upper reaches of Hakapupu catchment within the Calder Steward forestry estate (Figure 68). The culvert is set at the same gradient as the surrounding stream, has good water depth and low velocity and does not impede fish passage in any way.

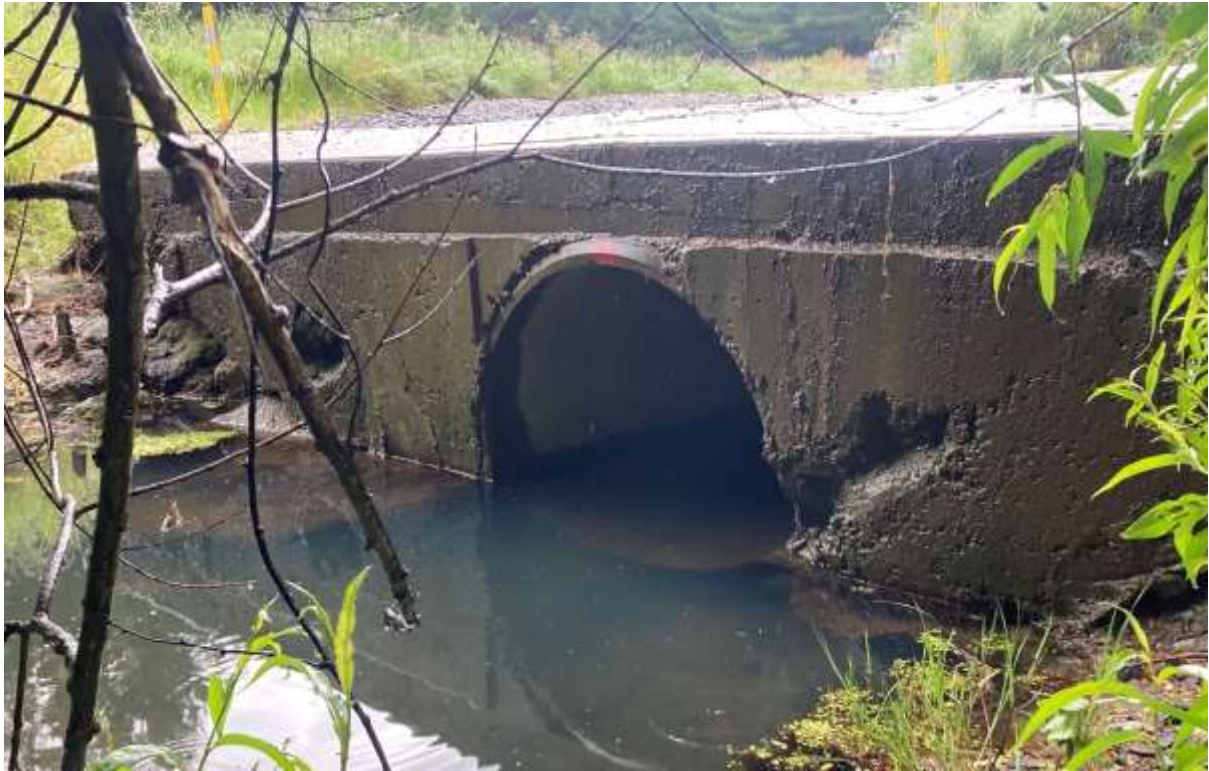
Figure 69 Downstream view of the H10 culvert

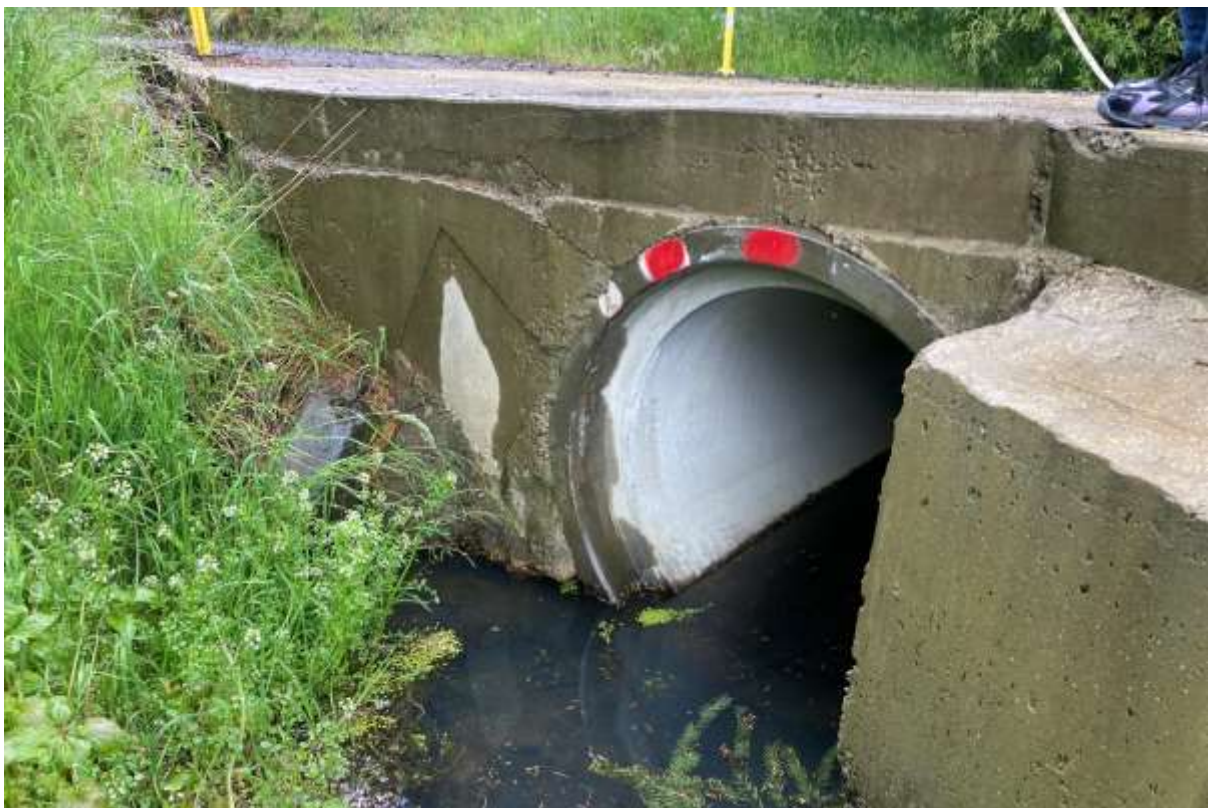
Figure 70 Upstream view of the H10 culvert

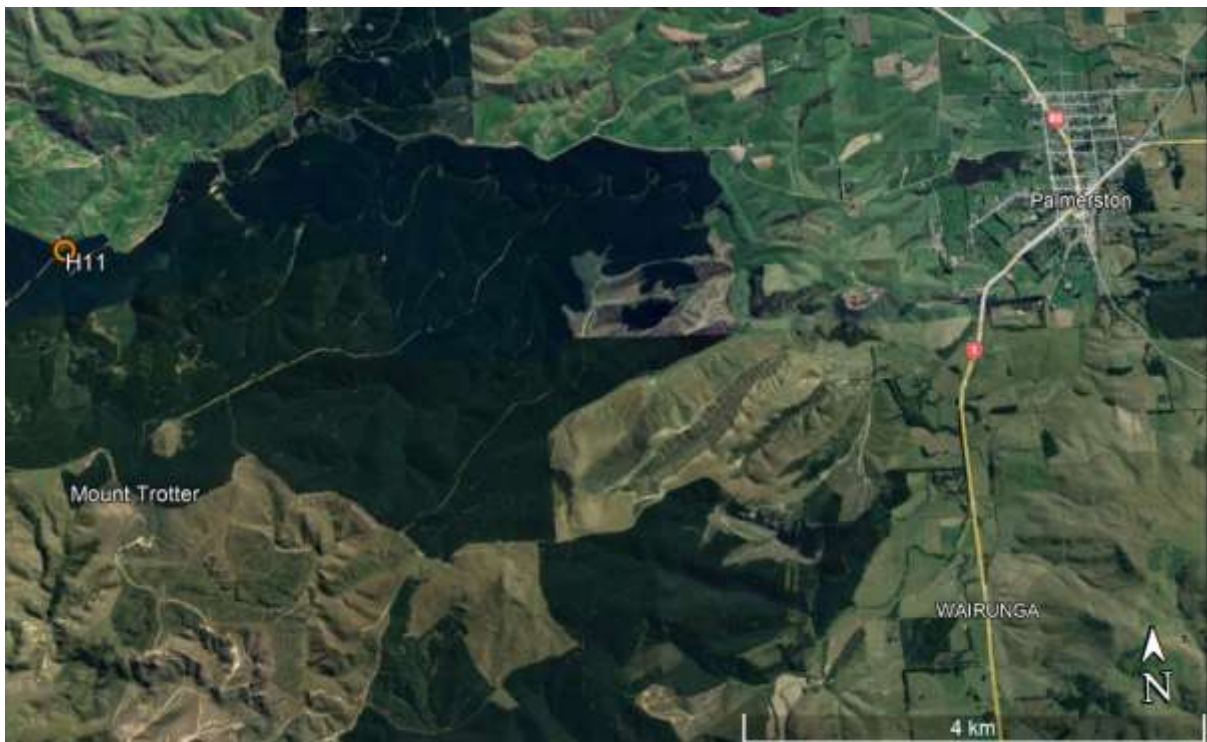
**Figure 71** Location of the H11 culvert

Culvert H11 is located in the upper reaches of the Hakapupu catchment in the Calder Stewart Forestry estate (Figure 71). The structure is a steel box culvert with a slightly raised lip on the upstream edge (Figure 73), however historic floods have undermined the structure and it had collapsed at the downstream end. At low flows all surface water is directed underneath the structure to reappear at the downstream end (Figure 72).

At the time of assessment, there was not continuous surface flow in the reach surrounding the culvert, with the stream consisting of a series of disconnected pools. As such, it is likely that the culvert would create a high risk to fish passage at moderate flows, but not at the low flows observed in mid-December. Although its remediation

priority is low in its current state, the continued degradation of the culvert due to flood damage will likely result in the need to replace the structure in the medium term.
