**NORTHERN GULLY SILT POND EMBANKMENT
FINAL CONSTRUCTION REPORT**

NORTHERN GULLY SILT POND EMBANKMENT

CONSTRUCTION REPORT

MACRAES MINING COMPANY LIMITED
NORTHERN GULLY SILT POND EMBANKMENT
FINAL CONSTRUCTION REPORT

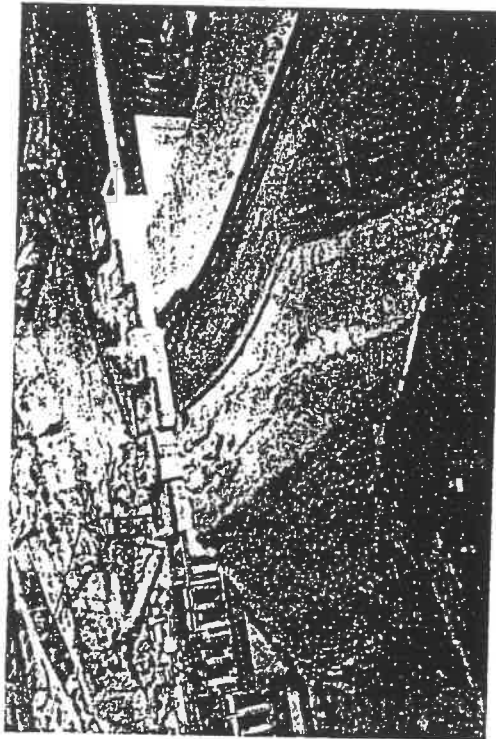
Fig. 5: Connection Between Rockfill Dam and Concrete Dam (Guri Hydroelectric Project) Showing Smooth Concrete Surface Under Impervious Earth Core.
