Natural Hazards at Glenorchy

May 2010

Executive Summary

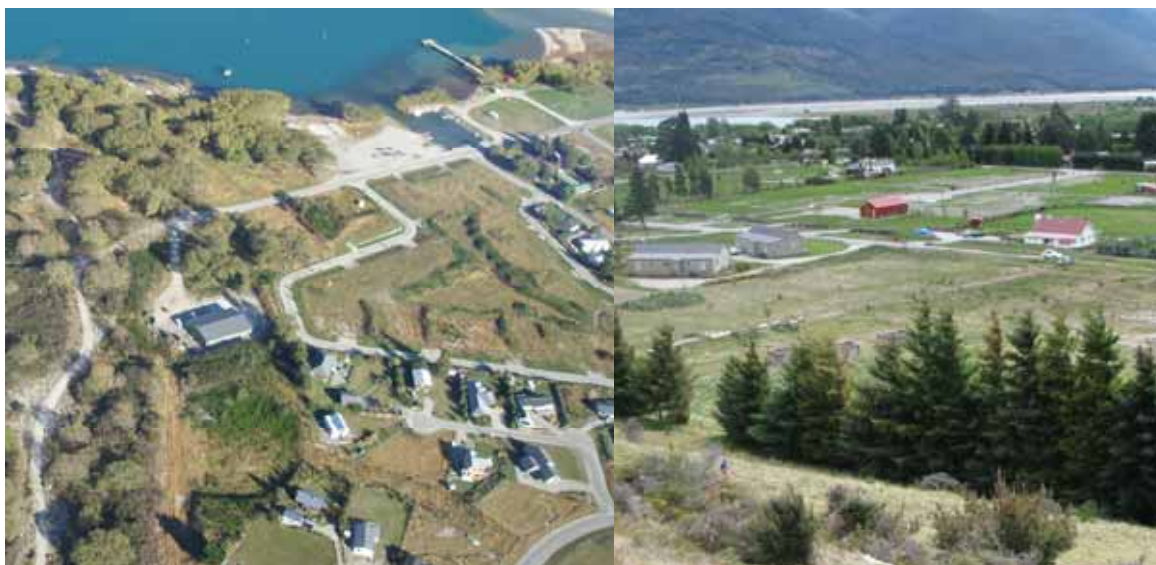
Figure 1.1 Parts of Glenorchy from the air (left) and the Bible terrace (right). Newly formed and planned residential subdivisions can be seen in both photographs. Left photograph courtesy of GNS Science

Located at the northern end of Lake Wakatipu, Glenorchy is a small township originally established by scheelite miners during the mid-to-late 19th century. While land uses within the region have included merino sheep farming and timber milling, more recently Glenorchy has become a gateway community to adventure tourism activities, such as high country tramping, kayaking and scenic sightseeing. The township is mainly comprised of residential and tourism-based operations as well as a primary school, Department of Conservation offices, and other community amenities (Figure 1.1).

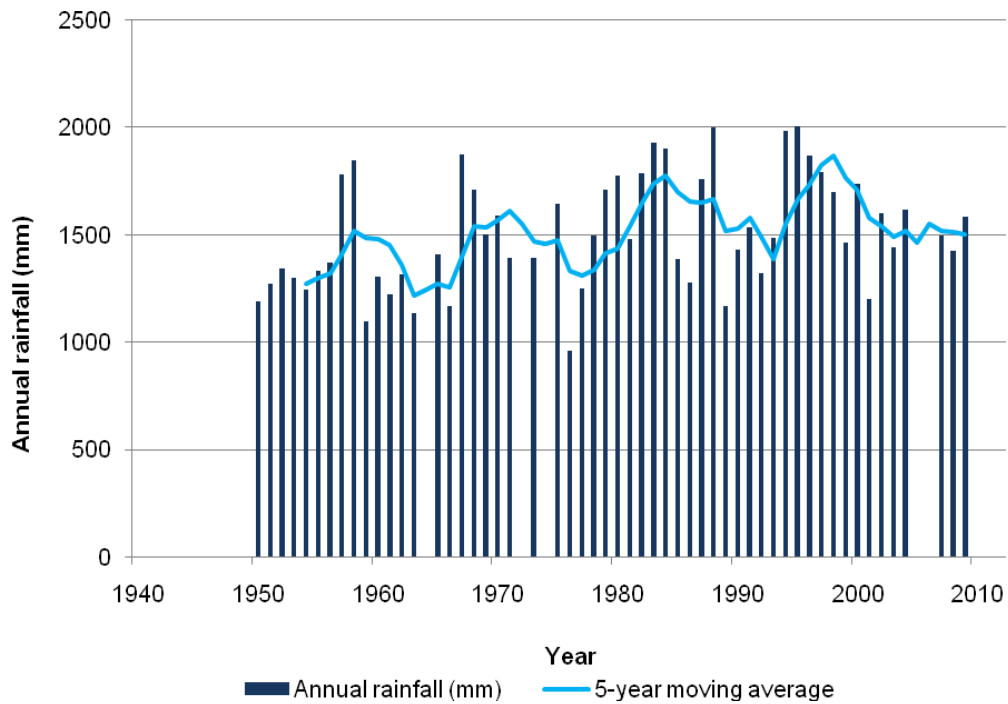
Figure 3.2 Annual rainfall totals for the Rees at Earnslaw gauge, 1950-2009. Missing record in: 1964, 1972, 1974, 2005 and 2006

In the Glenorchy area, the longest rainfall record is for the Earnslaw gauge (Figure 3.1) in the Rees River catchment (Figure 3.2). Between 1950 and 2000, average annual rainfall increased by more than 500mm at this site. Mojzisek (2005) agrees with these findings where a significant upward trend in total precipitation, rain days, consecutive wet days and number of very wet days in the vicinity of Glenorchy have been identified (Appendix 1). Since the turn of the century however, annual rainfall totals in north-western Otago have generally declined again, and this trend has also been evident at the Earnslaw gauge.

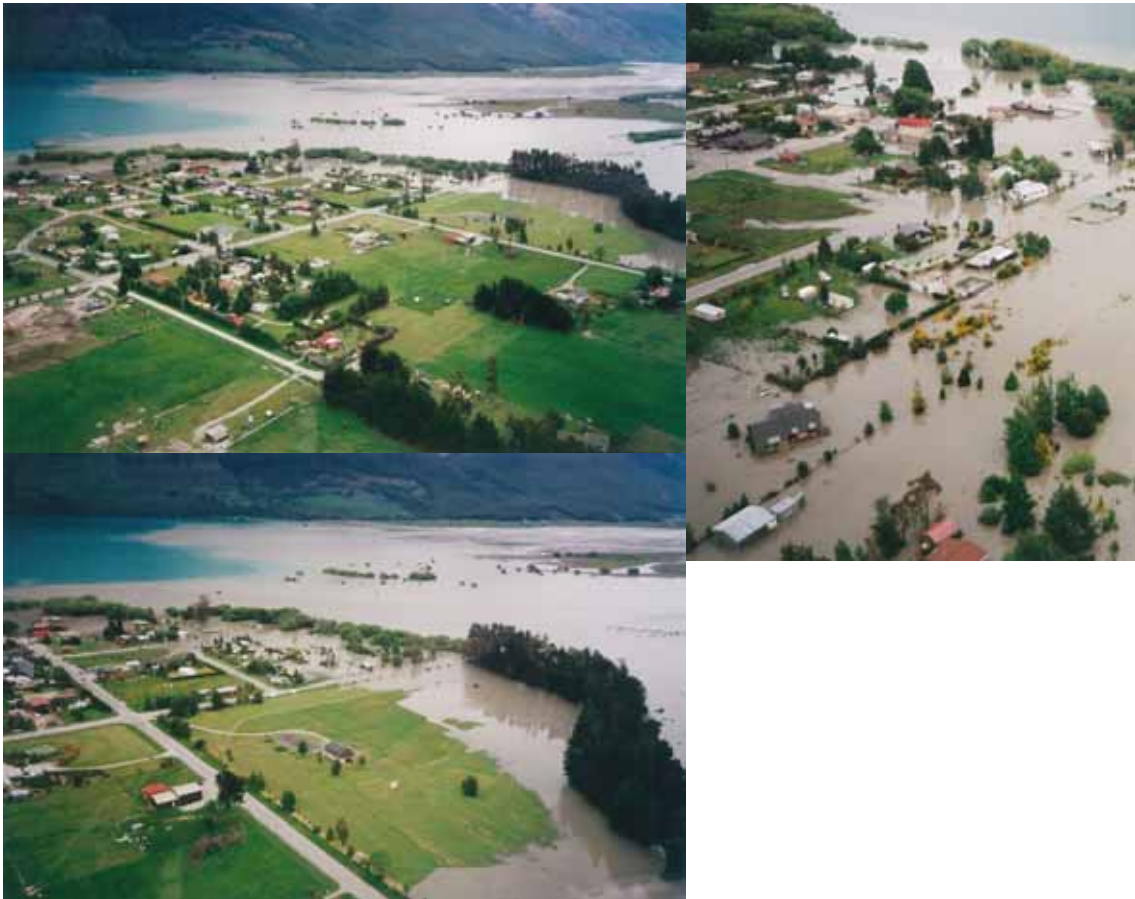
Figure 3.3 The lower margins of Glenorchy showing lake inundation on 19 November 1999

The primary hazard associated with Lake Wakatipu, that directly impacts Glenorchy, is prolonged inundation from high lake levels, particularly in the townships lower lying areas (Figure 3.3). The level of Lake Wakatipu has been observed to vary through a range of nearly 3.9m with a mean level of approximately 310 metres above sea level (masl). The flood of November 1999 was the highest lake level on record at 312.77 masl (URS, 2003) with the second highest level being recorded in September 1878 at 312.60 masl (Figure 3.4). The maximum extents of lake inundation from the November 1999 event are presented in Figure 3.5 (URS, 2007a).

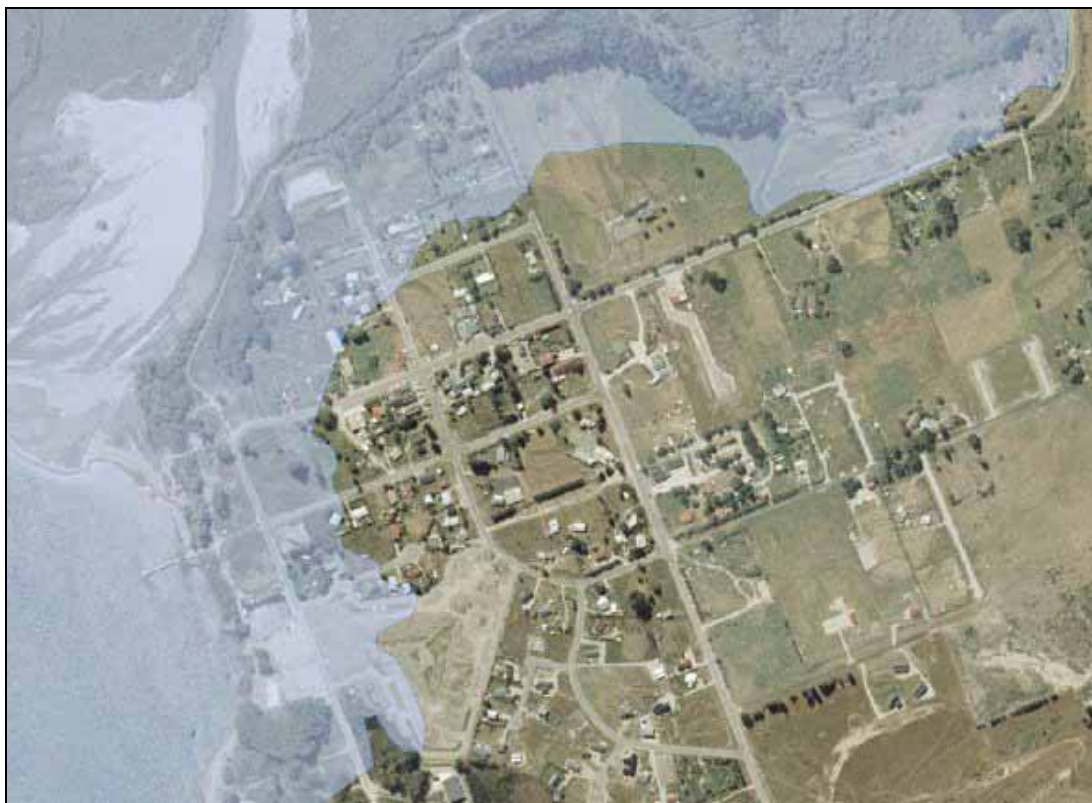
Figure 3.5 Maximum level of Lake Wakatipu in Glenorchy; November 1999 (URS, 2007a)

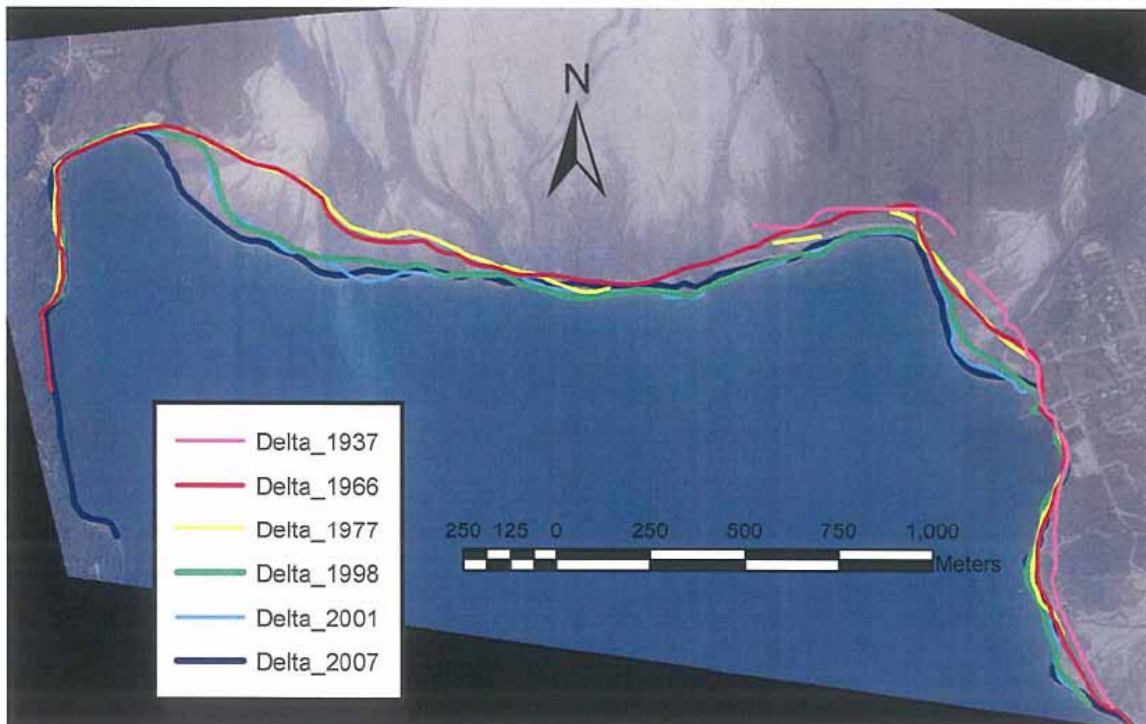
Figure 3.7 Lake shoreline advances 1937-2007 (M. Wild, 2007)

Sediment deposited into the head of Lake Wakatipu has formed deltas from the Dart and Rees Rivers and the Buckler Burn. Since the late 19th century both the Dart and Rees deltas have advanced 180-200m and 90-175m respectively (URS, 2007b). Investigating the formation of this delta complex, as well as others within the Otago region, is part of a PhD studentship at the University of Canterbury being funded by the Otago Regional Council, which is expected to be completed in 2011. Figure 3.7 shows some of the initial results from this investigation where lake shorelines have been mapped from aerial photography between 1937 and 2007.

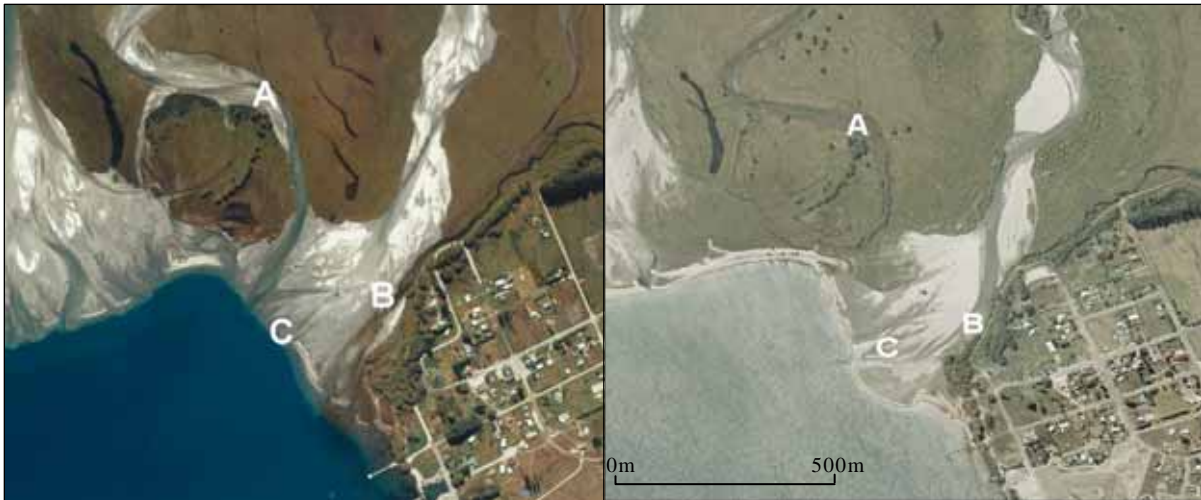
The Rees River fairway varies between 160m and 400m wide while occupying the eastern 1.7km of the Dart/Rees Rivers floodplain. Figure 3.8 shows the position of the main Rees channel at the Lake/Glenorchy confluence in 1989 and 2006. These images represent the dynamic, changing nature of the Rees River system over a relatively short period.

In 1989 most of the flow in this section of the river is located in the western branch (A) of the Rees. However, during this 17-year period, significant changes in channel position upstream of the confluence have diverted the majority of this flow into the eastern branch, placing it directly adjacent to Glenorchy (B). Having the majority of flow located adjacent to Glenorchy increases the community's susceptibility to Rees River erosion and flood hazards. In response to this shift in location, the Glenorchy-Rees floodbank was constructed in 2000 to mitigate the effects of flooding and to train the Rees away from Glenorchy (URS, 2007b). Substantial growth of the Rees Delta (C) into Lake Wakatipu during this period is also evident (Figure 3.8). Channel form and delta growth between these years are likely to have been influenced by large flood events in 1994, 1995 and 1999.

Figure 3.8 The Rees River and Glenorchy in 1989 (left) and 2006 (right)

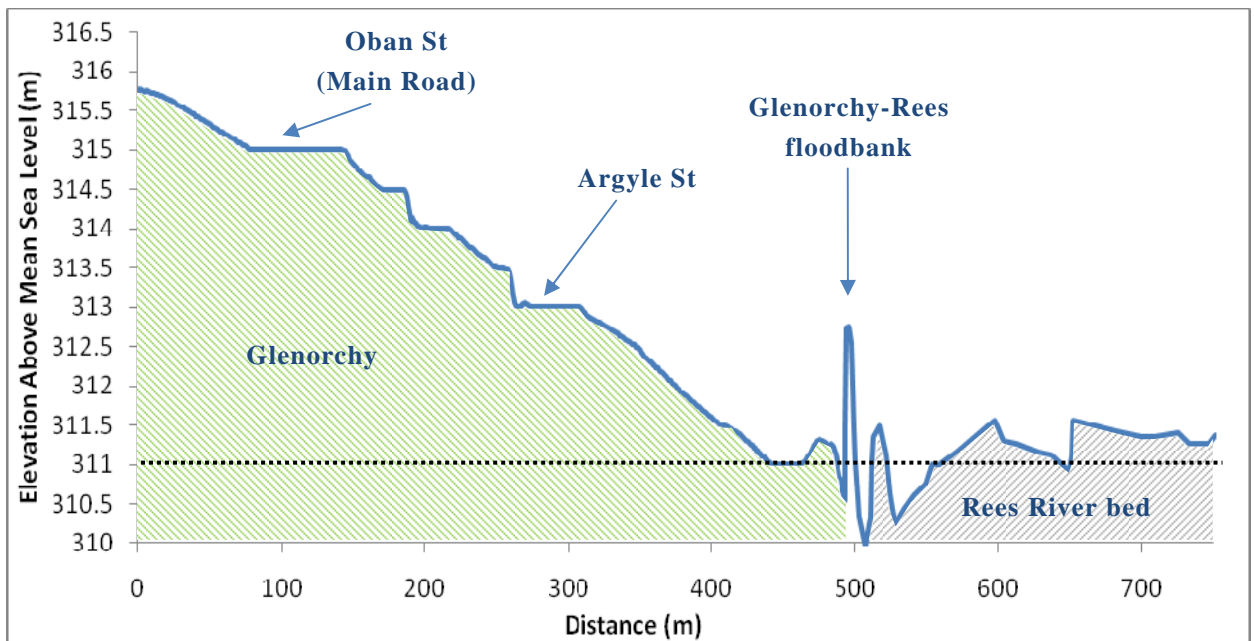
Cross-section information indicates that this is a likely scenario as the bed of the Rees River is already higher than some lower-lying parts of Glenorchy. Figure 3.9 shows a cross-section of the Rees River bed that has been joined to the DEM of the township (Figure 2.3 and Figure 3.10). The black dotted line represents 311m⁸ and indicates that a large part of the Rees River bed lies above or at similar levels to parts of Glenorchy. As the delta continues to advance and grow, it is anticipated that the Rees River bed levels will rise accordingly, consequently increasing Glenorchy's risk.

Figure 3.9 Cross-section of the Rees River, surveyed in December 2006, and Glenorchy showing the elevation of the river bed with respect to the township

⁸ As noted in Section 3.1, 311m is the point at which low lying parts of Glenorchy become inundated by the lake. Therefore, this level indicates that the Rees River bed level is elevated above these lower margins of the township.

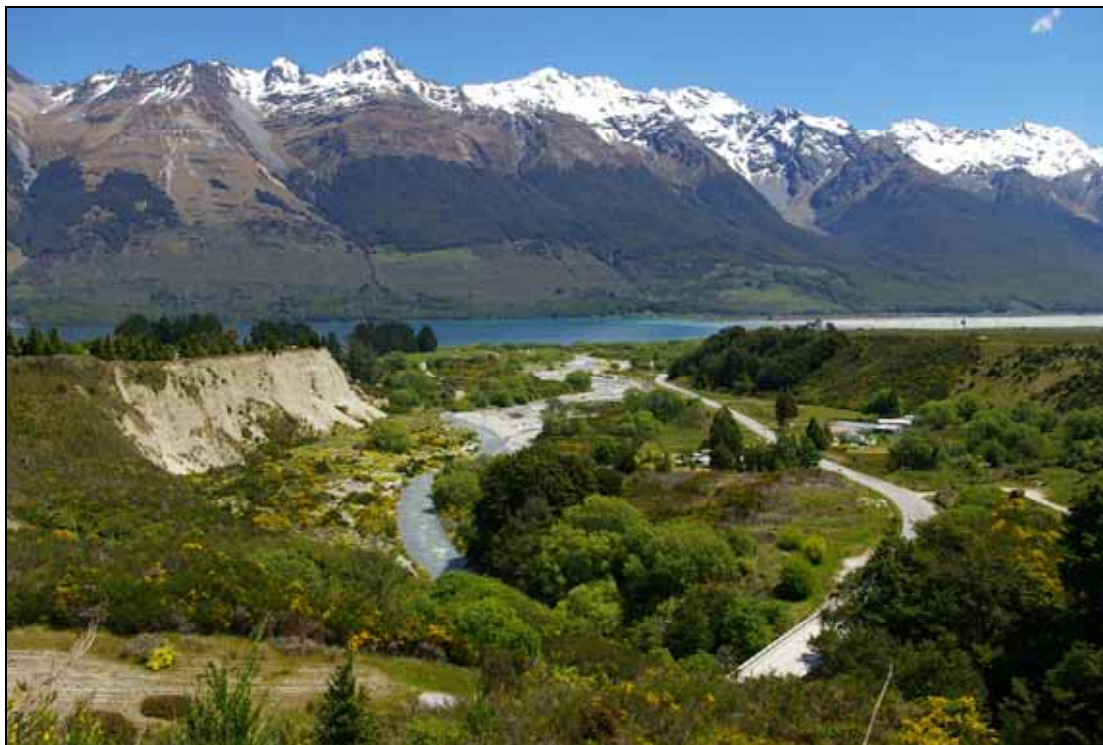
Figure 3.11 The lower Buckler Burn floodplain incised into old alluvial terraces seen at a higher level on the left and right of the image

The Buckler Burn drains the eastern slopes of the Richardson Mountains with the length of the catchment extending 16 km down to Lake Wakatipu, and is located to the south-southeast of Glenorchy. The lower 6.5km of the catchment is a narrow gorge about 400m wide at the top, and 150-200m deep, cut in the base of a valley fan (Figure 2.2). Upstream of the Glenorchy-Queenstown Road bridge the gorge is cut down into schist with the last 1.8km incised into old lake and gravel deposits (Figure 3.11). Hazards that have potential risk for Glenorchy, resulting from the Buckler Burn, include the possible avulsion of the channel due to aggradation and/or a large debris/flood flow sourced from the breach of a natural dam in the upper catchment.

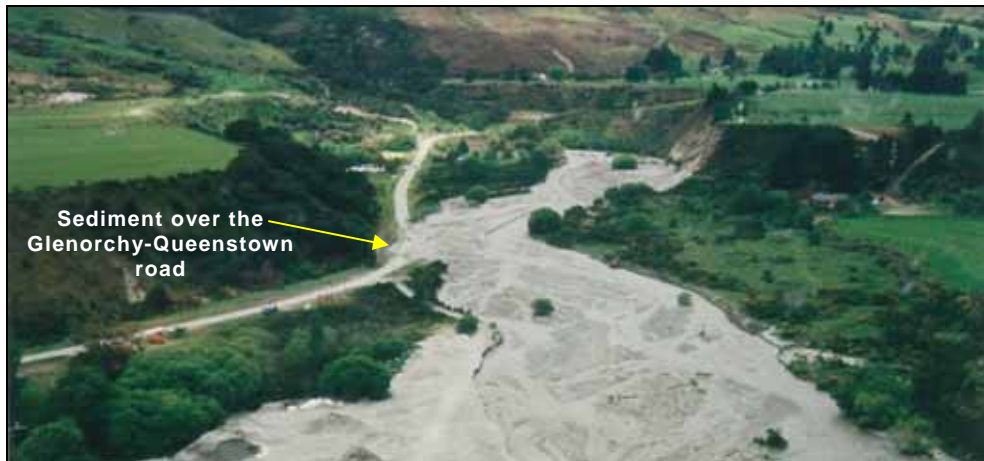
During the 1999 flood event, the point where the Buckler Burn is closest to the Glenorchy-Queenstown Road aggraded significantly. Figure 3.12 shows that a large volume of sediment was deposited over the Buckler Burn fan-delta during this event and overtopped the road embankment on the true right of the channel.

Figure 3.12 Lower Buckler Burn aggradation following the 1999 flood event

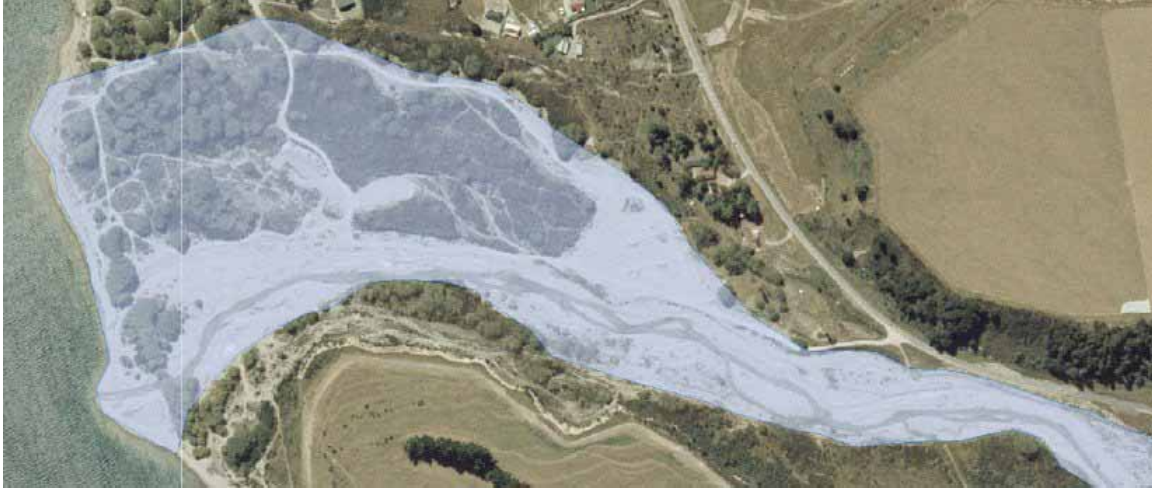
Modelling for a $170\text{m}^3/\text{s}$ flow event⁹ in the Buckler Burn showed that flood levels are still contained within the current channel and floodplain limits¹⁰ (Figure 3.13). URS (2007a) note that flooding is contained within the existing floodplain. However, if bed levels continued to aggrade without intervention there would be significant risk of the existing bank protection being overtopped and floodwaters flowing down the main road into Glenorchy (URS, 2007a). This is a natural process that has formed the sediments on which Glenorchy is now located.

Figure 3.13 Buckler Burn flood extent for a 170m³/s peak flood event (URS, 2007a)

⁹ $170\text{m}^3/\text{s}$ peak flow is assessed as having a 1:100 year return period (URS, 2007a). This flow is chosen to be representative of effects during a “flood”.

¹⁰ Flood modelling of the Buckler Burn used cross-section information surveyed in December 2006, and therefore flood hazard extents are mapped based on bed levels at that time. These extents represent one scenario therefore should be regarded as indicative. The dynamic and variable nature of Buckler Burn flood/debris hazards means they are very difficult to model accurately.

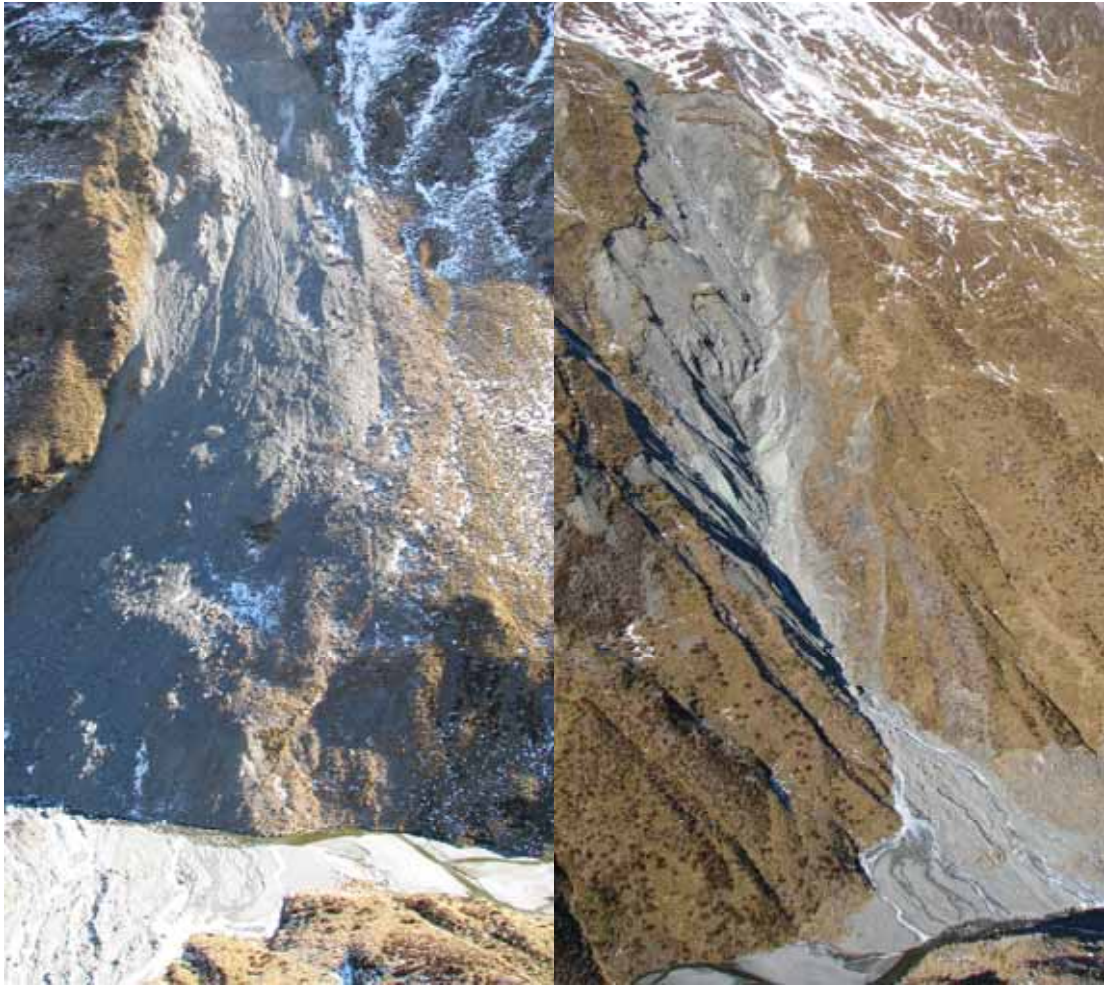
Figure 3.14 Large landslides in the upper Buckler Burn catchment on the true left of the channel (right image) and true right of the channel (left image). Depending on the nature of the Buckler Burn channel and quantity of sediment brought down by these slides, the channel can dam at this location

Geologically, recent large-scale mass movement and slope instability in the upper catchment of the Buckler Burn (Figure 3.14) has led to the formation of a landslide dam at about 1,000 masl (Figure 3.15). This feature has been the subject of investigations undertaken by the Otago Regional Council since 2004. Opus (2004a) note that there is potential for ongoing landslide activity at this location and in turn, potential for this feature to become larger. An inspection undertaken in 2009 revealed that no water was impounded at that time (Figure 3.15). However it is important to note that dam formation and impoundment is largely dependent on the frequency and magnitude of rainfall events and snow-melt. Should the dam re-form and subsequently fail, large quantities of water, sediment and/or debris may flow down the Buckler Burn gorge causing aggradation on the fan-delta. This scenario could result in the Buckler Burn leaving its channel and flowing down the main road towards Glenorchy.

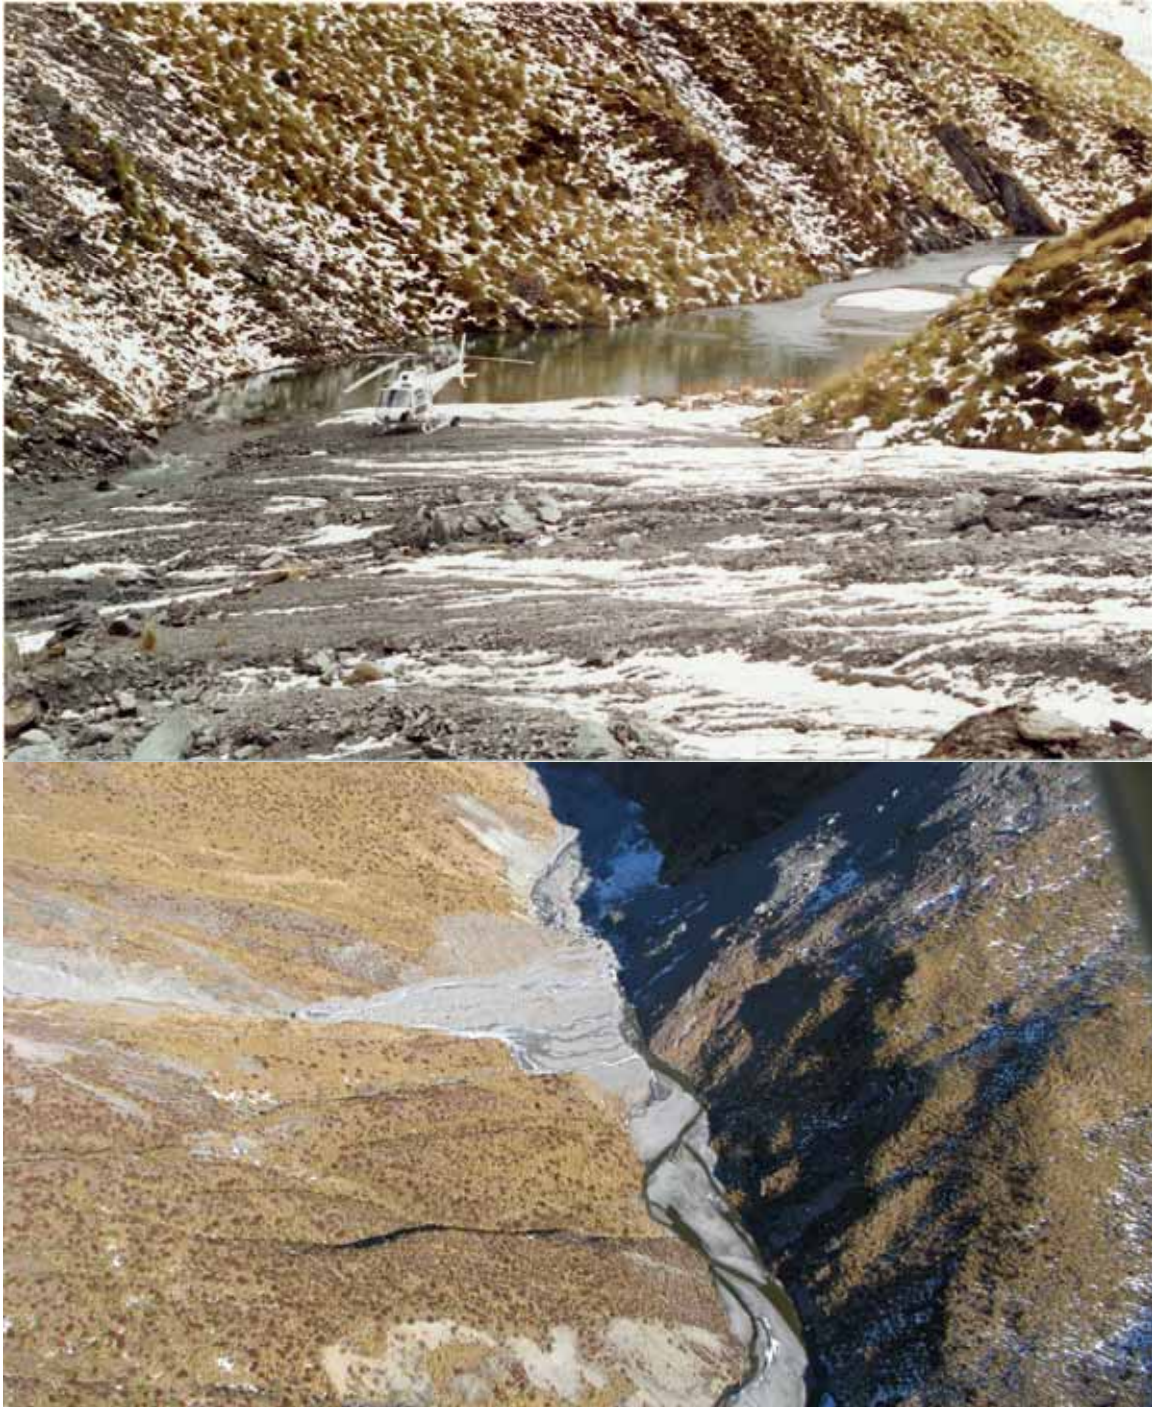
Figure 3.15 The Buckler Burn Landslide Dam in 2004 (top), looking upstream and in 2009 (bottom), looking downstream

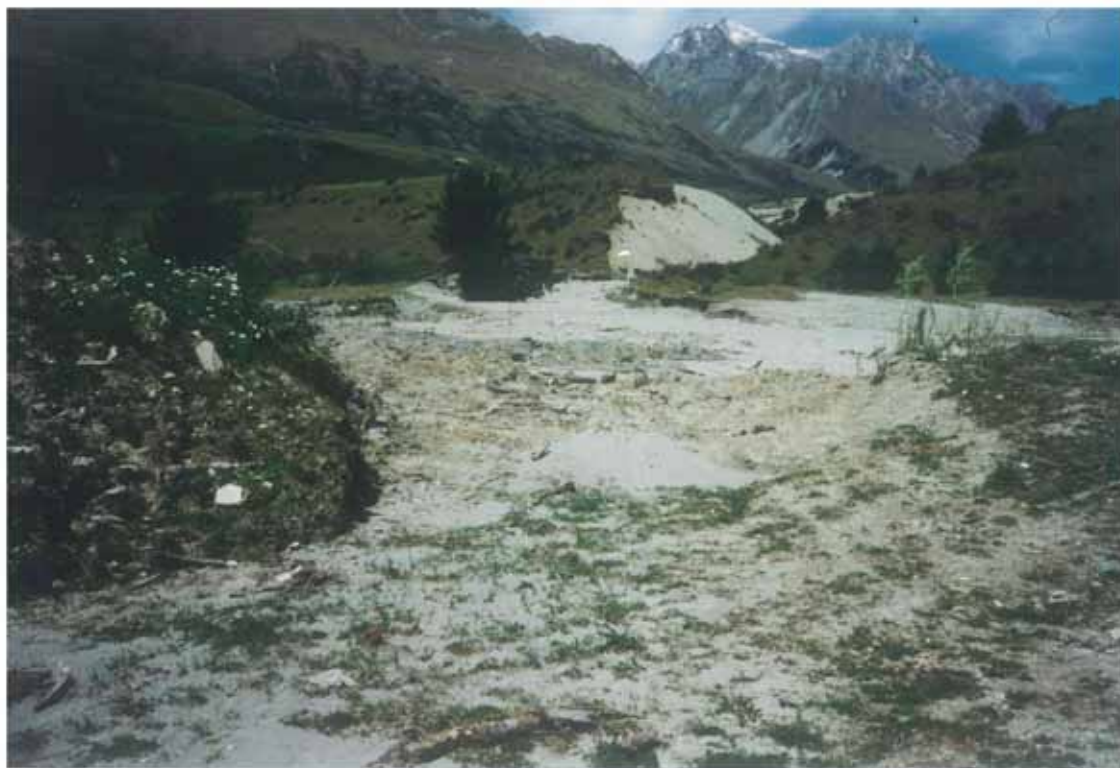
Figure 3.16 Sedimentation resulting from the November 1999 flood event across the Bible Stream alluvial fan

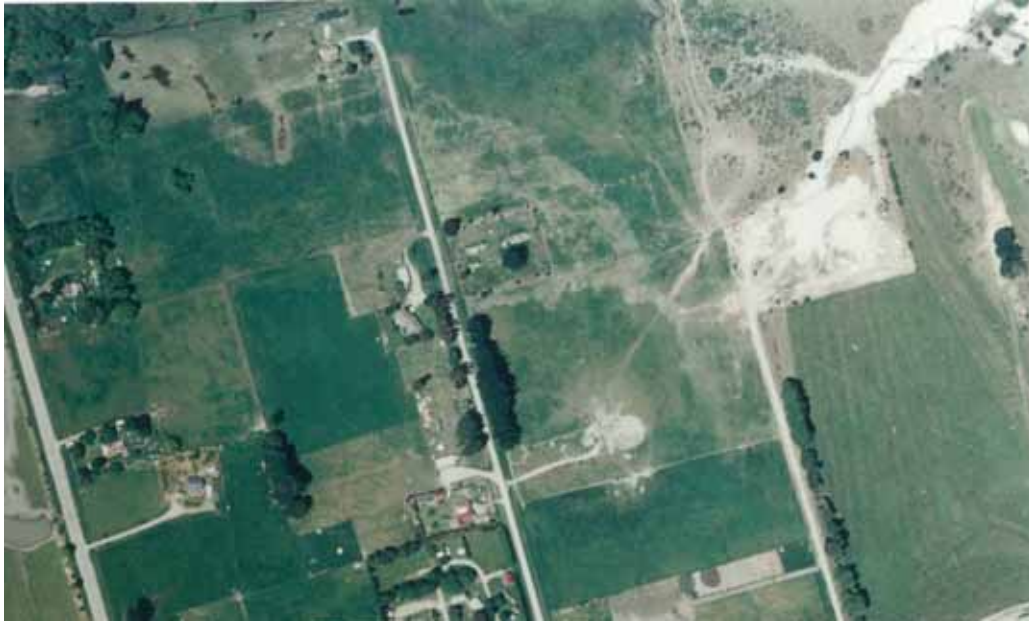
Figure 3.17 Sedimentation resulting from the November 1999 flood event across the Bible Stream alluvial fan

This assessment indicated that floodwater, under a breach scenario, would flow north-west towards Glenorchy. As floodwaters reach the limits of the Bible Stream debris fan, velocities would reduce and water would start to flow north-east towards the depression on the township's eastern margin, shown by blue arrows in Figure 3.19 (URS, 2007a). These inundation and flow characteristics were observed in the November 1999 flood event and are evident in Figure 3.17.

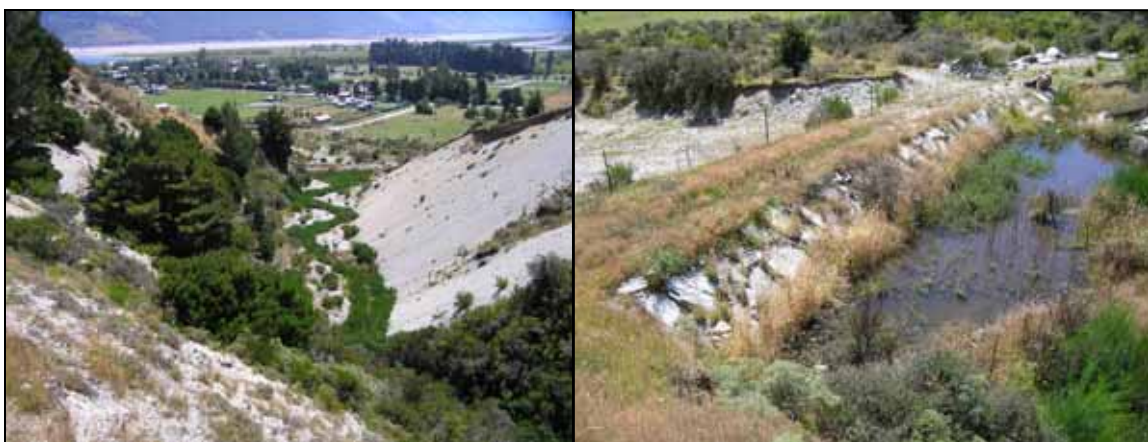
Figure 3.18 The Bible Stream Gully (left) and associated dam embankment (right)

Two informal structures—a dam embankment created at the terraces lower margins (Figure 3.18) and a small diversion channel—divert flow away from Glenorchy and into the Rees River wetland. This feature has a storage capacity estimated to be less than a few hundred cubic metres when full. The structure discharges directly into the diversion channel and does not have an engineered spillway therefore, excessive flows in the catchment are likely to overtop this feature with flows re-entering the historic flow paths towards Glenorchy (URS, 2007b)

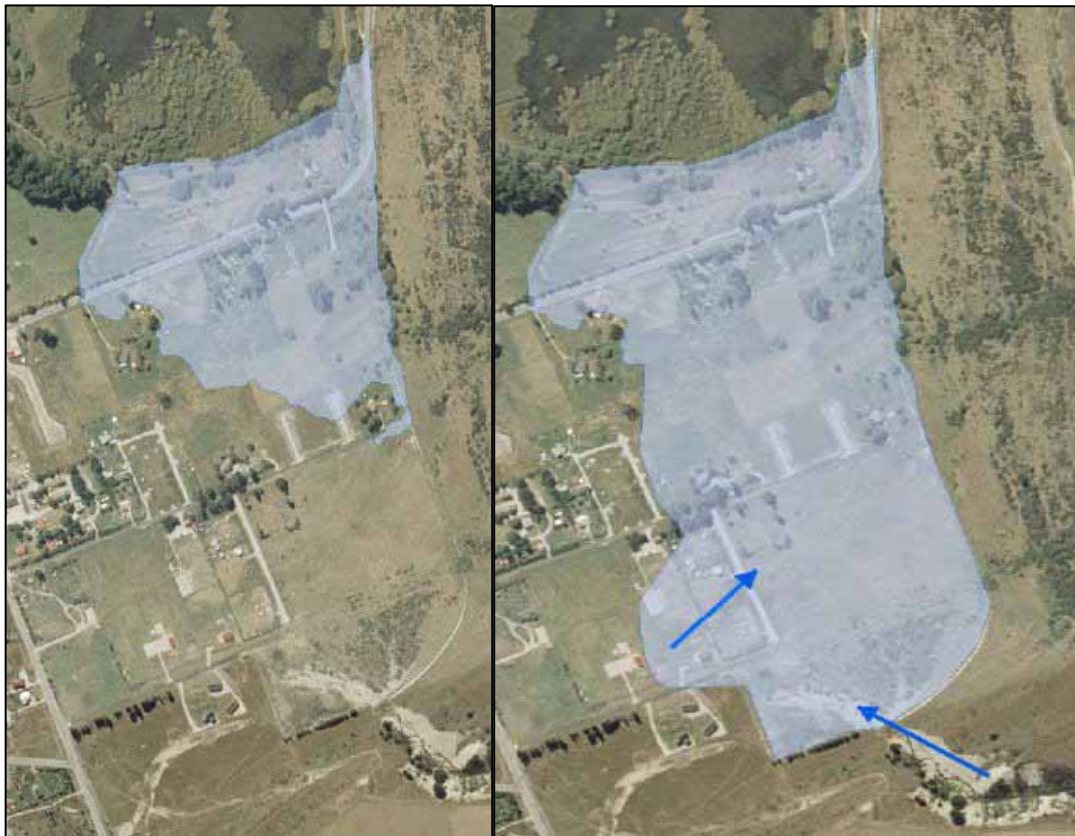
Figure 3.19 Bible Stream flood extents both assessed scenarios (left – no breach, right – dam breach) (URS, 2007a)

Flood assessment for the Bible Stream catchment was undertaken for two hypothetical scenarios¹¹ (Figure 3.19). These were a breach scenario at the dam embankment and a less likely scenario where the diversion channel coped with flows and no overtopping occurred. Figure 3.19 shows the ponding areas associated with each scenario, with most of the flow being directed into the depression located to the east of Glenorchy (Figure 2.3).

¹¹ Flood and debris flows derived from the Bible Stream are very unpredictable and characteristic of variable alluvial fan hazards. Therefore, the flood extents represented in Figure 3.19 should be regarded as indicative, as flood and debris flows may occur outside these extents, depending on the nature of that event and the effects of surface features such as buildings, fences and drains.
