# Summary of Risks to South Dunedin

## Buildings, Parks & Transport

South Dunedin

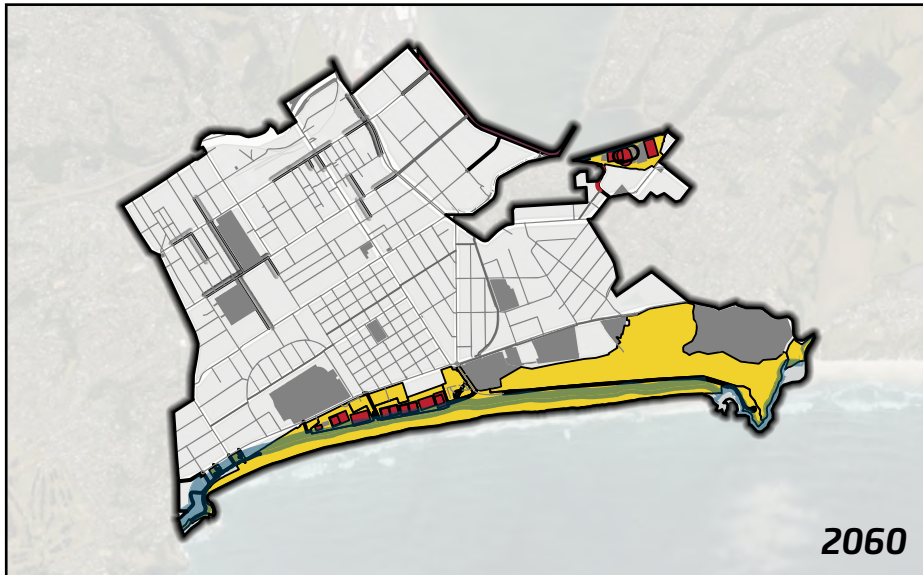
**Figure 5.19 Open spaces and roads risk due to coastal erosion**

Explainer: These maps show the risk to transport and open spaces due to coastal erosion, noting that there is a high level of uncertainty regarding coastal erosion risk due to data limitations at present (e.g. scale of screening study and accounting for impact of engineered structures). The maps indicate that coastal erosion risk to transport and open spaces is identified at the Otago Harbour coastal edge and the St Clair-St Kilda coastline at present day and mid-century, with high risk to some playing fields emerging at mid century.

Hazard data source: WSP, 2024

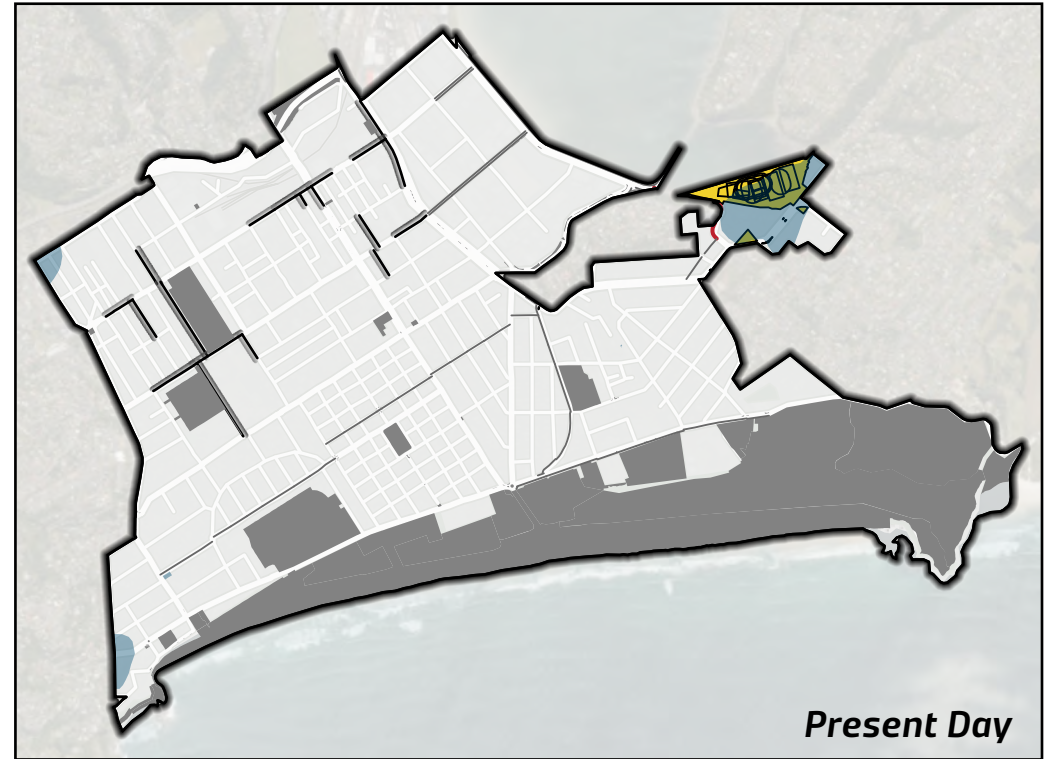
## Landslide

**Explainer:** These maps show the risk to roads and open spaces due to landslide. Risk ratings for individual roads and open spaces are based on exposure of each asset to landslides, combined with their vulnerability rating (roads – extreme, open spaces - high). The maps illustrate that this type of landslide risk is confined to areas around the South Dunedin boundary. Landslide risk is not assessed at future timeframes due to the absence of spatial data that incorporates the influence of climate change (groundwater level rising or increased rainfall intensity) on landslide. Landslides can severely damage transport and open spaces resulting in sudden collapse or failure and posing a potential risk to life. Landslide damage to parks can cause loss of field function, with potentially prohibitively high repair costs.

**Hazard data source:** DCC Hazard database data provided for South Dunedin Future programme

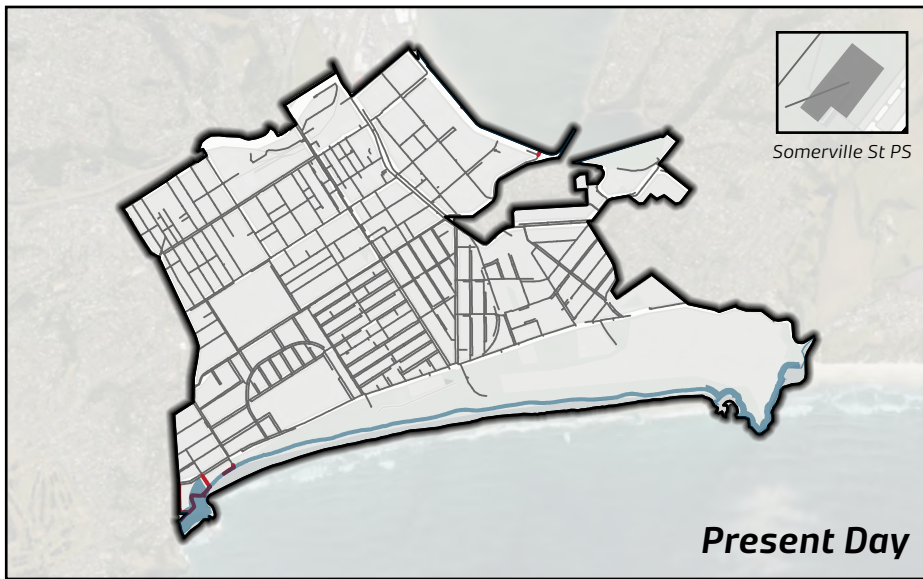
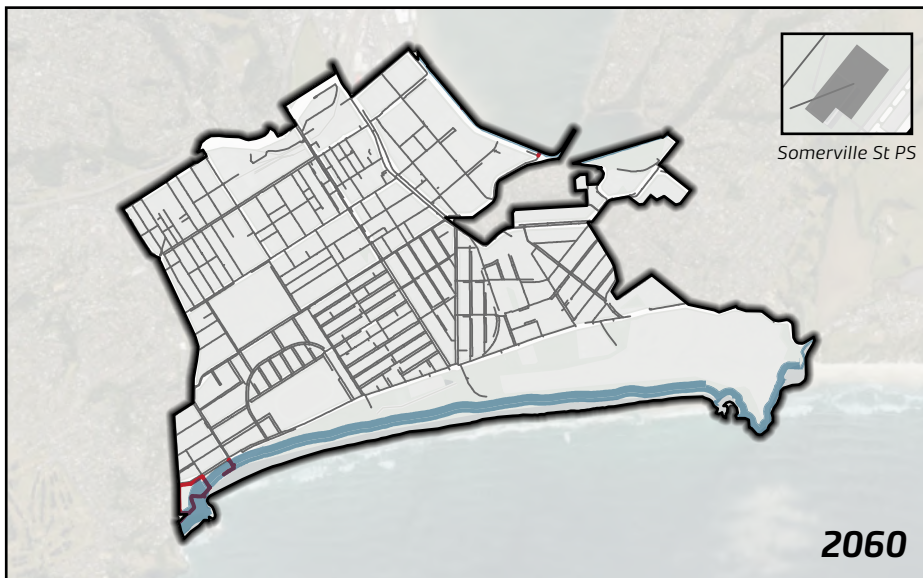
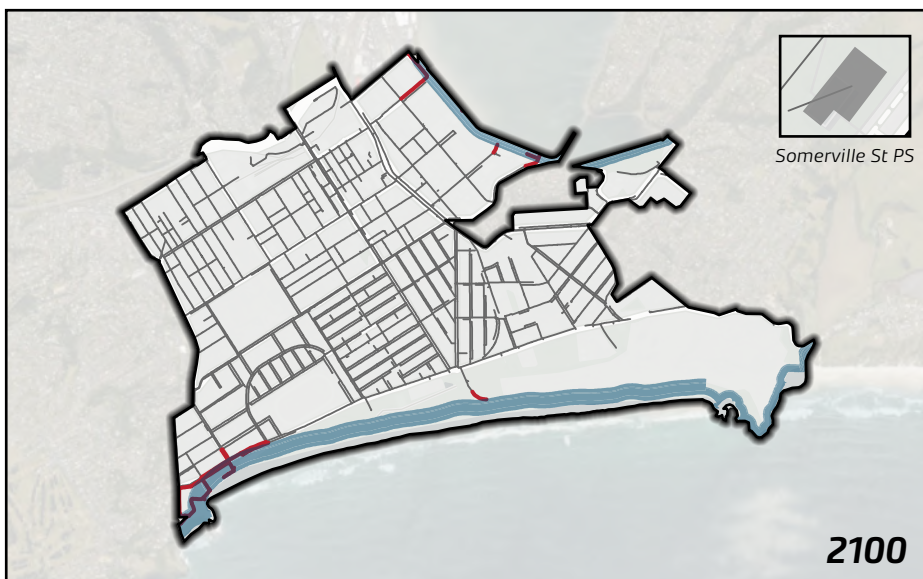
**Figure 5.28 Water supply infrastructure risk due to coastal erosion**

**Explainer:** These maps show the risk to water supply due to coastal erosion (blue shading), noting that there is a high level of uncertainty regarding coastal erosion risk due to data limitations at present (e.g. scale of screening study and accounting for impact of engineered structures). The maps illustrate that coastal erosion risk to water supply is largely confined to the St Clair-St Kilda coastline at present day with risk to some pipe sections arising from the Otago Harbour at late-century.

**Hazard data source:** WSP, 2024

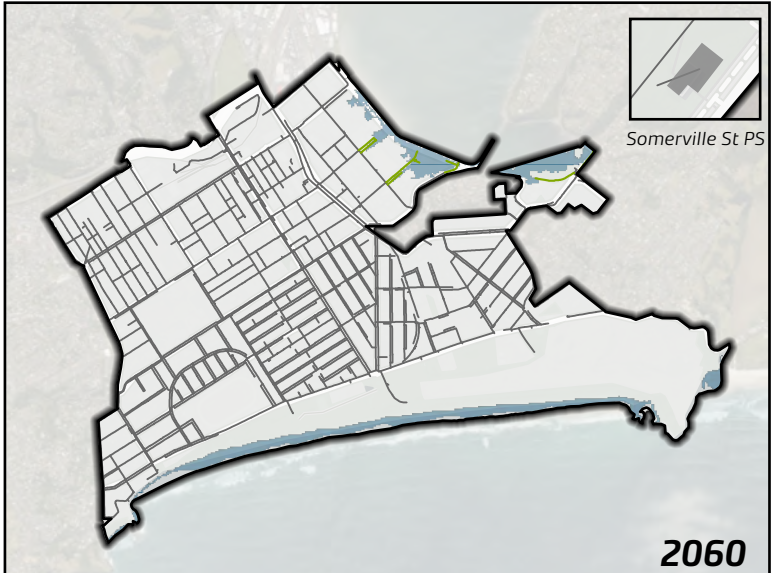
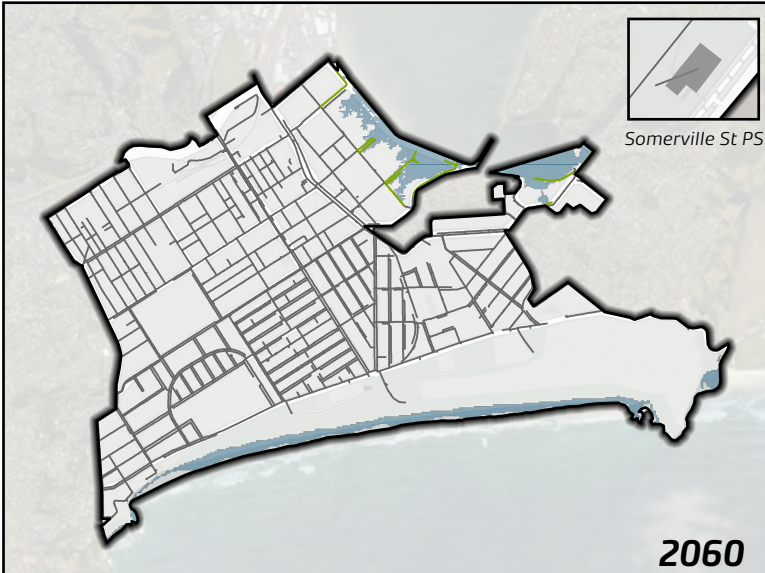
**Figure 5.30 Water supply infrastructure risk due to coastal inundation**

**Explainer:** These maps show the risk to water supply infrastructure due to coastal inundation (blue shading). Risk ratings for individual water supply pipe sections are based on exposure of each asset to modelled coastal inundation extents, combined with the vulnerability of the asset to inundation. Although many water supply pipes and the associated above ground infrastructure (pump stations, valves etc) are extremely exposed to frequent, severe, flooding (>10 % AEP) at late century, they are rated as having very low vulnerability coastal inundation as they do not tend to sustain damage during such events. The maps illustrate coastal inundation risk is low for most water supply pipes within South Dunedin under the assessed timeframes.

South Dunedin Future Boundary  
 1% AEP coastal inundation extent

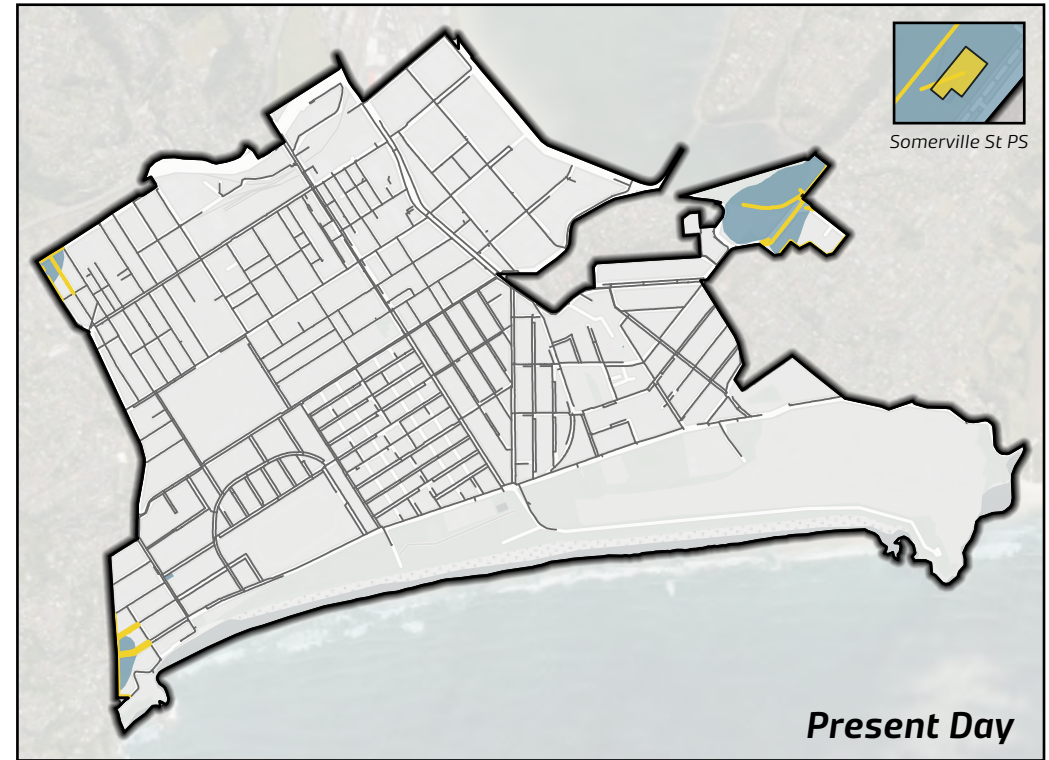
**Explainer:** These maps show the risk to water supply due to landslide, where some pipes at the South Dunedin boundary are rated medium risk. Risk ratings for individual water supply pipes are based on exposure of each asset to landslides, combined with their vulnerability rating. Landslides can severely damage water supply resulting in sudden collapse or failure. The maps illustrate that landslide risk is confined to areas around the South Dunedin boundary. Landslide risk is not assessed at future timeframes due to the absence of spatial data that incorporates the influence of climate change (groundwater level rising or increased rainfall intensity) on landslide. **Disclaimer:** These maps are not intended to assess landslide risk at individual asset level, which requires consideration of a site specific landslide risk as well as more detailed asset information. The landslide extent is based on known landslide areas and does not account for other potential sources of landslide nor represent the extent of the area of deposition/runout.

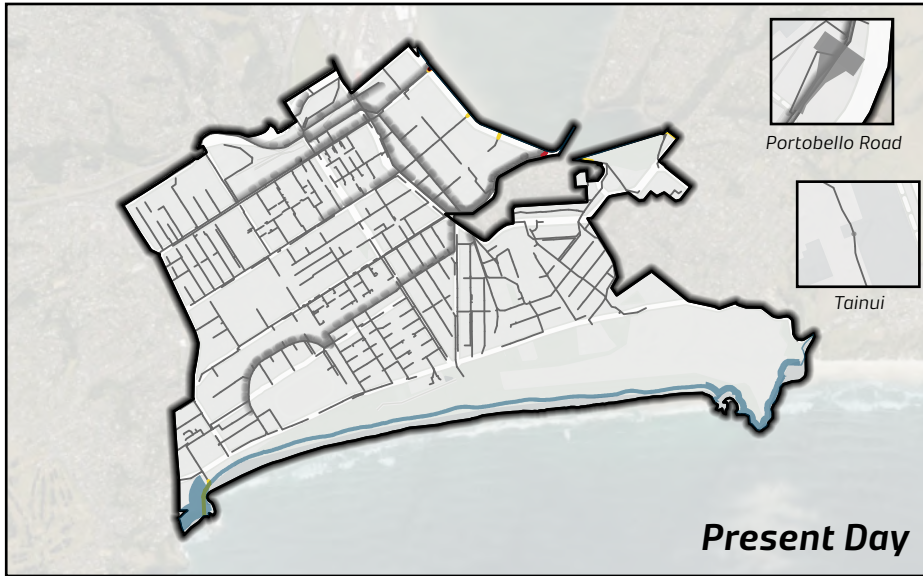
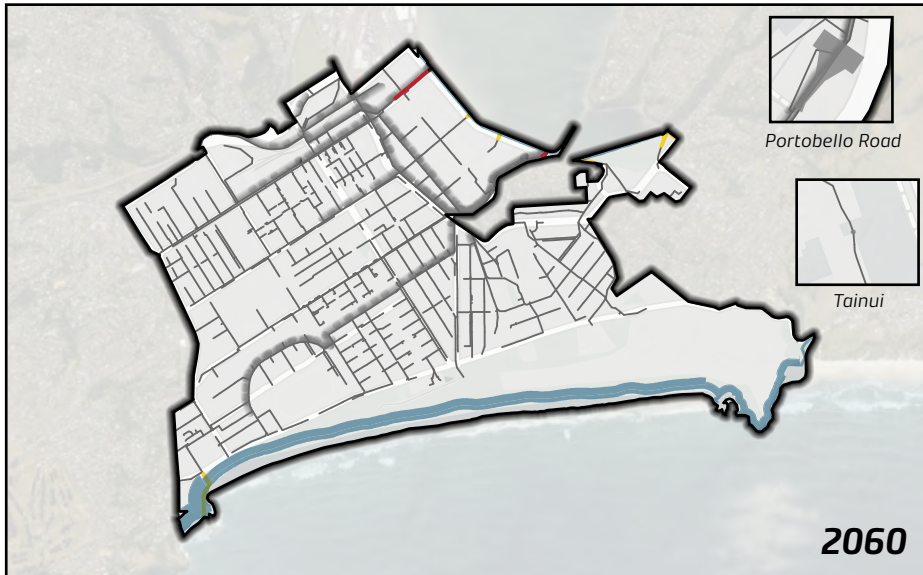
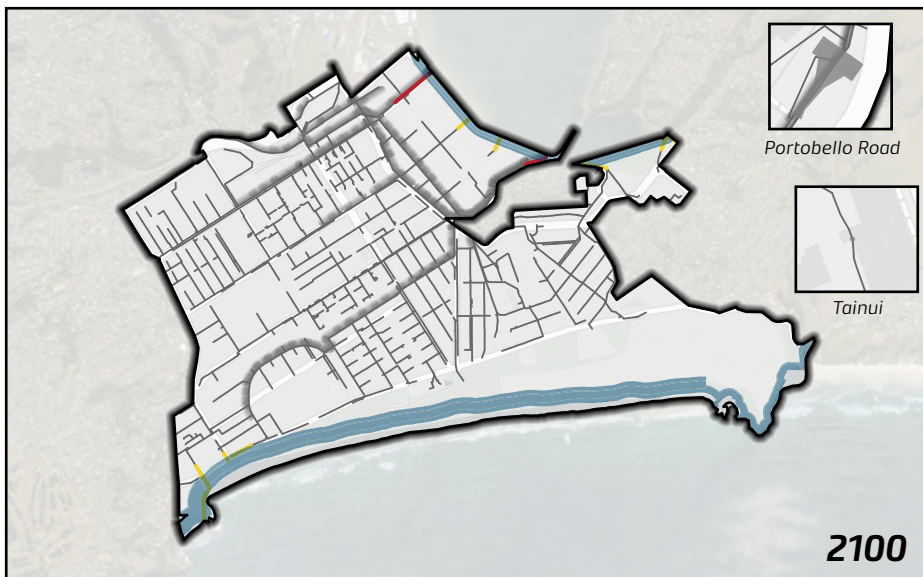
**Figure 5.34 Stormwater infrastructure risk due to coastal erosion**

**Explainer:** These maps show the risk to stormwater infrastructure due to coastal erosion, noting that there is a high level of uncertainty regarding coastal erosion risk due to data limitations at present (e.g. scale of screening study and accounting for impact of engineered structures). The maps indicate that coastal erosion risk to stormwater is confined to the Otago Harbour coastline at present day, and increases to a small number of pipes along the St Clair-St Kilda Coastline at mid-century, with higher risk of erosion at the St Clair end of the beach.

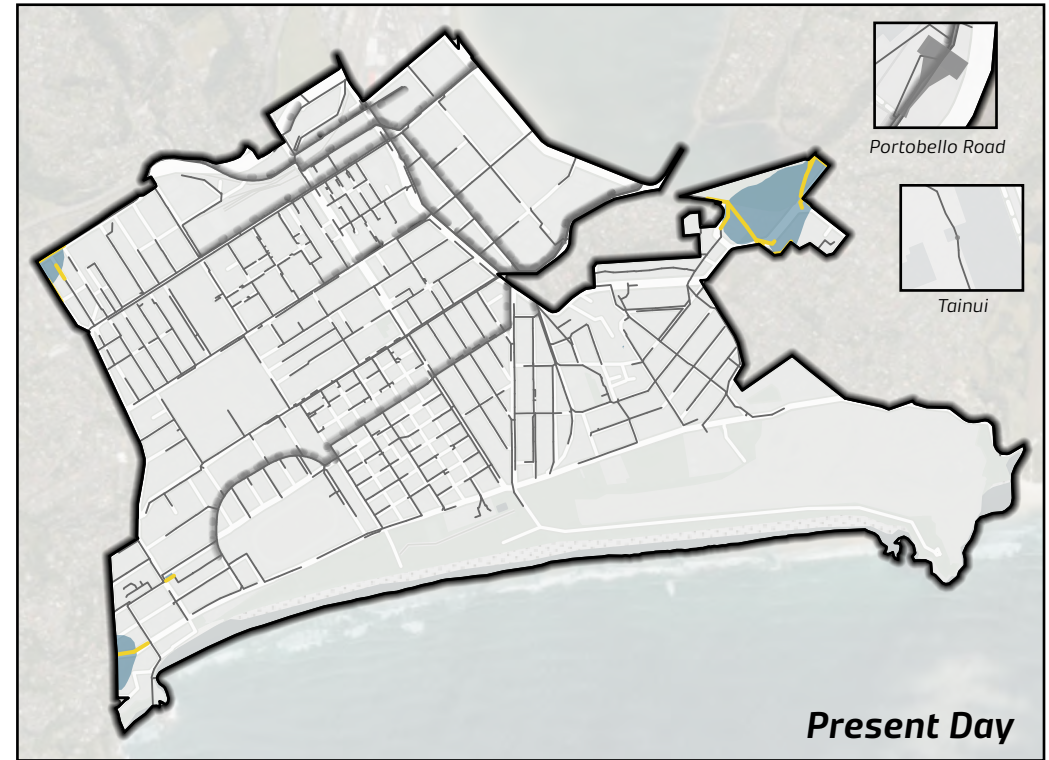
**Explainer:** These maps show the risk to stormwater infrastructure due to landslide, where some pipes at the South Dunedin boundary are rated medium risk. Risk ratings for individual stormwater pipes are based on exposure of each asset to landslides, combined with their vulnerability rating and adjusted for pipe criticality (grey shadow on pipe). Landslides can severely damage stormwater resulting in major repairs and reduction in level of service. The maps illustrate that landslide risk is confined to areas around the South Dunedin boundary. Landslide risk is not assessed at future timeframes due to the absence of spatial data that incorporates the influence of climate change (groundwater level rising or increased rainfall intensity) on landslide. **Disclaimer:** These maps are not intended to assess landslide risk at individual asset level, which requires consideration of a site specific landslide risk as well as more detailed asset information. The landslide extent is based on known landslide areas and does not account for other potential sources of landslide nor represent the extent of the area of deposition/runout.

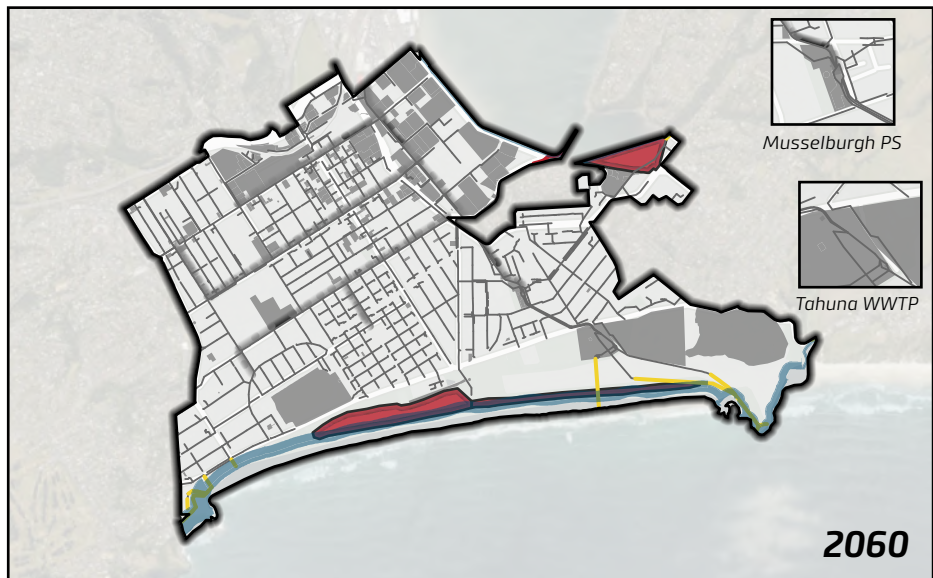
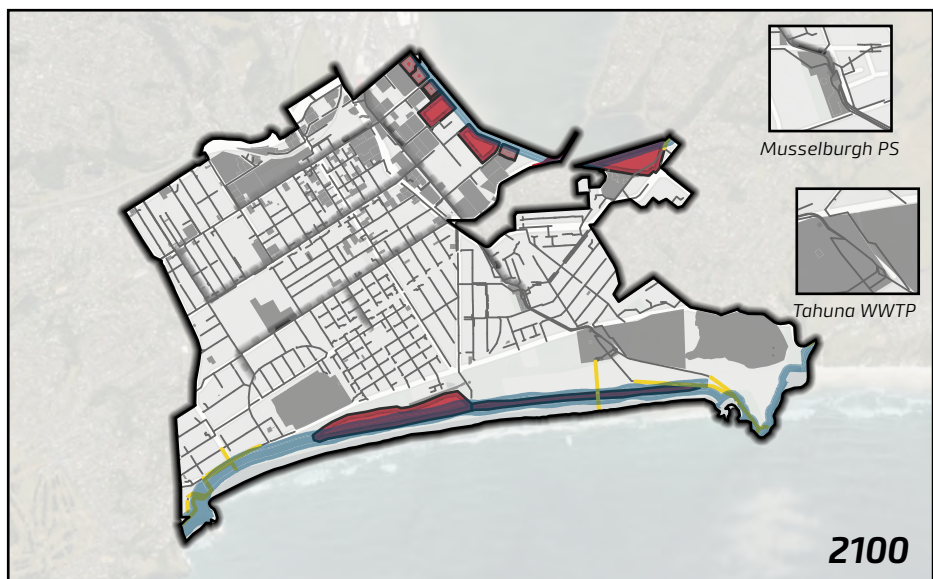
**Figure 5.40 Wastewater infrastructure and contaminated land (HAIL sites) risk due to coastal erosion**

**Explainer:** These maps show the risk to wastewater and HAIL sites due to coastal erosion (blue shading), noting that there is a high level of uncertainty regarding coastal erosion risk due to data limitations at present (e.g. scale of screening study and accounting for impact of engineered structures). The maps illustrate that coastal erosion risk to wastewater is confined to the St Clair-St Kilda coastline at all timeframes. The maps illustrate a high risk to HAIL sites located along the St Clair-St Kilda and Harbour coastlines at all timeframes.

South Dunedin Future Boundary	Coastal erosion	<b>Wastewater Pipe (Risk)</b>	<b>Structures (Risk)</b>	<b>HAIL Site (Risk)</b>
Major criticality		High	High	High
		Medium	Medium	Medium
		Low	Low	Low
		Not exposed to scenarios assessed	Not exposed to scenarios assessed	Not exposed to scenarios assessed

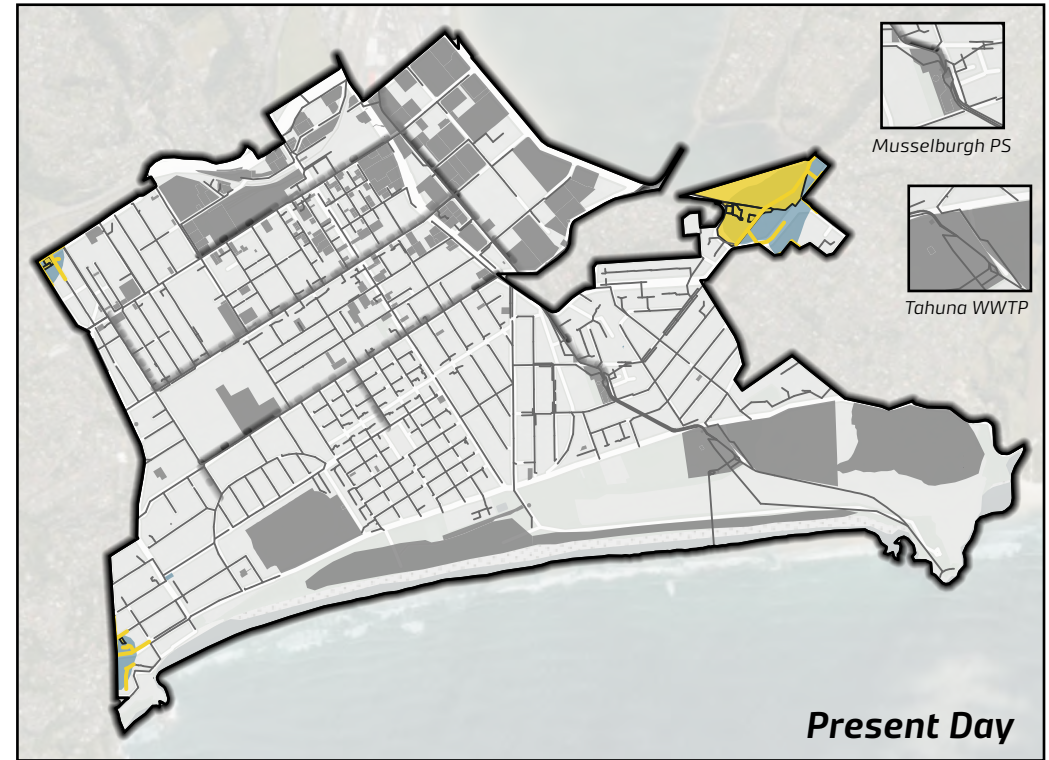
**Explainer:** These maps show the risk to wastewater infrastructure and HAIL sites due to landslide. Risk ratings for individual wastewater pipes are based on exposure of each asset to landslides, combined with their vulnerability rating and adjusted for pipe criticality (grey shadow on pipe). Landslides can severely damage wastewater resulting in sudden collapse or failure and posing a potential risk to life in critical assets. The maps illustrate that some pipes and HAIL sites at the South Dunedin boundary are rated medium risk. Landslide risk is not assessed at future timeframes due to the absence of spatial data that incorporates the influence of climate change (groundwater level rising or increased rainfall intensity) on landslide.
