Project Number: 6-CO082.00

Mount Cooee Landfill Development Plan and Resource Recovery Centre Geotechnical Interpretive Report

27 April 2023

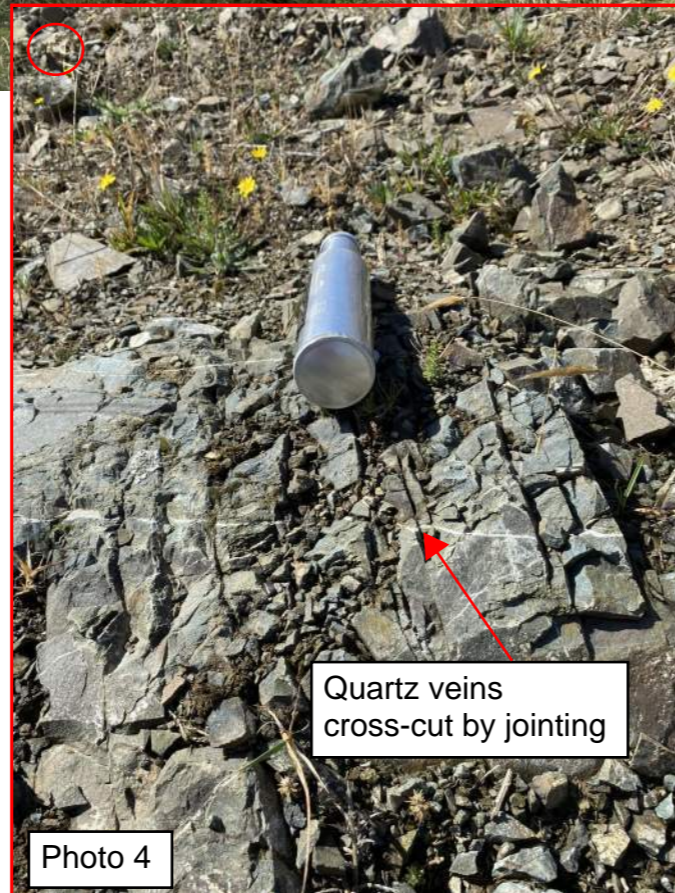
Photo 4

Quartz veins cross-cut by jointing

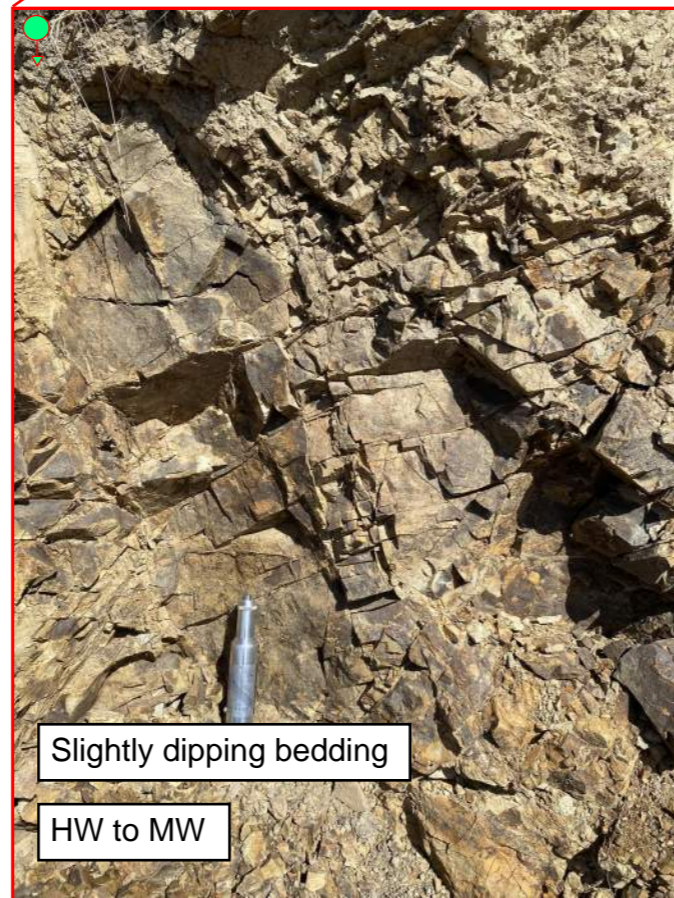
Slightly dipping bedding

HW to MW

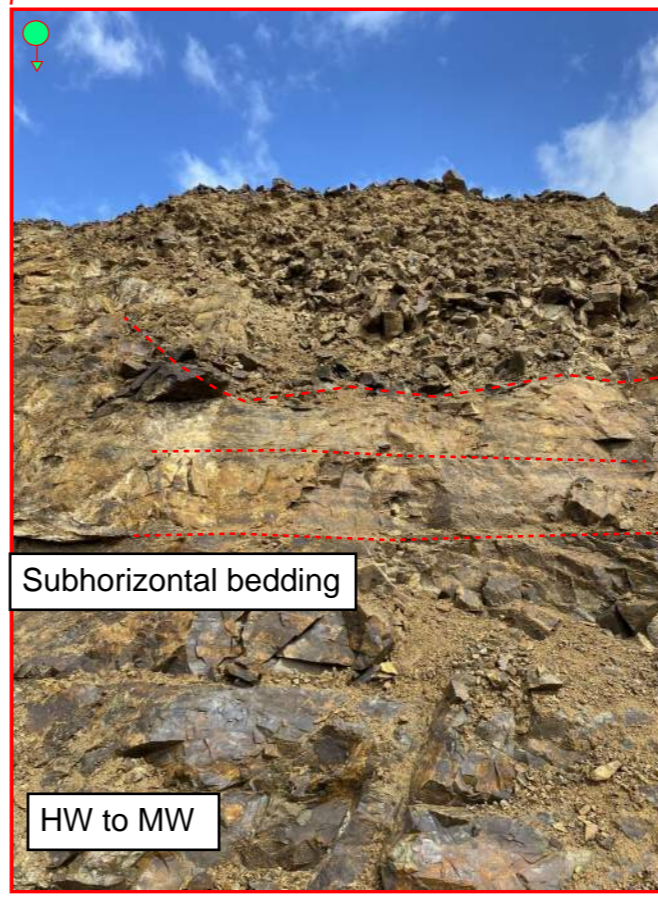
Subhorizontal bedding

HW to MW

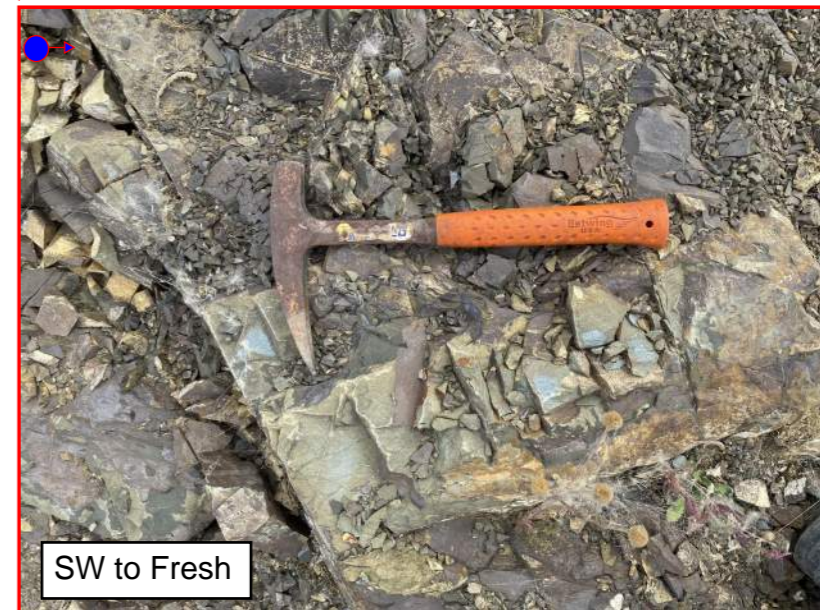
SW to Fresh
